## 7 Summary of Actual Manipulation Results

Results of manipulation such as implementing Isolation Condenser System, Reactor Core Isolation Cooling System, Primary Containment Venting System and Alternative Water Injection etc at the power station after the earthquake show at the chart 7.1(1) ~ (5). Manipulation results are summarized based on confirmed exchanged information between the Headquarter and the power station, and operator task journal etc. Hereafter, it is possible that as per detailed analyses of other parameters and clear attestation by persons involved, clarification of facts advances more and we may find information related to the movement of equipment, which is not confirmed at this report. In that case, we would like to announce that facts in each case.

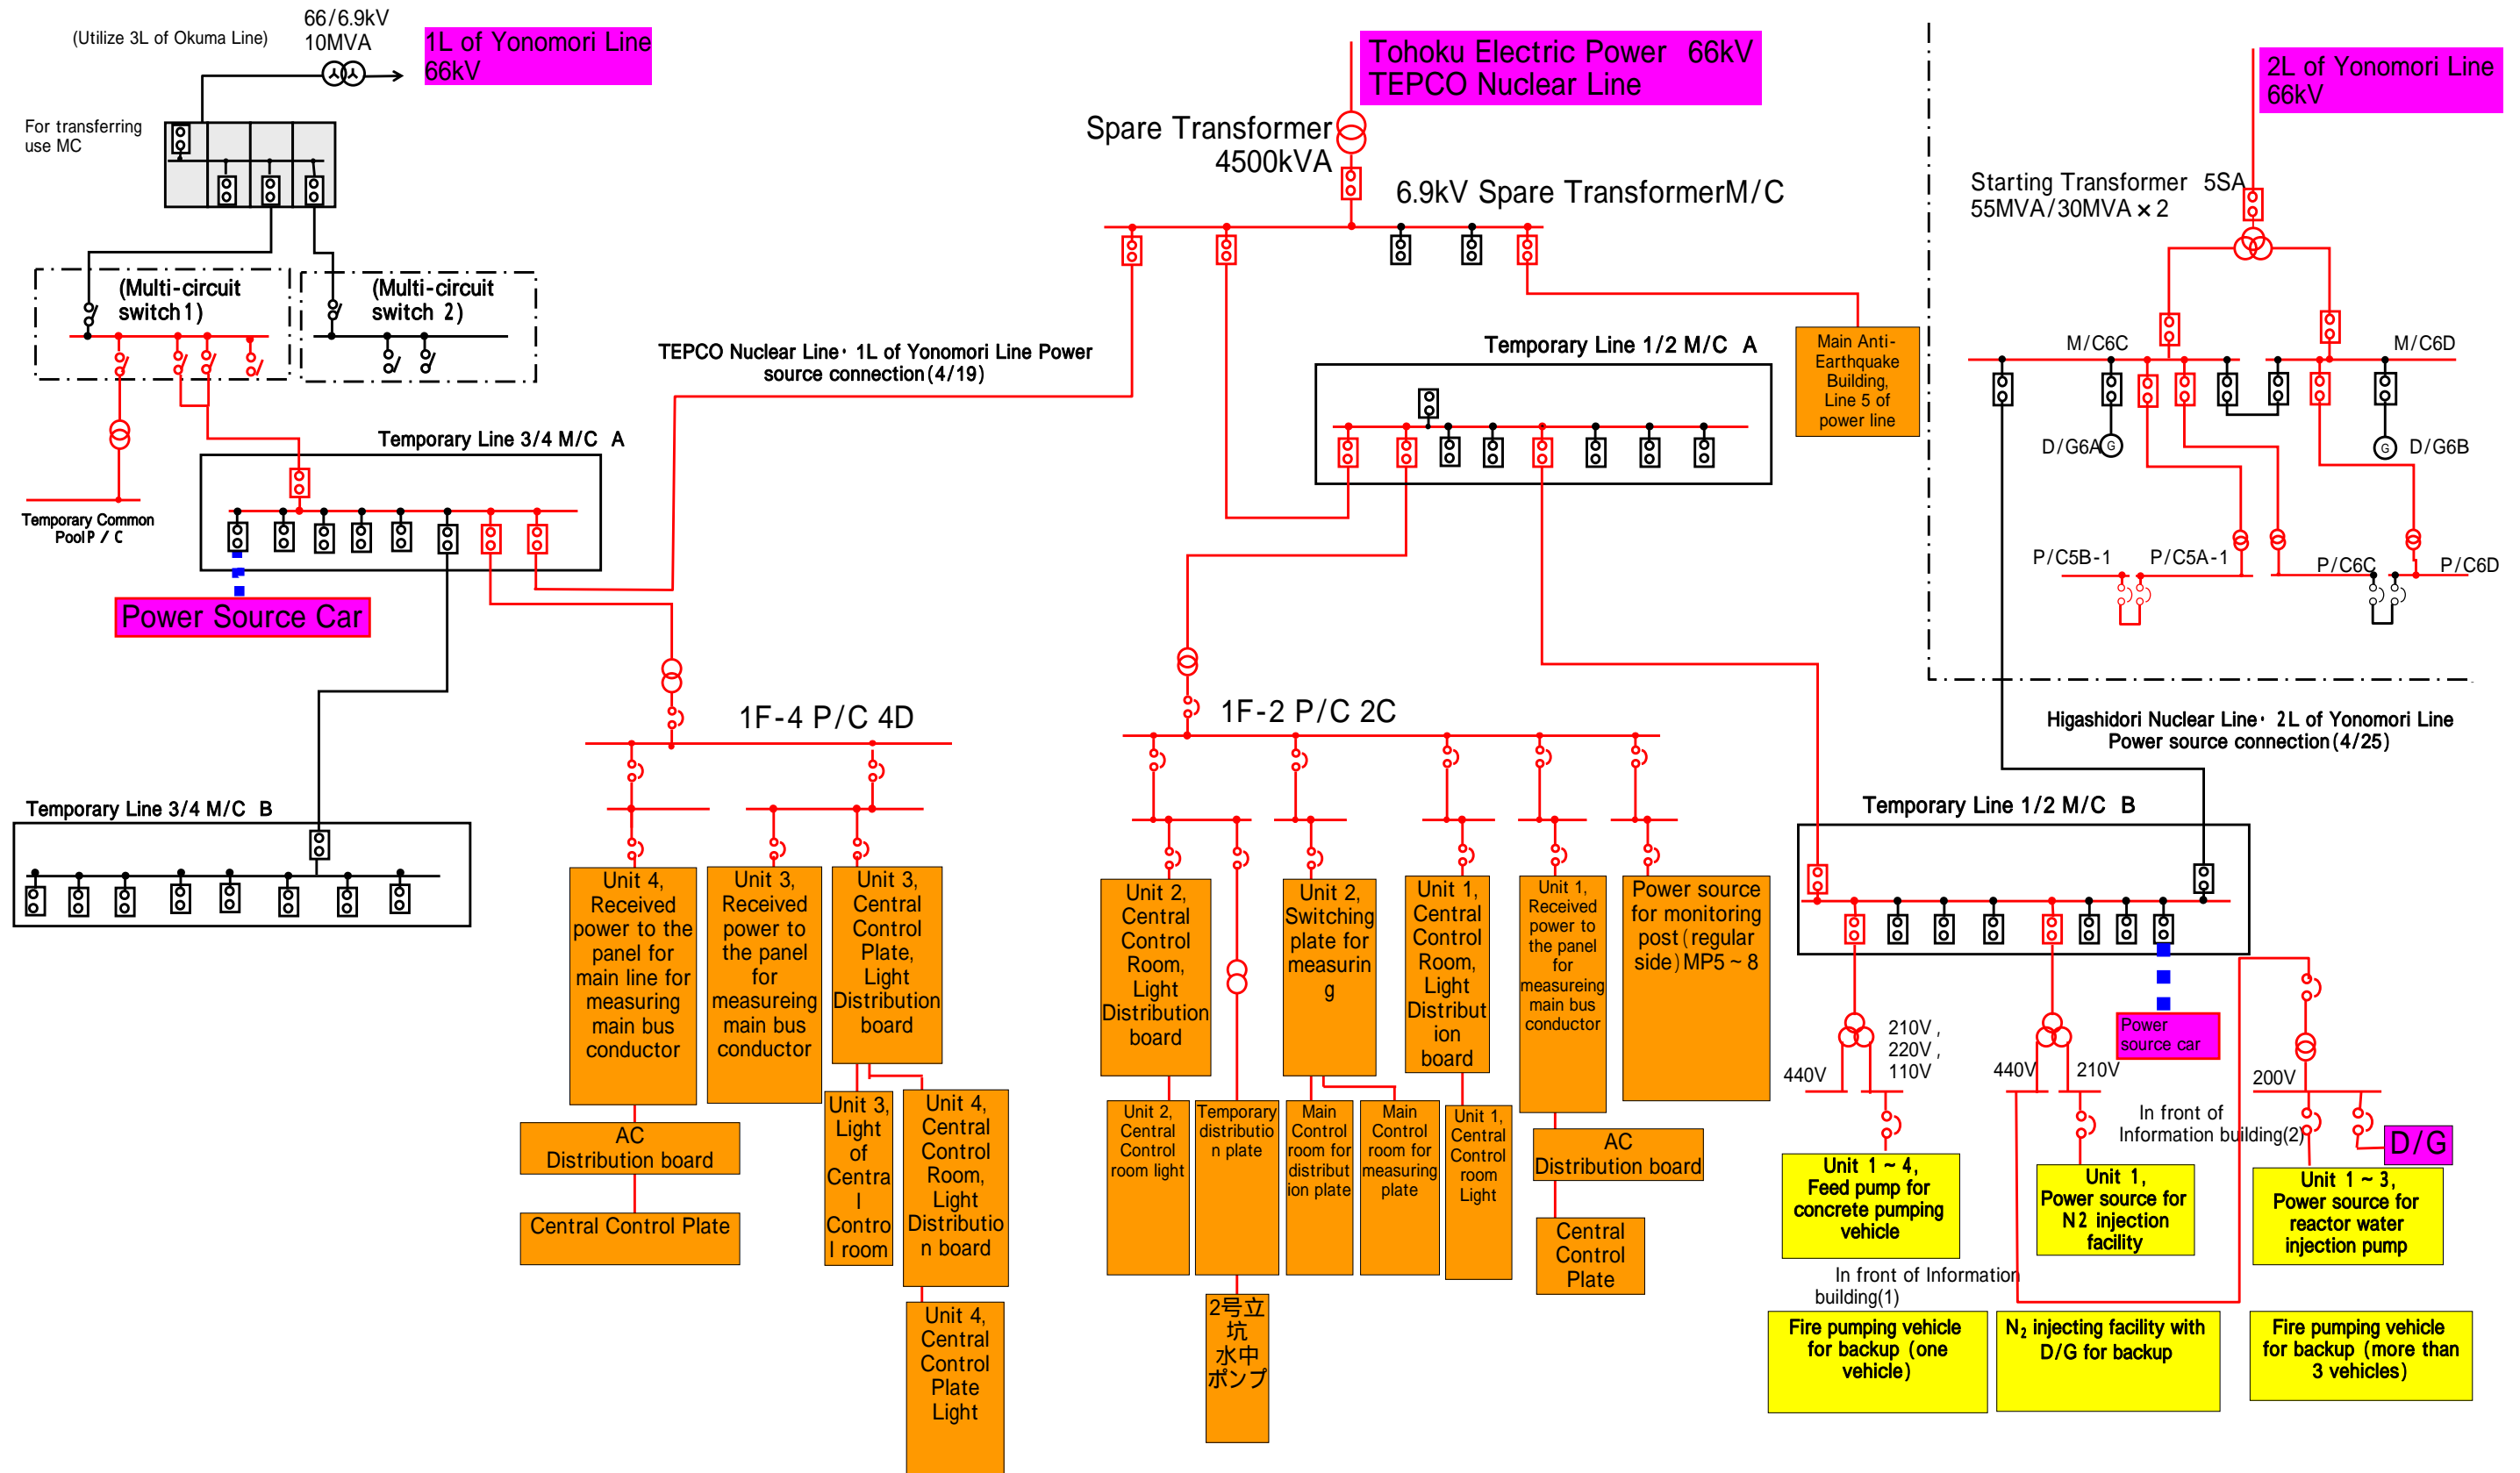
# Fukushima Nuclear Power Station 1 ~ 4, Single Wire Circuit Diagram, Temporary Power

1F1	1F2	1F3	1F4	1F5	1F6	Common pool Centralized RW
NPS")		<p>tripped due to external power shutdown of 1/2u (Toden Genshiryoku line of Tohoku Electric) by earthquake.</p> <ul style="list-style-type: none"><li>■ 4/11 17:56 1/2u external power (Toden Genshiryoku line of Tohoku Electric) restored.</li><li>■ 4/11 18:04 Reactor water injection pump of 1u to 3u restarted.</li></ul> <p>(Current power condition, as of 4/26, will be shown in "single-line diagram of Unit 1 to 4 of Fukushima Daiichi NPS")</p>
