## Main works and steps for the decommissioning

## I. Confirmation of the reactor conditions

## II. Progress status by each plan

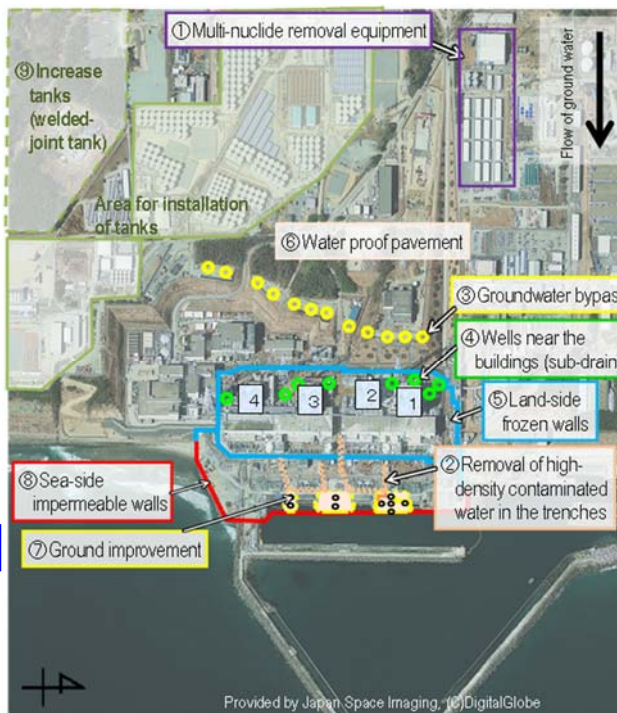
Contaminated water countermeasures are implemented with the following three principles:

### 1. Eliminate contamination sources

- Multi-nuclide removal equipment
- Remove contaminated water in the trench

### 2. Isolate water from contamination

- Pump up ground water for bypassing
- Pump up ground water near buildings
- Land-side frozen walls
- Waterproof pavement

### 3. Prevent leakage of contaminated water

- Soil improvement by sodium silicate
- Sea-side impermeable walls
- Increase tanks (welded-joint tanks)

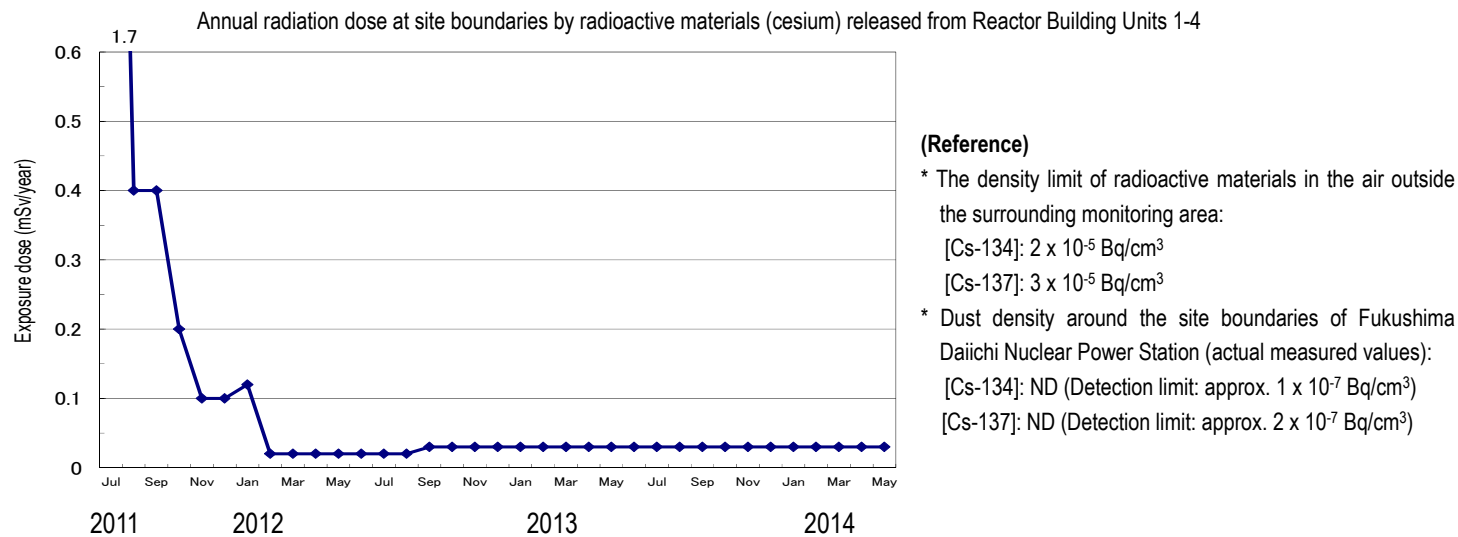
The density of radioactive materials newly released from Reactor Building Units 1-4 in the air measured at site boundaries was evaluated at approx.  $1.3 \times 10^{-9}$  Bq/cm<sup>3</sup> for both Cs-134 and -137. The radiation exposure dose due to the release of radioactive materials was 0.03 mSv/year (equivalent to approx. 1/70 of the annual radiation dose by natural radiation (annual average in Japan: approx. 2.1 mSv/year)) at the site boundaries.

(Note) Different formulas and coefficients were used to evaluate the radiation dose in the facility operation plan and monthly report. The evaluation methods were integrated in September 2012. As the fuel removal from the spent fuel pool (SFP) commenced for Unit 4, the radiation exposure dose from Unit 4 was added to the items subject to evaluation since November 2013.

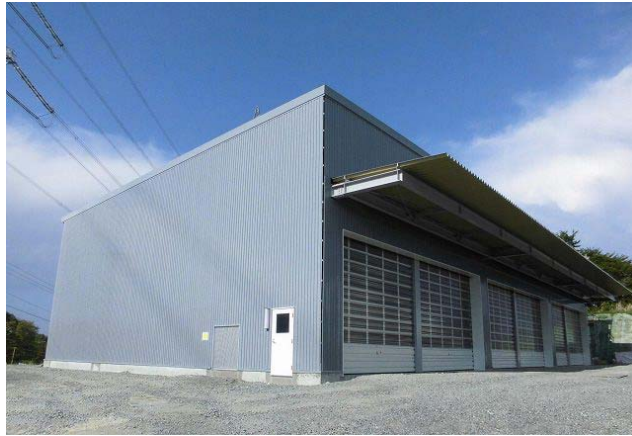
Figure 8: External appearance of the vehicle maintenance site

- To maintain vehicles used within the site, a vehicle maintenance site was established (operation will commence from June 1) (see Figure 8).
- Aiming to improve and enhance workers' diets, a Fukushima meal service center capable of serving 3,000 meals will be built in the Ohgawara district of Ohkuma town by the end of fiscal 2014. On May 29, a groundbreaking ceremony for the center was held (see Figure 9).

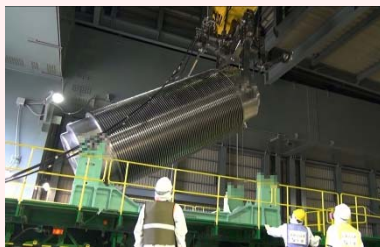
Fuel removal status

Loading the transportation container onto the trailer

Fuel removal from Unit 4 SFP has been underway since Nov. 18, 2013. The work at Unit 4 will be accomplished around the end of 2014.

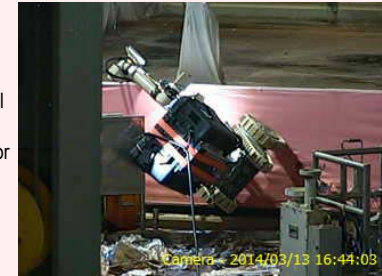
Status of remote-control robot falling down

- To investigate the contamination status of the Reactor Building 5th floor, investigative equipment (gamma camera, radiation dose gauge, optical camera) will be suspended through holes drilled in the building roof. In addition, core samples on the 5th floor are collected using a remote-control robot.
- To ensure the operation route of the robot used to collect floor core samples, fences on the operating floor<sup>(6)</sup> were removed using the remote-control robot (March 13 and 14).
- As the robot fell while in operation and the battery became low, the robot could not be collected. Removal of fences was completed and the core was collected within the accessible range (from March 20-26).

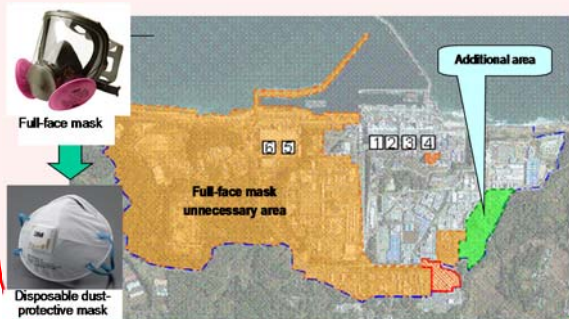
Full-face mask unnecessary area

In the J tank installation area on the south side on the site of the site, as decontamination was completed, the area will be set as full-face mask unnecessary area (from May 30), where for works not handling contaminated water, wearing disposable dust-protective masks will be deemed sufficient.

Operation based on the rules for mask wearing according to radioactive material density in air and decontamination/ ionization rules was defined, and the area is being expanded.

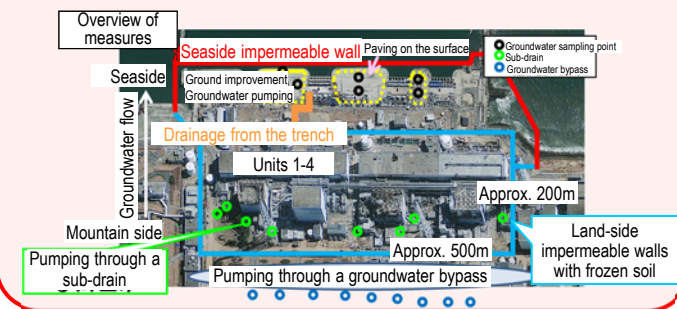
- Removing contaminated water in branch trenches and closing them (completed on September 19, 2013)
    - Treatment and removal of contaminated water in the main trench

- Unit 2: Treatment commenced on November 14, 2013, freezing toward water stoppage commenced on April 2
      - Unit 3: Treatment commenced on November 15, 2013
