Main works and steps for the decommissioning

Progress status

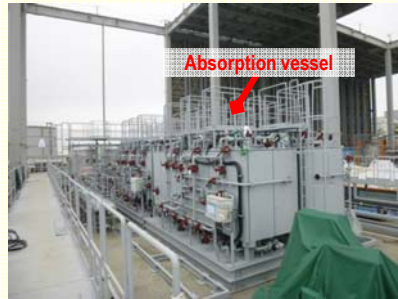
<Installation status of additional multi-nuclide removal equipment>

Regarding multi-nuclide removal equipment (ALPS), 3-system operation has been maintained except for planned suspension from late June. Regarding the additional multi-nuclide removal equipment, test operation using high-density contaminated water will begin from mid-September. Regarding high-performance multi-nuclide removal equipment, similar test operation will begin from October. Work to verify the performance of the high-performance absorbent also began using the equipment for the verification test from August 20.

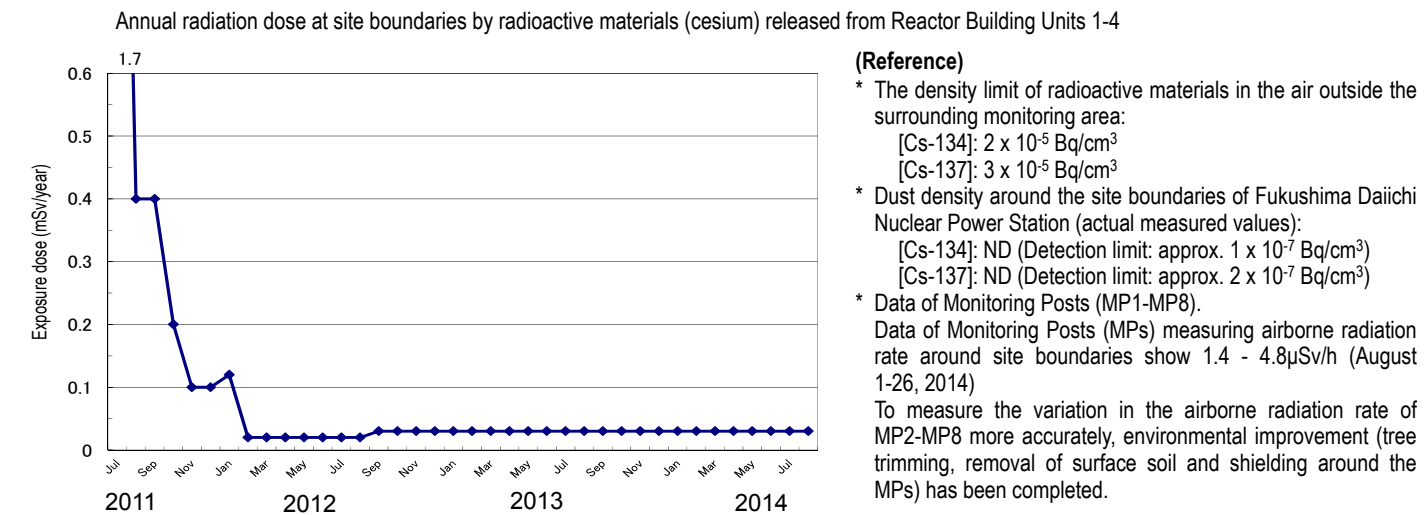
The density of radioactive materials newly released from Reactor Building Units 1-4 in the air measured at site boundaries was evaluated at approx. 1.3×10^{-9} Bq/cm³ for both Cs-134 and -137. The radiation exposure dose due to the release of radioactive materials was 0.03 mSv/year (equivalent to approx. 1/70 of the annual radiation dose by natural radiation (annual average in Japan: approx. 2.1 mSv/year)) at the site boundaries.

Note: Different formulas and coefficients were used to evaluate the radiation dose in the facility operation plan and monthly report. The evaluation methods were integrated in September 2012. As the fuel removal from the spent fuel pool (SFP) commenced for Unit 4, the radiation exposure dose from Unit 4 was added to the items subject to evaluation since November 2013.

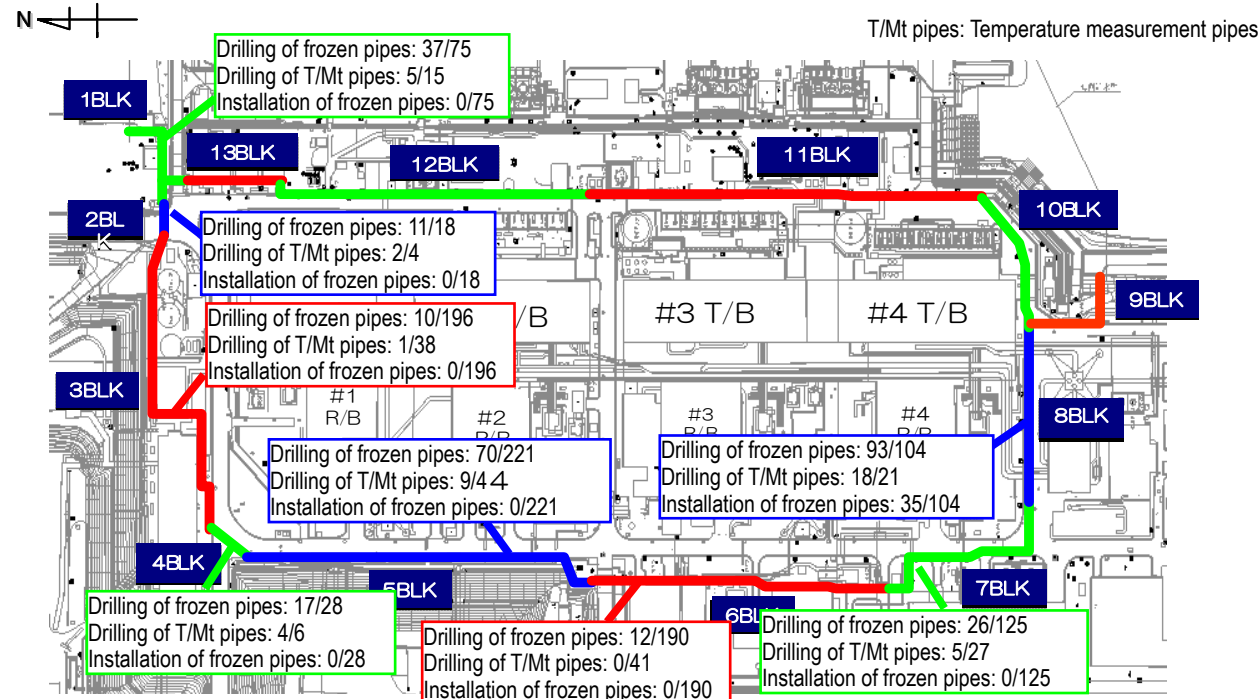
Figure 2: Status of drilling for frozen-soil impermeable walls and installation of frozen pipes

- To facilitate the installation of frozen-soil impermeable walls surrounding Units 1-4 (a subsidy project of the Ministry of Economy, Trade and Industry), drilling to place frozen pipes commenced (from June 2). As of August 27, drilling at 320 points (for frozen pipes: 276 of 1,545 points, for temperature-measurement pipes: 44 of 315 points) and installation of frozen pipes at 35 of 1,545 points had been completed (see Figure 2).

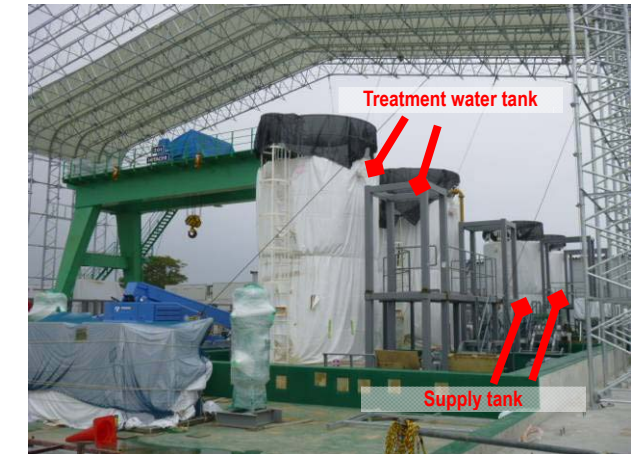
Figure 4: Installation status of high-performance multi-nuclide removal equipment

- Regarding the high-performance multi-nuclide removal equipment, a subsidy project of the Ministry of Economy, Trade and Industry, foundation construction (from May 10) and installation of equipment (from July 14) are underway

(see Figure 4). Prior to the hot test beginning in October, a verification test to check removal performance and replacement cycle of the high-performance absorbent, the verification test is underway using the equipment installed for the test (from August 20).

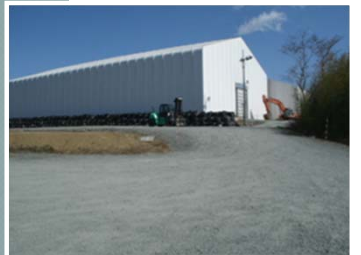
Rubble (container storage)

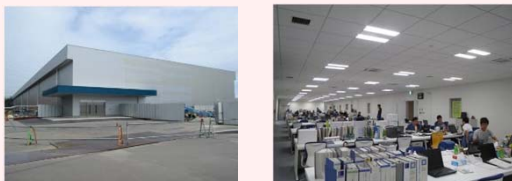
To share information with the field and expedite the response to issues, a New Administrative Office Building is under construction on the site of Fukushima Daiichi Nuclear Power Station.

External and internal appearances of the New Administrative Office Building

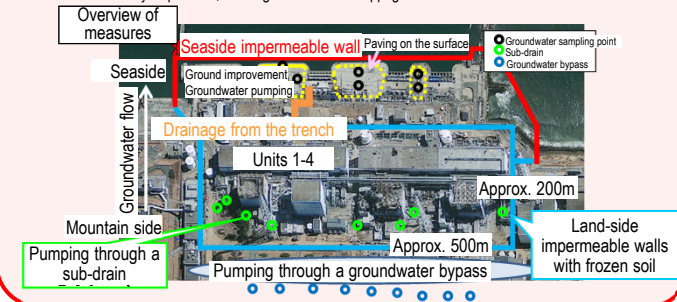
- Removing contaminated water in branch trenches and closing them (completed on September 19, 2013)
 - Treatment and removal of contaminated water in the seawater pipe trench

- Unit 2: November 14, 2013 – April 25, 2014, treatment of cesium and strontium. Freezing toward water stoppage commenced on April 2.
 - Unit 3: November 15, 2013 – July 28, 2014, treatment of cesium. From early September, freezing toward water stoppage will commence
