## Main works and steps for decommissioning

## Progress status

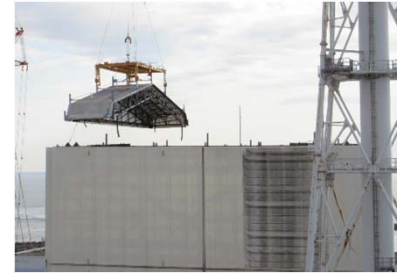
(Dismantling of the Unit 1 building cover)

Toward fuel removal from Unit 1 SFP, the building cover is being dismantled.

Dismantling of the building cover started in July 2015. The dismantling is being conducted steadily with anti-scattering measures fully implemented and radioactive materials monitored..

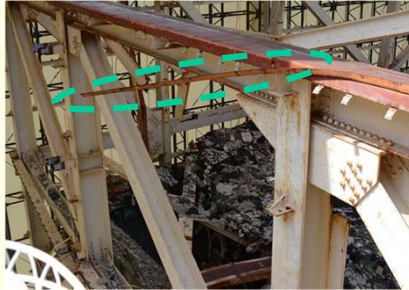
<Example of interfering steel frames to be removed>

To facilitate rubble removal from the top of Unit 1 Reactor Building (R/B), removal of roof panels from the building cover started on July 28 and all panels had been removed by October 5.

Following the removal, after regular spraying of anti-scattering agents and investigation into the status of rubble, removal of interfering steel frames will start for installing sprinklers as anti-scattering measures.

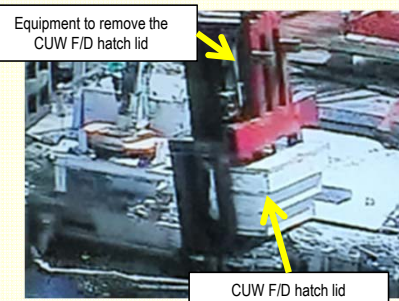
<Removal of CUW F/D hatch lid>

On October 15, the hatch lid of the Reactor Water Clean-up System filtering desalination device (CUW F/D)<sup>(Note)</sup>, a large piece of rubble inside the Unit 3 spent fuel pool, was removed, marking the removal of all large rubble on the fuel rack.

After the removal, among four spent fuel assemblies located under the hatch lid, a slight distortion of fuel handles was detected in two fuel assemblies. Treatment of these assemblies will be considered.

(Note): CUW F/D hatch lid is fix approx. 2.6t of underwater a concrete structure of approx. 1m x 1m x 2m

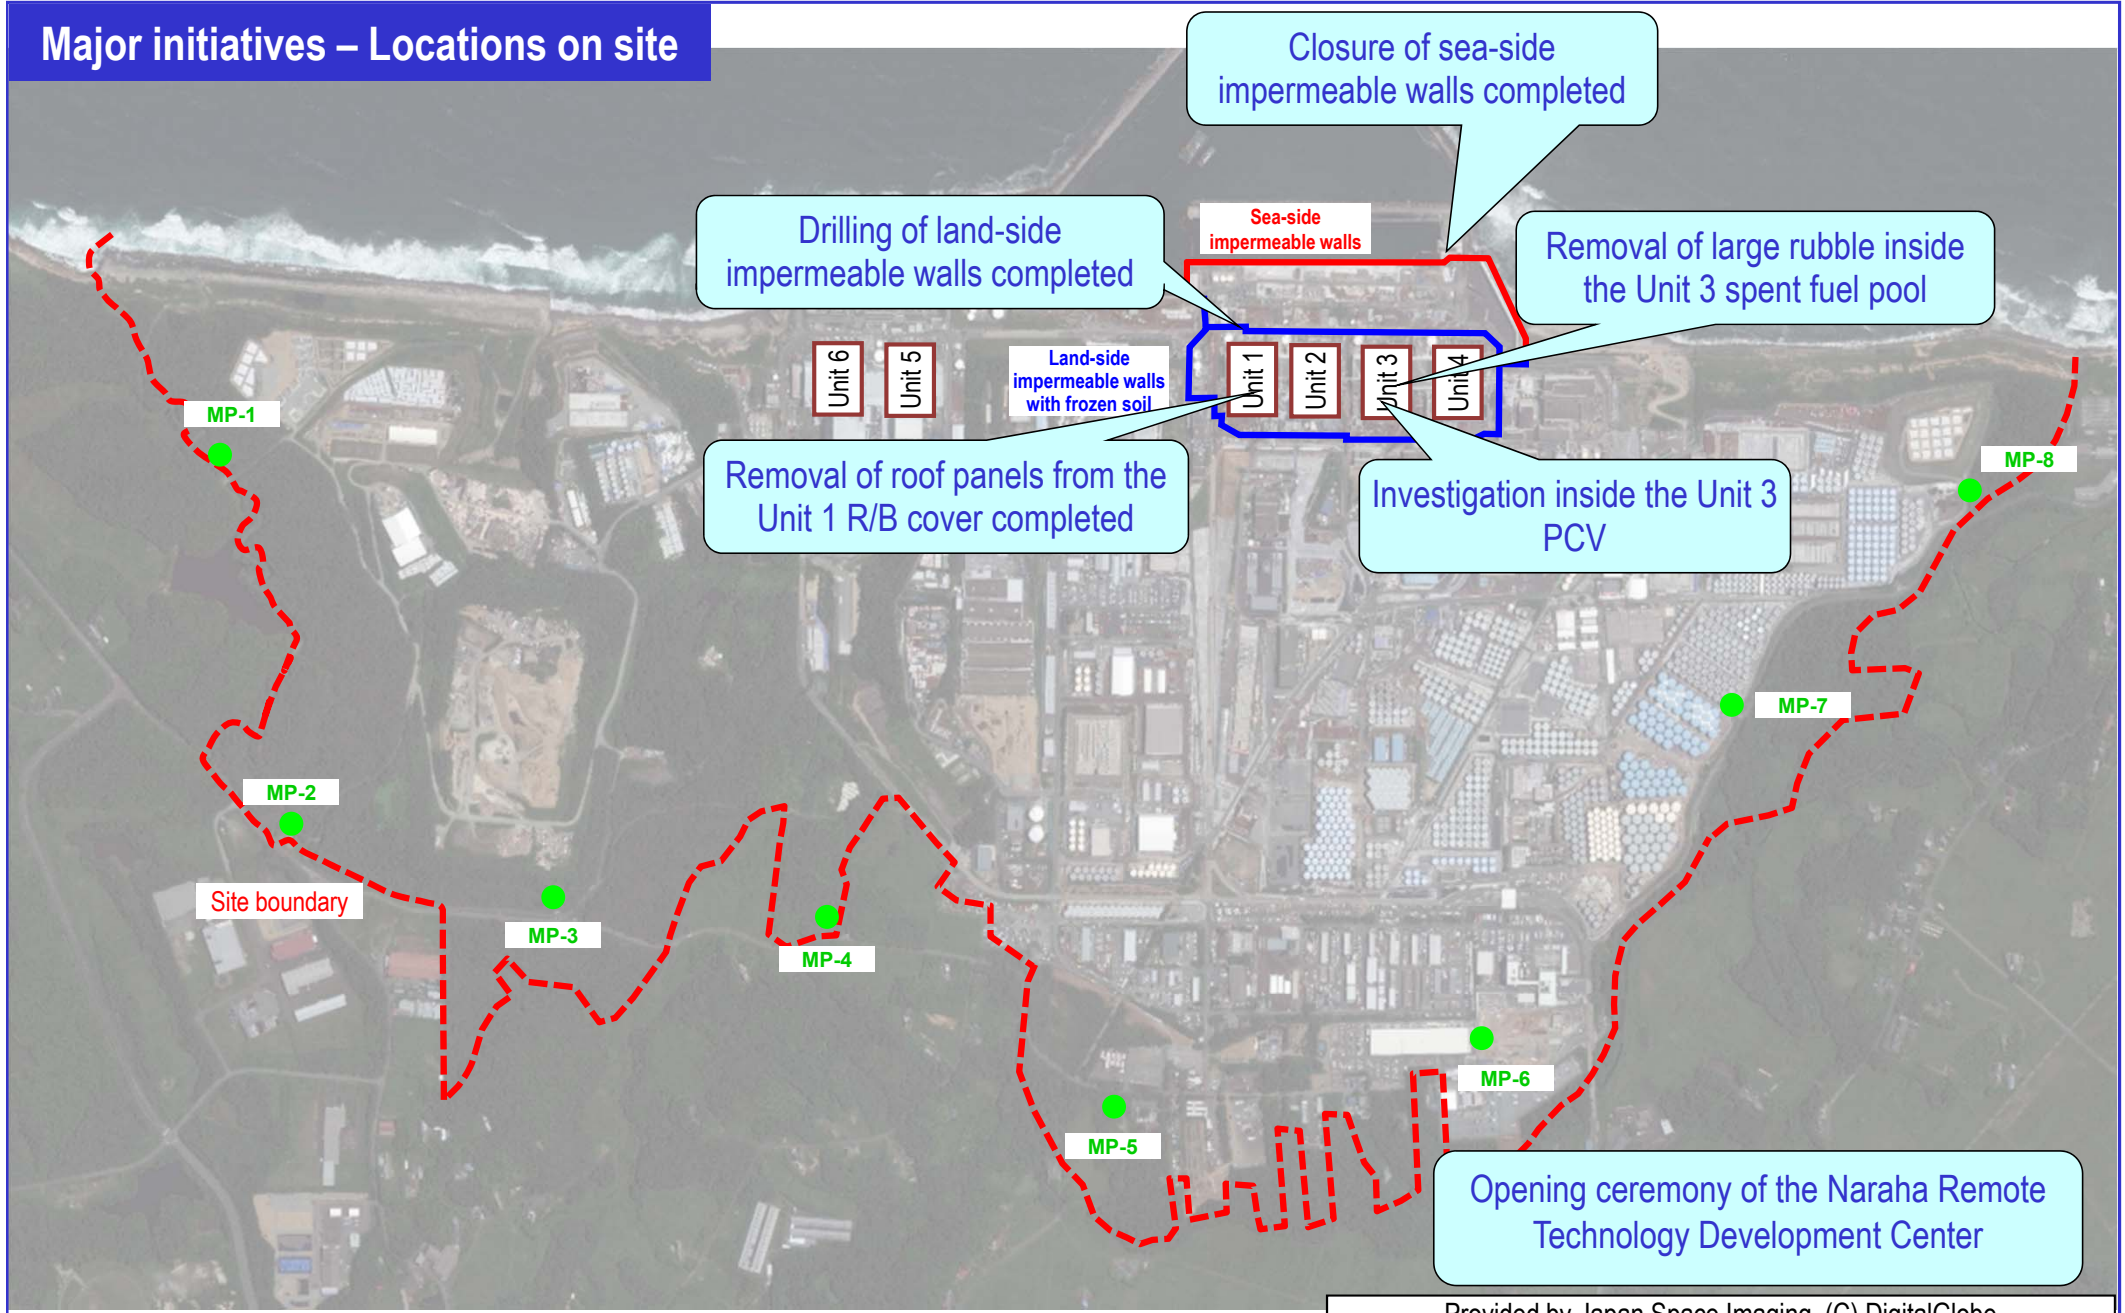
## Major initiatives – Locations on site

\* Data of Monitoring Posts (MP1-MP8.)

We improved the measurement conditions of monitoring posts 2 to 8 for precise measurement of air dose rate. Construction works such as tree-clearing, surface soil removal and shield wall setting were implemented from Feb. 10 to Apr. 18, 2012.
