Main decommissioning works and steps

Progress Status and Future Challenges of the Mid- and Long-Term Roadmap toward Decommissioning of TEPCO Holdings' Fukushima Daiichi Nuclear Power Station Units 1-4 (Outline)

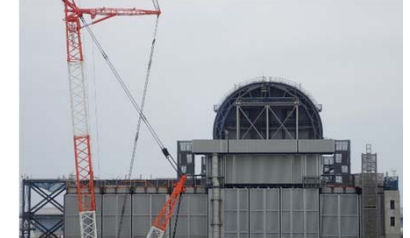
Installation of a cover for fuel removal at Unit 3 (August 28, 2017)

To prepare for fuel removal from Unit 3 SFP, works to install the cover are underway.

As dose reduction measures on the Reactor Building operating floor, the decontamination and installation of shields were completed in June and December 2016 respectively. Installation of a cover for fuel removal started from January 2017.

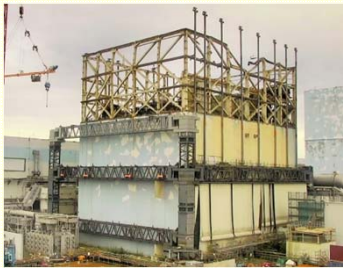
Unit 1 building cover
<Installation of north-side pillars and beams>
(photo from the northwest side on August 31)

The removal of the pillars and beams of the building cover started from March 31, 2017 and was completed on May 11.

Work to install windbreak fences, which will reduce the dust scattering during rubble removal, is underway. Pillars and beams on the north side, for which modification was completed, were installed during the period August 29-31. Installation will continue sequentially.

- The removal of pillars and beams of the building cover started from March 31, 2017 and was completed on May 11. Work to install windbreak fences, which will reduce dust scattering during rubble removal, is underway. Modified pillars and beams were installed during the period August 29-31 and installation will continue sequentially.
- Toward formulating a work plan for rubble removal, the rubble status and dose rate measurement on the well plug were additionally investigated during the period May 22 – August 25 to identify the conditions around the well plug.

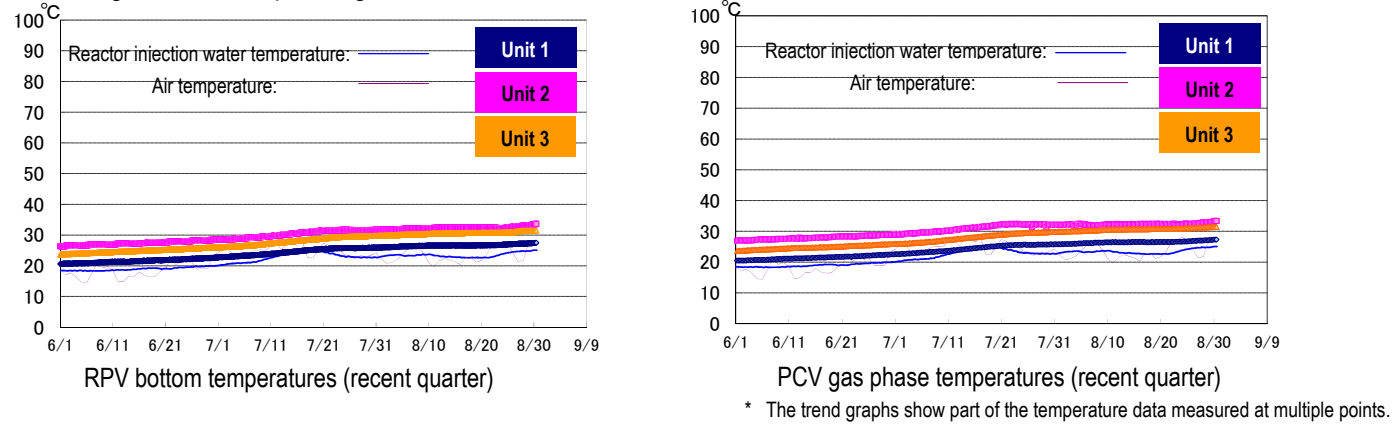
Through continuous reactor cooling by water injection, the temperatures of the Reactor Pressure Vessel (RPV) bottom and the Primary Containment Vessel (PCV) gas phase were maintained within the range of approx. 25 to 35°C for the past month, though it varied depending on the unit and location of the thermometer.

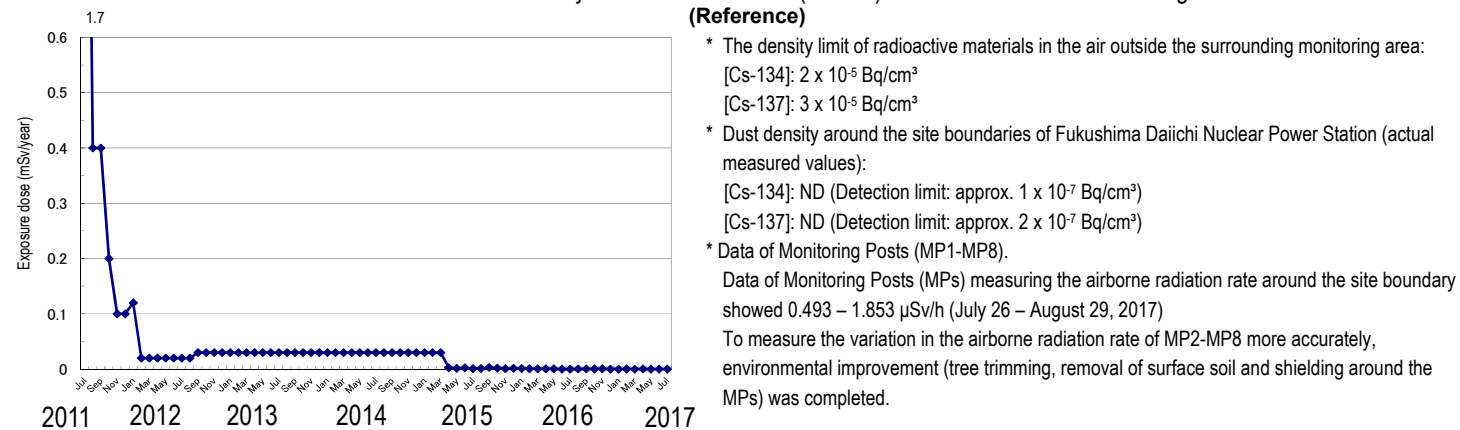
As of July 2017, the density of radioactive materials newly released from Reactor Building Units 1-4 in the air and measured at the site boundary was evaluated at approx. 1.3×10^{-12} Bq/cm³ for Cs-134 and 3.4×10^{-12} Bq/cm³ for Cs-137, while the radiation exposure dose due to the release of radioactive materials there was less than 0.00021 mSv/year.

Annual radiation dose at site boundaries by radioactive materials (cesium) released from Reactor Building Units 1-4

Note: Different formulas and coefficients were used to evaluate the radiation dose in the facility operation plan and monthly report. The evaluation methods were integrated in September 2012. As the fuel removal from the spent fuel pool (SFP) commenced for Unit 4, the radiation exposure dose from Unit 4 was added to the items subject to evaluation since November 2013. The evaluation has been changed to a method considering the values of continuous dust monitors since FY2015, with data to be evaluated monthly and announced the following month.

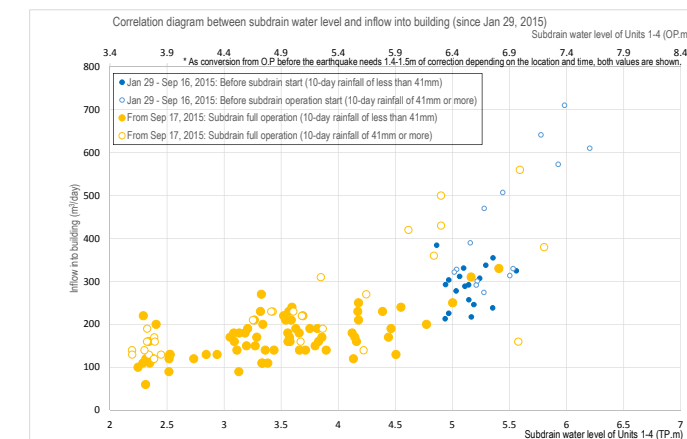
- Since the subdrains went into operation, the inflow into buildings tended to decline to below 150 m³/day when the subdrain water level declined below T.P. 3.0 m, while the inflow increased during rainfall.

Figure 1: Correlation between inflow such as groundwater and rainwater into buildings and the water level of Unit 1-4 subdrains

- On August 2, the water level at Subdrain Pit No. 51 southwest of the Unit 4 Reactor Building temporarily declined below the water level of the building. The radioactive material density in the groundwater near the pit remained within the past scope and no influence on the water level decline was identified. As the decline was considered attributable to the effect of drilling around the pit, the work method was changed to drilling with water filled in the subject place. Any potential inversion of the water level between the building and groundwater will be promptly notified and measures taken to correct the judgement, notification and announcement based on this incident.

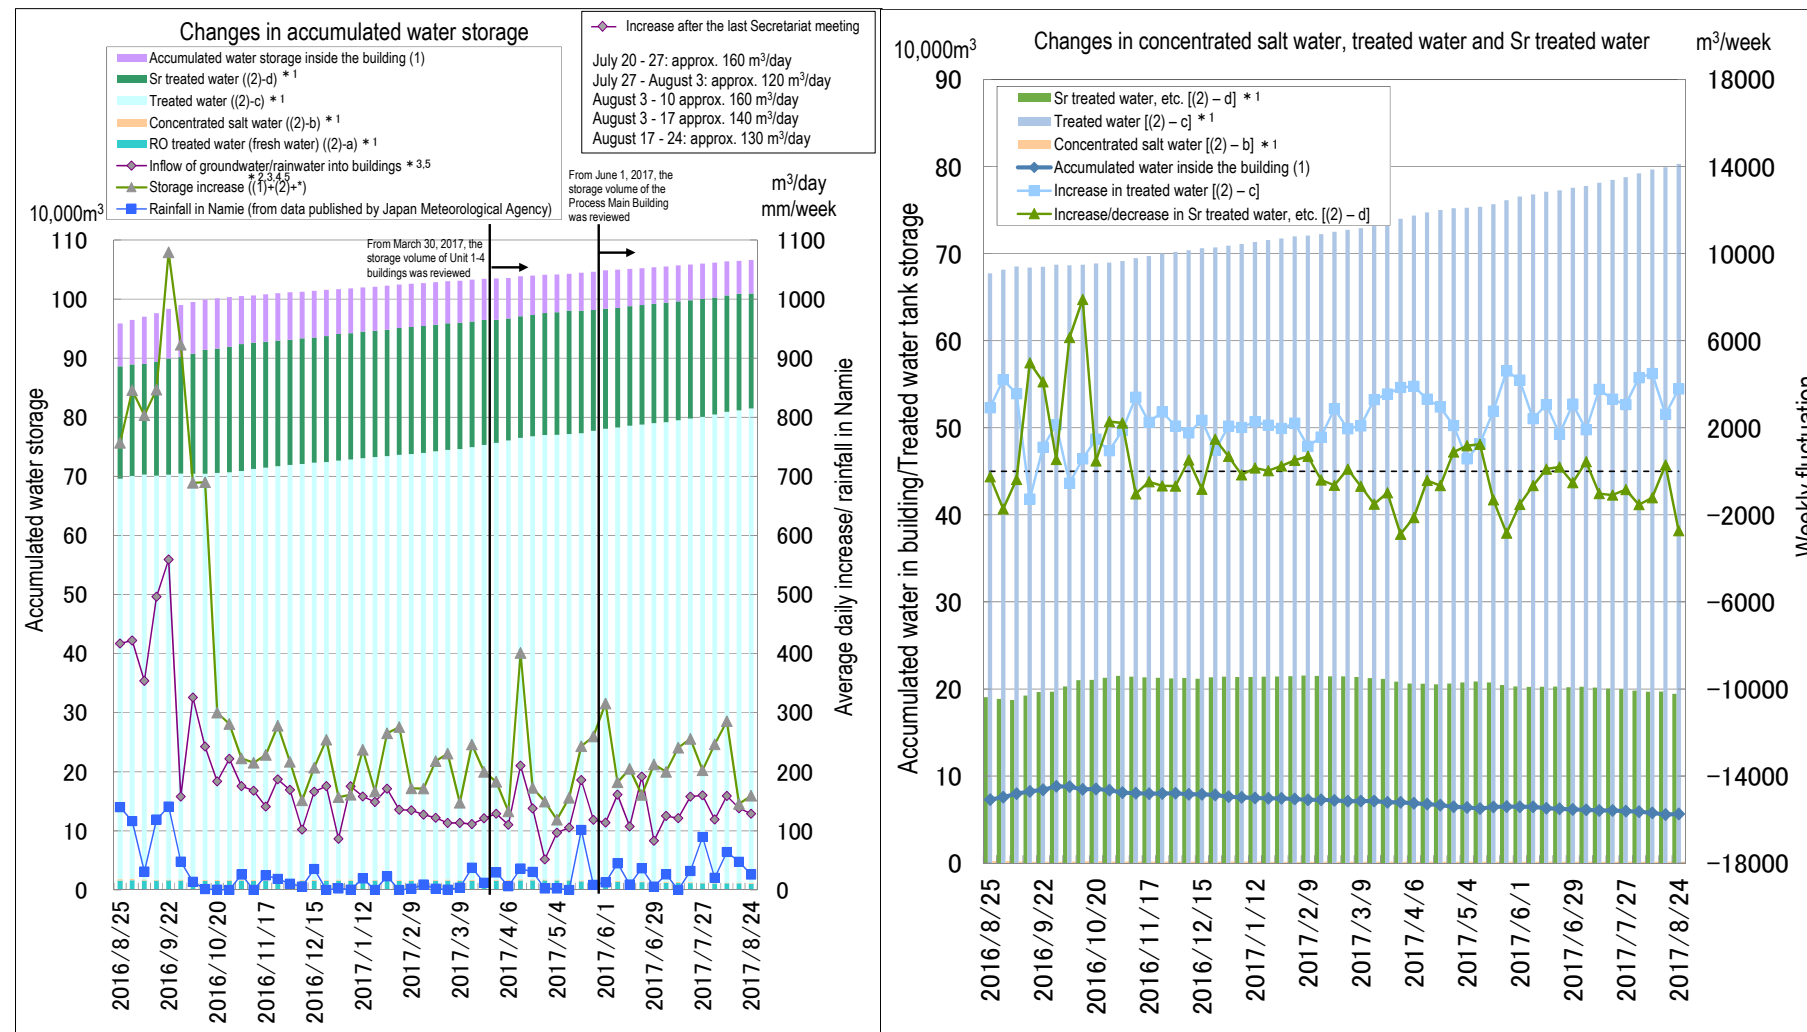
Figure 3: Status of accumulated water storage

As of August 24, 2017

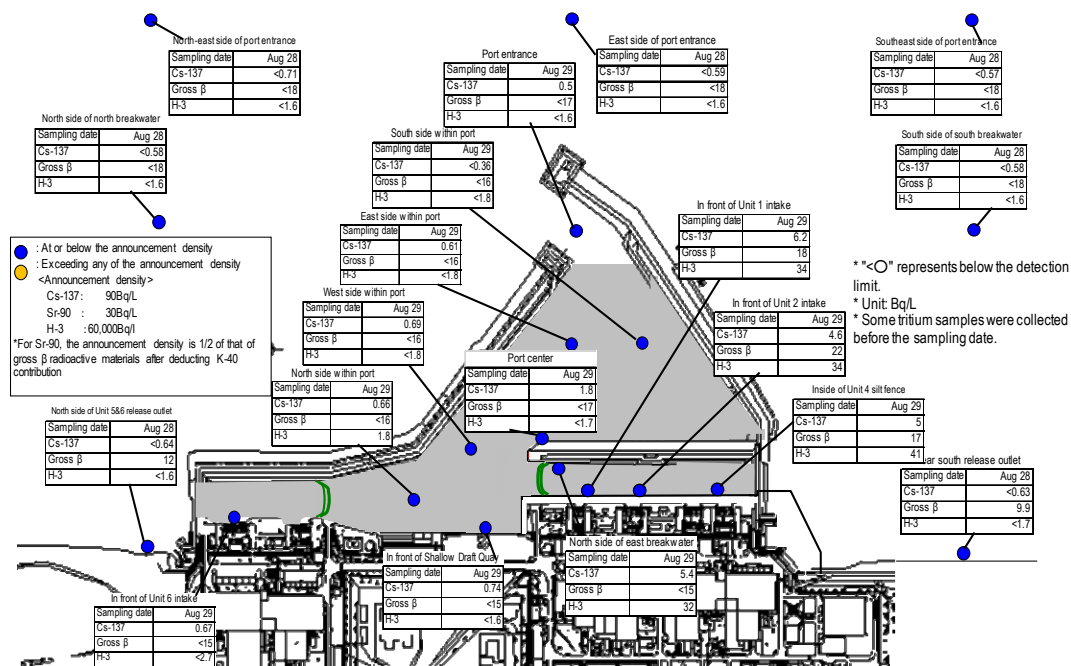
Figure 5: Seawater density around the port

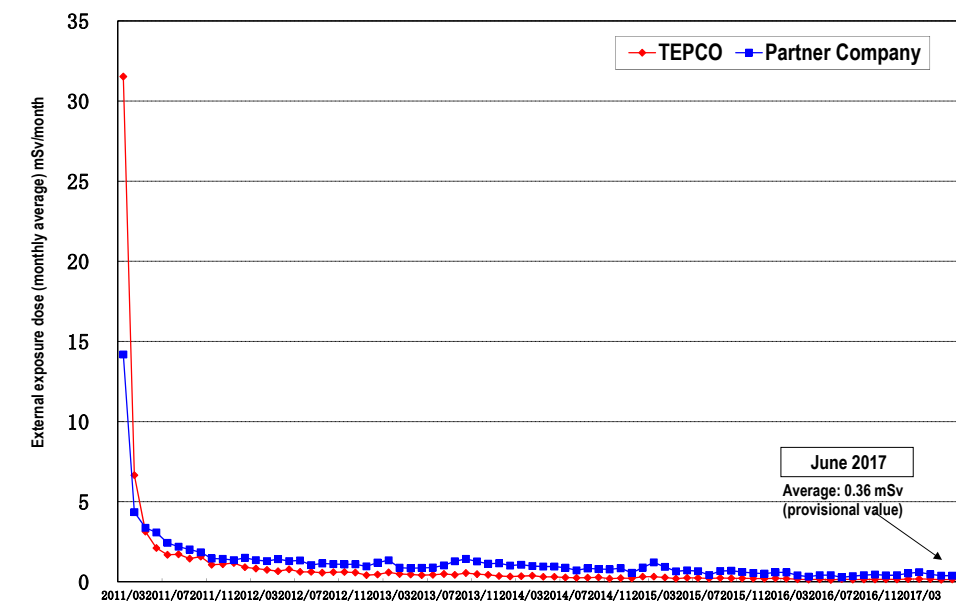
Figure 7: Changes in monthly individual worker exposure dose (monthly average exposure dose since March 2011)

- The monthly average exposure dose of workers remained at approx. 0.81 mSv/month during FY2014, approx. 0.59 mSv/month during FY2015 and approx. 0.39 mSv/month during FY2016. (Reference: Annual average exposure dose 20 mSv/year \cong 1.7 mSv/month.

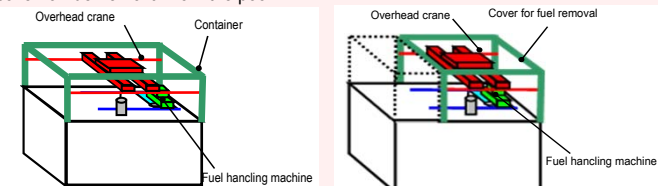
Examination of the following two plans continues: Plan 1 to share a container for removing fuel assemblies and debris from the pool; and Plan 2 to install a dedicated cover for fuel removal from the pool.

Image of Plan 1

Image of Plan 2
