Progress Status of Sub-drain Purification Test

Feb. 27, 2012

Tokyo Electric Power Company

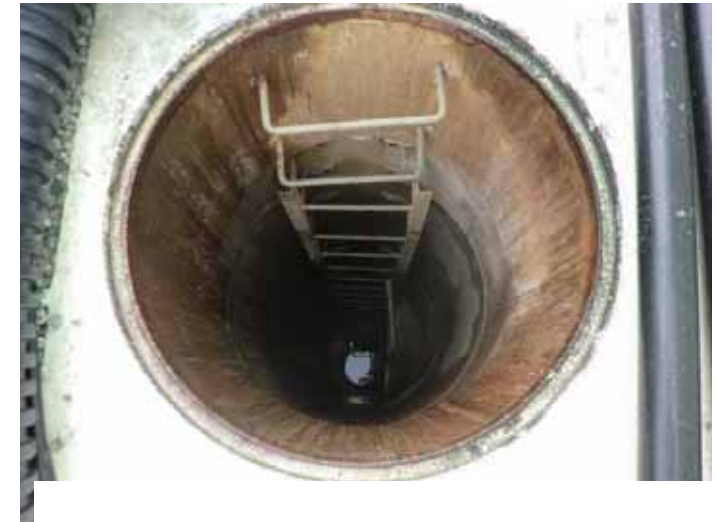
- Sub-drain equipment is installed in order to prevent groundwater around building from flowing into the building, drawing groundwater via operation of sub-drain pump and balancing groundwater level.
- Lowering groundwater level by drawing sub-drain water is a strong measure to prevent groundwater from inflowing into the building.

Inside of the Sub-drain pit

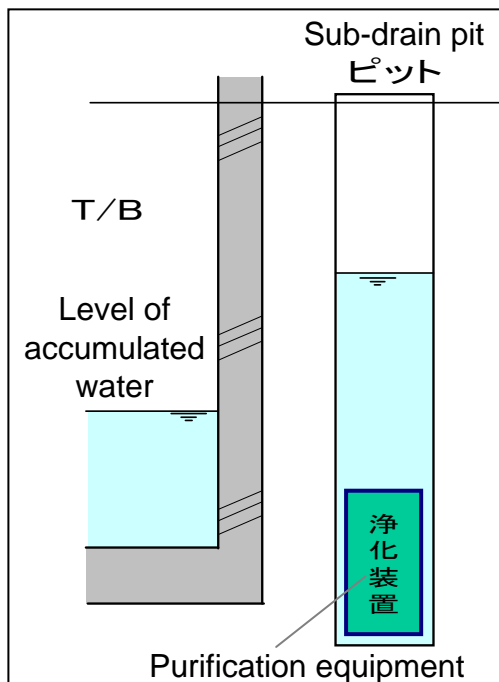
Purification test

Purify sub-drain via purification equipment and confirm below detection limit.

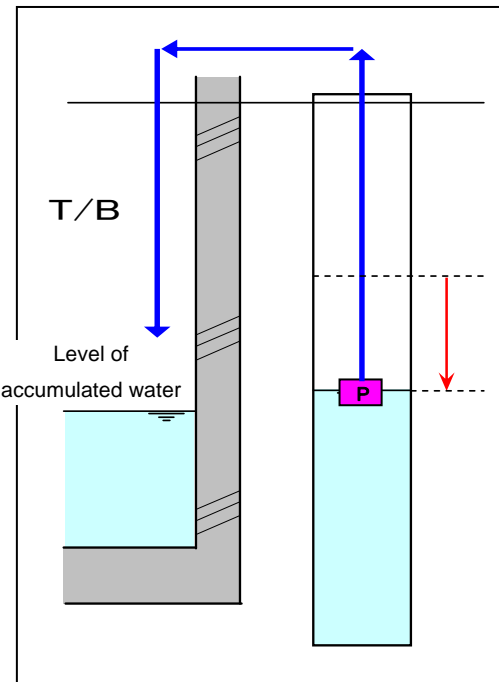
Drawing up test

Lower accumulated water in the pit to the level of that in the T/B. (Draw up into the T/B)

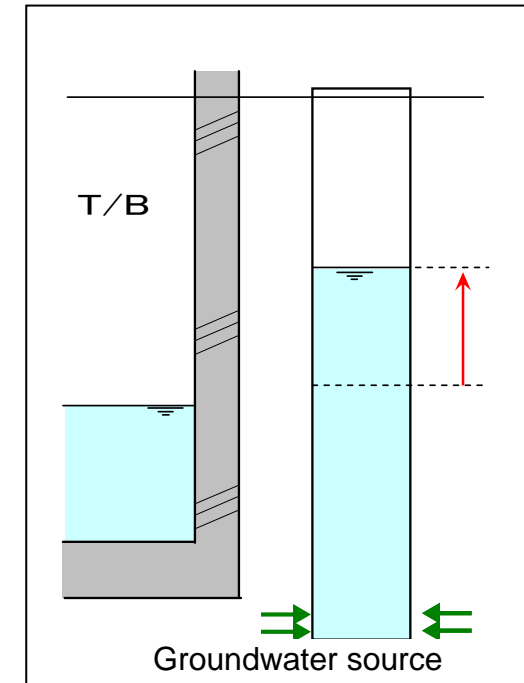
Confirm water quality of groundwater source

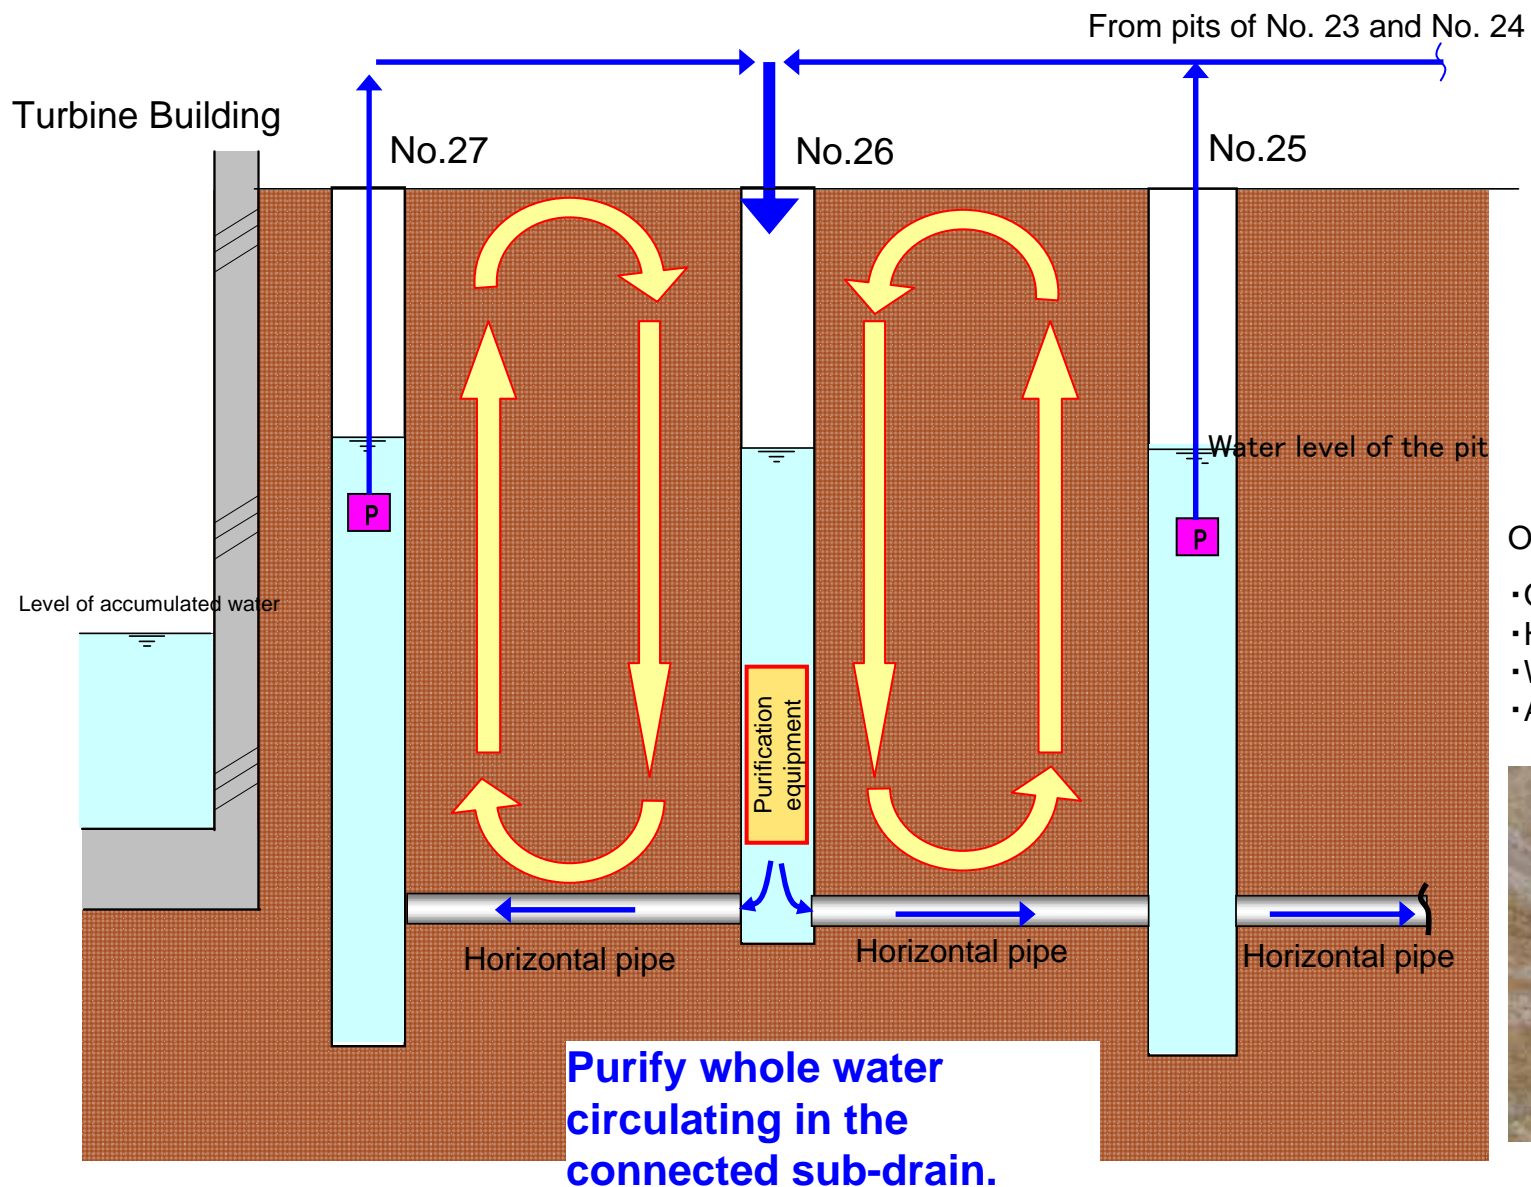
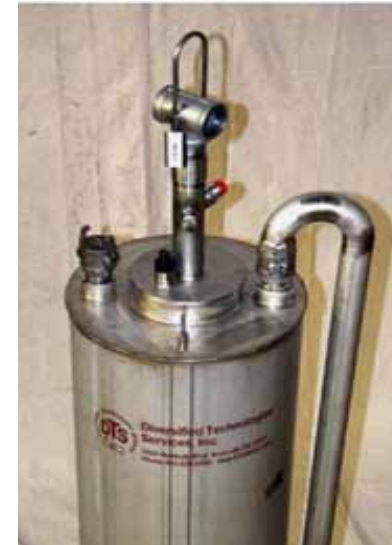
Sub-drain Water Purification Methods

Overview of purification device

- Outside diameter: 457mm (18 inch)
- Height: 1829mm
- Watertight weight: 422kg
- Adsorbent: active carbon, resin

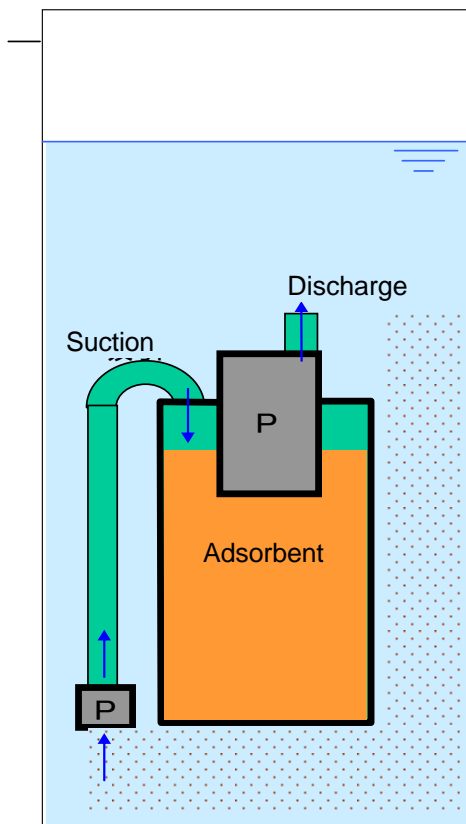
▽Ground

- Adsorbent of purification equipment can process water-dissolved Cs, but doesn't have capability of adsorbing Cs adhered to suspended materials etc.
- Based on the evaluation result, there is a view that radiation adhered to suspended materials would affect.

- Not able to purify sub-drain water at Unit 2 below detection limit
- Because we confirmed muddiness in the water at Unit 2 pit and there is a possibility that purification equipment can not work sufficiently due to suspended solids, change purification equipment structure and implement purification test with installation of coagulation settling equipment for suspended matter.
- Purified the sub-drain water at Unit 4 below detection limit (under follow-up while continuing purification test)
- Because the sub-drain water at Units 5 and 6 is almost not contaminated, we are implementing “drawing up test” of Sub-drain.

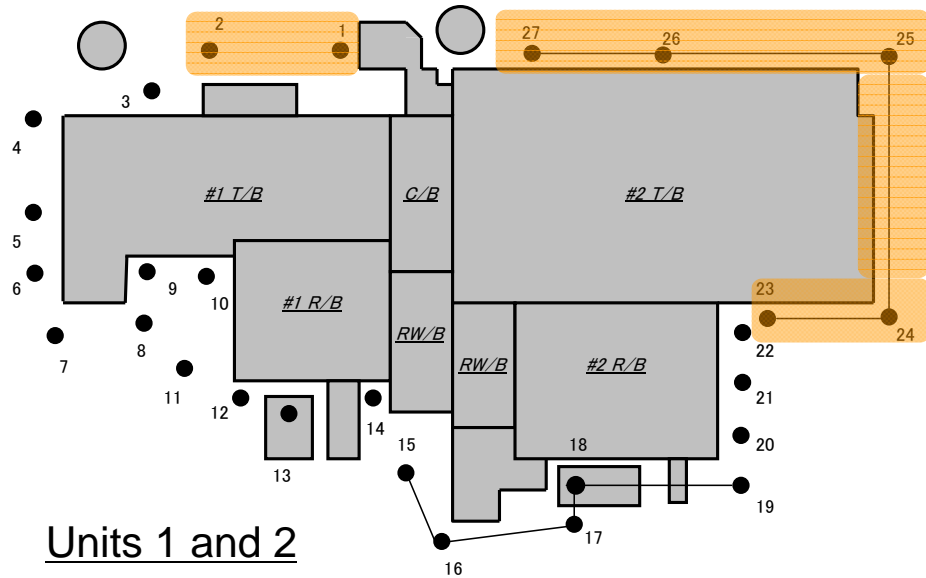
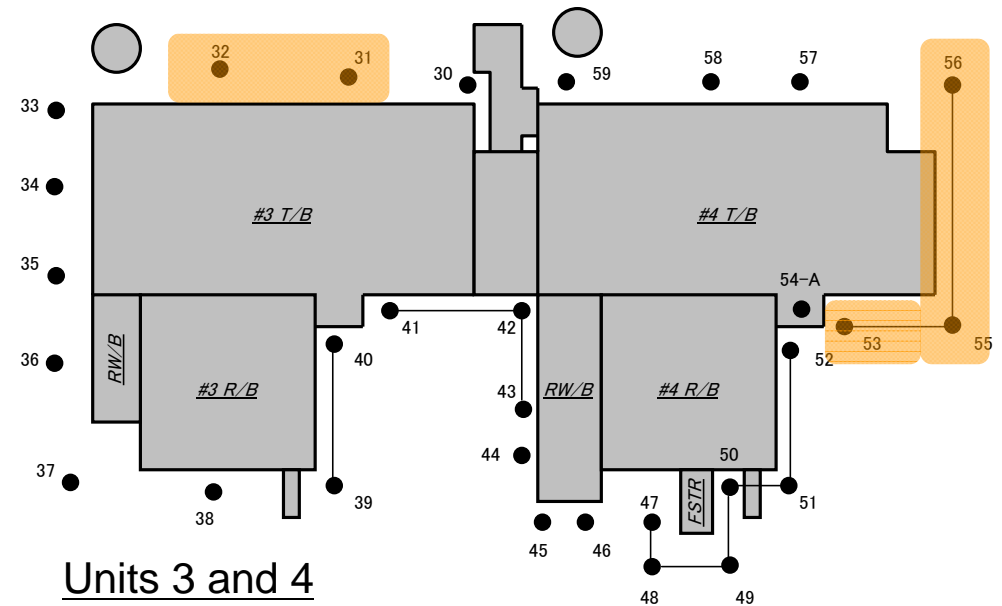
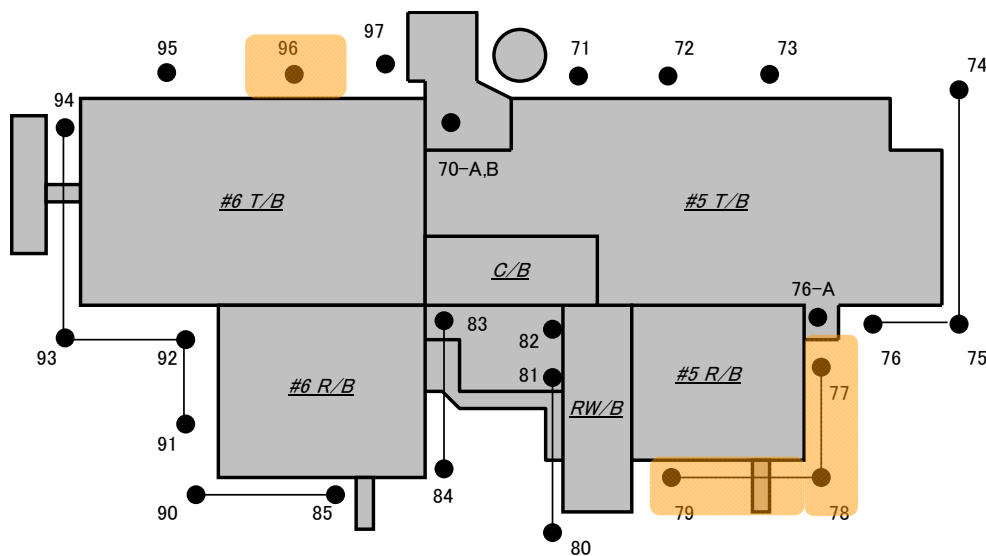
<Ref> Layout of Sub-drain Pits

- Units 1-4: Implement purification test/pump restoration from T/B side, relatively easy to restore.
- Units 5 and 6: Sub-drains are nearly sound. Test target is a point of each at R/B and at T/B.

Sub-drain targeted for tests
