Progress Status Classified by Issues (Photos and Figures)

Issues	Countermeasures	Implementation Status	Reference (Photos and Figures)
I. Cooling (1) Cooling the Reactor	Unit 1 Countermeasure [76] Improvement of work environment	Removal of debris, Measurement of radiation dose, Enter into the building (May 9) RPV water gauge proof (May 10) PCV pressure proof (May 11) Setting water level indicator of underground in Reactor Building (May 27) Setting temporary RPV puessure indicator

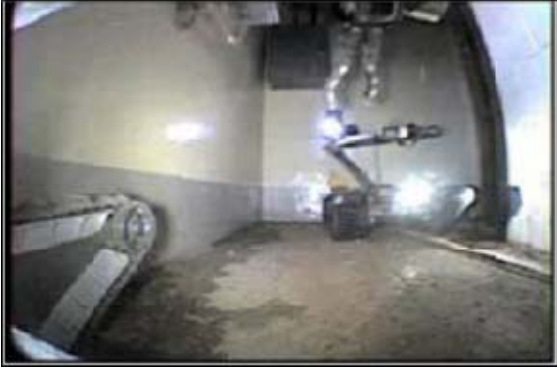
<p>Checking inside of the reactor buildings by Packbot</p>

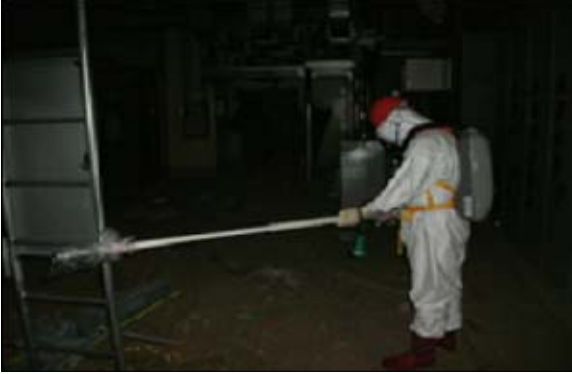
<p>Measuring radiation dose inside of reactor building</p>

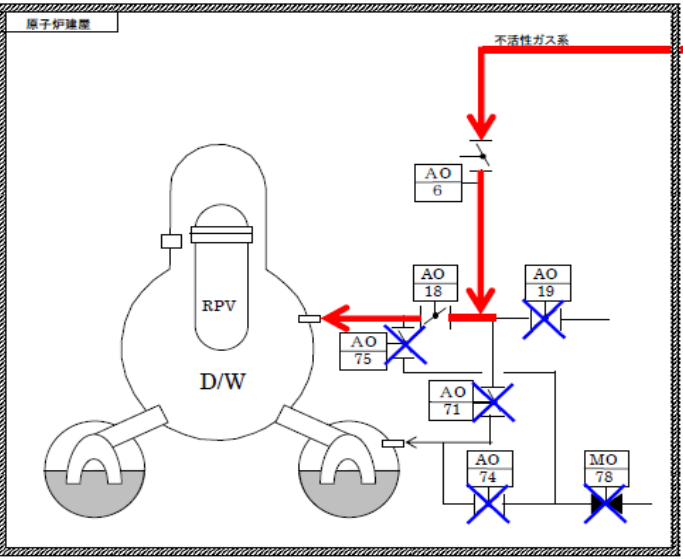
<p>System outline of nitrogen injection</p>

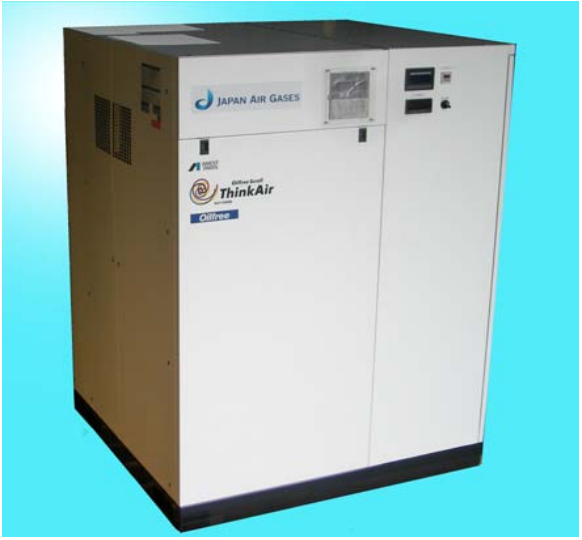
<p>Nitrogen supply apparatus</p>

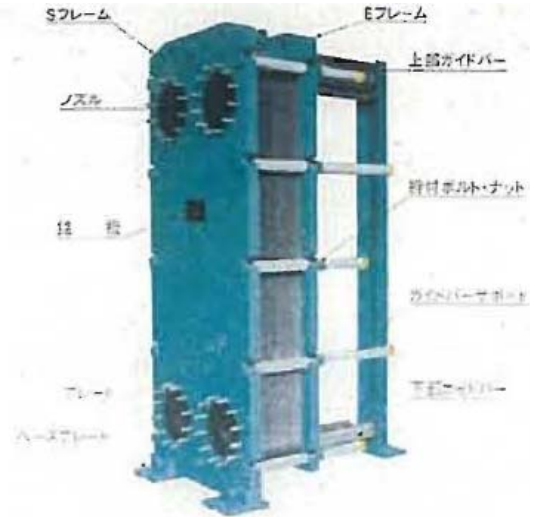
<p style="border: 1px solid black; display: inline-block; padding: 2px;">Plate-type heat exchanger</p> </div> <div style="text-align: center;">

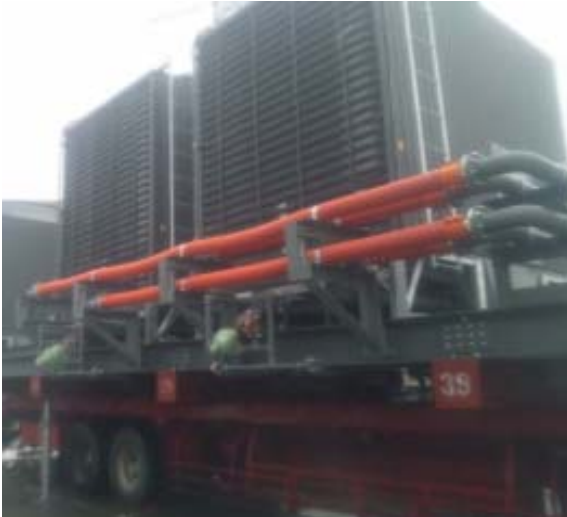
<p style="border: 1px solid black; display: inline-block; padding: 2px;">Cooling tower unit</p> <p style="font-size: small; margin-top: 5px;">June 3, Completion of build-up of cooling unit on the trailer</p> </div> </div> <div style="margin-top: 20px; text-align: right;"> <div style="border: 1px solid black; padding: 5px; width: fit-content;"> Demolished and removed debris at the truck bay door, which would be obstacle for installation of alternative cooling system (from May 10 to May 15) </div> <div style="text-align: center; margin-top: 5px;">

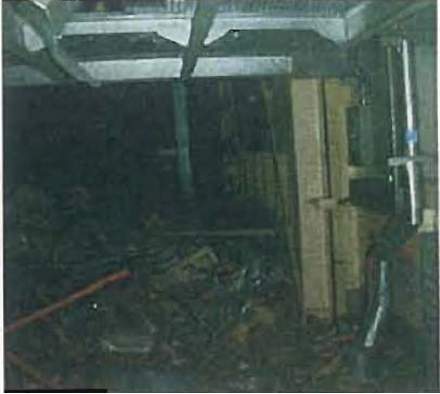
<p style="font-size: small;">Inside reactor building of Unit 1 in front of the truck bay door</p> </div> </div> </div>

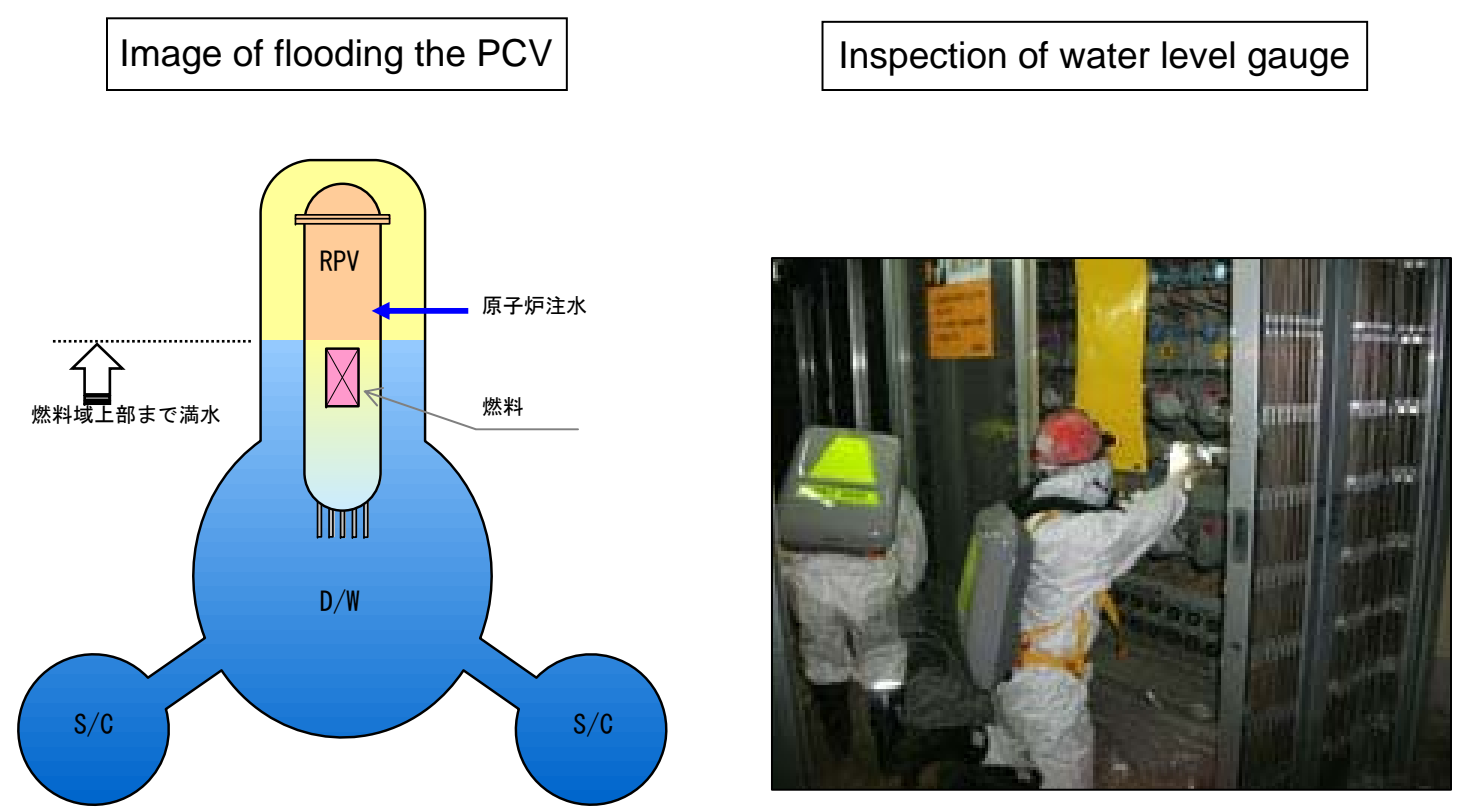
<p>The diagram shows a cross-section of the reactor vessel (RPV) inside the primary containment vessel (PCV). The RPV contains fuel (燃料) and is being flooded with water (原子炉注水) from above. The PCV contains a D/W (Dewar Water) tank and two S/C (Steam Condensers). The photo shows a worker in a white protective suit inspecting a water level gauge.</p>	
	Countermeasure [16] Seal the leakage location in the PCV			
	Countermeasure [9] Flood the PCV	- We started the flooding operation on May 6, however since leakage from the primary containment vessel was found, sealing of the leakage point is being considered.

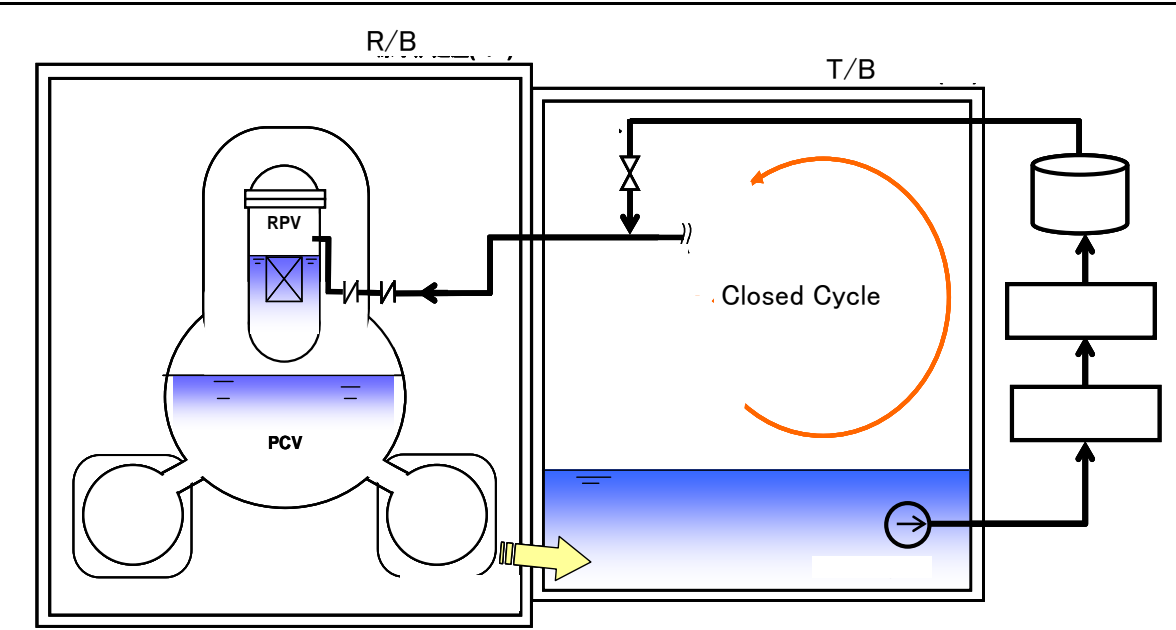
<p>The diagram illustrates a closed cycle system for water reuse. It shows the RPV and PCV connected to a system with a pump (R/B) and a tank (T/B). The cycle is labeled 'Closed Cycle' and shows water being pumped from the T/B tank back into the PCV to cool the reactor.</p>
		<div style="border: 1px solid black; padding: 5px; width: fit-content; margin: 0 auto;">System outline of water reuse as reactor coolant by processing accumulated water</div>

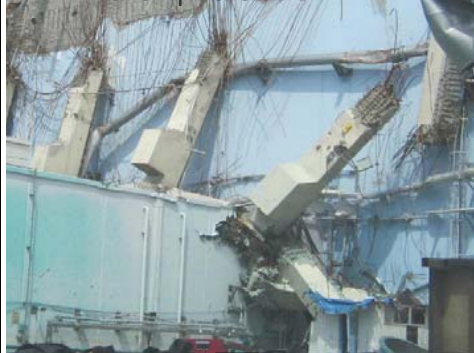
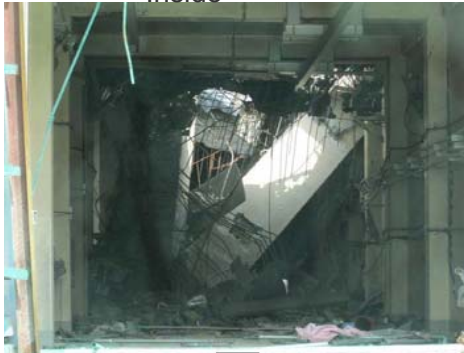
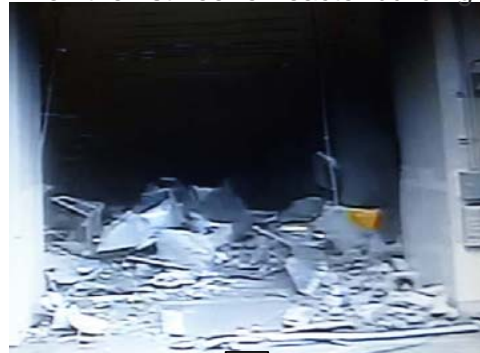
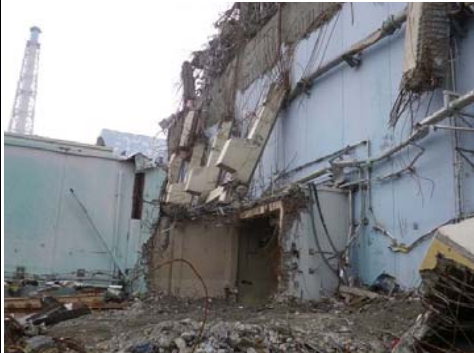
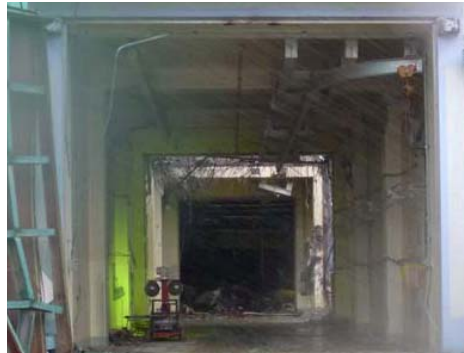
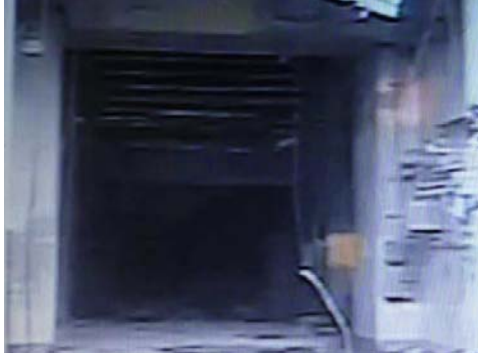
Countermeasure [9] Flood the PCV		(After removal May 25)	(After removal May 30)	(After removal June 4)
	Countermeasure [14] Fuel cooling by minimum water injection rate		Status of debris demolition and removal work		
	Countermeasure [12,45] Consideration and preparation for reuse of processed water	- Implementing injection line work (ongoing from April 16) - Change Unit 3 reactor injection pump to upland pump (May 27) - In service with the launch of accumulated water treatment

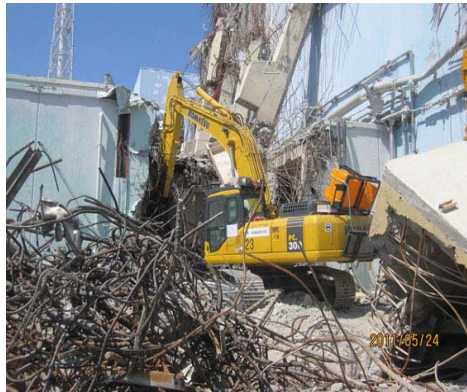
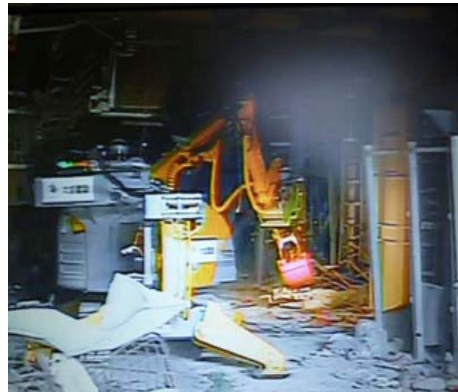
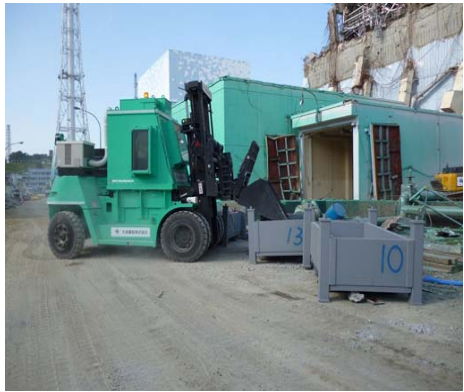
Countermeasure [12,14,45] Establishment of circulating injection cooling	Continue to Step 2	Removal of outside pillars by a radio controlled backhoe	Removal of debris by "Brokk" (wired remote control)	Packing into container by a shielded forklift

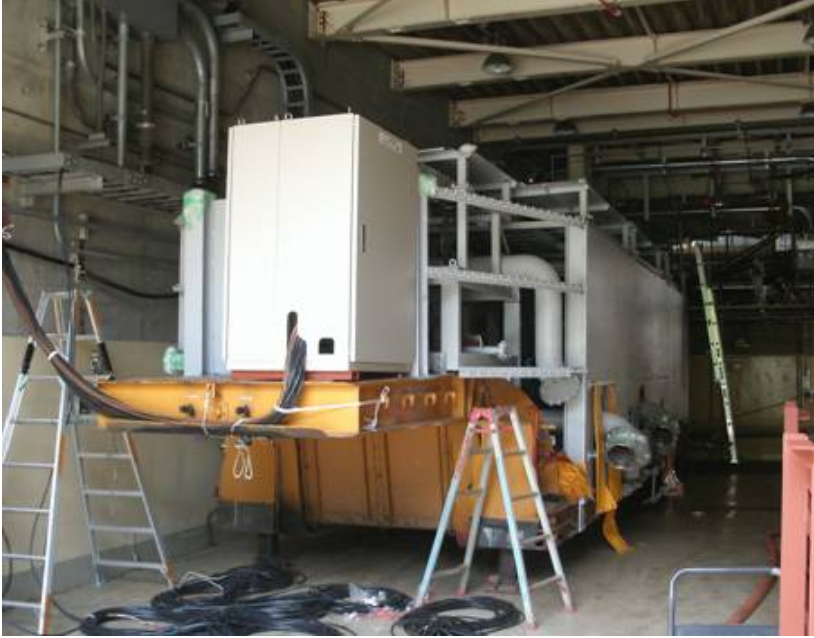
<div style="border: 1px solid black; padding: 5px; text-align: center; margin-top: 5px;">Unit 2 Heat Exchanger Unit</div>
	Countermeasure [23,27] Install heat exchanger	- Installed heat exchanger and operating circulating cooling system (from May 31) - Temperature of spent fuel pool: approximately 31 °C (as of June 6)	
	Unit 3	Countermeasure [22] Continuation of water injection by "Giraffe" etc - Standby as backup after restoration to normal water injection line - Reliability improvement: enhanced durability of hoses - Measures to reduce radiation dose: switch to remote-controlled operation (arm, water injection operation)	<div style="border: 1px solid black; padding: 5px; text-align: center; margin-bottom: 5px;">Unit 3 Spent Fuel Pool</div>

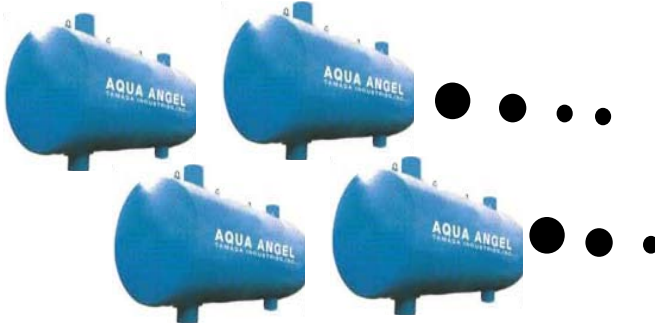
<p style="text-align: center; background-color: blue; color: white; padding: 2px;">Underground tanks for treated water (image)</p>

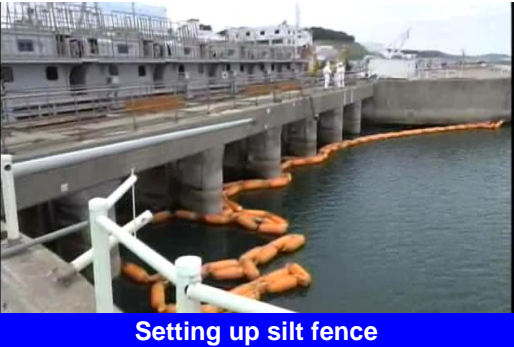
<p style="text-align: center; background-color: blue; color: white; padding: 2px;">Setting up silt fence</p>	
	Countermeasure [65] Containment of high-level radioactive water	<ul style="list-style-type: none"> - closure of sea water pipe vertical shaft Unit 2: completed on June 2, Unit 3: completed on May 26, Unit 4: completed on April 6 - closure of pits and others Unit 1: completed on May 17 (planned) Unit 2: completed on June 9 Unit 3: completed on June 10 Unit 4: completed on June 10

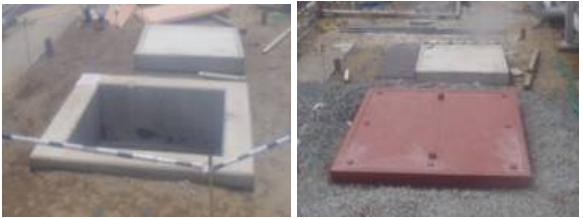
<p style="text-align: center; background-color: blue; color: white; padding: 2px;">Closure of sewer pipe vertical shaft (left: before closure, right: after closure)</p>

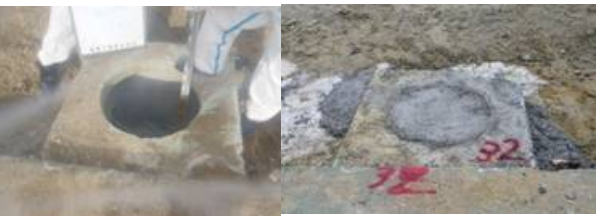
<p style="text-align: center; background-color: blue; color: white; padding: 2px;">Closure of pit (left: before closure, right: after closure)</p>

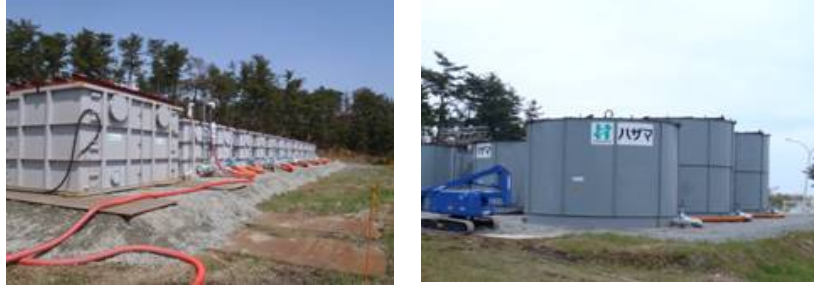
<p style="text-align: center;"><Adsorption of Cesium by zeolite></p>

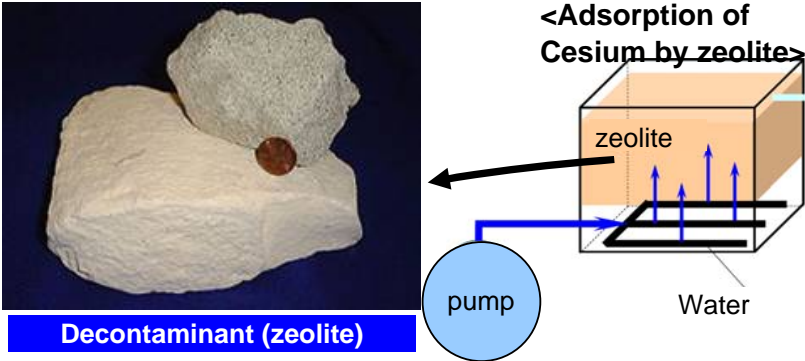
<p style="text-align: center;"><Outside view of the system></p>

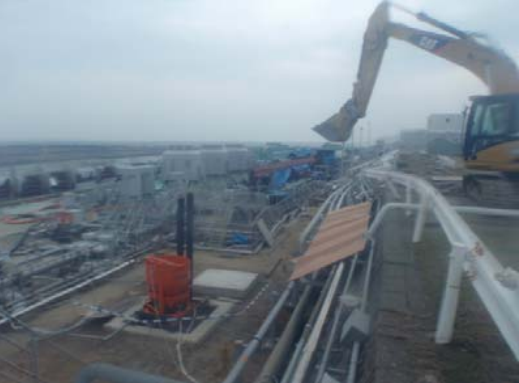
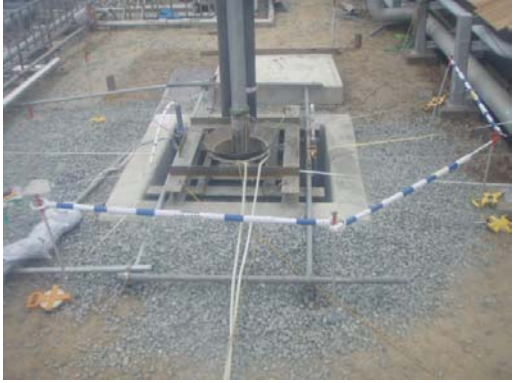
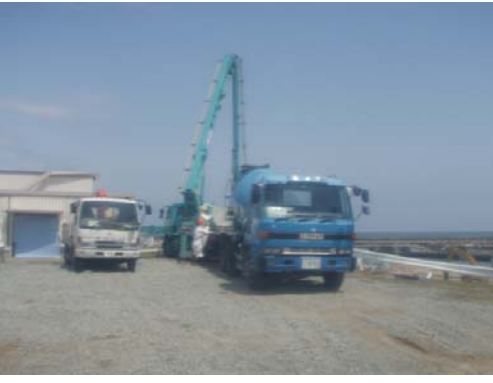
</div> <div style="display: flex; justify-content: space-around; margin-top: 10px;"> <div style="border: 1px solid black; padding: 2px 5px;">Putting in crushed stone</div> <div style="border: 1px solid black; padding: 2px 5px;">Concrete placement</div> <div style="border: 1px solid black; padding: 2px 5px;">Mortar placement</div> </div>

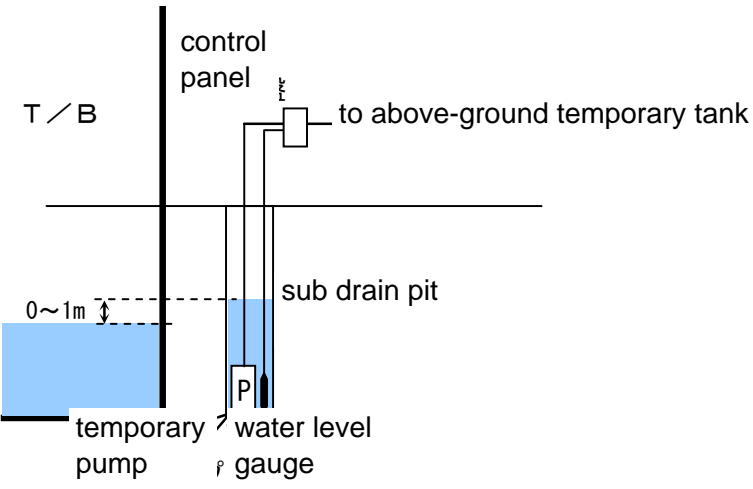
<p style="text-align: center;">Image of sub drain pump management</p>
	Countermeasure [68] Examination of shielding wall of groundwater	<ul style="list-style-type: none"> - Considering underground water flow based on seepage analysis <p><next step></p> <ul style="list-style-type: none"> -Implement most appropriate method to shield underground water by evaluating water shield effect, earthquake resistance, durability, etc. -Implement study for optimization of shielding section, installation plan and construction schedule. 	<div style="display: flex; justify-content: space-around;">

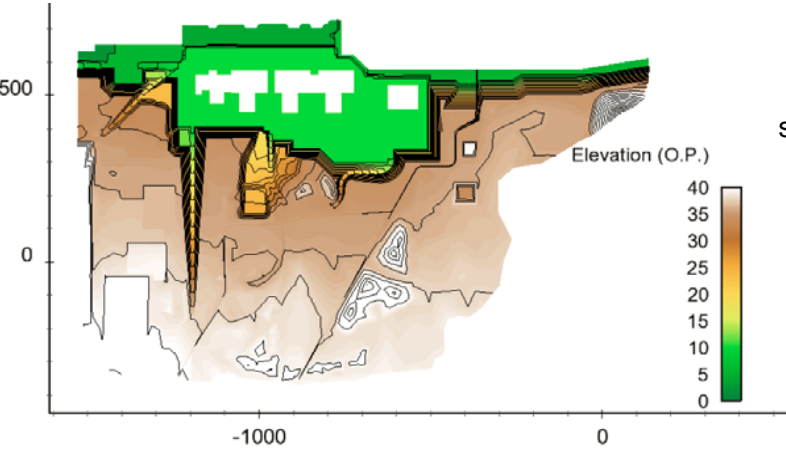
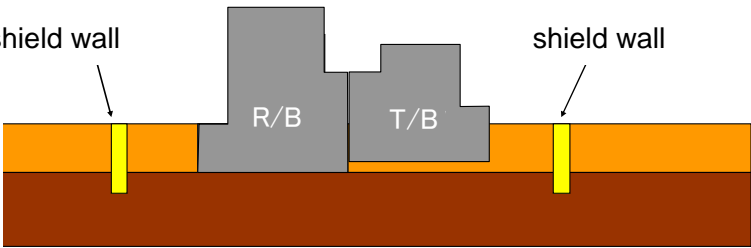
</div> <div style="display: flex; justify-content: space-around; margin-top: 10px;"> <div style="text-align: center;">Seepage analysis model</div> <div style="text-align: center;">Image of measure to shield groundwater</div> </div>

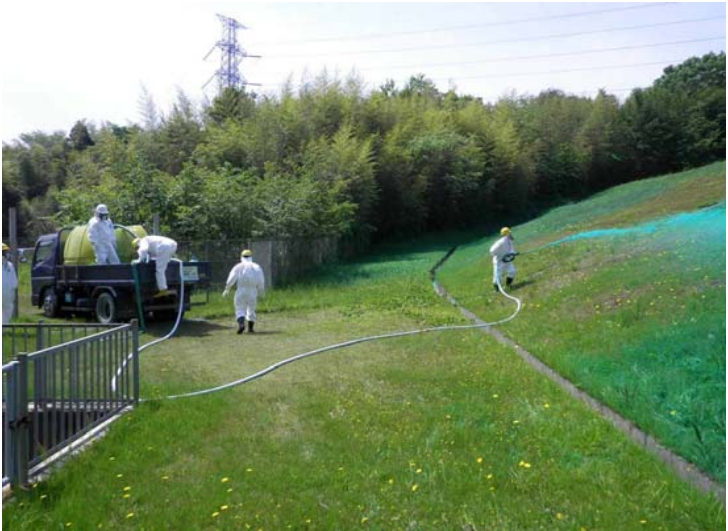
<p style="text-align: center;">Dispersion of inhibitors in the Power Station (slope)</p>

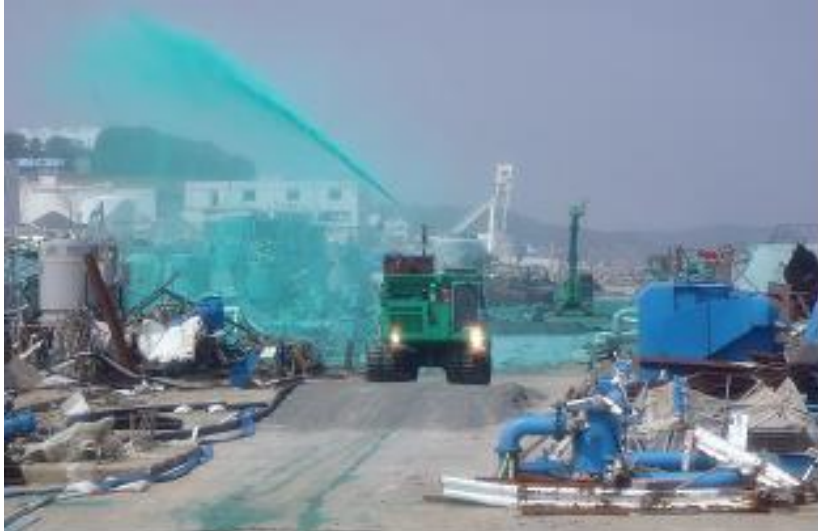
<p style="text-align: center;">Dispersion of inhibitors around turbine buildings of Units 1 to 4</p>

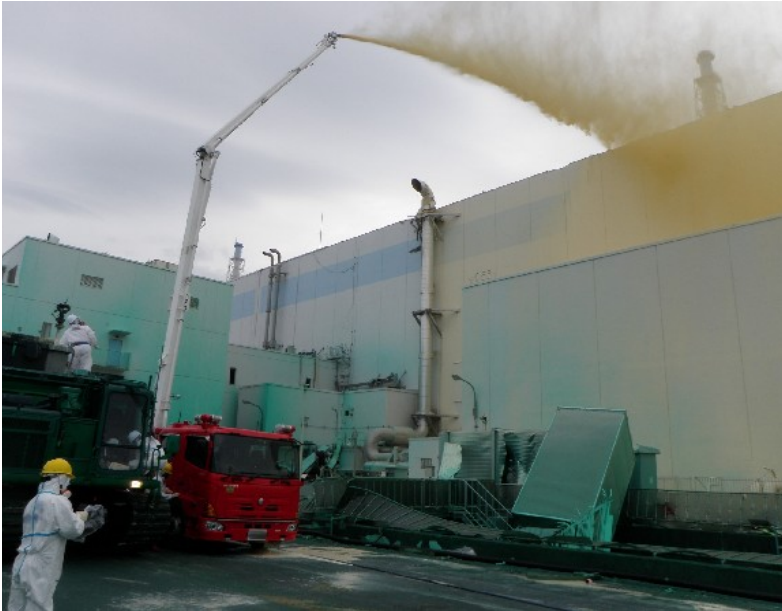
<p style="text-align: center;">Dispersion of inhibitors around turbine buildings of Units 1 to 4 (Dispersion by bending spray tower vehicles to Turbine Building at Unit 1)</p>

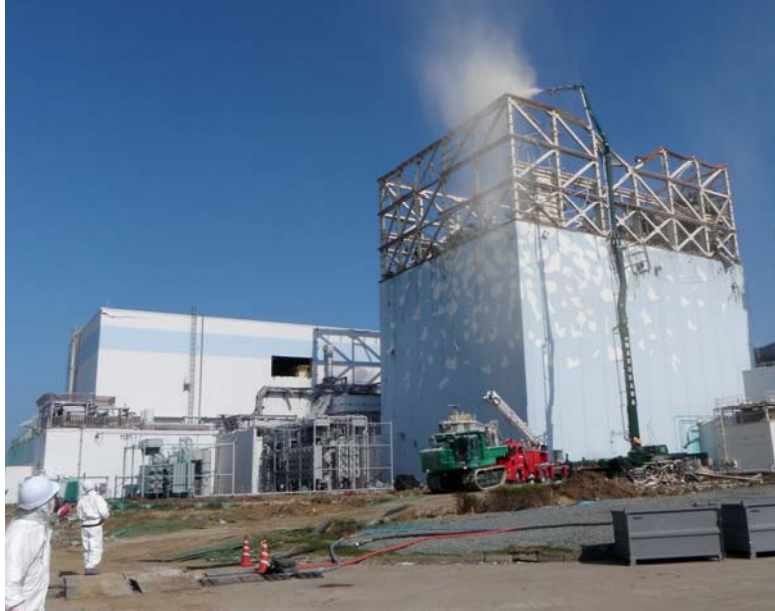
<p style="text-align: center;">Dispersion of inhibitors around turbine buildings of Units 1 to 4 (Dispersion by bending spray tower vehicles to Reactor Building at Unit 1)</p>

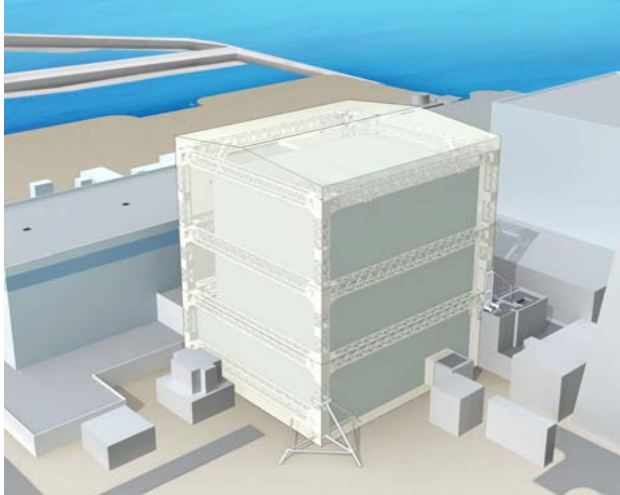
<p style="text-align: center;">Image after installation of reactor building cover for Unit 1</p>

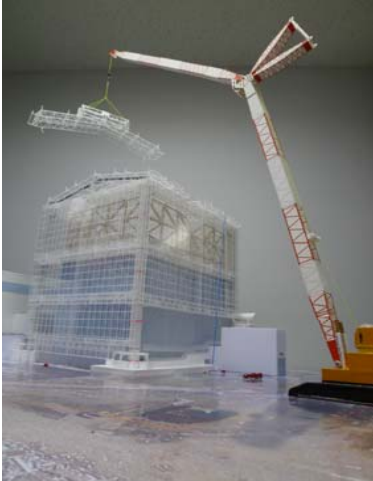
<p style="text-align: center;">Image of construction of Covering R/B</p> 《Unit 3 and 4》 - Start of preparation construction work (planned from the end of June)	《Unit 1 progress status》

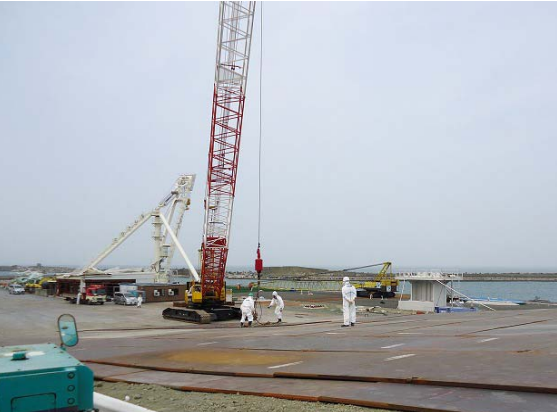
<p style="text-align: center;">laying steel plates</p> <p style="text-align: center;">Preparation work (Shallow Draft Quay)</p>

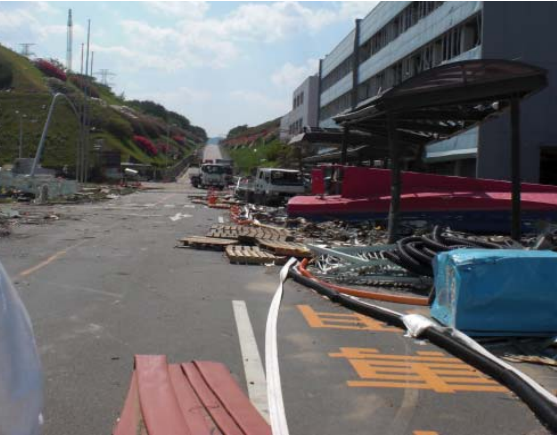
<p style="text-align: center;">Preparation work (road for crawler crane)</p>

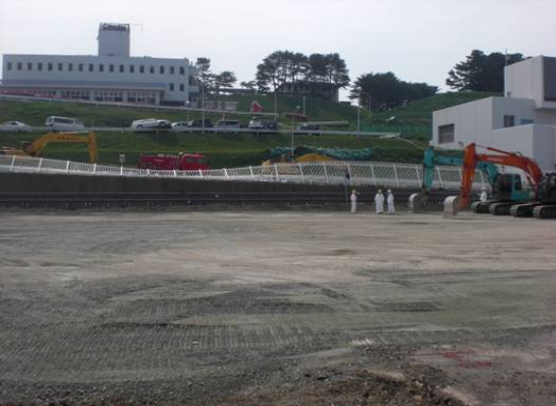
<p style="text-align: center;">completion of laying steel plates (finished at June 11)</p>

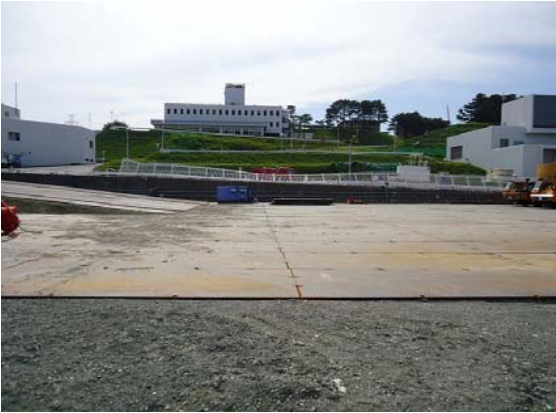
<p style="text-align: center;">completion of laying steel plates (finished at June 11)</p>

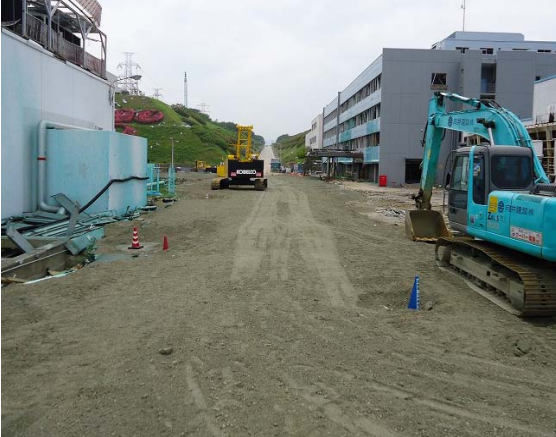
<p style="text-align: center;">Preparation work (road for crawler crane)</p>

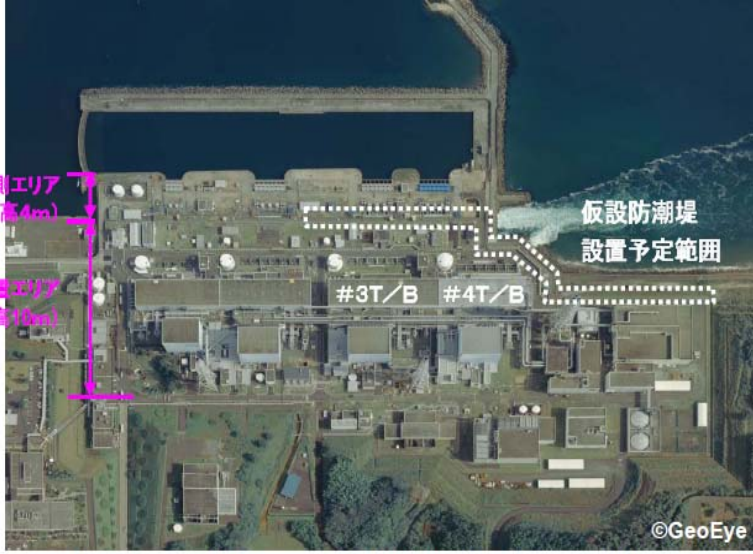
<p>Planned Temporary Tide Barrier (white dotted line)</p> </div> <div style="text-align: center;">

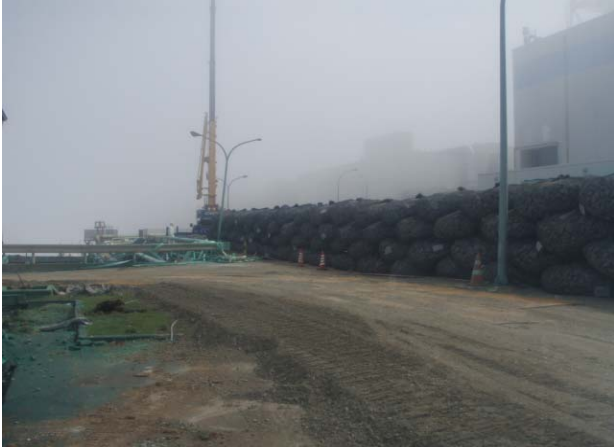
<p>Temporary Tide Barrier (1)</p> </div> </div>
	Countermeasure [70] Enhancement of countermeasures against tsunami	<ul style="list-style-type: none"> - Starting installation of temporary tide barrier from May 18 Completion Target : end of June 	<div style="display: flex; justify-content: space-around;"> <div style="text-align: center;">

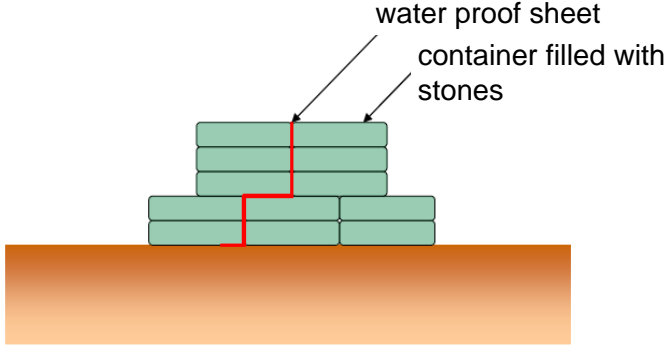
<p>Corss-Section of Temporary Tide Barrier (image)</p> </div> <div style="text-align: center;">

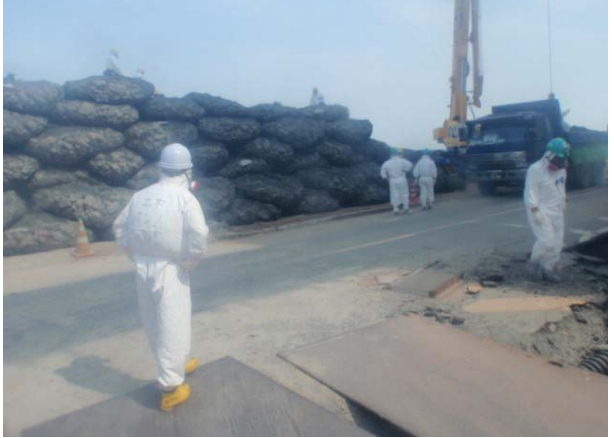
<p>Temporary Tide Barrier (2)</p> </div> </div>

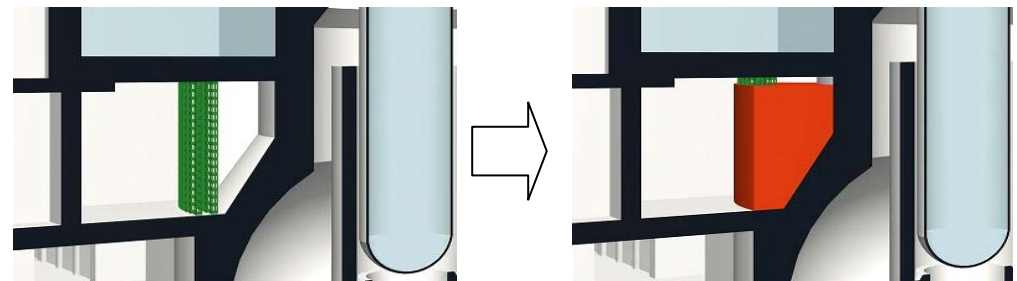
</div> <div style="display: flex; justify-content: space-around; width: 100%; margin-top: 5px;"> <div style="text-align: center;">Steel pillar installation</div> <div style="text-align: center;">Concrete wall</div> </div> <div style="display: flex; justify-content: space-around; width: 100%; margin-top: 10px;"> <div style="border: 1px solid black; padding: 2px;">Removing debris</div>

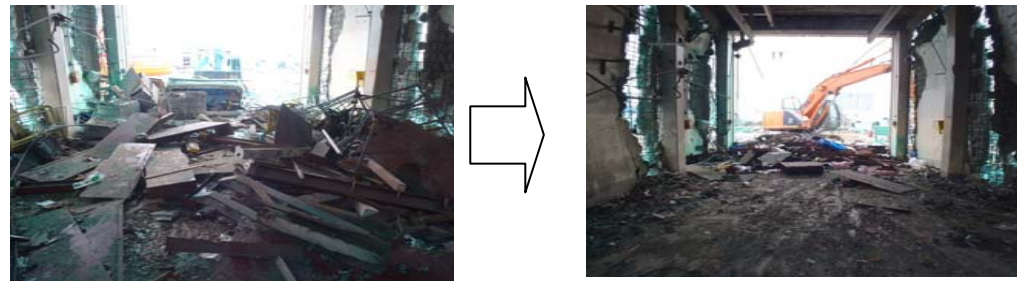
</div> <div style="text-align: center; margin-top: 5px;">Removing debris at truck-bay door</div> <div style="display: flex; justify-content: space-around; width: 100%; margin-top: 10px;"> <div style="border: 1px solid black; padding: 2px;">Securing route</div>

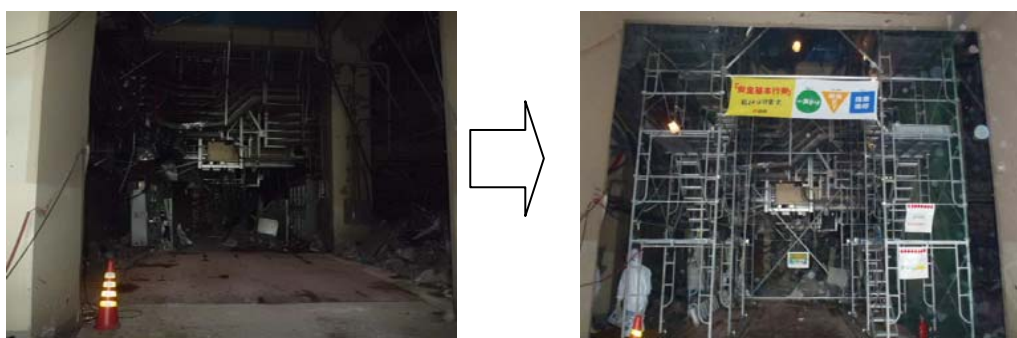
</div> <div style="text-align: center; margin-top: 5px;">Establish a foothold at hatch</div> <div style="display: flex; justify-content: space-around; width: 100%; margin-top: 10px;"> <div style="border: 1px solid black; padding: 2px;">Installation of supporting structure under the bottom of spent fuel pool</div>

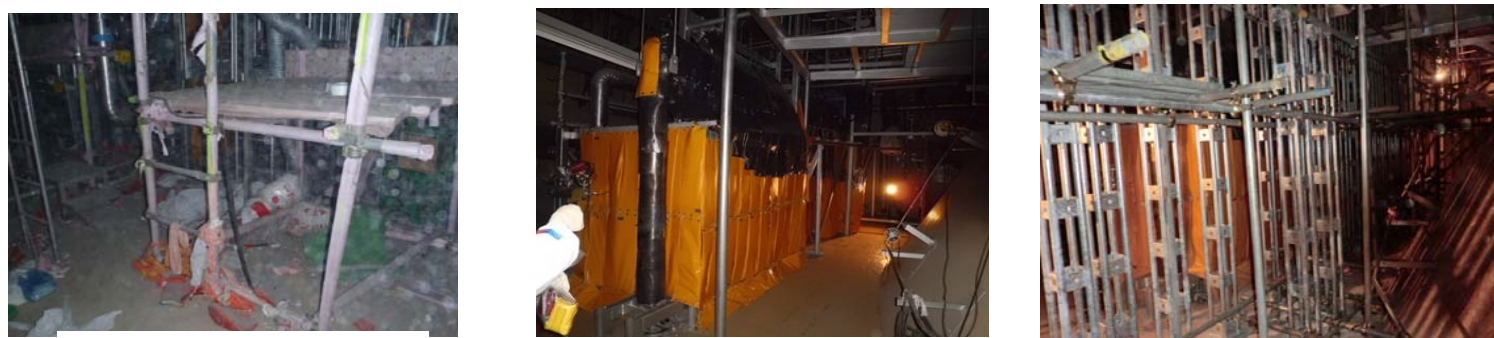
</div> <div style="display: flex; justify-content: space-around; width: 100%; margin-top: 5px;"> <div style="text-align: center;">Before the work</div> <div style="text-align: center;">Removing obstacle・install shielding</div> <div style="text-align: center;">Steel pillar installation (as of June 15)</div> </div> </div>

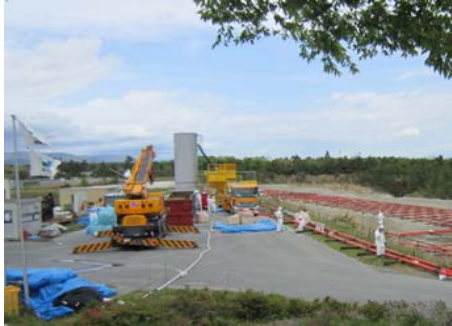
<p>Overview of the facility</p> </div> <div style="text-align: center;">

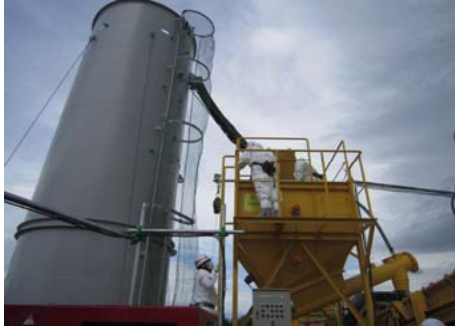
<p>Slurry production facility</p> </div> </div> <div style="display: flex; justify-content: space-around; margin-top: 10px;"> <div style="text-align: center;">

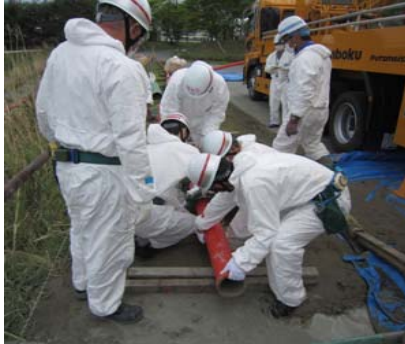
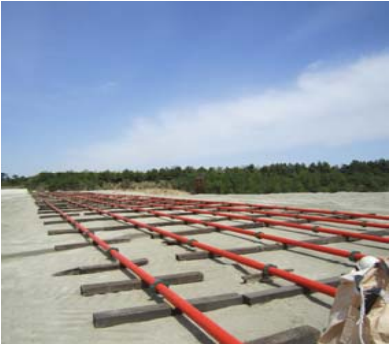
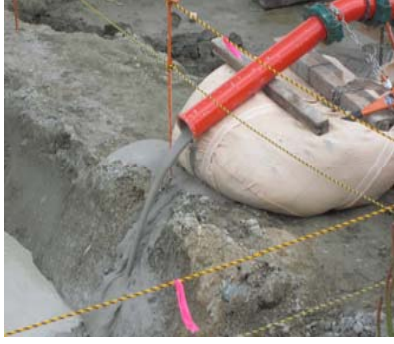
</div> </div> <div style="background-color: #e0e0ff; text-align: center; padding: 5px; margin-top: 10px;">Placement of device at Fukushima Daiichi Nuclear Power Station</div>

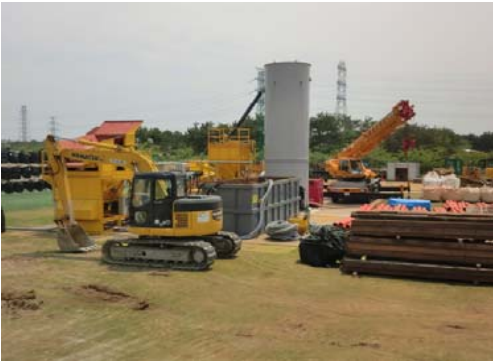
<ul style="list-style-type: none"> ・maintenance of equipment ・carry out water injection training by connecting slurry production facility and concrete pumping vehicle"zou-san 3" (June 16, 17) 	<div style="display: flex; justify-content: space-around;"> <div style="text-align: center;">

<p>Installation of slurry plant</p> </div> <div style="text-align: center;">

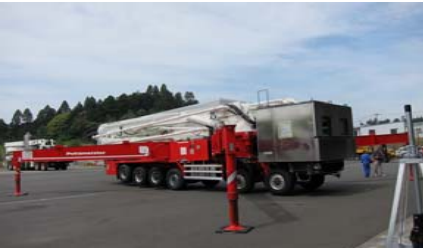
<p>Concrete pumping vehicle"zou-san 3"</p> </div> <div style="text-align: center;">

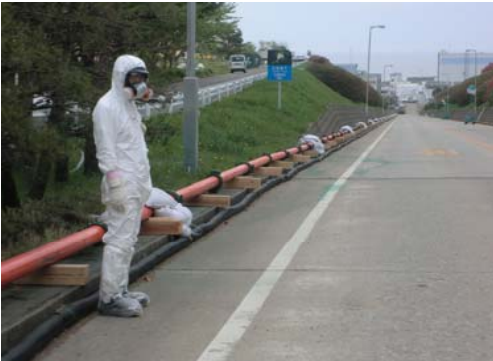
<p>Transfer pipe</p> </div> <div style="text-align: center;">

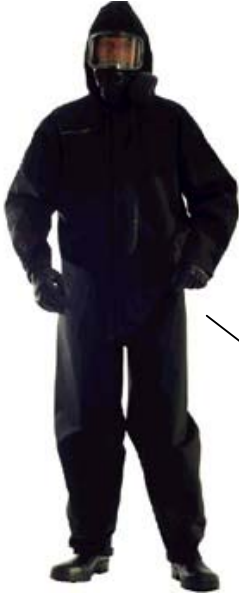
<p>Special protective gear: Protective suit which can be expected to shield beta ray and low-energy gamma ray</p>

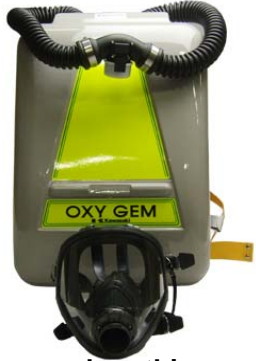
<p>Closed-circuit oxygen breathing apparatus: It can realize a long 120-minute usage, circulating aspirated air with oxygen inside the cylinder. It's suitable for usage in oxygen-less hazardous area.</p>

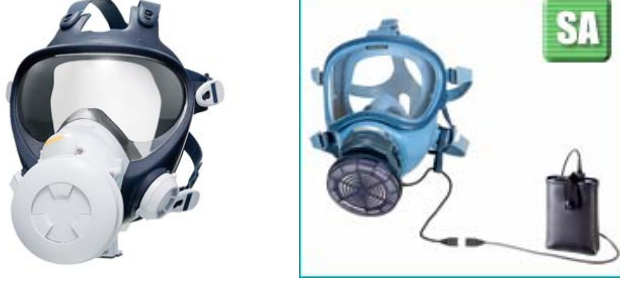
<p>Respiratory protective device with electric fan: The mask can blow in cleaned air which is filtered using electric fan. Internal pressure is kept higher than environmental pressure in order to reduce the risk of inhaling particulate. Also, it realizes to breathe freely and lighten loss of bodily strength.</p>

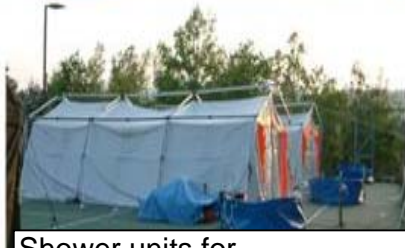
<p>Shower units for decontamination of workers</p> </div> <div style="width: 50%;">

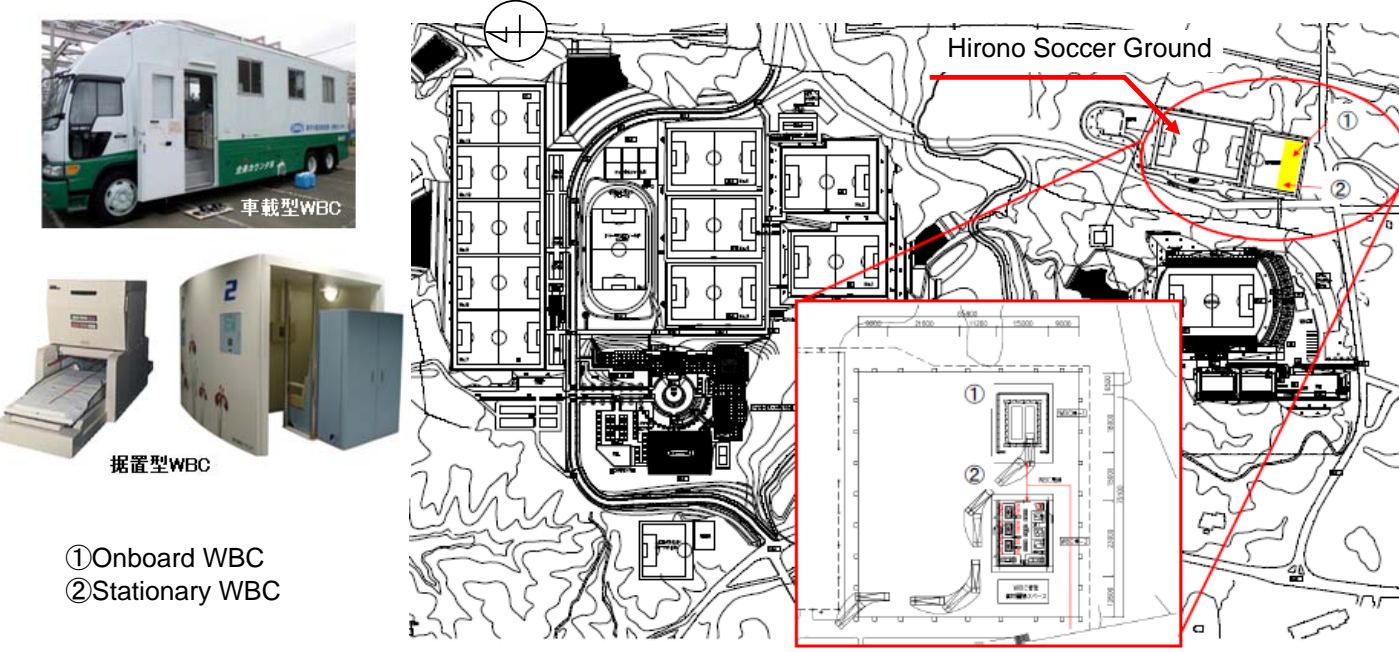
<p>① Onboard WBC ② Stationary WBC</p>

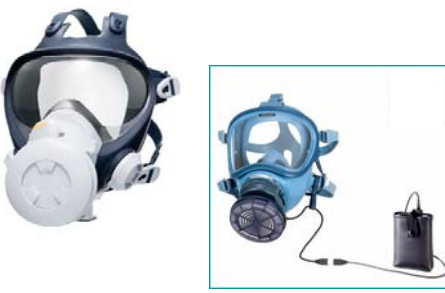
<p>Mask with blower</p> </div> <div style="text-align: center;">
