Progress Status Classified by Issues (Photos and Figures)

Issues	Countermeasures	Implementation Status	Reference (Photos and Figures)
<p style="writing-mode: vertical-rl; transform: rotate(180deg);">I. Cooling</p> <p style="writing-mode: vertical-rl; transform: rotate(180deg);">(1) Reactor</p>	<p>Countermeasure [76] Improvement of working environment</p>	<p>Removal of debris, Measurement of radiation dose, Entrance into the building (May 9) RPV water level gauge calibration (May 10) PCV pressure gauge calibration (May 11) Installation of water level gauge at basement of Reactor Building (May 27) Installation of temporary RPV pressure gauge (Jun. 3)</p>	<div style="display: flex; justify-content: space-around;"> <div style="text-align: center;">

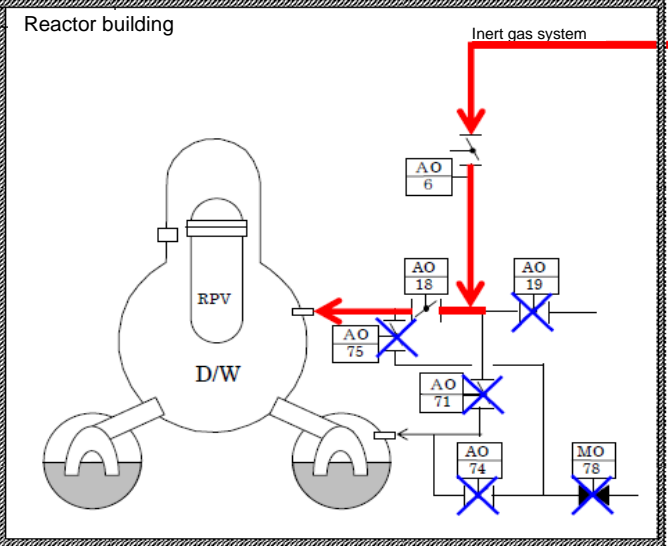
<p>Countermeasure [11] Nitrogen gas injection</p>	<p>Implementing from Apr. 6</p>	<div style="text-align: center; margin-bottom: 10px;"> <p>Nitrogen gas supply apparatus</p> </div> <div style="display: flex; justify-content: space-between;"> <div style="width: 60%;">

<p>System outline of nitrogen gas injection</p> </div> <div style="width: 35%; text-align: center;">

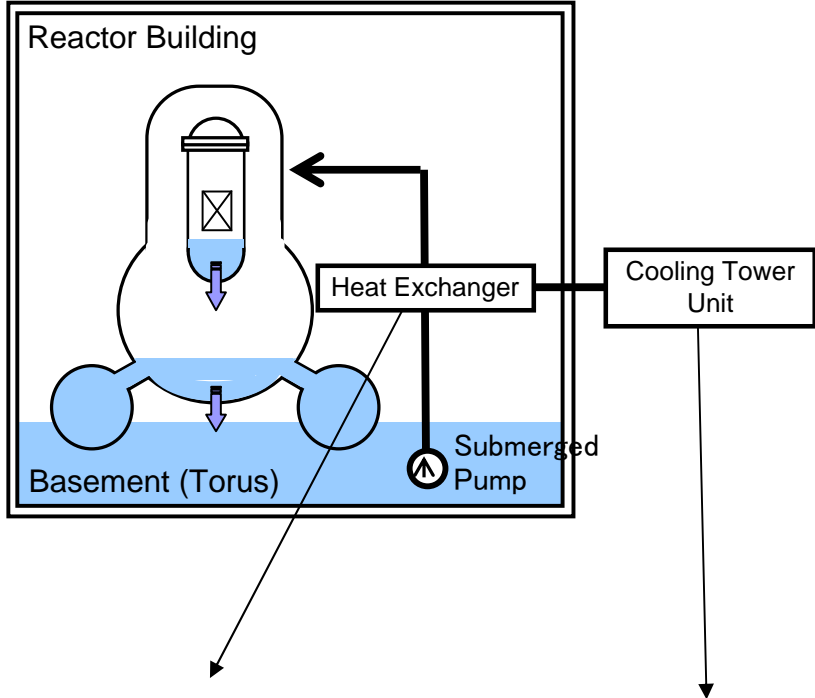
Issues	Countermeasures	Implementation Status	Reference (Photos and Figures)
I. Cooling (1) Reactor	Unit 1 Countermeasure [13] Securing heat exchange function for the reactor	<p>- Due to the leakage from the primary containment vessel (PCV), we judged that it is difficult to secure water level of PCV.</p> <p>- Therefore, we changed the plan to give priority to the establishment of circulating water cooling for the reactor.</p> <p>- We are studying the reactor cooling system by using heat exchanger as a mid to long term solution.</p> <p>(work implemented)</p> <p>- Completed the assembly of cooling tower unit and shielding equipment to reduce exposure dose for outdoor work (from May 17 to Jun. 17)</p>	<p>[Under consideration] Outline of circulating cooling system within the reactor building</p>

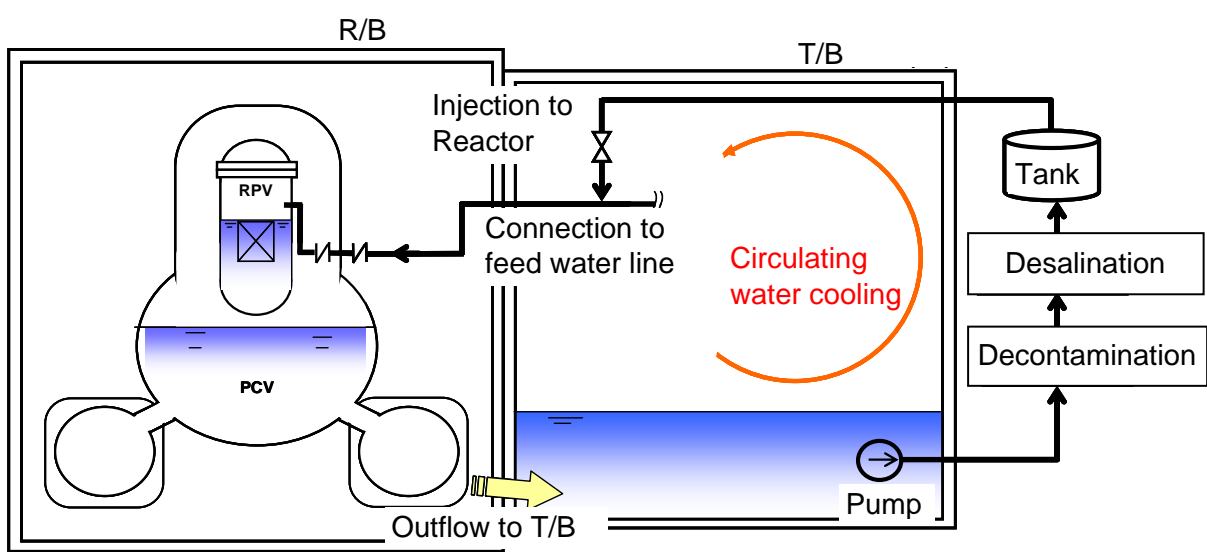
Countermeasures [12,14,45] Initiation and implementation of circulating water cooling	- Started circulating water cooling from Jun. 27

<div style="border: 1px solid black; padding: 5px; text-align: center; margin-top: 10px;">System outline of water reuse as reactor coolant by processing accumulated water</div>

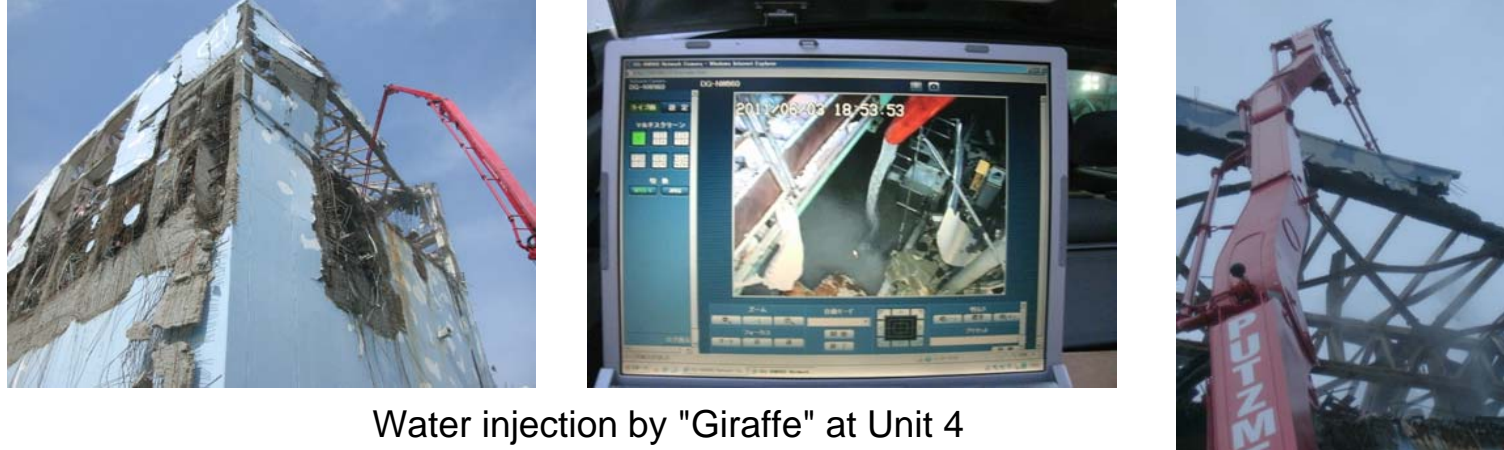
<p style="text-align: center;">Water injection by "Giraffe" at Unit 4</p>
	Countermeasure [24] Restoration of normal cooling system	- Water injection by installing alternative equipment of "Giraffe" (from Jun. 17)

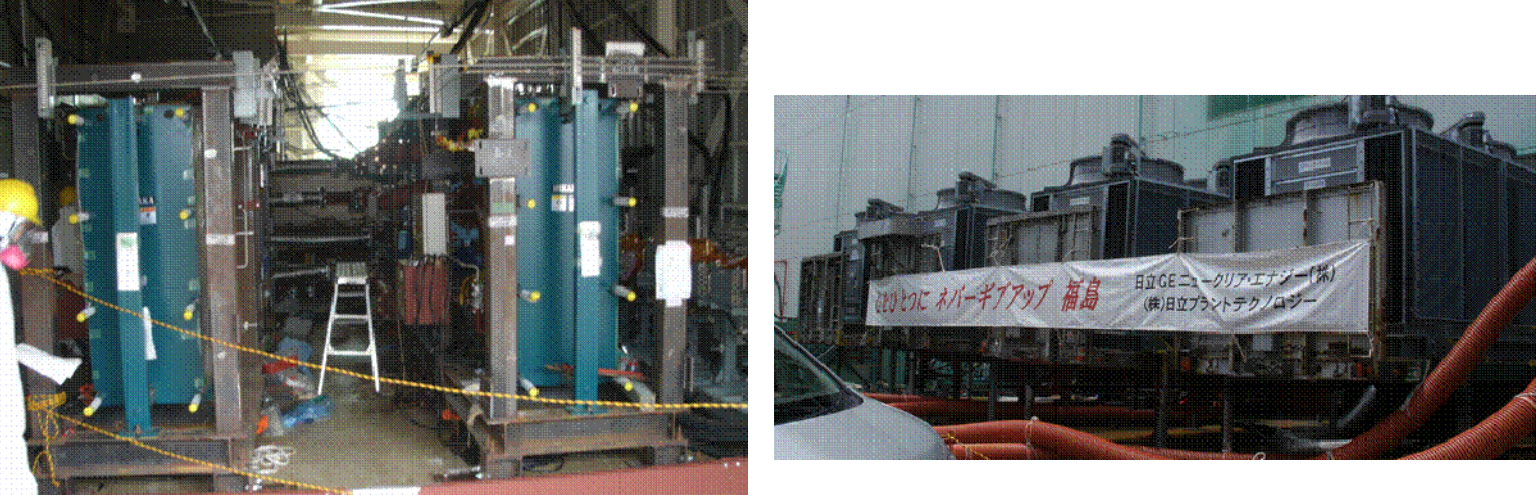
<div style="display: flex; justify-content: space-around; margin-top: 10px;"> <div style="border: 1px solid black; padding: 5px; text-align: center;">Unit 4 Heat Exchanger Unit</div> <div style="border: 1px solid black; padding: 5px; text-align: center;">Air Fin Cooler</div> </div>

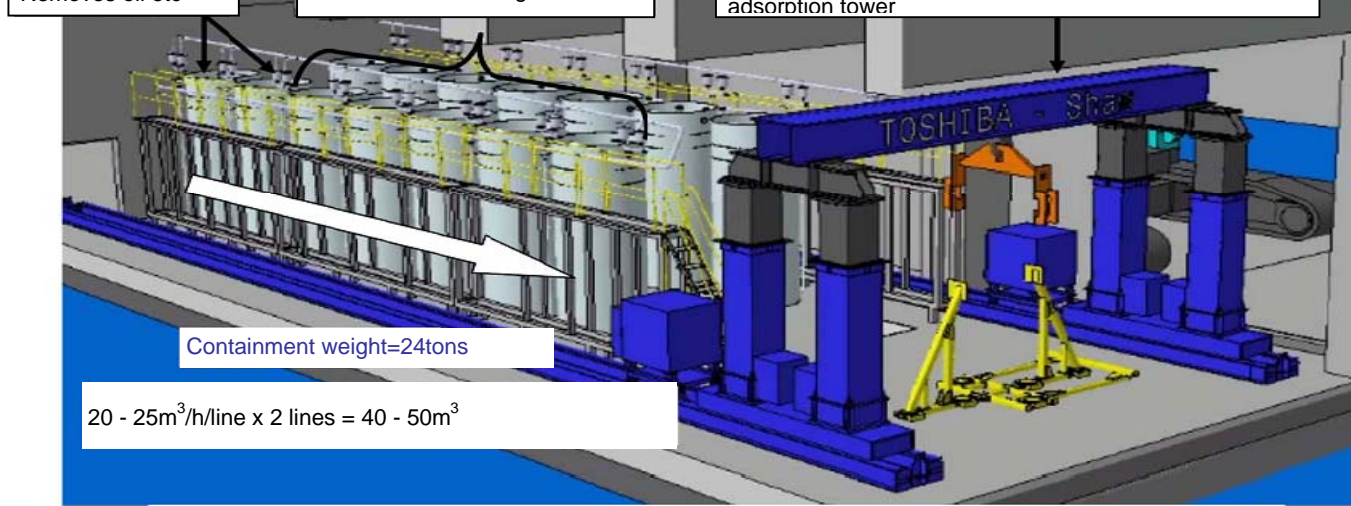
<p>Removes oil etc</p> <p>Removes Cs. Front row contains low level adsorption material, the back row contains high level</p> <p>Install special heavy machinery for lifting (hydraulic) and transfer machinery indoors, remove and transfer waste adsorption tower</p> <p>Containment weight=24tons</p> <p>20 - 25m³/h/line x 2 lines = 40 - 50m³</p> </div> <div style="margin-top: 20px; border: 1px solid black; padding: 5px;"> <p style="text-align: center;">Expansion of Decontamination Capacity</p> <div style="display: flex; justify-content: space-around; align-items: center;"> <div style="border: 1px solid black; padding: 5px; text-align: center;">Kurion (USA)</div> <div style="font-size: 2em;">↔</div> <div style="border: 1px solid black; padding: 5px; text-align: center;">AREVA (France)</div> </div> <div style="display: flex; justify-content: space-around; align-items: center; margin-top: 10px;"> <div style="font-size: 2em;">↙</div> <div style="border: 2px solid black; padding: 5px; text-align: center;">SARRY (USA, Japan)</div> <div style="font-size: 2em;">↘</div> </div> </div>

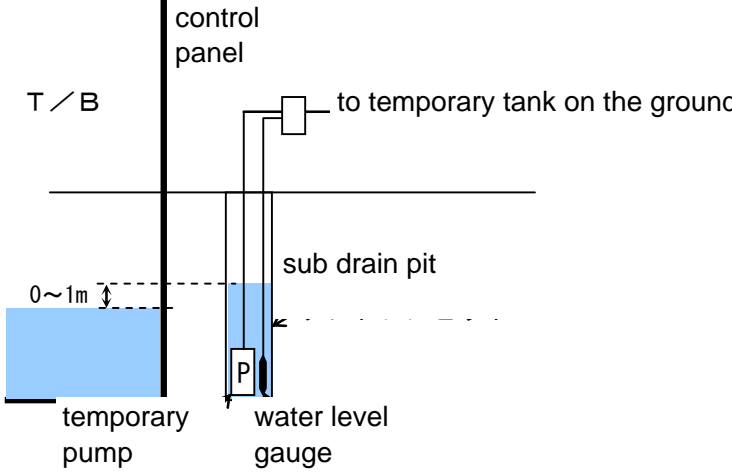
<p>Image of sub drain pump control</p> </div>

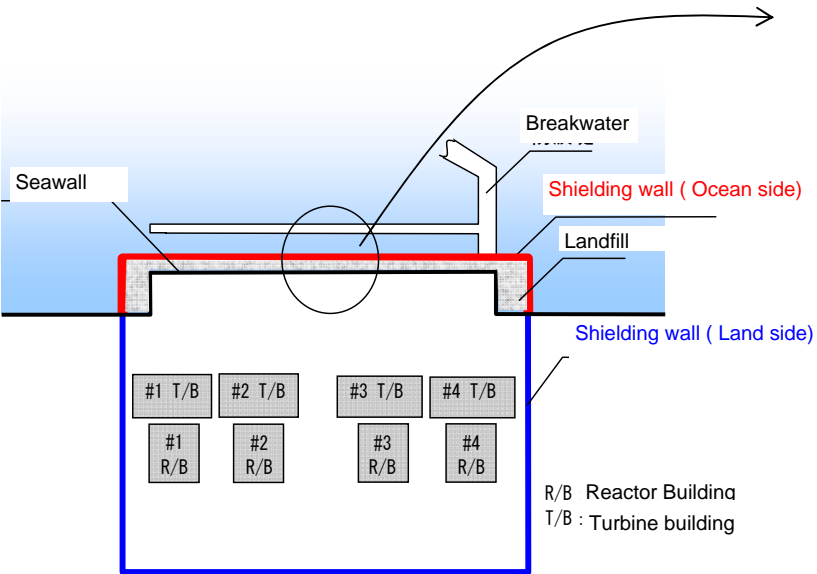
Countermeasure [68] Construction of shielding wall of groundwater	<ul style="list-style-type: none"> -Considering underground water flow based on seepage analysis -Under investigation of underground water level, water quality, etc. by boring. <next step> -Evaluate the water shield effect, earthquake resistance, durability, etc. then consider the most appropriate method to shield underground water -Implement study for optimization of shielding section, installation plan. -Start construction for sea side area during Step 2 -Investigate and study for landward area by the end of Step 2 	<div style="display: flex; justify-content: space-between;"> <div style="width: 45%;">

<p style="font-size: small;">R/B : Reactor Building T/B : Turbine building</p> </div> <div style="width: 45%;"> <p style="text-align: center;">Image of groundwater shielding</p>

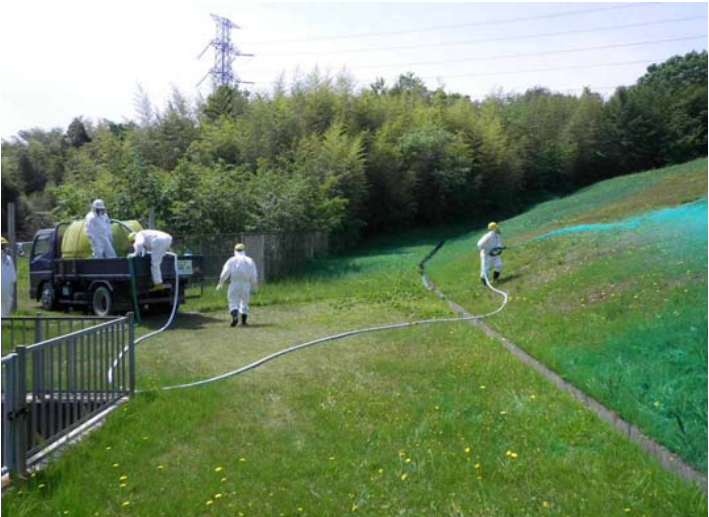
<p>Dispersion of inhibitors in the Power Station (slope)</p> </div> <div style="text-align: center;">

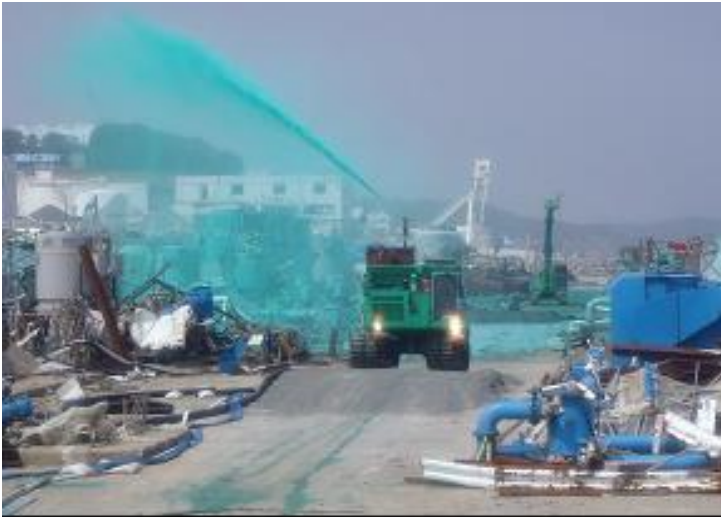
<p>Dispersion of inhibitors around buildings of Unit 1 to 4 by crawler dump</p> </div> </div> <div style="display: flex; justify-content: space-around; margin-top: 20px;"> <div style="text-align: center;">

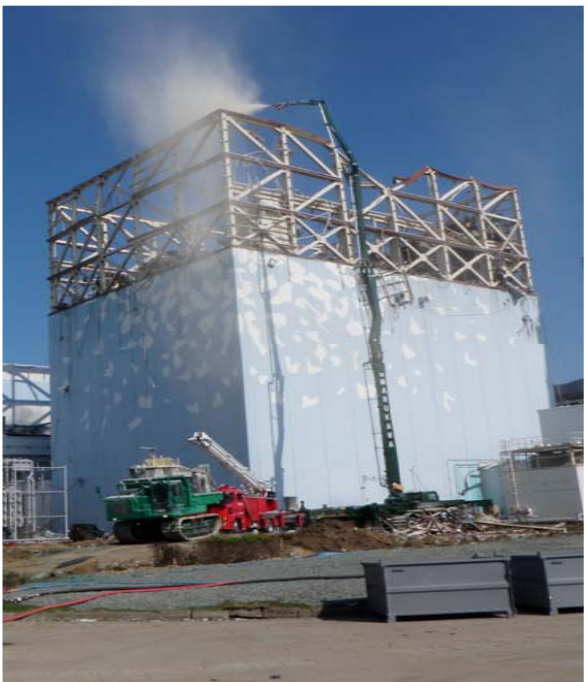
<p>Dispersion of inhibitors by bending spray tower vehicle</p> </div>

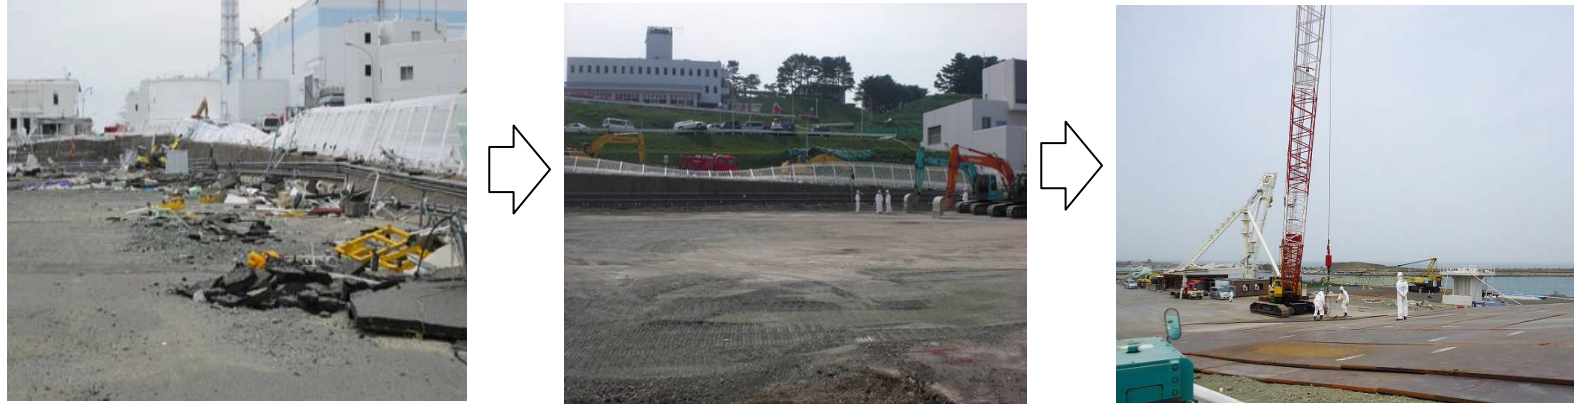
<p style="text-align: center;">Before Laying pavement and leveling Laying steel plates</p>

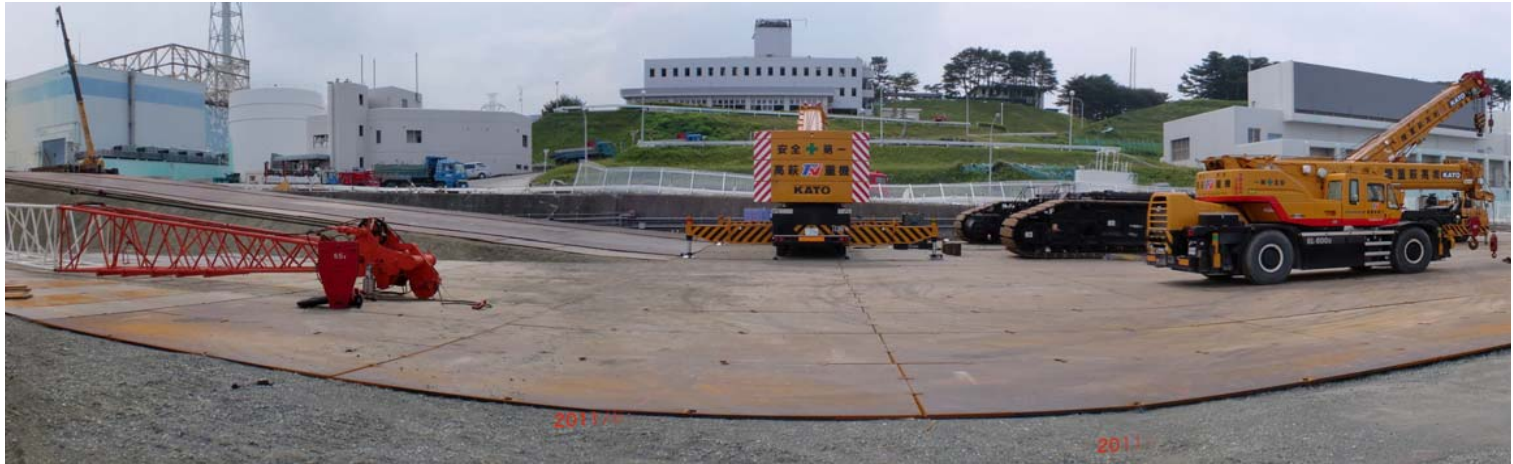
<p style="text-align: center;">Preparation work (Improvement of condition of shallow draft quay, completion of laying steel plates (finished on Jun. 11))</p>

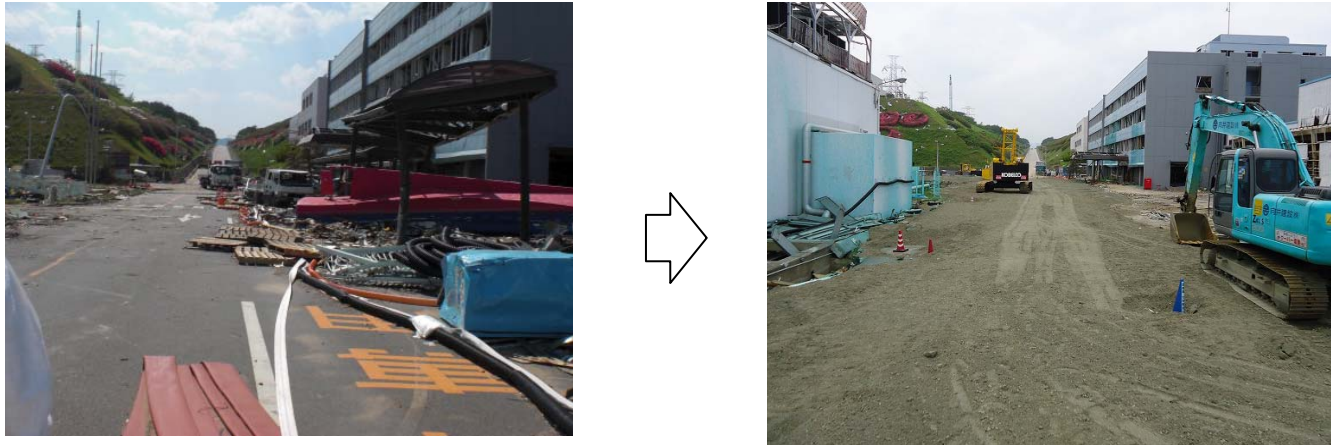
<p style="text-align: center;">Preparation work (road for crawler crane)</p>

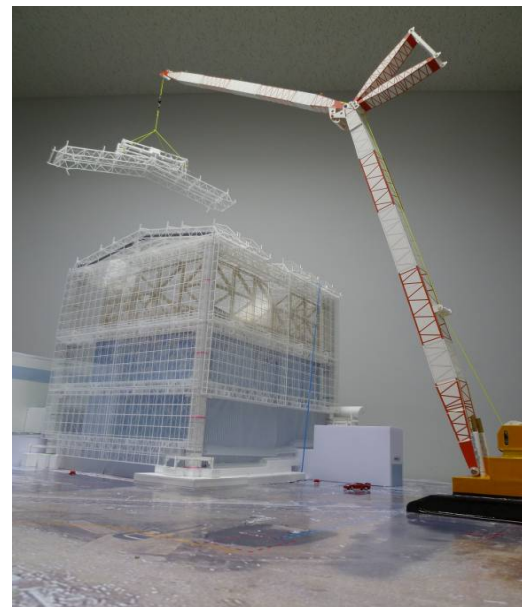
Installation model of reactor building cover for Unit 1

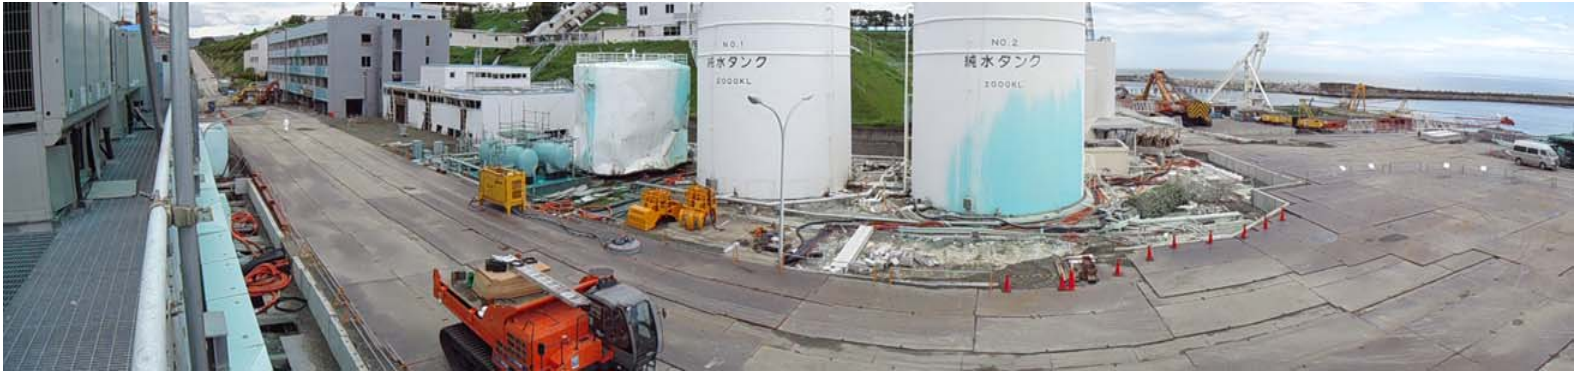
<p>Status of preparation work (shallow draft quay ~ road for crawler crane)</p> </div> <div style="display: flex; justify-content: space-around;"> <div style="text-align: center;">

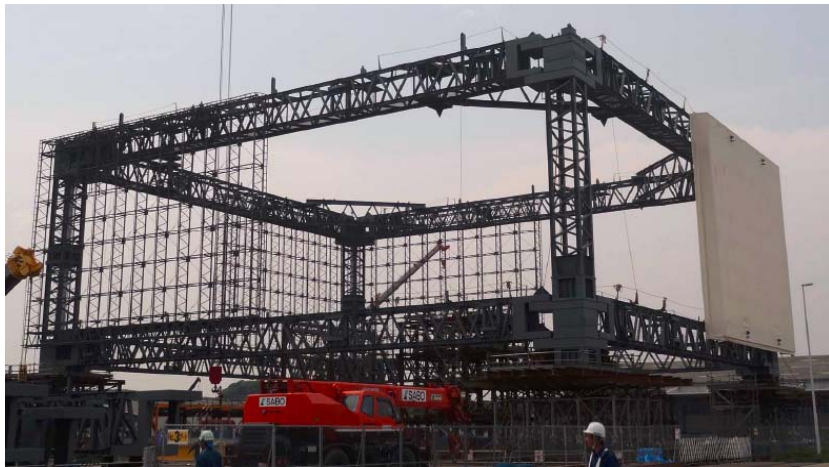
<p>Temporary assembly of reactor building cover for Unit 1 (at Onahama Port)</p> </div> <div style="text-align: center;">

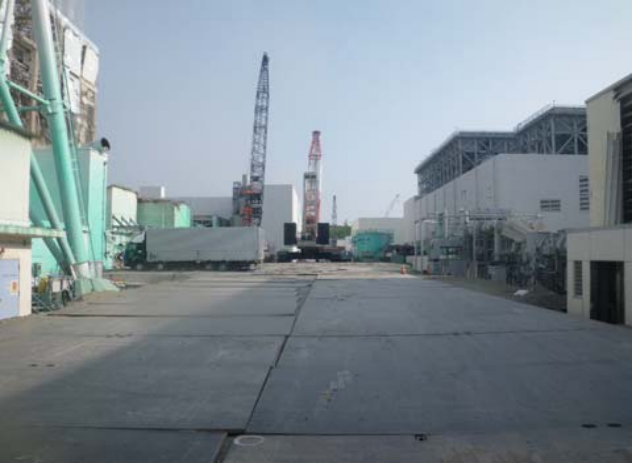
<p>Maintenance of roads for large-size crane</p>

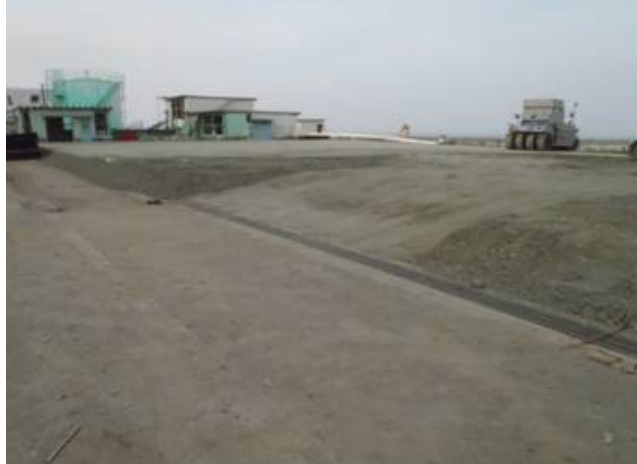
<p>Maintenance of working area for assembling steel frames</p>

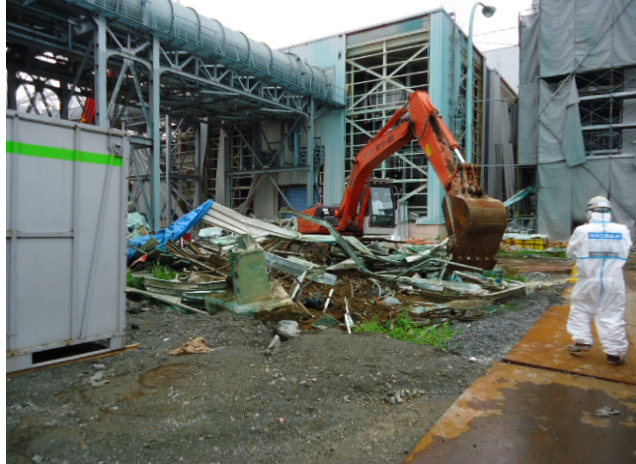
<p>Removal of debris</p>

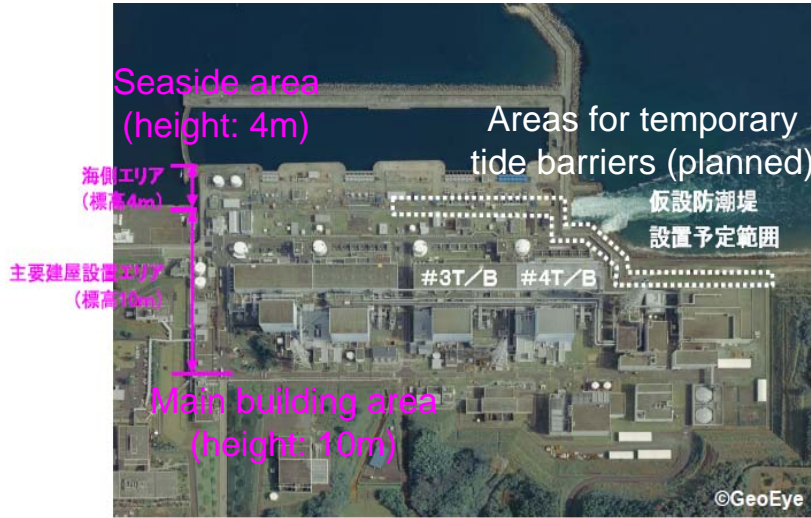
<p>Countermeasure [70] Enhancement of countermeasures against tsunami</p>	<p>-Started installation of temporary tide barrier on May 18 and completed on June 30</p>	<div style="display: flex; justify-content: space-around;"> <div data-bbox="2092 430 2680 735">

<p>Cross-section of temporary tide barrier (image)</p> </div> <div data-bbox="1365 861 1944 1291">

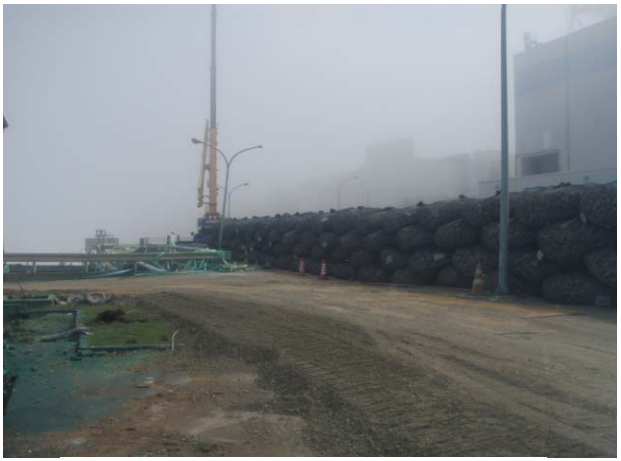
<p>Temporary tide barrier (1)</p> </div> <div data-bbox="2003 861 2597 1291">

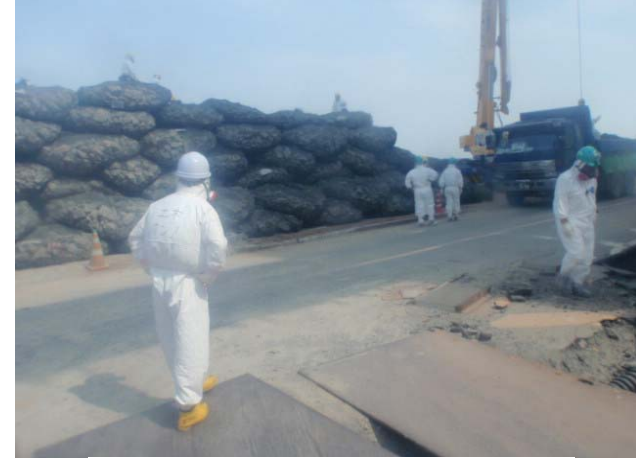
<p>Temporary tide barrier (2)</p> </div> <div data-bbox="1365 1375 1944 1816">

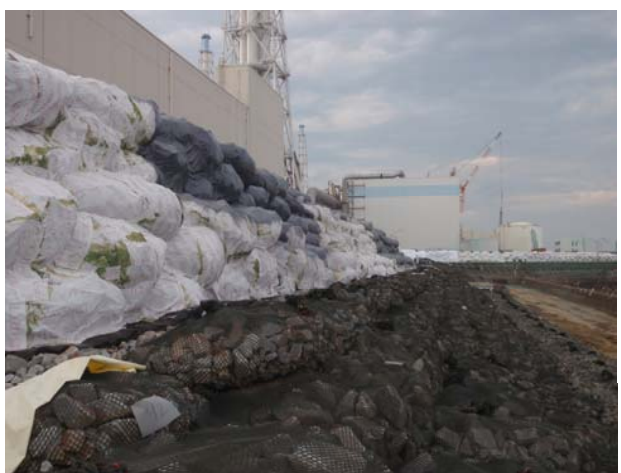
<p>Temporary tide barrier (3)</p> </div> <div data-bbox="2003 1375 2597 1816">

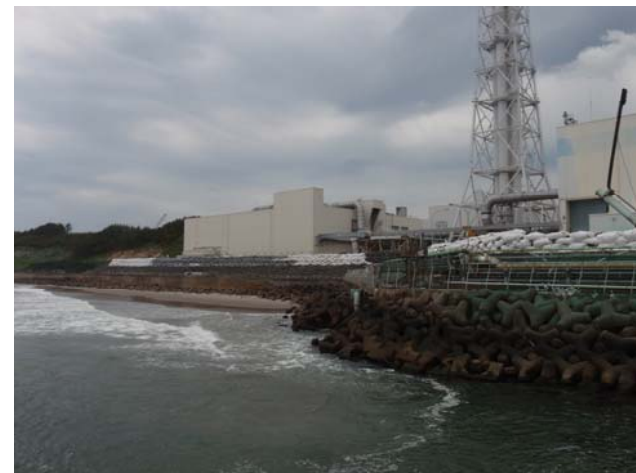
<p>Temporary tide barrier (4)</p> </div> </div>

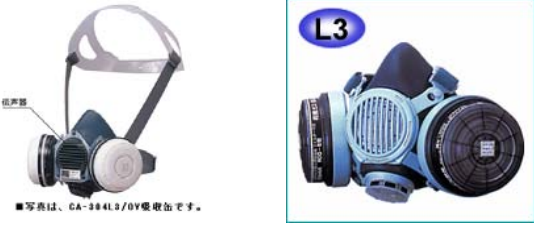
<p><small>*Source: vendor catalogue</small></p> <p>Half-faced mask: In case that radioactivity density is low and stable, workers put on half-face masks, not full-face, (with goggles), which enables to lighten the workload of workers.</p>

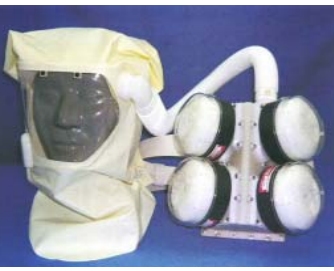
<p><small>*Source: vendor catalogue</small></p> <p>Hood mask; Keeping the inner pressure positive, the mask prevents influx of outer air. Continuous ventilation helps exhausting the inner humidity and prevents heat injuries.</p>
