Progress Status Classified by Issues (Photos and Figures)

Issues	Progress etc.	Reference (Photos and Figures)
I. Cooling (1) Reactor	<p>[Unit 1]</p> <p>Improvement of working environment</p> <p>Removal of debris, measurement of radiation dose, entrance into buildings (May 9)</p> <p>RPV water level gauge calibration (May 10)</p> <p>PCV pressure gauge calibration (May 11)</p> <p>Installation of water level gauge at basement of Reactor Building (May 27)</p> <p>Installation of temporary RPV pressure gauge (Jun. 3)</p>	<div style="display: flex; justify-content: space-around;"> <div style="text-align: center;">

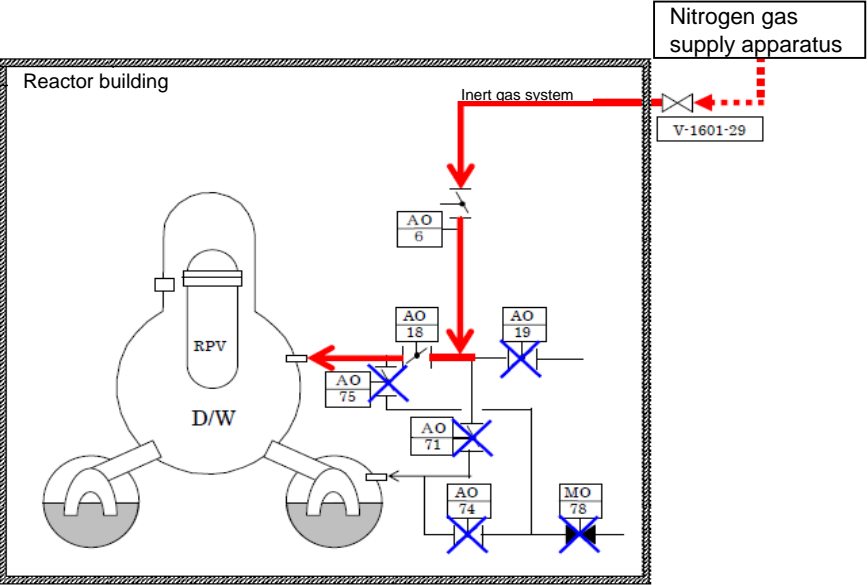
<p>System outline of nitrogen gas injection</p> </div> <div style="text-align: center;">

<p>Nitrogen gas injection</p> <p>Implementing from Apr. 6</p>	<div style="display: flex; justify-content: space-around;"> <div style="text-align: center;">

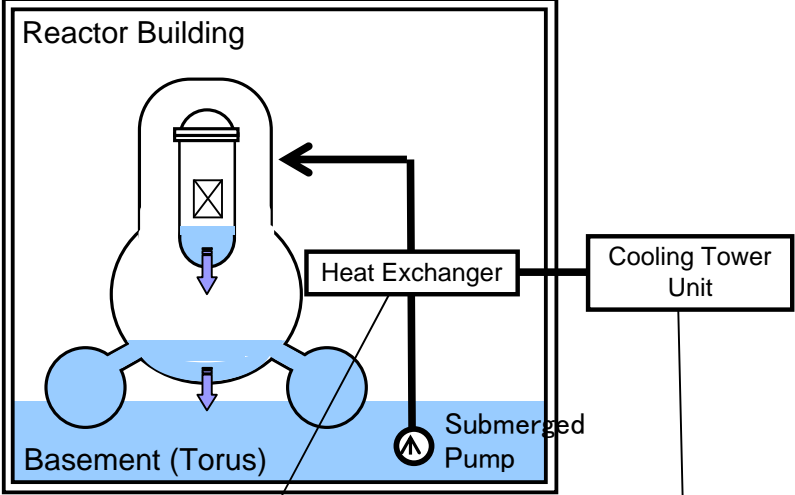
Issues	Progress etc.	Reference (Photos and Figures)
<p>I. Cooling</p> <p>(1) Reactor</p>	<p>Secure heat exchange function</p> <ul style="list-style-type: none"> - Due to the leakage from the primary containment vessel (PCV), judged that it was difficult to secure water level of PCV. - Therefore, prioritize the achievement of circulation cooling of reactors by circulating water cooling. - For the reactor cooling facilities using heat exchanger, examining its implementation as mid to long term measures. <p>(Work implemented)</p> <ul style="list-style-type: none"> - Completed the assembly of cooling tower unit and shielding equipment to reduce exposure dose for outdoor work (from May 17 to Jun. 17) 	<div data-bbox="1199 457 1843 552" style="border: 1px solid black; padding: 5px; margin-bottom: 10px;"> <p>[Under consideration] Outline of circulating cooling system within the reactor building</p> </div>

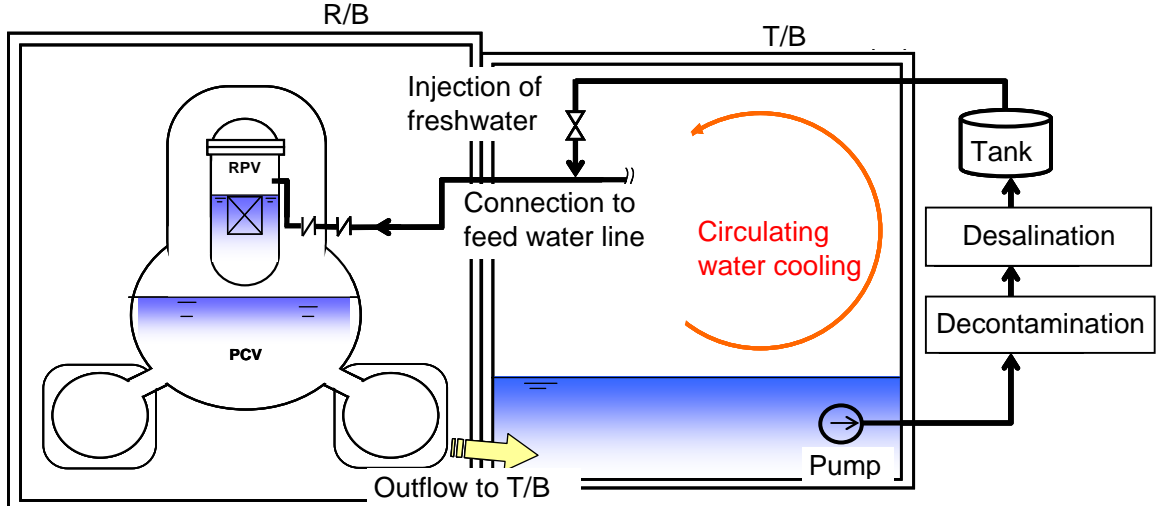
</div>
		<div style="border: 1px solid black; padding: 5px; width: fit-content; margin: 0 auto;"> <p>System outline of water reuse as reactor coolant by processing accumulated water</p> </div>

<p>Consideration and preparation of reuse of accumulated water</p> <ul style="list-style-type: none"> - Work on injection line (from May 21) - Started circulating water cooling from Jun. 27 <p>Initiation and implementation of circulating water cooling</p> <ul style="list-style-type: none"> - Started circulating water cooling from Jun. 27 	<div style="text-align: center;">

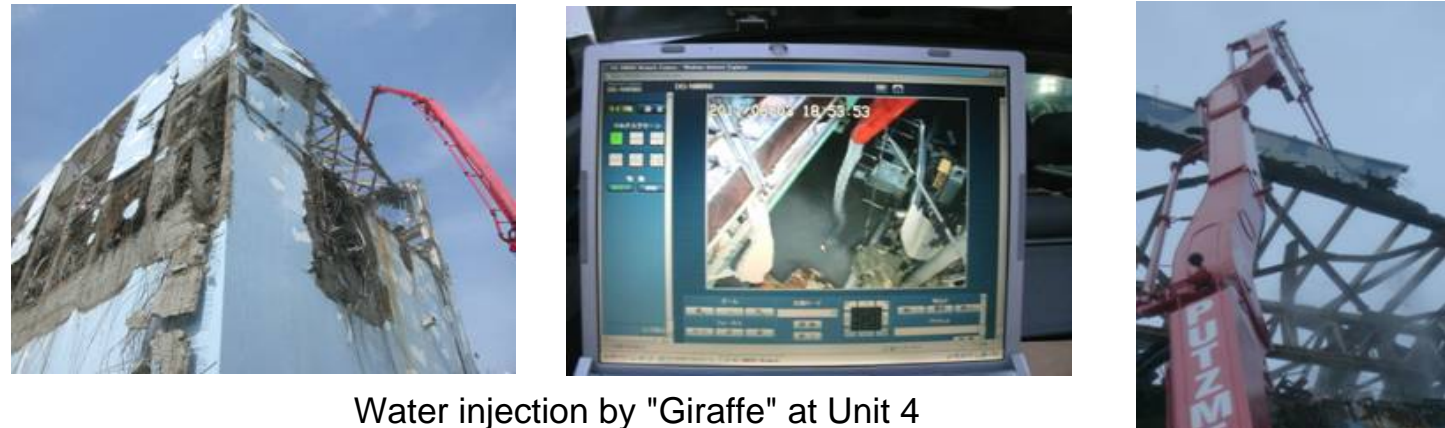
<p>Water injection by "Giraffe" at Unit 4</p>
	<p>Restoration of normal cooling system</p> <ul style="list-style-type: none"> - Water injection by installing alternative equipment to "Giraffe" (from Jun. 17) - Switch to water injection line of circulating cooling system (from Oct. 3)

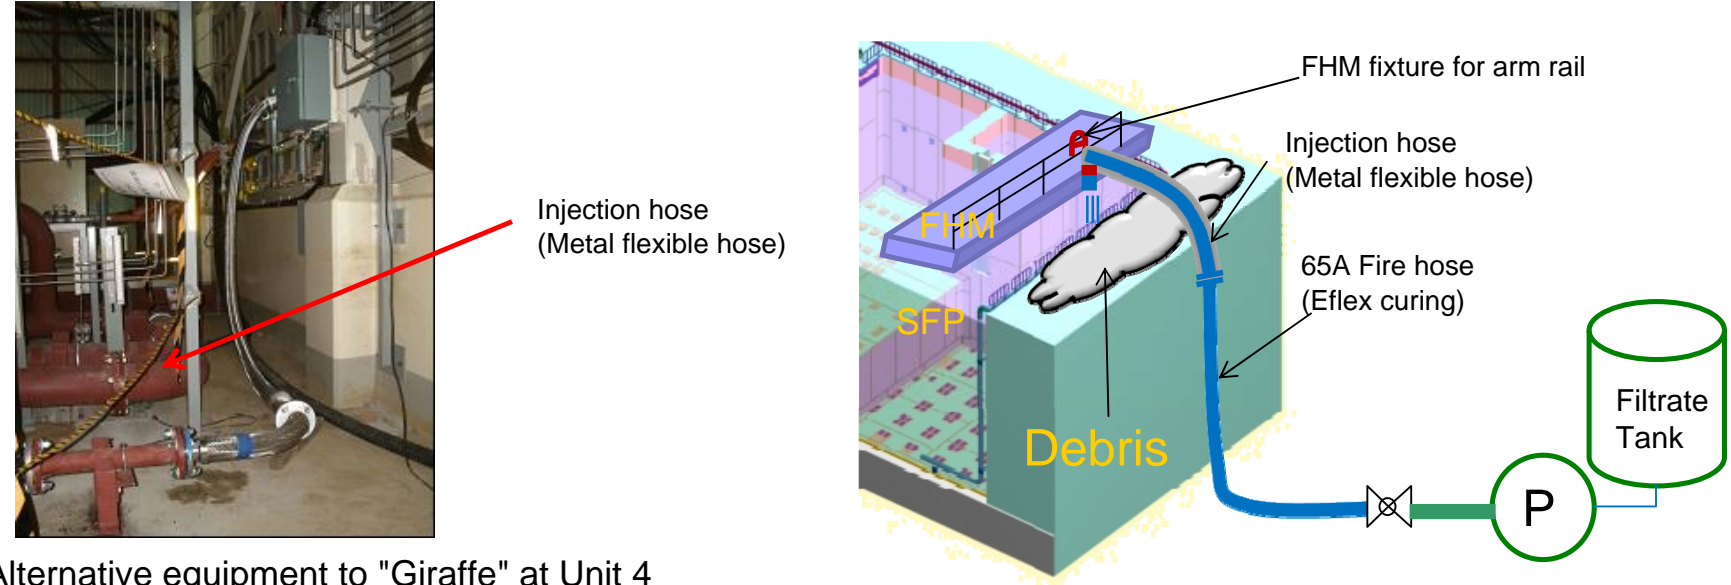
<p>Injection hose (Metal flexible hose)</p> <p>Alternative equipment to "Giraffe" at Unit 4</p> <p>Alternative equipment to "Giraffe" at Unit 4 (as of Jun.17)</p> <p>Schematic labels: FHM, SFP, Debris, FHM fixture for arm rail, Injection hose (Metal flexible hose), 65A Fire hose (Eflex curing), Filtrate Tank, P</p>

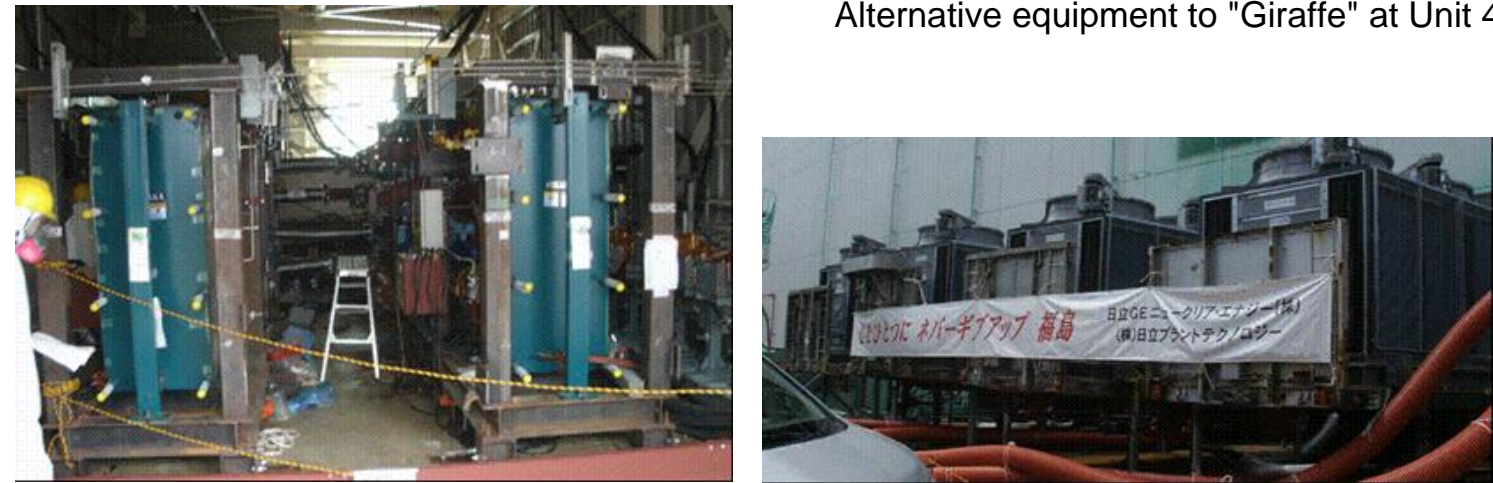
<p>Unit 4 Heat Exchanger Unit</p> <p>Air Fin Cooler</p>

<p>Installation of heat exchanger</p> <ul style="list-style-type: none"> - Installation work of heat exchanger completed. Circulating cooling system is under operation (from Jul. 31).

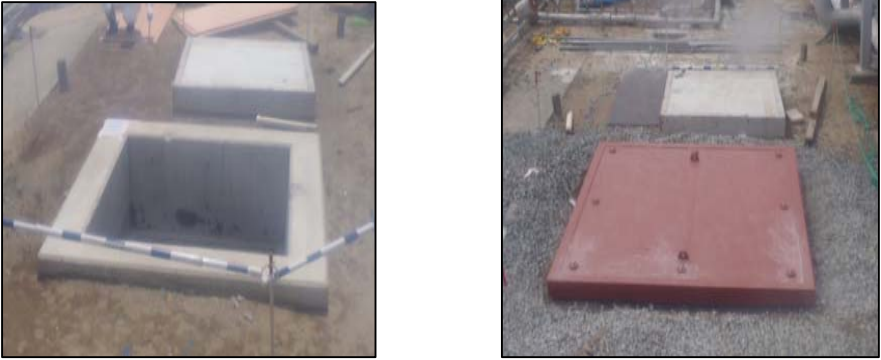
<p style="color: white; background-color: blue; padding: 2px;">Closure of sea water piping vertical shaft (left: before closure, right: after closure)</p> </div> <div style="text-align: center;">

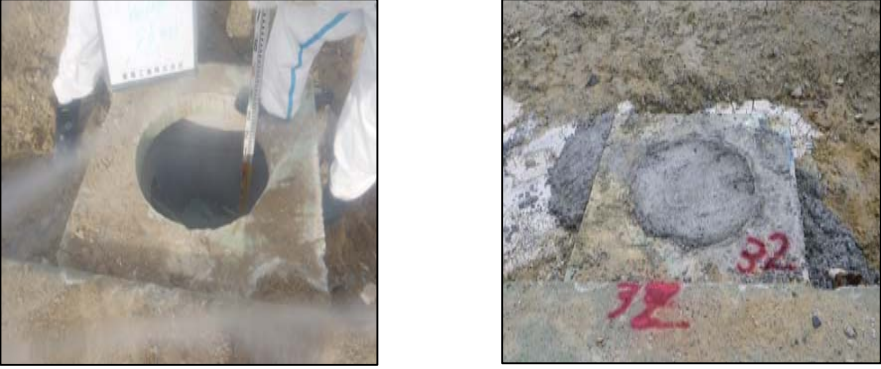
<p style="color: white; background-color: blue; padding: 2px;">Closure of pit (left: before closure, right: after closure)</p> </div> </div>

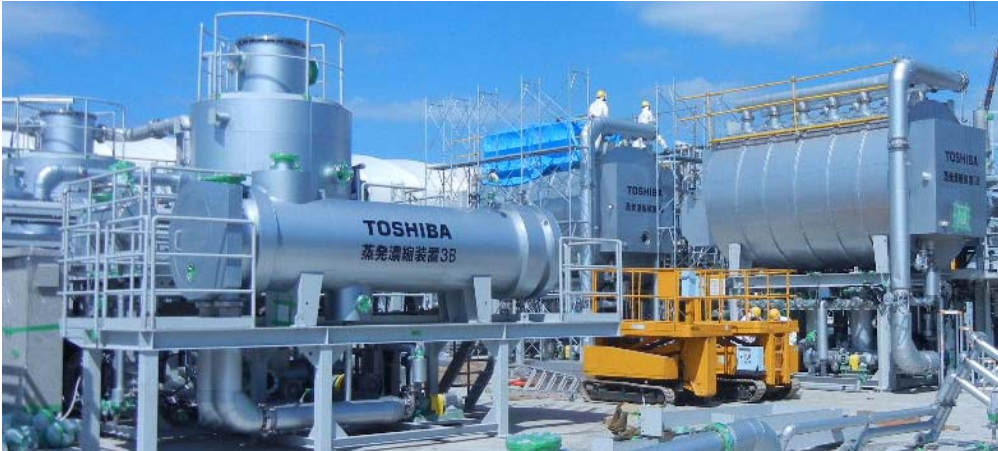
<p style="text-align: center;">Evaporative concentration apparatus (3A, 3B, 3C)</p>

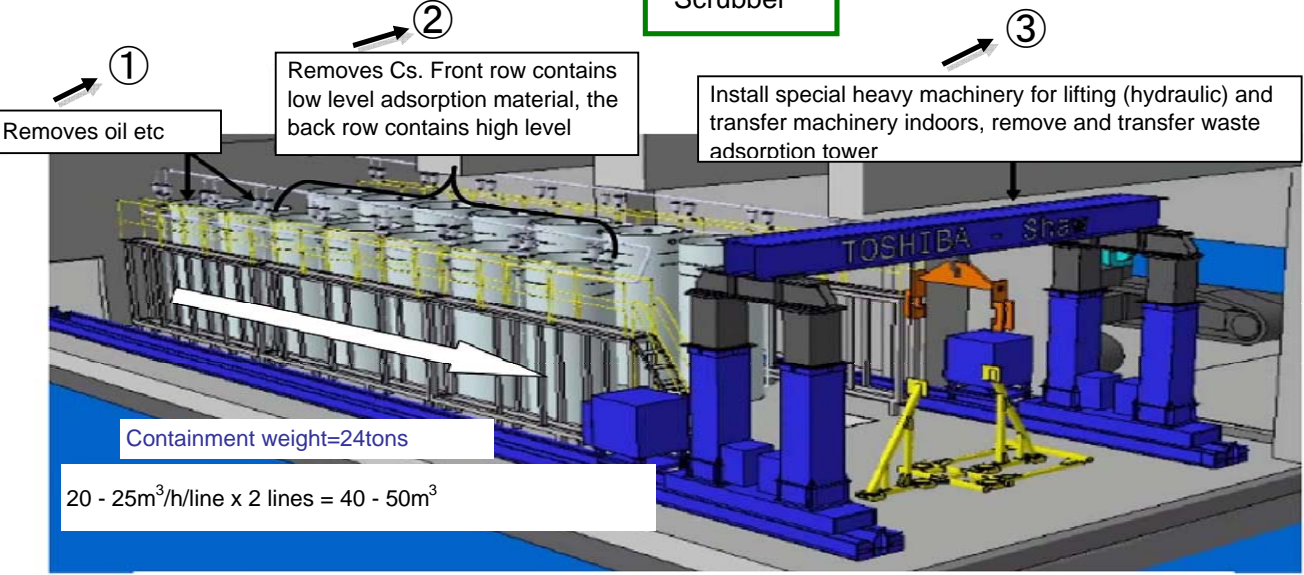
<p style="text-align: center;">Cesium adsorption apparatus (SARRY)</p>

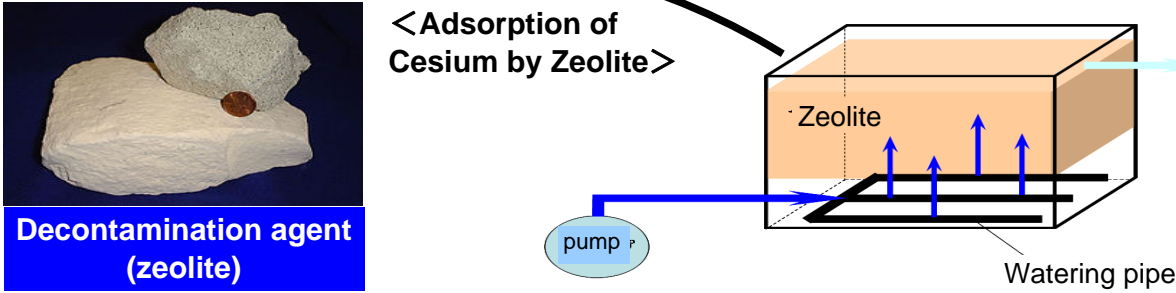
</div> </div> </div> </div> <div style="text-align: center; margin-top: 20px;"> <p><Adsorption of Cesium by Zeolite></p>

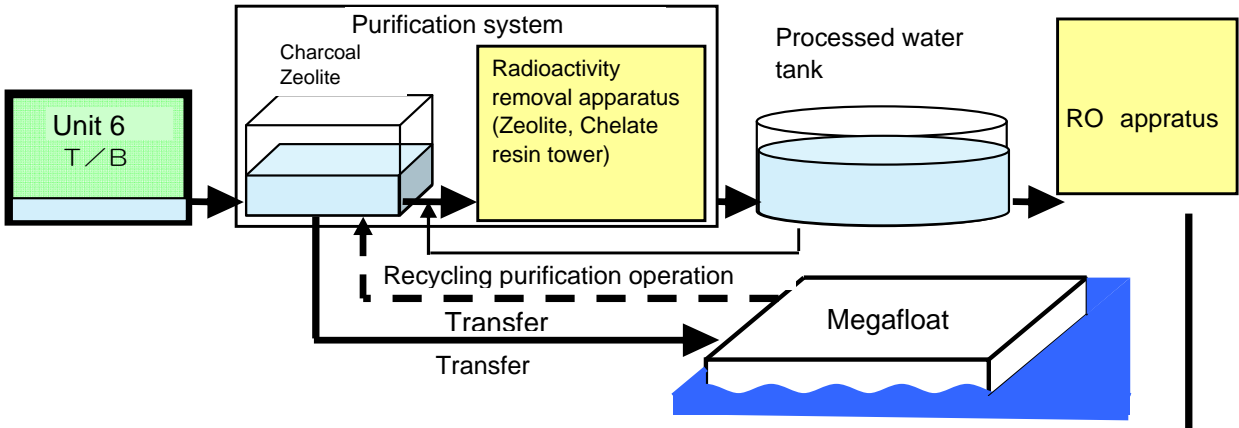
</div> <div style="text-align: center; margin-top: 20px;"> <p>Purification system</p>

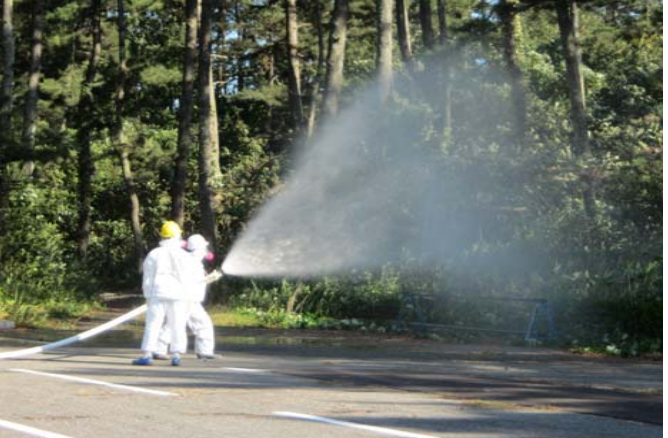
<p style="background-color: blue; color: white; padding: 5px; text-align: center;">Sprinkling purified accumulated water in Unit 6 T/B within the site</p> </div>

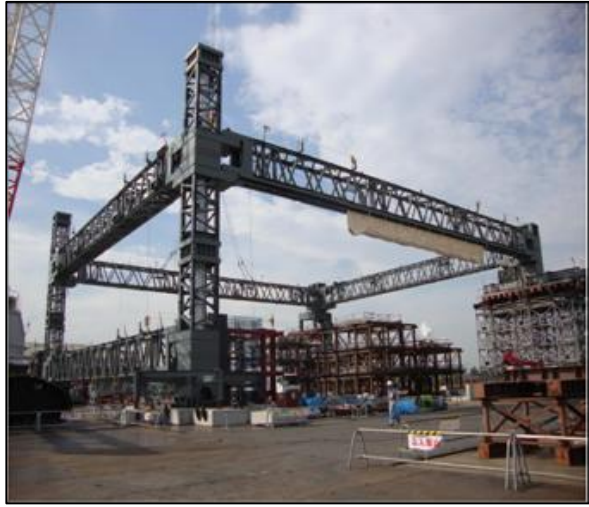
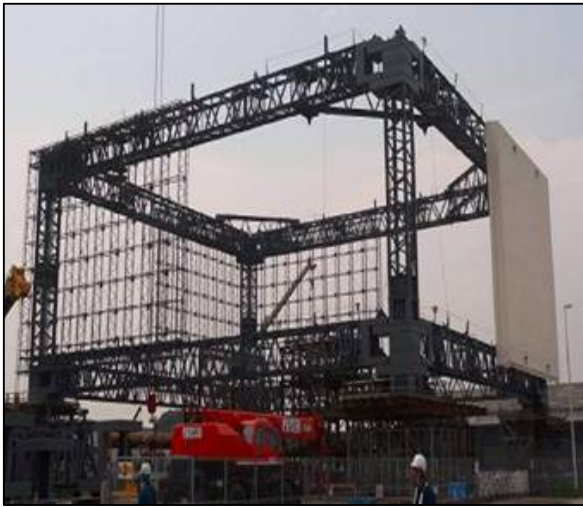
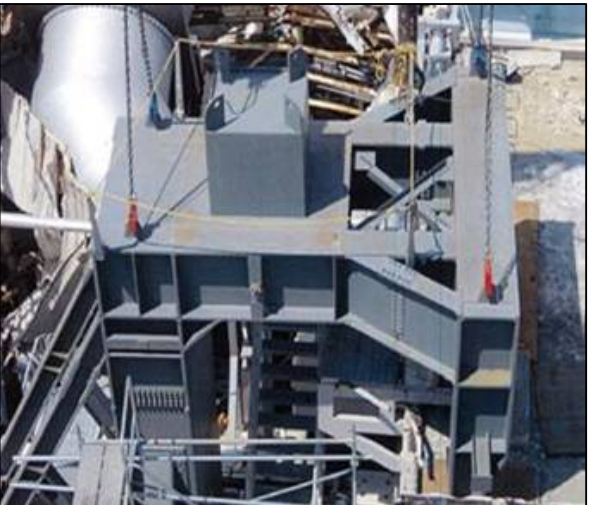
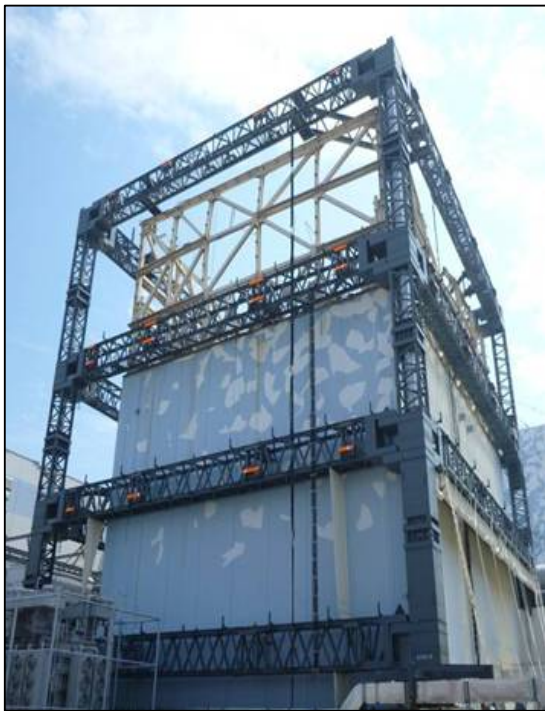
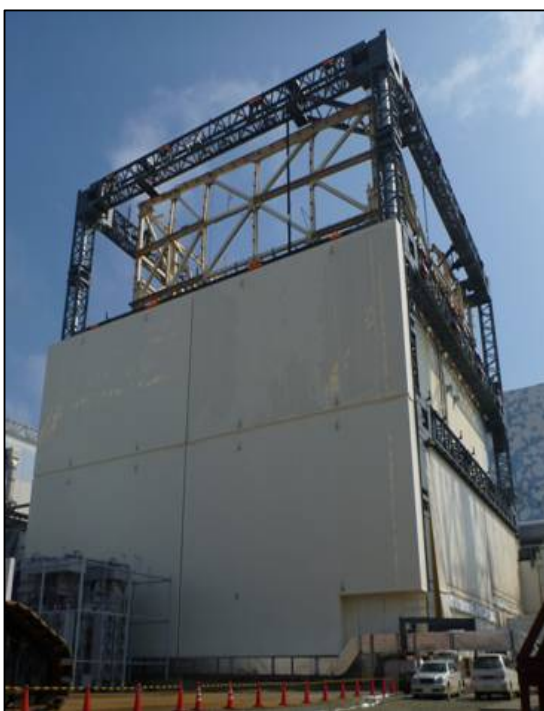
<p>Temporary assembly of reactor building cover (at Onahama port)</p> <p>Temporary assembly of reactor building cover (at Onahama port)</p> <p>Beginning of main construction of reactor building cover</p> <p>Main steel-frame work of main structure</p> <p>Main steel-frame work of main structure</p> <p>Start steel-frame work on Aug. 10</p> <p>Completion of steel-frame work on Sep. 9 (Northwest side)</p> <p>Setting wall panel as of Sep. 15 (Northwest side)</p>

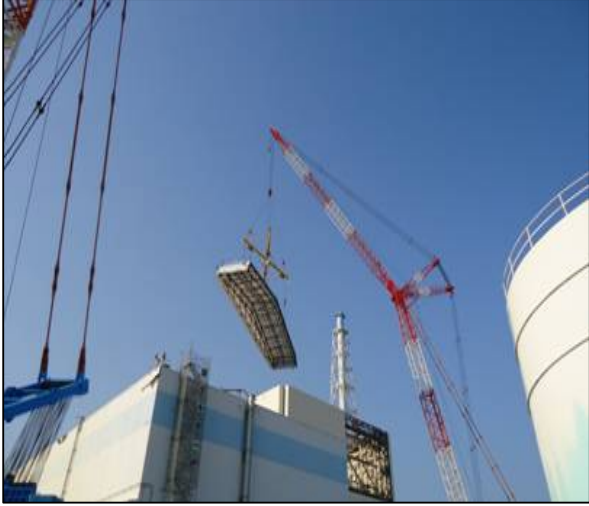
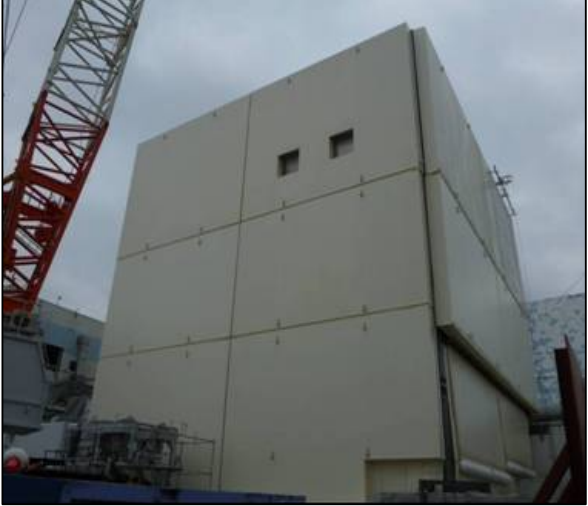
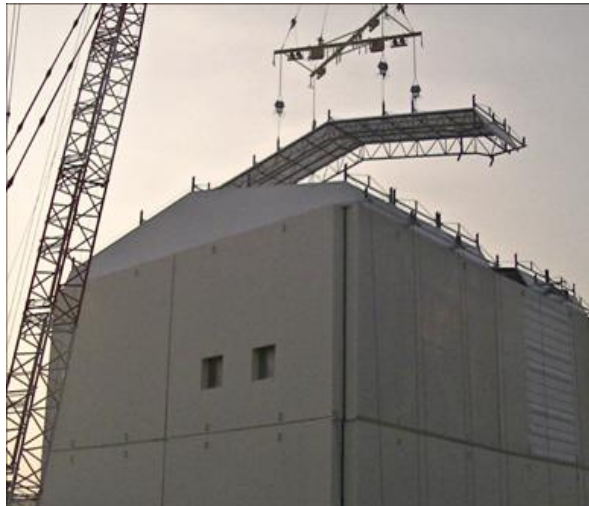
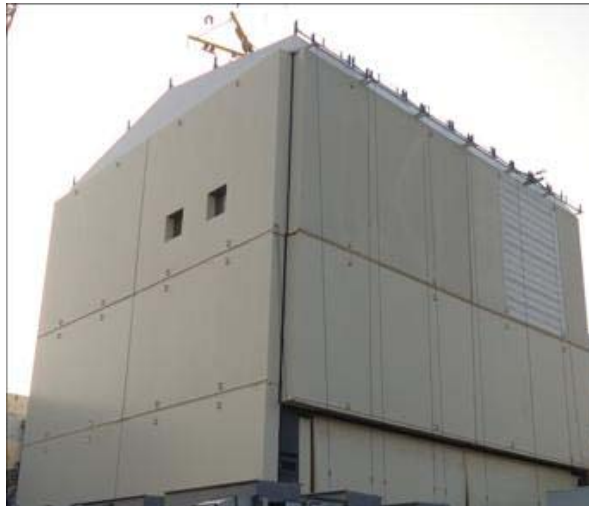
Setting roof panel on Oct. 8	Completion of setting wall panel on Oct. 10 (North side)
		Setting roof panel on Oct. 14	Completion of setting roof panel on Oct. 14

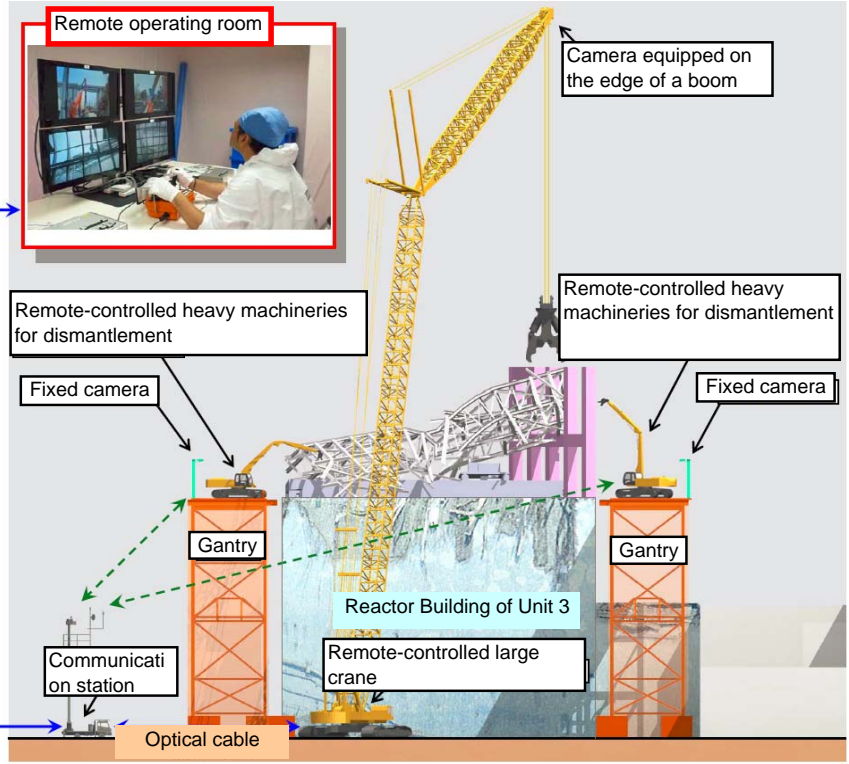
<p>Image of removal of debris on top of the reactor building</p>

Issues	Progress etc.	Reference (Photos and Figures)				
II. Mitigation (5) Atmosphere / Soil	<p>[Unit 3]</p> <p>Removal of debris on top of the reactor buildings</p> <ul style="list-style-type: none"> • Commencement of preparation work from Jun. 20 • Commencement of main work from Sep. 10

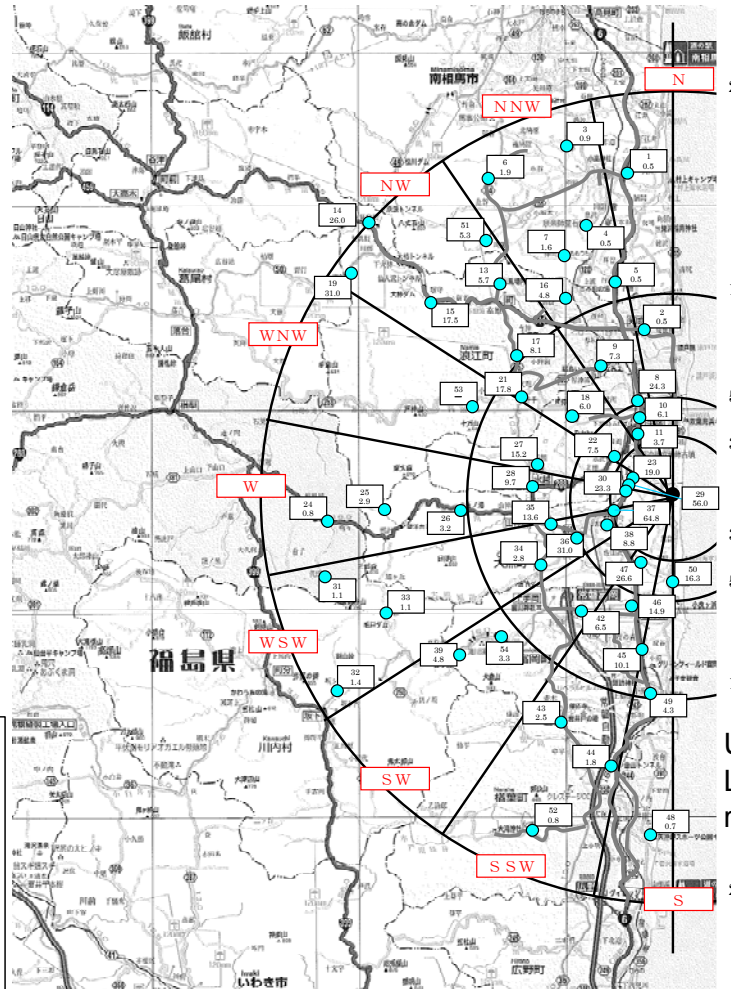
<p>Measurement result of air dose rate of within 20 km radius (date: Oct. 11, 2011)</p>

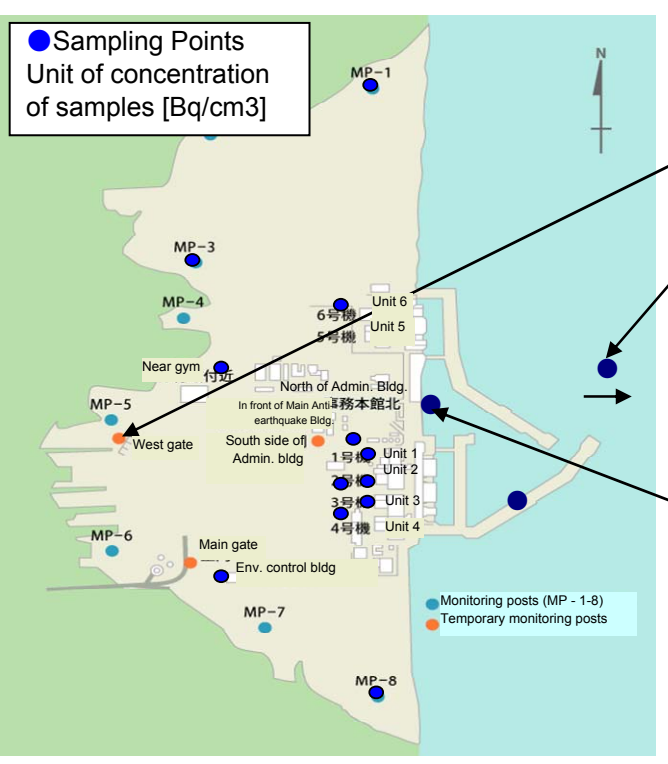
<p>Fukushima Daiichi measuring points of airborne radiation concentration</p> <ul style="list-style-type: none"> ● Sampling Points Unit of concentration of samples [Bq/cm³] ● Monitoring posts (MP-1-8) ● Temporary monitoring posts

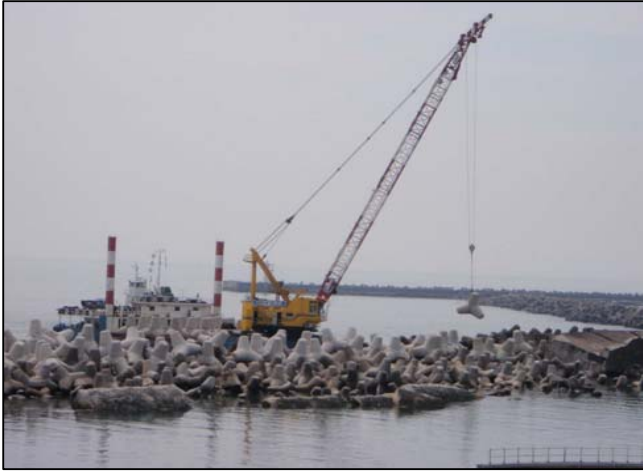
<p>Tide barrier of Unit 5/6 (construction work)</p>
