# Progress Status Classified by Issues (Photos and Figures)

Issues	Progress etc.	Reference (Photos and Figures)
I. Cooling (1) Reactor	<p>[Unit 1]</p> <p><b>Improvement of working environment</b></p> <p>Removal of debris, measurement of radiation dose, entrance into buildings (May 9)</p> <p>RPV water level gauge calibration (May 10)</p> <p>PCV pressure gauge calibration (May 11)</p> <p>Installation of water level gauge at the basement of the reactor building (May 27)</p> <p>Installation of temporary RPV pressure gauge (Jun. 3)</p>	<div style="display: flex; justify-content: space-around;"> <div style="text-align: center;">

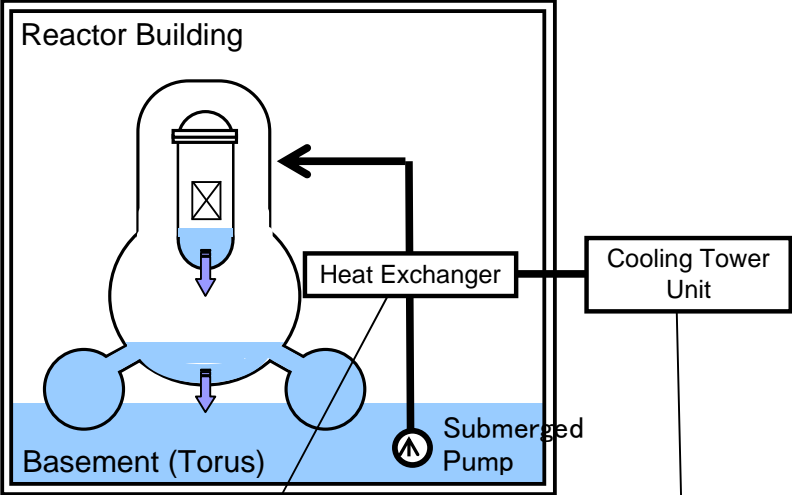
Issues	Progress etc.	Reference (Photos and Figures)
<p>I. Cooling</p> <p>(1) Reactor</p>	<p><b>Secure heat exchange function</b></p> <ul style="list-style-type: none"> <li>- Due to the leakage from the primary containment vessel (PCV), judged that it was difficult to secure water level of PCV.</li> <li>- Therefore, prioritized the achievement of circulation cooling of reactors by circulating water cooling.</li> <li>- For the reactor cooling facilities using heat exchanger, examining its implementation as mid and long term measures.</li> </ul> <p>(Work implemented)</p> <ul style="list-style-type: none"> <li>- Completed the assembly of cooling tower unit and shielding equipment to reduce exposure dose for outdoor work (from May 17 to Jun. 17)</li> </ul>	<p>[Under consideration] Outline of circulating cooling system within the reactor building</p>

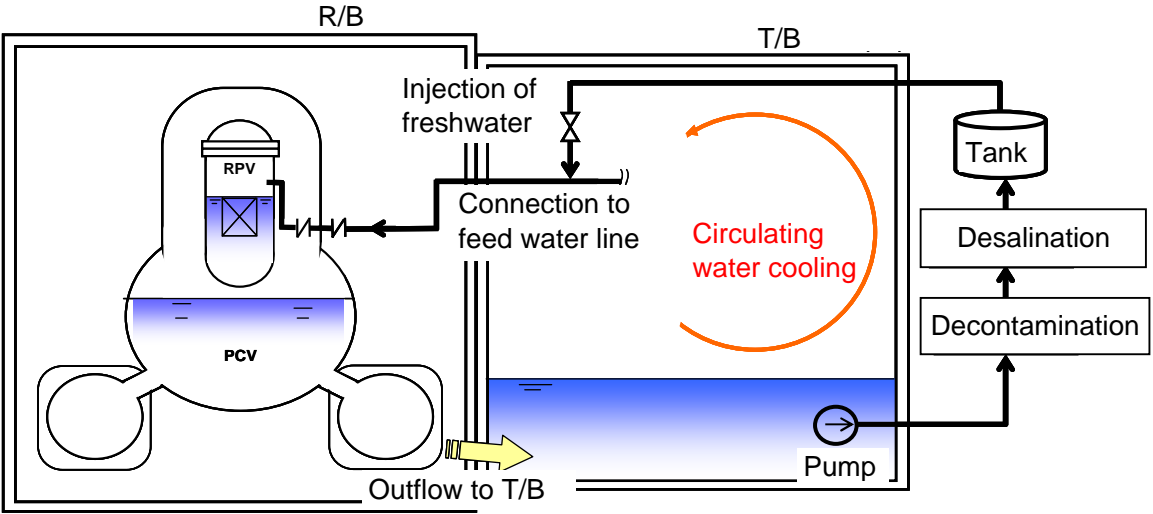
<p><b>Consideration and preparation of reuse of accumulated water</b></p> <ul style="list-style-type: none"> <li>- Work on injection line (from May 21)</li> <li>- Started circulating water cooling from Jun. 27</li> </ul> <p><b>Initiation and implementation of circulating water cooling</b></p> <ul style="list-style-type: none"> <li>- Started circulating water cooling from Jun. 27</li> </ul> <p><b>Installation of PCV gas control system</b></p> <ul style="list-style-type: none"> <li>- Started installation from Oct. 10.</li> </ul>	<div style="text-align: center; margin: 10px 0;">

</div> <div style="text-align: center; border: 1px solid black; padding: 5px; margin: 10px auto; width: fit-content;"> <p>System outline of water reuse as reactor coolant by processing accumulated water</p> </div>

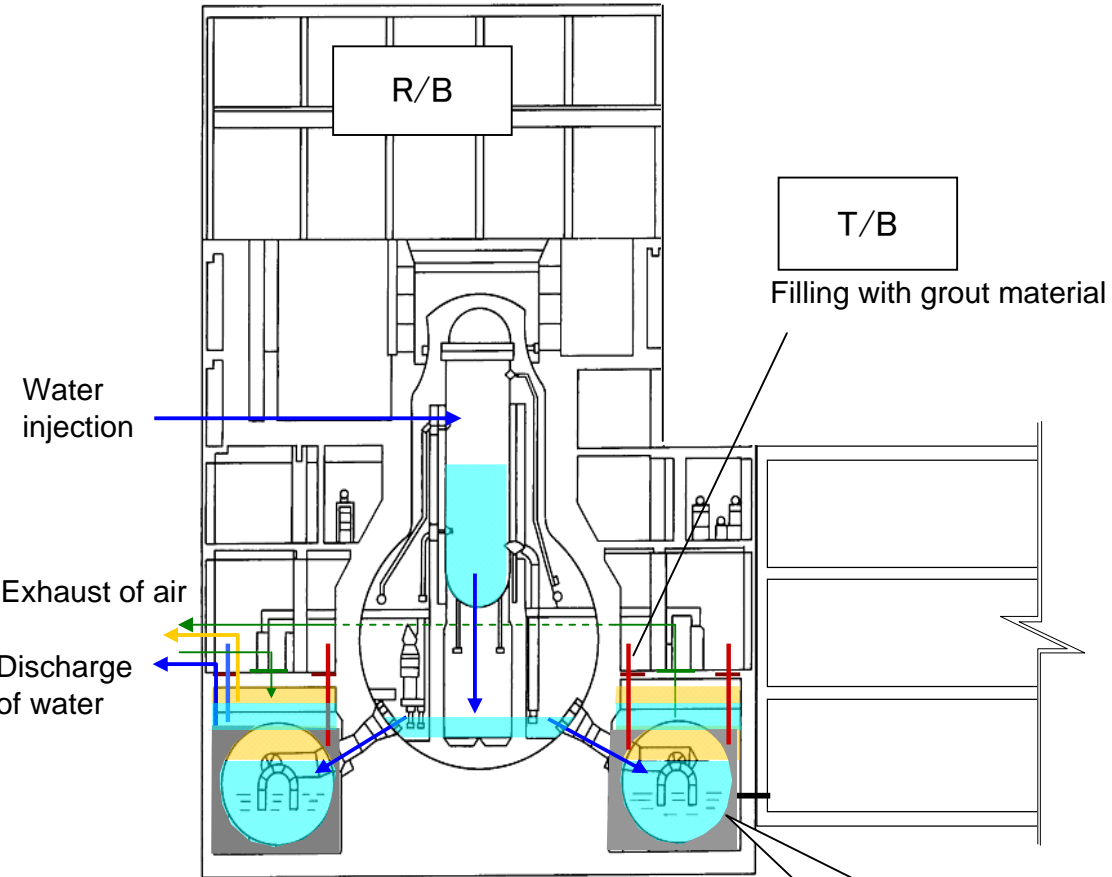
<div data-bbox="2021 1654 2549 1816" style="border: 1px solid black; padding: 5px; margin-top: 10px;"> <p>Drilling the 1st floor of the reactor building, filling the whole torus room with grout material.</p> </div>

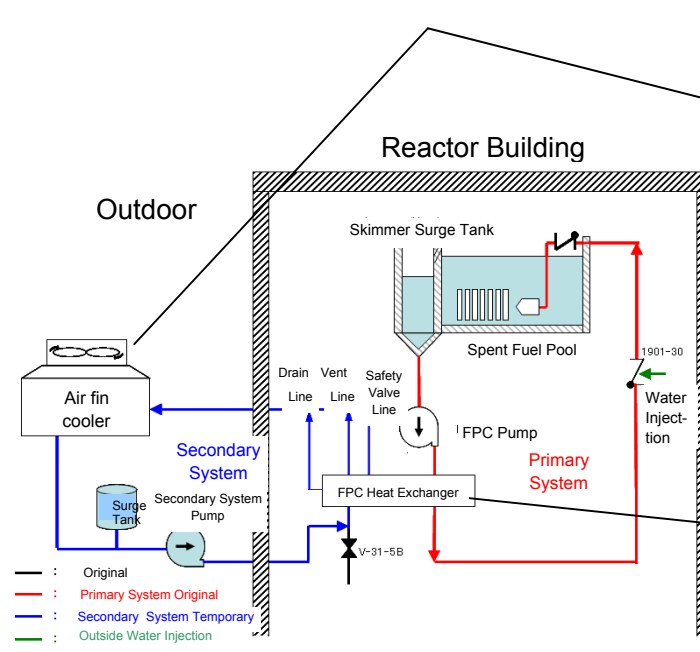
<p><b>Restoration of normal cooling system</b></p> <ul style="list-style-type: none"> <li>- Radiation measurement by γcamera and robot (from Apr. 30 to May 6)</li> <li>- Radiation reduction by flushing and shielding facility (from May 11 to May 15)</li> <li>- Water injection through normal cooling system (from May 29)</li> </ul>

<p style="text-align: center;">Overview of SFP cooling function</p>

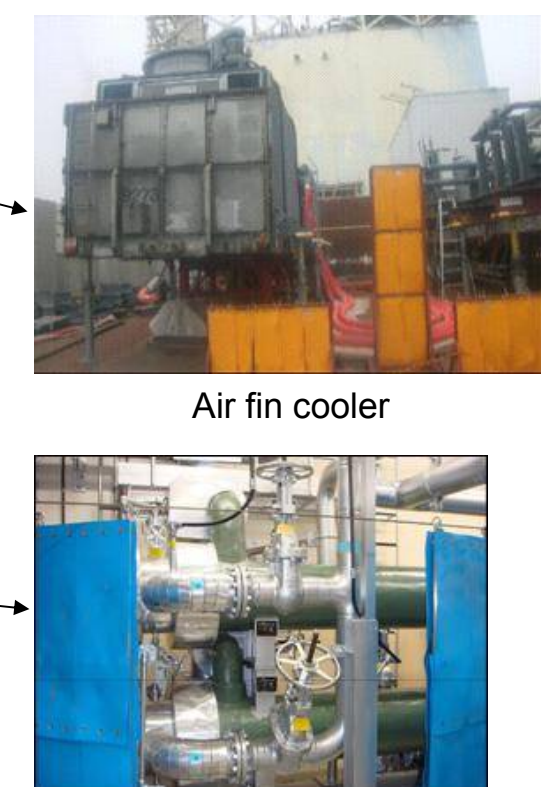
<p><b>Installation of heat exchanger</b></p> <ul style="list-style-type: none"> <li>- Installation work of heat exchanger completed. Circulating cooling system is under operation (from Aug. 10).</li> </ul>

<p style="text-align: center;">Air fin cooler</p> <p style="text-align: center;">Existing heat exchanger</p>

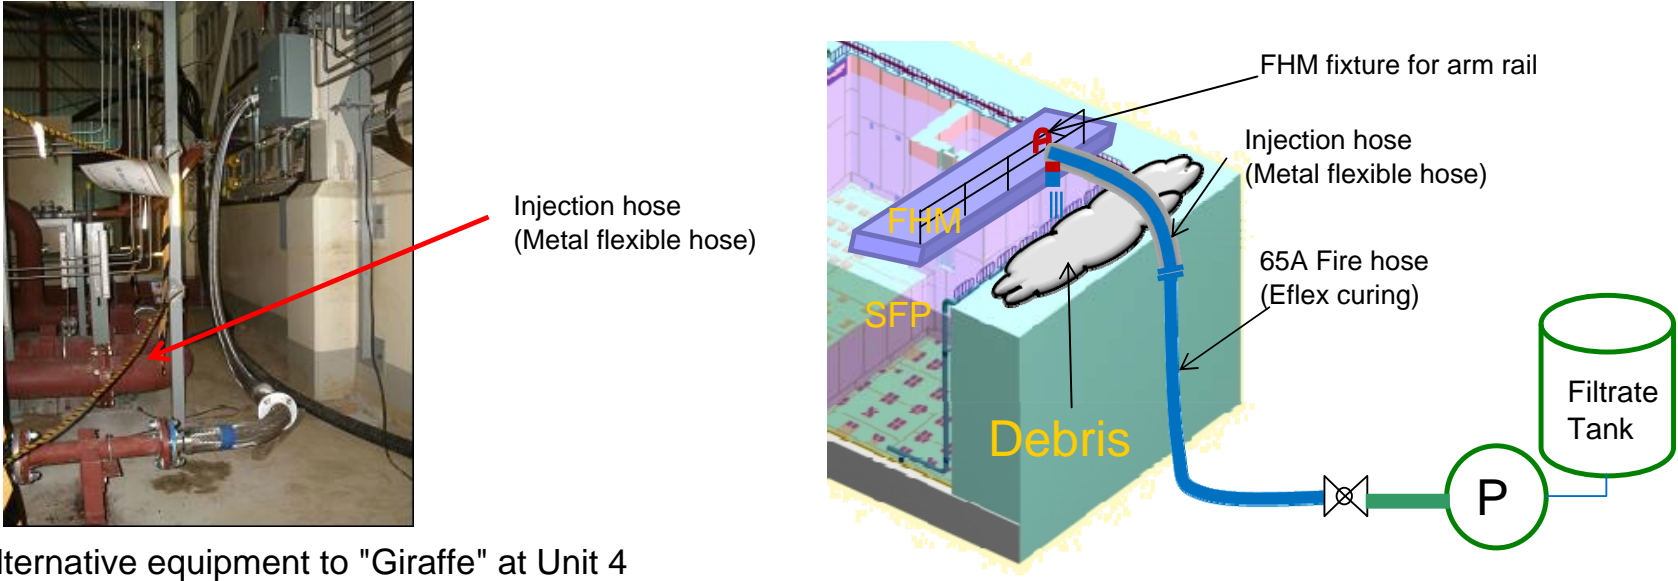
<p>Injection hose (Metal flexible hose)</p> <p>FHM fixture for arm rail</p> <p>Injection hose (Metal flexible hose)</p> <p>65A Fire hose (Eflex curing)</p> <p>Debris</p> <p>Filtrate Tank</p> <p>P</p> <p>Alternative equipment to "Giraffe" at Unit 4</p> <p>Alternative equipment to "Giraffe" at Unit 4 (removed)</p>

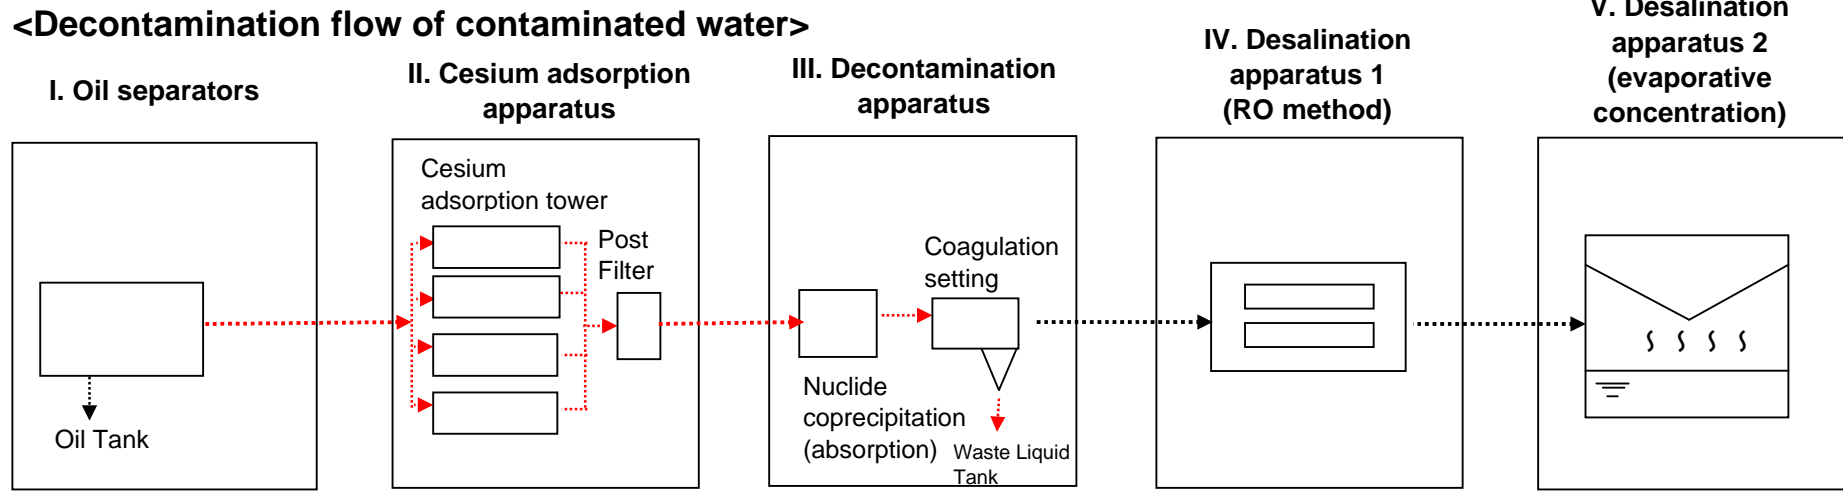
Issues	Progress etc.	Reference (Photos and Figures)
II. Mitigation (3) Accumulated Water	<p>[High level]</p> <p>Installation of Treatment Facility/Continuance of Elimination and Treatment of Contaminated Water in the Building</p>	<p><b>&lt;Decontamination flow of contaminated water&gt;</b></p>

<p>I. Oil separators Oil Tank</p> <p>II. Cesium adsorption apparatus Cesium adsorption tower Post Filter</p> <p>III. Decontamination apparatus Coagulation setting Nuclide coprecipitation (absorption) Waste Liquid Tank</p> <p>IV. Desalination apparatus 1 (RO method)</p> <p>V. Desalination apparatus 2 (evaporative concentration)</p>

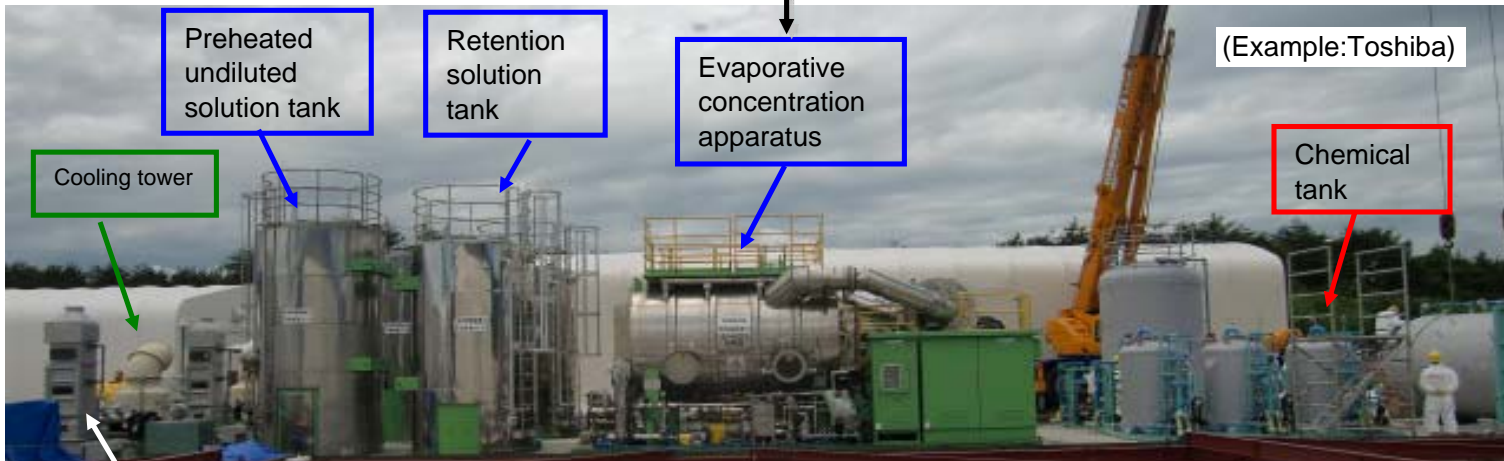
<p>Evaporative concentration apparatus (3A, 3B, 3C)</p>

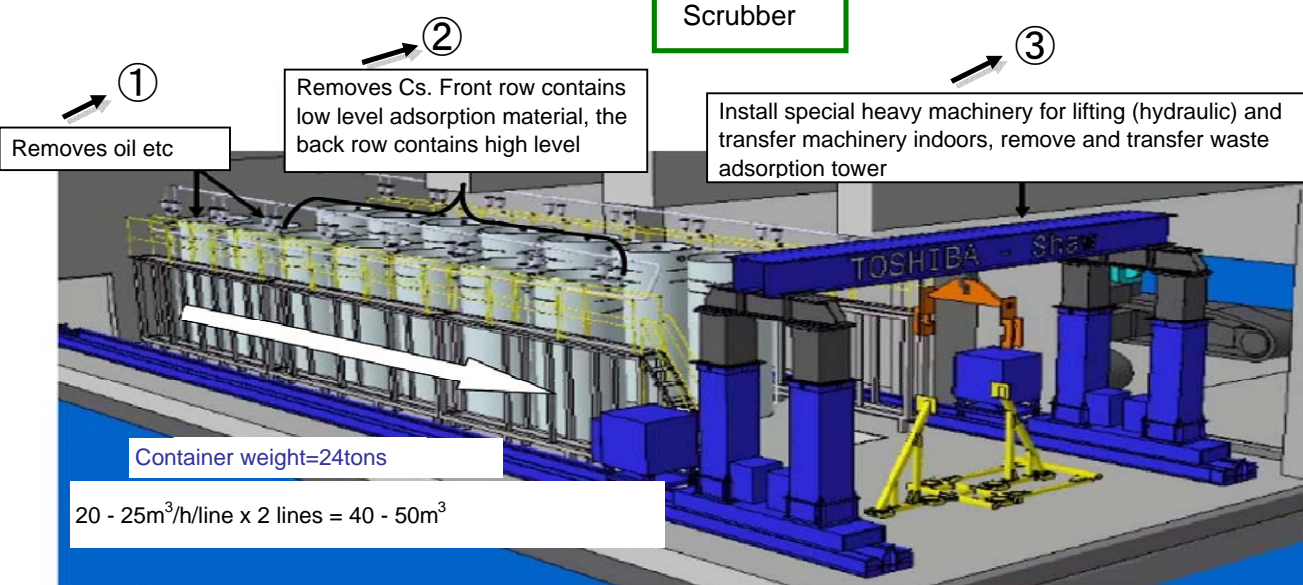
<p>① Removes oil etc</p> <p>② Removes Cs. Front row contains low level adsorption material, the back row contains high level</p> <p>③ Install special heavy machinery for lifting (hydraulic) and transfer machinery indoors, remove and transfer waste adsorption tower</p> <p>Container weight=24tons</p> <p>20 - 25m<sup>3</sup>/h/line x 2 lines = 40 - 50m<sup>3</sup></p> <p>Cesium adsorption apparatus (SARRY)</p>

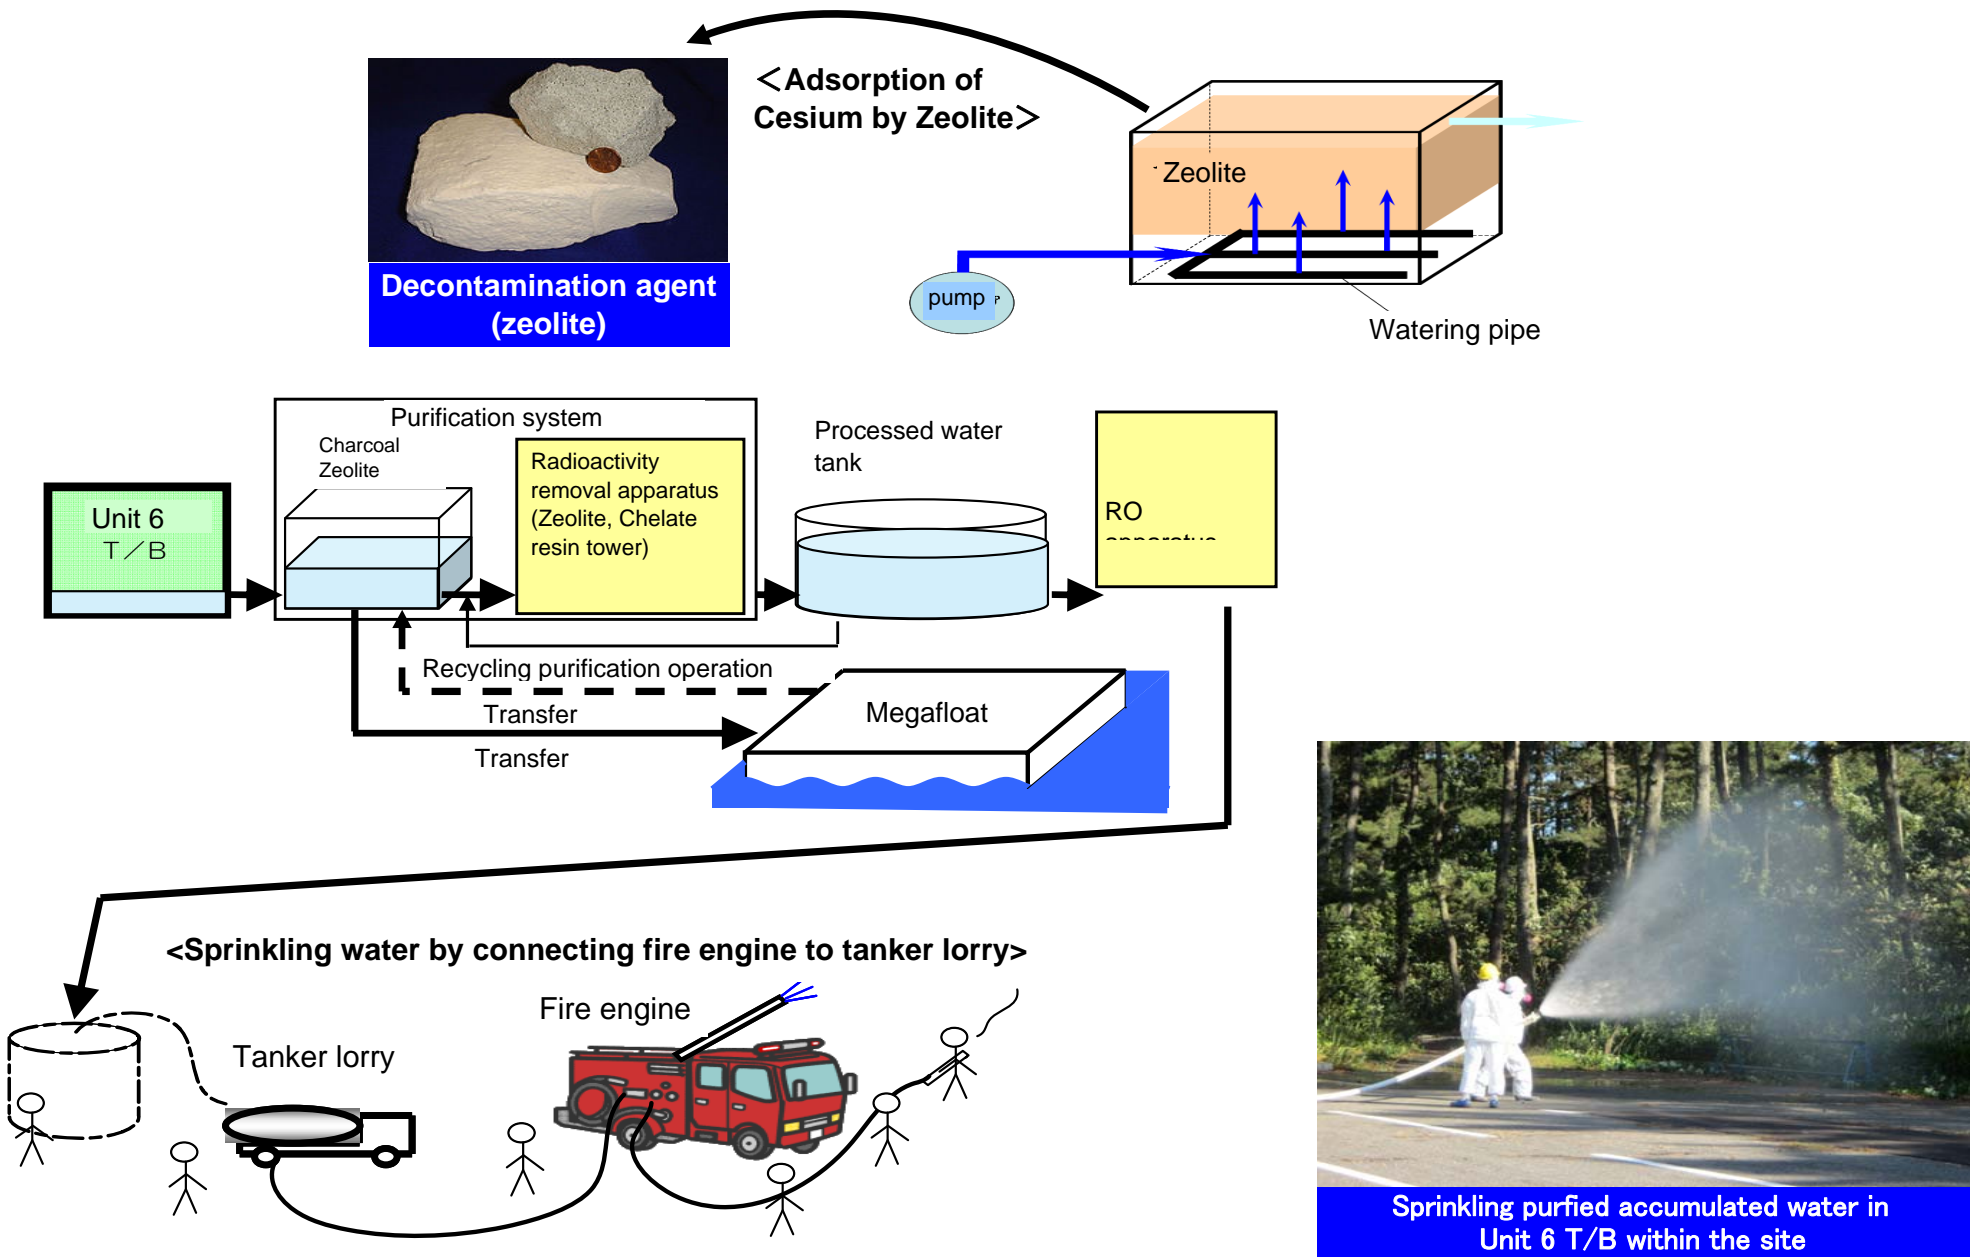
</div> </div> </div> </div>
	<p>Utilization of decontamination agent (zeolite)          Setting in water, self-circulation and adsorption of cesium by zeolite</p> <p>Full-scale decontamination in operation (from May 1), after transferring accumulated water in Unit 6 T/B to receiver tanks for low level water.</p> <p>Sprinkling purified accumulated water in Unit 6 T/B (below bathing area guideline) within the site (from Oct. 7)</p>	<div style="text-align: center;"> <p>&lt;Adsorption of Cesium by Zeolite&gt;</p>

<p>Decontamination agent (zeolite)</p> <p>Zeolite</p> <p>Watering pipe</p> <p>Unit 6 T/B</p> <p>Purification system</p> <p>Charcoal Zeolite</p> <p>Radioactivity removal apparatus (Zeolite, Chelate resin tower)</p> <p>Processed water tank</p> <p>RO apparatus</p> <p>Transfer</p> <p>Transfer</p> <p>Recycling purification operation</p> <p>Megafloat</p> <p>&lt;Sprinkling water by connecting fire engine to tanker lorry&gt;</p> <p>Tanker lorry</p> <p>Fire engine</p> <p>Sprinkling purified accumulated water in Unit 6 T/B within the site</p> </div>

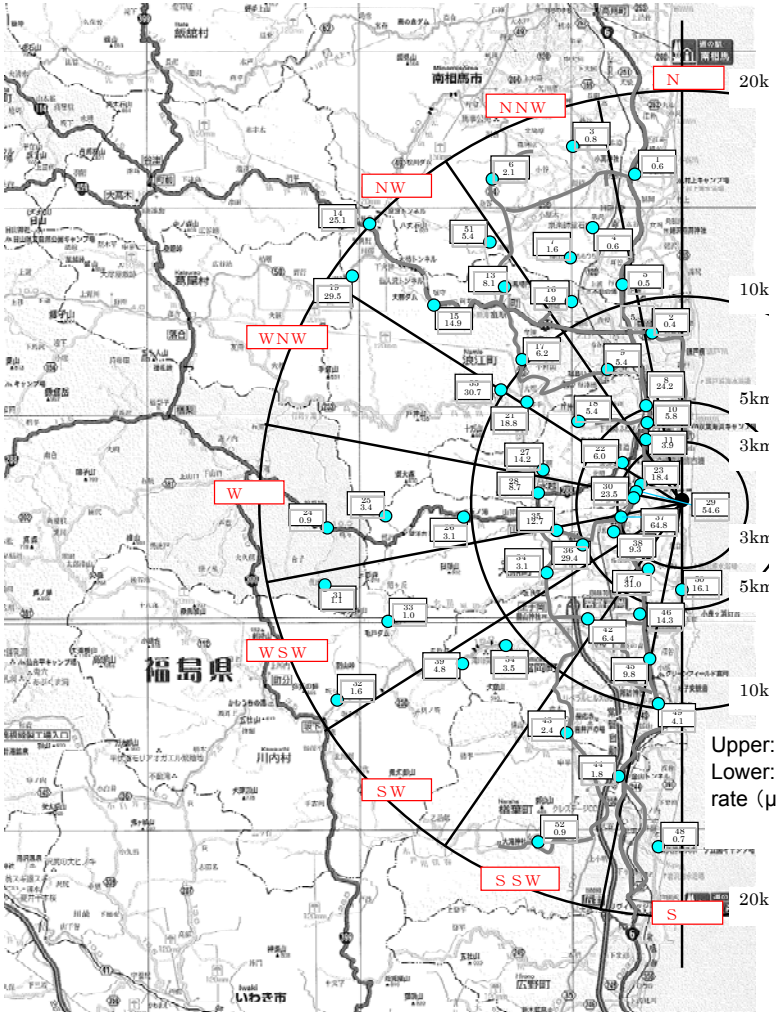
<p>Measurement result of air dose rate of within 20 km radius (date: Nov. 8, 2011)</p>

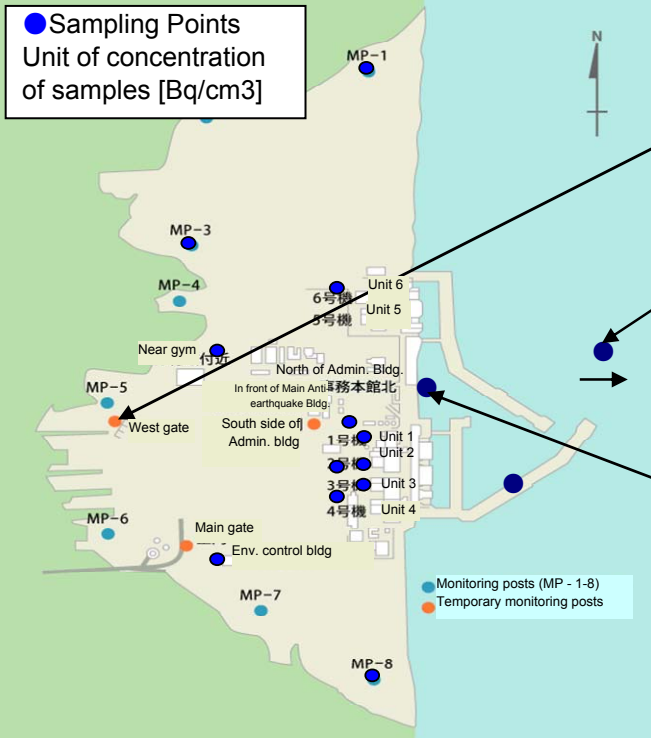
<p>Fukushima Daiichi measuring points of airborne radioactivity concentration</p> <ul style="list-style-type: none"> <li>● Sampling Points</li> <li>Unit of concentration of samples [Bq/cm<sup>3</sup>]</li> <li>● Monitoring posts (MP - 1-8)</li> <li>○ Temporary monitoring posts</li> </ul>

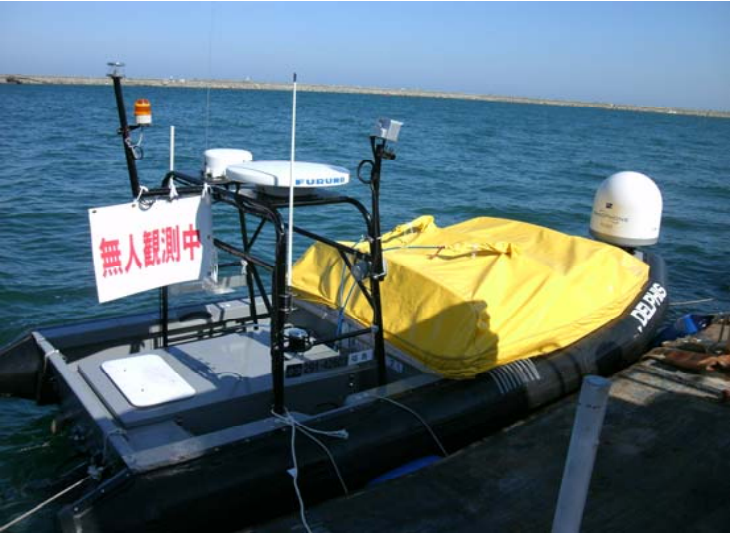
<p>Overview of an unmanned survey boat [DELPHIS]</p> </div> <div style="text-align: center;">

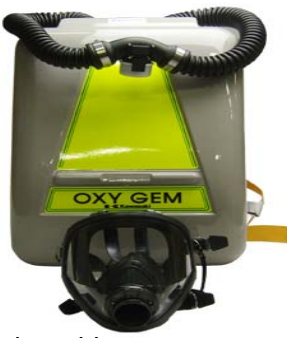
<p>Closed-circuit oxygen breathing apparatus: It can realize a long 120-minute usage, circulating aspirated air with oxygen inside the cylinder. It is suitable for usage in oxygen-less hazardous area. *Source: vendor catalogue</p>

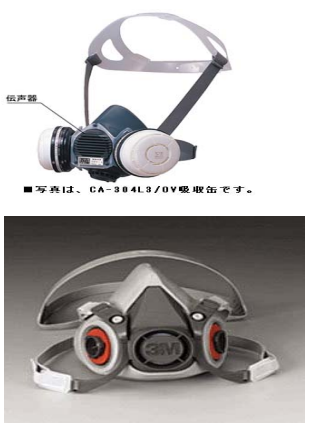
<p>Half-faced mask: In case that radioactivity density is low and stable, workers put on half-faced masks (with goggles), not full-face, which enables to lighten the workload of workers.</p>

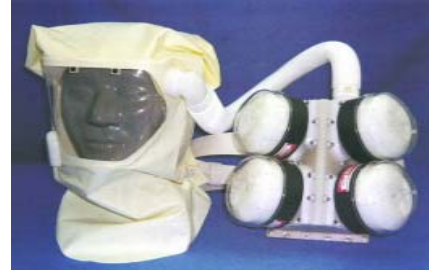
<p>Hood mask; Keeping the inner pressure positive, the mask prevents influx of outer air. Continuous ventilation helps exhausting the inner humidity and prevents heat injuries. *Source: vendor catalogue</p>
