<Photo> Unit 4 Seawater Heat Exchanger Building
Recovery of power panel and cables (permanent installation)

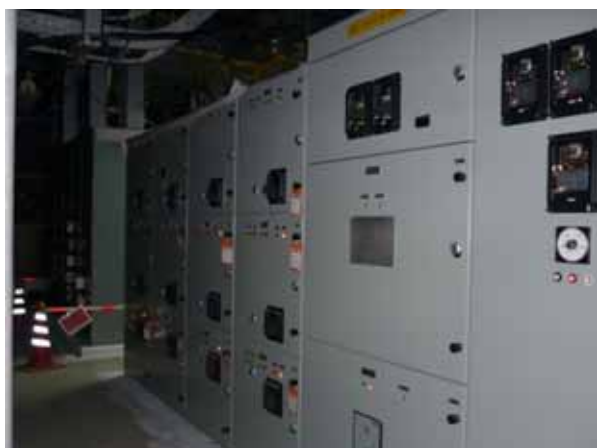
Power panel (permanent installation) (Recovered on January 30, 2012)
(Photo on February 24, 2012)

On February 24, 2012 followed by the recovery of the power panel (permanent installation), power sources of the residual heat removal equipment cooling system (A), the residual heat removal equipment cooling seawater system (A), and the emergency diesel generator cooling system (A) were switched from the temporary power supply to the power panel (permanent installation).

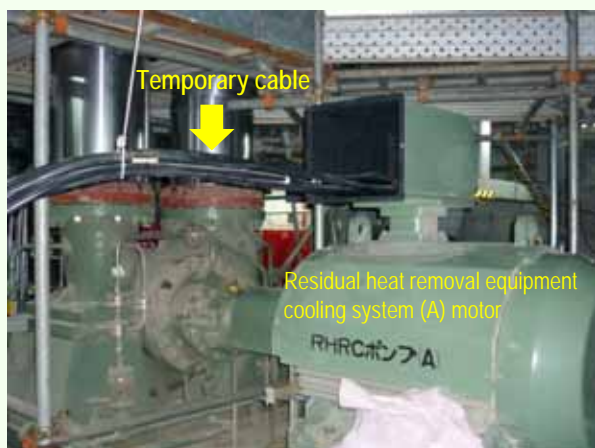
< Residual heat removal equipment cooling system (A) >

Temporary cable connection (Photo on February 24, 2012)

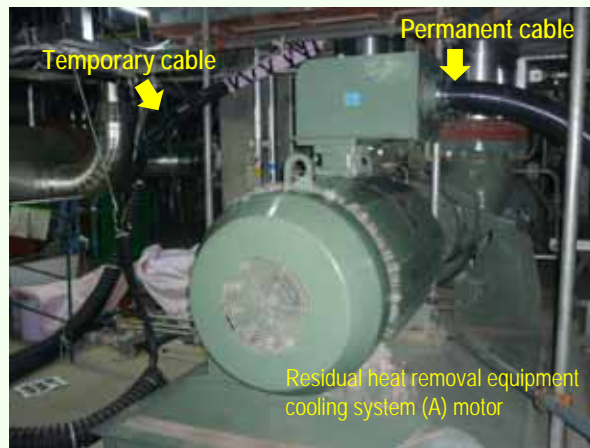
After switching to permanent cable (Photo on March 1, 2012)

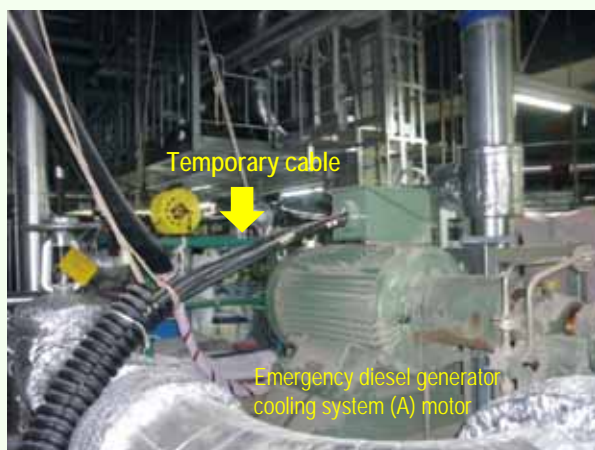
< Emergency diesel generator cooling system (A) >

Temporary cable connection (Photo on February 24, 2012)

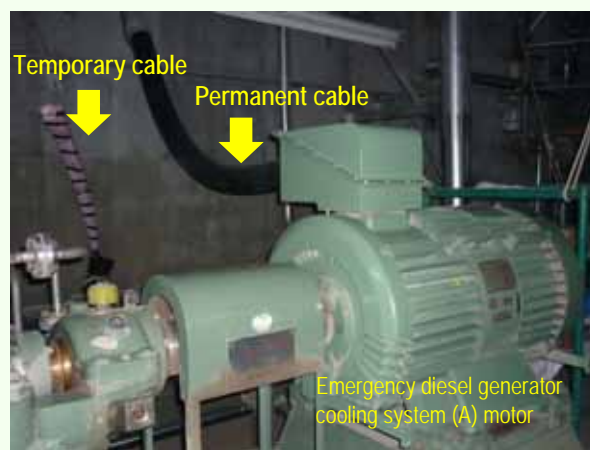
After switching to permanent cable (Photo on March 1, 2012)
