<Photo> Major progress status/topics

Unit 1 Installation of the power panel (M/C 1C) was completed
As substitute for the Unit 1 power panel (M/C 1C) damaged by the tsunami of Tohoku-Chihou-Taiheiyo-Oki Earthquake, a new power panel was manufactured and the installation at the site (Annex of Reactor Building) was completed on March 28, 2012.

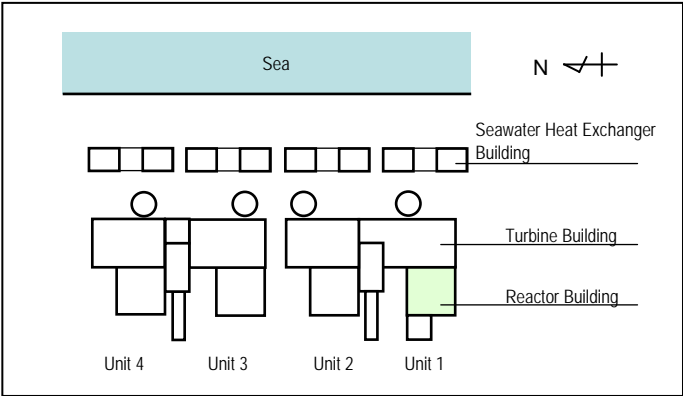
(1) Lift up and entry
(Photo on March 15, 2012)

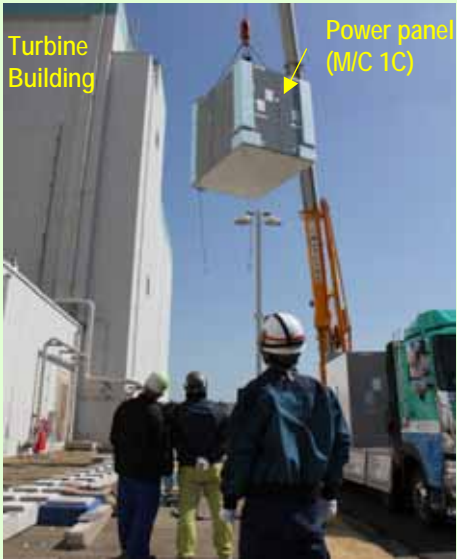
(2) Lift up and entry
(Lift down to the installation location)
(Photo on March 15, 2012)

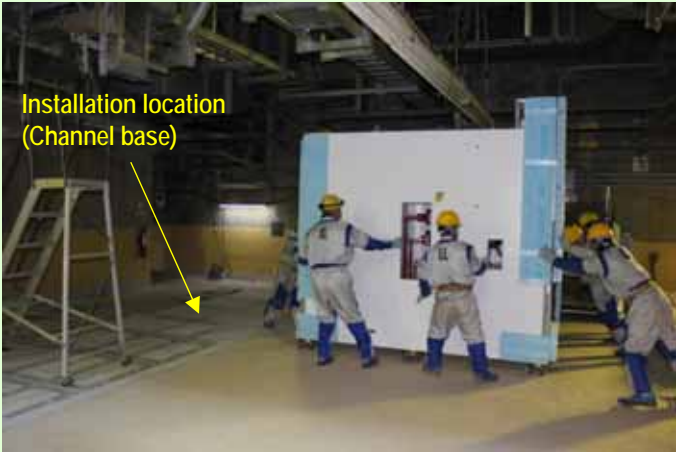
(3) Moving after lift down
(Photo on March 15, 2012)

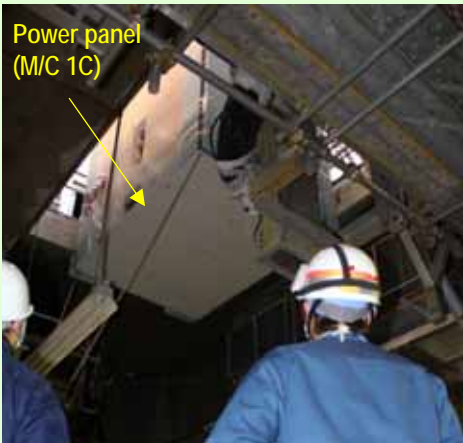
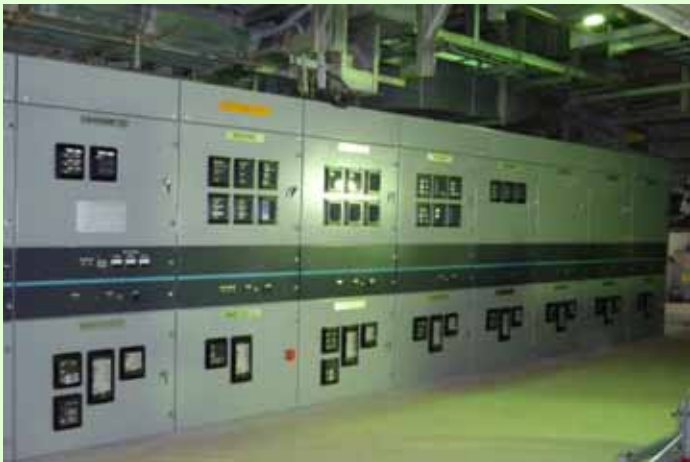
(4) Installation of the power panel (M/C 1C) was completed
(Installation was completed on March 28, 2012)
(Photo on April 2, 2012)

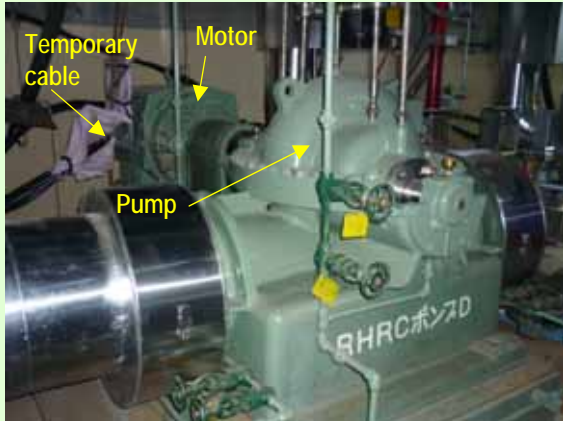
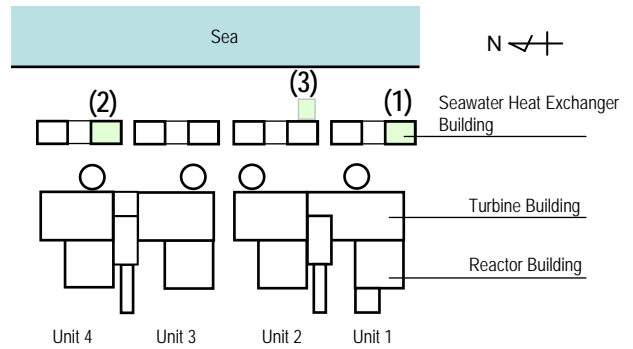
Motor and pump after function check
(Function check was completed on March 15, 2012)
(Photo on March 26, 2012)

(1) Unit 1 Function check of the residual heat removal equipment cooling system (D system) was completed

As repair of motor and pumps for the Unit 1 residual heat removal equipment cooling system (D system) was completed, the trial running using temporary cables was conducted to confirm that there was no problem with the system on March 15, 2012.

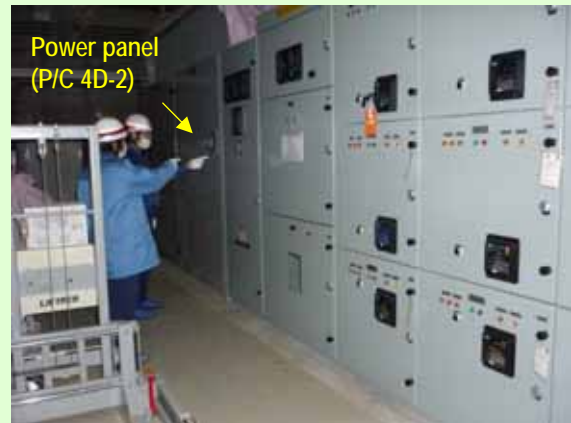
Function check
(Function check and switch to permanent installation was completed on March 23, 2012)
(Photo on March 23, 2012)

(2) Unit 4 Permanent installation of the power panel (P/C 4D-2) was completed

As substitute for the Unit 4 power panel (P/C 4D-2) damaged by the tsunami of Tohoku-Chihou-Taiheiyo-Oki Earthquake, a new power panel was manufactured and the installation at the site was completed on March 8, 2012. As the function check including withstand voltage tests confirmed that there was no problem with the system, the system started to receive power supply and completed the permanent installation of the power panel on March 23, 2012.

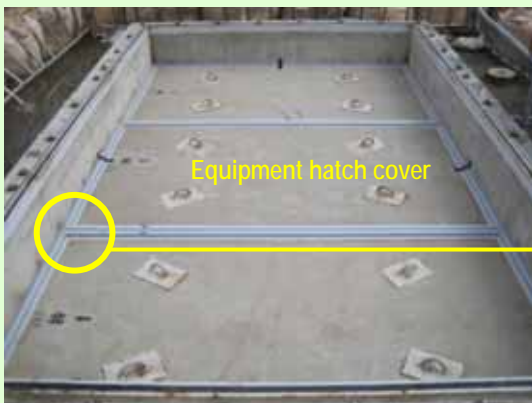
Watertight of the cover space using seal material
(Photo on March 23, 2012)

(3) Watertight work of Units 1-4 Seawater Heat Exchanger Building was completed

Watertight work (replacement with high-strength doors, space filling of equipment hatch cover using seal material, space filling between pipes and external walls through which the pipes penetrate using seal material, etc.) to prevent facilities from being wet or submerged was completed on March 31, 2012, as part of emergency safety measures for equipment exit and building penetration parts of Units 1-4 Seawater Heat Exchanger Building which were damaged by the tsunami of Tohoku-Chihou-Taiheiyo-Oki Earthquake.

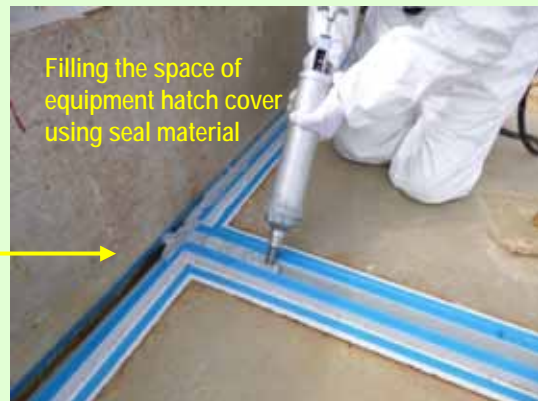
Filling the cover space using seal material
(Photo on March 23, 2012)
