Leakage of transformer insulation oil from the outdoor hazardous material storage tank at the “Wild Bird Forest” in the Fukushima Daiichi Nuclear Power Station premise

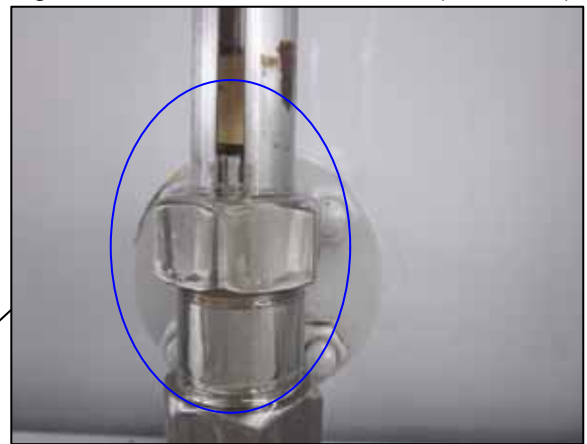
Leaking section at the center connection (NO.4 tank)

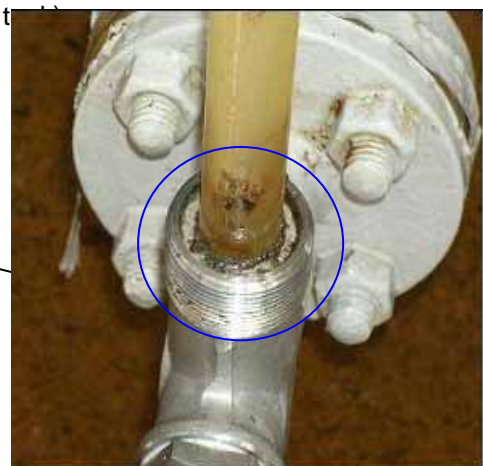
Leaking section at the oil gage (NO. 3)
