Installation of power panel (P/C 1C-2) at Unit 1 Seawater Heat Exchanger Building (July 10)

Function check completed for the residual heat removal cooling system (C system) in Unit 1 Seawater Heat Exchanger Building (July 24)

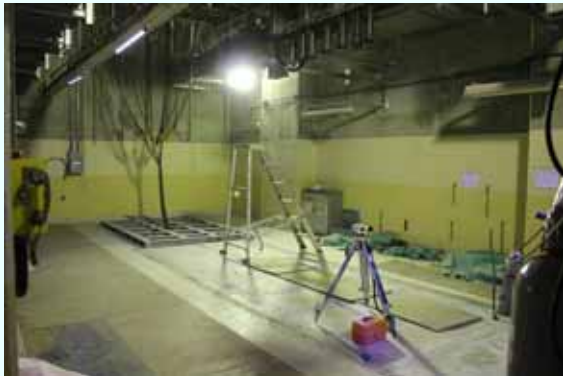
Before installation
(Photo taken on June 8, 2012)

The newly manufactured power panel (P/C 1C-2) at Unit 1 Seawater Heat Exchanger Building (to replace the power panel damaged by the Tsunami) has been installed on July 10.

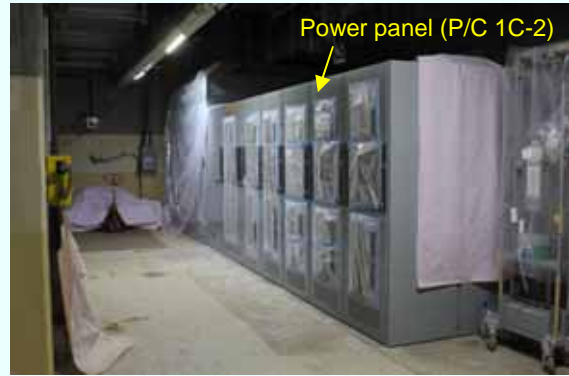
Installation completed on July 10, 2012
(Photo taken on July 24, 2012)

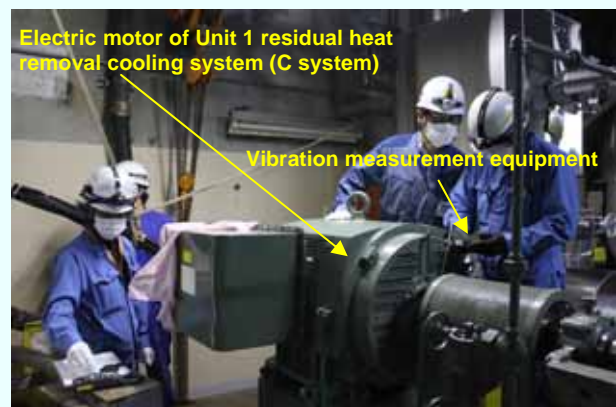
Function check after the electric motor installation
(Vibration measurement during trial operation)
(Photo taken on July 24, 2012)

The electric motor of the residual heat removal cooling system (C system) in Unit 1 Seawater Heat Exchanger Building damaged by the Tsunami was fixed and moved back on the first floor of the Seawater Heat Exchanger Building on May 22. Test operation using the temporary power supply and cables was completed on July 24 and no problem was found as a result.
