Permanent installation of the emergency diesel generator facilities (A) in Unit 1 Reactor Building Annex (February 13)

Carry-in and installation of the auxiliary facilities of the emergency diesel generator (H) in Unit 1 Reactor Building Annex (February 23)

Permanent installation of the electric motors of the residual heat removal system cooling systems (A and C) in Unit 1 Seawater Heat Exchanger Building (February 12)

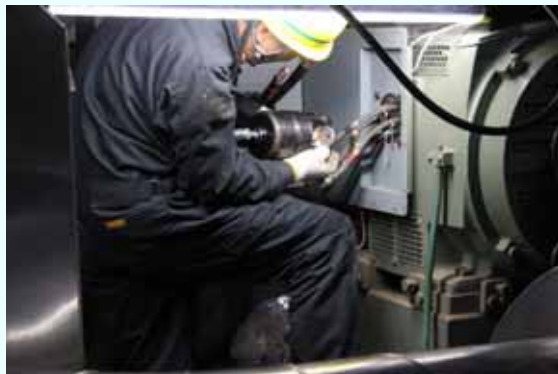
Switching to the permanent cable completed
(Photo taken on February 7, 2013)

Since Unit 1 power panel (P/C 1C-2) damaged by the Tsunami was permanently installed, the power supply to the electric motors of the residual heat removal system cooling systems (A and C) was switched from temporary power supply to the permanent power panel on February 12. As the electric motors were confirmed to operate properly after switching the power supply, the permanent installation has been completed.

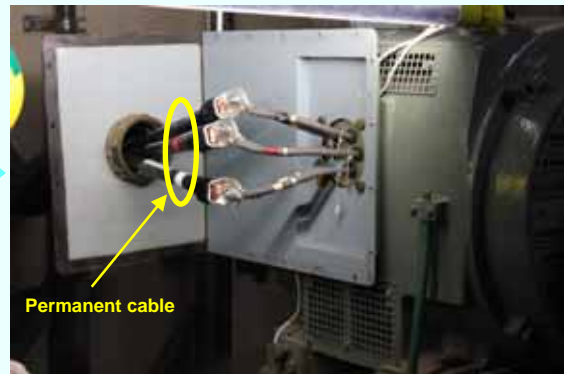
Trial operation of the electric motor of the residual heat removal system cooling system pump (A) [Permanent installation (A&C) completed on February 12, 2013]
(Photo taken on February 7, 2013)

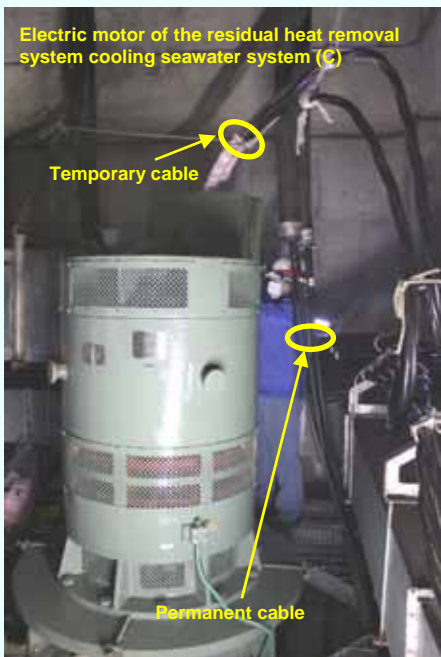
Before switching to the permanent cable (Photo taken on February 8, 2013)

Since Unit 1 power panel (P/C 1C-2) damaged by the Tsunami was permanently installed, the power supply to the electric motors of the residual heat removal system cooling seawater systems (A and C) was switched from temporary power supply to the permanent power panel on February 8. As the electric motors were confirmed to operate properly after switching the power supply, the permanent installation has been completed.

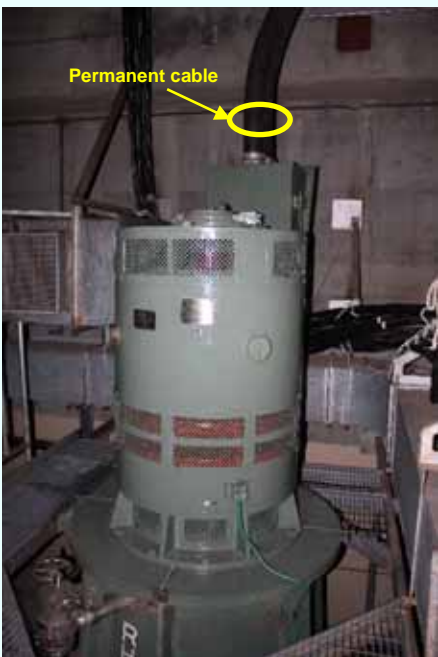
Switching to the permanent cable completed (Photo taken on February 8, 2013)

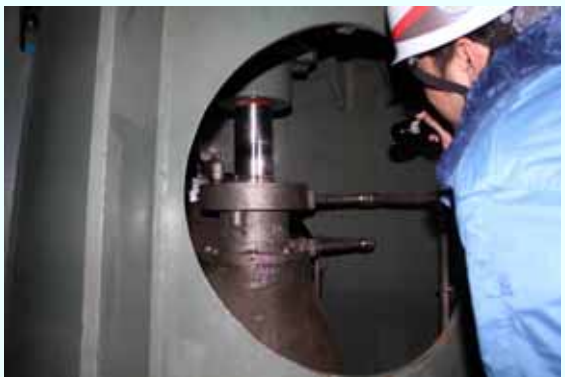
Trial operation of the electric motor of the residual heat removal system cooling seawater system pump (C) [Permanent installation completed on February 8, 2013] (Photo taken on February 8, 2013)

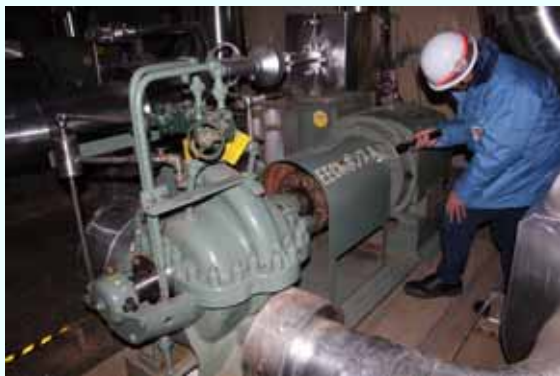
Trial operation of the electric motor of the emergency diesel generator cooling system (A)
[Permanent installation completed on February 5, 2013]
(Photo taken on February 5, 2013)

Since Unit 1 power panel (P/C 1C-2) damaged by the Tsunami was permanently installed, the power supply to the electric motor of the emergency diesel generator cooling system (A) was switched from temporary power supply to the permanent power panel on February 5. As the electric motor was confirmed to operate properly after switching the power supply, the permanent installation has been completed.

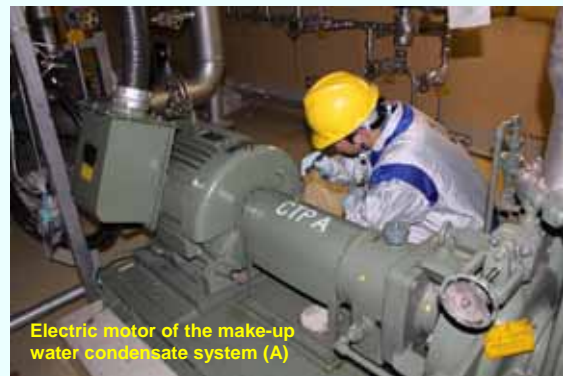
Trial operation [Permanent installation completed on February 7, 2013]
(Photo taken on February 7, 2013)

Since Unit 1 power panel (P/C 1C-1) damaged by the Tsunami was permanently installed, the power supply to the electric motor of Unit 1 make-up water condensate system (A) was switched from temporary power supply to the permanent power panel on February 7. As the electric motor was confirmed to operate properly after switching the power supply, the permanent installation has been completed.

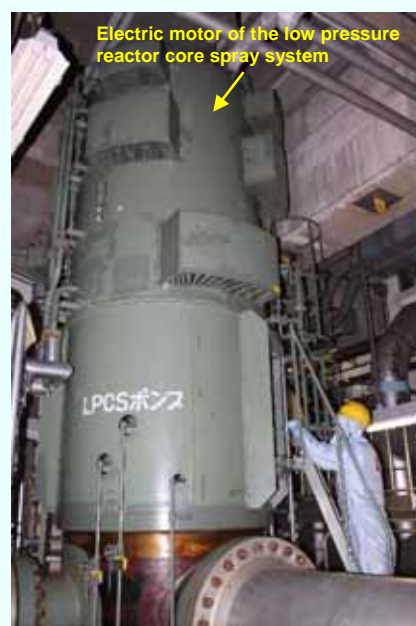
Trial operation [Permanent installation completed on February 23, 2013]
(Photo taken on February 23, 2013)

After Unit 1 power panel (M/C 1C) damaged by the Tsunami was permanently installed, power supply was provided to the electric motor of Unit 1 low pressure reactor core spray system. As the electric motor was confirmed to operate properly as a result of trial operation, the permanent installation has been completed on February 23.

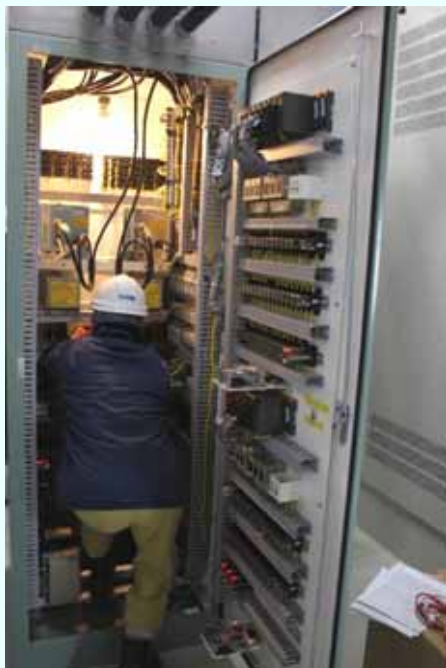
Function check
(Photo taken on February 12, 2013)

Unit 1-2 discharge channel monitor damaged by the Tsunami was replaced with a newly manufactured one. As the monitor was confirmed to operate properly as a result of function check, the permanent installation has been completed on February 18. (Previously announced on February 20, 2013)

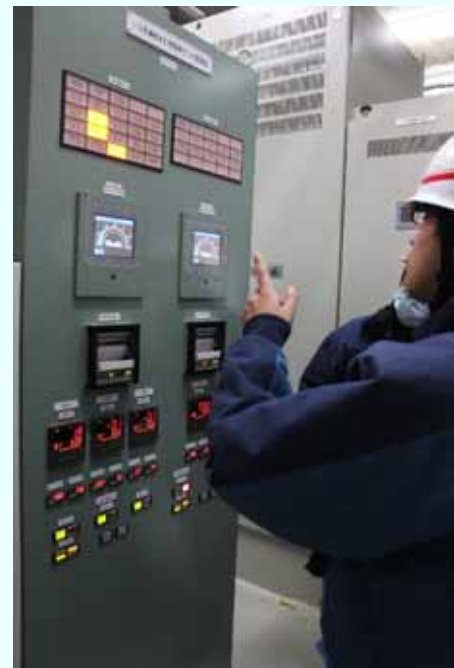
Function check [Permanent installation
completed on February 18, 2013]
(Photo taken on February 12, 2013)
