Permanent installation of the power panel (M/C 1HPCS) in Unit 1 Reactor Building Annex (March 1)

Permanent installation of the emergency diesel generator (H) facilities in Unit 1 Reactor Building Annex (March 21)

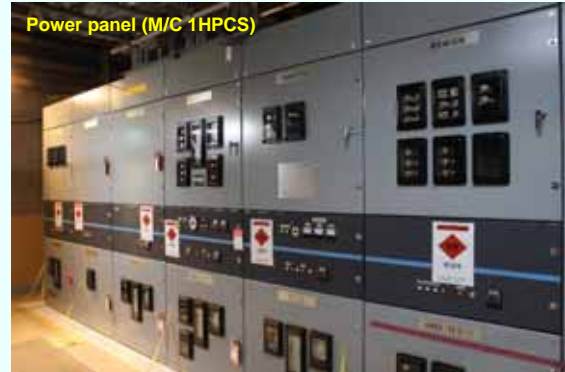
After function check [Permanent installation completed on March 1, 2013] (Photo taken on March 12, 2013)

The power panel (M/C 1HPCS) damaged by the Tsunami in Unit 1 Reactor Building Annex was permanently installed on March 1 after proper function was confirmed at function check.

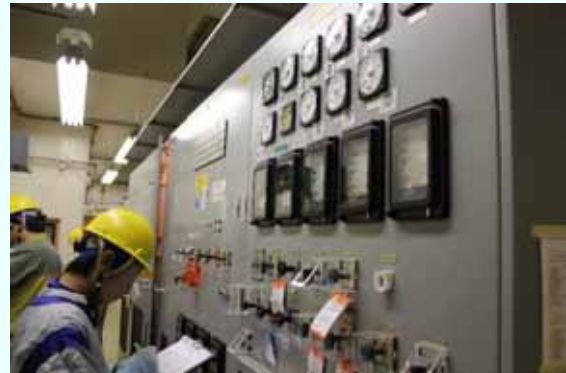
Trial operation (control panel) [Permanent installation completed on March 21, 2013] (Photo taken on March 19, 2013)

The emergency diesel generator (H) facilities damaged by the Tsunami (control panel, generator, diesel engine and component equipment) in Unit 1 Reactor Building Annex were permanently installed on March 21 after proper function was confirmed at function check.

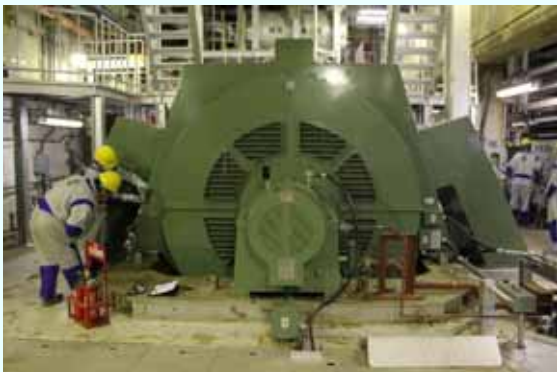
Trial operation (generator) [Permanent installation completed on March 21, 2013] (Photo taken on March 21, 2013)

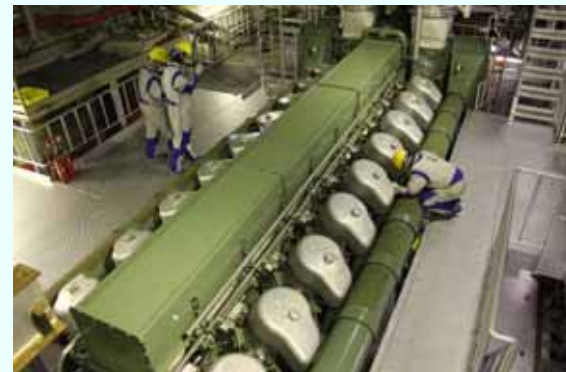
Trial operation (upper part of the diesel engine) [Permanent installation completed on March 21, 2013] (Photo taken on March 21, 2013)

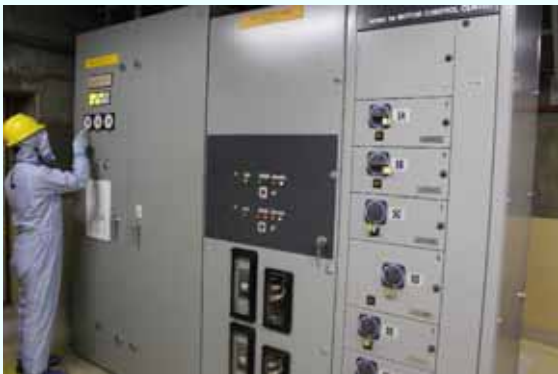
After function check (charger panel) [Permanent installation completed on March 12, 2013] (Photo taken on April 1, 2013)

Unit 1 DC power supply (charger and battery) damaged by the Tsunami was permanently installed on March 14 after proper function was confirmed at function check.

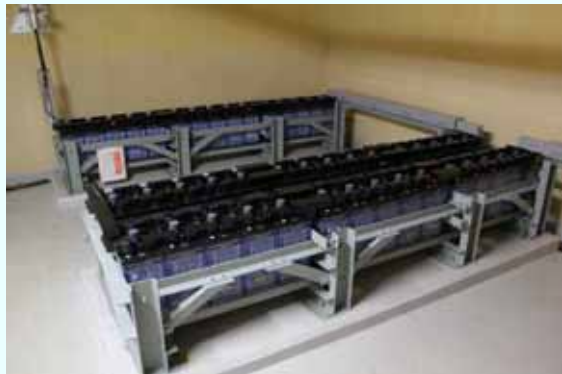
After function check (battery) [Permanent installation completed on March 14, 2013] (Photo taken on March 14, 2013)

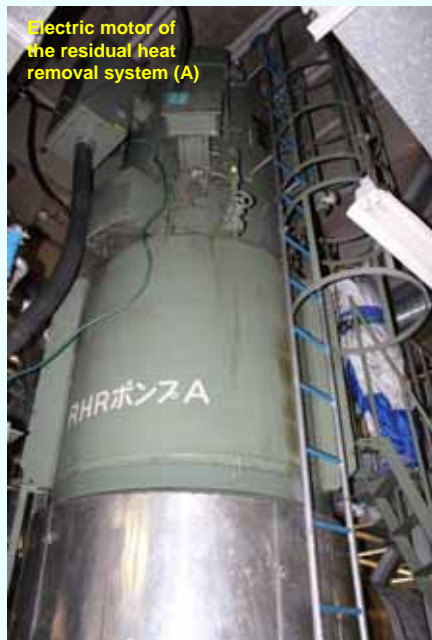
Trial operation [Permanent installation completed on March 15, 2013] (Photo taken on March 15, 2013)

Since Unit 1 power panel (M/C 1C) damaged by the Tsunami was permanently installed, power was supplied to the electric motor of Unit 1 residual heat removal system (A). As the electric motor was confirmed to operate properly as a result of trial operation, the permanent installation has been completed on March 15.

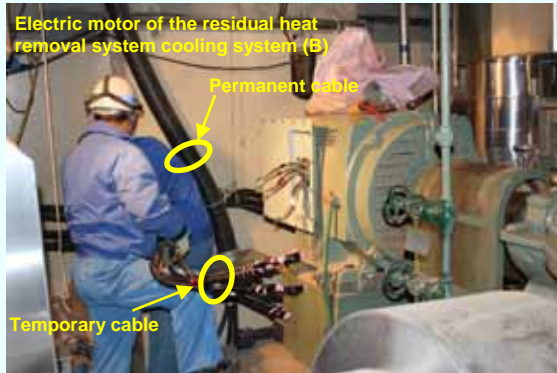
Removal of temporary cable
(Photo taken on February 26, 2013)

Since Unit 1 power panel (P/C 1D-2) damaged by the Tsunami was permanently installed, the power supply to the electric motors of the residual heat removal system cooling systems (B and D) was switched from temporary power supply to the permanent power panel on March 1. As the electric motors were confirmed to operate properly after switching the power supply, the permanent installation has been completed.

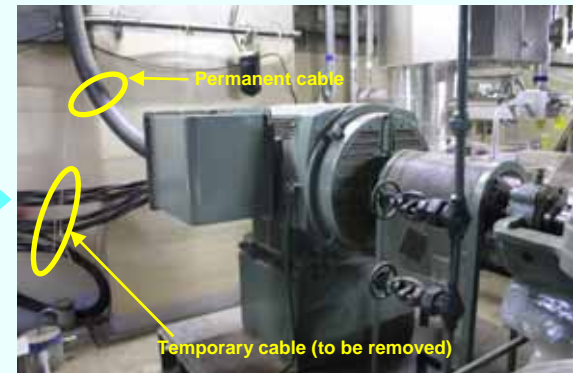
Switching to the permanent cable completed for the electric motor of the residual heat removal system cooling system (B)
[Permanent installation completed on March 1, 2013]
(Photo taken on March 14, 2013)

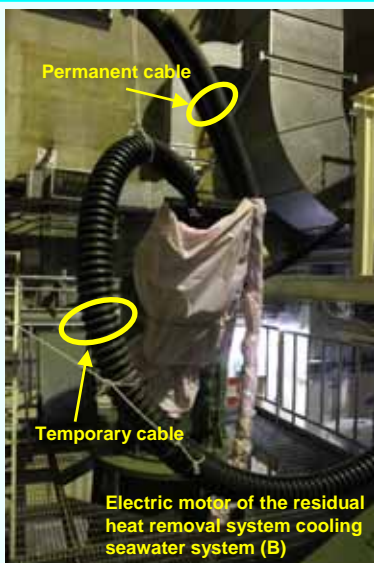
Before switching to the permanent cable
(Photo taken on February 25, 2013)

Since Unit 1 power panel (P/C 1D-2) damaged by the Tsunami was permanently installed, the power supply to the electric motors of the residual heat removal system cooling seawater systems (B and D) was switched from temporary power supply to the permanent power panel on March 4. As the electric motors were confirmed to operate properly after switching the power supply, the permanent installation has been completed.

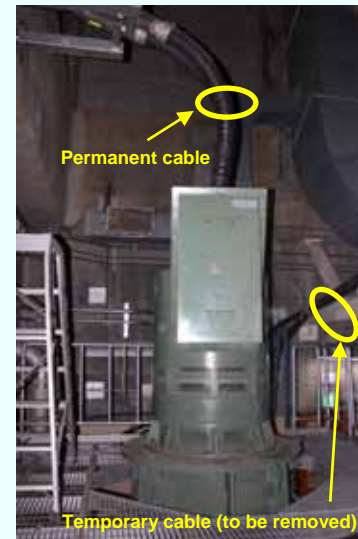
Switching to the permanent cable completed for the electric motor of the residual heat removal system cooling seawater system (B)
[Permanent installation completed on March 4, 2013]
(Photo taken on March 14, 2013)

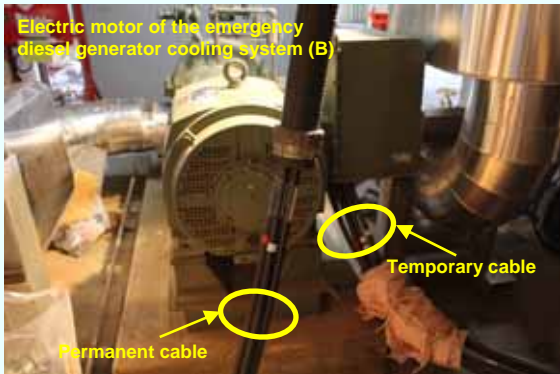
Before switching to the permanent cable
(Photo taken on February 25, 2013)

Since Unit 1 power panel (P/C 1D-2) damaged by the Tsunami was permanently installed, the power supply to the electric motor of the emergency diesel generator cooling system (B) was switched from temporary power supply to the permanent power panel on March 1. As the electric motor was confirmed to operate properly after switching the power supply, the permanent installation has been completed.

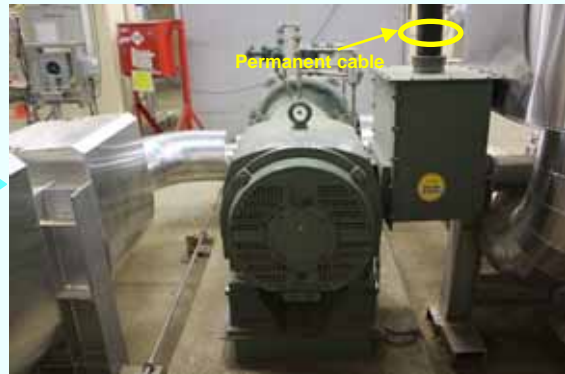
Switching to the permanent cable completed for the electric motor of the emergency diesel generator cooling system (B)
[Permanent installation completed on March 1, 2013]
(Photo taken on April 1, 2013)

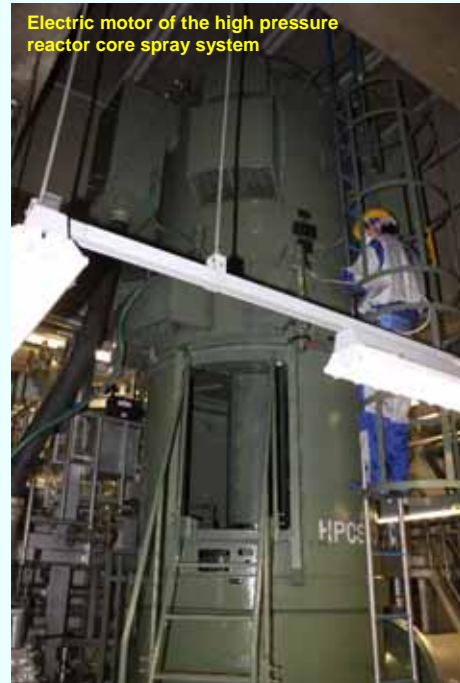
Trial operation [Permanent installation completed on March 25, 2013]
(Photo taken on March 25, 2013)

Since Unit 1 power panel (M/C 1HPCS) damaged by the Tsunami was permanently installed, power was supplied to the electric motor of Unit 1 high pressure reactor core spray system. As the electric motor was confirmed to operate properly as a result of trial operation, the permanent installation has been completed on March 25.

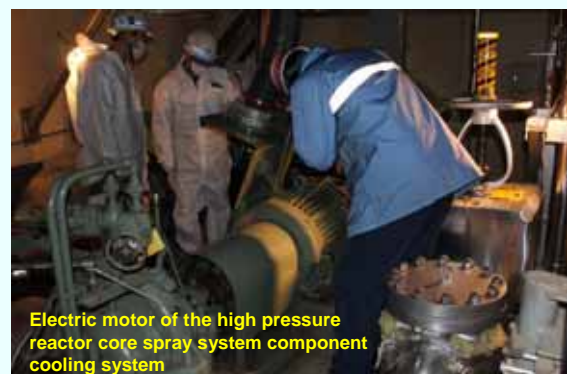
Trial operation [Permanent installation completed on March 14, 2013]
(Photo taken on March 14, 2013)

Since Unit 1 power panel (M/C 1HPCS) damaged by the Tsunami was permanently installed, power was supplied to the electric motor of Unit 1 high pressure reactor core spray system component cooling system. As the electric motor was confirmed to operate properly as a result of trial operation, the permanent installation has been completed on March 14.

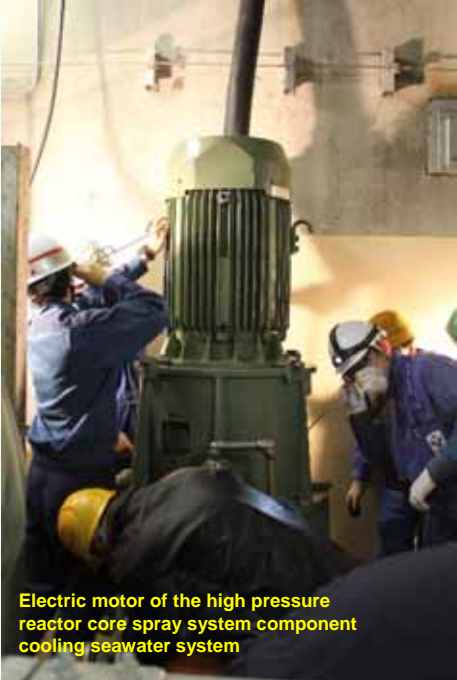
Electric motor of the high pressure reactor core spray system component cooling seawater system

Trial operation
 [Permanent installation completed on March 18, 2013]
 (Photo taken on March 18, 2013)

Since Unit 1 power panel (M/C 1HPCS) damaged by the Tsunami was permanently installed, power was supplied to the electric motor of Unit 1 high pressure reactor core spray system component cooling seawater system. As the electric motor was confirmed to operate properly as a result of trial operation, the permanent installation has been completed on March 18.

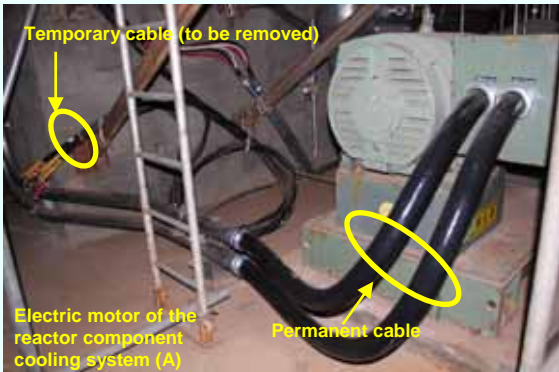
Switching to the permanent cable completed for the electric motor of the reactor component cooling system (A)
 [Permanent installation completed on March 8, 2013]
 (Photo taken on March 14, 2013)

Since Unit 1 power panels (system A: P/C 1C-2, system B: P/C 1D-2) damaged by the Tsunami were permanently installed, the power supply to the electric motors of the reactor component cooling systems (A and B) was switched from temporary power supply to the permanent power panels on March 8. As the electric motors were confirmed to operate properly after switching the power supply, the permanent installation has been completed.
