Key safety measures at Fukushima Daiichi  
Nuclear Power Station

# Reference materials

November 8, 2013

Tokyo Electric Power Co., Inc.

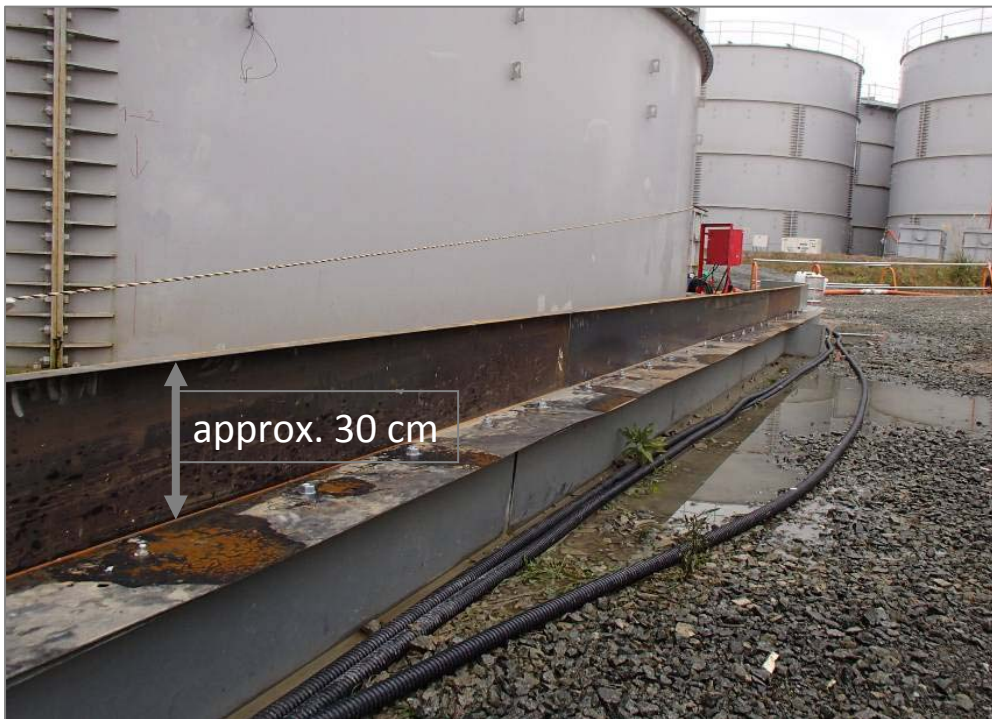
Dikes with steel plating installed (H4 north)

- **Elevation of existing dikes by using steel plates (stopgap dike)**
  - Elevation of dikes in H4 north, where contamination levels are highest; area B, where foundations are tilted; and at those locations in H1 east where crowns on dikes are low (high level contamination)
  - Plan to complete elevations in all other areas within the year (plans for app. 30 cm-high elevations)
- **Further elevation of dikes using concrete, etc (improvement in credibility)**
  - Being designed in detail

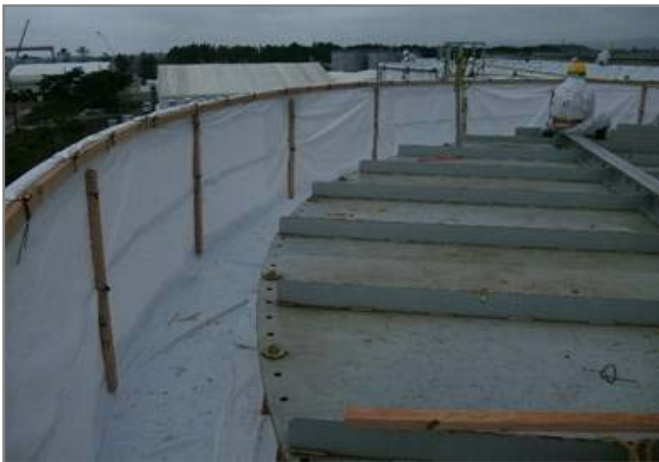
Tank inspection platform

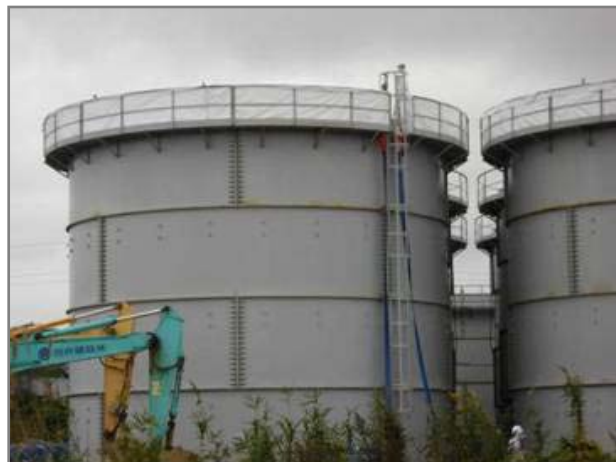
Full view of tank

Situation with temporary gutters installed on tanks in area H4

- Installing gutters clamps down on influx of rainwater by approx. 60%

- \*Temporary gutters installed (Oct. 24, 2013) at points where high level contamination was found (parts of H4 north and east)

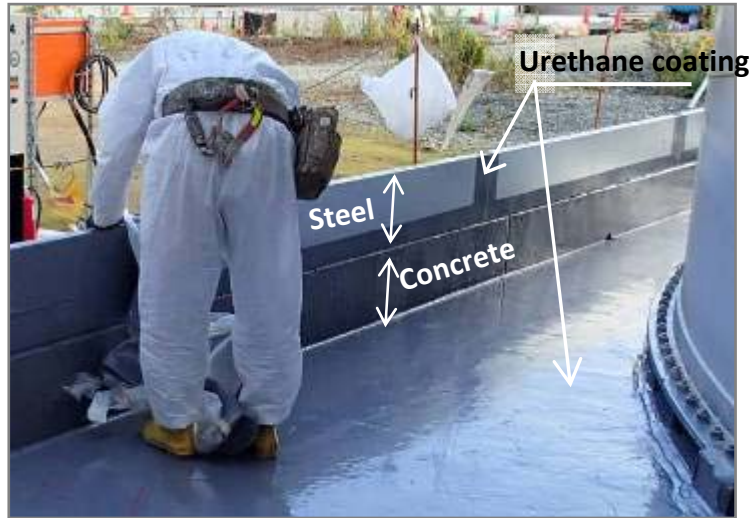
- \* Cover concrete surfaces inside the dikes and improve waterproofing
- \* Prevent rainwater from spreading into the soil between soil-fill and concrete dikes, apply facing using concrete (process currently under study)

Photo showing status when covered

●Covering concrete surfaces inside the dikes, facing for surface of ground inside soil-fill dikes (goal of end of current fiscal year)

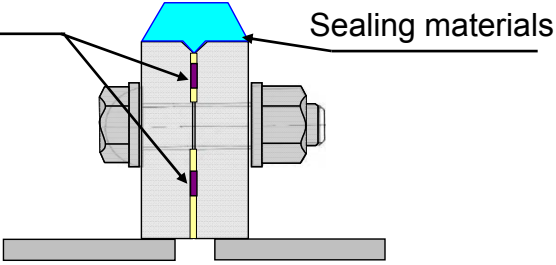
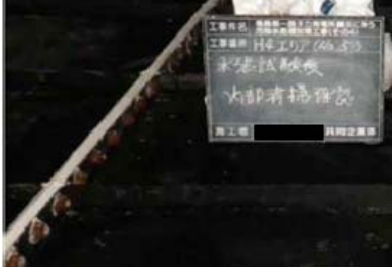
Type	Cross-section view of bottom panels waterproofing structure	Construction example	No. of tanks
TYPE-1 ※

<p>Sealing materials</p> <p>Water expandable waterproofing materials</p>

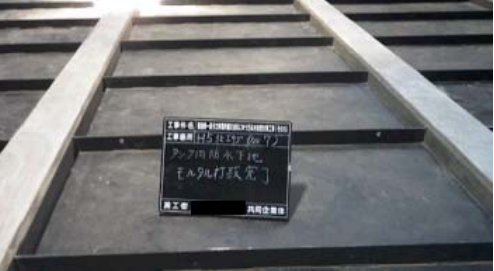
<p>Modified asphalt coating sheet</p> <p>Sealing materials</p> <p>Water expandable waterproofing materials</p> <p>1:2 mortar</p>

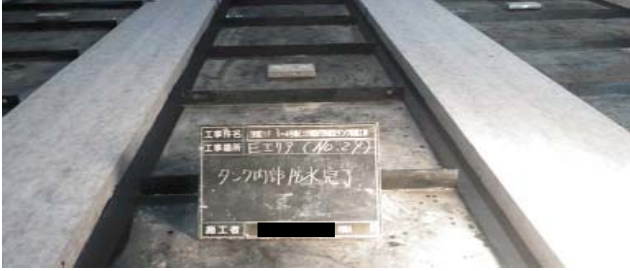
<p>Modified asphalt coating sheet</p> <p>Sealing materials</p> <p>Water expandable waterproofing materials</p> <p>Joint caulking</p> <p>1:2 mortar</p>

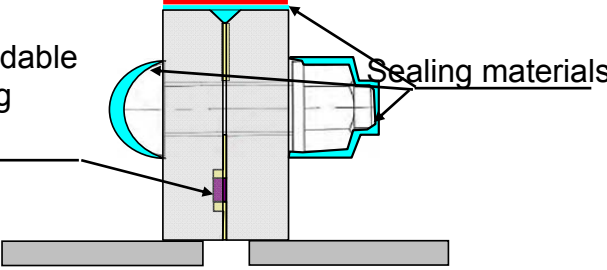
<p>Water expandable waterproofing materials</p> <p>Sealing materials</p>

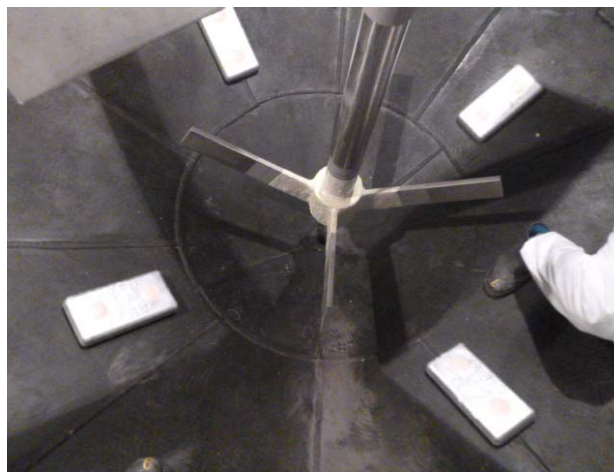
Batch treatment tank 1C  
(after rubber lining attached)

- Corrosion countermeasures for batch treatment tanks
  - ✓ Apply rubber lining to inner surfaces
  - ✓ Install gasket-type sacrificial anodes for flanges, which can develop corrosion in their gaps

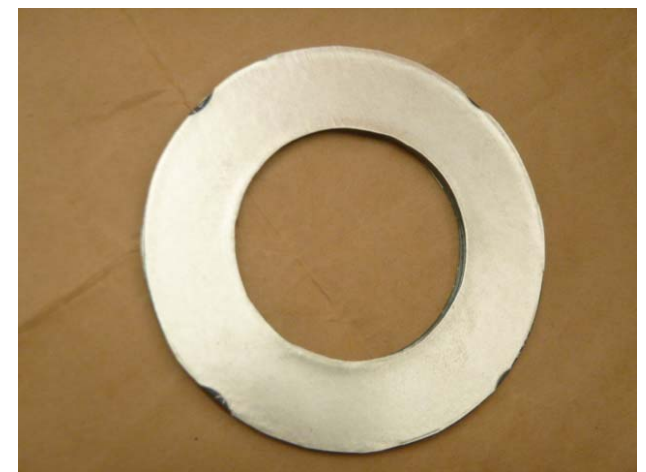
Gasket-type sacrificial anode

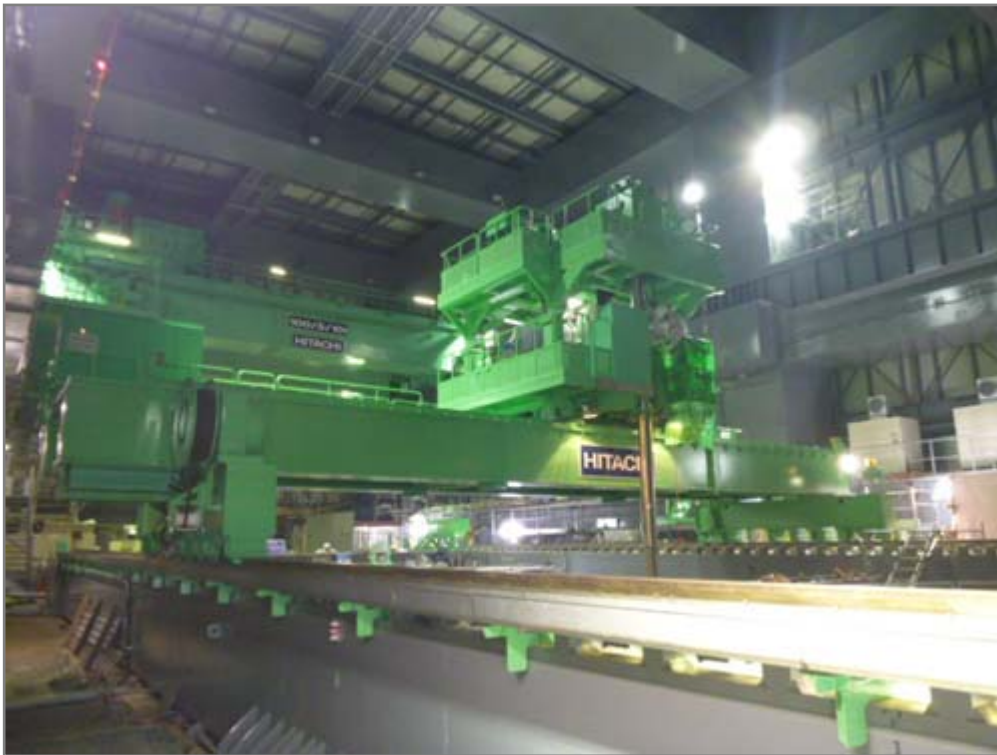
(1) Overall view of fuel handling equipment  
(photo taken from the north side of  
operating floor)

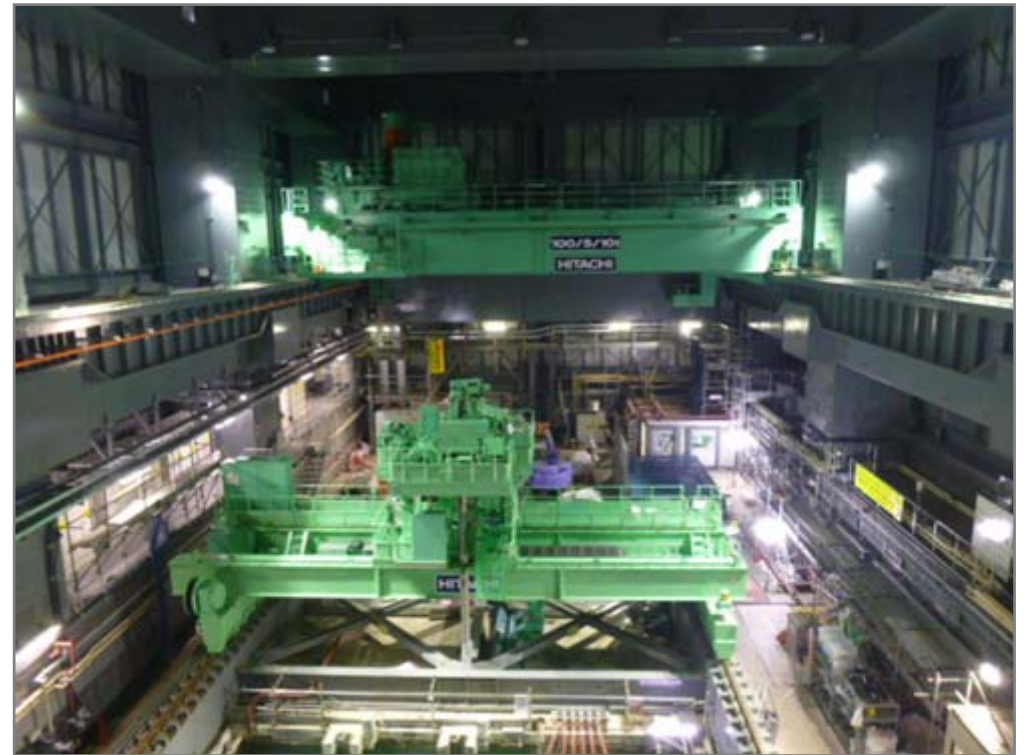
(2) Status of installation of fuel handling  
equipment and crane (photo taken from north  
side of operating floor)

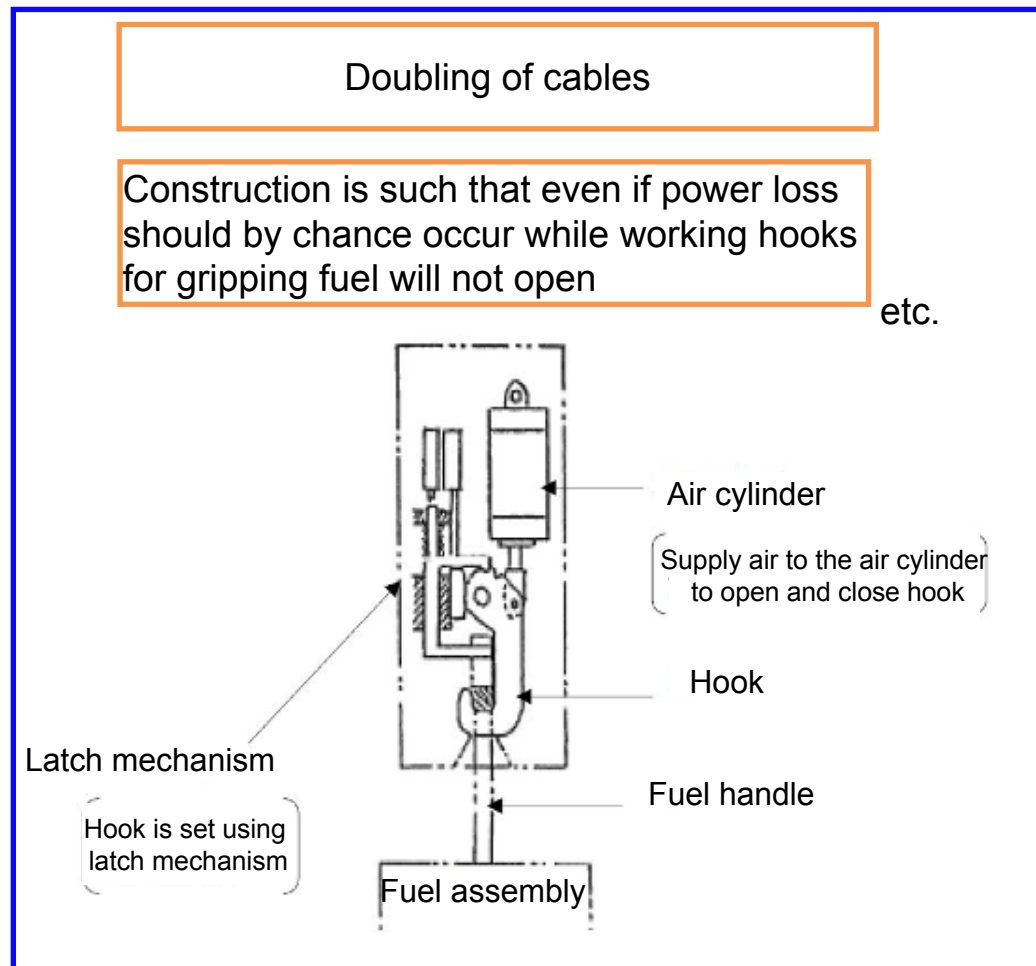
(1) Safety measures in the fuel handling equipment

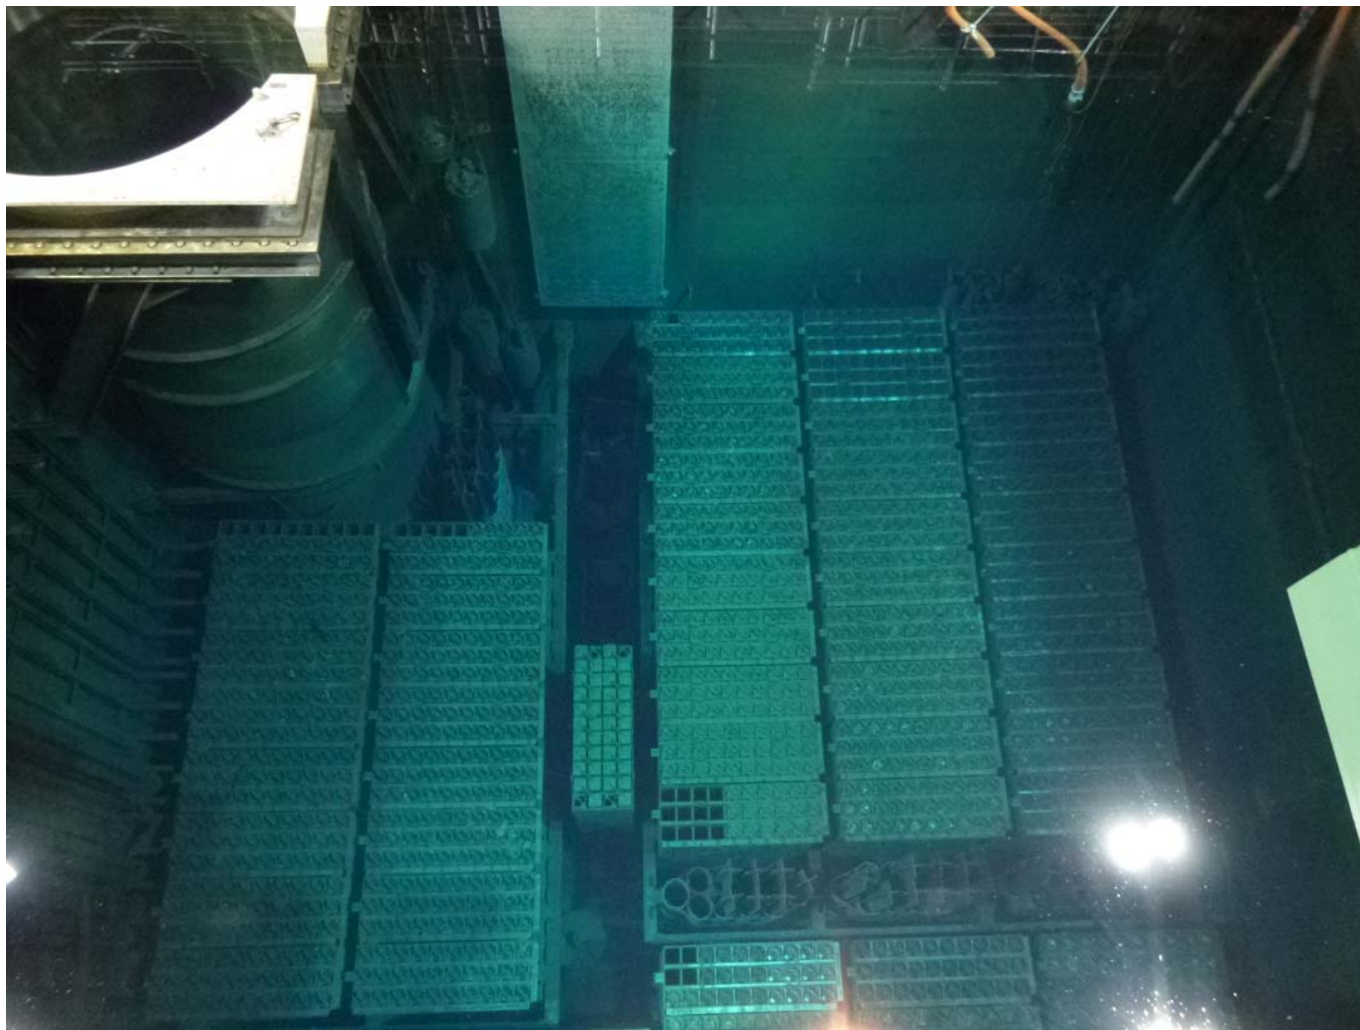
- Conditions inside of pool after dropped debris has been removed
