Findings from the latest analyses using MAAP5

1. Latest analysis of Unit-1 by MAAP5.01

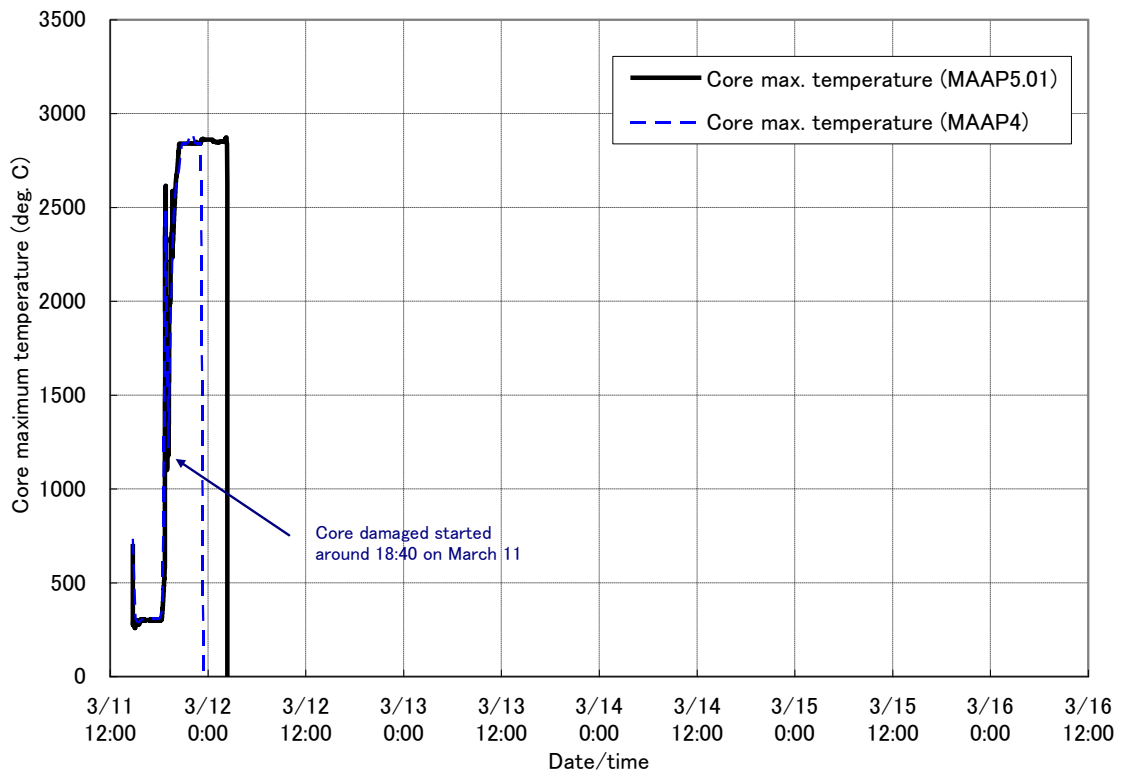
Figure 1-4 Core temperature changes of Unit-1

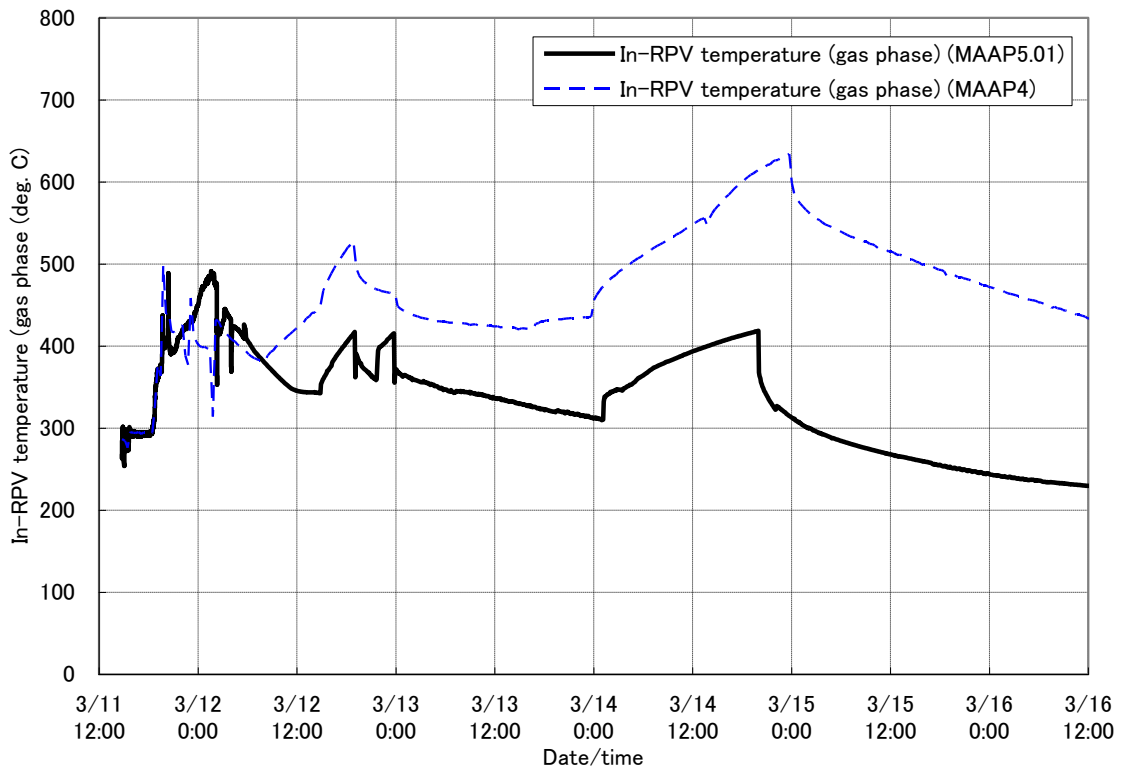
Figure 1-5 Gaseous temperature changes in RPV of Unit-1

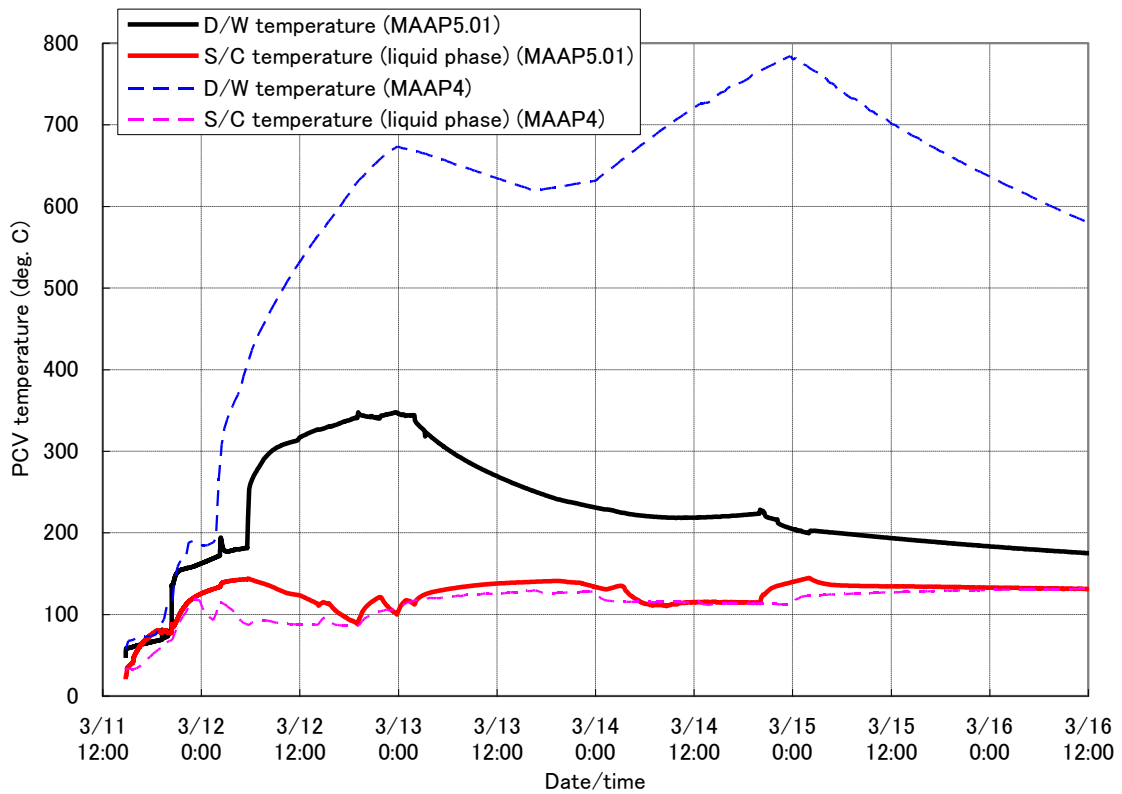
Figure 1-6 PCV temperature changes of Unit-1

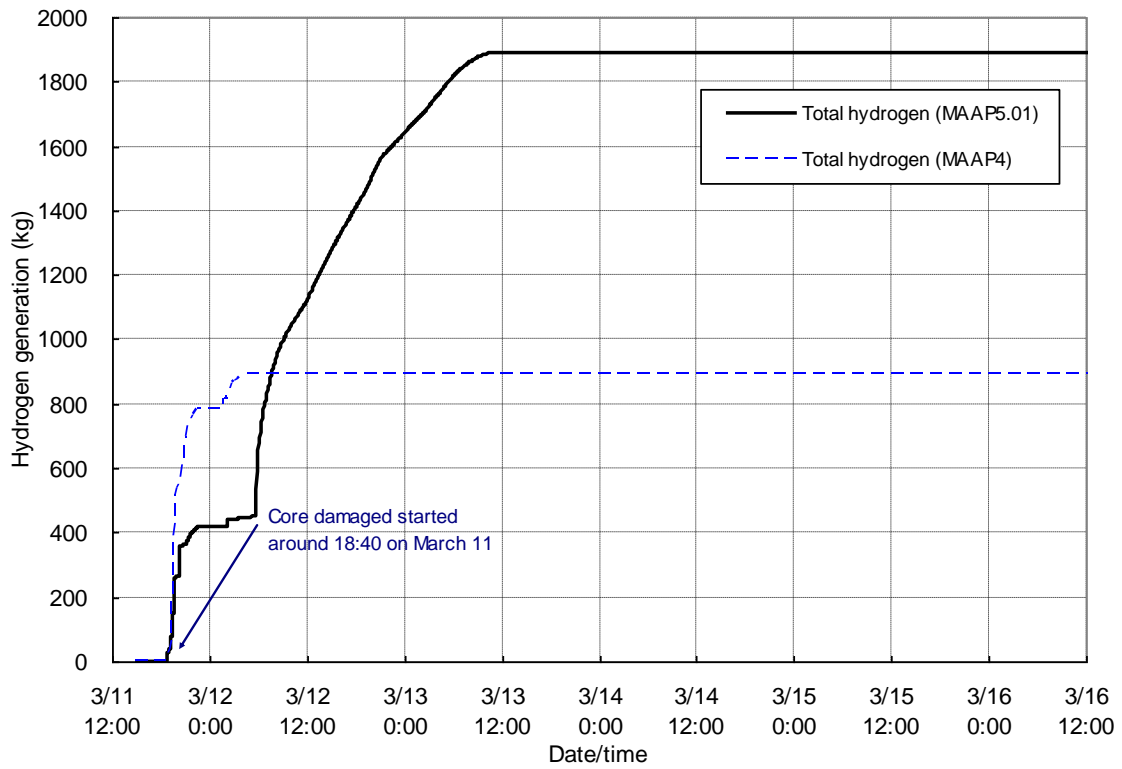
Figure 1-7 Hydrogen gas generation at Unit-1

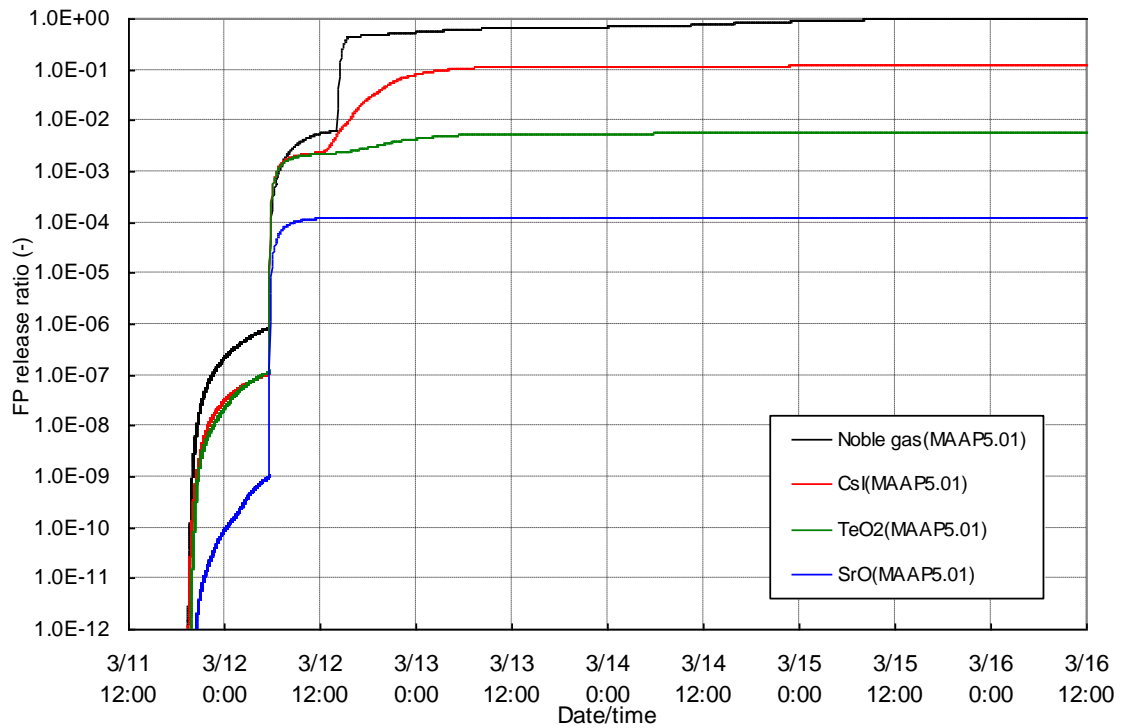
Figure 1-8 FP release ratio at Unit-1 (1/4)

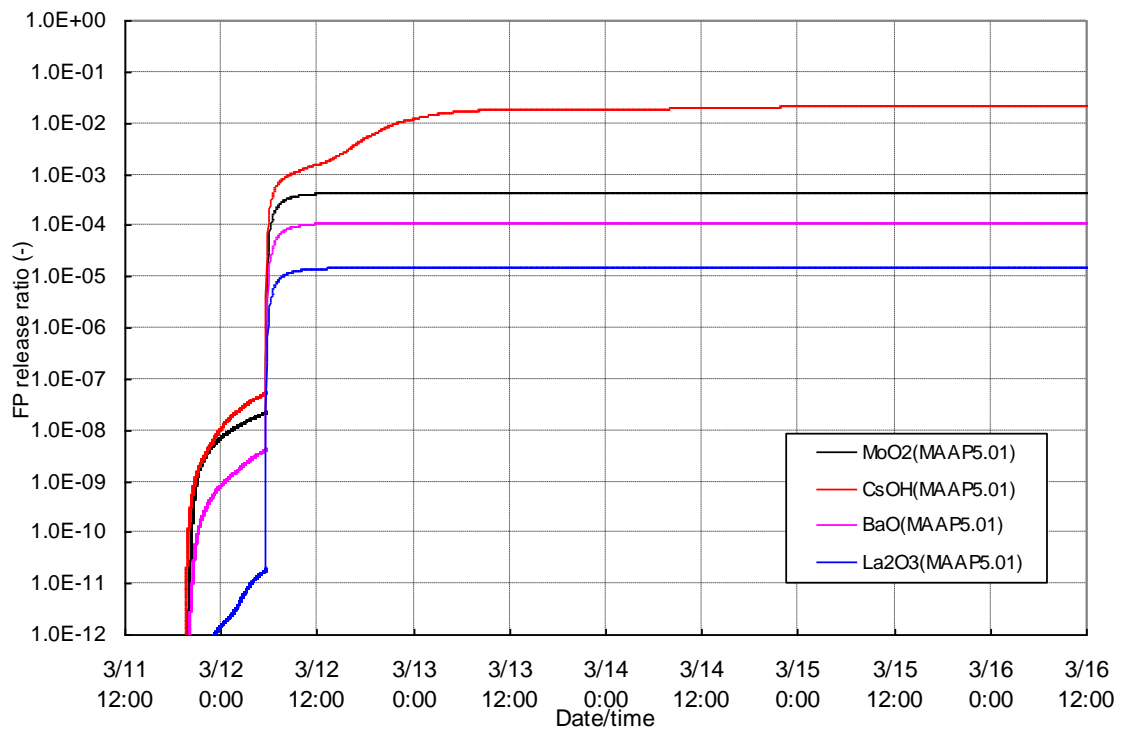
Figure 1-9 FP release ratio at Unit-1 (2/4)

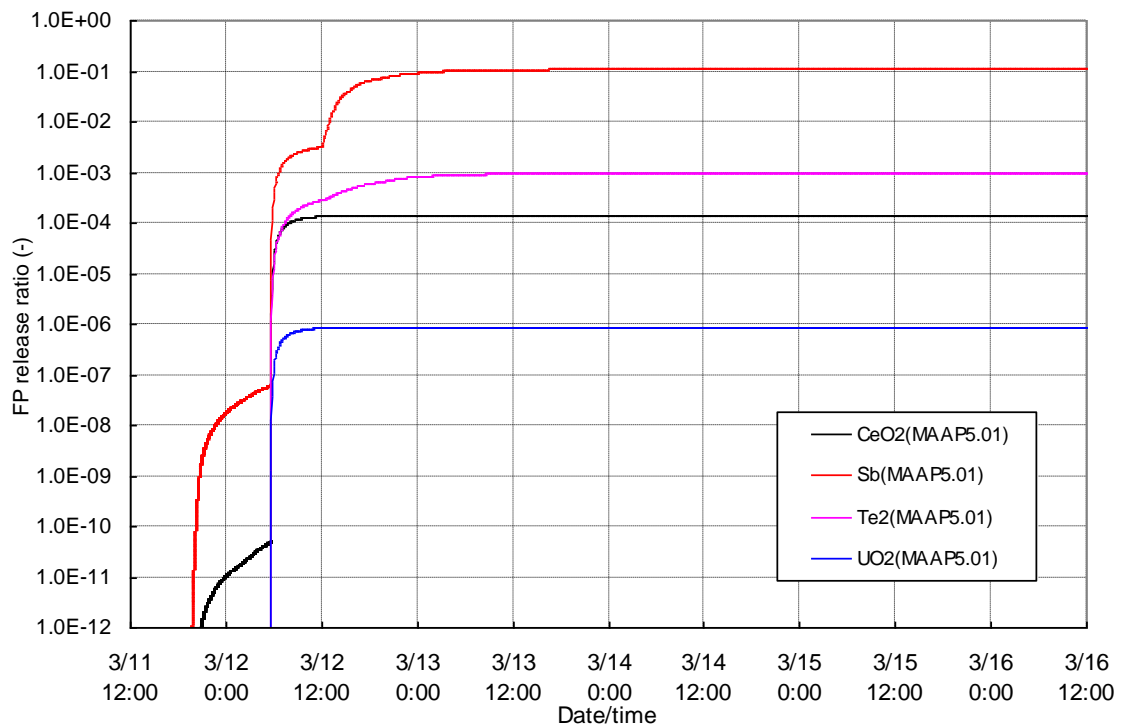
Figure 1-10 FP release ratio at Unit-1 (3/4)

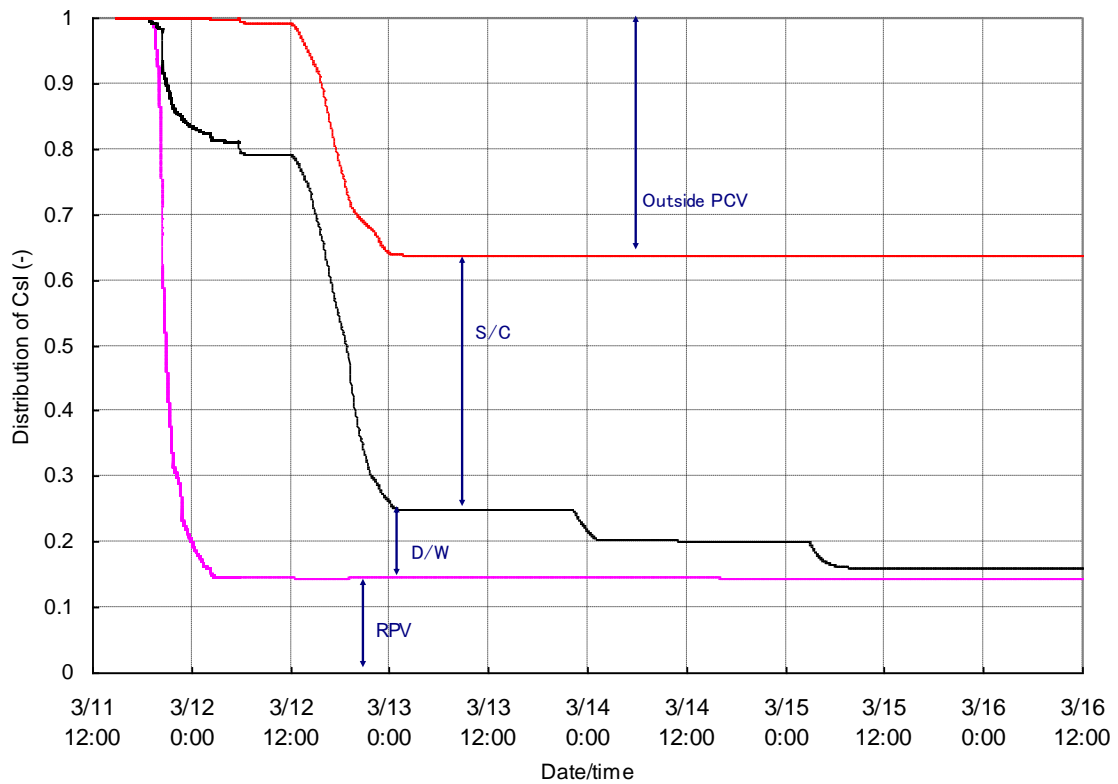
Figure 1-12 Distribution of FPs at Unit-1 (1/2)

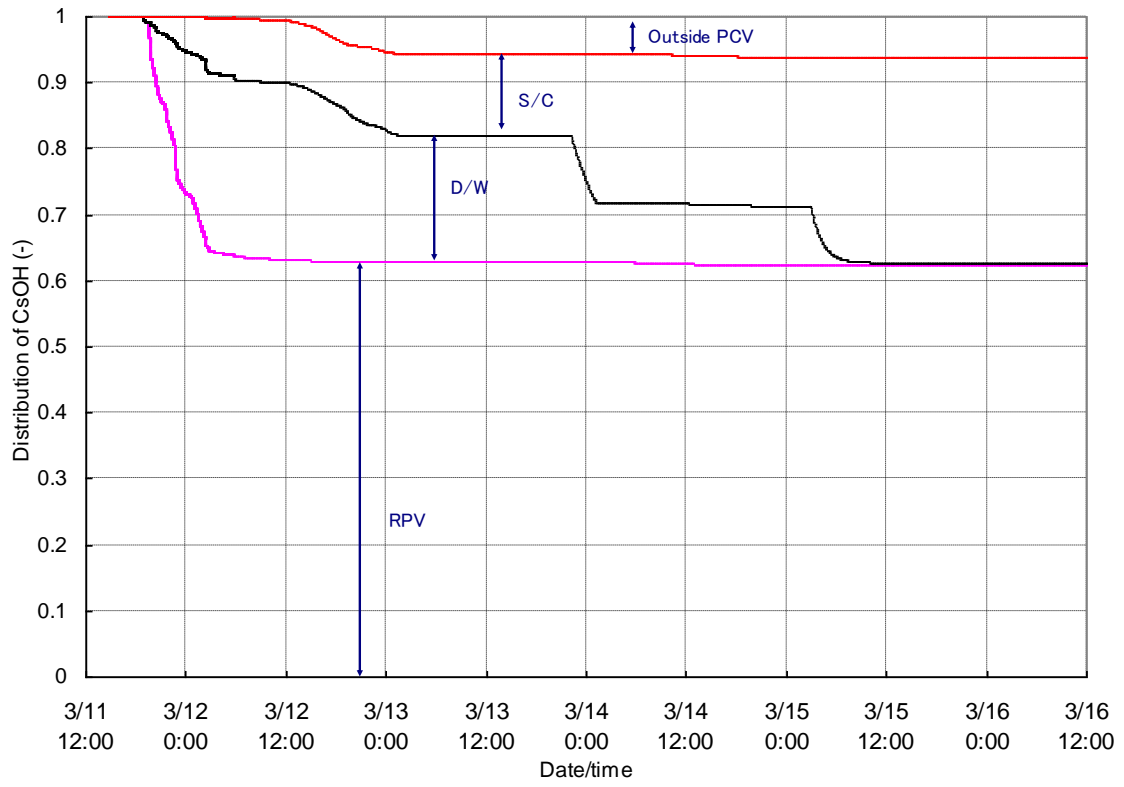
Figure 1-13 Distribution of FPs at Unit-1 (2/2)

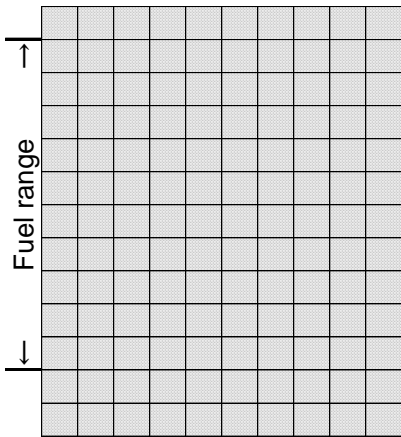
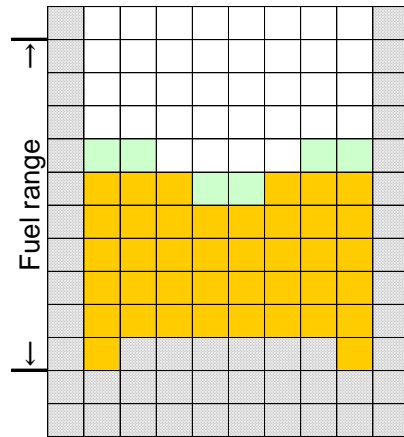
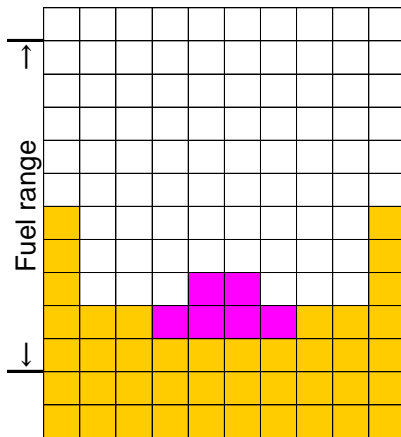
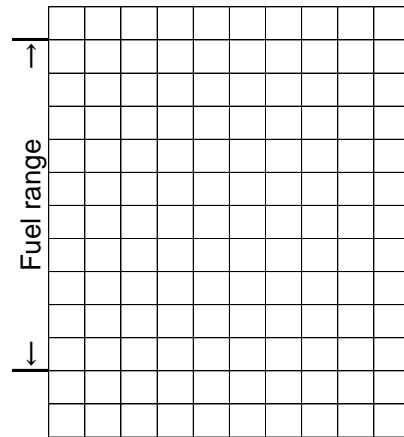
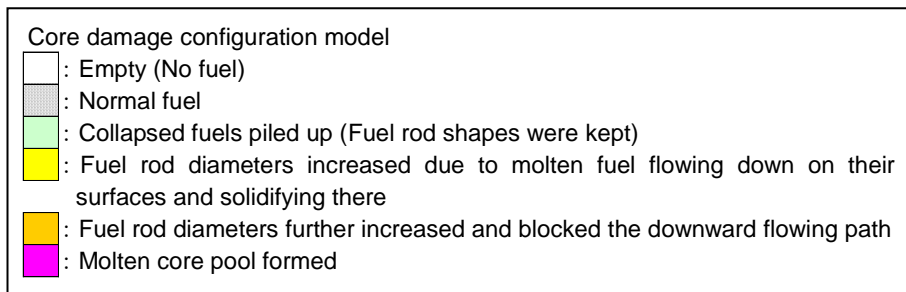
About 3.9 hours after SCRAM

About 5.0 hours after SCRAM

About 11.5 hours after SCRAM

About 12.0 hours after SCRAM

Figure 1-14 Core status of Unit-1

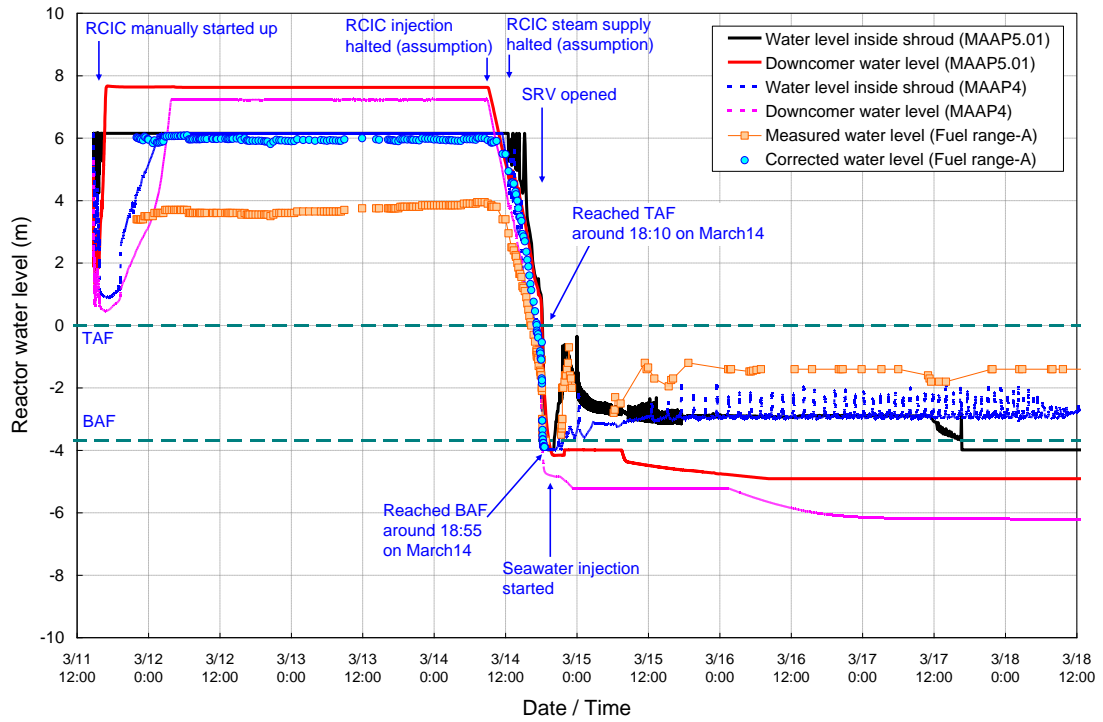
Figure 2-1 Reactor water level changes of Unit-2

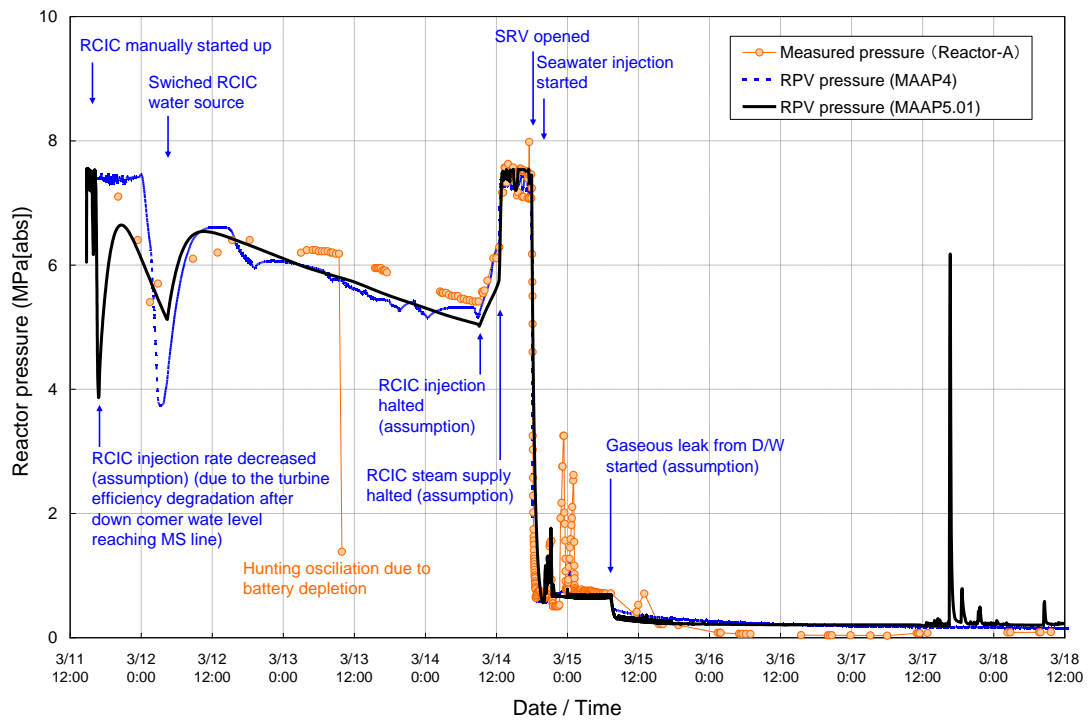
Figure 2-2 RPV pressure changes of Unit-2

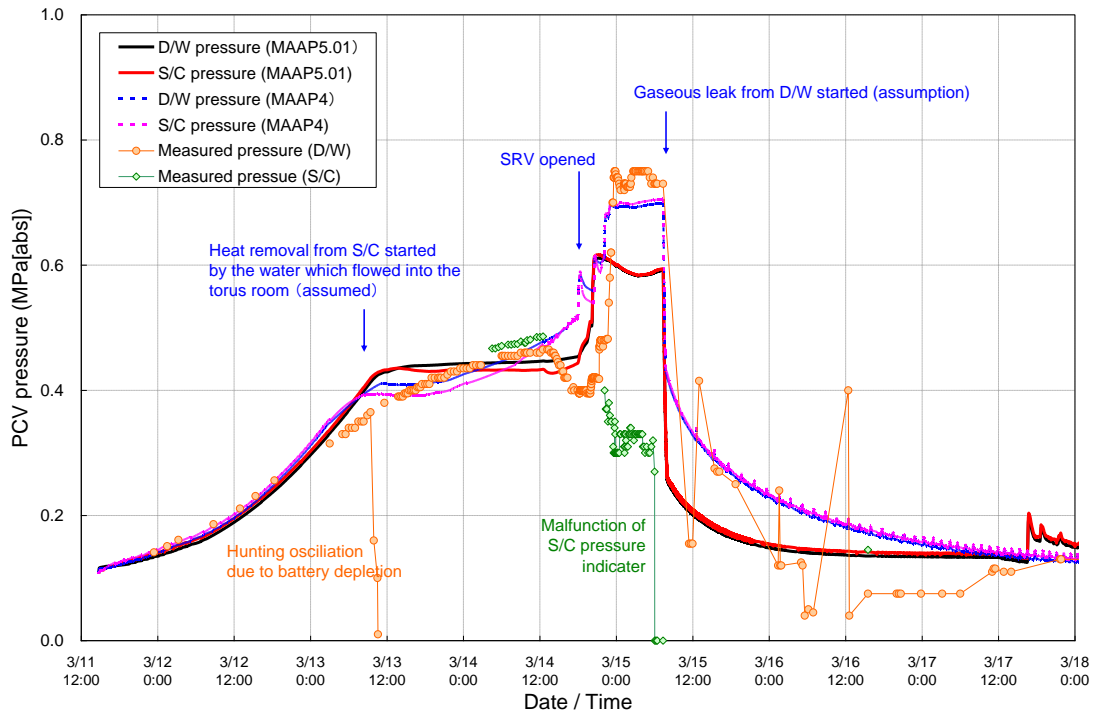
Figure 2-3 PCV pressure changes of Unit-2

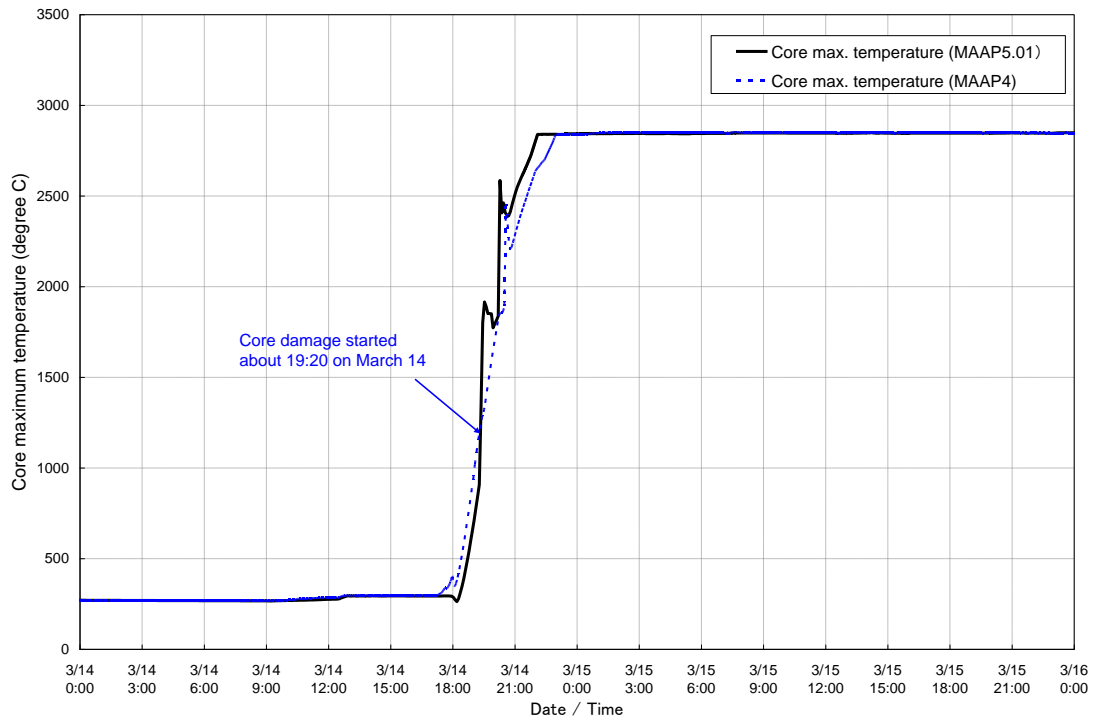
Figure 2-4 Core temperature changes of Unit-2

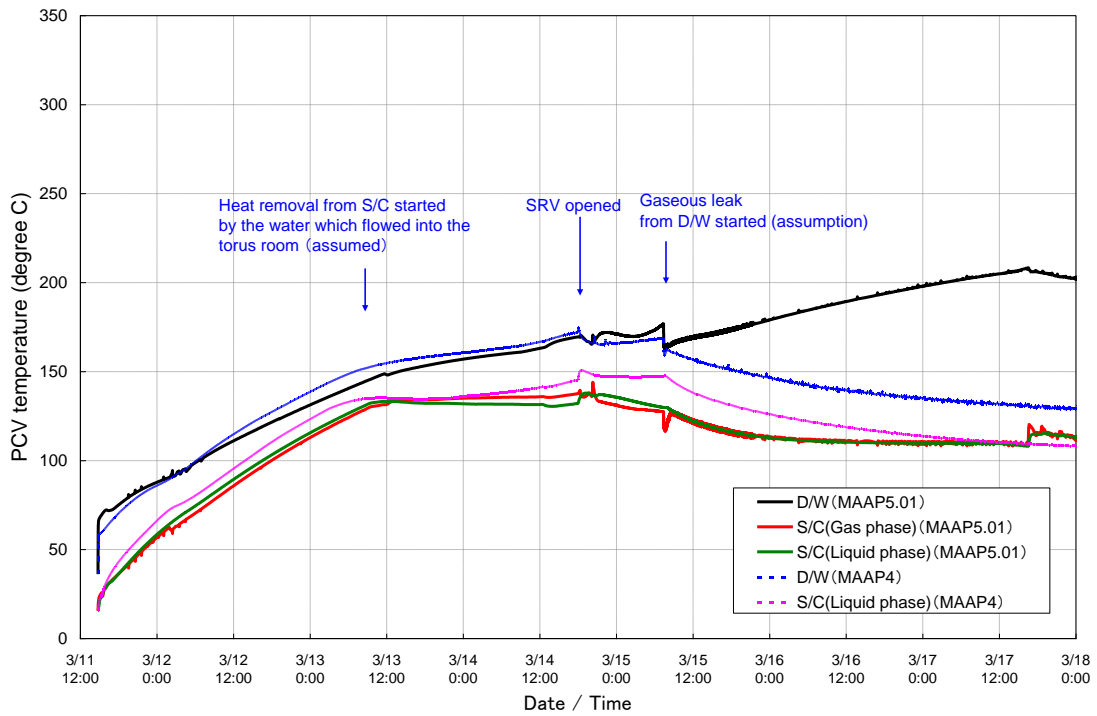
Figure 2-5 PCV temperature changes of Unit-2

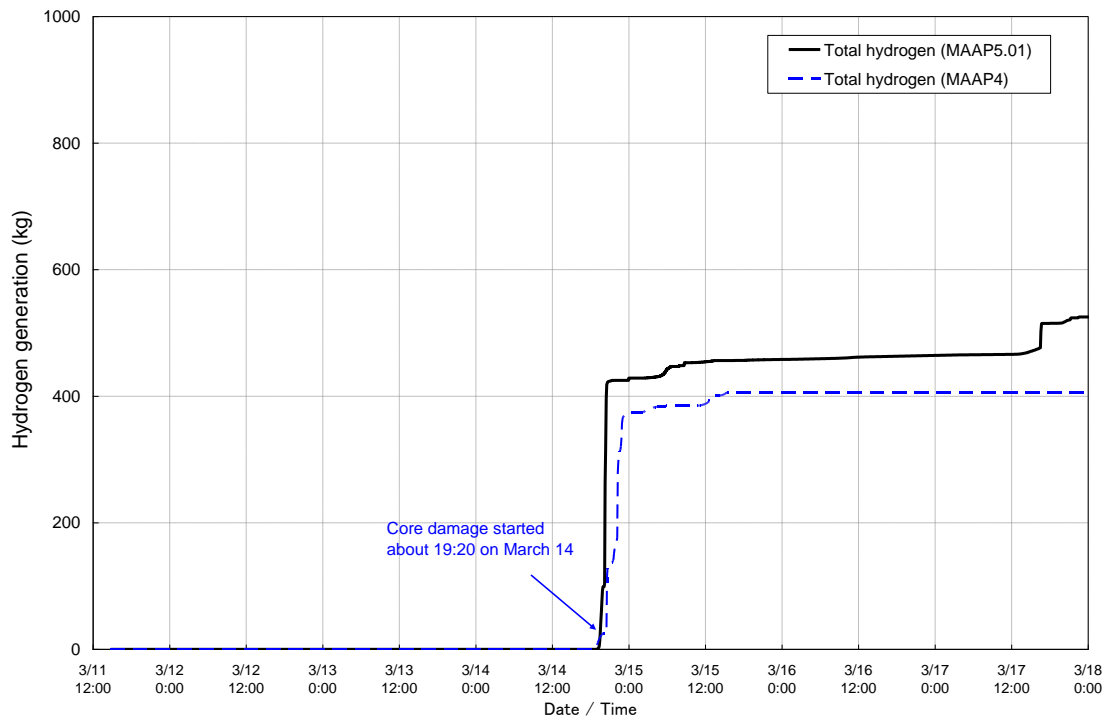
Figure 2-6 Hydrogen gas generation at Unit-2

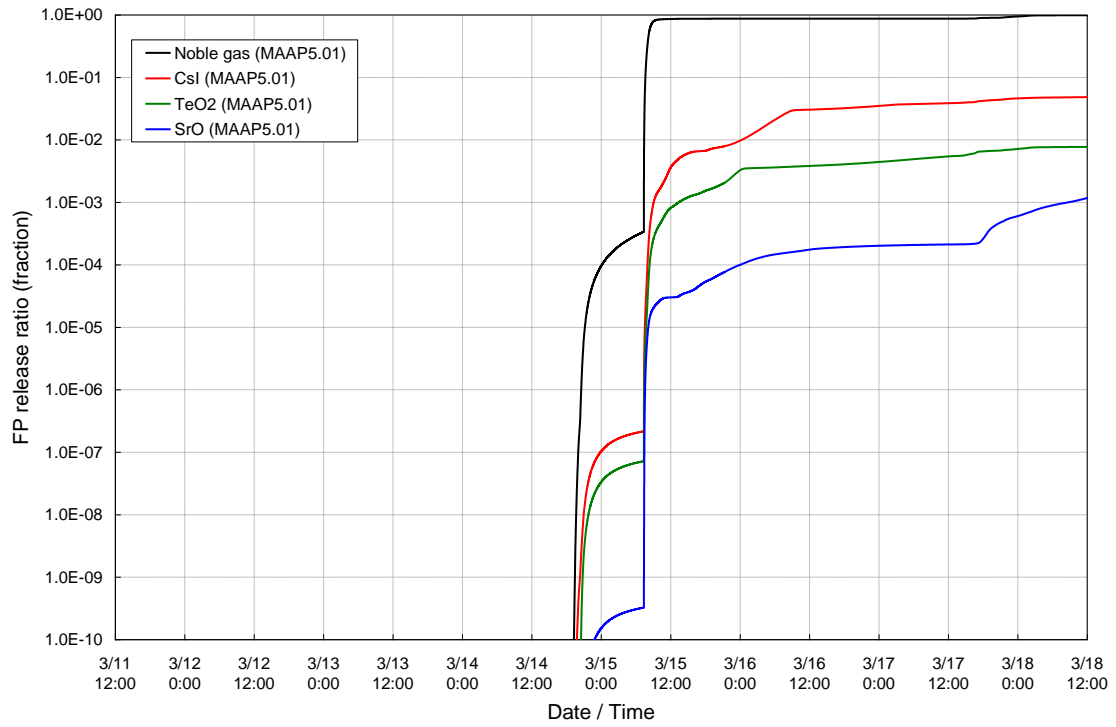
Figure 2-7 FP release ratio at Unit-2 (1/4)

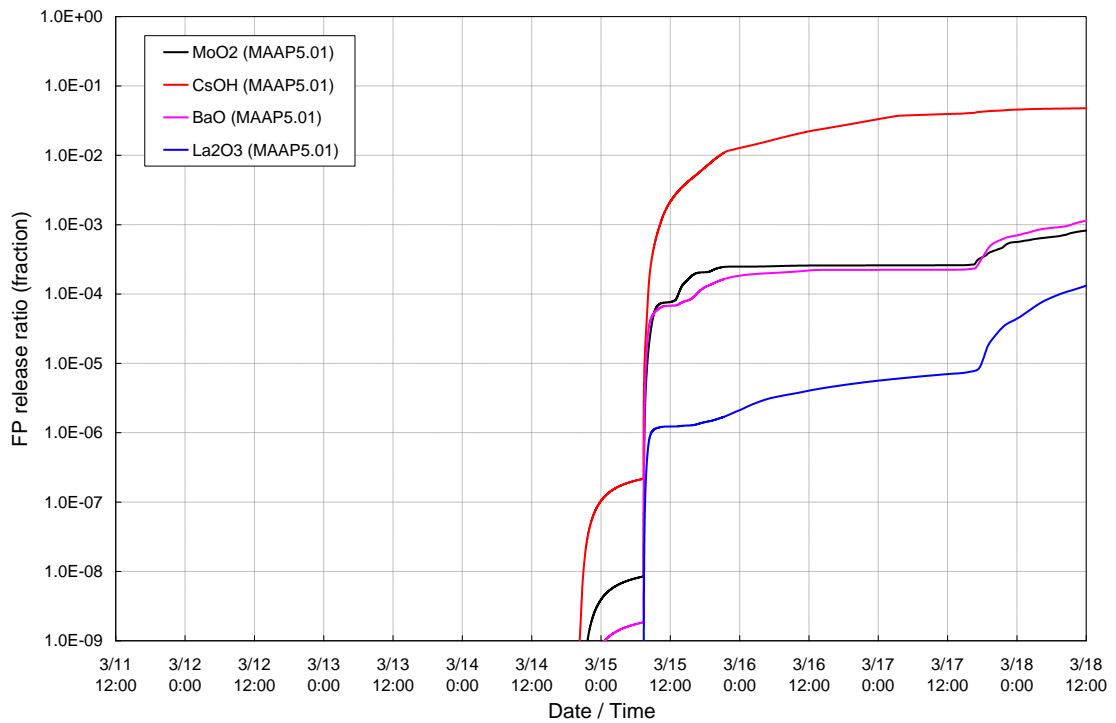
Figure 2-8 FP release ratio at Unit-2 (2/4)

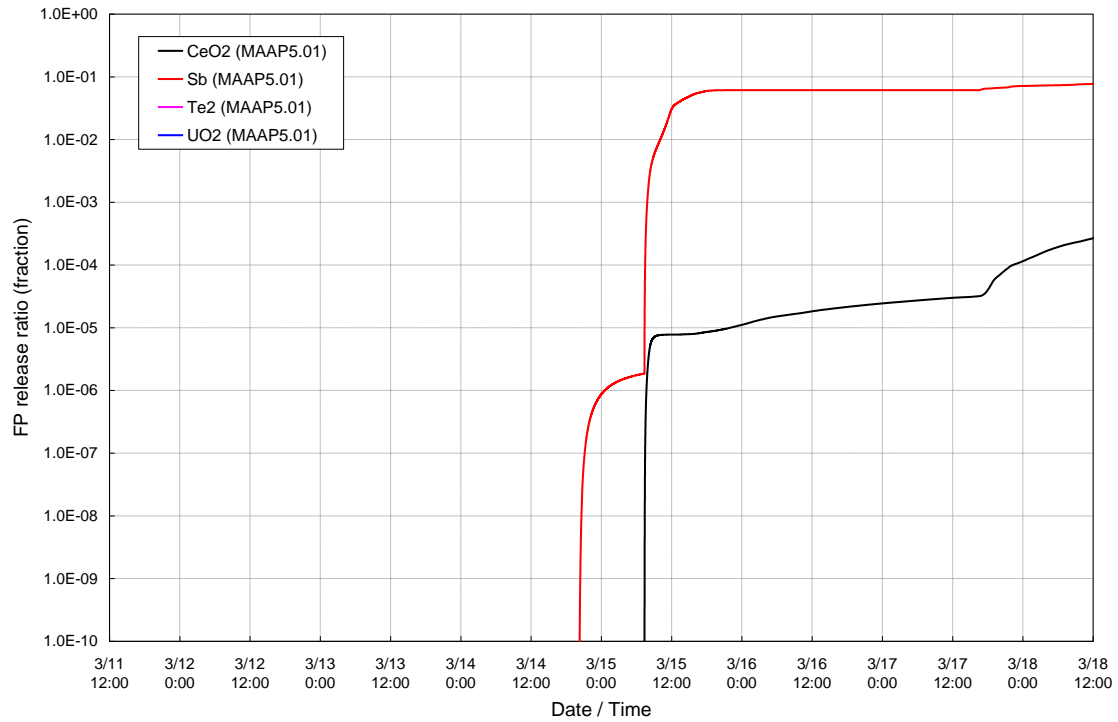
Figure 2-9 FP release ratio at Unit-2 (3/4)

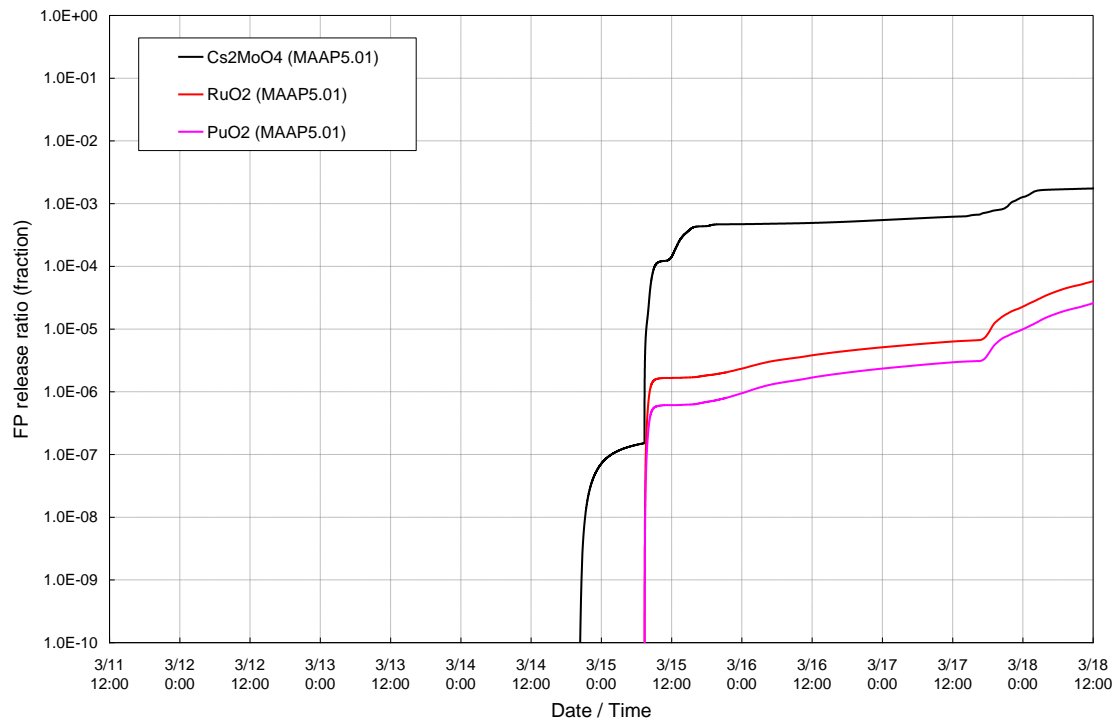
Figure 2-10 FP release ratio at Unit-2 (4/4)

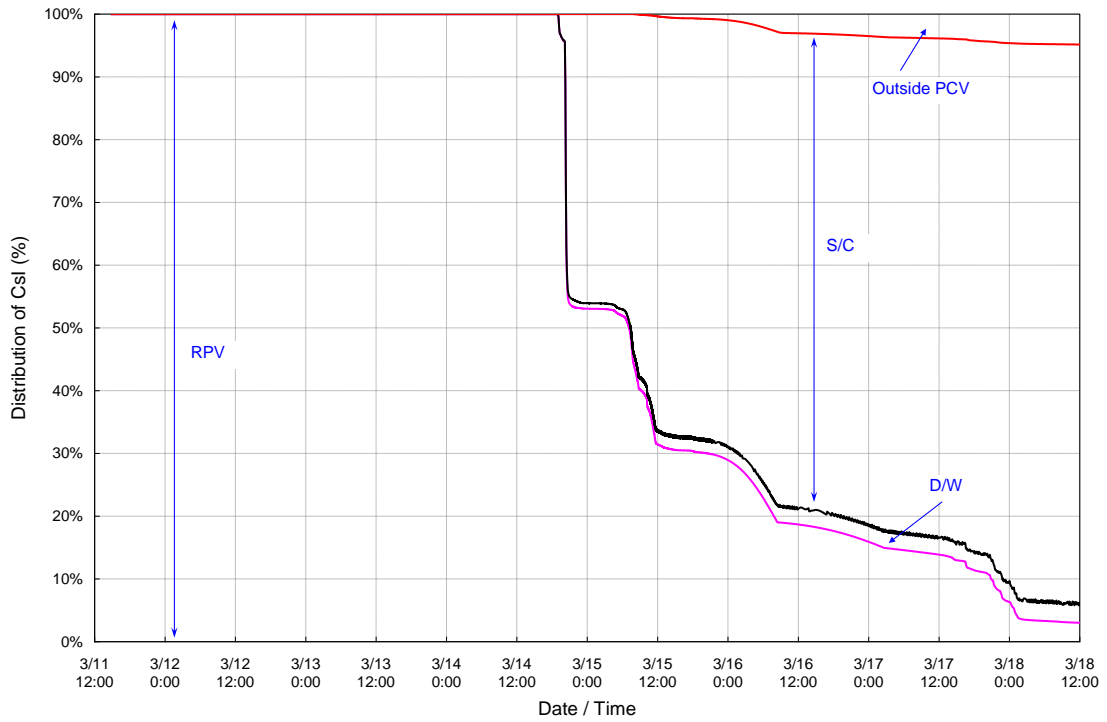
Figure 2-11 Distribution of FPs at Unit-2 (1/2)

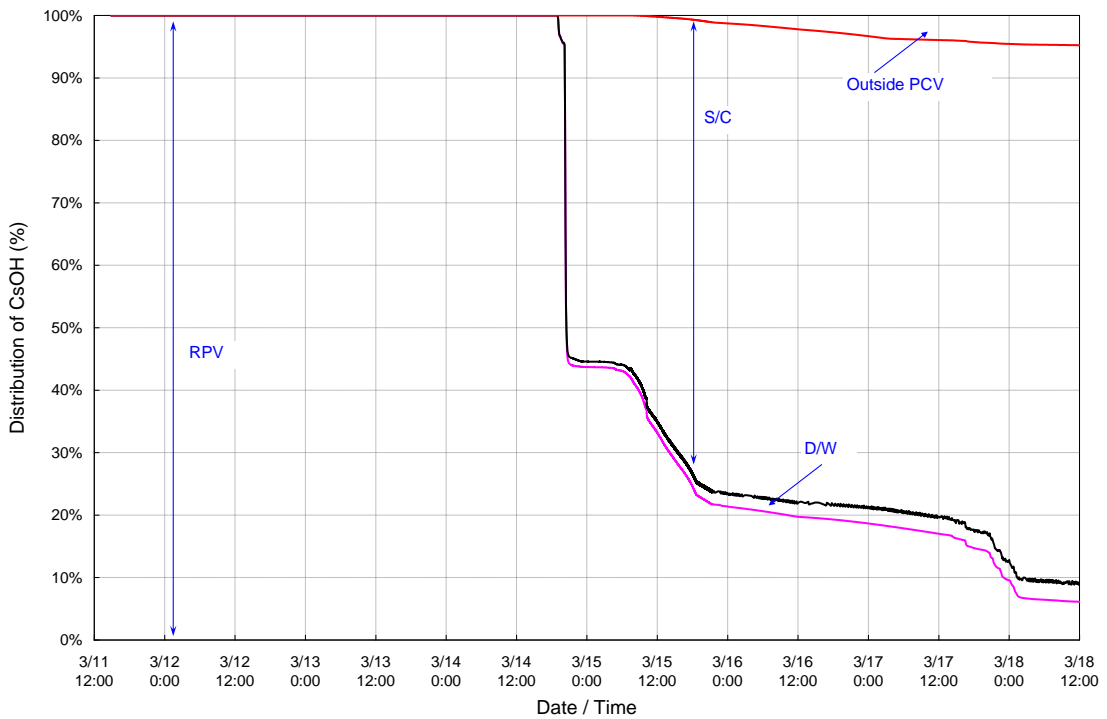
Figure 2-12 Distribution of FPs at Unit-2 (2/2)

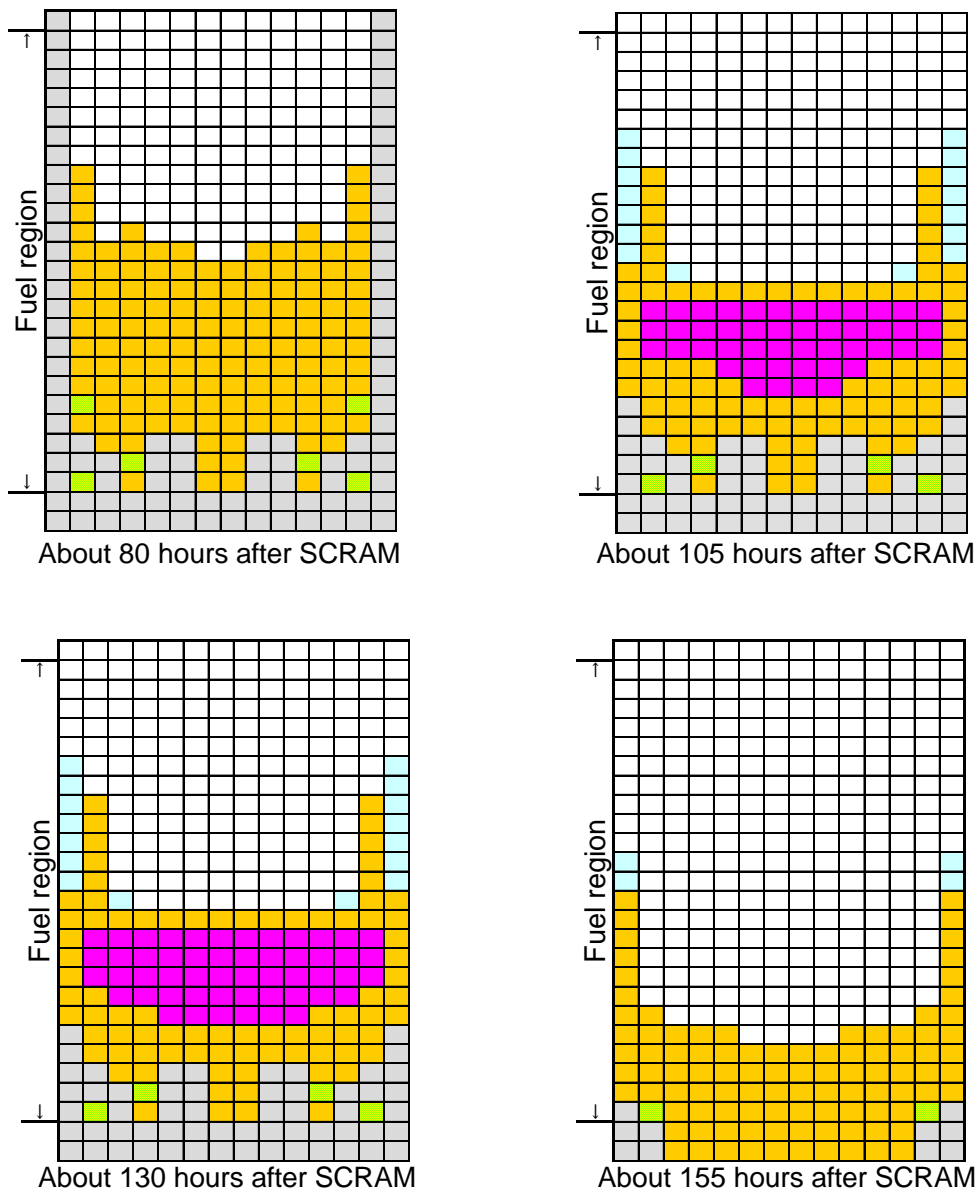
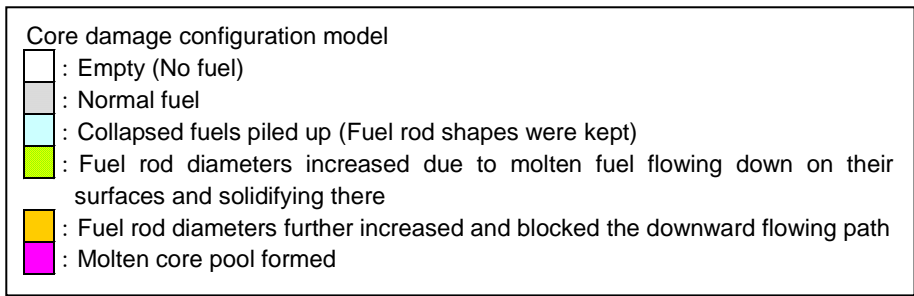
Figure 2-13 Core status of Unit-2

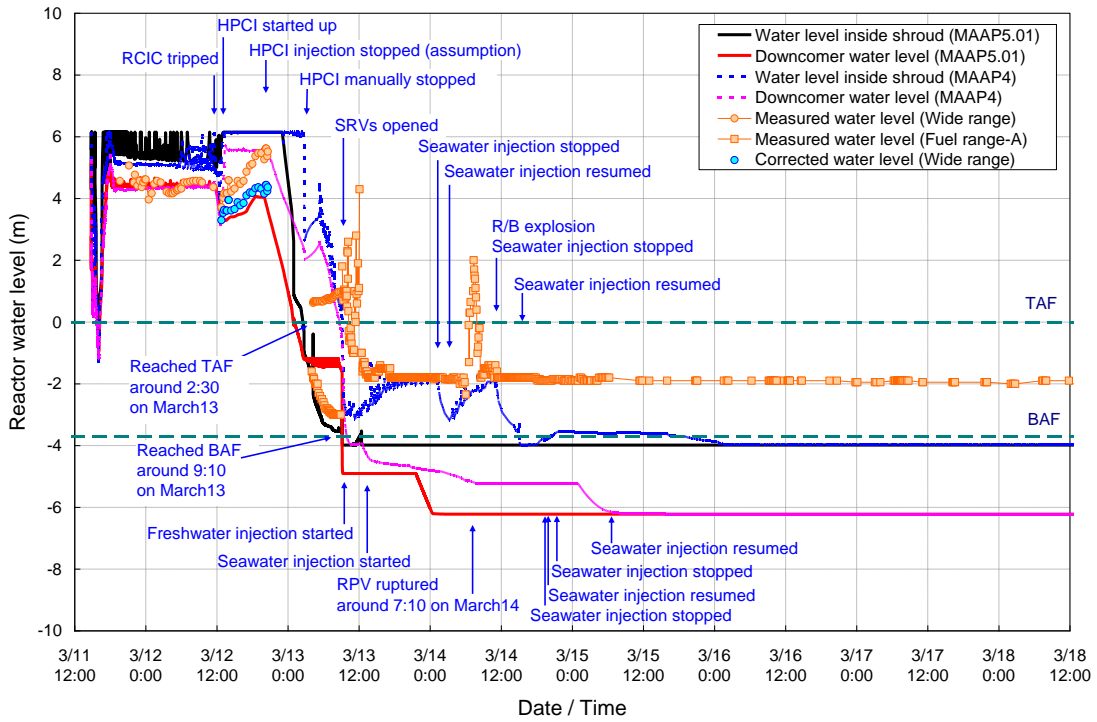
Figure 3-1 Reactor water level changes of Unit-3

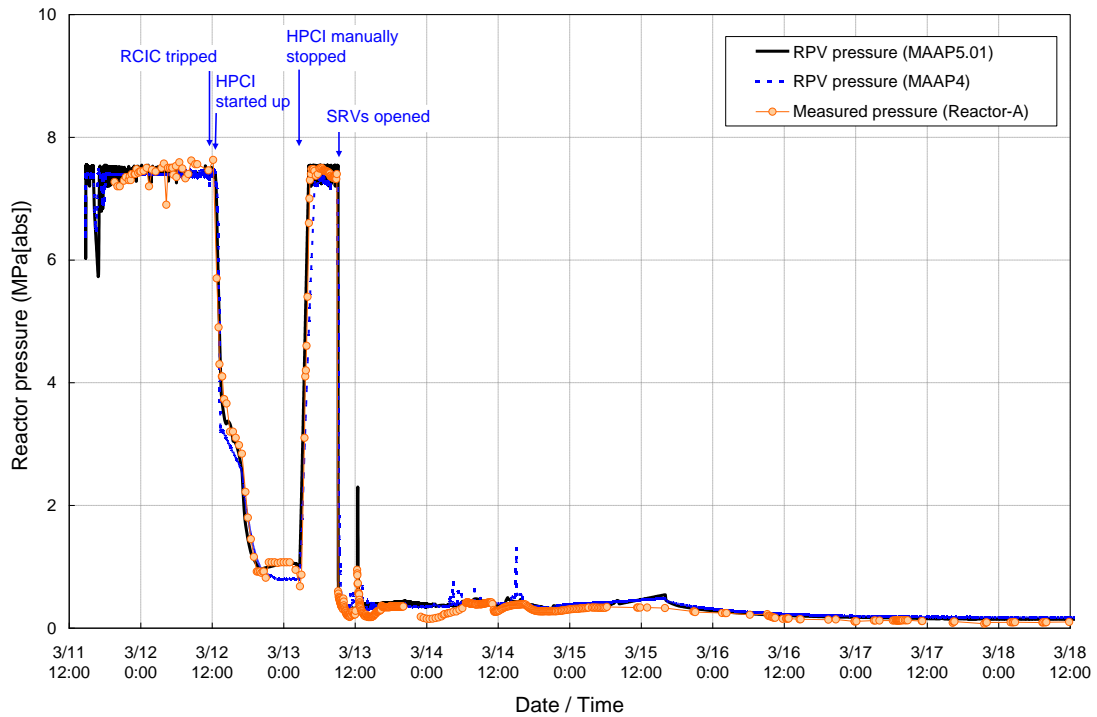
Figure 3-2 RPV pressure changes of Unit-3

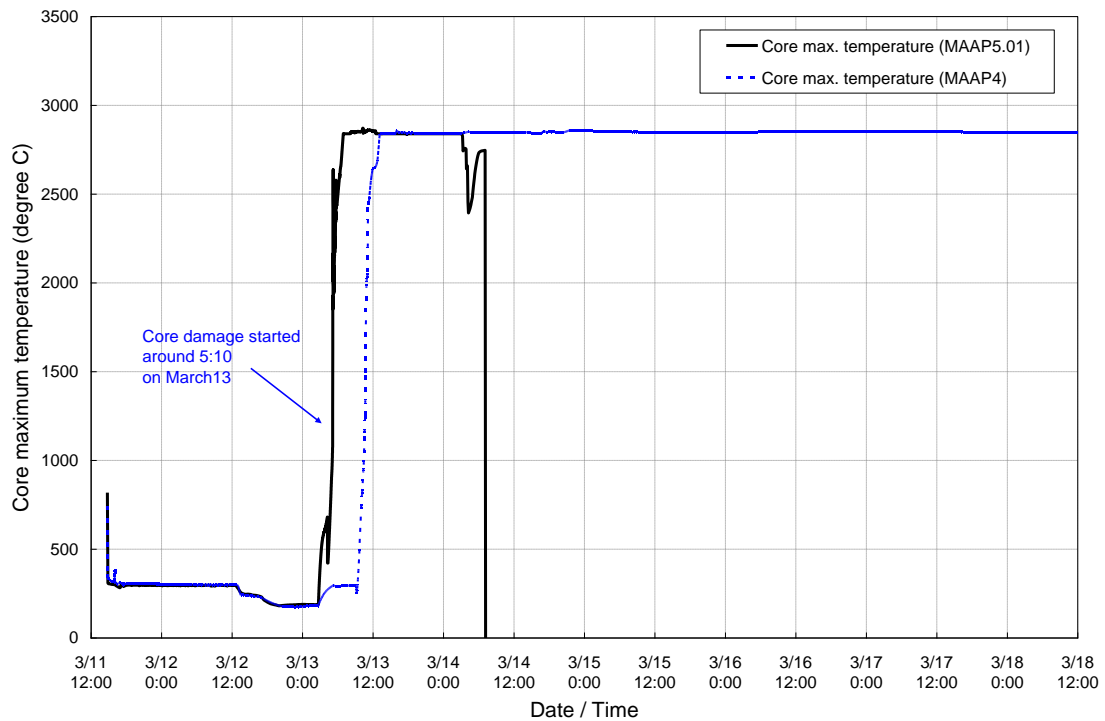
Figure 3-4 Core temperature changes of Unit-3

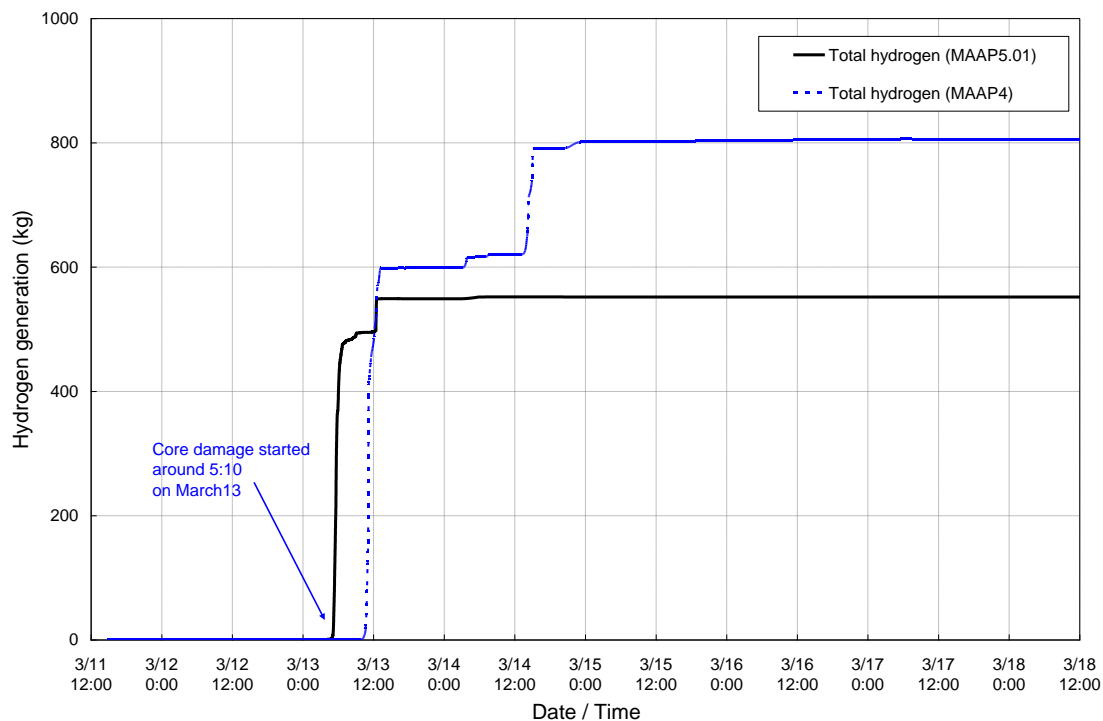
Figure 3-6 Hydrogen gas generation at Unit-3
