Findings from the latest analyses using MAAP5

1. Latest analysis of Unit-1 by MAAP5.01

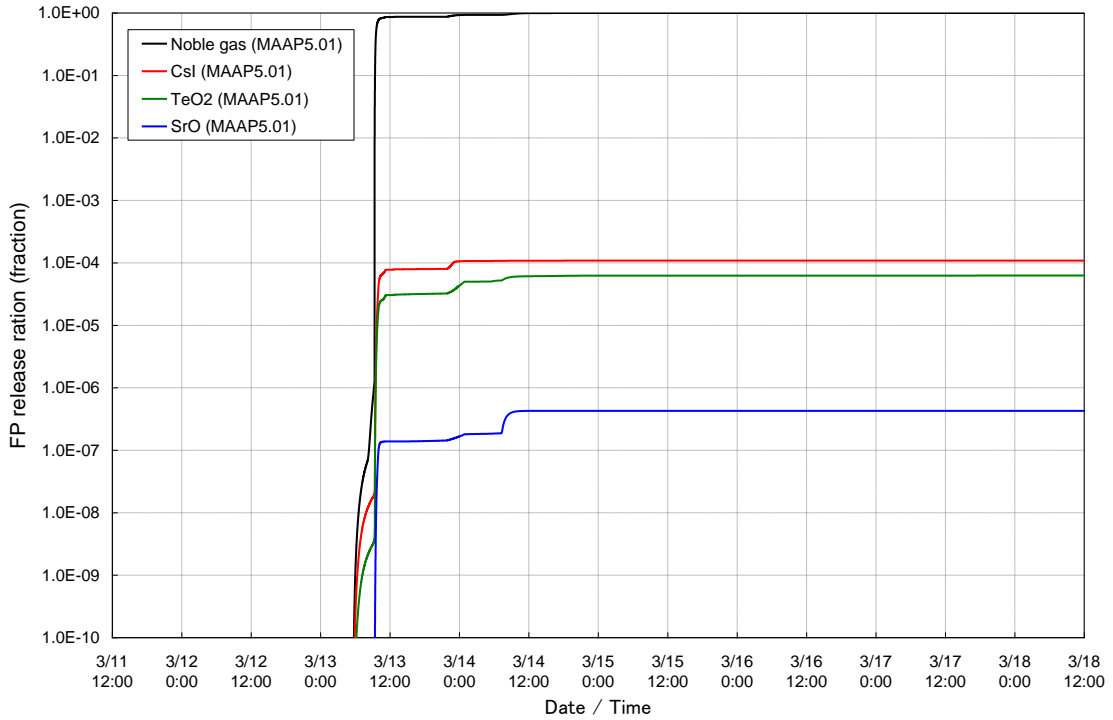
Figure 3-7 FP release ratio at Unit-3 (1/4)

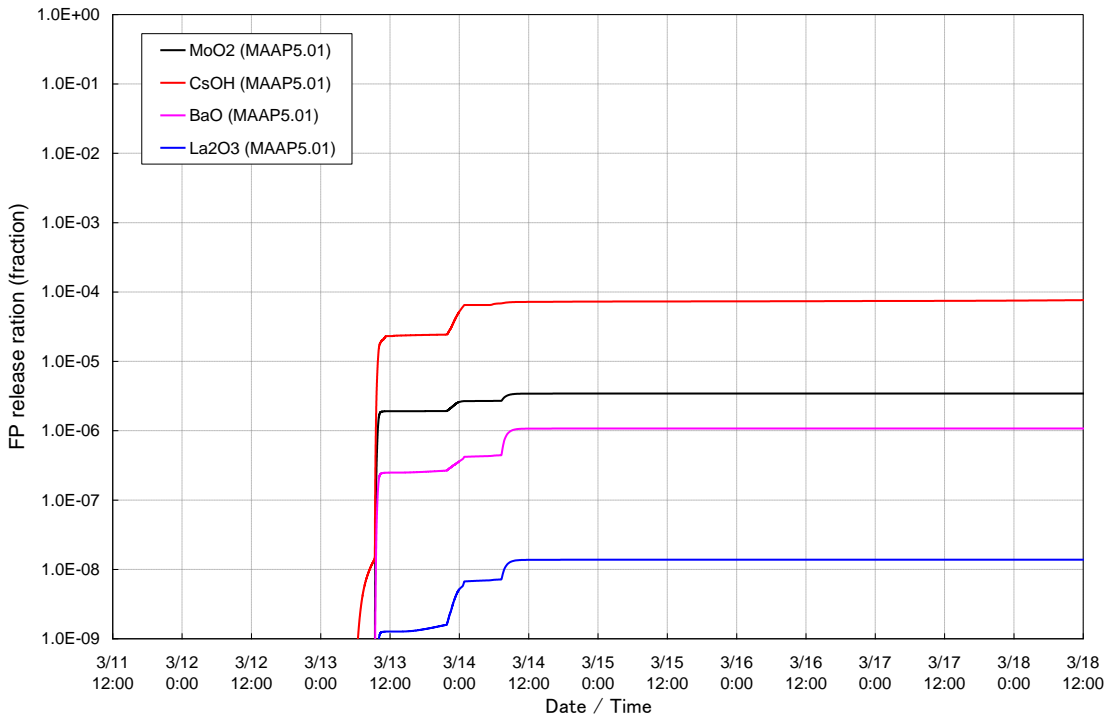
Figure 3-8 FP release ratio at Unit-3 (2/4)

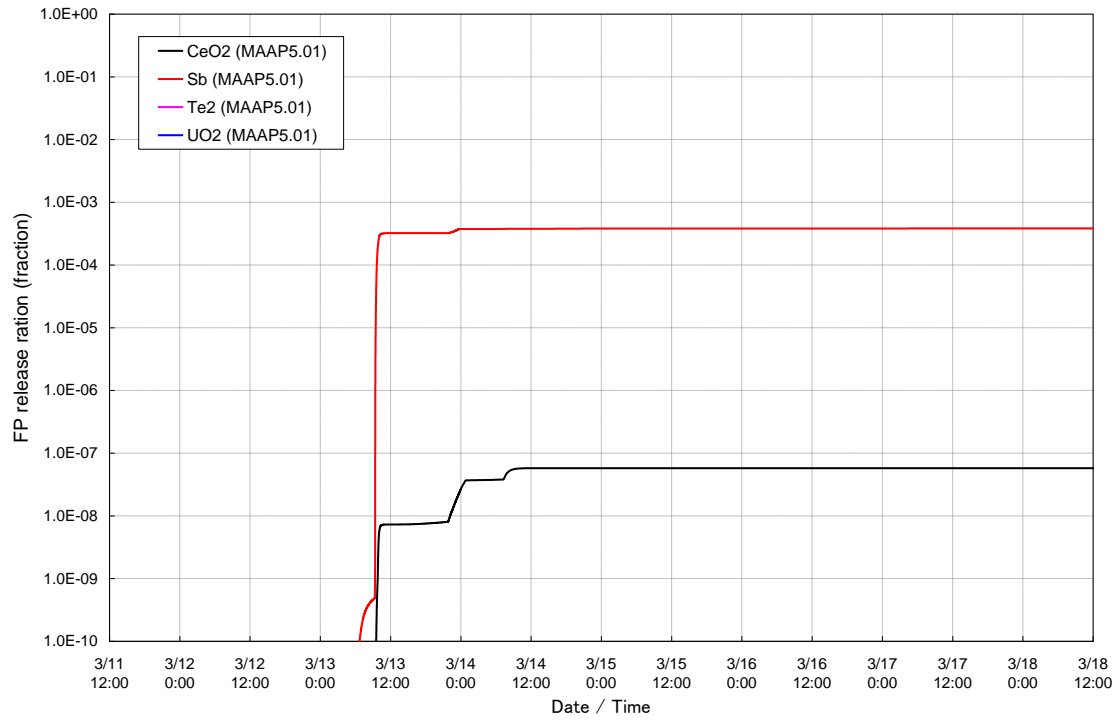
Figure 3-9 FP release ratio at Unit-3 (3/4)

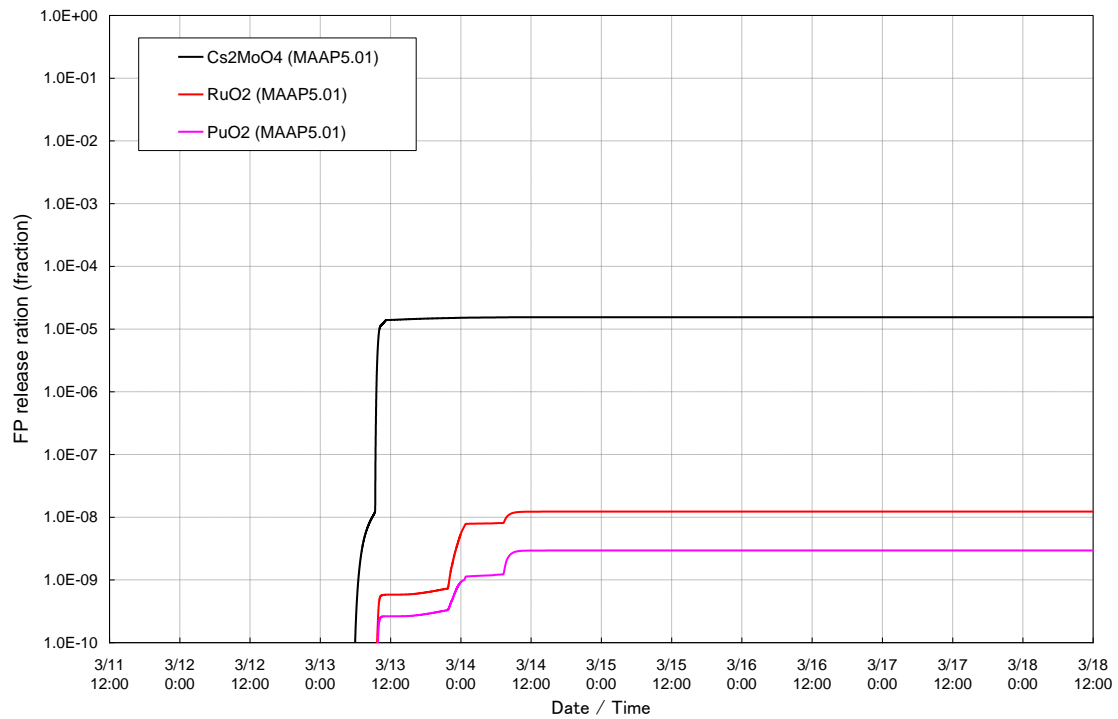
Figure 3-10 FP release ratio at Unit-3 (4/4)

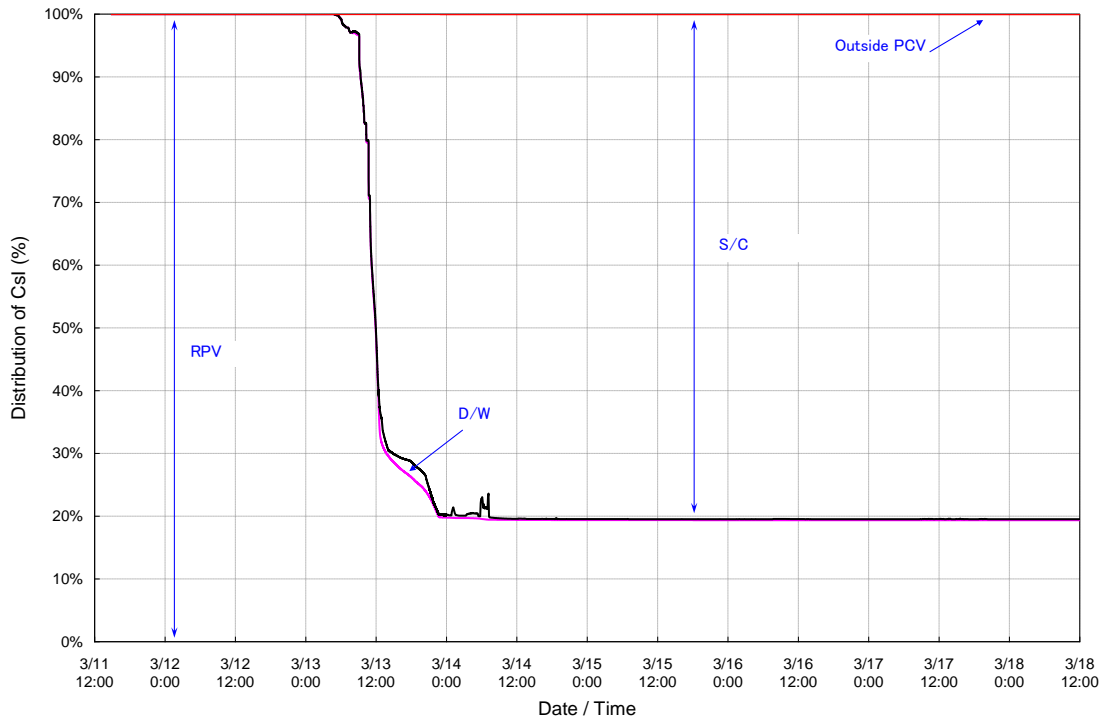
Figure 3-11 Distribution of FPs at Unit-3 (1/2)

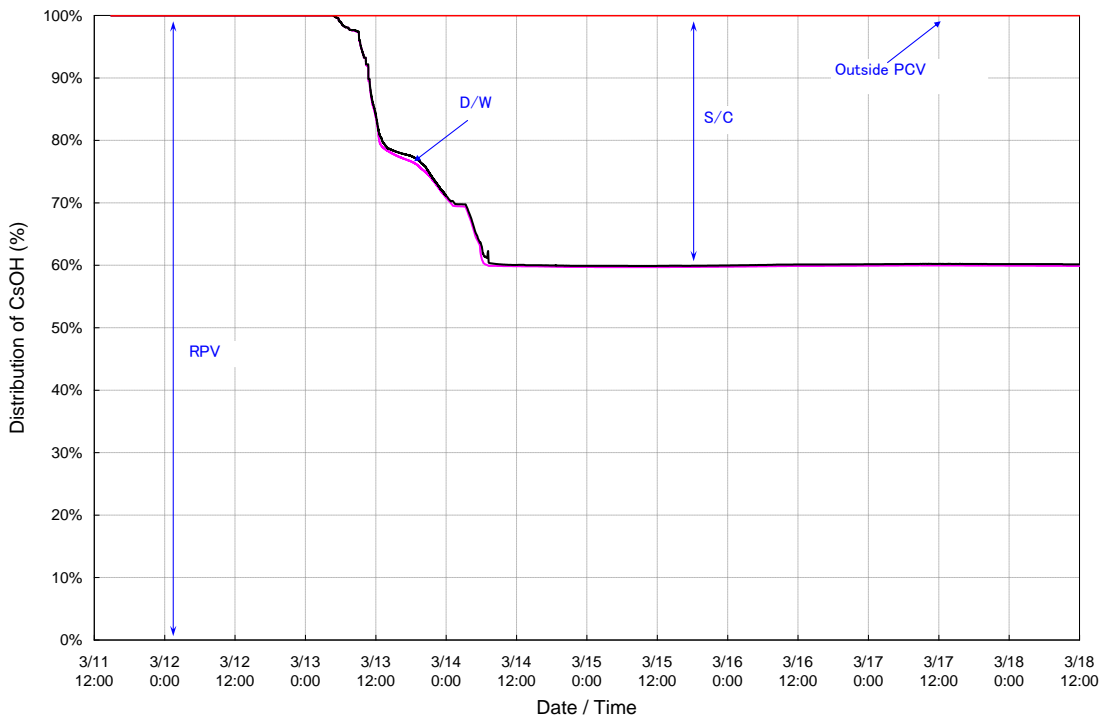
Figure 3-12 Distribution of FPs at Unit-3 (2/2)

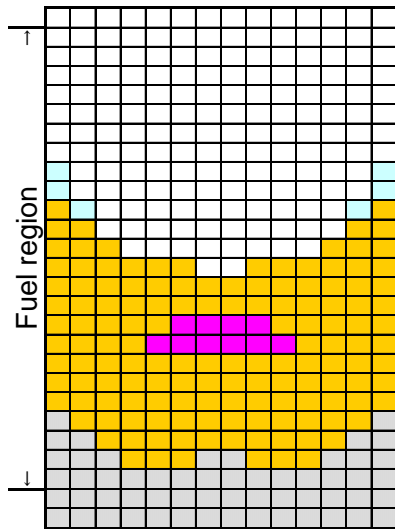
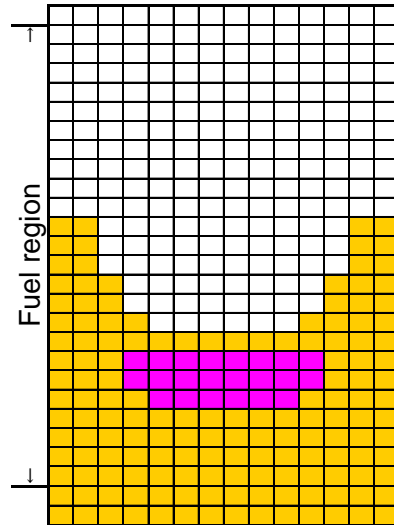
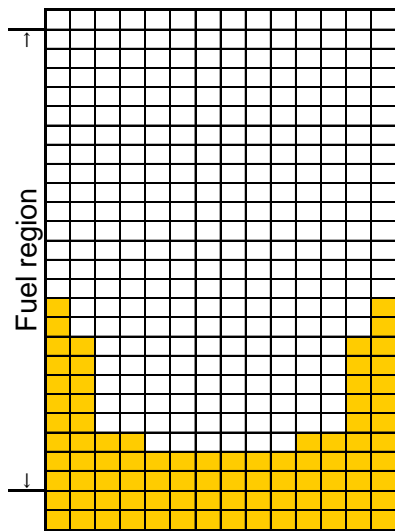
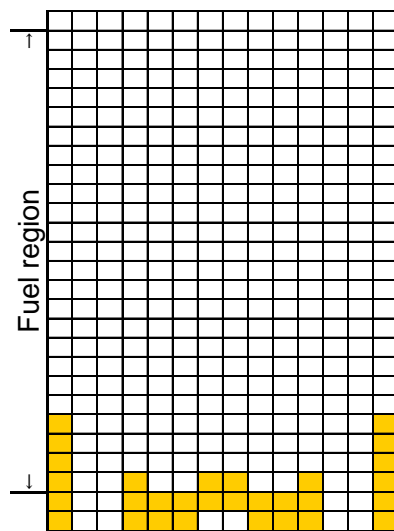
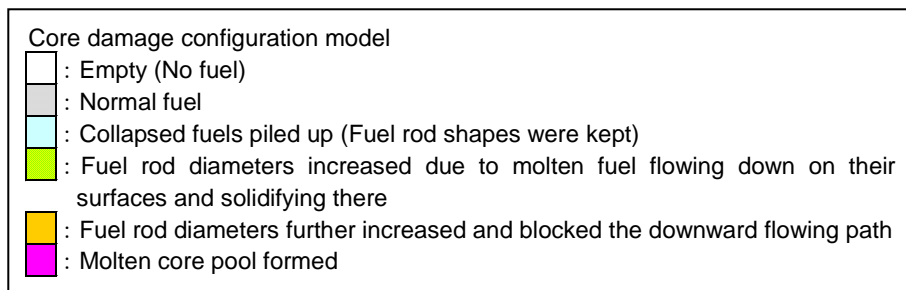
About 42 hours after SCRAM

About 44 hours after SCRAM

About 46 hours after SCRAM

About 64 hours after SCRAM

Figure 3-13 Core status of Unit-3
