Behavior of primary containment vessel pressure starting about 12 o'clock on March 14th in Unit 2

1. Outline of phenomena and subjects of investigation

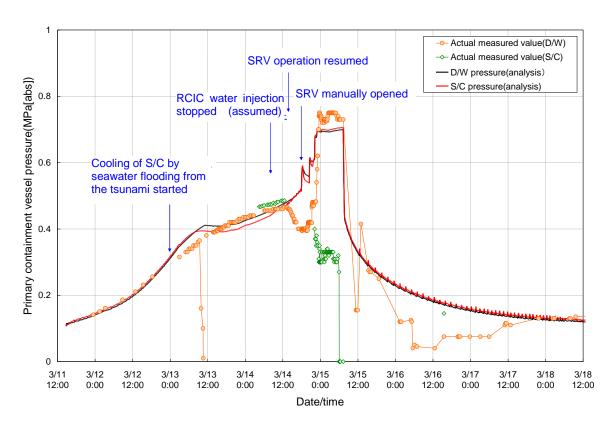
Fig.1 Change of PCV pressure

Therefore, the following qualitative scenario can be made. During RCIC operation, if it is assumed that the effect of ① is smaller than the effect of ②, PCV pressure monotonously increases until the RCIC stops. When the RCIC stops, the PCV pressure decreases because the accumulated energy of the PCV decreases. If the reactor pressure increases to the point at which the SRV operates, the pressure decrease of the PCV stops, since energy transfer to the S/C resumes depending on the magnitude correlation between ① and ③. In addition, the actual pressure behavior of the PCV, described in Fig. 1, shows first a monotonous increase, then a decrease and finally a stop of the pressure decrease.

However, if time change of the PCV pressure is observed, water injection into the reactor by the RCIC stops at about 9:00 on the 14th, which is estimated from the increase of the reactor pressure, and start of pressure reduction of the PCV is at about 13:00 when SRV operation resumes. This behavior is different from the above qualitative explanation. In addition, after some time, when reactor pressure decreases to below 1 MPa at about 18:00 by manually opening the SRV by remote operation from the main control room using a temporary battery power supply, no change in PCV pressure is observed although a lot of steam (and energy) flows into the S/C. Thus, the following chapters describe the detailed investigation of the pressure behavior of the PCV.

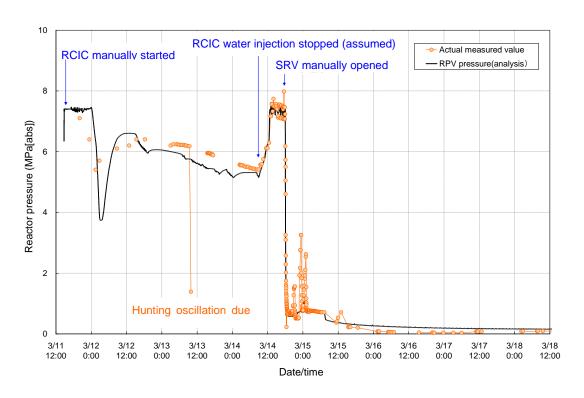
Fig.2 Change of reactor pressure

gauge. If the reactor water injection stops, the reactor pressure starts to increase, since the supply of relatively low temperature water from the S/C stops. According to Fig.2 which shows the time change of reactor pressure, it can be observed that reactor pressure increase started at about 9:00. Therefore, the stop of reactor water injection by RCIC is evaluated as taking place at about 9:00.

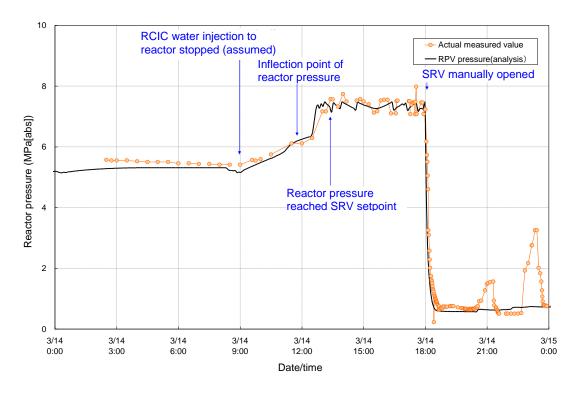
Fig.3 Change of reactor pressure (expanded scale)

Fig. 3 shows close-up of time changes of reactor pressure. While the reactor pressure increase started at about 9:00, the rapid pressure increase is observed after the increase of reactor pressure stops once at about 12:00. The following hypotheses can be considered about this.

Fig. 3 also shows the analysis result obtained using the MAAP code under these conditions (except for resumption of water injection). Fig. 3 reproduces well the slow reactor pressure increase by the continuing steam supply to the RCIC turbine and also the rapid reactor pressure increase by the RCIC turbine trip.

However these hypotheses, in which energy transfer from the RPV to the S/C stops at about 12:00, cannot explain the status reasonably, because the actual start of the pressure decrease in the PCV is after 13:00.

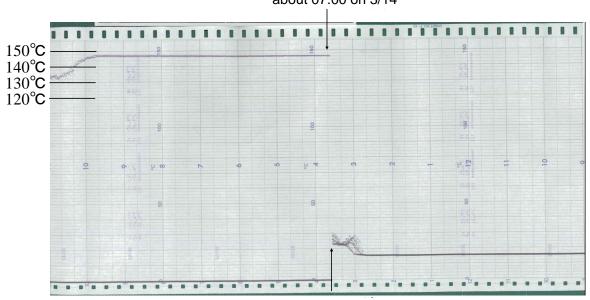
Fig.4 Record chart of water temperature of S/C

The SRV of Unit 2 opened a few times before the tsunami hit and its discharge behavior was recorded in the chart of the S/C temperature shown in Fig. 4. The thermometer was installed at O.P.350mm as shown in Fig. 5 and it measured temperature at a point a short distance below the S/C center and at 8 positions which were at intervals of 45° in the radial direction. Regarding the water temperature changes in the charts, it is confirmed that water temperature changed greatly in some locations, and this captured the localized temperature change of the S/C by operation of the SRV. The steam from the SRV was discharged from the T quencher located at the bottom of the S/C. The temperature increased as the thermometer was closer to the T quencher, and it is thought that temperature scattering occurred because of the turbulence at discharge. Moreover it is observed that the thermometer far from the T quencher increased continuously and moderately towards the equilibrium temperature. This is considered to reflect the situation that the location around the thermometer was relatively calm and the temperature of the liquid phase increased gradually.

In the chart shown in Fig. 4, temperature data are recorded after resumption of water level indicator at about 7:00 on March 14th. The water temperature of the S/C is about 146 $^{\circ}$ C at about 7:00 and about 148 $^{\circ}$ C at about 12:00. The pressure of the S/C at about 12:00 is 0.46MPa, and the saturation temperature corresponding to this pressure is 148.7 $^{\circ}$ C. Therefore, at least up to the depth where the S/C water thermometer was installed, the temperature is considered to be almost constant. On the other hand, although accurate estimation of the time is difficult, temperature decrease is observed from about 13:00 when operation of the SRV resumed.

This temperature decreasing behavior agrees in timing with the pressure decreasing behavior of the PCV. The saturation temperature at 15:30, when the PCV pressure decreased to 0.43 MPa, is 146.2 $^{\circ}$ C. The temperature at the water thermometer position at this time is about 132 – 134 $^{\circ}$ C, which is lower than saturated temperature. This means that the S/C water temperature does not decrease due to the pressure decrease of the PCV. Therefore, it is estimated that pressure decrease of the PCV is caused by water temperature decrease of the S/C.

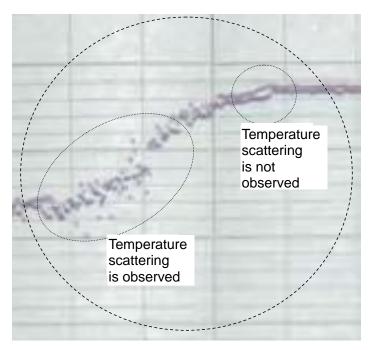
Fig.7 Temperature change of 2 thermometers during SRV operation after RCIC stops

The meaning of resumption of the SRV operation is resumption of the energy inflow to the S/C from the viewpoint of energy balance, thus it is difficult to explain the behaviors of decrease of temperature and pressure while energy inflows. Fig. 7 shows behavior of the water thermometer of the S/C after the RCIC stopped. In the water temperature behavior, existence or non-existence of temperature scattering is observed similar to the behavior during SRV operation before the tsunami hit. However, the difference from behavior before the tsunami is that occurrence of temperature scattering differs by time zone not by position. Although it cannot be declared what meaning this has, it is also possible to assume that the early stage of the temperature decrease is the temperature decrease by the liquid phase and after that the temperature decrease is accompanied by the influence of steam.

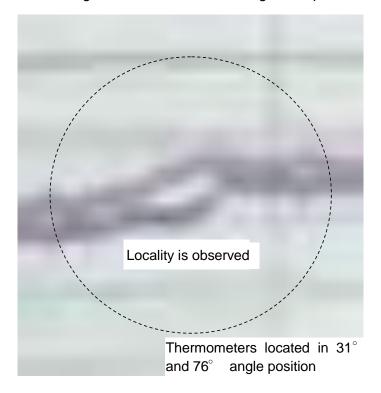
Fig.7 Temperature change of 2 thermometers during SRV operation after RCIC stops (close-up)

Fig. 8 shows close-up in the early stage of the temperature decrease. It is observed that two thermometers at 31° position and 76° position of Fig. 9 show different behavior in temperature decrease. That is, it is observed that there is locality in the decreasing behavior of the temperature decrease. This temperature decreasing behavior is considered to be the proof of the operation of the SRV. The battery was connected to SRV (A) in Unit 2. Table 1 shows the preset pressure. From the value of the measured reactor pressure (slightly below about 7.5 MPa), it is probable that SRV (A) was operated by the relief valve mode and it was assumed that the pressure is relieved from the T quencher near the 76°thermometer, as you can see in Fig.10.. There is high possibility that Main Steam Line A was fulfilled with water, because the RCIC turbine steam was extracted from Main Steam Line B.

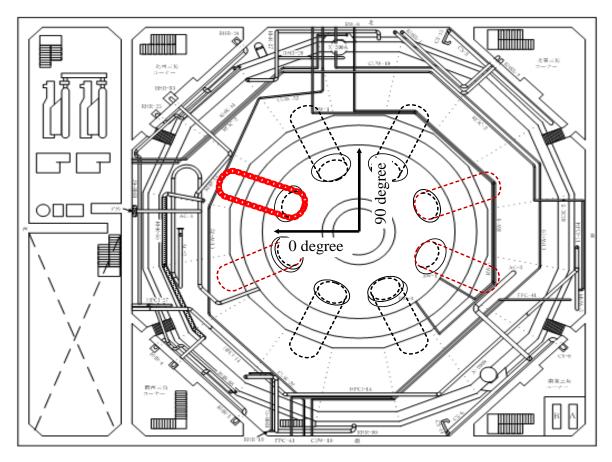
Fig. 9 Relationships between layout of S/C and vent pipes.

The red dotted line indicates vent pipes with quencher piping.

Highest dose is observed around the vent pipe indicated by the bold red line.
