Completion of X brace removal on the west side of the Unit 1 reactor building at the Fukushima Daiichi Nuclear Power Station

<Reference>
September 25, 2018
Tokyo Electric Power Company Holdings, Inc.
Fukushima Daiichi D&D Engineering Co.

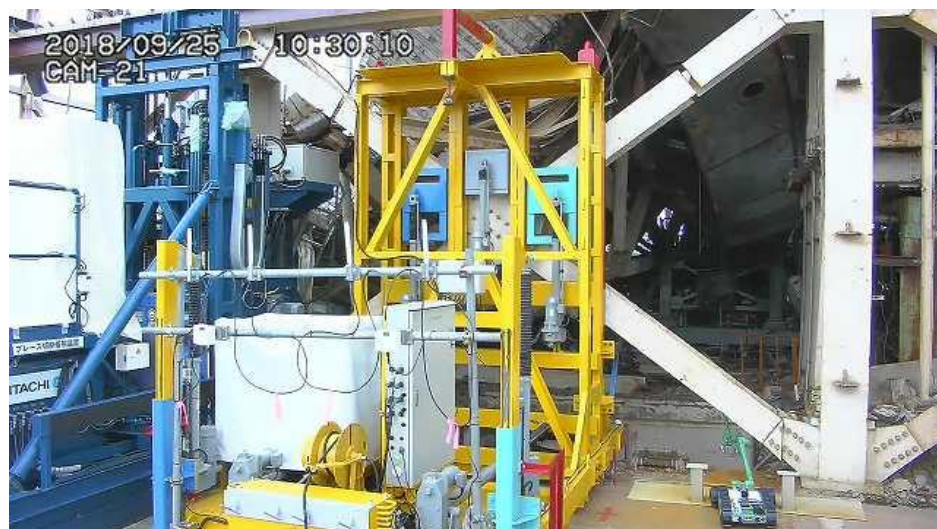
Bandsaw being used to cut off the X brace while a gripper is holding it

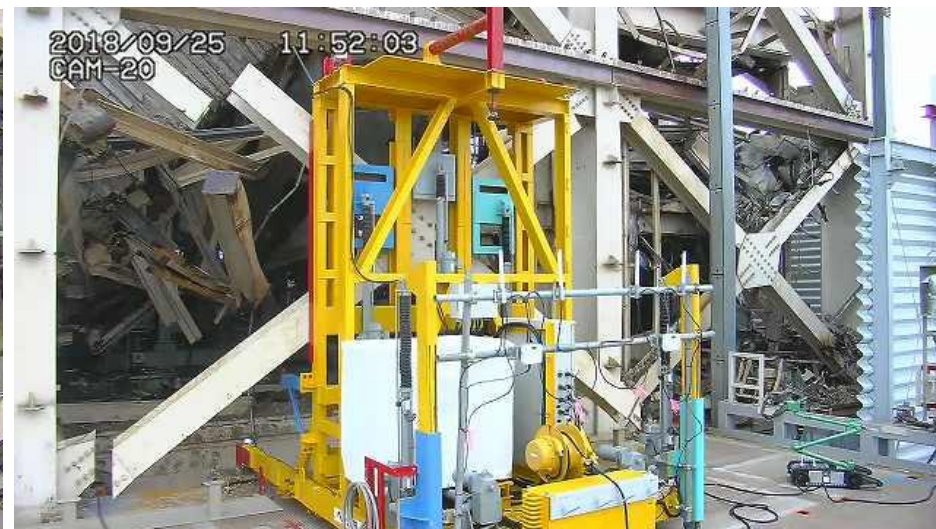
Gripper pulling out the X brace
