Main works and steps for the decommissioning

Progress status

Progress toward decommissioning: Fuel removal from the spent fuel pool (SFP)

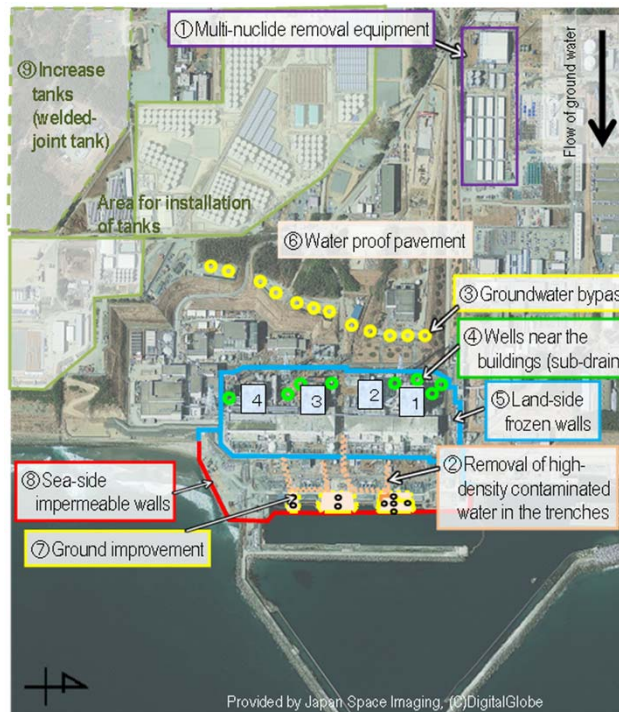
Contaminated water countermeasures are implemented with the following three principles

1. Remove sources of contamination

- ① Multi-nuclide removal equipment
- ② Remove contaminated water in the trench

2. Isolate water from contamination

- ③ Pump up ground water for bypassing
- ④ Pump up ground water near buildings
- ⑤ Land-side frozen walls
- ⑥ Water proof pavement

3. Prevent leakage of contaminated water

- ⑦ Soil improvement by sodium silicate
- ⑧ Sea-side impermeable walls
- ⑨ Increase tanks (welded-joint tank)

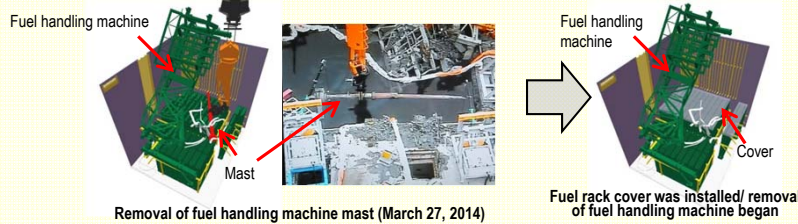
Removal of fuel handling machine mast (March 27, 2014)

Removal of Unit 3 fuel handling machine

As the removal of rubble such as steel, roof materials and concrete inside the pool was almost complete, removal of the fuel handling machine began from April 19.

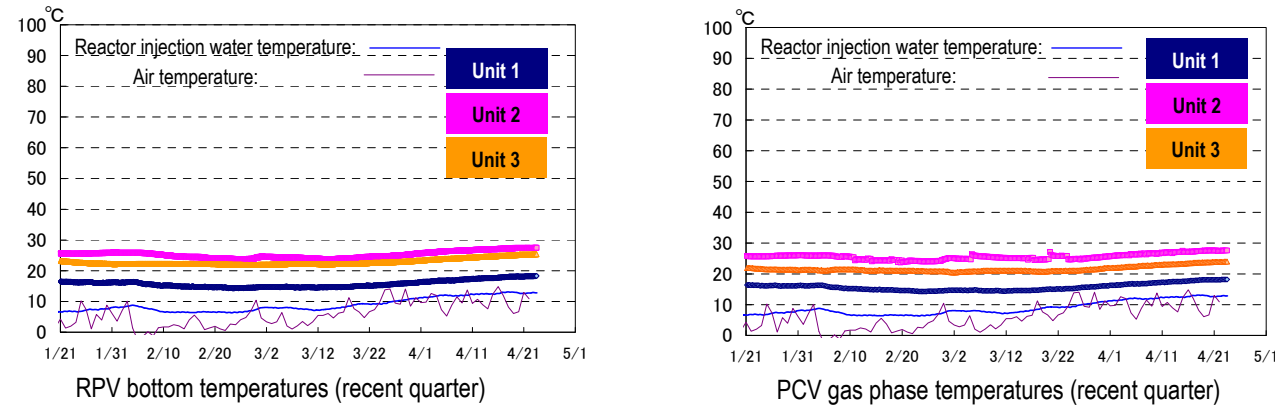
Through continuous reactor cooling by water injection, the temperatures of the Reactor Pressure Vessel (RPV) bottom and the Primary Containment Vessel (PCV) gas phase have been maintained within the range of approx. 15 to 35°C for the past month, though they vary depending on the Unit and location of the thermometer.

* The trend graphs show part of the temperature data measured at multiple points.

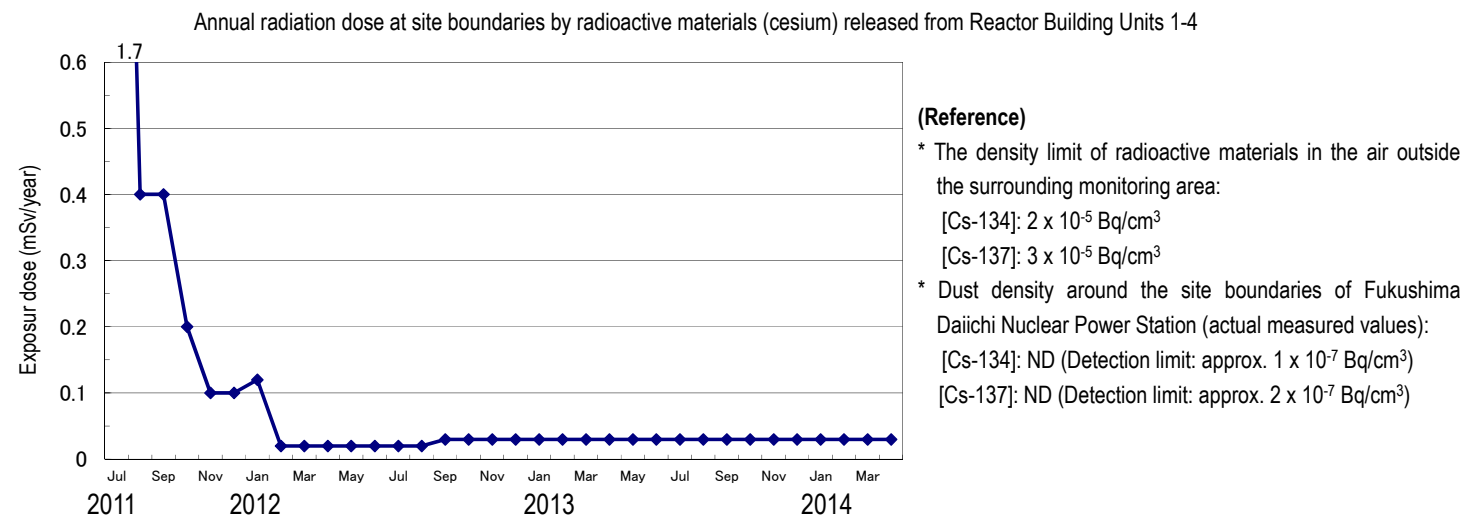
The density of radioactive materials newly released from Reactor Building Units 1-4 in the air measured at site boundaries was evaluated at approx. 1.3×10^{-9} Bq/cm³ for both Cs-134 and -137. The radiation exposure dose due to the release of radioactive materials was 0.03 mSv/year (equivalent to approx. 1/70 of the annual radiation dose by natural radiation (annual average in Japan: approx. 2.1 mSv/year)) at the site boundaries.

(Note) Different formulas and coefficients had been used to evaluate the radiation dose in the facility operation plan and monthly report. The evaluation methods were integrated in September 2012. As the fuel removal from the spent fuel pool (SFP) commenced for Unit 4, the radiation exposure dose from Unit 4 was added to the items subject to evaluation since November 2013.

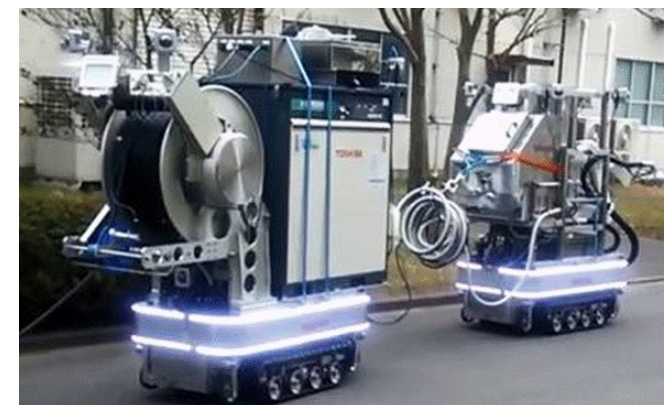
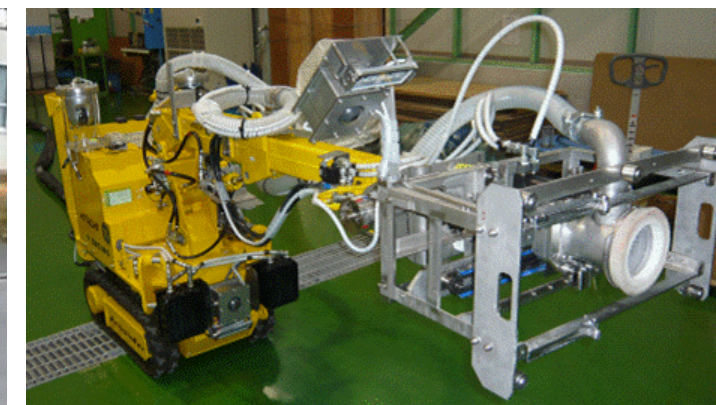
Figure 4: Remote decontamination equipment in demonstration

Dry ice blast decontamination equipment

High-pressure water decontamination equipment

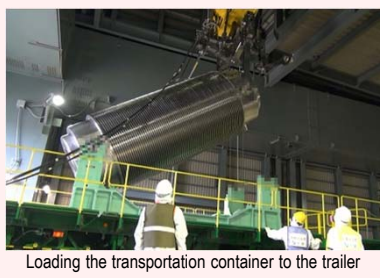
Loading the transportation container to the trailer

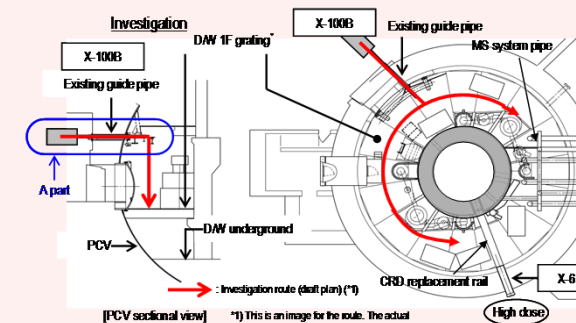
Investigation route inside the PCV (draft plan)

- Crawler-type equipment with a shape-changing structure which allows it to enter the PCV from the narrow access entrance (bore: ϕ 100mm) and stably move on the grating is currently under development. A field demonstration is scheduled for the 2nd half of FY2014.

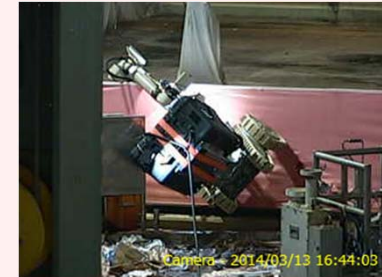
- To investigate the contamination status of the Reactor Building 5th floor, investigative equipment (gamma camera, radiation dose gauge, optical camera) will be suspended through holes drilled in the building roof. In addition, core samples on the 5th floor are collected using remote-control robot.
- To ensure the operation route of the robot for collecting floor core samples, fences on the operating floor⁽⁶⁾ were removed using the remote control robot (March 13 and 14).
- As the robot fell during the operation and the battery became low, that robot could not be collected. Removal of fences was completed and the core was collected within the accessible range (from March 20-26).

Status of remote-control robot falling down

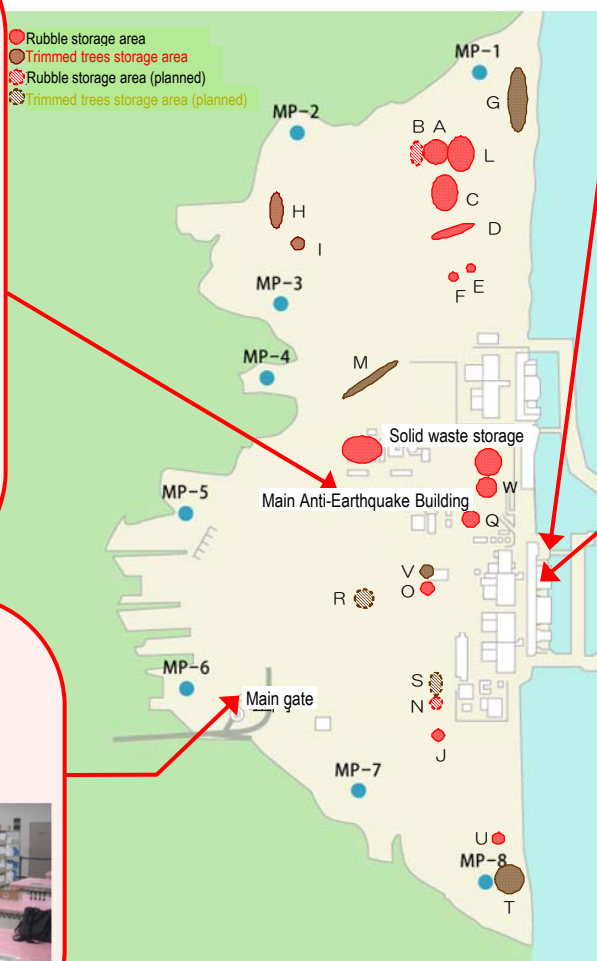
Installation of impermeable walls on the sea side

To prevent contamination expansion into the sea when contaminated water leaks into groundwater, impermeable walls are being installed (scheduled for completion in September 2014).

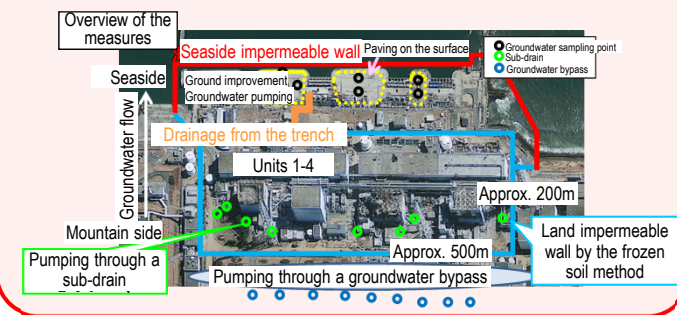
- To prevent the ingress of rainwater, the ground surface is being paved with asphalt (commenced on November 25, 2013)
- Removing contamination sources

- Removing contaminated water in branch trenches and closing them (completed on September 19, 2013)
 - Treatment and removal of contaminated water in the main trench (Unit 2: Treatment commenced on November 14, 2013; Unit 3: on November 15, 2013) (Frozen water stoppage, water removal: Freeze partially commenced on April 2)
