Main works and steps for decommissioning

Progress status

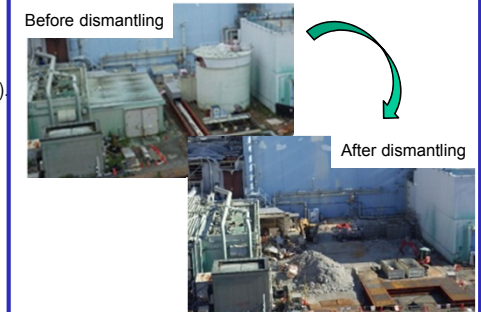
(Preparation around the Unit 2 Reactor Building)

Toward fuel removal from Unit 2 SFP, preparation around the building is underway.

Dismantling of hindrance buildings around the Reactor Building has been underway since September 2015 to clear a work area to install large heavy-duty machines, etc.

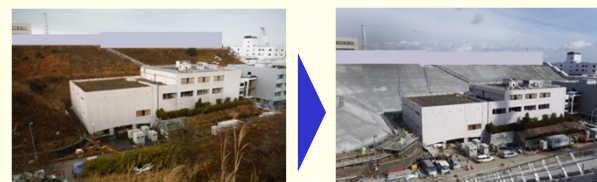
<Status of facing>

To reduce the radiation dose on site and control rain water seeping underground, a wide-area of pavement (facing) was conducted in the area except around Unit 1-4 buildings etc. by March, where more than 90% of the target site is completed.

Before facing

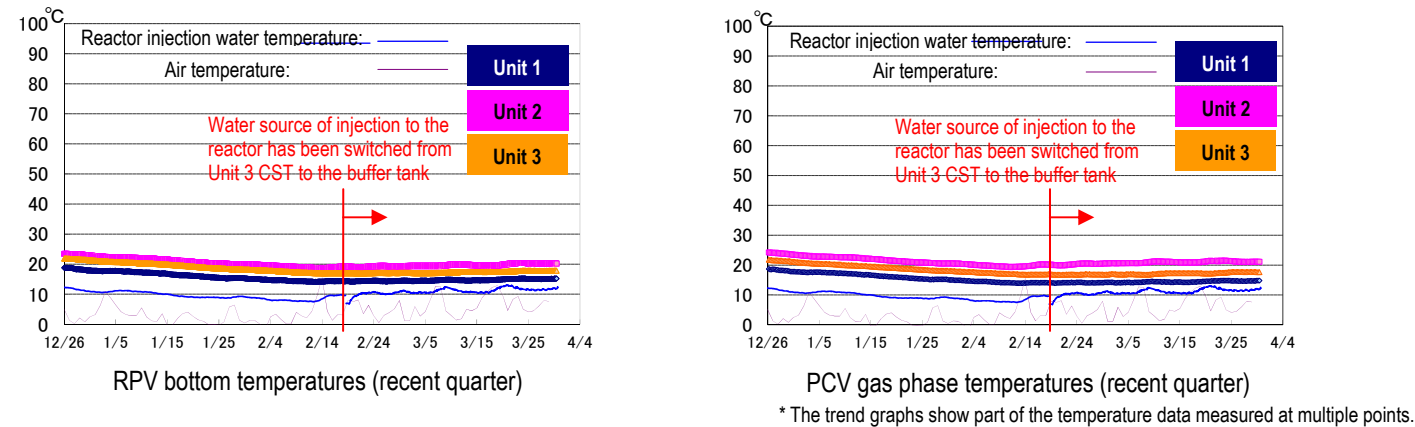
Through continuous reactor cooling by water injection, the temperatures of the Reactor Pressure Vessel (RPV) bottom and the Primary Containment Vessel (PCV) gas phase have been maintained within the range of approx. 15 to 35°C for the past month, though they vary depending on the unit and location of the thermometer.

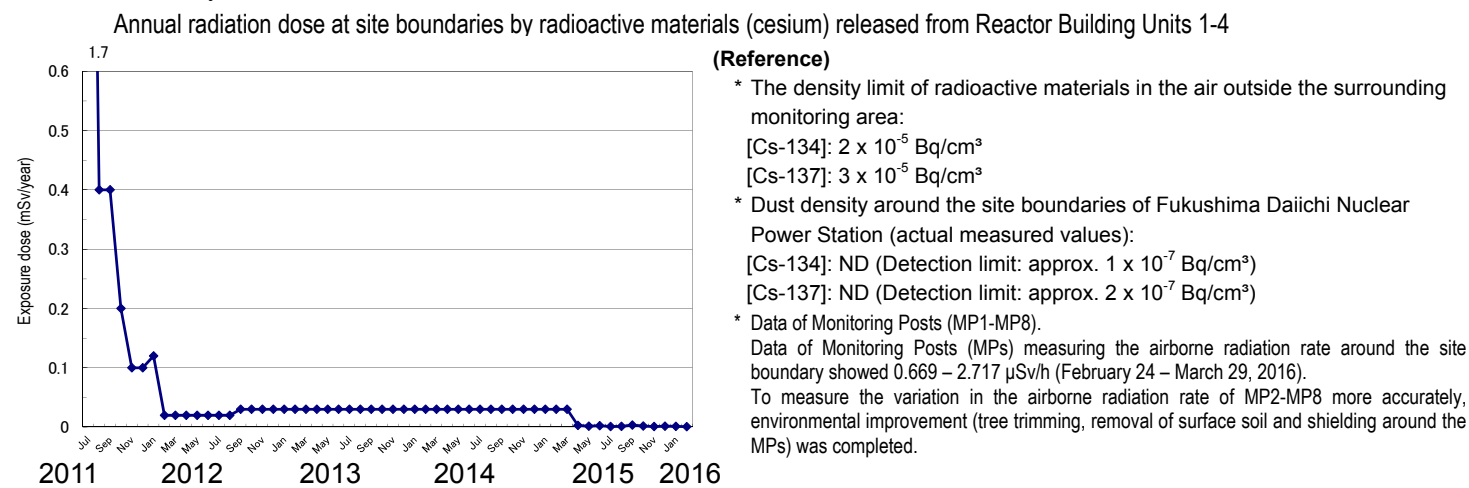
As of February 2016, the density of radioactive materials newly released from Reactor Building Units 1-4 in the air and measured at the site boundary was evaluated at approx. 1.3×10^{-11} Bq/cm³ for Cs-134 and 5.0×10^{-11} Bq/cm³ for Cs-137 respectively. The radiation exposure dose due to the release of radioactive materials was less than 0.00068 mSv/year at the site boundary.

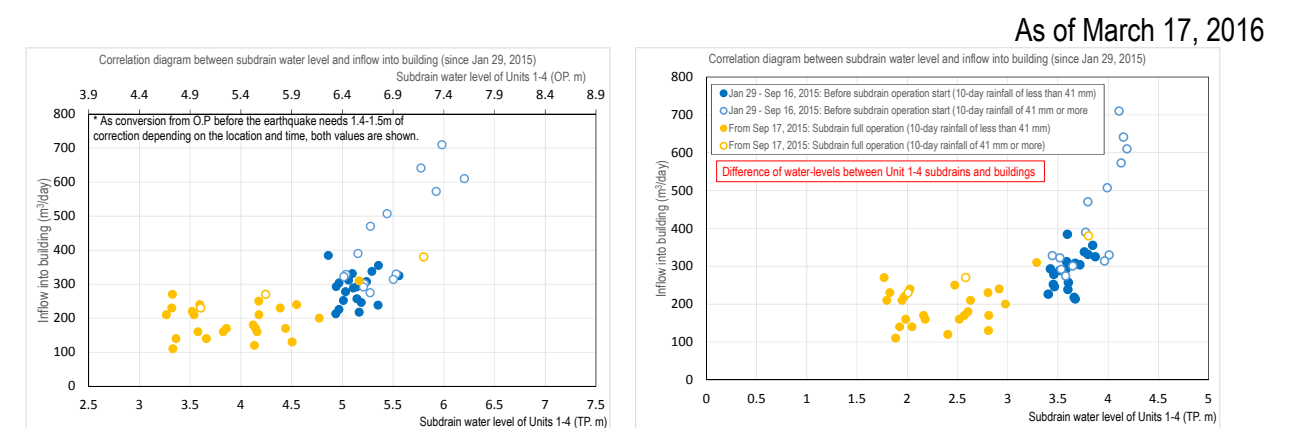
Figure 1: Evaluation of inflow into buildings after the subdrains went into operation

Inflow into buildings declined to approx. 150-200 m³/day during times when the subdrain water level decreased to approx. TP 3.5 m or when the difference with the water levels in buildings decreased to approx. 2 m after the subdrains went into operation.

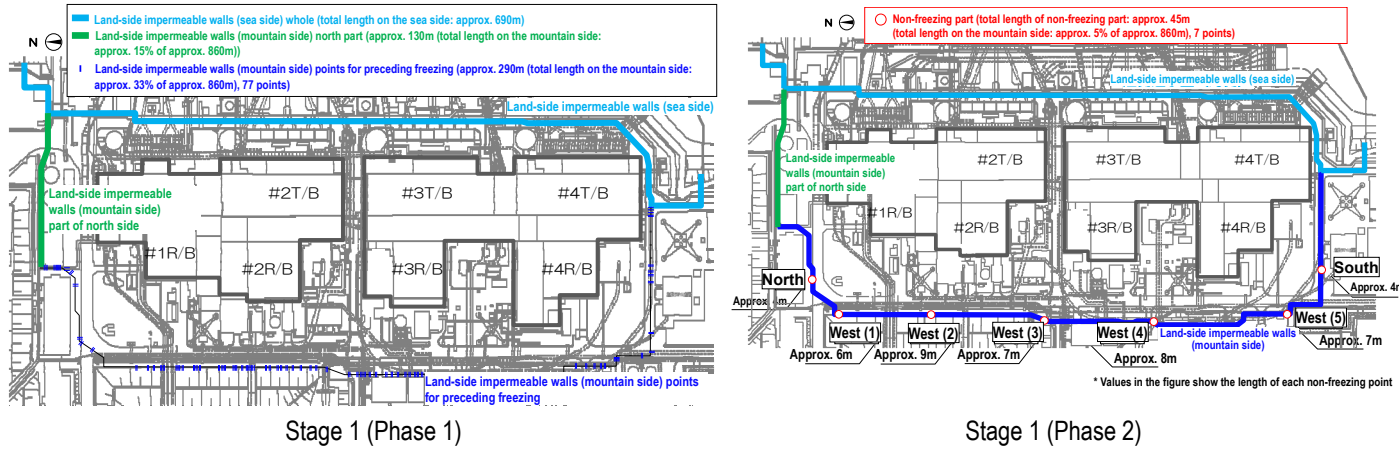
Figure 2: Scope of freezing of land-side impermeable walls

For closure of the land-side impermeable walls, freezing will be advanced in the following three stages to ensure steady freezing with no leakage of contaminated water from buildings:

- ✓ Stage 2: A stage between Stages 1 and 3.
- ✓ Stage 3: A stage of complete closure.
- As the implementation plan related to land-side impermeable walls (for Stage 1) was authorized on March 30, freezing in the scope of Stage 1 (Phase 1) started on March 31.

Regarding the land-side impermeable walls to control the increase in contaminated water, following the authorization of the implementation plan on March 30, freezing started on March 31 for the whole portion on the sea side and a portion on the mountain side.

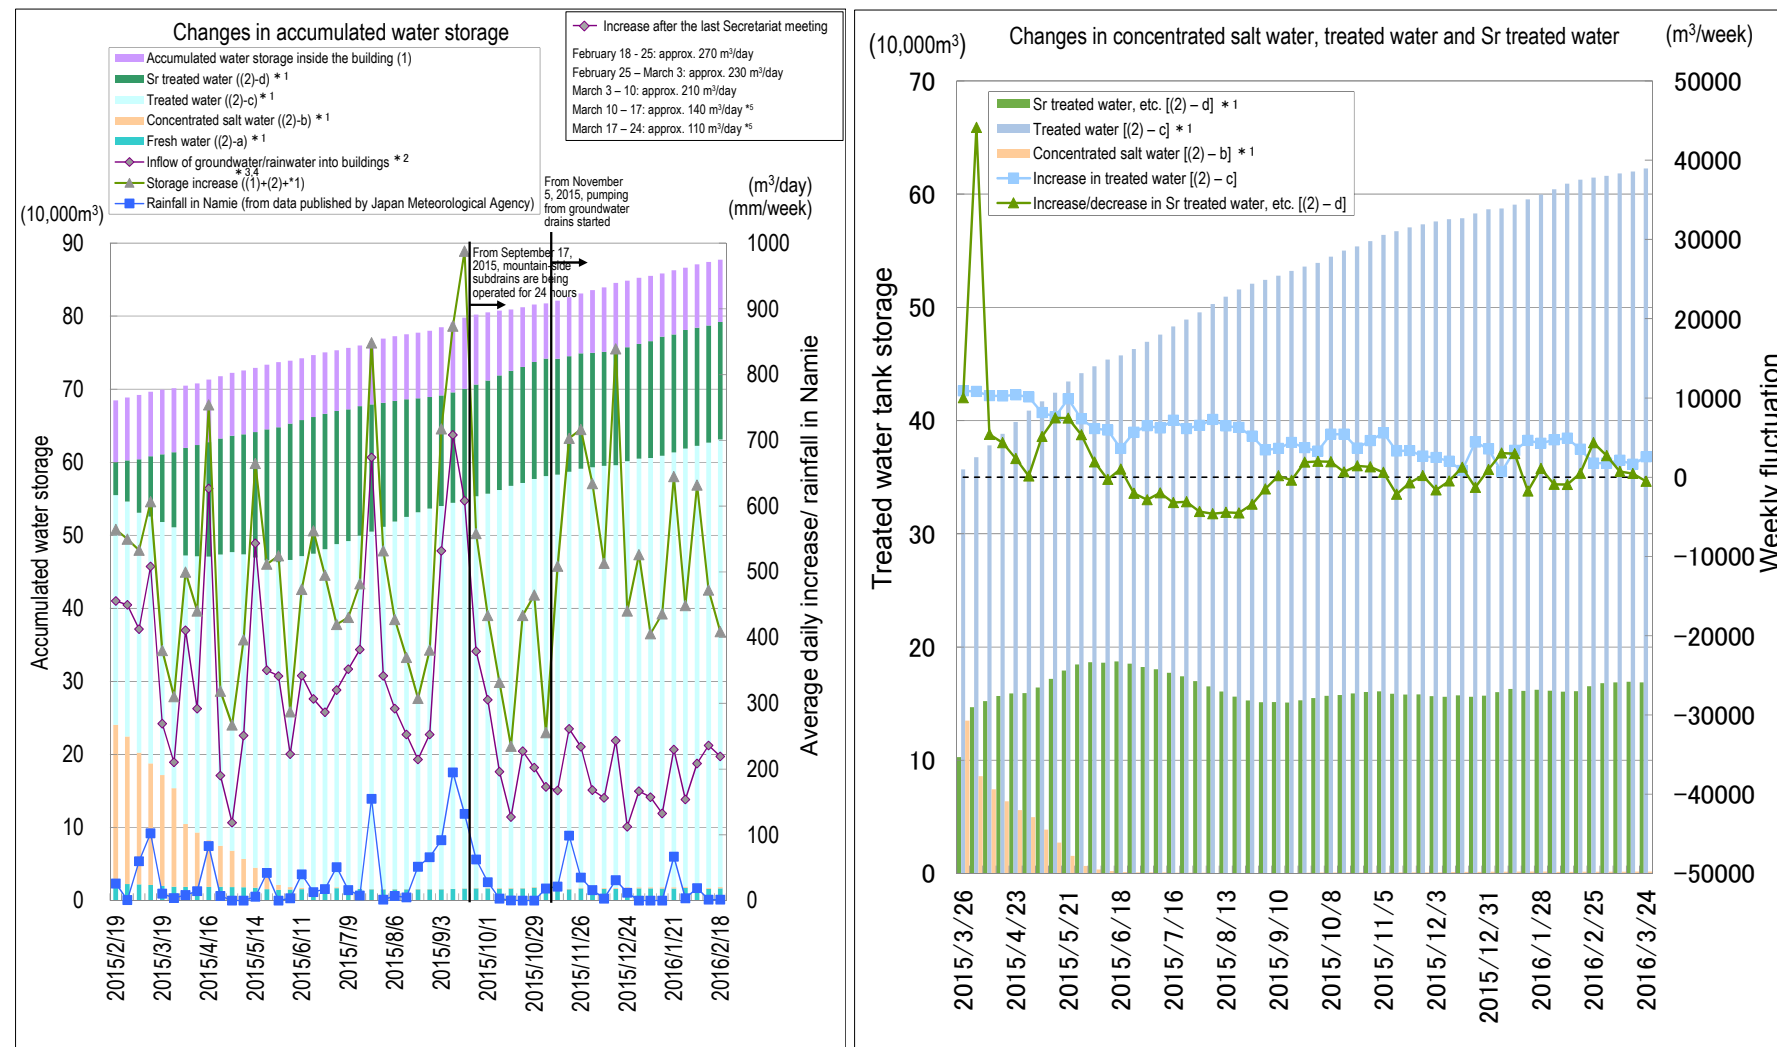
Figure 3: Status of accumulated water storage

- To reduce the risks of strontium-treated water, treatment by additional and high-performance multi-nuclide removal equipment is underway (existing: from December 4, 2015; additional: from May 27, 2015; high-performance: from April 15, 2015). As of March 24, approx. 184,000 m³ had been treated.

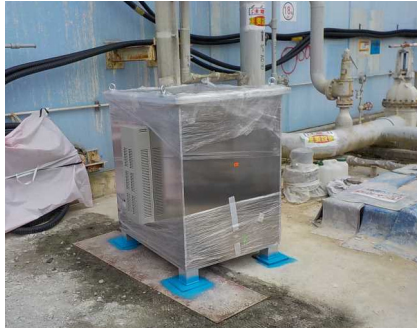
Figure 4: Muon measurement device (small device)

- Capturing the location of fuel debris inside the Unit 2 reactor through measurement using muons
 - To capture the location of fuel debris inside the Unit 2 reactor, measurement via the muon transmission method, the effect of which was confirmed based on measurement results of Unit 1, started on March 22 using a new small device developed by the subsidy for decommissioning and contaminated water treatment project “Development of Technology to Detect Fuel Debris inside the Reactor.” Though the RPV bottom was excluded from the scope of Unit 1 measurement, the whole RPV will be included in the scope of Unit 2 measurement (see Figure 5).

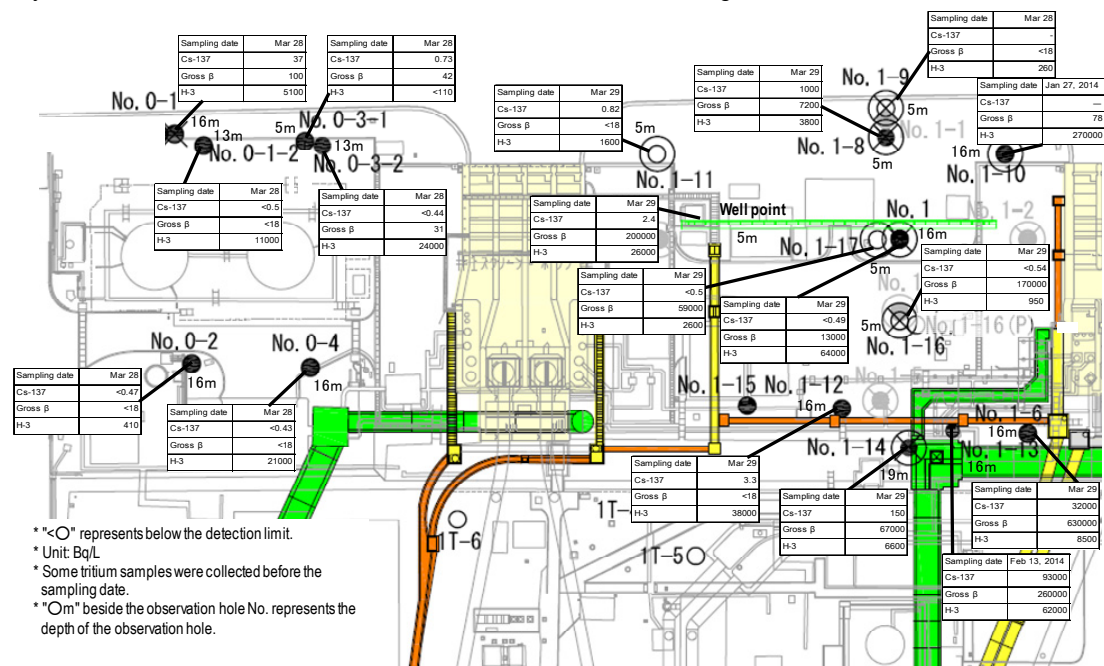
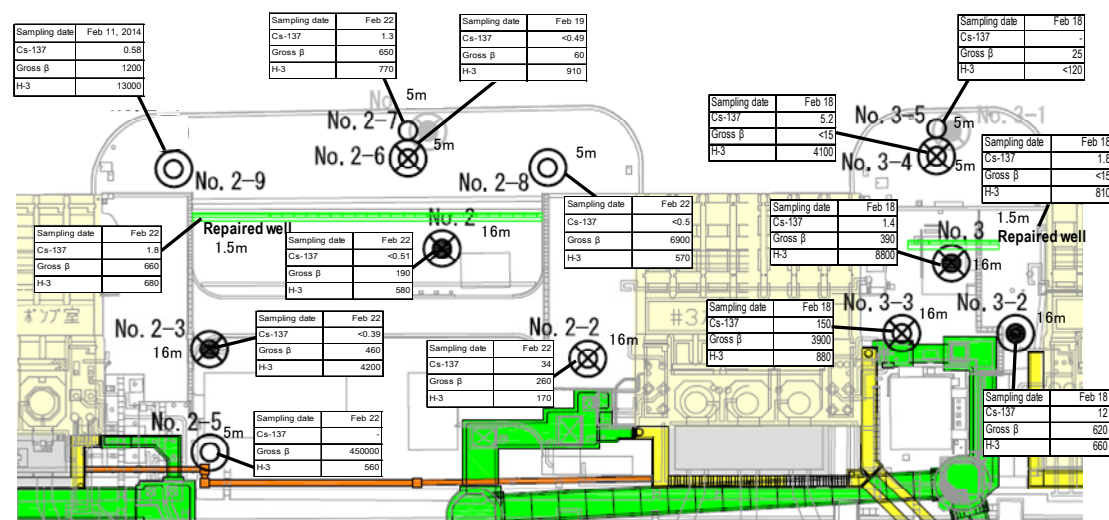
Figure 6: Groundwater density on the Turbine Building east side

- Regarding radioactive materials in the groundwater near the bank between the Unit 2 and 3 intakes, though the density of gross β radioactive materials at groundwater Observation Hole No. 2-5 had remained constant at around 10,000 Bq/L, it has been increasing since November 2015 and currently stands at around 300,000 Bq/L. Since December 18, 2013, pumping of groundwater continued (at the well point between the Unit 2 and 3 intakes: December 18, 2013 - October 13, 2015; at the repaired well point: from October 14, 2015).

- Regarding radioactive materials in the groundwater near the bank between the Unit 3 and 4 intakes, though the density of gross β radioactive materials at groundwater Observation Hole No. 3-2 had been increasing to around 1,200 Bq/L since December 2015, it currently stands at around 800 Bq/L. Since April 1, 2015, pumping of groundwater continued (at the well point between the Unit 3 and 4 intakes: April 1 – September 16, 2015; at the repaired well point: from September 17, 2015).

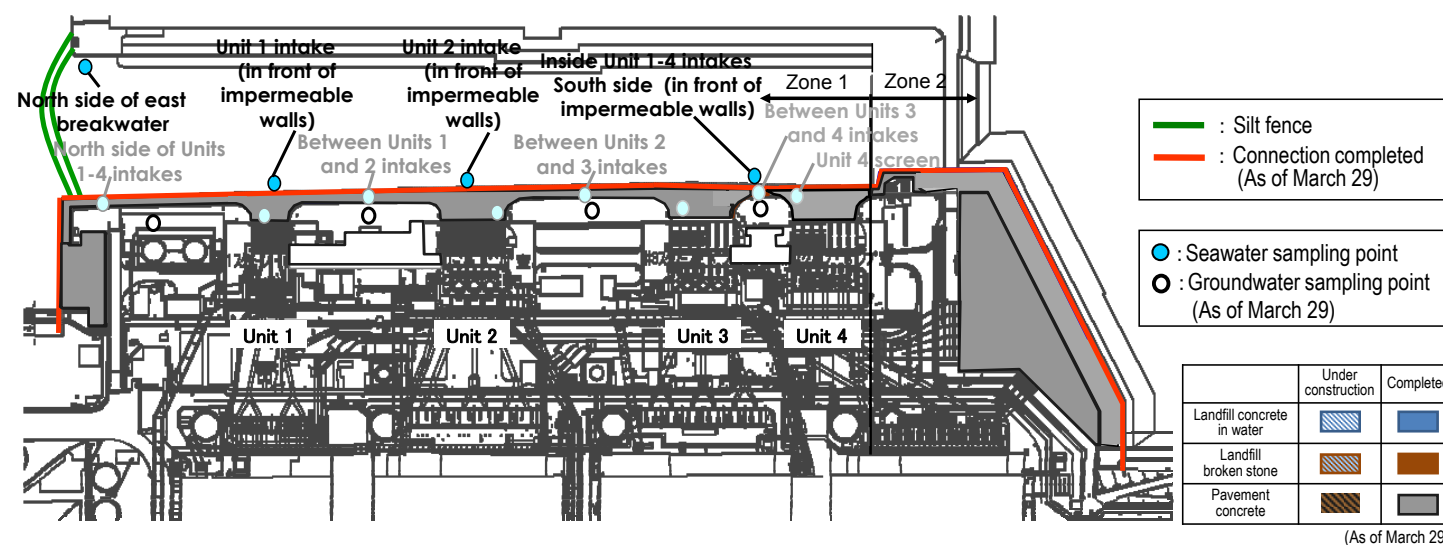
Figure 8: Progress status of impermeable walls on the sea side

- Regarding the sea-side impermeable walls, following completion of the landfill inside the impermeable walls using broken stone on February 10, surface treatment was conducted and completed on March 29.

- Impermeable walls are being installed on the sea side of Units 1-4, to prevent the flow of contaminated groundwater into the sea.
- The installation of steel pipe sheet piles was completed in September 2015 and they were connected in October 2015. These works completed the closure of sea-side impermeable walls.

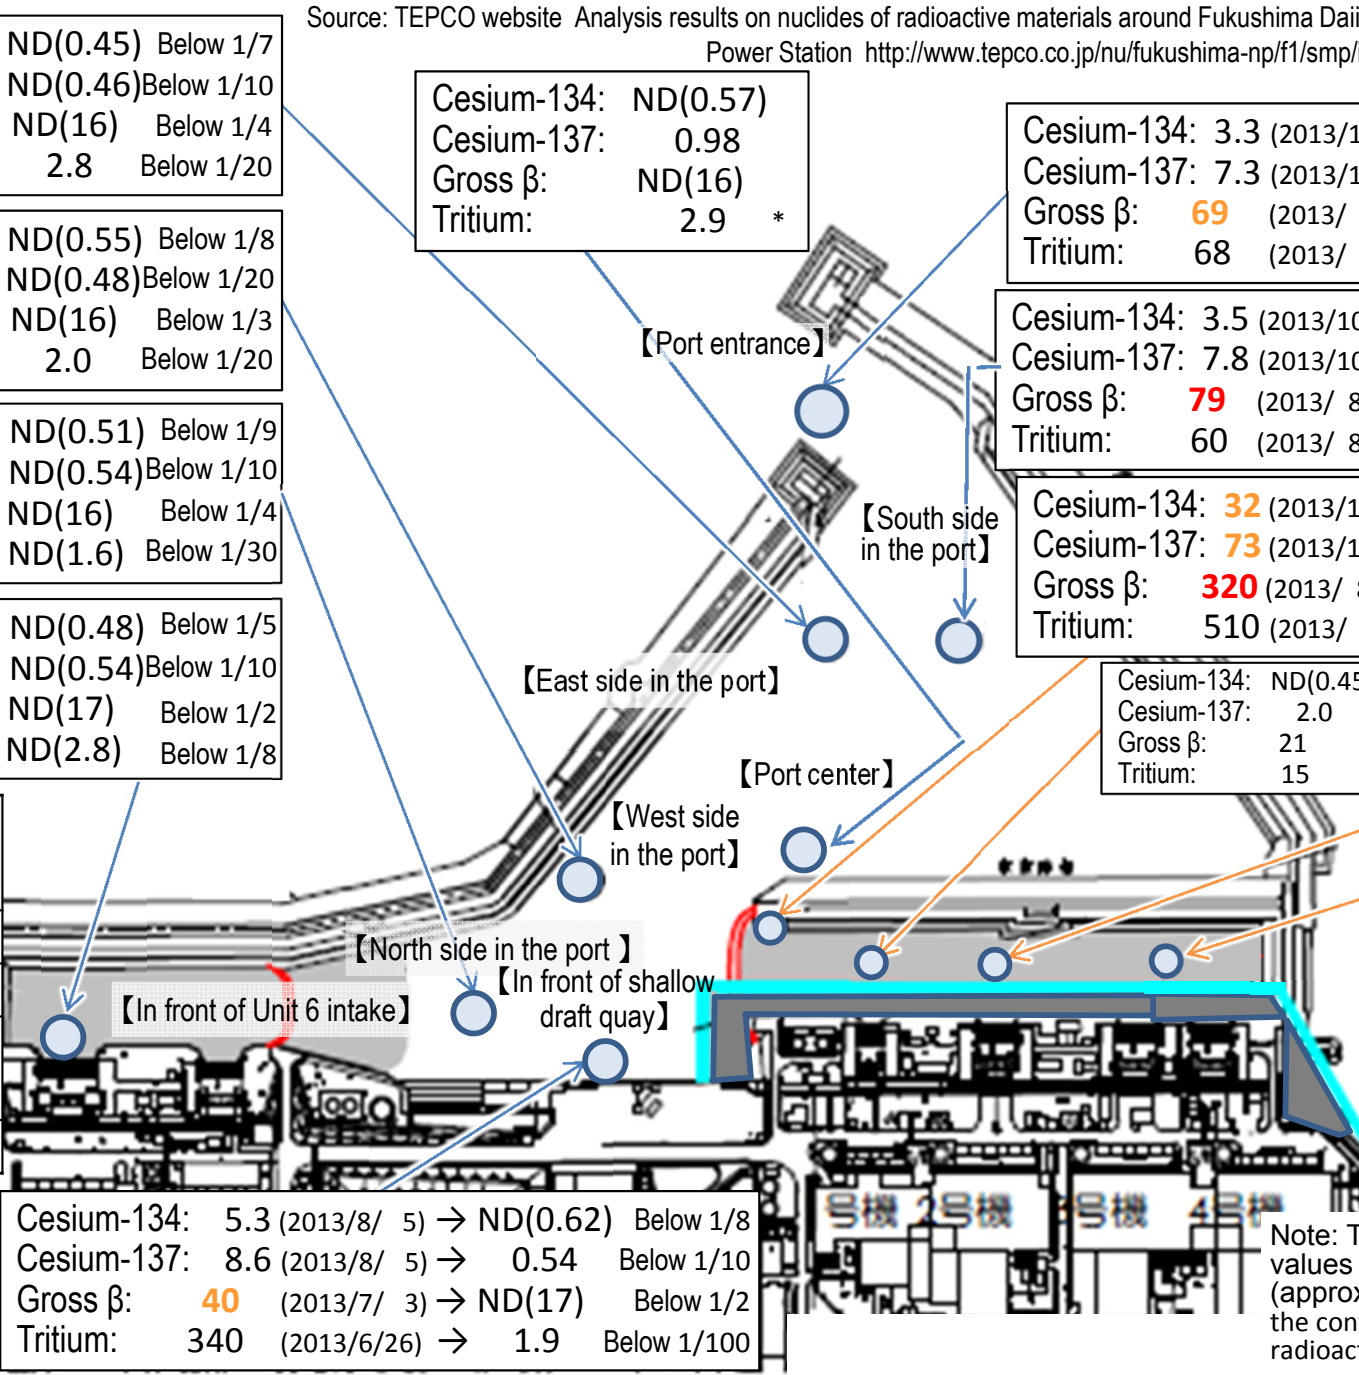
Cesium-134: 5.3 (2013/8/ 5) → ND(0.62) Below 1/8
Cesium-137: 8.6 (2013/8/ 5) → 0.54 Below 1/10
Gross β: **40** (2013/7/ 3) → ND(17) Below 1/2
Tritium: 340 (2013/6/26) → 1.9 Below 1/100

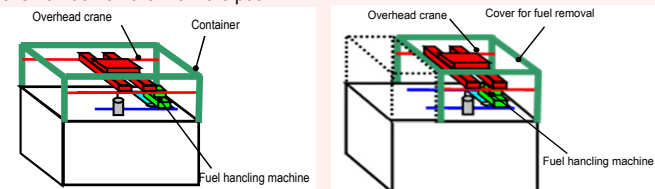
Examination of the following two plans continues: Plan 1 to share a container for removing fuel assemblies and debris from the pool; and Plan 2 to install a dedicated cover for fuel removal from the pool.

Image of Plan 1

Image of Plan 2

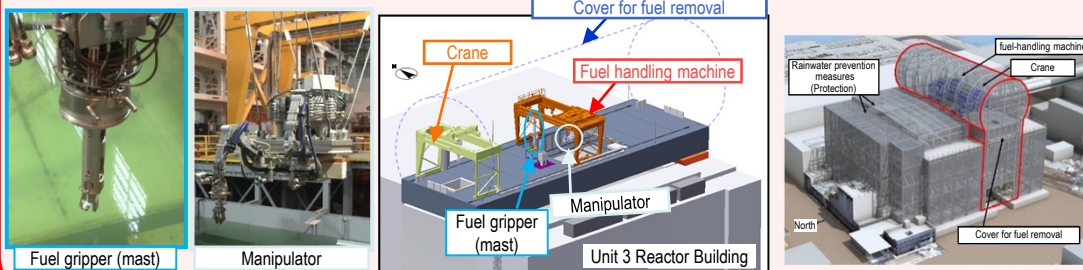
Image of entire fuel handling facility inside the cover

Fuel gripper (mast) Manipulator Fuel-handling facility (in the factory)

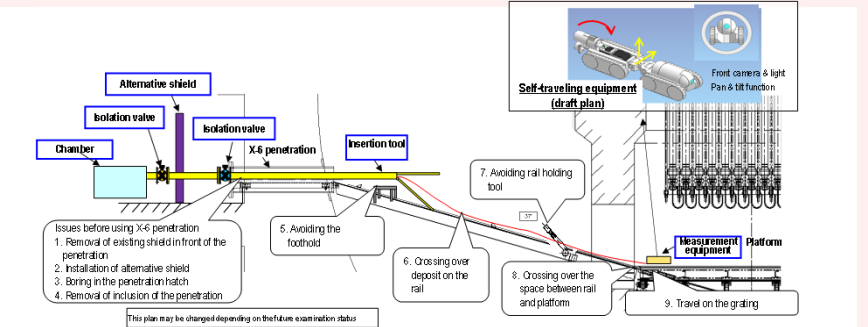
Investigative issues inside the PCV and equipment configuration (draft plan)

- To start the investigation into the inside of PCV, dose on the floor surface in front of X-6 penetration needs to be reduced to approx. 100 mSv/h. As the dose was not decreased to the target level through decontamination (removal of eluted materials, decontamination by steam, chemical decontamination, surface grind), dose reduction methods including anti-dust scattering measures will be re-examined. Investigations inside the PCV will be conducted according to the decontamination status.

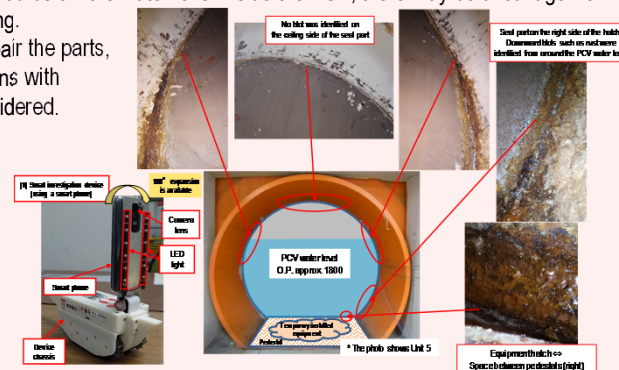
Investigation inside the PCV

Given blots such as rust identified below the water level inside the PCV, there may be a leakage from the seal to the extent of bleeding. Methods to investigate and repair the parts, including other PCV penetrations with a similar structure, will be considered.
