Investigation result of inside of the Primary Containment Vessel (PCV), 1F-2

January 23, 2012

Tokyo Electric Power Company

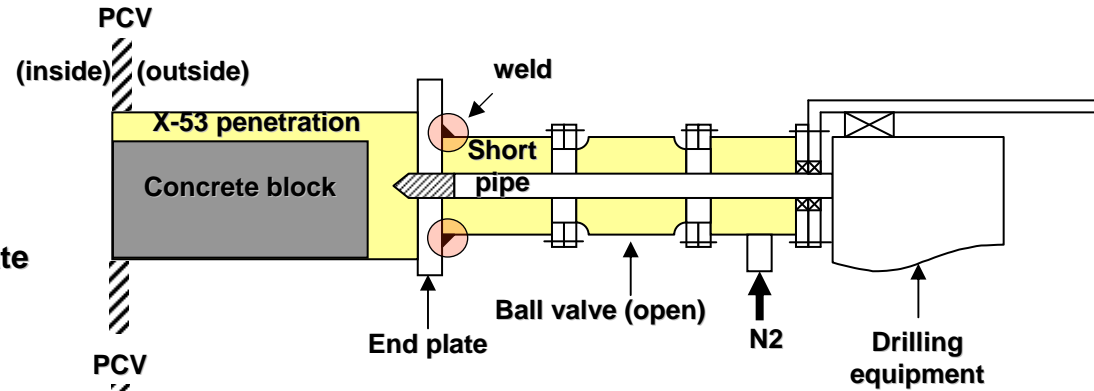
I. Make a hole

- ① Weld a short pipe to X-53 penetration
- ② Attach a valve spool and a drilling equipment, and make a hole to the end plate

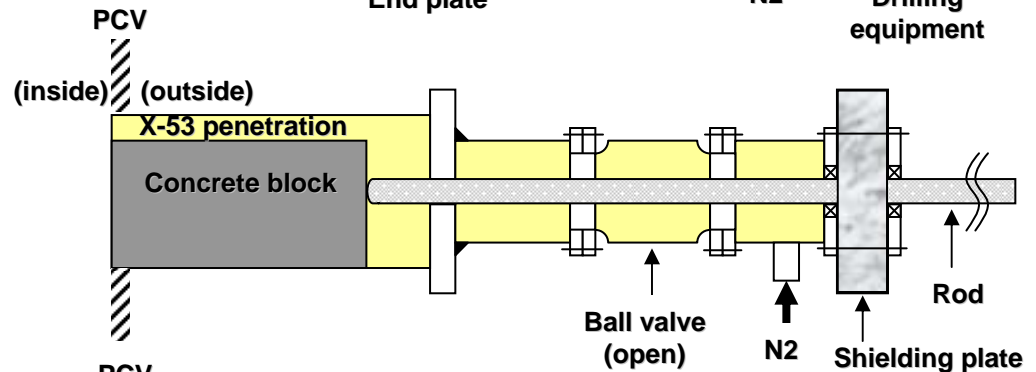
II. Drop the block

Attach a shielding plate to the flange, insert a rod and drop the concrete block

[drill and drop the block]

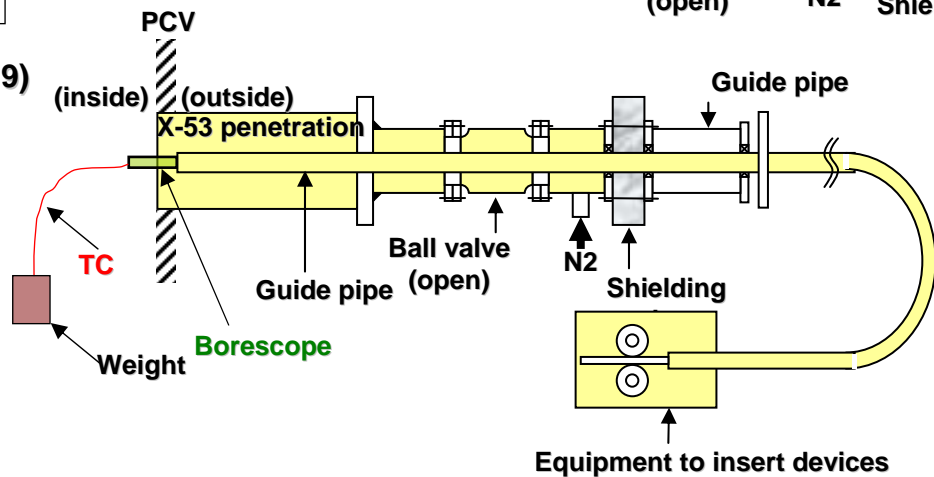
III. Check inside the PCV

- ① Remove the end plate and attach the flange for the guide pipe
- ② Insert a borescope and check inside

[check inside]

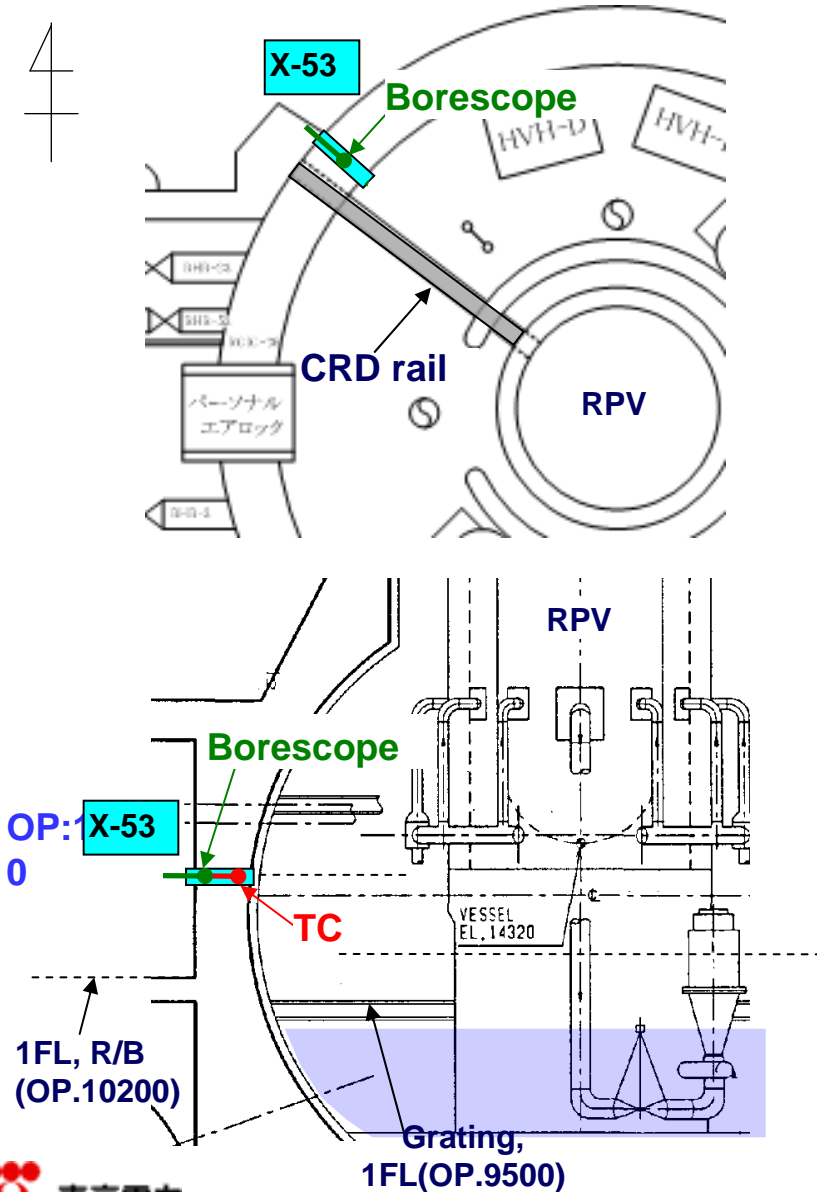
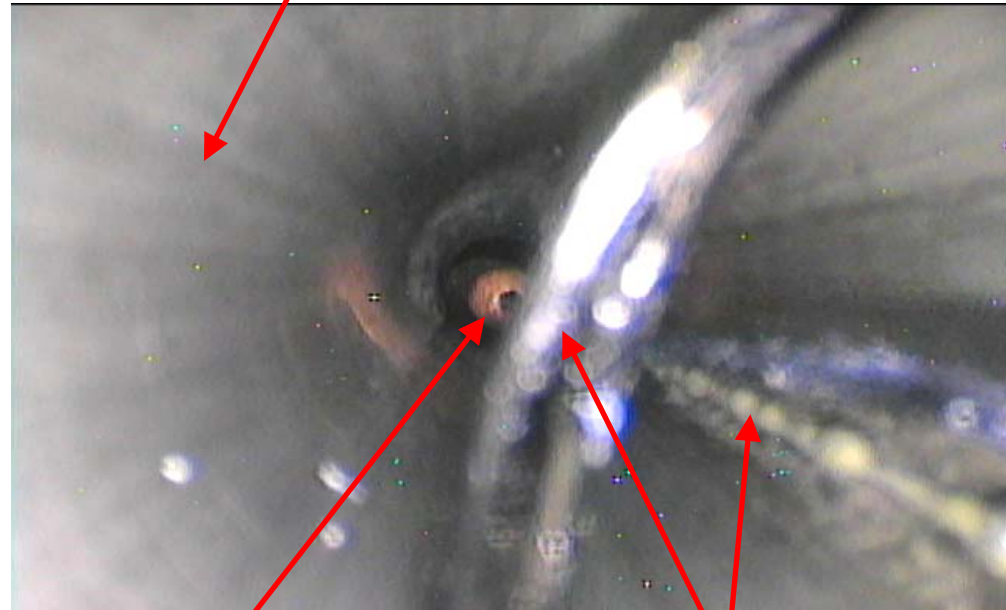
3. Photos inside of PCV, 1F-2①

Guide pipe
(inside diameter 13mm)

Weights to pull
the thermo
couple into the
dry well

Thermo couple

Inside the guide pipe located in X-53 penetration
(Before the borescope enters the PCV)

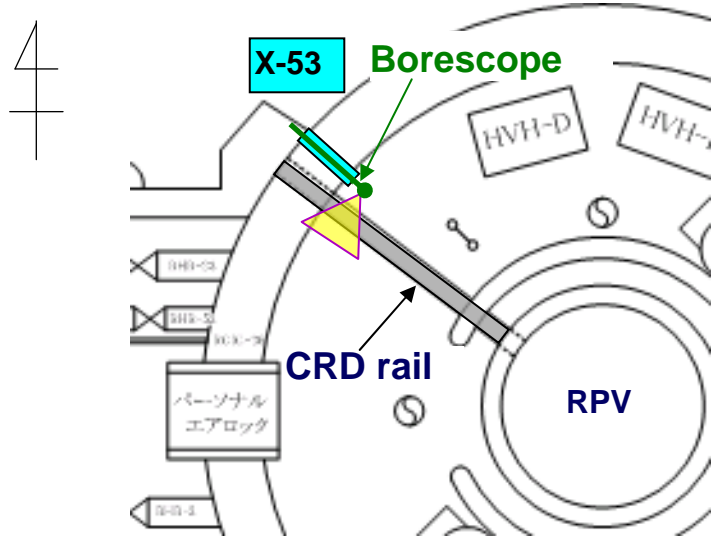
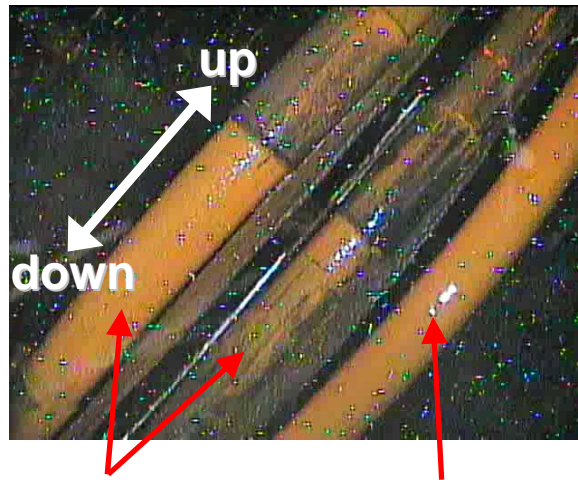
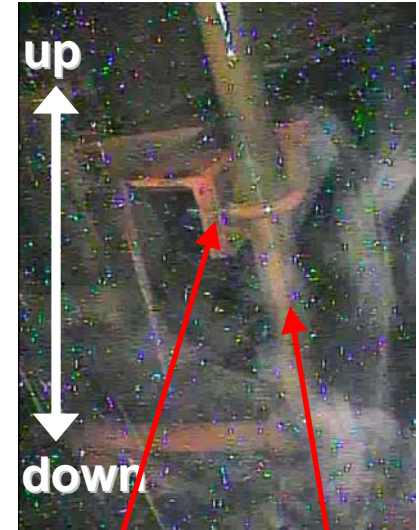
3. Photos inside of PCV, 1F-2②

Neutron flux monitoring cable pipe

IA (Instrument Air-system) Pipe (gauge: 25A)

Support

IA Pipe

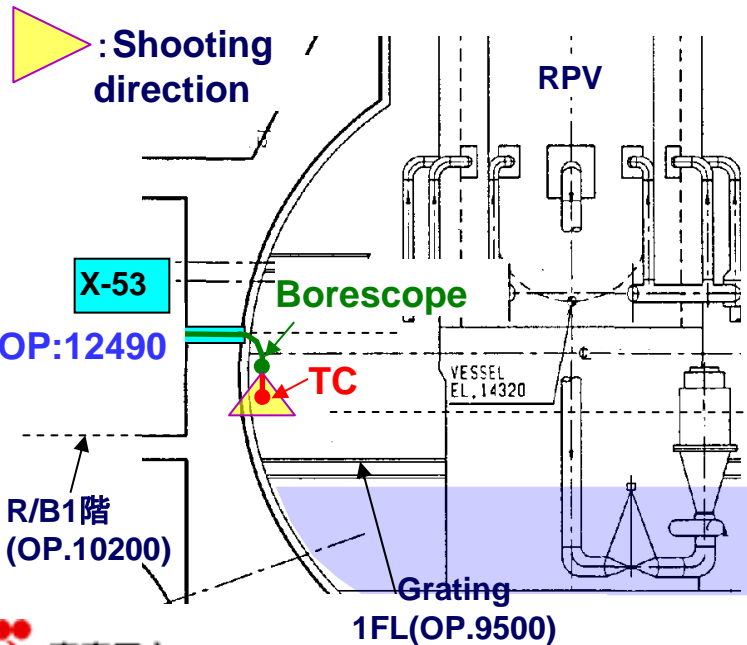
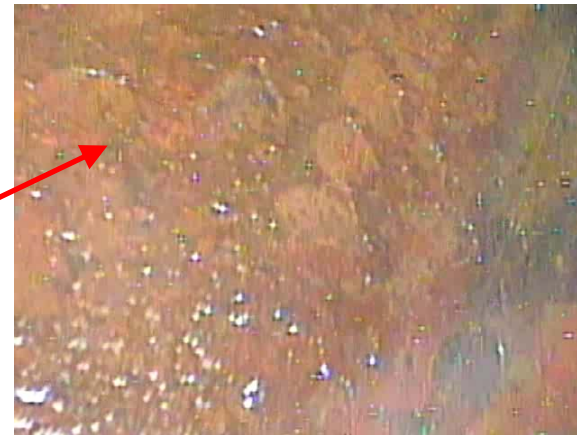
Deposit

Internal wall of PCV

- The visibility was extremely low (tens of cm) as numerous water drops were falling from above. We could not take similar quality pictures as Unit 5. We could see the internal wall of the PCV (with reddish brown deposits), part of piping, part of support, part of OP9500 gratings.
- The atmospheric temperature in the PCV was around 45 Celsius as it was always measured.
- We assumed that the water level in the PCV was around 9500~OP10000. But there was no water at OP9500 gratings (water surface was below)

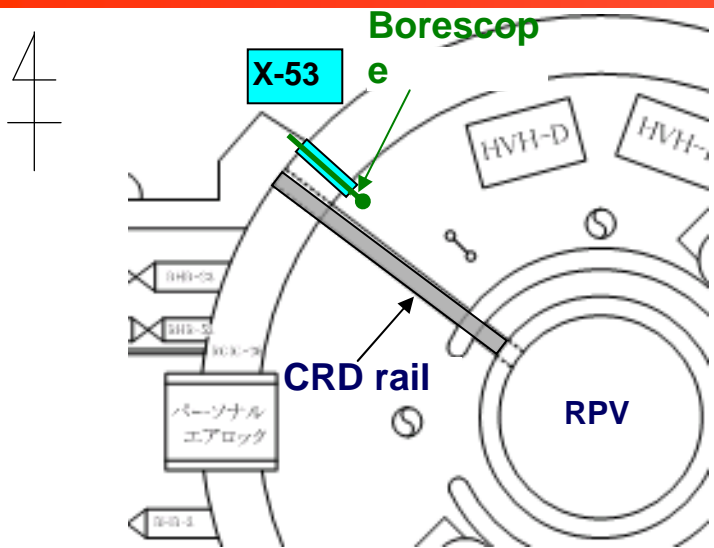
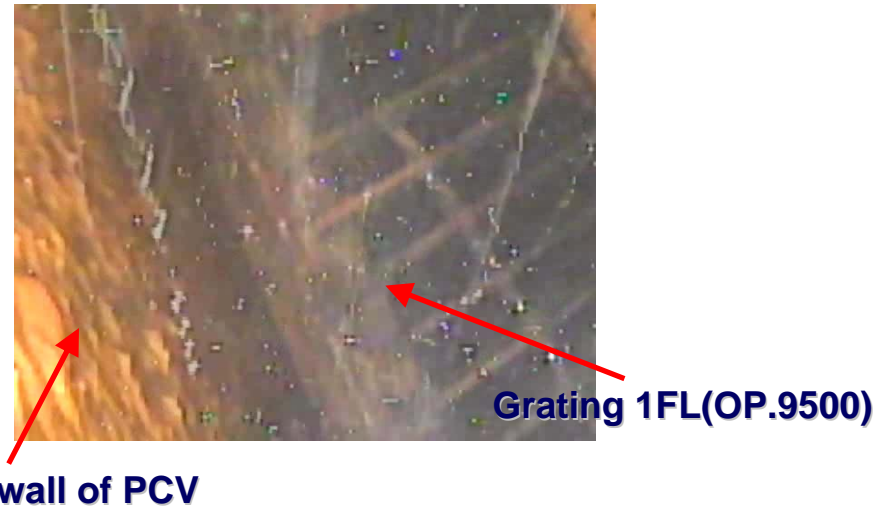
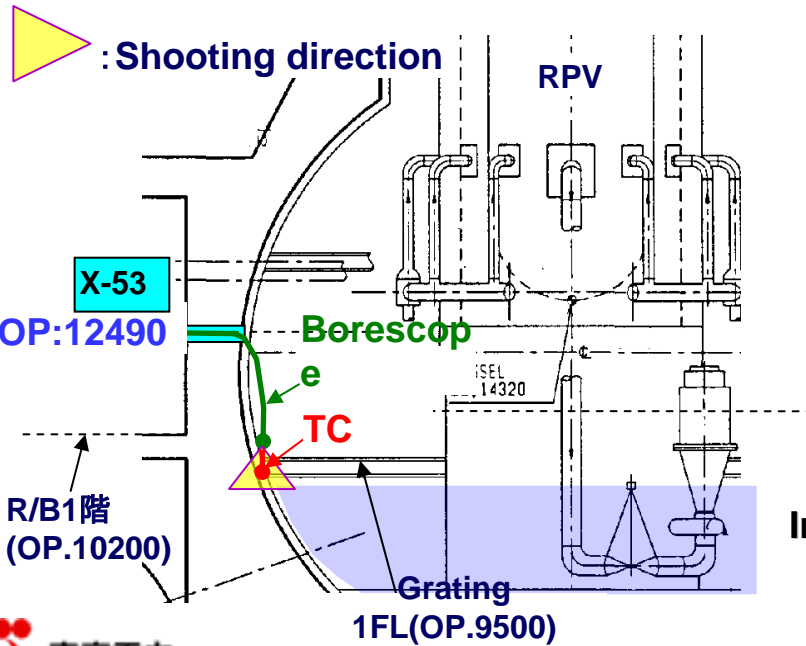
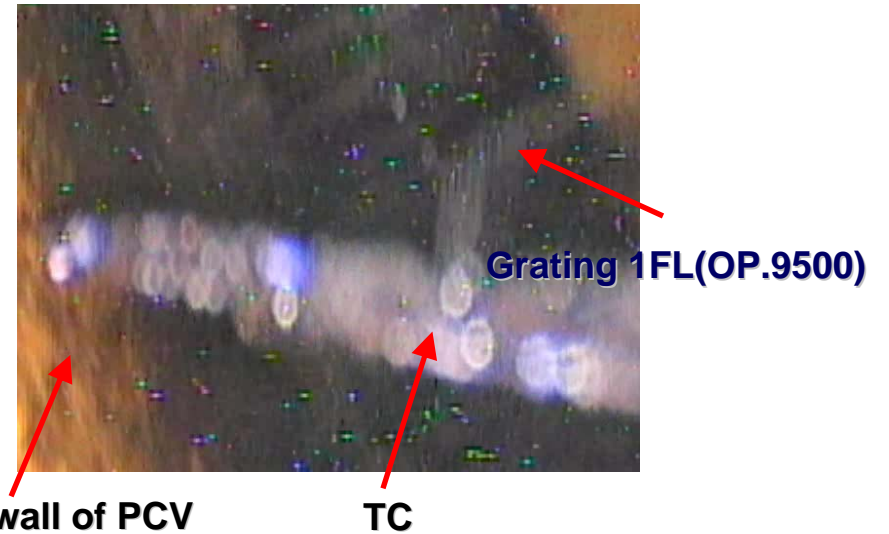
3. Photos inside of PCV, 1F-2③

Around the grating, 1FL, Dry well

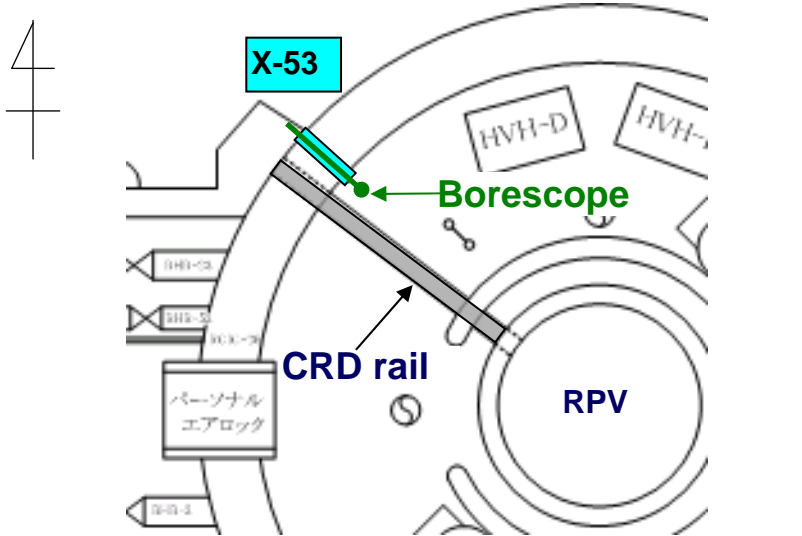
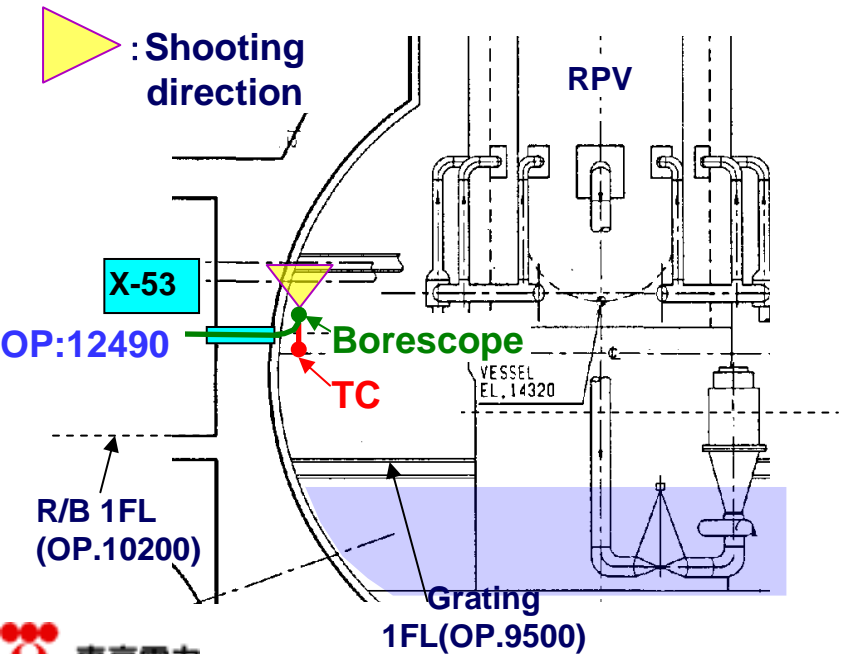
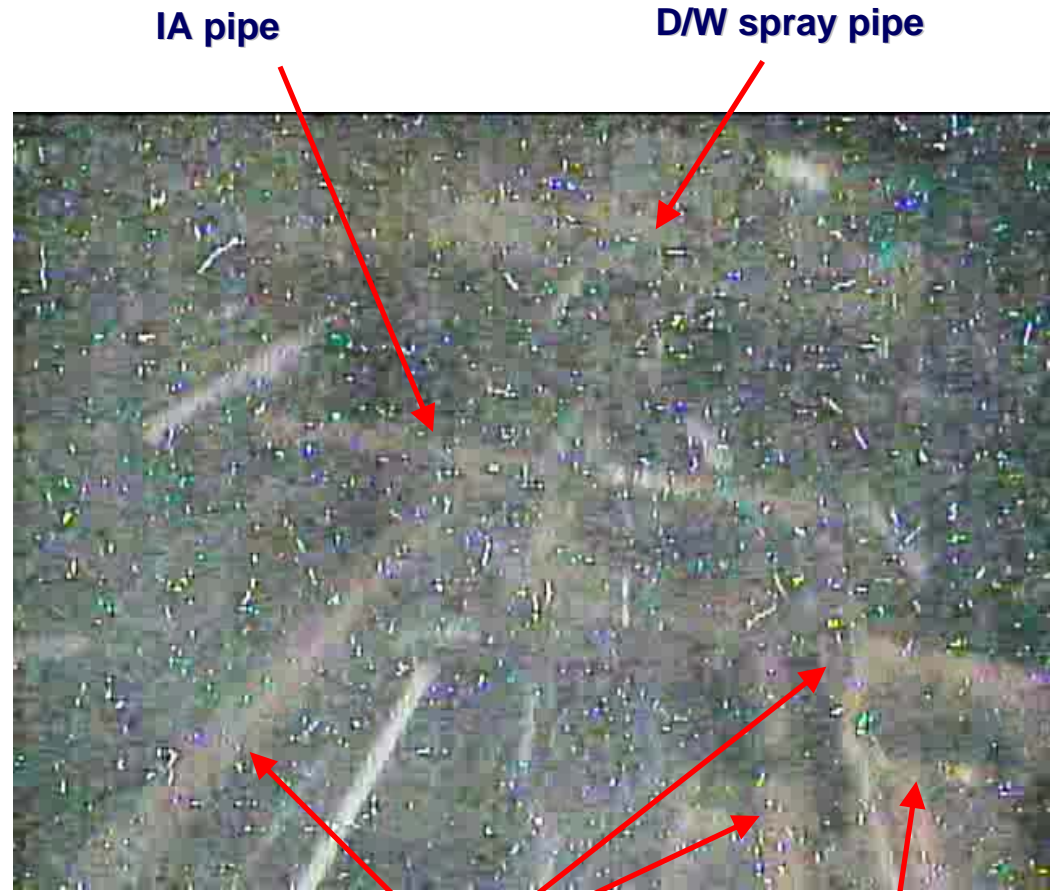
3. Photos inside of PCV, 1F-2④

Neutron flux monitoring cable pipe
Pipe support (Type L)

Looking up from X-53 penetration

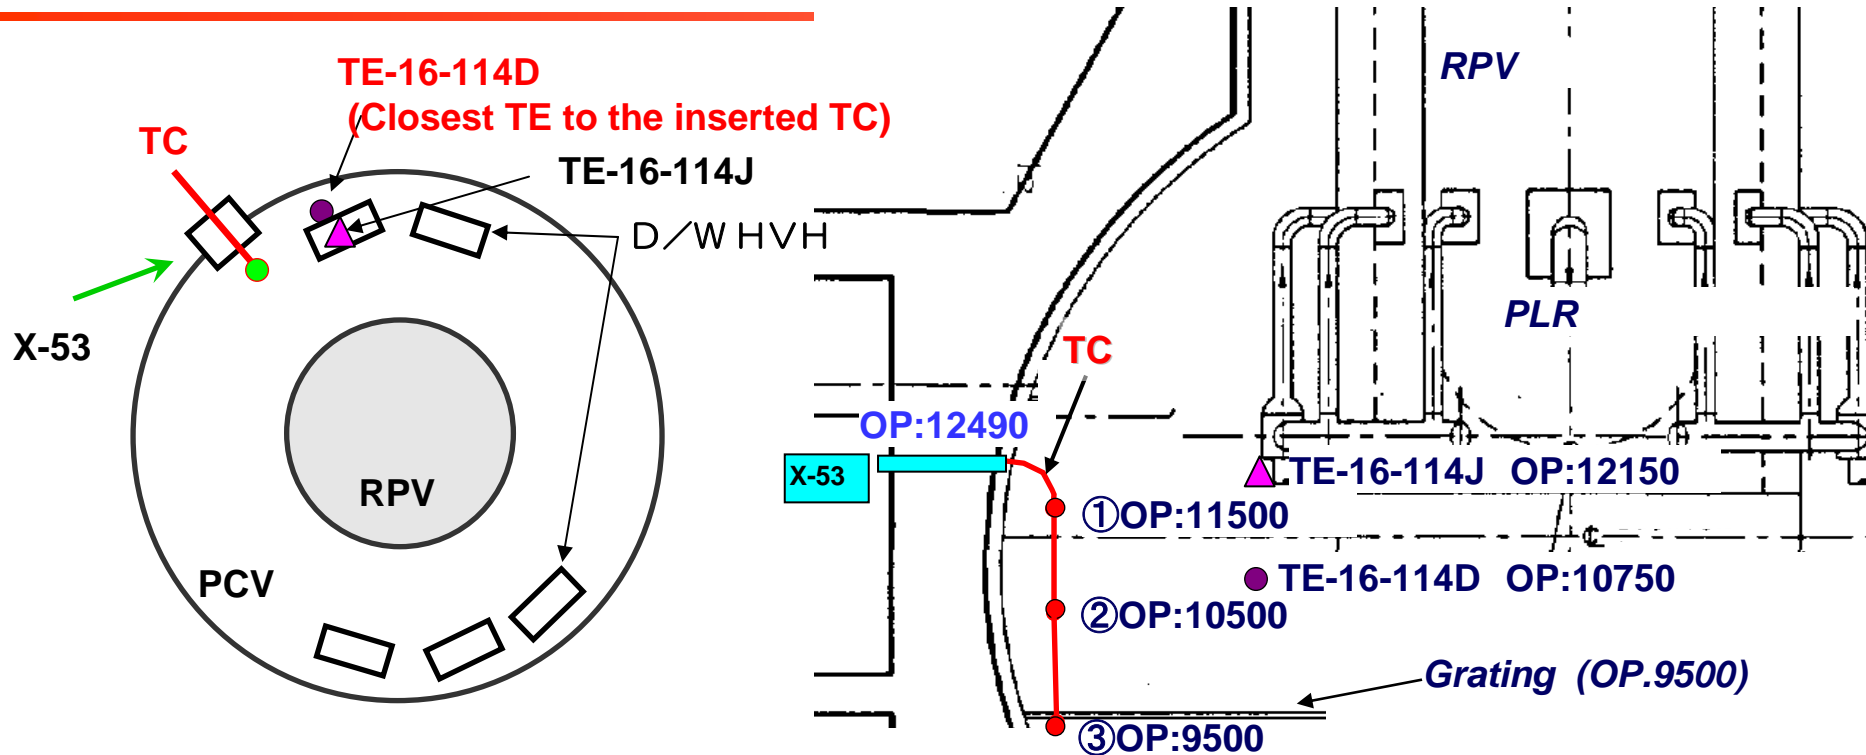
4. Comparison of temperature with the main thermometer)

Temperature inside the PCV	Comparison with the main thermometer
① (OP11500) 44.7°C	We observed similar temperature with main thermometers nearby. TE-16-114D(return air D/W HVH cooler : OP10750(72° direction) 42.6°C (10:00 AM) TE-16-114J(supply air D/W HVH cooler : OP12150(73° direction) 45.1°C (10:00 AM)
② (OP10500) 44.7°C	
③ (OP9500) 45.7°C

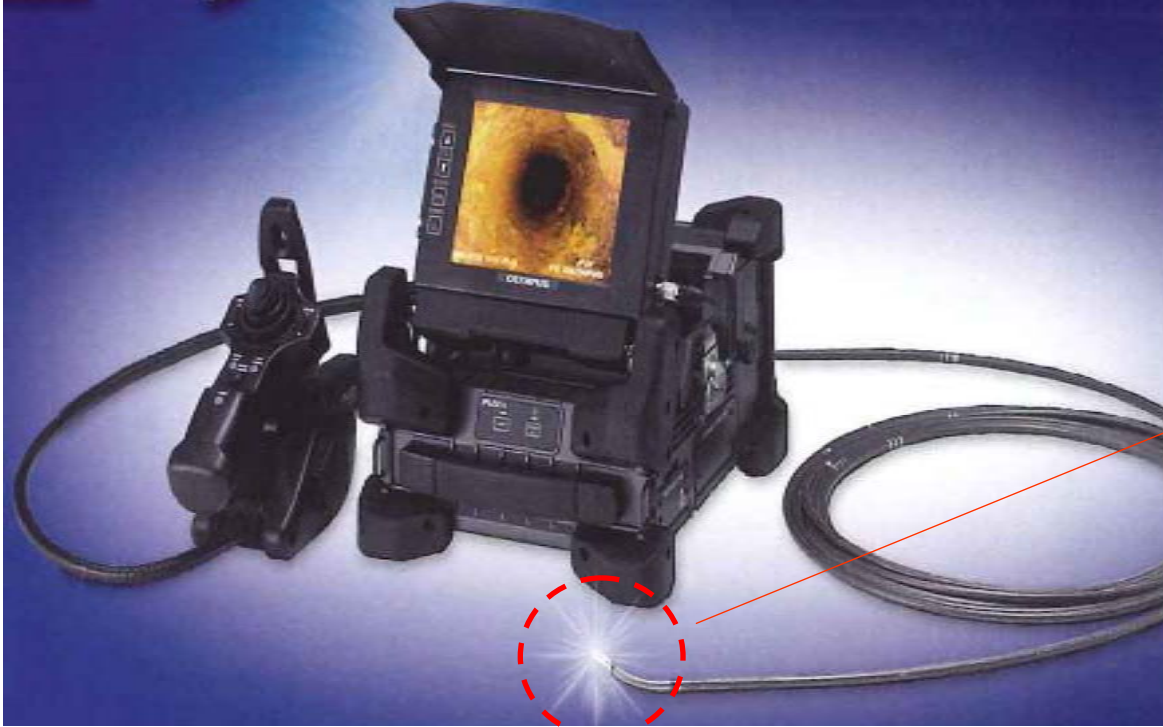
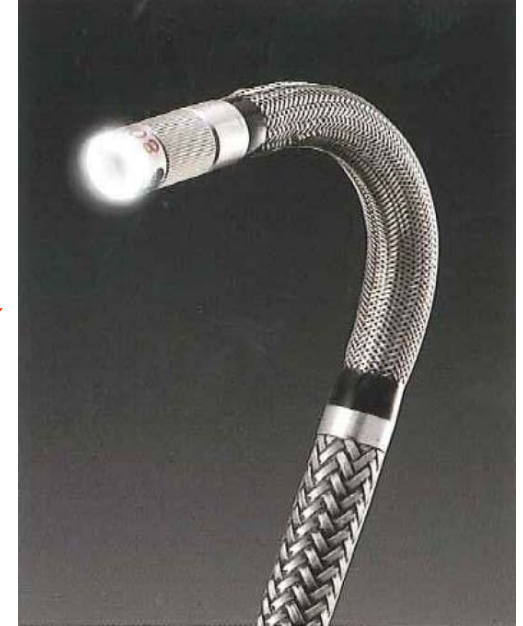
Outline of the borescope (reference)

<Specification>

External diameter of the borescope	Φ8.5mm
Length of the borescope	10m(inserted to PCV: 2m)
Temperature range	~100°C(air)、~30°C(water)
Radiation resistance	1000Gy
