<Reference>
May 24, 2013
Tokyo Electric Power Company

Boring Survey Around the Underground Reservoirs and the Future Plan

[Boring survey results of the underground reservoir No.2 (Previously announced)]

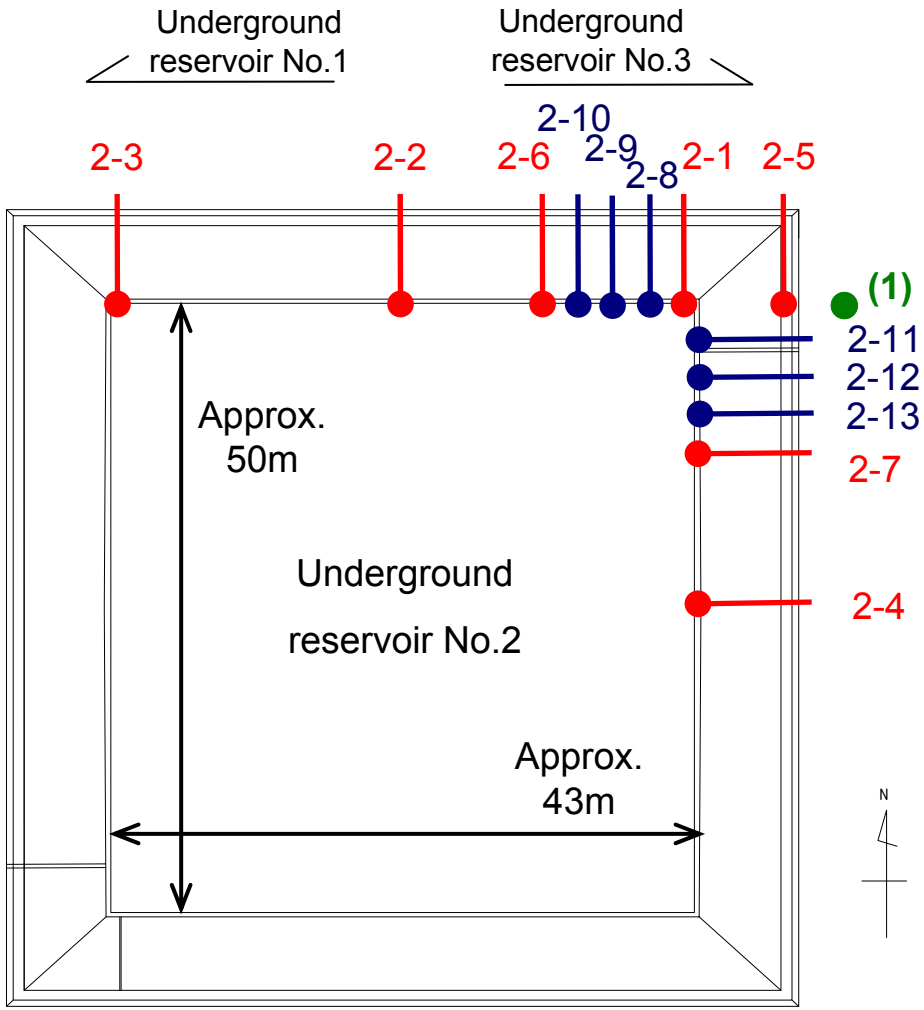
- Additional 6 borings were performed to identify the leakage location of the underground reservoir No.2.
- Sampling and analysis of the boring holes will be performed again to understand the distribution of all β densities.

Underground reservoir No.2 Observation Holes	Sampling date	All β (Bq/cm^3)
2-1	May 10	ND (<2.8×10^{-2})
2-2	May 10	ND (<2.8×10^{-2})
2-3	May 8	ND (<2.8×10^{-2})
2-4	May 8	ND (<2.8×10^{-2})
2-5	May 12	ND (<3.0×10^{-2})
2-6	May 12	ND (<3.0×10^{-2})
2-7	May 13	ND (<3.2×10^{-2})
2-8	May 23	ND (<3.2×10^{-2})
2-9	May 21	ND (<2.8×10^{-2})
2-10	May 22	1.0×10^{-1}
	May 23	7.1×10^{-2}
2-11	May 22	3.3×10^{-2}
	May 23	ND (<3.2×10^{-2})
2-12	May 21	2.9×10^{-1}
	May 22	3.8×10^{-1}
2-13	May 23	ND (<3.2×10^{-2})

Geological survey hole	Sampling date	All β (Bq/cm^3)
(1)	May 12	ND (<3.0×10^{-2})
