MISSION REPORT

IAEA INTERNATIONAL PEER REVIEW MISSION ON MID-AND-LONG-TERM ROADMAP TOWARDS THE DECOMMISSIONING OF TEPCO'S FUKUSHIMA DAIICHI NUCLEAR POWER STATION UNITS 1-4

(Third Mission)

Tokyo and Fukushima Prefecture, Japan
9 – 17 February 2015

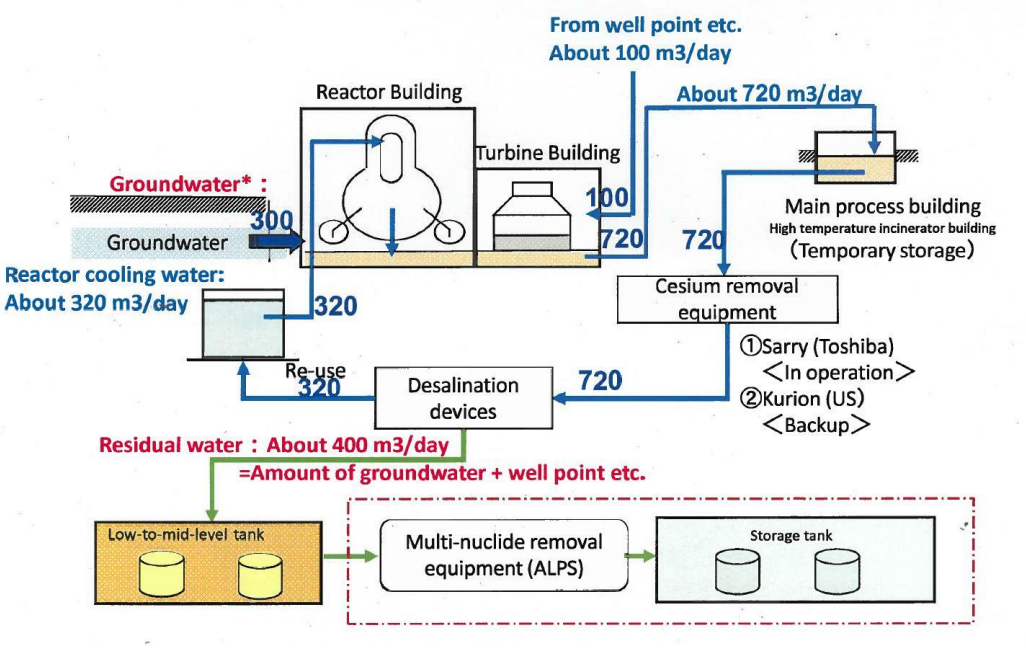
Ingress of groundwater into the reactor and turbine buildings has continued and the volume of contaminated water to be managed continues to increase. Measures taken in the recent past, namely operation of the groundwater by-pass system and stoppage of leaks into a waste treatment building (further discussed below), have resulted in reducing daily ingress of groundwater by 100 m^3/day. However, the daily increase of contaminated water continues to be 400 m^3/day, as before, because 100 m^3/day of contaminated groundwater is now being pumped into the turbine buildings from the seaside areas (Fig. 1).

FIG. 1. Overview of contaminated water management showing current balance of water volumetric flow rates

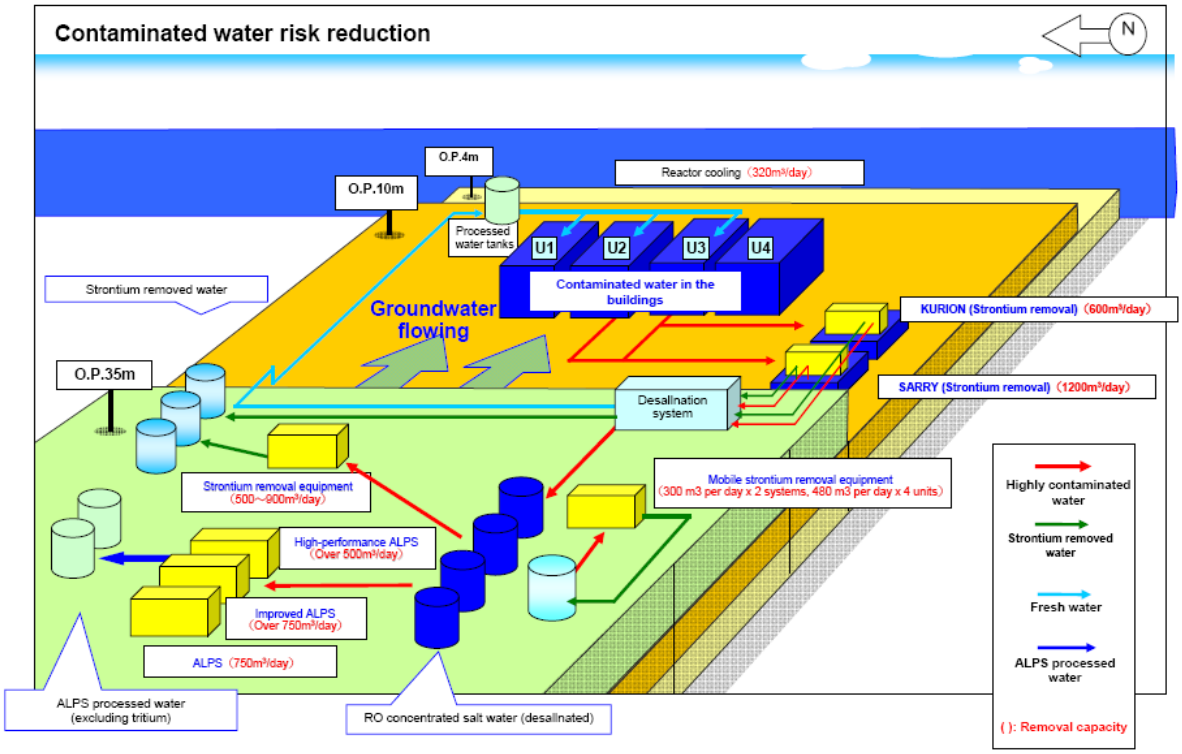
The overall schematic for contaminated water treatment is shown in Fig. 2 below. According to TEPCO's strategy for managing contaminated water accumulating in the buildings, the water is first pumped from the turbine buildings to the Centralized Radioactive Waste Treatment Facility buildings and then treated to remove caesium isotopes using two parallel systems, namely "Caesium adsorption apparatus" and "2nd Caesium adsorption apparatus" (labelled "Kurion" and "Sarry", below). Removing the gamma emitting caesium isotopes as the first step, facilitates further use and management of the treated water. These two caesium removal systems have continued to operate successfully, consistently achieving caesium decontamination factors of 10,000 or more. As of 26th February 2015, the cumulative volume thus treated amounts to approximately 1.16 million m^3. These two systems have now been enhanced by adding strontium removal capability. As a result, the capacity for removing caesium and strontium upfront is now 1800 m^3/day (600 m^3/day for "Caesium adsorption apparatus" and 1200 m^3/day for "2nd Caesium adsorption apparatus").

FIG. 2. Contaminated water treatment and storage scheme.

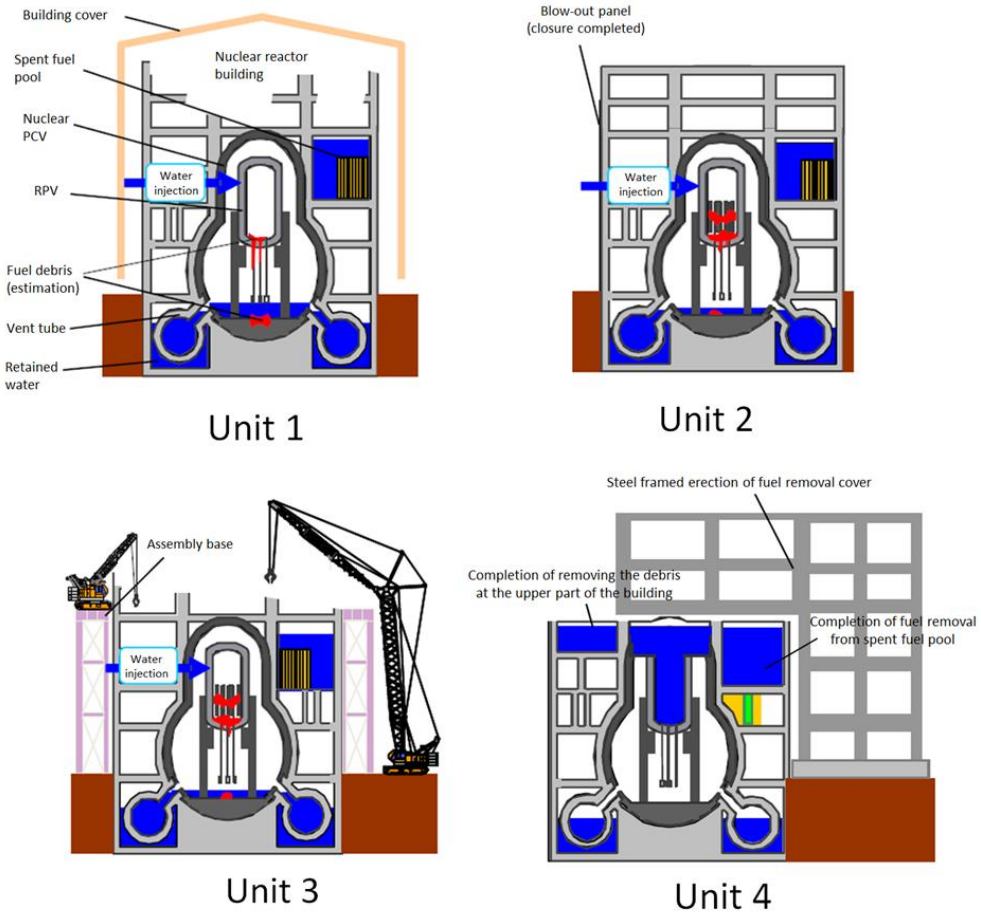
Figure 3 illustrates the current fuel and fuel debris situation in Units 1-4.

FIG. 3. Recent fuel and fuel debris status at Units 1-4.

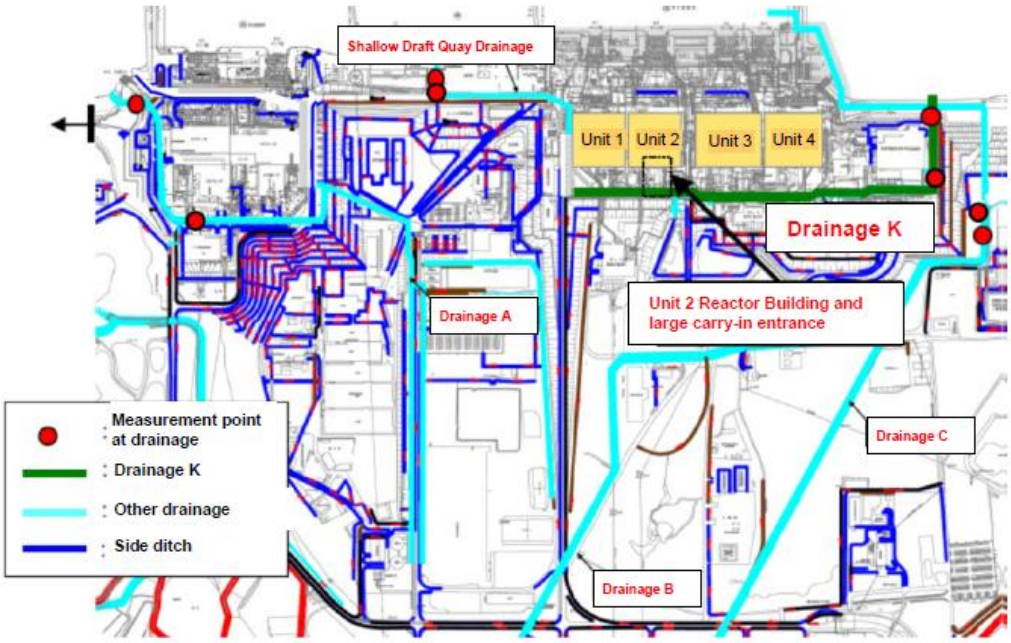
At the same time TEPCO also published their data of water contamination levels in the K drainage channel since April 2014. These results show increased contamination levels associated with periods of rainfall (Fig. A-2). (TEPCO's explanation for the delay in disclosing this information, subsequent actions to improve information disclosure and the IAEA experts' views in this matter are discussed below under "Public communication").

FIG. A-1. Diagram showing the location of drainage channels at 1F site

After determining the likely source TEPCO expeditiously implemented measures to reduce contamination spread by placing zeolite filled porous bags around the rooftop drain outlet, spreading waterproof sheets on the rooftop and placing 'purification materials' (zeolite bags and sorbent impregnated fibrous material) in the branch channel connecting the rooftop to the main channel. During the site visit, the IAEA experts observed that the dose rate near the 'purification materials' was about an order of magnitude higher than the general background in the channel, indicating that caesium was being captured. Fig. A-3 below shows TEPCO officials and IAEA experts inside K drainage channel near the point at which the branch channel connected to Unit 2 service entrance rooftop meets the K drainage channel.

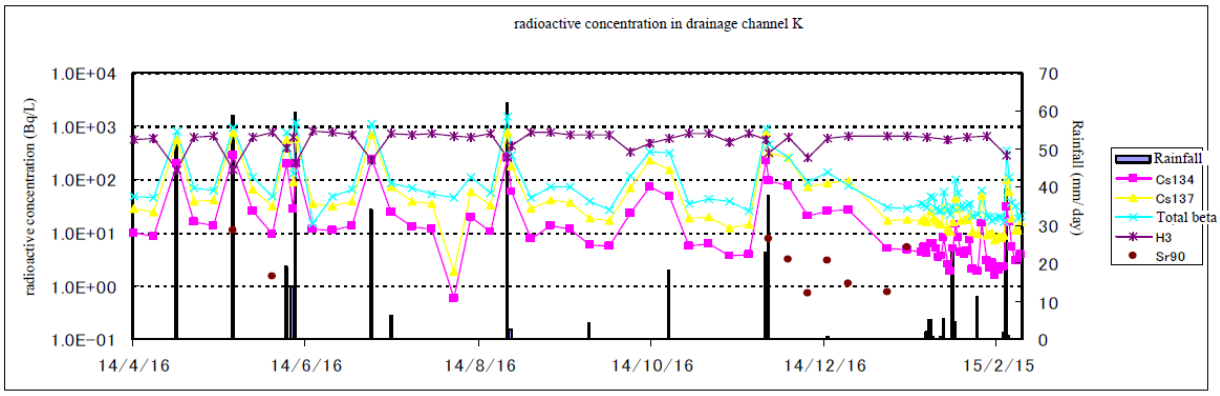
FIG. A-2. Water radioactivity and rainfall profile in K drainage channel
