The Development of and Lessons from the Fukushima Daiichi **Nuclear Accident**

Greetings and Introduction to This Booklet

The accounts in this booklet about the Fukushima Daiichi and Daini nuclear power stations have been drawn up based on the material contained in TEPCO's Fukushima nuclear accident investigation report.

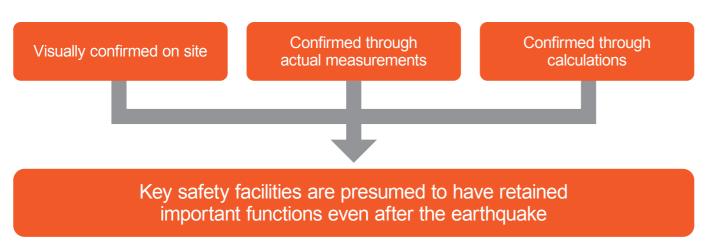
No damage from the earthquake to key safety facilities has been confirmed.

A magnitude 9.0 earthquake occurred at 2:46 p.m. on March 11, 2011 (Friday), with an epicenter on the ocean floor off the coast of Sanriku. The Fukushima Daiichi Nuclear Power Station was among those hit by strong shaking. However, Units 1, 2, and 3—operating at the time of the earthquake—all made emergency trips. Additionally, their emergency diesel generators started up and cooling of their reactor cores began.

The earthquake caused damage to some routine equipment, such as power transmission and receiving facilities, but no damage to key safety facilities, such as emergency diesel generators and coolant injection and heat removal equipment, has been confirmed

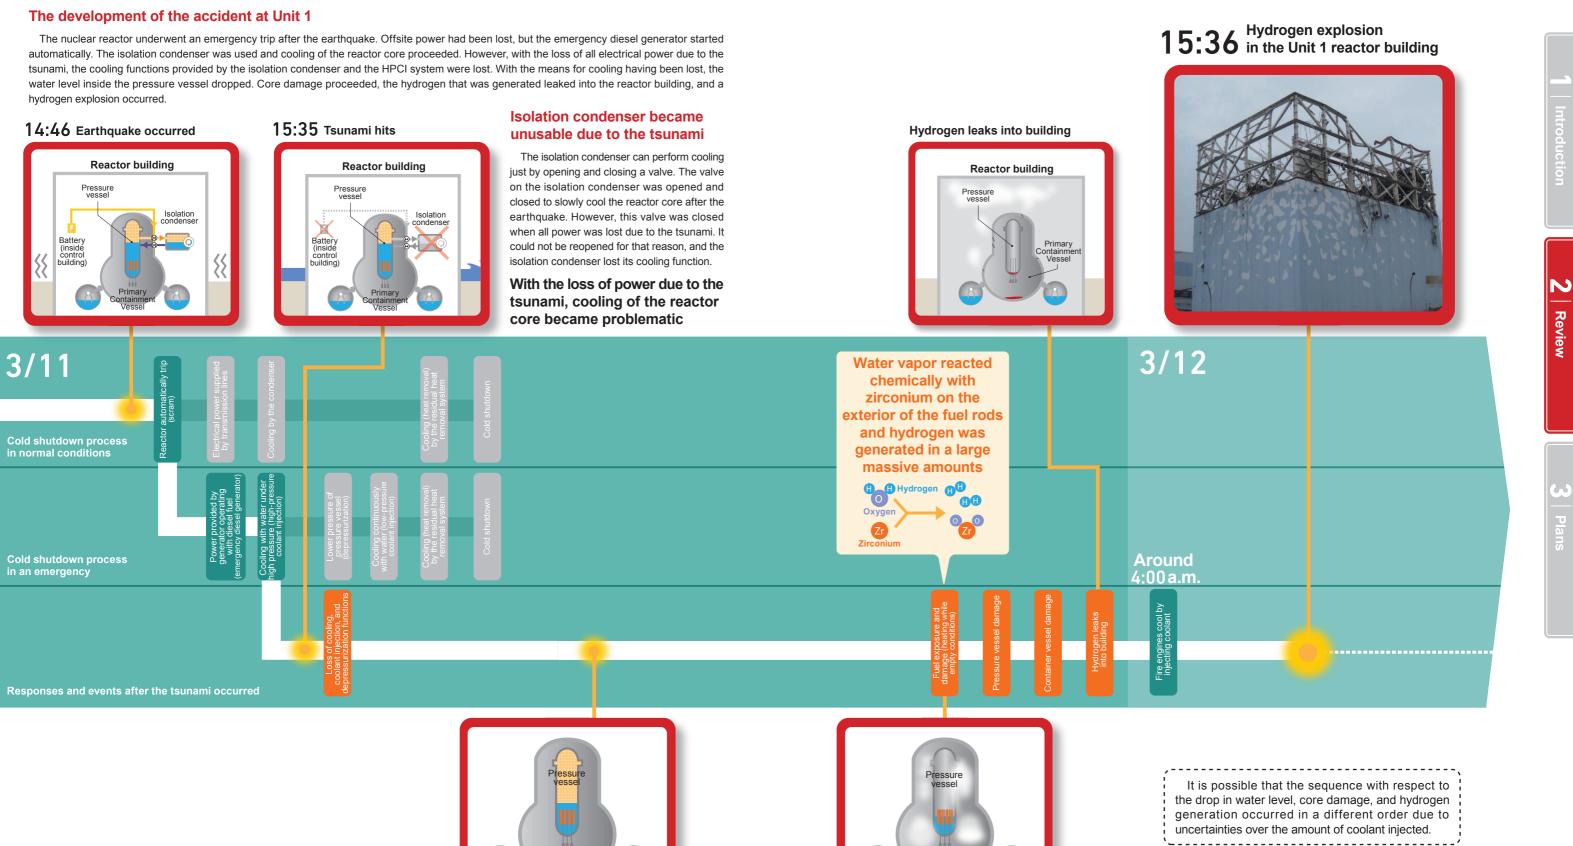
The development of the accident at Unit 1

Offsite power was lost due to the earthquake at Unit 1, but the emergency diesel generator started and function was preserved with respect to maintaining safety. However, owing to the tsunami, all power, both AC and DC, was lost and the Unit's "cooling down" function became unusable. Due to this, the water level in the reactor continued to drop, the reactor core was damaged, and the hydrogen generated as a result leaked inside the reactor building, leading to a hydrogen explosion.

But the tsunami that struck about 50 minutes after the earthquake and the flood waters that came with it caused the loss of the emergency diesel generators, batteries (DC power sources), and all sources for the power panels² and so forth. With the loss of all power sources, the isolation condensers tripped functioning, and the HPCI systems could not be activated. Additionally, owing to the loss of monitoring and measurement function, it became impossible to confirm the status of the reactor and other equipment. After this, the water in the pressure vessel continued to evaporate. About four hours later, the fuel was exposed above the water's surface and core damage began.

Because the surface temperature of the exposed fuel rods rose due to decay heat, the surface of the fuel rods reacted with the water vapor in the pressure vessel and large amounts of hydrogen were generated. The hydrogen that leaked from the damaged parts (thought to be leaked from the top flanges of reactor pressure vessel head and such produced by the temperature rise) of the primary containment vessel gathered in the upper parts of the reactor building. It ignited for some reason and at 3:36 p.m. on March 12-about 24 hours after the tsunami struck-exploded. Also, the melted reactor core penetrated the bottom of the pressure vessel and eroded the concrete on the surface of the primary containment vessel

Water level inside the pressure vessel dropped

Lessons from the accident	Problem(s) that arose
1: Protection from tsunami	 The buildings and areas outside were flooded due to the tsunami.
2:Guaranteeing power sources/means of injecting coolant	 All coolant injection and heat removal function was lost due to the loss of all AC and DC power. Owing to the inability to inject coolant or remove heat, the water level inside the pressure vessel dropped and, approximately 4 hours after the tsunami, the core was damaged.

3:Impact mitigation after core damage	 The hydrogen generated due to the core damage leaked from the pressure and primary containment vessels to the inside of the reactor building and a hydrogen explosion occurred. The melted reactor core penetrated the pressure vessel and eroded the concrete of the primary containment vessel.

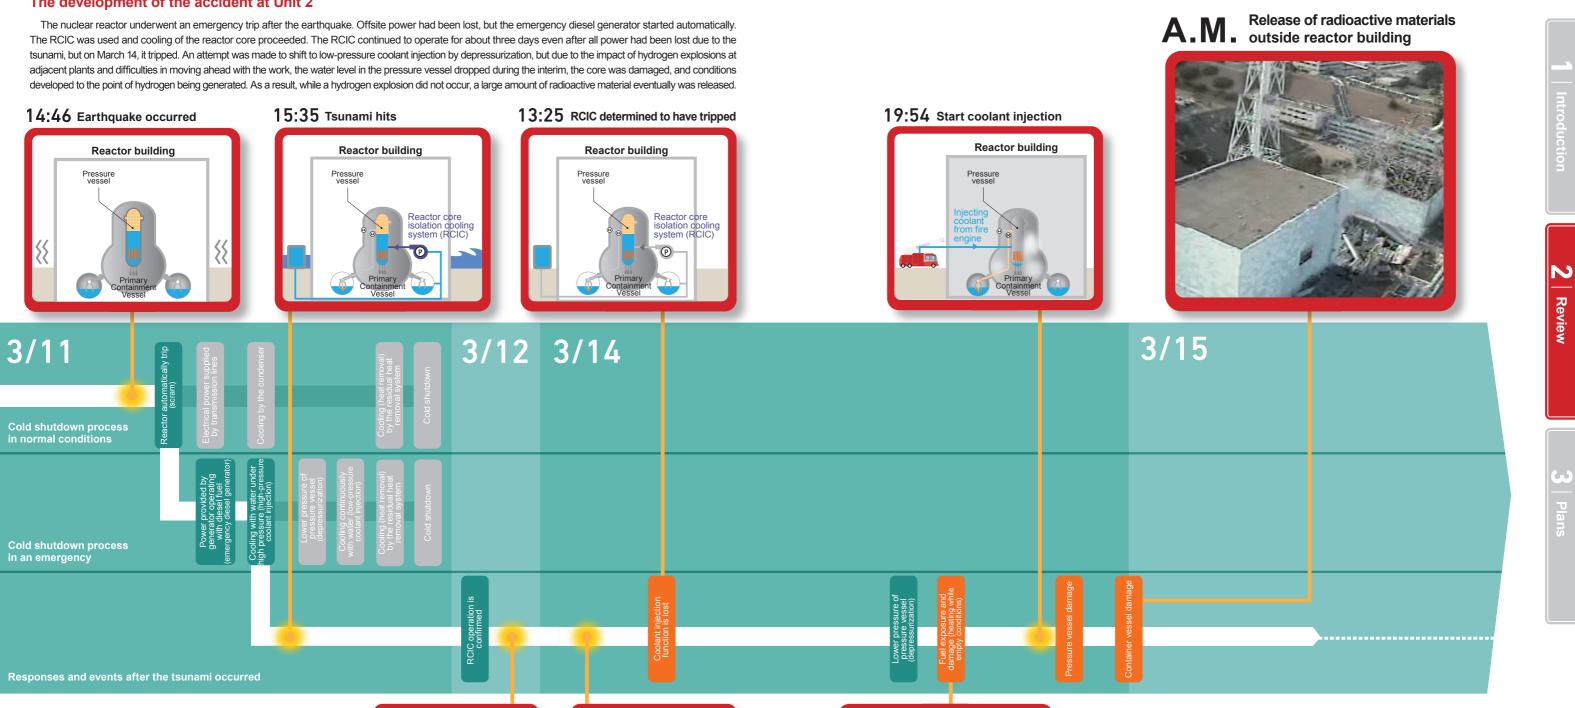
The development of the accident at Unit 2

The situation followed almost the same course as at Unit 1 up to this point. However, in the case of Unit 2 the RCIC had been operating prior to the tsunami striking. Even after all power was lost it continued to operate, and so it was able to continue coolant injection for about three days. During that period, a power-supply car was connected to the power panels that escaped being submerged and should have been able to perform coolant injection with other cooling systems. Work to maintain power was moving forward, but because of cables being damaged by a hydrogen explosion that occurred at 3:36 p.m. on the 12th at Unit 1, the power-supply car became unusable. Furthermore, a hydrogen explosion occurred at Unit 3 at 11:01 a.m. on the 14th. The fire engine and hoses that had been completely readied were damaged and became unusable. At 1:25 p.m. that same day, the RCIC tripped. Time was required after this had been confirmed for pressure to be reduced. The water level fell, the reactor core was damaged, and at the same time hydrogen was generated.

It is presumed that hydrogen leaked into the reactor building with the damage to the pressure and primary containment vessels following the core damage, but at Unit 2, a panel on the side of the upper part of the reactor building opened due to the impact of the hydrogen explosion at Unit 1. It is surmised that for this reason, hydrogen escaped to the outside and an explosion of the reactor building was avoided.

On the other hand, we surmise that the most radioactive material to be released from any of the three buildings came from Unit 2. We presume that this is because at Units 1 and 3 the "venting"-an operation that entails the removal of a certain amount of radioactive materials via the water in the suppression pool and releasing the gas to outside the primary containment vessel-was successful. We presume that at Unit 2, in contrast, the vent line could not be thrown open, venting failed, and gas that included radioactive materials direct from the primary containment vessel leaked out.

Cause of core damage was failure to reduce pressure

At Unit 2 and Unit 3, after the reactor cores stopped, water levels in the reactors were maintained (the reactors cooled) owing to the operation of HPCI systems that can inject coolant into pressure vessels experiencing high pressure. However, after a certain amount of time the HPCI systems tripped and the situation was such that they could not be restarted. In such a case, it was necessary to lower the pressure in the pressure vessels, inject coolant into those vessels using the low-pressure coolant injection system, and cool the reactor cores. However, because it was not possible either to quickly open the "safety relief valve" in order to reduce pressure, or to inject coolant, water levels in the pressure vessels dropped and the reactor cores were damaged.

Lessons from the accident	Problem(s) that arose
1: Protection from tsunami	• The buildings and areas outside were flooded due to the tsunami.
2:Guaranteeing power sources/means of injecting coolant	 Due to the loss of all AC and DC power, all coolant injection and heat removal functions were lost except the RCIC. At the same time, the RCIC became uncontrollable. It operated for several days, but subsequently tripped. After the RCIC tripped, time was needed to reduce the pressure of the pressure vessel. The water level fell and core damage eventually occurred.

3:Impact mitigation after core damage	 After the core was damaged, the primary containment vessel was also damaged and both hydrogen and radioactive material were leaked to the outside.

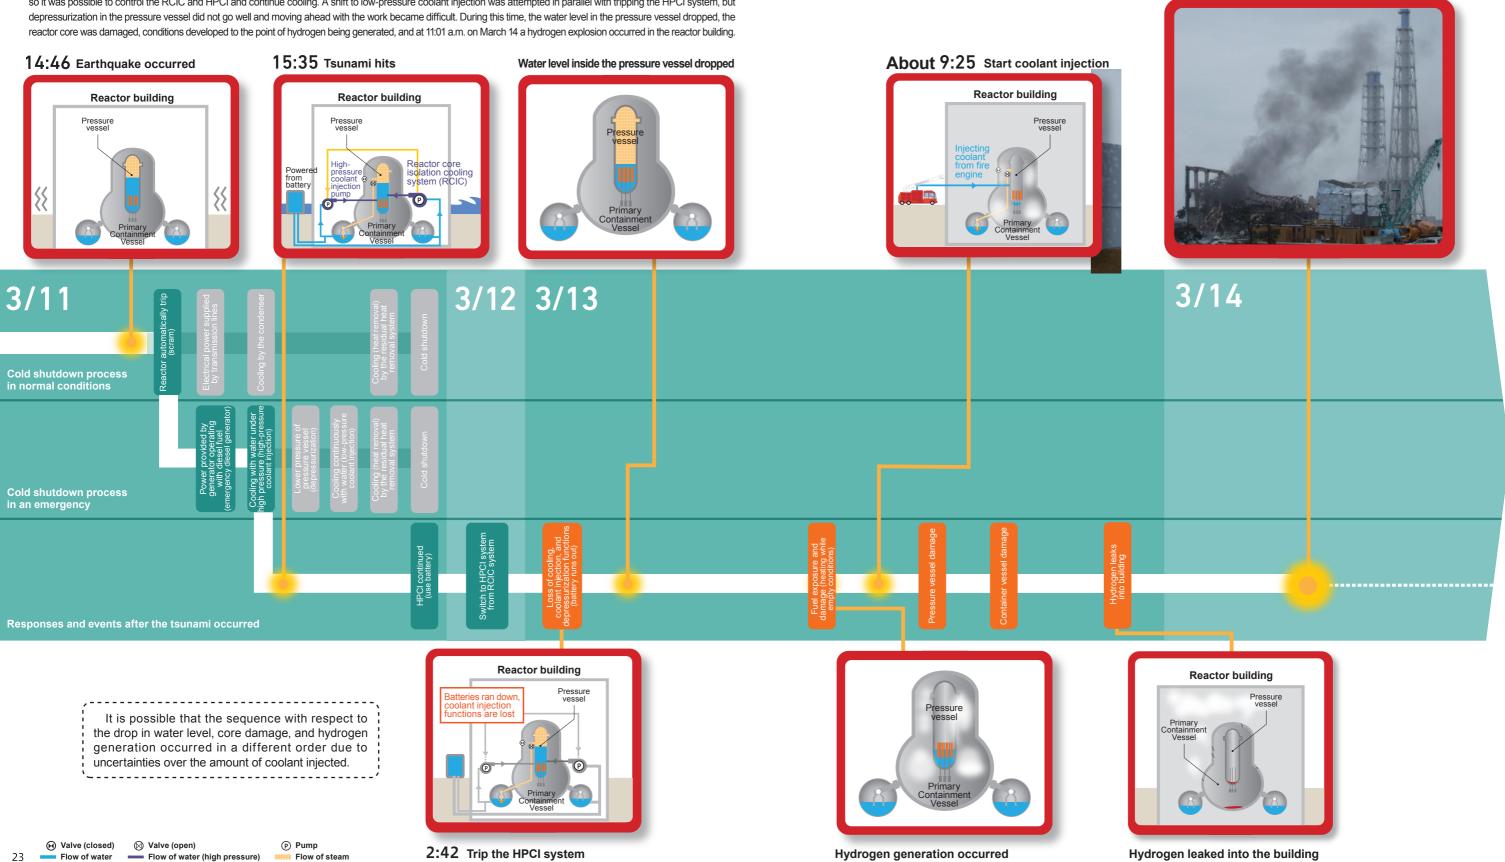
The development of the accident at Unit 3

Coolant injection continued for approximately a day and a half, after which the HPCI system was tripped to change over to injecting coolant at low pressure (with a diesel driven fire pump). However, depressurization after this took time, the water level dropped, and the result was the generation of hydrogen and damage to the core.

Coolant injection from fire engines began after the fall in pressure had been confirmed, but owing to the hydrogen that had leaked from the primary containment vessel a hydrogen explosion occurred at 11:01 a.m. on March 14.

The nuclear reactor underwent an emergency trip after the earthquake. Offsite power had been lost, but the emergency diesel generator started automatically. The RCIC was used and cooling of the reactor core proceeded. The emergency diesel generator tripped due to the tsunami. However, the batteries (DC power) relieved damage and so it was possible to control the RCIC and HPCI and continue cooling. A shift to low-pressure coolant injection was attempted in parallel with tripping the HPCI system, but

11:01 Hydrogen explosion in the Unit 3 reactor building

Lessons from the accident	Problem(s) that arose
1: Protection from tsunami	 The buildings and areas outside were flooded due to the tsunami.
2:Guaranteeing power	• The loss of all AC power caused the loss of AC-powered coolant injection and heat removal function.
sources/means of injecting coolant	 Once the HPCI system had tripped, depressurization in the pressure vessel took time, the water level dropped, and the result was core damage.

3:Impact mitigation after core damage	• The hydrogen generated due to the core damage leaked from the pressure and primary containment vessels to the inside of the reactor building and a hydrogen explosion occurred.

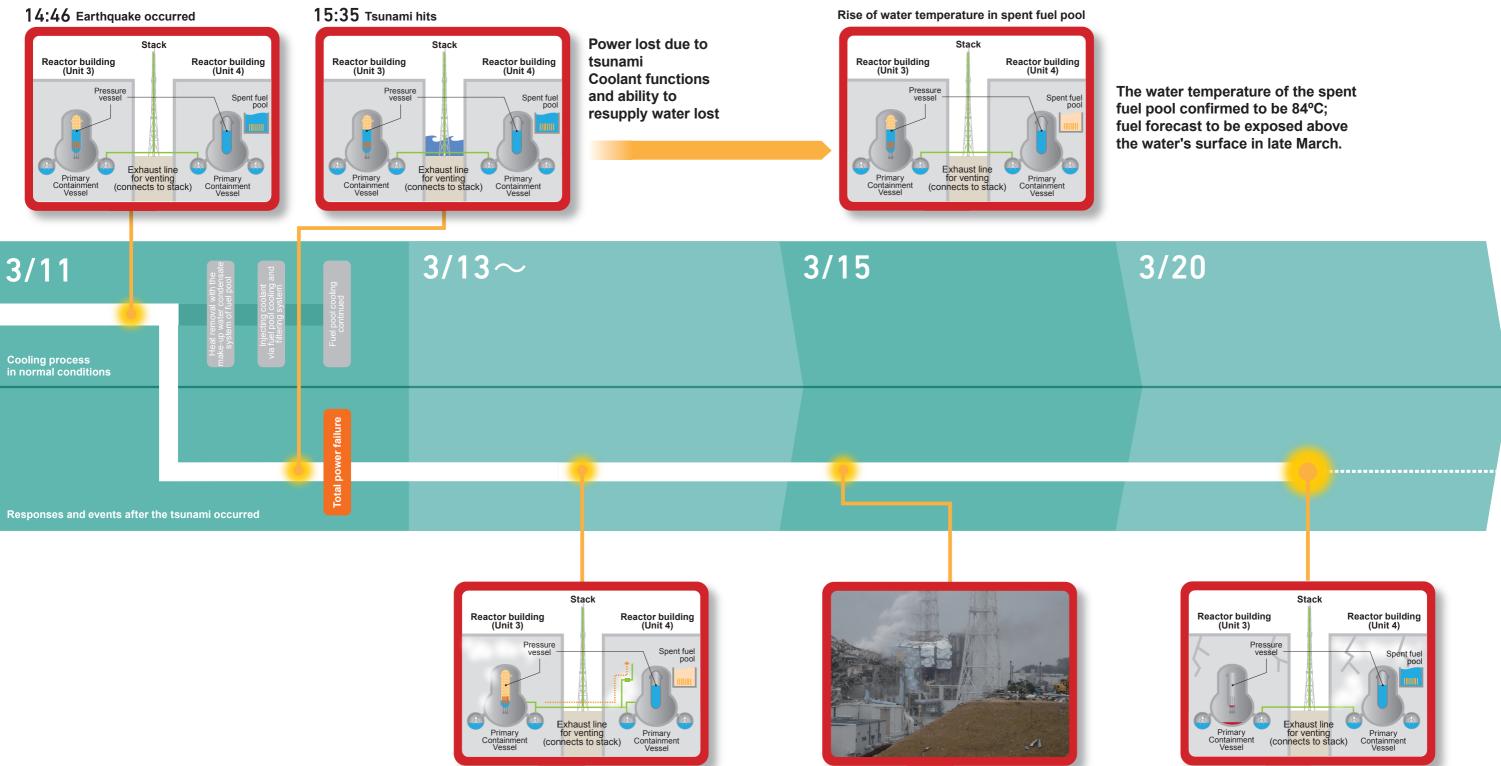
Changes in the reactor building (Unit 4)

Unit 4 was not in operation because planned outages were being conducted, but a hydrogen explosion occurred in the reactor building in the early morning on March 15. The cause is presumed to have been hydrogen generated at Unit 3 that flowed into Unit 4 through the exhaust pipes.

Offsite power was also lost due to the earthquake at Unit 4, which was not in operation because planned outages were underway. After the tsunami struck, it was no longer possible to use the emergency diesel generator and all power was lost. Due to the loss of cooling and resupply functions attendant with the loss of power, there were worries about the drop in water level caused by the evaporation of water in the spent fuel pool, where the fuel was being stored. However, it was forecast that the fuel would not become exposed above the water's surface until late March. For that reason, it was recognized that there was some leeway time-wise for responding, but then a hydrogen explosion occurred in the reactor building due to an inflow of hydrogen into the Unit 4 reactor building through the vent lines attendant with the venting at Unit 3.

Around 6:14 a.m. Hydrogen explosion in the Unit 4 reactor building

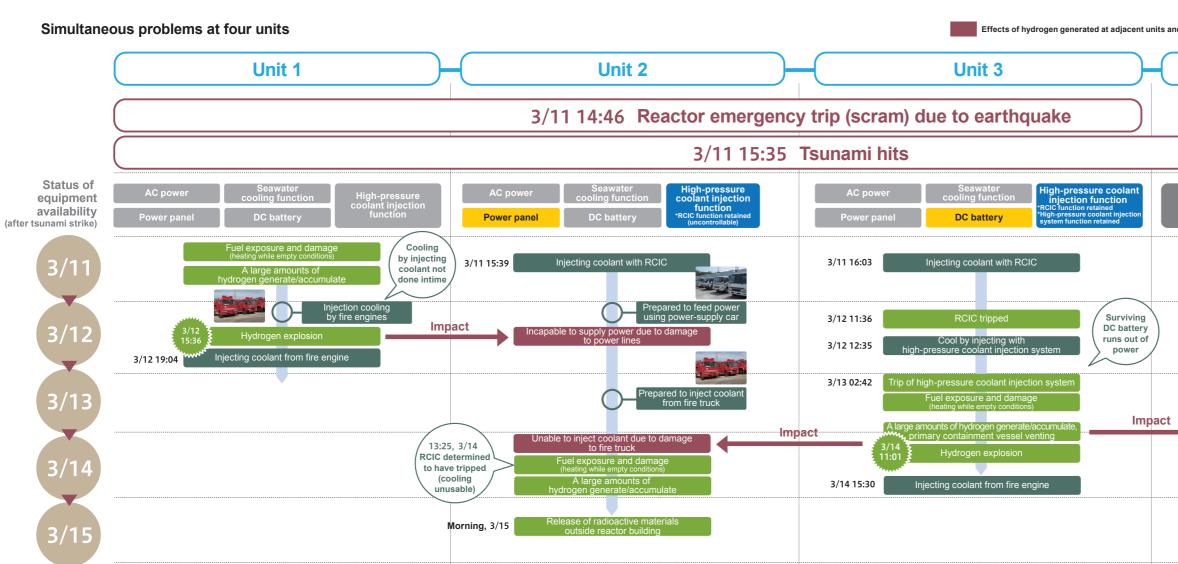
The magnification of damage due to simultaneous accidents at Units 1 to 4

In the Fukushima nuclear accident, multiple reactors experienced disasters simultaneously, leading to the accident. This created a situation in which responses had to be pursued in parallel. In addition, the progression of the accident at one unit hindered the responses at the other ones.

Accident at adjacent reactor produces expansion of damage

The situation after the tsunami was most urgent at Unit 1, where both coolant injection and heat removal had been interrupted. Preparations were being made to inject coolant into Unit 1 using fire protection lines and fire engines, but coolant injection did not happen in time. The water level in the reactor dropped, leading to the generation of hydrogen and eventually core damage. Also, the hydrogen that was generated leaked into the reactor building and, approximately one day after the tsunami at 3:36 p.m. on March 12, a hydrogen explosion occurred. The hydrogen explosion at Unit 1 damaged the power lines that had been laid down at Unit 2 as well as the power lines being readied at Unit 3. This had a big impact on the work being done to restore power at both Units 2 and 3.

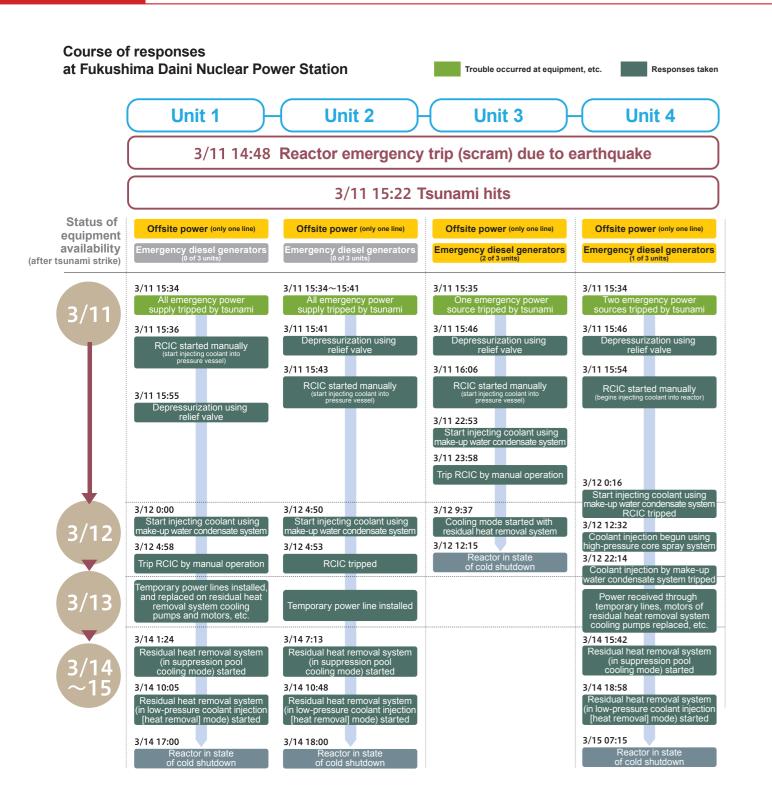
Fukushima Daini Nuclear Power Station Units 1, 2, 3, and 4 were all able to receive AC power of some sort even after the tsunami. Also, it was possible to put all of the units into cold shutdown by changing the motors of seawater pumps that had been damaged and laying down temporary cables to the motors while coolant was being injected.

Venting preparations moved forward

At Fukushima Daini Nuclear Power Station, heat removal functions were lost at Units 1, 2, and 4 due to the tsunami. Coolant was injected and the reactor cores were cooled, but there was no place for the steam (heat) generated by this to escape and the pressure in the primary containment vessels gradually rose. For that reason, preparations were made to vent the primary containment vessels at each unit. However, thanks to the success of the efforts to restore heat removal function that were taking place in parallel, workers were able to achieve cold shutdowns without having to perform venting.

On the other hand, it was not possible to remove heat from the reactors because the seawater pumps were damaged by the tsunami.

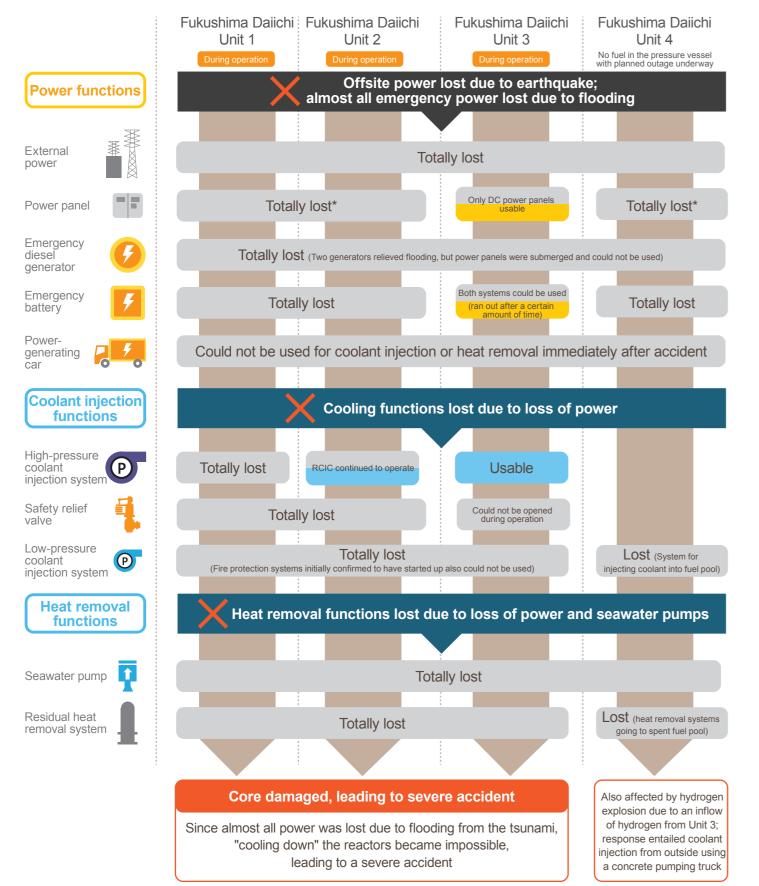
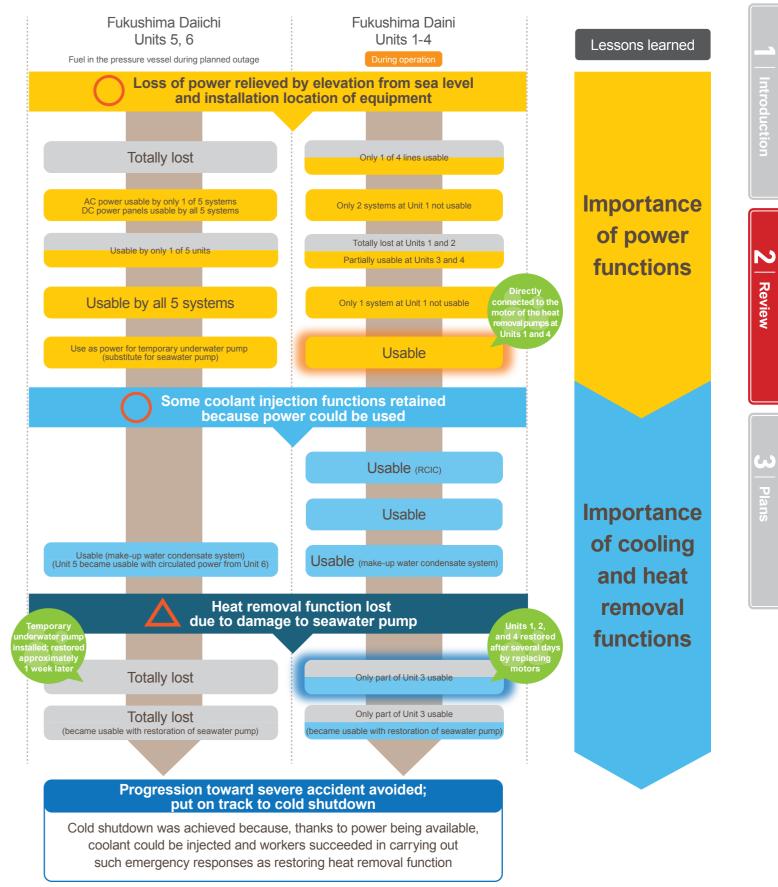
Comparative view of equipment damage situation after the tsunami struck (Fukushima Daiichi: Units 1-6, Fukushima Daini: Units 1-4)

Despite the fact that they were damaged by the earthquake and tsunami like Fukushima Daiichi Nuclear Power Station Units 1-4, Units 5 and 6 at that station, as well as Fukushima Daini Nuclear Power Station, escaped a severe accident. What were the differences in these cases?
