The 6th Progress Report
on the Investigation and Examination of
Unconfirmed and Unsolved Issues
on the Development Mechanism
of the Fukushima Daiichi Nuclear Accident

November 10, 2022

Tokyo Electric Power Company Holdings, Inc.

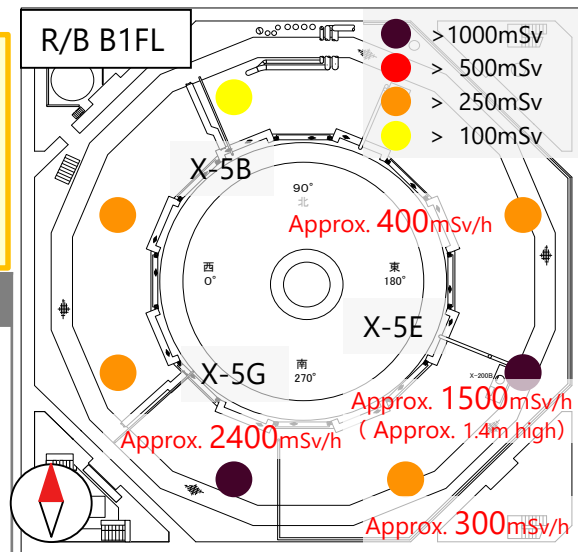
Dose rate in the torus room (on the catwalk; measured in May 2014)

- Several hundred to 2,400mSv/h dose rates were observed on the catwalk.
- The concrete shielding (650mm thick) was sufficient to attenuate the radiation in the southeast area of the 1st floor, so the impact was not significant.

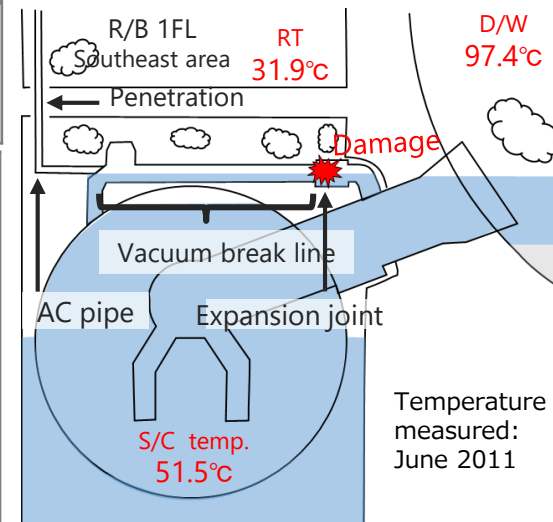
Estimated steam generation path

- The AC pipe floor penetration was located almost directly above the expansion joint of the vacuum break line where the leak was confirmed.
- PCV water level at the time was about the level of the expansion joint breakage point, and there was a possibility that gas (steam) inside the PCV was leaking out.

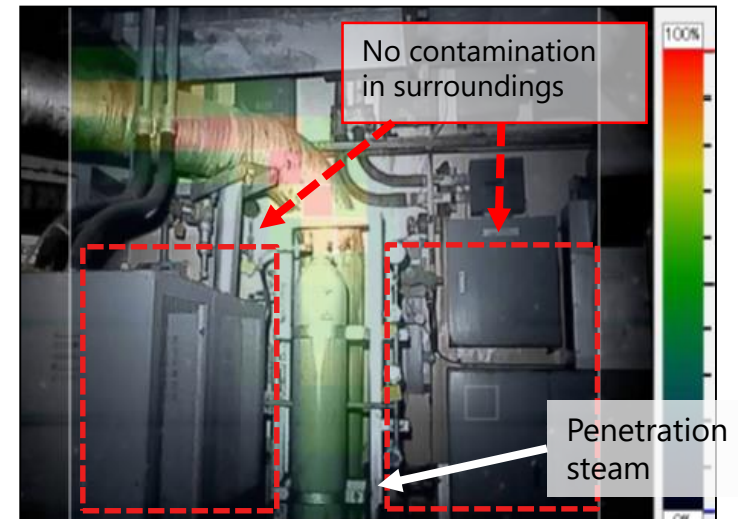
γ camera photo (direction (a)); December 2013)

- High dose was confirmed at the AC piping in the photo center.
- No contamination of surrounding structures expected to be contaminated by steam.
- No significant contamination at floor penetrations where steam was leaking.

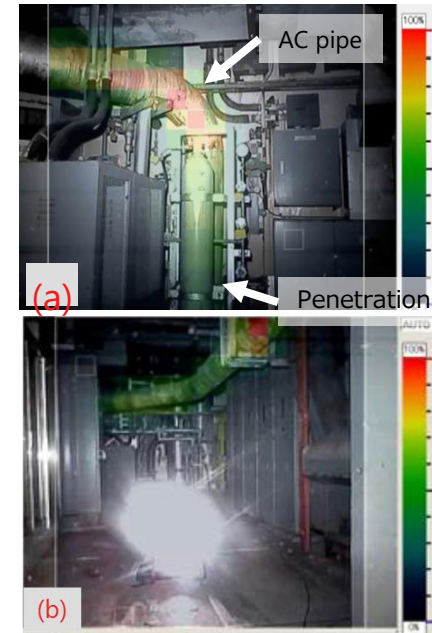
γ camera photo (Dec. 2013)

- γ camera measurement confirmed contamination along AC piping.
- Contamination remained within the piping and there was no transfer of radioactive materials to the southeast area.

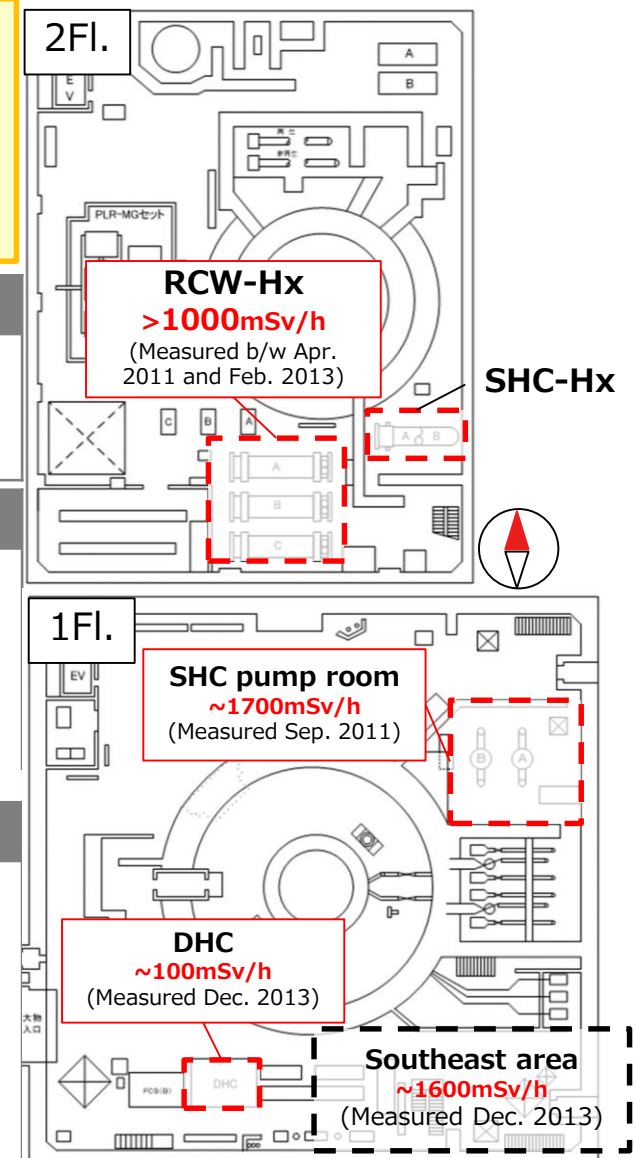
RCW system loads around the southeast area

- Possible residual RCW system water in DHC, RCW-Hx, and SHC-Hx, which could cause high dose rate if leaked to the southeast area.
- Water traces were observed near the AC system piping floor penetration in the southeast area.
→The surface dose rate of the collected floor sample (0.38mSv/h) was not significantly different from the surface dose rate of the area without the water traces (0.14mSv/h), suggesting that there was no leakage of RCW system water.

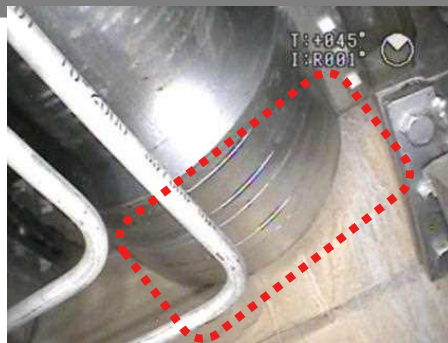
- No evidence of leakage in the X-31 penetration area.
- Dose rate in the room was low (several tens of mSv/h).
- Contamination was considered to have remained inside the penetration area and did not migrate into the TIP room.

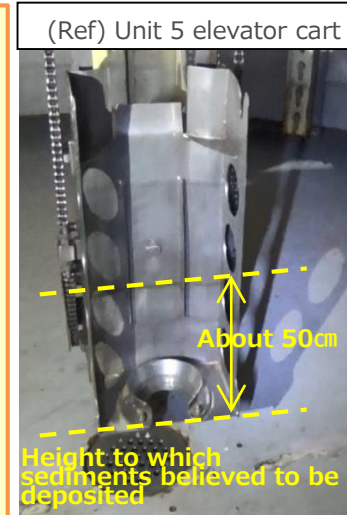
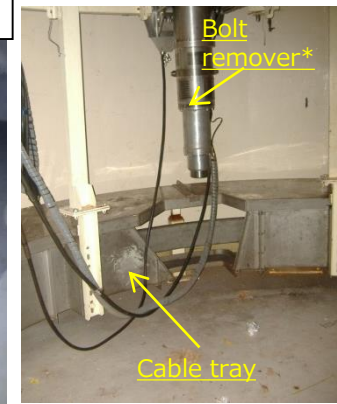
State of the Unit 2 containment vessel bottom

- Deposits looking like pebbles and clay were all over the pedestal bottom.
 - It was confirmed that there was no major deformation or damage to structures such as the rotating frame of the CRD exchange machine, the frame of the intermediate work platform, the struts, and the cable tray.
 - No deformation of the cable tray (stainless steel, 4mm thick) was observed, although it had a deposit that looked like solidified melt.
- ⇒ It was possible that when deposition on the cable tray started, the temperature of the deposited material was not at the temperature causing the tray thermal deformation.

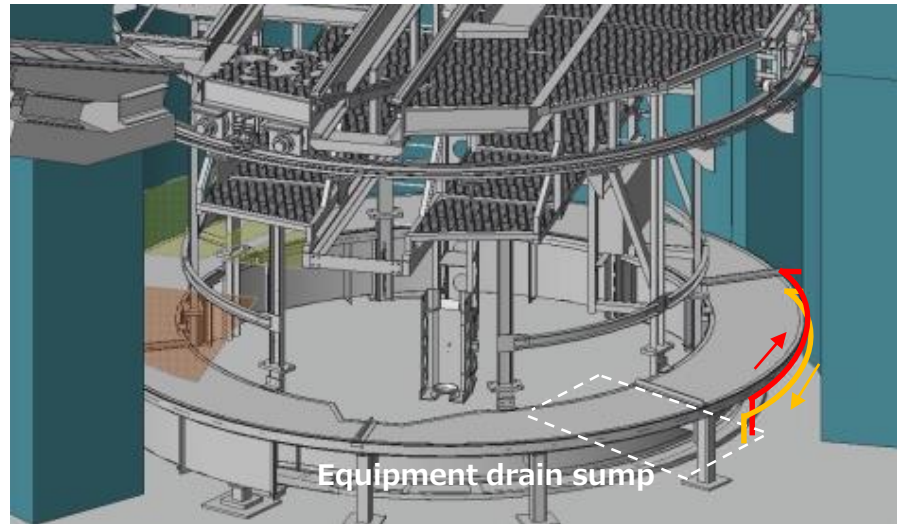
RCW piping in pedestal
(Arrows: Normal cooling water flow)

Thickness	Material	Melting point
Cable tray	~ 4mm	Stainless steel	~ 1450°C
Equipment drain sump lid	~ 3mm	Carbon steel	~ 1500°C
RCW Piping	~ 3.7mm	Carbon steel*	~ 1500°C*

*Material near the equipment drain sump was stainless steel (m. p. ~1450°C).

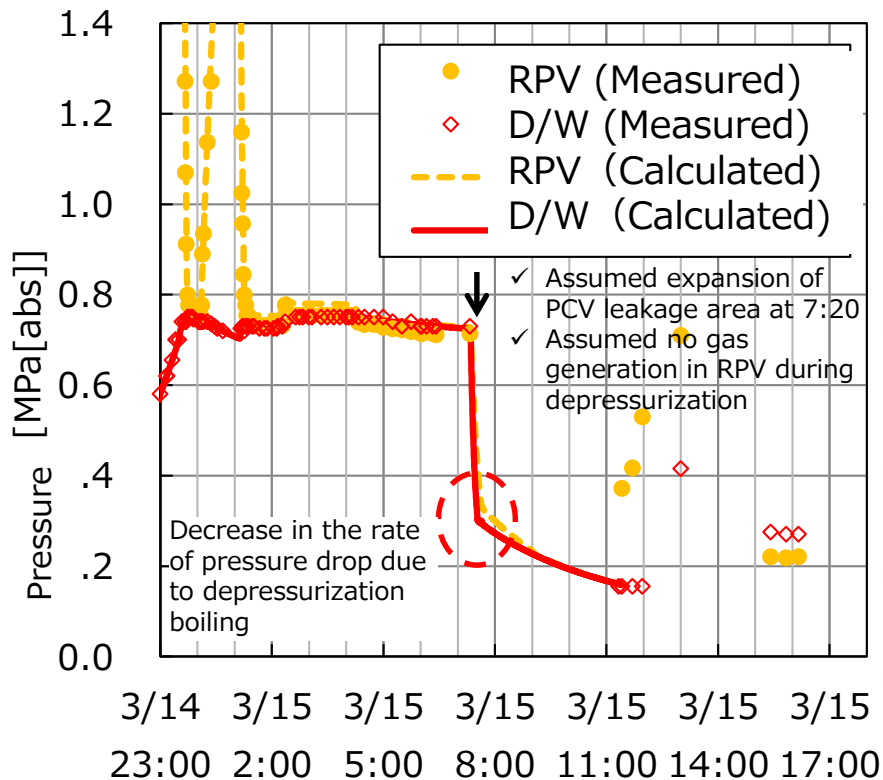
Fig. Analysis results given PCV leakage area that reproduced D/W depressurization

Analysis (using the GOTHIC code) evaluated the PCV gas phase leakage area that reproduced the depressurization after 7:20 on March 15, and the results indicated that **large-scale leakage must continue throughout the depressurization period.**

⇒ **Depressurization after 7:20 on March 15 was unlikely to be caused solely by gas phase leakage from PCV.**

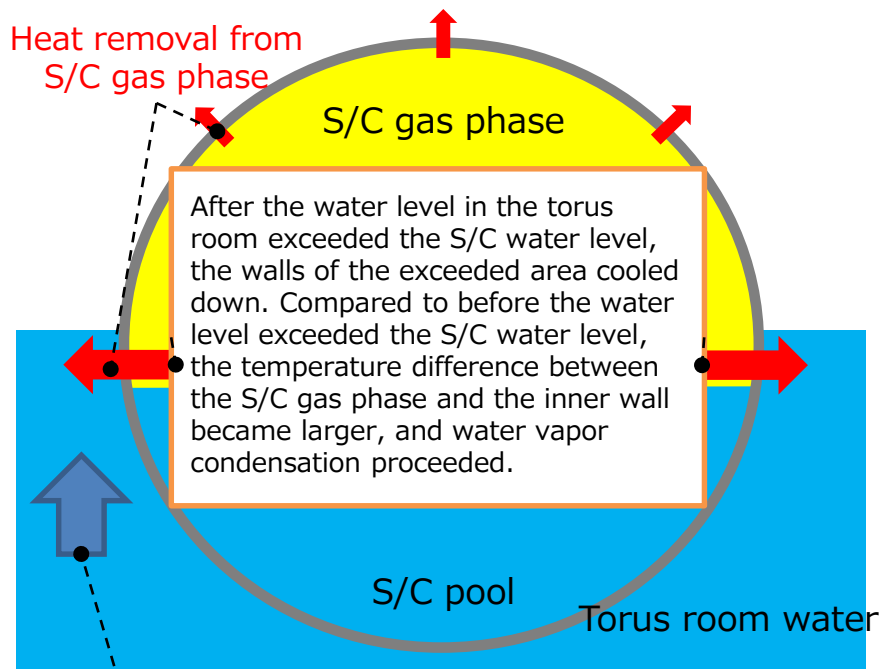
Fig. Image of rising water level in torus room

One possible scenario for increased condensation after 7:20 compared to earlier times is that the water level in the torus room rose and exceeded the S/C pool water level, which might have accelerated cooling of the S/C gas phase and increased condensation of water vapor.

Torus room water level rose due to tsunami, groundwater inflow, and leakage from S/C pool

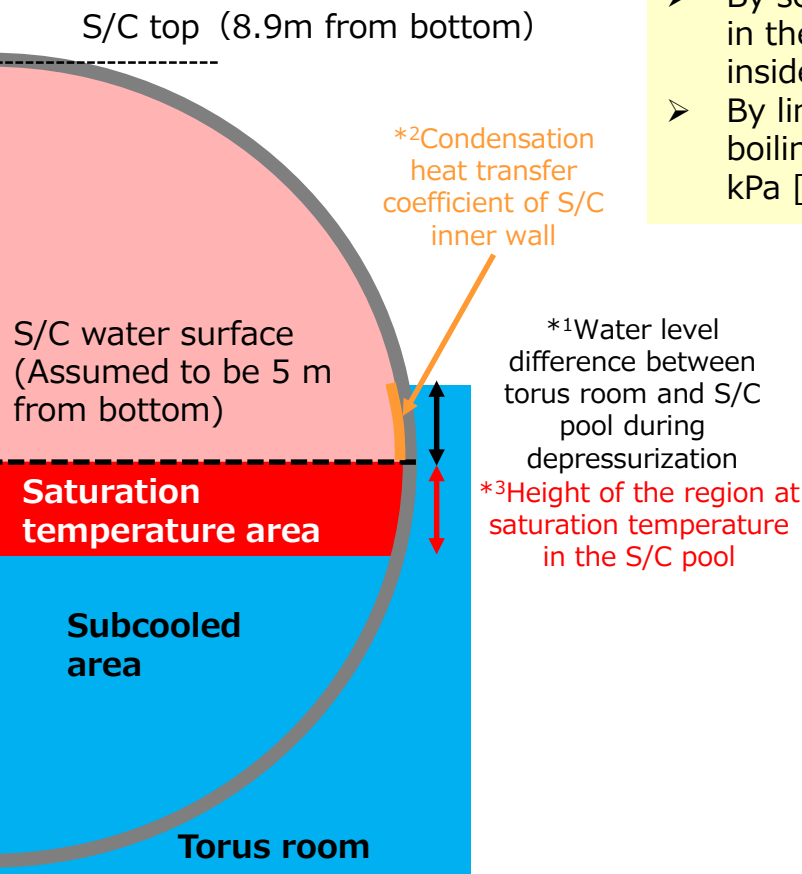
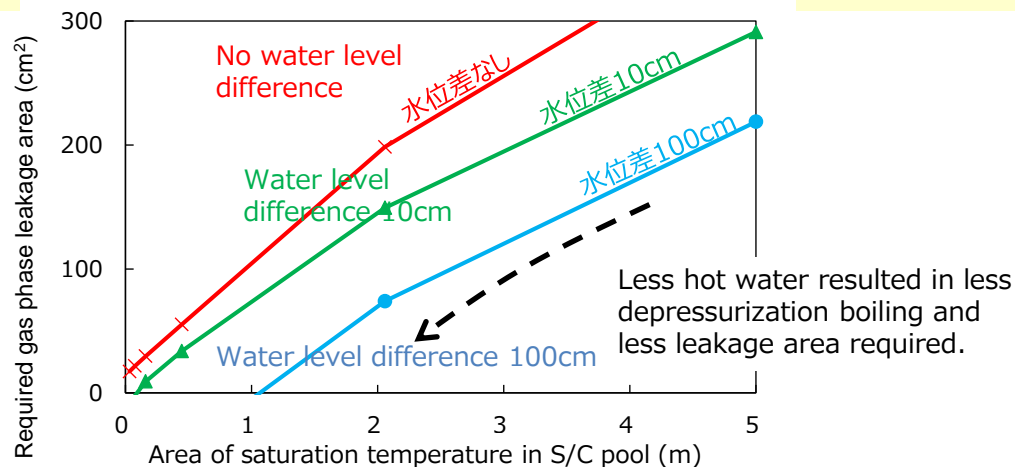
Fig. Variation of required leakage area with respect to height of saturated temperature region for S/C pool water. (Assuming no non-condensable gas in the PCV)

Leakage area required for depressurization after 7:20 on the 15th, including effect of condensation on S/C wall, was evaluated and found to be significantly reduced from the area of 300cm² required for depressurization due to gas phase leakage alone (below figure).

Less hot water resulted in less depressurization boiling and less leakage area required.

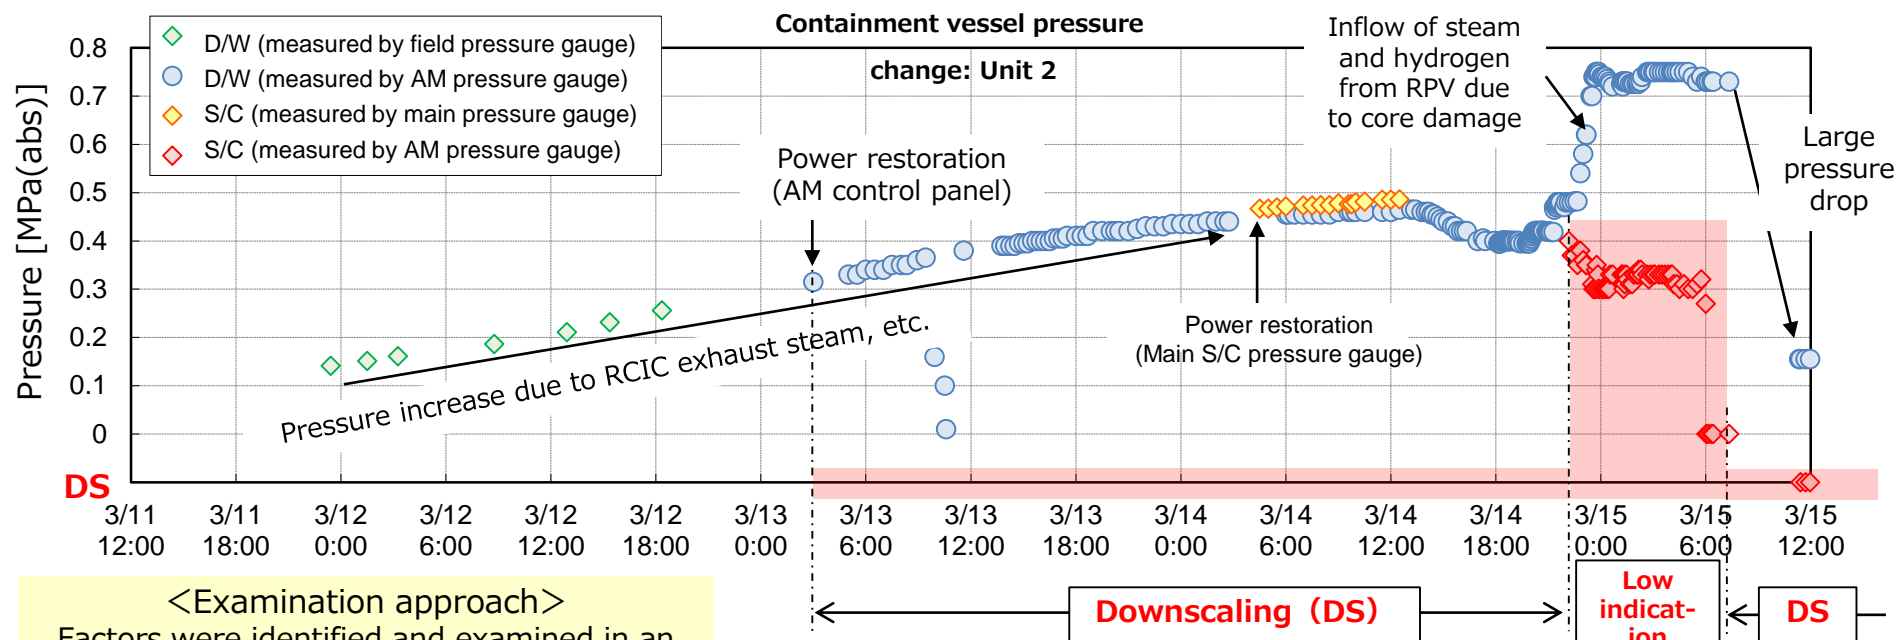
- Of the containment pressure gauges used in Unit 2 at the time of the accident, the S/C pressure gauge for accident management (AM) was connected to the battery at 3:00 on March 13 and power was restored, but **it showed values that differed significantly from those of other pressure gauges**, including downscaling (hereafter referred to as DS) and an indicated value approximately 400kPa lower than the D/W pressure.
- Such a large discrepancy between D/W pressure and S/C pressure does not occur due to the structure of the containment vessel, and **it was extremely likely that the S/C pressure gauge for AM was not indicating the actual pressure**, since it was indicating DS.
- Since containment pressure is a very important parameter in accident response, we examined the factors that caused the S/C pressure gauge for AM to show an abnormal indication value.

The S/C pressure gauge for AM was presumed to have shown an abnormal indication value that was far from the actual value due to electrical failure caused by submersion in water.

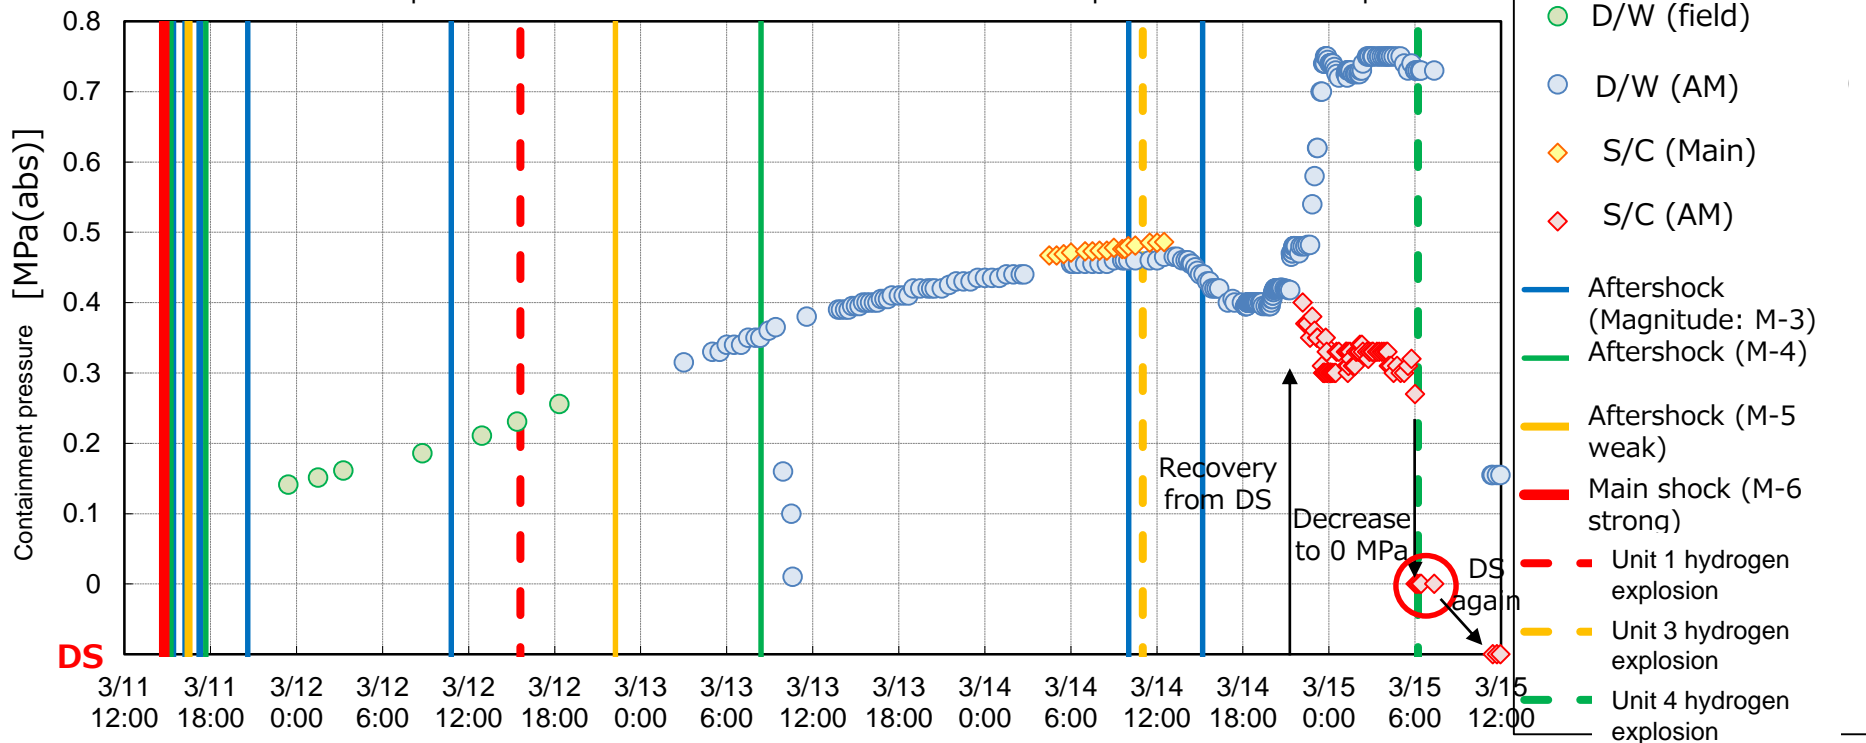
Containment pressure behavior of Unit 2 and time series of earthquake shocks and explosions

After examining the possibility that the main body of the S/C pressure gauge for AM was damaged by the earthquake shocks and explosions of other units, it was considered unlikely that either of these factors was a direct cause of the drop in the indicated values at DS and around 6:00 on March 15.

- If earthquake shocks or explosions damaged the pressure gauge itself or ruptured the cable, it is unlikely that the indicated value would be restored from DS, so it is unlikely that the gauge was damaged by this factor before March 15.
- The indicated value of the S/C pressure gauge for AM dropped sharply to 0 MPa at 6:02 on March 15, but no earthquake occurred around that time.
- The hydrogen explosion at Unit 4 occurred very close by, but the explosion was not a direct cause of the drop in the indicated value because it occurred after the 0 MPa reading was reached. (0 MPa: March 15, 6:02. Unit 4 hydrogen explosion: March 15, 6:12)

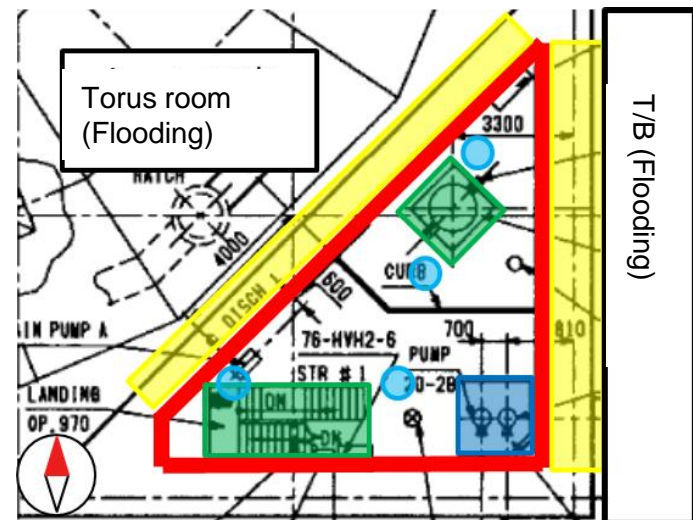
Middle lower ground Fl. Southeast triangle corner

After examining the possibility that the main body of the S/C pressure gauge for the AM was damaged and showed DS when the tsunami arrived on March 11, it was considered unlikely that the pressure gauge was damaged by the impact of the tsunami arrival.

There are multiple tsunami entry routes to the installation site of the S/C pressure gauge for the AM, but all of them are difficult to reach with the momentum of the tsunami still intact.
 ⇒It is unlikely that the impact of the tsunami caused the DS.

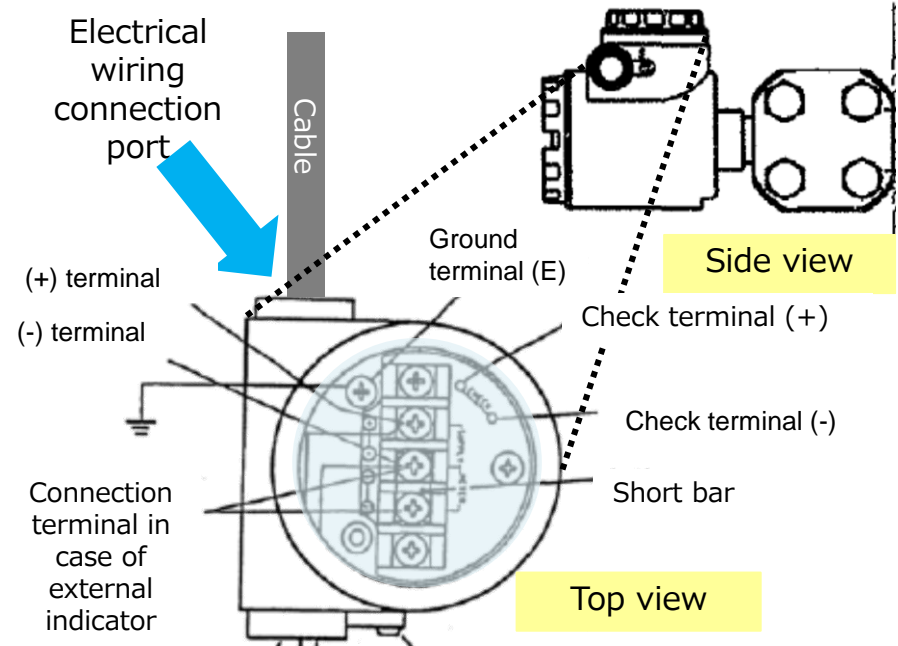
Schematic diagram of S/C pressure gauge and terminals for AM

The terminal section might have been flooded, resulting in a combination of short circuit, ground fault, and insulation degradation, which might have caused the S/C pressure gauge for the AM to show DS or a low indication value.

- A short circuit would work to increase the indicated value, which might cause equipment failure in some cases.
 - There was a high possibility that the pressure gauge was submerged in water and became flooded inside.
- ⇒A short circuit was quite possible.

- If the current leaked out of the electric circuit and the current value decreased, this might result in DS or a decrease in the indicated value.
 - Insulation resistance of the control panel was not measured.
 - There was a high possibility that the pressure gauge was submerged in water and became flooded inside.
- ⇒There was a strong possibility of ground fault or insulation degradation.

*Although the S/C pressure gauge for the AM was IP67 (dust-proof and immersion-proof), water might enter the interior of the instrument if submerged conditions were persisting.

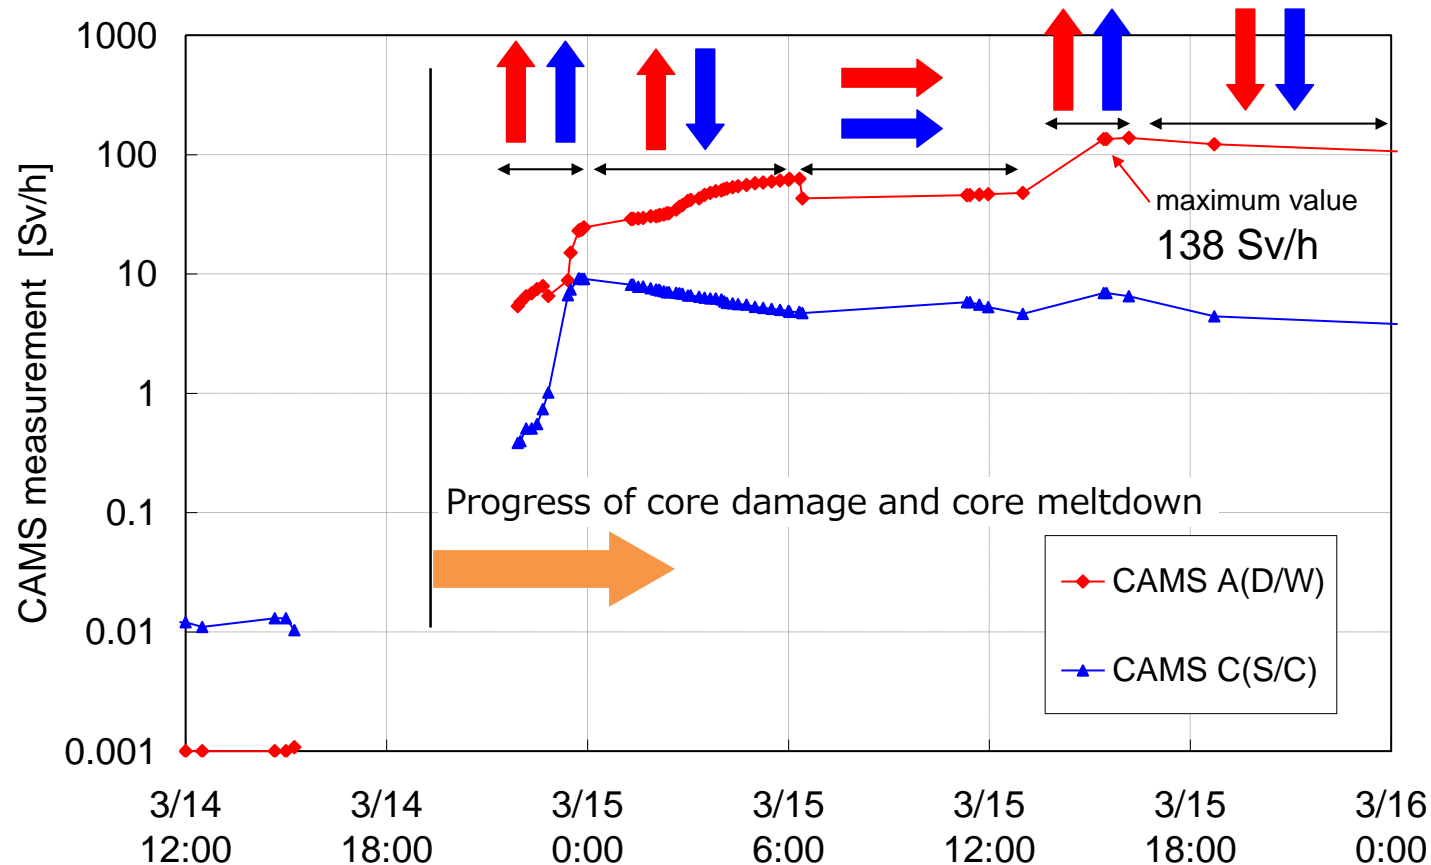
CAMS measurements for Unit 2

- After the core was damaged, CAMS measurements were resumed on the night of March 14, and they were always about one order of magnitude lower in the S/C.
- At the start of core damage, FPs moved via SRVs from S/C to D/W, and large amounts of FPs would be expected to be present in S/C, but the measured values were different.

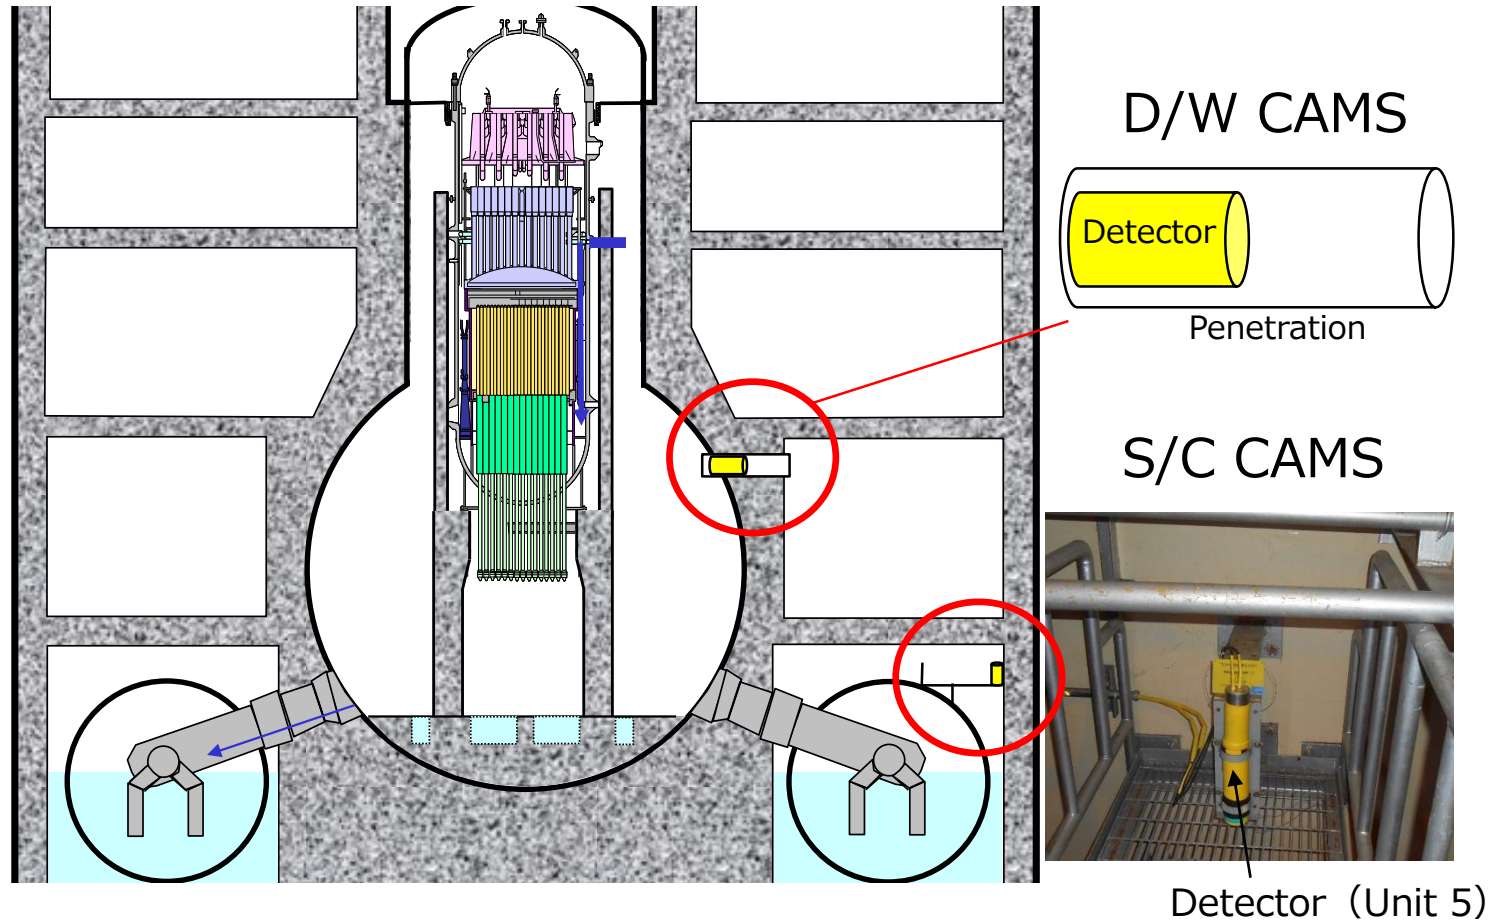
Locations of CAMS detectors

D/W CAMS: Located immediately adjacent to the D/W inside

S/C CAMS: Installed on the wall of the torus room a little away from the S/C

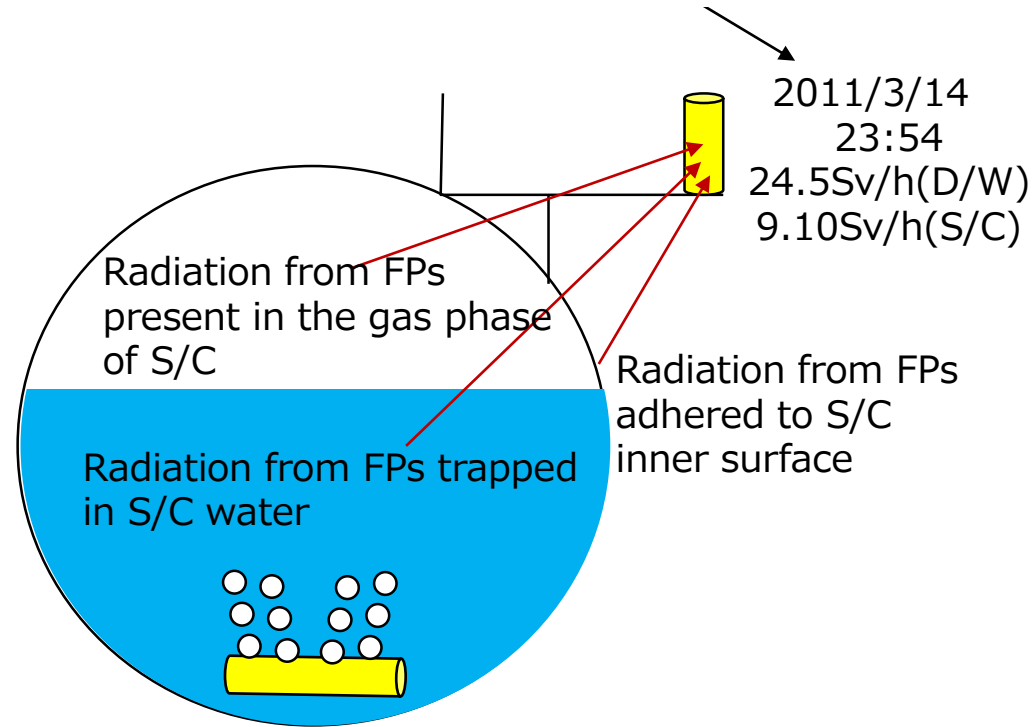
The measured value of 9.1Sv/h on March 14 at 23:54 was the sum of radiation from 3 sources

The evaluation map conservatively assumed that only the contribution of noble gases be taken into account, which was **equivalent to 460Sv/h after 81.8h and 240Sv/h after 197.4h in the case of 100% total emission**, while the contribution of noble gases was estimated to be **about 1.2 Sv/h at most** out of the **measured value** of 9.1Sv/h.

→In other words, the S/C CAMS measurements and the evaluation map were inconsistent due to the influence of the S/C CAMS location.

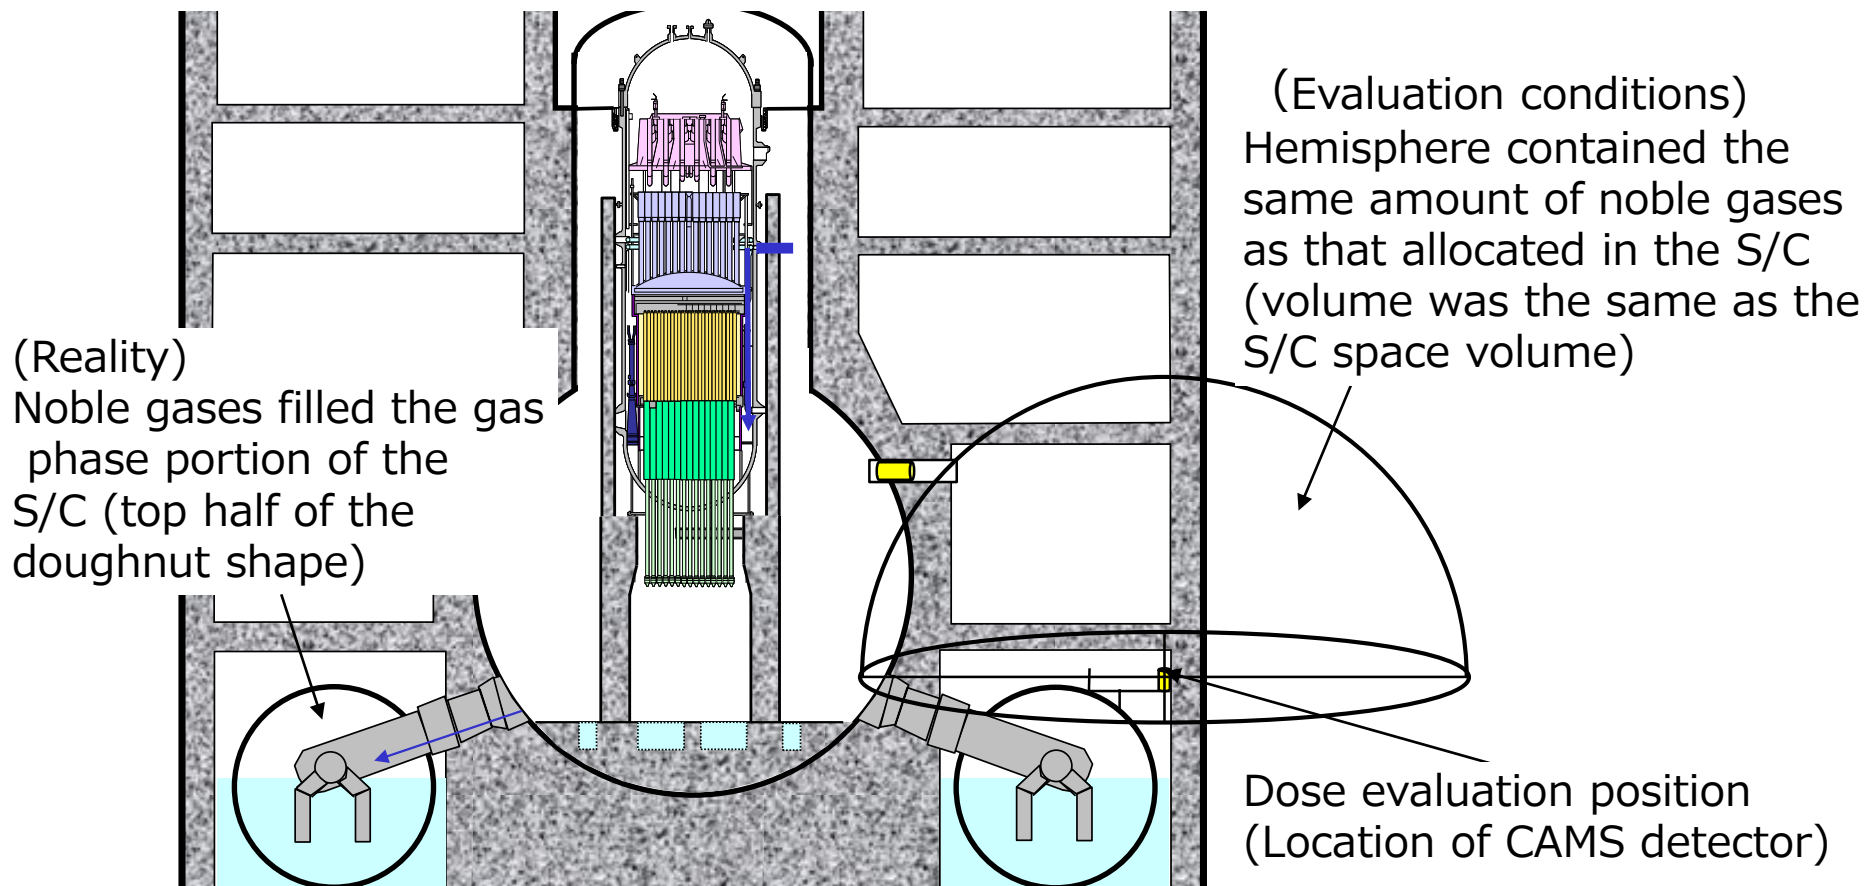
Dose rate calculation method used in the methodology for evaluating core damage ratio

The method used to obtain the core damage ratio was based on a simplified dosimetry calculation method that assumed a hemispherical plume. An inconsistency was caused by the distance between S/C wall (shielding) and CAMS location (distance from the source) not being considered. (However, at the time of the Fukushima Daiichi NPS accident, core meltdowns were also evaluated using D/W CAMS values, so the effect of underestimation was small.)

Lesson learned: When estimating core conditions from CAMS dose rates, attenuation due to shielding and distance between the source and the CAMS detector must be properly considered.

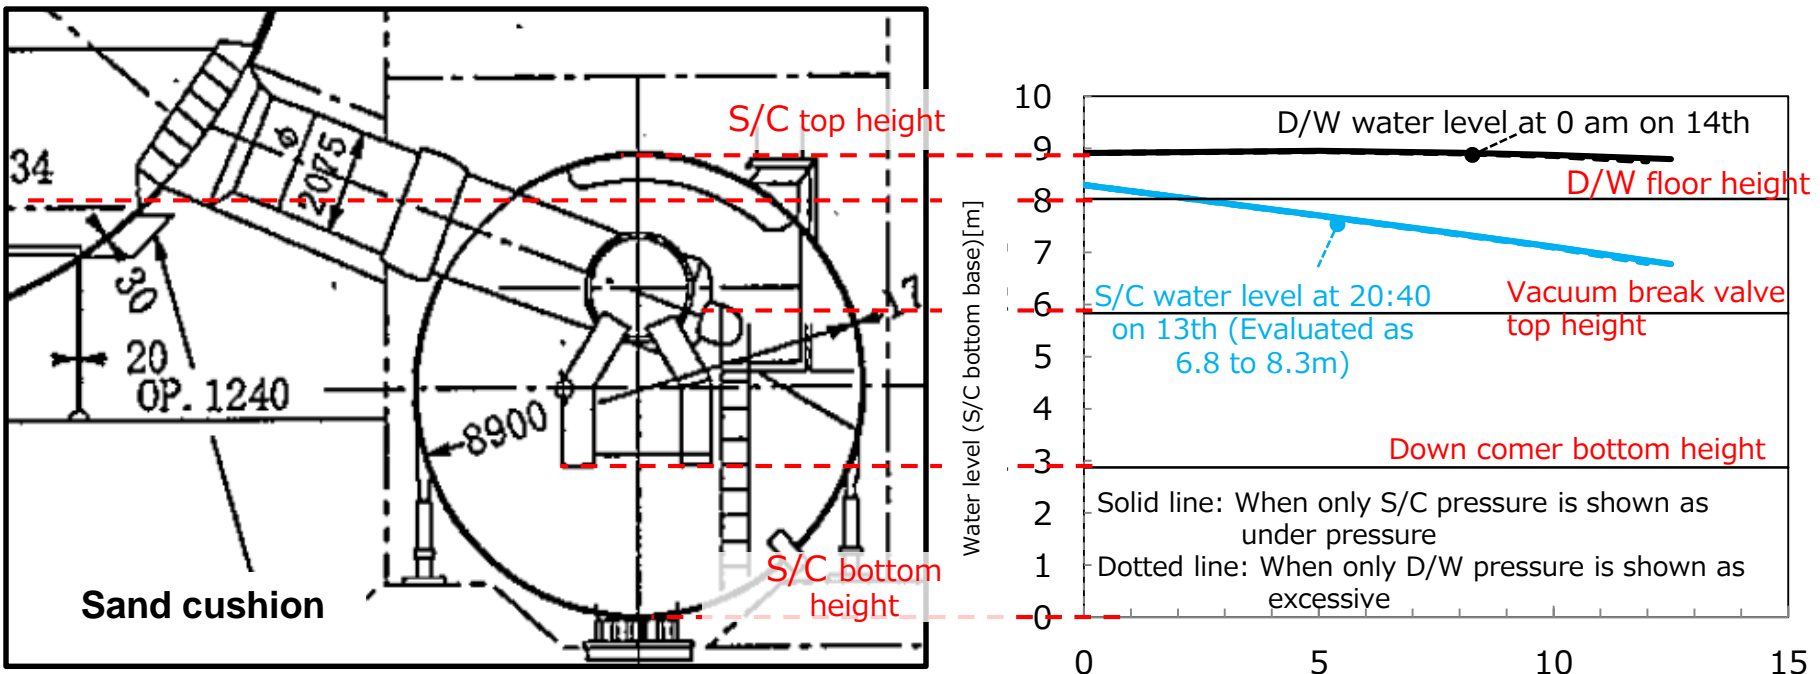
Fig. Results of S/C water level evaluation at 20:40 on March 13

- Based on the D/W-S/C pressure difference of +50kPa before depressurization, the S/C water level at 20:40 on the 13th was estimated to be 6.8 to 8.3m from the bottom of the S/C (depending on the D/W-S/C pressure difference, below figure).
- Estimated maximum rise of S/C water level during approximately 12h from the start of the first venting to 20:40 on the 13th was 0.9m. (Estimated value of water pushed out of the vent pipe during venting + steam inflow from the reactor)

⇒ Based on the evaluation result of the S/C water level at 20:40 on the 13th (6.8-8.3m), it was estimated that the S/C water level was at least 5.9m from the bottom of the S/C when the first venting started.

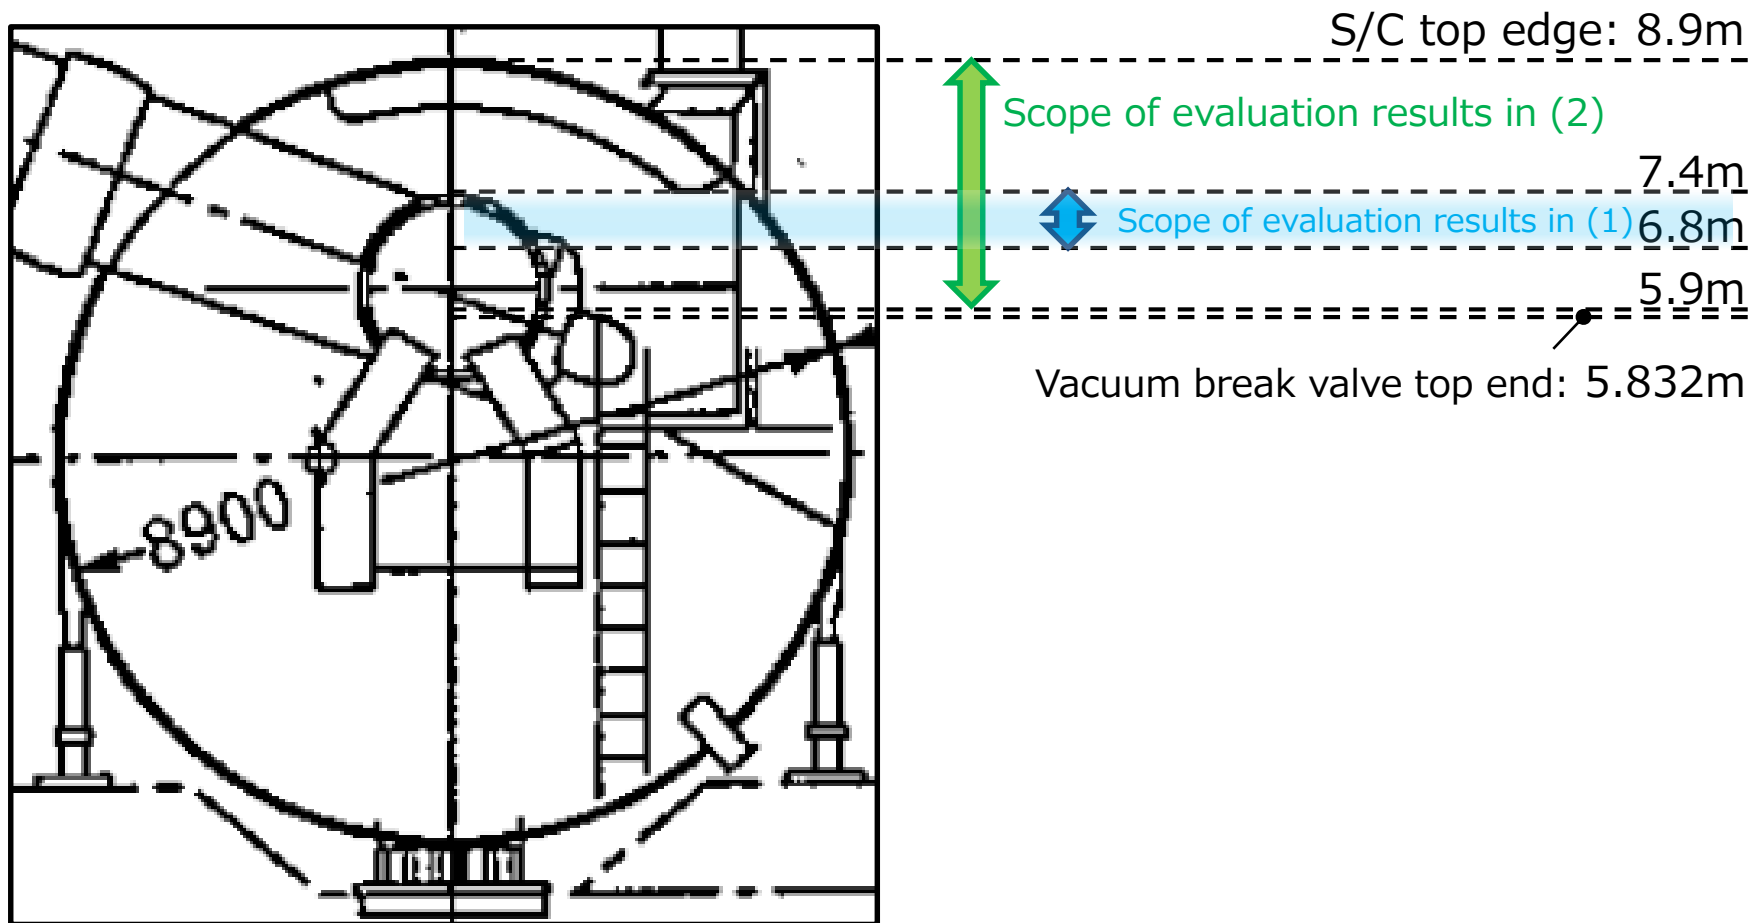
Although there were uncertainties in the time of S/C spray and D/W spray and the amount of water injected, based on the evaluation using the S/C water level in (1) and the containment pressure in (2), the range of the S/C water level at the start of the first venting was estimated to be around 7m from the bottom of the S/C, which was higher than the vacuum break valve position.

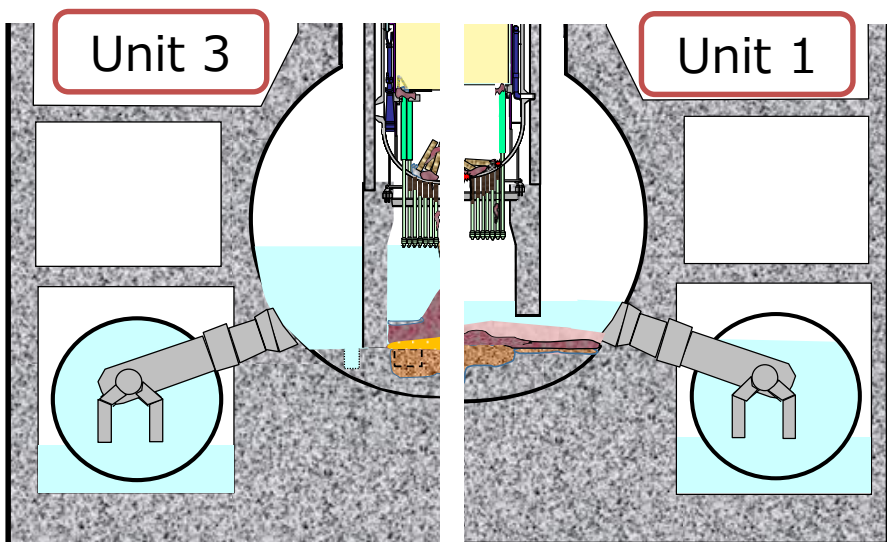
Fig. Current D/W water level (image)

- In Unit 3, the presence of water flowing back from the S/C in the pedestal might have inhibited spreading and MCCI during fuel debris fallout, and it might not have resulted in damage to the shell below the D/W.
- Leakage from the sand cushion drainpipe in Unit 1 suggested that the shell below the D/W was damaged.

⇒ The high S/C water level estimated in this study was consistent with the observed fact that the current water level in the D/W of Unit 3 was higher than that of Unit 1, and that it could be treated as a possible accident progression scenario.

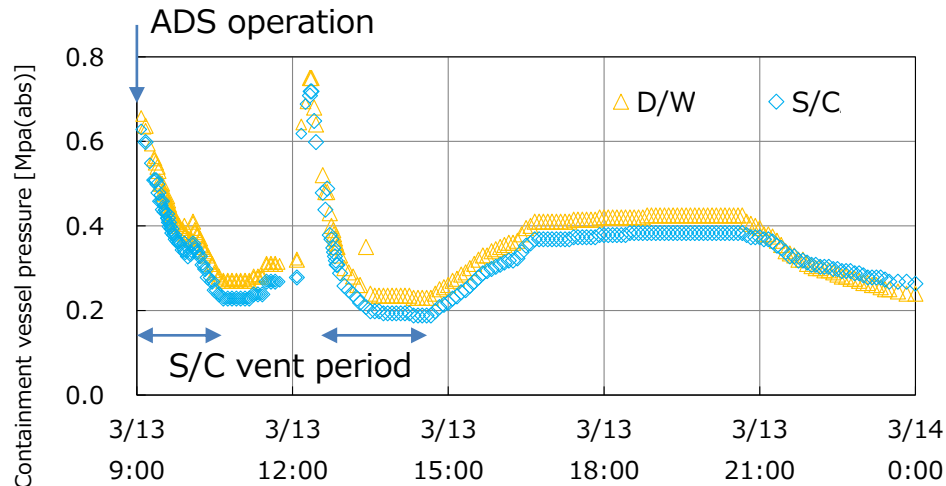
Fig. Containment pressure after ADS activation in Unit 3

- It is important to understand the containment pressure data in order to estimate the accident progression (containment vessel venting, gas phase leakage from the pressure vessel and containment vessel, hydrogen explosion, etc.) and the cooling status of the fuel debris after the reactor depressurization of Unit 3 at around 9:00 on March 13.
- Based on the estimation of the S/C water level at the time of containment venting of Unit 3 after 9:00 on March 13 and previous studies, we further examined accident progression scenarios for Unit 3 from 9:00 on March 13 to 0:00 on March 14.

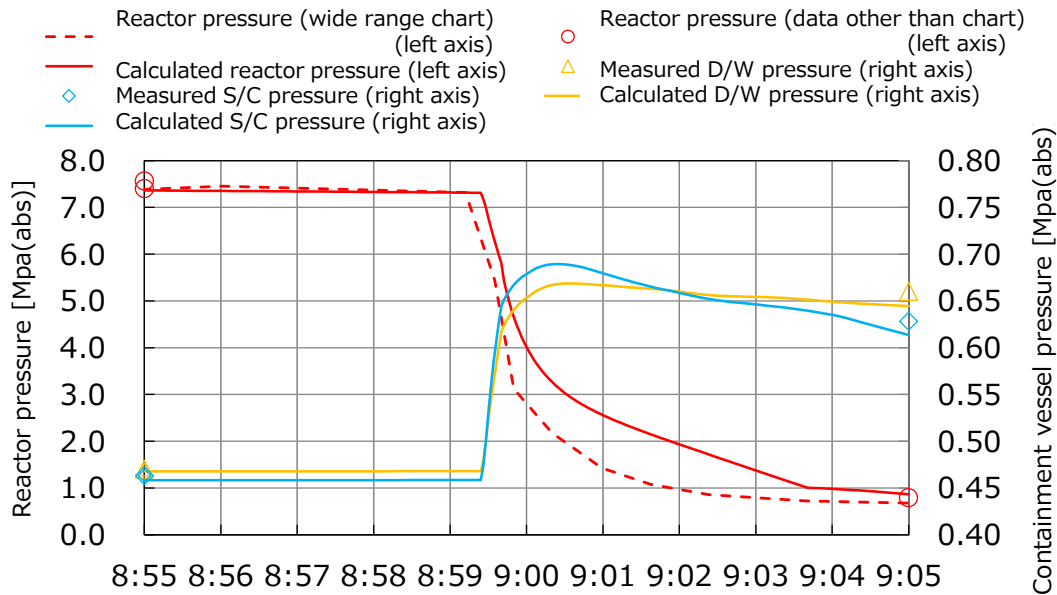
Fig. Evaluation results (gas-phase leakage area of pressure vessel: 30 cm²)

- The minimum leakage area that could roughly reproduce the relationship between D/W and S/C pressures at 9:05 and the RPV pressure was found to be 30cm² (upper figure: there was a difference between measured and evaluated RPV pressure decompression rates, but if leakage area were further reduced, discrepancy from the measured RPV pressure value would further increase).
- ⇒ It was estimated that gas phase leakage from the RPV to the D/W occurred at about the same time as the ADS operation. A possible cause was the high temperatures in the RPV.

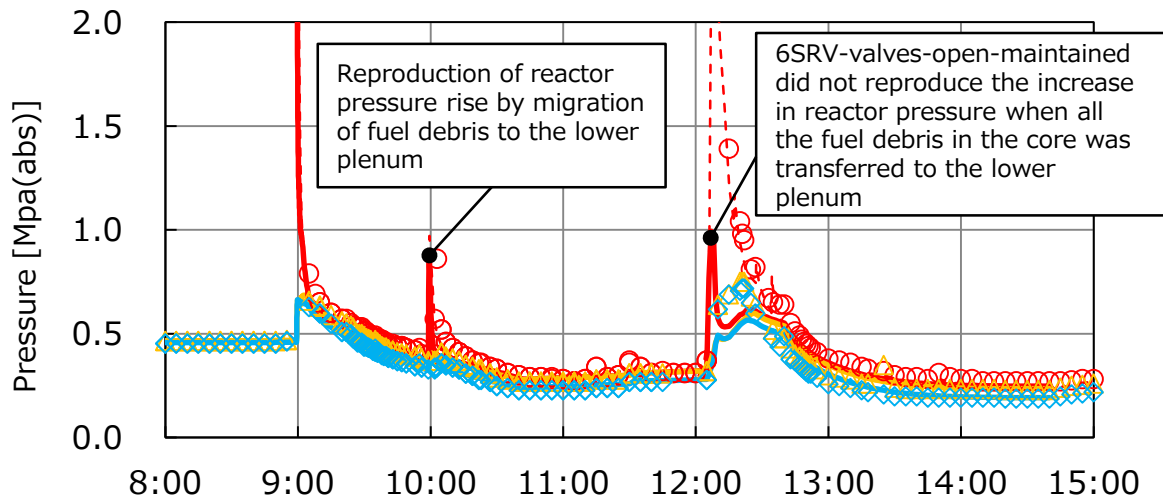
Fig. Evaluation results (6 SRV valves opening maintained case)

- In the 6-valves-open-maintained case, the increase in reactor pressure around 12:00 could not be reproduced even when all the fuel debris was transferred from the core to the lower plenum (above figure). But it was confirmed the pressure behavior could be generally reproduced, in the fully closed SRV case.
- It was highly probable that the 6 SRVs could no longer be kept open from just after the ADS activation to around 12:00. The cause of the inability to keep the SRV open could be lack of a power supply or deterioration of the SRV operating environment due to high temperatures in the PCV.
