The 6th Progress Report
on the Investigation and Examination of
Unconfirmed and Unsolved Issues
on the Development Mechanism
of the Fukushima Daiichi Nuclear Accident

November 10, 2022

Tokyo Electric Power Company Holdings, Inc.

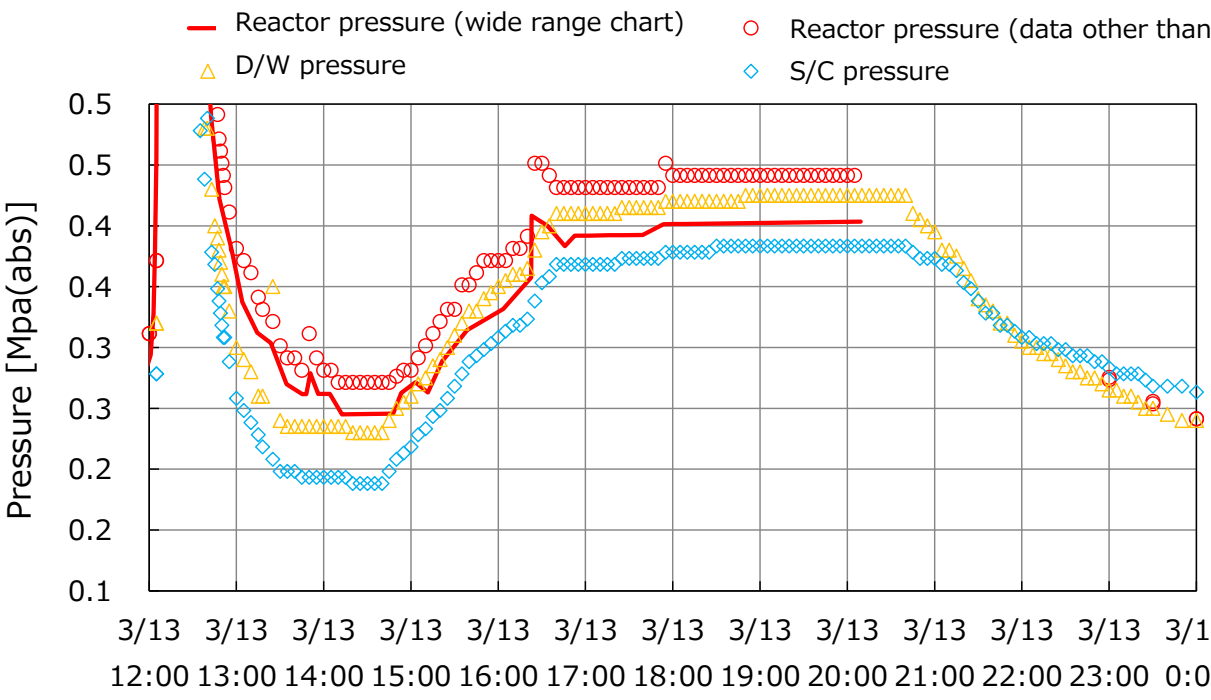
Containment pressure after venting
 about 14:40 & beyond: increased
 about 16:40 & beyond: almost constant
 about 20:40 & beyond: decreasing

- ⇒
- Factors of pressure change
- ✓ Gas phase leakage from D/W
 - ✓ Decrease in gas generation
 (Decrease in vapor generation due to depletion of water in RPV)

- Corrected RPV pressure was higher than D/W pressure during constant PCV pressure; possible gas generation in the RPV, such as evaporation of lower plenum water.
- Presumed gas phase leakage from RPV after ADS operation.
- ⇒ The PCV pressure did not increase under the condition of leakage from the RPV, so it was highly possible that there was gas phase leakage from the D/W after 16:40.

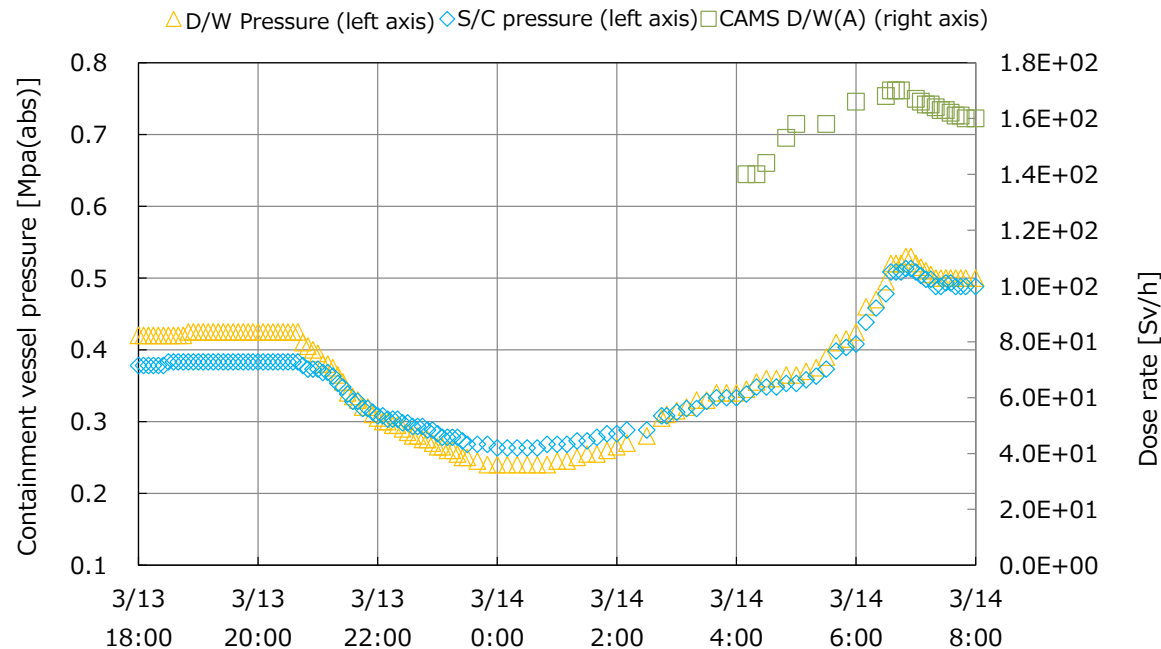
- Two possible reasons for the decrease in PCV pressure were "expansion of gas phase leakage" and "decrease in gas generation".
 - After around 0:00 on the 14th, the PCV pressure increased, and D/W CAMS(A) recorded a peak value (170Sv/h) at around 6:30 on the 14th; and other actual measurements were obtained that were suggestive of damage to the RPV lower head.
- ⇒ Qualitative estimation of D/W depressurization factors from around 20:40 on the 13th based on plant data behavior.

- PCV pressure began to increase after midnight on the 14th, and there was little possibility of expansion of the D/W gas phase leak.
 - The lower head of the RPV might have been in an undamaged state shortly before around 20:40 on the 13th. In addition, there was a high possibility that the fire trucks were not injecting all the water into the reactor at that time, and the water level in the RPV might have dropped.
- ⇒ The D/W depressurization from around 20:40 was thought to have been caused by gas phase leakage from the D/W and depletion of the lower plenum water which contributed to a decreased amount of water vapor generation in the RPV.

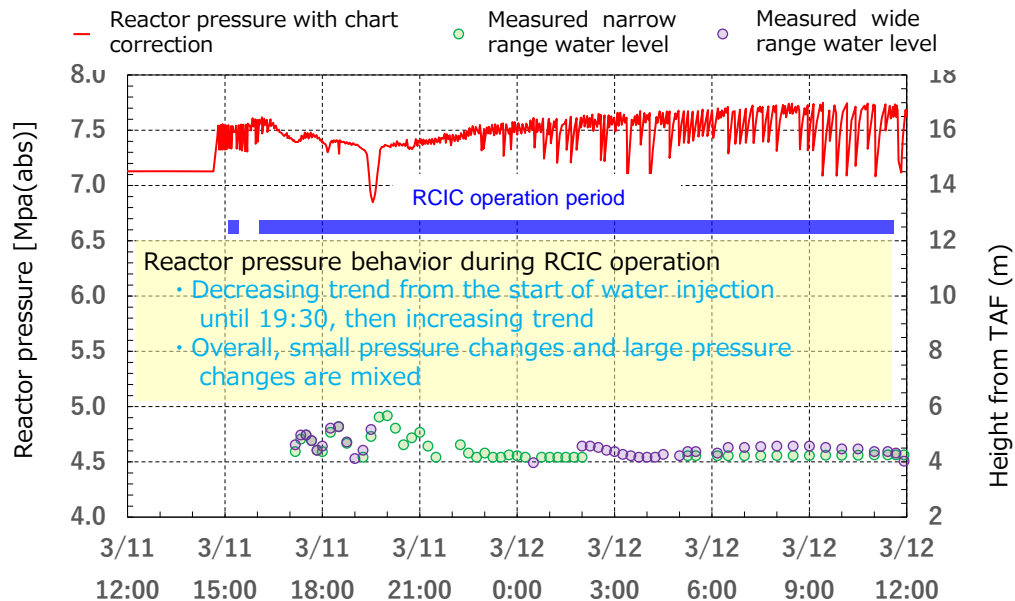
Fig. Reactor pressure and reactor water level during RCIC operation

- In the RCIC operation of Unit 3 after the arrival of the tsunami, the water source return line to the CST was utilized and the amount of water injected into the reactor was further adjusted to prevent it from tripping at the high reactor water level.
- The behavior of the reactor pressure during this period was recognized to be due to the complex situation in which the SRVs were opened and closed while RCIC was being operated in a special way.
- A study was conducted to confirm the validity of this qualitative explanation.

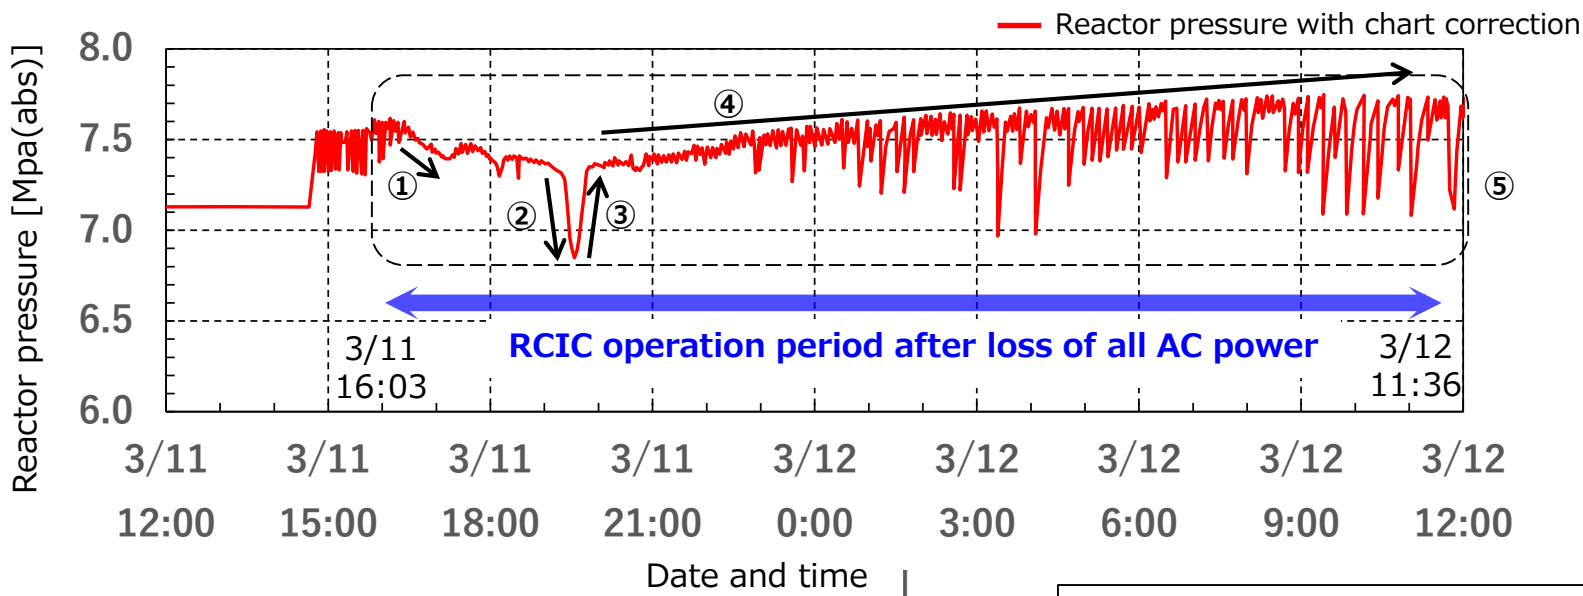
Reactor pressure behavior during RCIC operation after loss of all AC power

- ① Pressure slowly decreased from the start of water injection (3/11 16:16).
- ② The pressure drop accelerated from 19:20, and dropped to about 6.85 MPa[abs] (around 19:30).
- ③ The pressure began to rise from 19:30, reaching approximately 7.35 MPa[abs] (around 19:50).
- ④ After that, a gradual upward trend continued until RCIC stopped.
- ⑤ During this period, two behaviors were observed in the pressure change: a large pressure drop and rise, and a small pressure drop and rise.

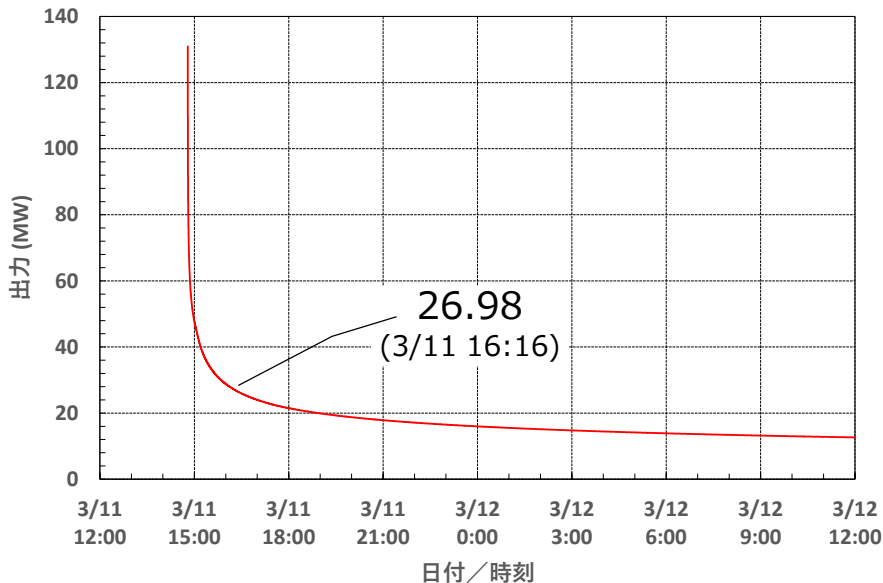
Fig. Time change of decay heat (Unit 3)

Decay heat at RCIC water injection start (16:16 on 11th) was ~ 27MW and less than the heat removal by normal RCIC operation of ~ 70MW

⇒ RCIC was operated during this period while the decay heat was reduced.

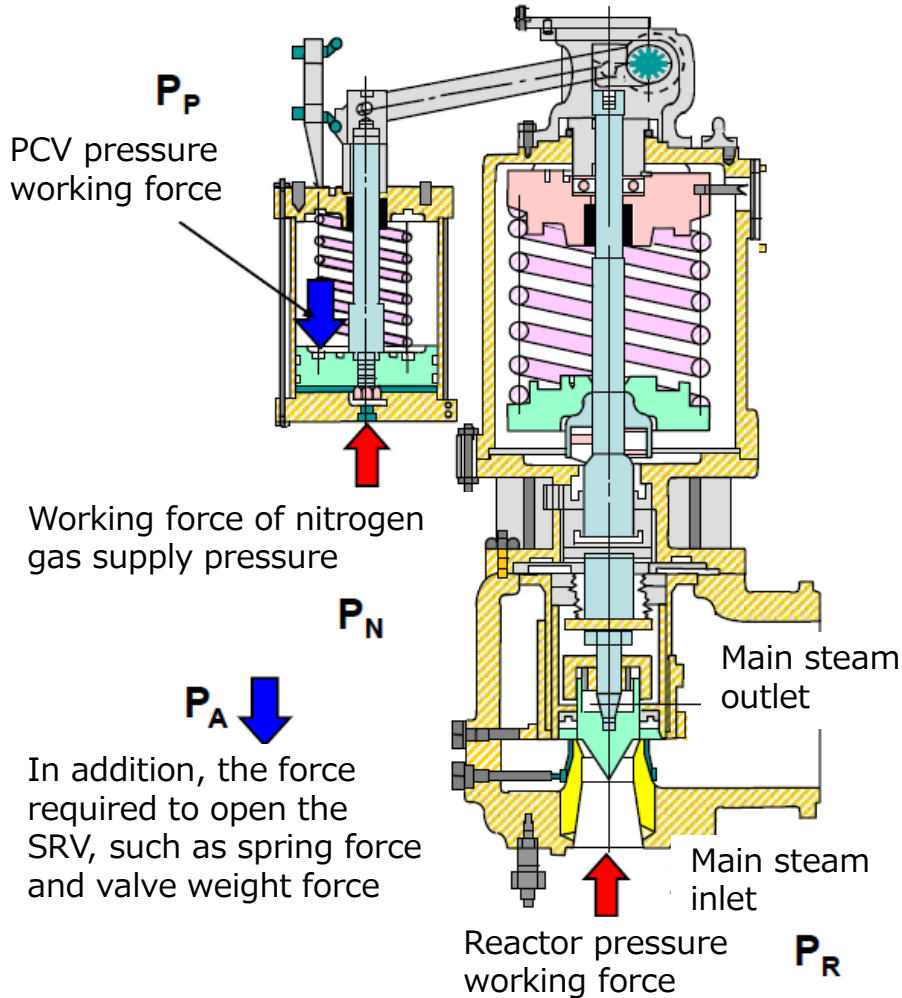
Fig. SRV cross-sectional view

→ Possibility of opening at a lower pressure than the set value due to a decrease in Young's modulus caused by an increase in spring temperature.

Since this was the time when the amount of steam generation had decreased due to the decrease in decay heat, it was possible that the pressure would drop, and the valve would close immediately even if it opened in any of the modes.

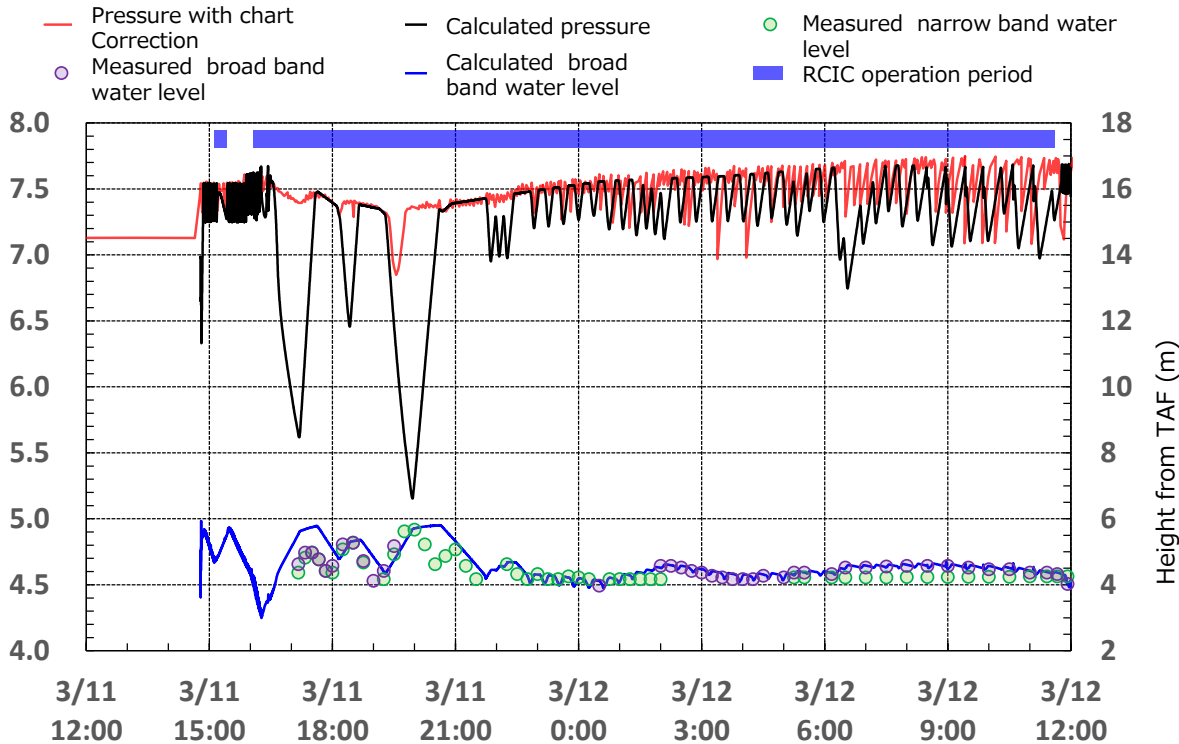
Fig. Reactor pressure and water level

⇒ Although there is a difference* between the analysis results and the measured values, the behavior of the reactor pressure was approximately reproduced.

- The large pressure drop represented at around 19:30 on the 11th was reproduced (analysis was the effect of RCIC water injection)
- For the period from around 21:00 on the 11th, the behavior of the reactor pressure shown in the chart was reproduced by opening and closing the SRV (limited opening) and water injection from the RCIC.

※ Main factor for difference

- In the analysis, water injected by RCIC tended to cause an excessive pressure drop due to its instantaneous mixing with water in the reactor.

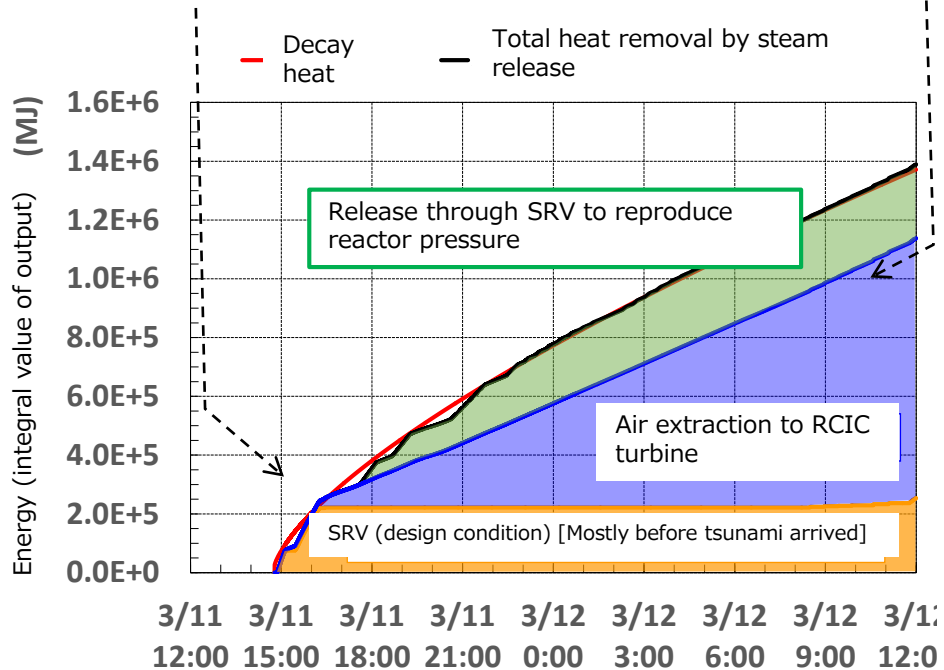
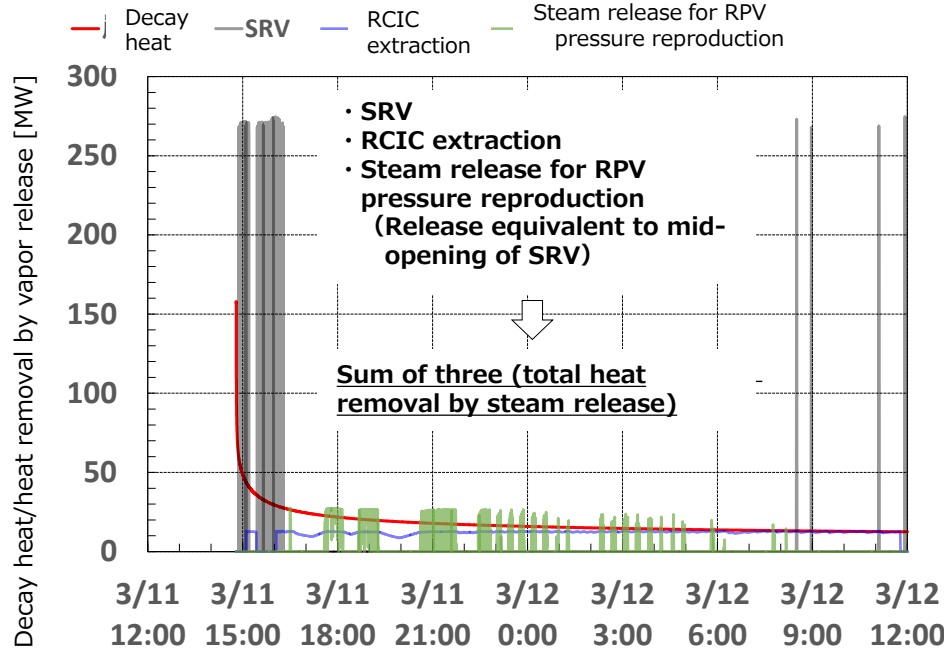
Fig. Relationship between decay heat and integral of heat removal by vapor release

➤ The results showed that in addition to the steam supplied to the RCIC turbine, excess steam released via the SRV (left figure, green area) was required to remove decay heat during the RCIC operation period.
⇒It was highly likely that steam was released via SRVs.

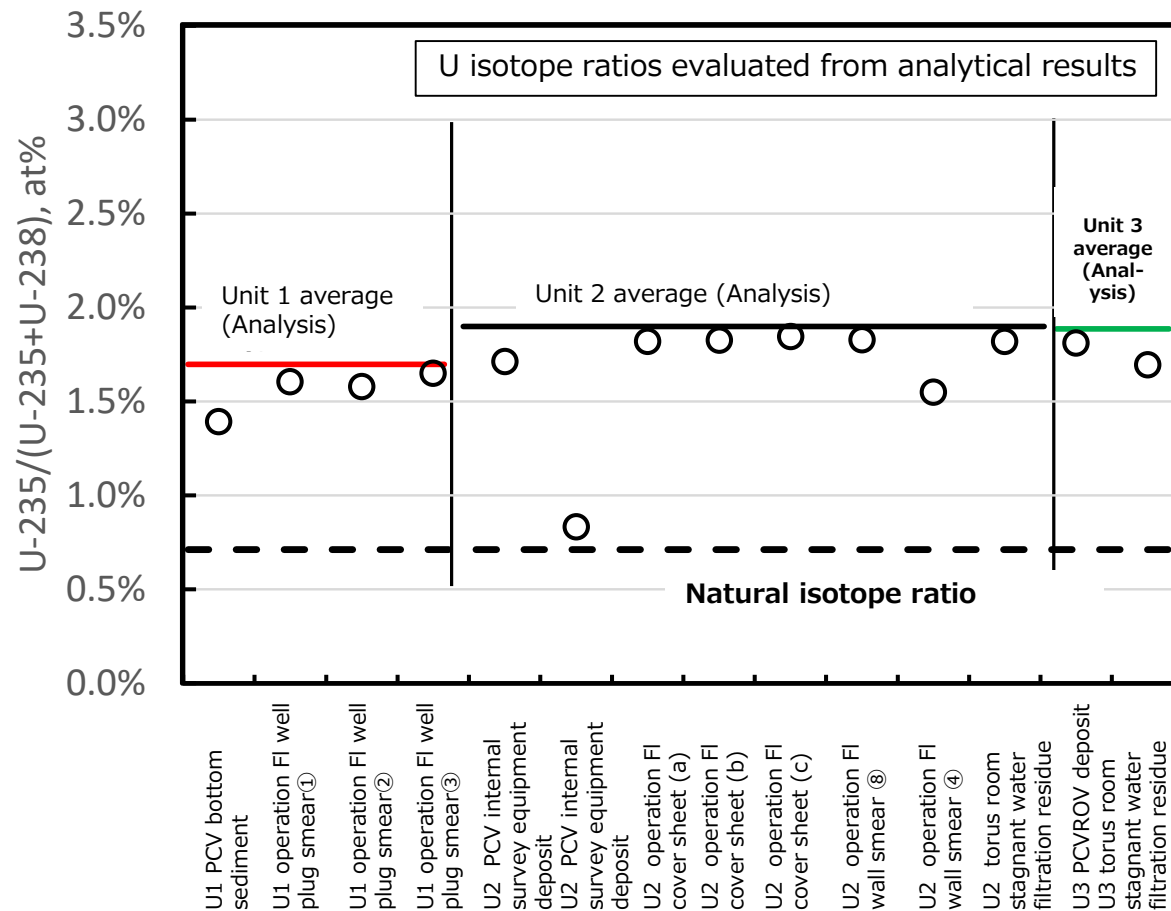
Many were found to be close to the core average calculated by the analysis code.

⇒ It is considered that the U isotope ratios close to the core average calculated values are due to diffusion and melt mixing under high temperatures at the time of the accident. The reason for this is that the distribution range of U isotope ratios of the products is narrowed due to diffusion and melt mixing of materials under high temperatures during accidents.

(Some samples were found to have nearly natural isotope ratios.)

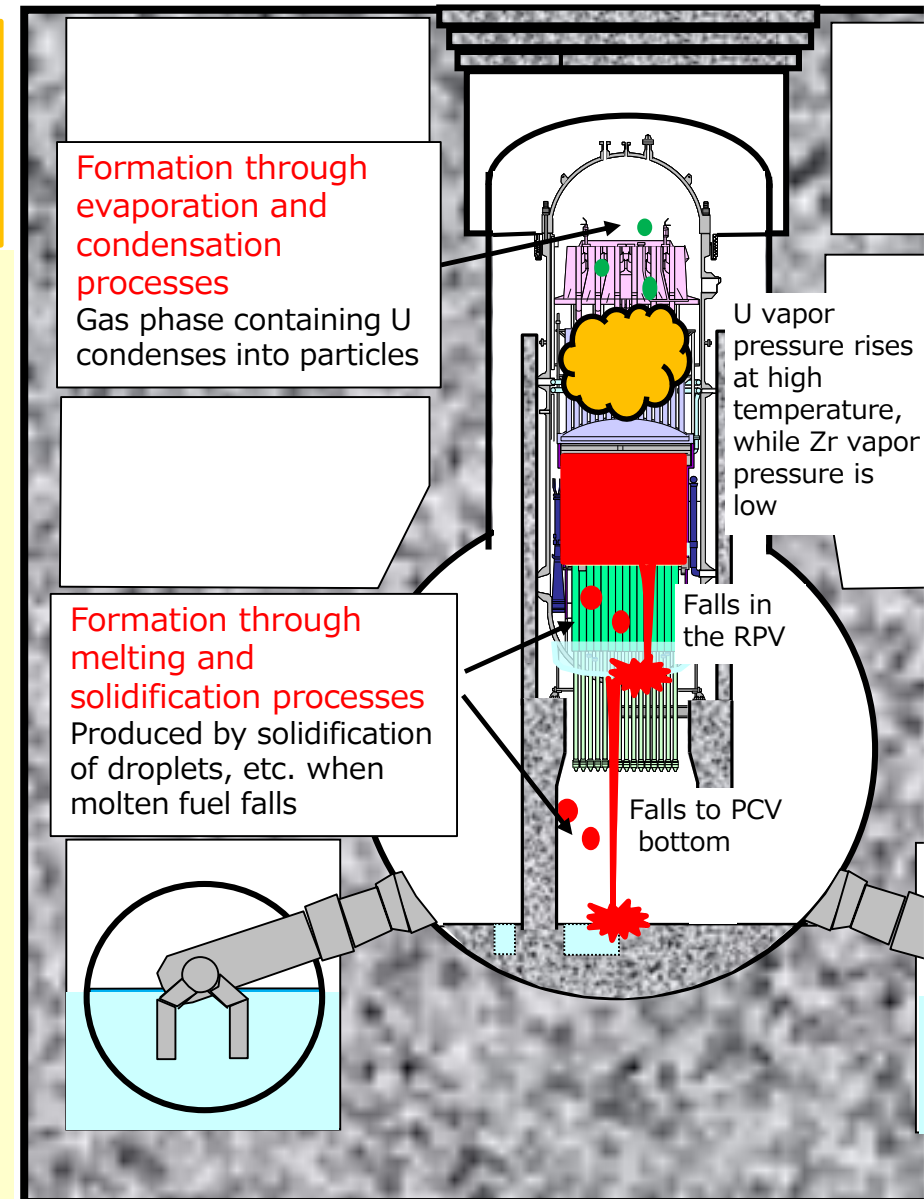
(1)-1 U-containing particles with α -Zr(O) phase (melting/solidification process)

- One of the particles detected in the sediment at the Unit 1 PCV bottom was approximately 2 μ m in diameter (lower left figure).
- It contained Zr, and it was presumed to have been formed through the melting and solidification processes.
- A high-Zr region (analysis point ② in the lower right figure) was observed in the (U,Zr)O₂ matrix (analysis points ①, ③, ④, ⑤).
- Analysis point ② was thought to be α -Zr(O) phase separated from (U,Zr)O_{2-x} during the cooling process (right figure).
- Lack of Zr oxidation suggested a reducing atmosphere (relatively hydrogen-rich situation) might have existed in the time before these particles solidified.

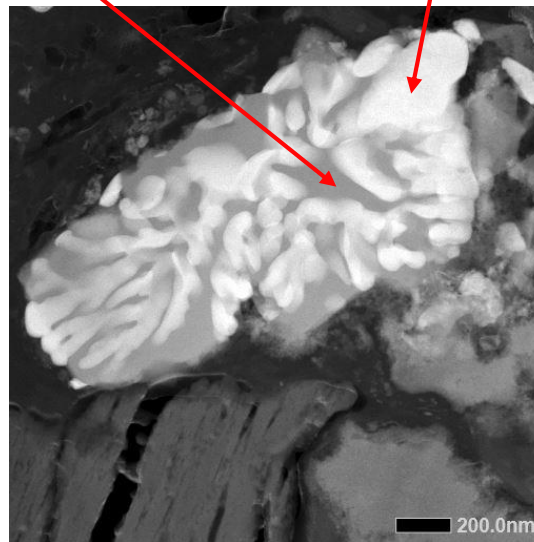
TEM image
(Unit 2 operating floor cover sheet)

- On the Unit 2 operating floor, particles consisting of fused together steel constituents (Fe,Cr) and fuel rod constituents (U,Zr) were found; the presence of Zr suggested that they were formed through the melting and solidification processes.
- The particles consisted of a mixed phase of cubic $(U,Zr,Fe,Cr)O_2$ and $FeCr_2O_4$, and were considered as particles that had phase-separated during the cooling process of the U-Zr-Fe-Cr-O system melt.
- This was consistent with existing findings that the fuel reacted with steel to form debris.
- Since the precipitate size depends on the cooling rate, it may be useful for estimating the cooling rate.

$FeCr_2O_4$ Cubic $(U,Zr,Fe,Cr)O_2$

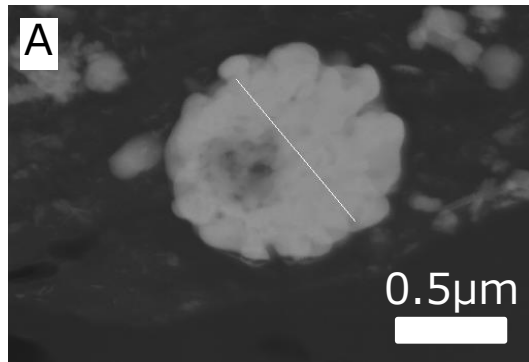
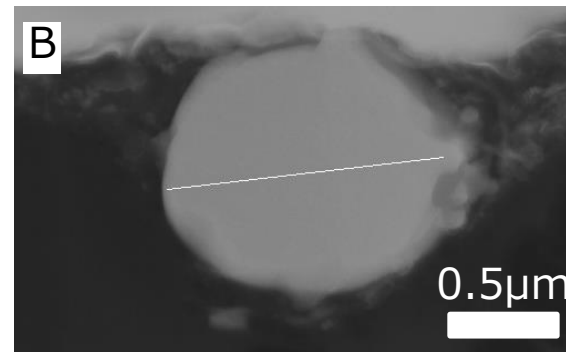
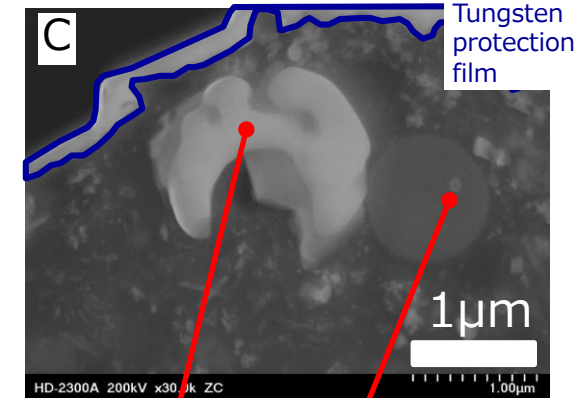
- U-containing particles containing almost no Zr were detected in a sample taken at the Unit 2 operating floor. It was considered that they were formed by evaporation and condensation.
- It was considered that a part of the U component in the fuel evaporated and immediately became UO_2 and produced particles.
- Particle A looked like a secondary particle of agglomerated particles with a diameter of $\sim 100\text{nm}$; particle B had a dense spherical shape formed by crystal growth of agglomerated particles like A was.
- Particle C (cubic UO_2) was a particle considered to be in an intermediate state between A and B in terms of crystal growth, and its shape suggested that it might have been deposited on the surface of nearby spherical amorphous- SiO_2 (on the right in the TEM image), which was later separated.

Cubic UO_2

Amorphous- SiO_2

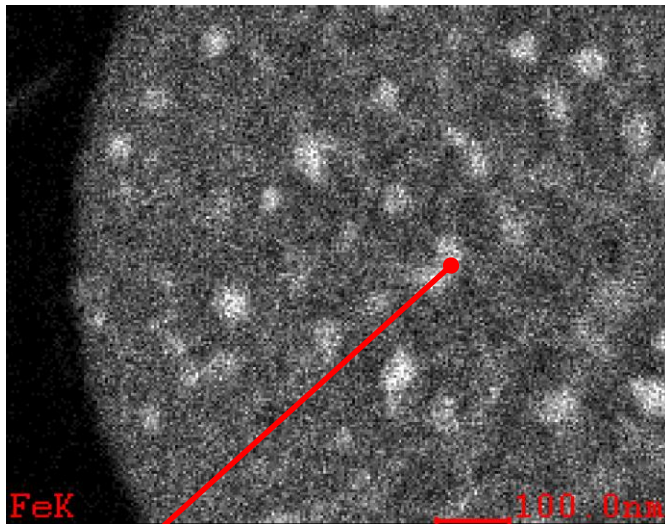
Pure Fe fine particle Fe distribution

- During the analysis of U-containing particles, one iron-based particle containing a small amount of U was found on the cover sheet of the Unit 2 operating floor.
- From the results of TEM-EDS and electron diffraction, pure Fe and Fe₃O₄ were found to be present together.
- Since the particle was spherical, it possibly formed from FeO in the liquid phase and separated into Fe and Fe₃O₄ during the cooling process.

Crystal structure analysis revealed body-centered cubic (pure Fe) and spinel (Fe₃O₄)

Coexistence of Fe and Fe₃O₄

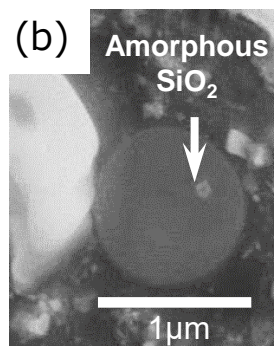
Amorphous SiO_2 particles found on Unit 2 operating floor

- They were presumed to have originated from Unit 2 based on the meteorological conditions at the time and the origin of the constituent elements.
- Based on the accident progression of Unit 2 (below right figure), it was considered that Si and Cs reacted in the RPV and formed particles, which migrated to the PCV when the PCV pressure was rising (marked by black arrows), and they were released into the environment through a rapid cooling process.

- Under high-temperature conditions by which Mo was released from the fuel, the formed SiO_2 particles would not contain Cs because of the high affinity between Cs and Mo.

- The fuel temperature at the time the particles migrated to the PCV might have been above the SiO_2 liquefaction temperature, above the Cs release temperature from the fuel, and below the Mo release temperature (depending on the atmosphere), i.e., in the 1500 to 2300 $^\circ\text{C}$ temperature range under a high hydrogen content atmosphere.
