Evaluation of the situation of
cores and containment vessels of
Fukushima Daiichi Nuclear Power Station
Units-1 to -3 and examination into unsolved
issues in the accident progression

Progress Report No. 6

November 10, 2022

Tokyo Electric Power Company Holdings, Inc.

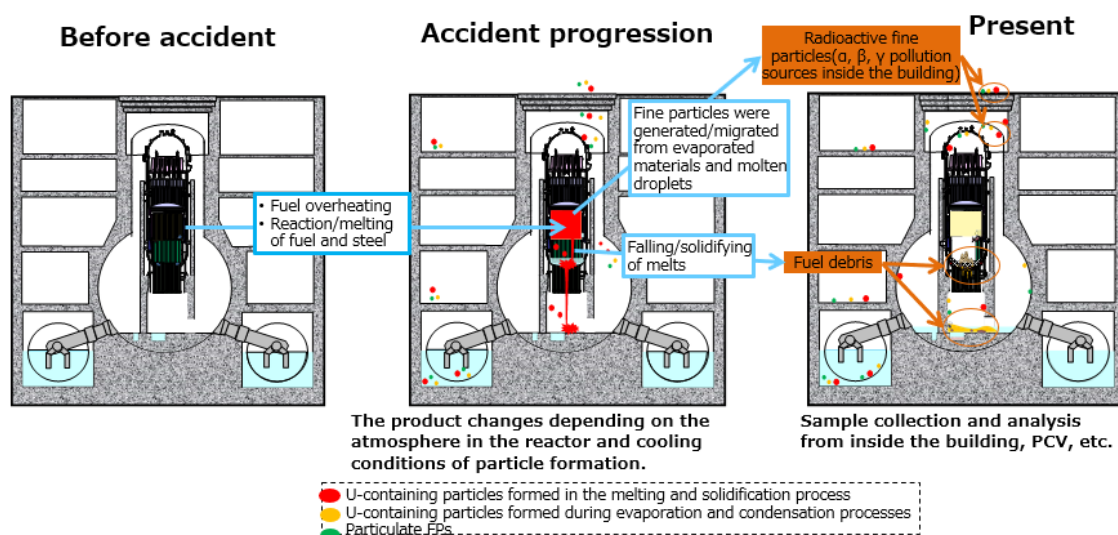
Figure 6.1 Relationship between the properties of radioactive particles and fuel debris and accident progression

Figure 6.1 shows formation and migration mechanisms of radioactive particles and fuel debris as the accident progresses. It is important to obtain information on the conditions at the time of the accident and the current properties of the fuel debris from the analysis of radioactive particulates spread inside and outside the reactor buildings.
