List of issues to be investigated

Reference [1] "Safety measures at the Kashiwazaki-Kariwa Nuclear Power Station of Tokyo Electric Power Company (First version, March 2013)"

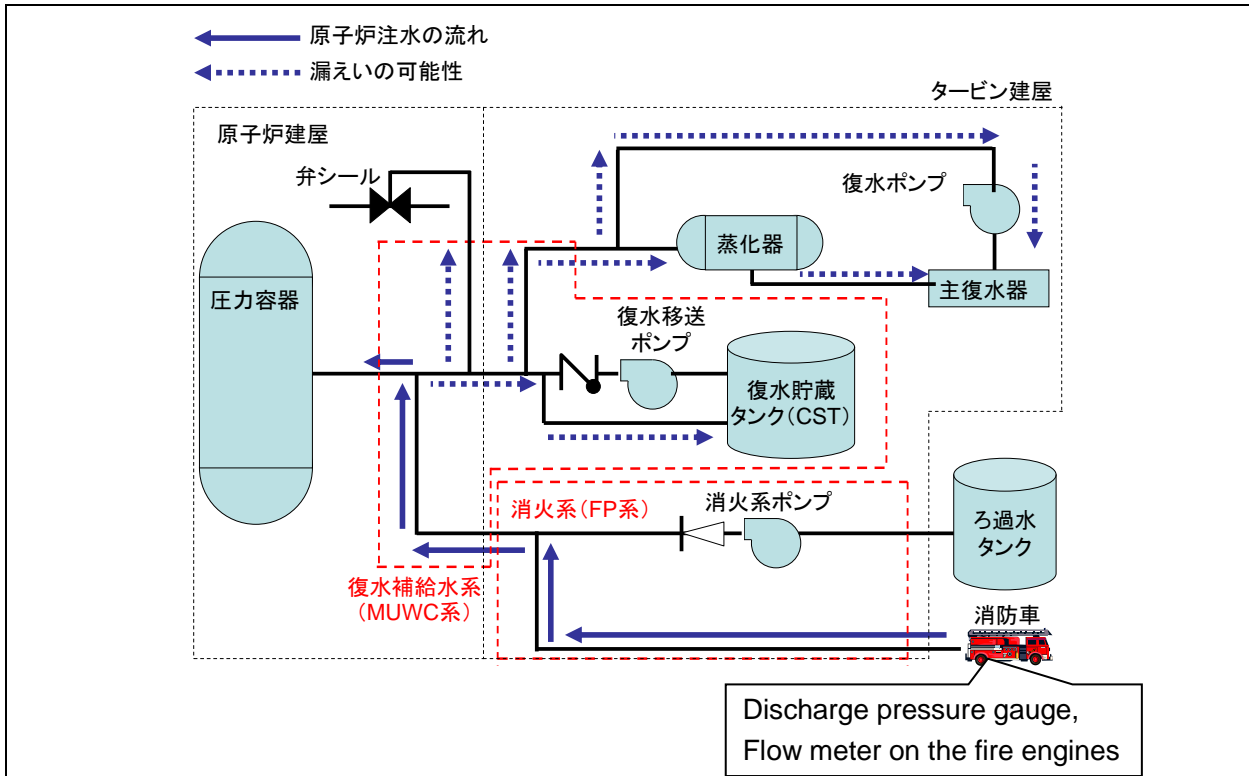
Figure Schematics of alternative water injection lines using fire engine pumps

Common/Issue-2	Common	Category A③	Class (1)	Safety measures in [1]: p36
Amounts of water injected to the reactor by fire engines			Results: Attachment 1-4, 1-5, 2-14	
<p>Ultimately, Unit-1 to Unit-3 lost all their water injection functions which had been expected to work in an accident, and fire engines were alternatively used for the emergency water injection.</p> <p>The information relevant to the amount of water injected was compiled as the estimated amount (daily average of the amount injected) based on the discharge pressure of fire engines and flow rate indicator readings at the time of the accident. But their accuracies are not satisfactory, and part of the water injected is considered to have flowed to other systems and equipment, bypassing the water injection line to each reactor unit.</p> <p>At Unit-1, for instance, water injection was interrupted at 01:10 on March 14th. At 20:00 on the same day, water injection was resumed (via the reactor core spray system), but no reactor pressure increase was observed, indicating a possibility of no water, or only a small amount, being injected. At 02:33 on March 23rd, when the reactor feedwater system started to inject water, the reactor and PCV pressure increased, probably due to steam generation. This indicates a possibility of no water, or only a small amount, having been injected before.</p> <p>In the MAAP analysis, the amount of water injected to the reactor was set substantially less than the amount of water injected by fire engines, in order to simulate the observed PCV pressure changes. The amount of water injected to the reactor is of critical importance in examining the accident progression. Therefore, the actual amount of water injected to the reactor needs to be clarified because it has a big uncertainty.</p>

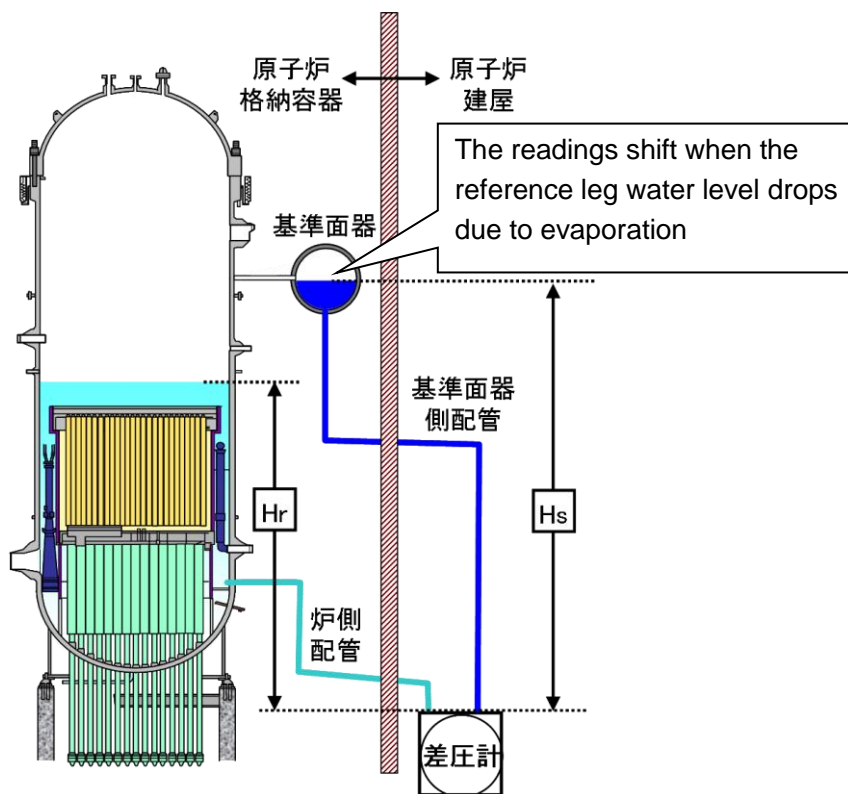
Figure Working principle of reactor water level indicators

At Unit-1, the reactor water level could not be temporarily measured after the station blackout caused by the tsunami. When the reactor water level indicators were restored by temporary battery supplies at 21:19 on March 11th, the water level indicators showed an increase despite the fact that no water was being injected into the reactor. In view of the measurement principle of water level indicators, the apparent increase of the water level is considered to be due to incorrect readings caused by water evaporation in the reference leg (piping on the reference water level side) of the water level indicators. Ultimately it is considered that Unit-2 and Unit-3 also experienced similar incorrect readings of the water level indicators.

Examination is to be done to clarify when and why the water level indicators began to give incorrect readings, because it may provide some clues to estimate the reactor situations at those times.

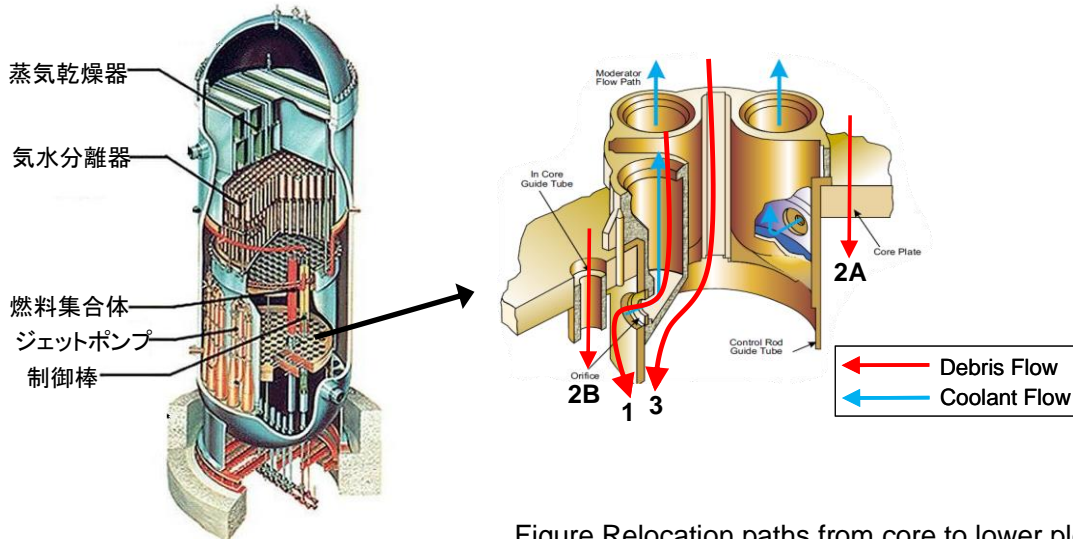
Figure Relocation paths from core to lower plenum

Common/Issue-6	Common	Category B②	Class (2)	Safety measures in [1] -
Molten core behavior on falling to the lower plenum				Results: Attachment 1-8
<p>MAAP employs basically Three Mile Island (TMI) knowledge in simulating the molten fuel relocation mechanism to the lower plenum, in which molten fuel destructs the core support plate and reaches the lower plenum. On the other hand, BWRs have complex lower structures, which could configure other molten fuel relocation paths to the lower plenum: via the coolant flow paths through a side entry orifice at the fuel support; or via the surrounding bypass region (whereto the molten fuel could migrate in the radial direction from the core) and, by damaging the shroud, further through the outer shroud region (downcomer region).</p> <p>In the MAAP analysis of Unit-1 to date, the reactor pressure showed a sharp peak at around 22:00 on March 11th. This comes from the model in the analysis that the molten fuel stayed temporarily on the core support plate for a while and, as soon as the core support plate was damaged, the molten fuel dropped instantaneously to the lower plenum, generating a large amount of hydrogen gas.</p> <p>It is necessary to clarify the molten fuel behavior during relocation to the lower plenum in order to contribute to understanding of the accident progression and estimation of the situation in the core and PCV.</p>

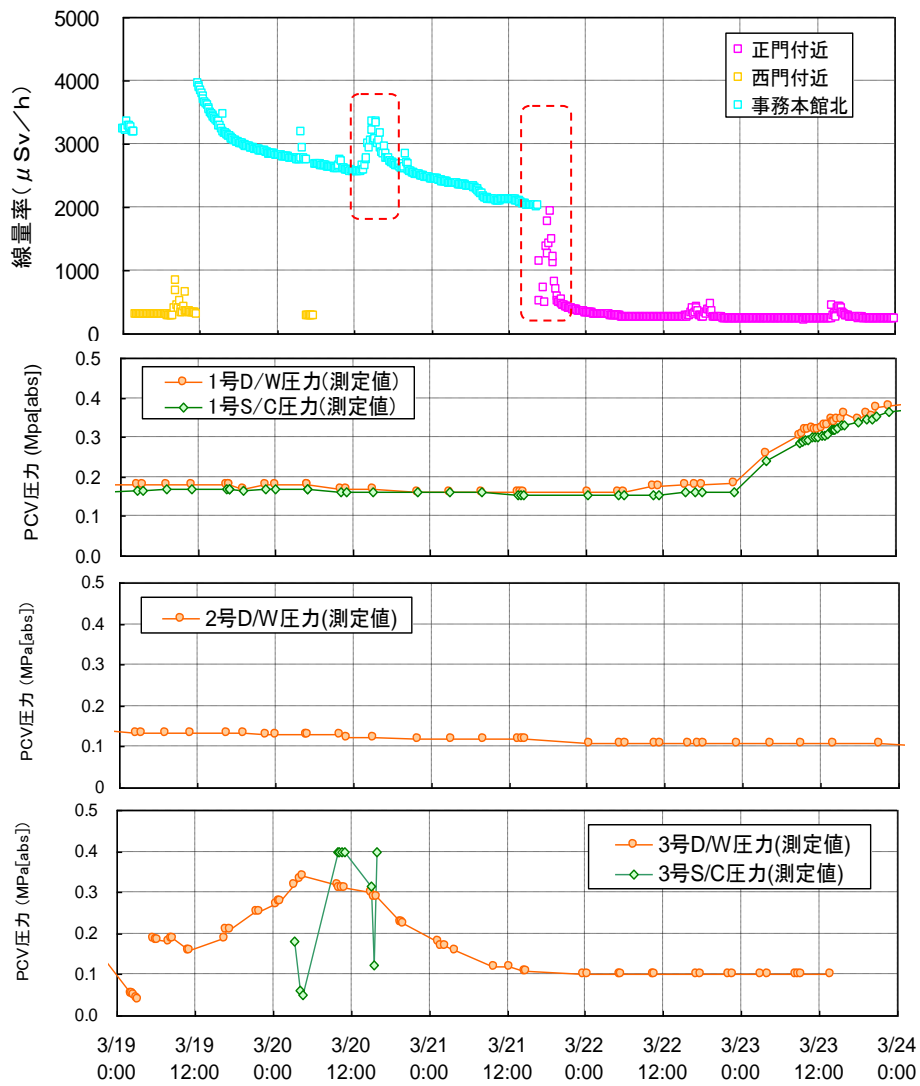
Figure Air dose rates at the Fukushima Daiichi NPS from March 19th to 23rd

Common/Issue-9	Common	Category B⑤	Class (2)	Safety measures in [1]: -
Air dose increases on around March 20 th				Results: Attachment: 3-6
<p>At Unit-1 and Unit-3, the water injection rate observed on the Accident Management (AM) panel showed a big decrease from March 20th and 21st for several days. This may indicate that the reactor cooling was not sufficient to prevent the release of radioactive materials. Further, at about 16:00 on March 21st when black smoke rose at Unit-3, a sharp increase was observed in the air dose rate near the main gate, although no significant changes were noticed in the DW pressures and the RPV pressures.</p> <p>The analysis using MAAP is terminated in about a week at the maximum after the earthquake. This is because the uncertainties of the analysis become larger with the extended time of analysis and the reliabilities of the results are significantly lowered.</p> <p>Fission products released around March 20th and 21st from the Fukushima Daiichi NPS might have caused radiation dose increases in parts of the Kanto region, depending on the wind directions, and might have led to some recommendations to refrain from tap water intake due to increased radioiodine concentration levels. Details of radioactive materials release behavior need to be clarified.</p>

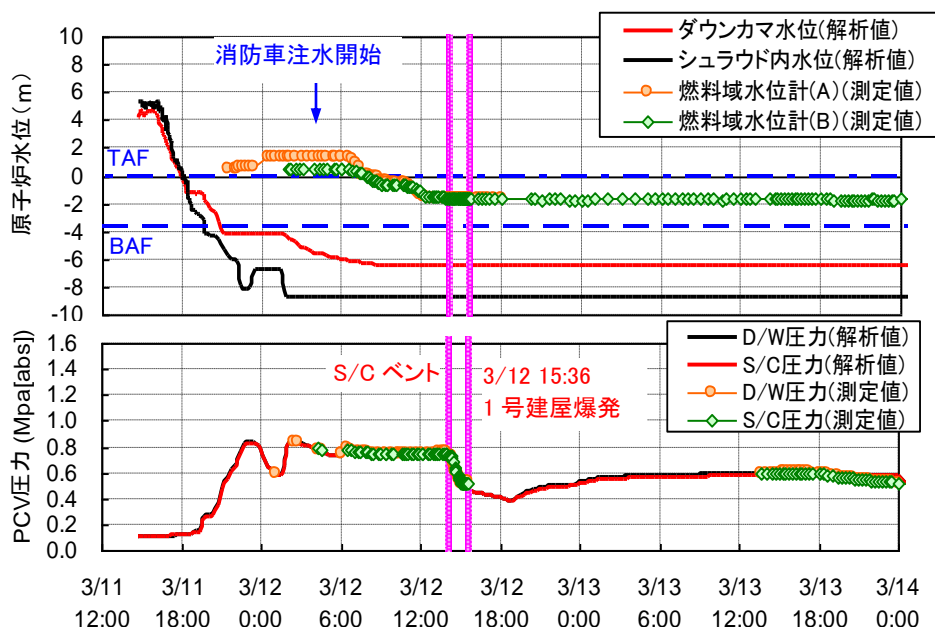
Figure RPV water level and PCV pressure changes at Unit-1 until the hydrogen explosion occurred

At Unit-1, the D/W pressure decrease was confirmed from 14:30 through around 14:50 on March 12th following the large S/C vent valve opening operation. At 15:36 on that day, hydrogen exploded in this reactor building and the roof and the outer walls of the top floor were heavily damaged.

These hydrogen explosions are considered to have been caused by hydrogen gas generated mainly by zirconium-water reactions which leaked out with steam to the reactor buildings. It is necessary to clarify the amounts of hydrogen gas generated and leak paths.

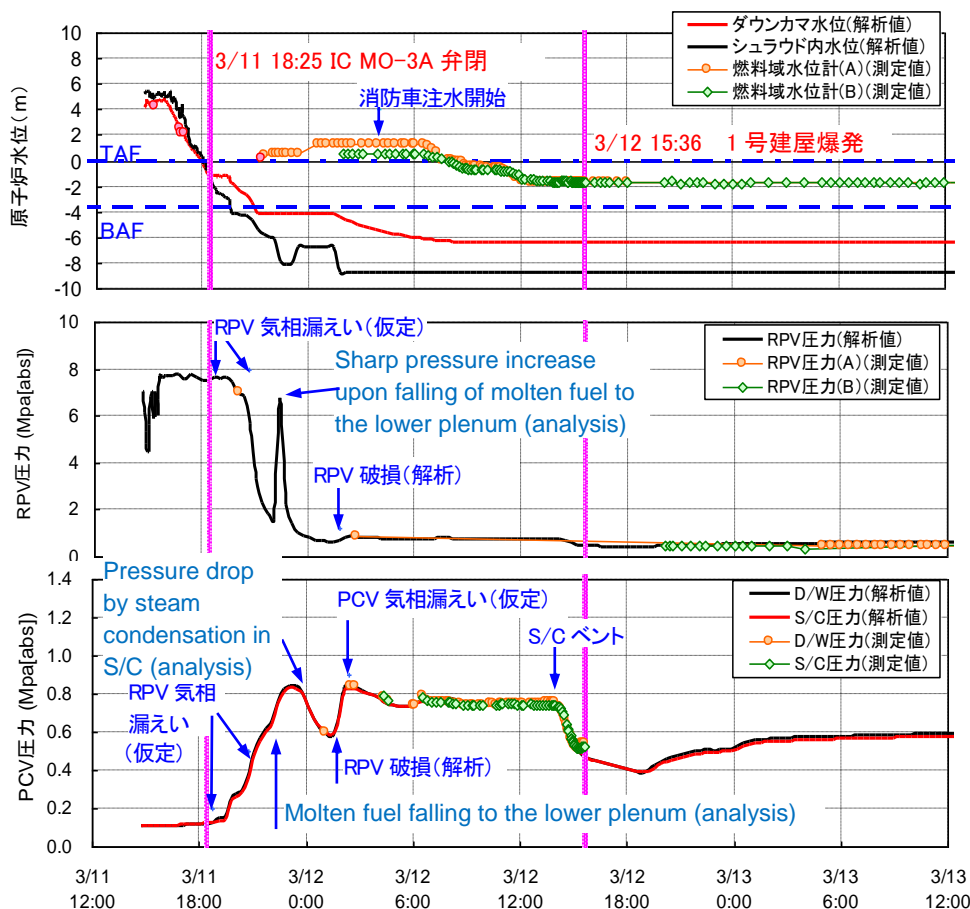
Figure Changes of Unit-1RPV water level, RPV pressure and PCV pressures

Unit-1/Issue-2	Unit-1	Category A⑤	Class (2)	Safety measures in [1]: -
Plant behavior if the Unit-1 ICs had functioned				Results: Attachment 1-7
<p>At Unit-1, the reactor pressure was being controlled after the earthquake by intermittent operation of the emergency isolation condensers (ICs). Immediately before all power supplies were lost due to tsunami, the IC operation had been incidentally in a halted situation. In the station blackout condition, the shift operators in the MCR noticed the display lamps indicating the IC (Sub-system A) isolation valves (MO-2A, MO-3A) as “Closed” outside the PCV at around 18:00 on March 11th. They took action to open the valves at 18:18 on March 11th, and confirmed the steam generating sounds and saw the steam when looking above the reactor building, but the amount of steam was limited and it stopped a while later. Concerned about the water inventory left in the IC shell side tank, at 18:25 the operators closed the isolation valve (MO-3A) on the return line.</p> <p>Post-accident surveys of the water level in the IC shell side tank showed that the water level of Sub-system A had been 65% (normal level was 80%) and the water in the tank had been sufficient. If the isolation valve (MO-3A) on the return line had not been closed at 18:25 on March 11th, the reactor cooling by the IC might have been continued.</p> <p>Therefore, the reason why the amount of steam generation was limited upon the opening of the IC Sub-system A isolation valves outside the PCV and why it stopped after a while (Unit-1/Issue-1) will be investigated. In addition the effect on the accident progression will be investigated, if the isolation valve of IC (Sub-system A) outside the PCV had been kept open after 18:25 on March 11th.</p>

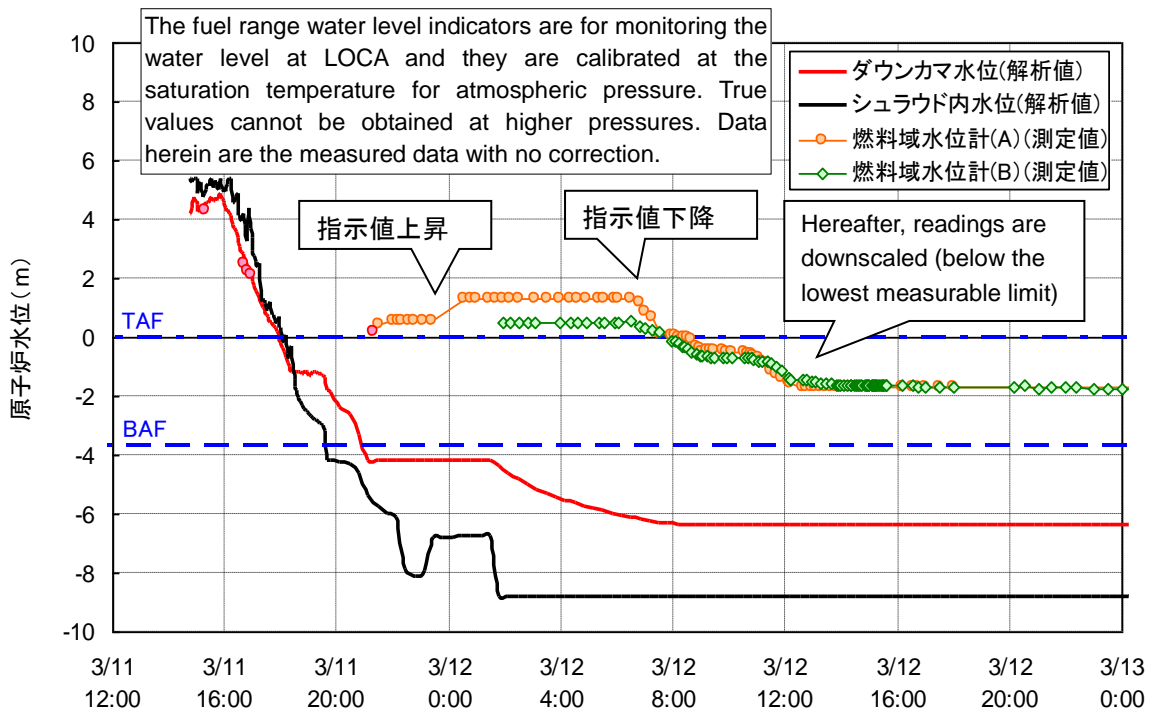
Figure Reactor water level changes at Unit-1

The fuel range water level indicators of the condensing water chamber type cannot show true values when the PCV temperature rises or the reactor pressure decreases, because the water in the piping in the condensation chamber evaporates. Therefore, the fuel range reactor water level indicators seem to have been already malfunctioning when restored by the temporary power supply.

But the water levels indicator readings tell the pressure difference between the reference leg and variable leg. It is possible that some information might be obtained on the reactor depressurization timings or reactor water levels.

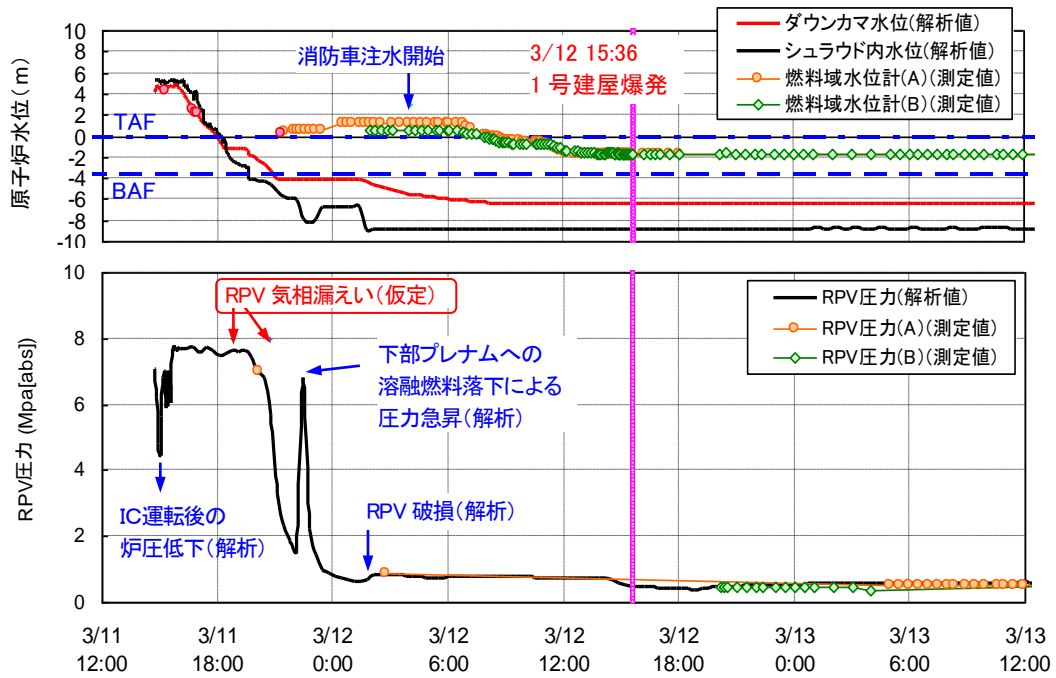
Figure RPV and PCV pressure changes at Unit-1

Unit-1/Issue-5	Unit-1	Category B③	Class (2)	Safety measures in [1]: pp27-36
Leaks in gaseous phase from Unit-1 RPV				Results: -
<p>At Unit-1, the RPV pressure measured 7.0MPa[abs] at 20:07 and the D/W pressure measured 0.6MPa[abs] at about 23:50 on March 11th, while the D/W pressure was 0.84MPa[abs] at 02:30 and the RPV pressure was 0.9MPa[abs] at 02:45 on March 12th. Although the exact timings are unclear, it was confirmed that the PCV pressure showed a big increase. And the RPV pressure decreased despite no depressurization operation.</p> <p>If the reactor water level drops and the core starts to be uncovered, the heat transfer from the overheated core and the overheated steam heat up the RPV pressure boundary above its normal temperatures. There may be a possibility that leak holes form for leaks in the gaseous phase at some of these upper locations before the molten fuel penetrates the RPV bottom, and the RPV pressure may decrease if the leak holes are big enough. Should that have occurred, it would affect the timings of RPV damage and the thermal and mechanical loads to the PCV after the RPV damage.</p> <p>The MAAP analysis assumed that the core temperatures were elevated by the overheating of the uncovered core and molten fuel, resulting in gaseous leaks from the RPV to the D/W through the in-core instrumentation dry tubes or the SRV flanges on the main steam line.</p> <p>But there is no direct evidence of measured plant parameters or observations that confirms leaks through these leak paths. Clarification is needed for grasping the core and PCV conditions.</p>

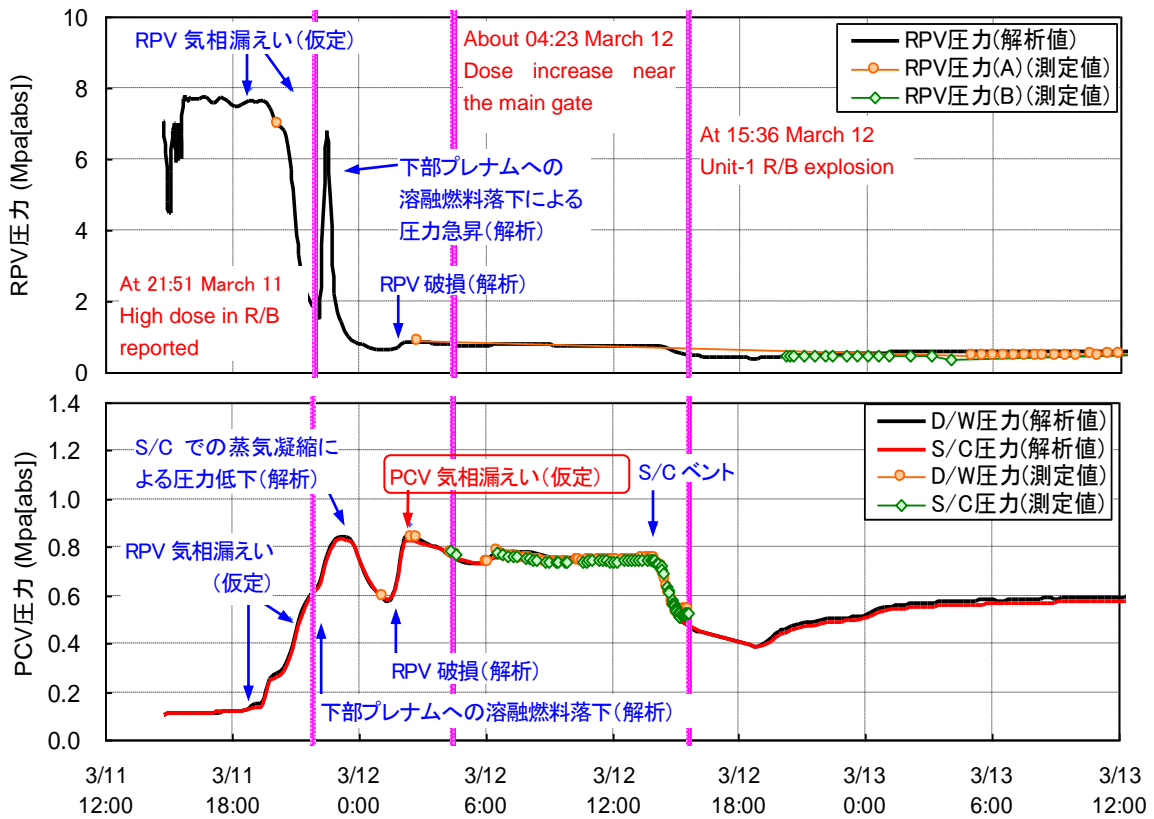
Figure RPV and PCV pressure changes at Unit-1

Unit-1/Issue-6	Unit-1	Category B④	Class (1)	Safety measures in [1]: pp.27-43
Leaks in gaseous phase from Unit-1 PCV				Results: -
<p>The Unit-1 DW pressure measured 0.6MPa[abs] at about 23:50 on March 11th, 0.84MPa[abs] at about 02:30 on March 12th and then stayed between 0.7MPa[abs] and 0.8MPa[abs] until it decreased at about 14:30 by the venting operation.</p> <p>Steam generation by water injection, the PCV temperature increases, the gas production by core-concrete reactions, etc. are likely to increase the PCV pressures. Nevertheless, it remained at a level which may indicate possible leaks from the PCV.</p> <p>In the meantime, shift operators entered the reactor building at about 21:00 on March 11th, when their APDs measured 0.8mSv instantaneously. They reported it upon return to the MCR at 21:51. At about 04:00 on March 12th and onward, the dose rates increased in wide areas near the main gate.</p> <p>The MAAP analysis assumed gaseous leaks from the PCV to the reactor building at about 03:10 on March 12th, about 12 hours after the earthquake. It was so assumed to roughly simulate the measured PCV pressure changes. But there is no direct evidence of measured plant parameters or observations that confirms the timing of leaks and their paths.</p> <p>Clarification is needed for grasping the PCV conditions.</p>

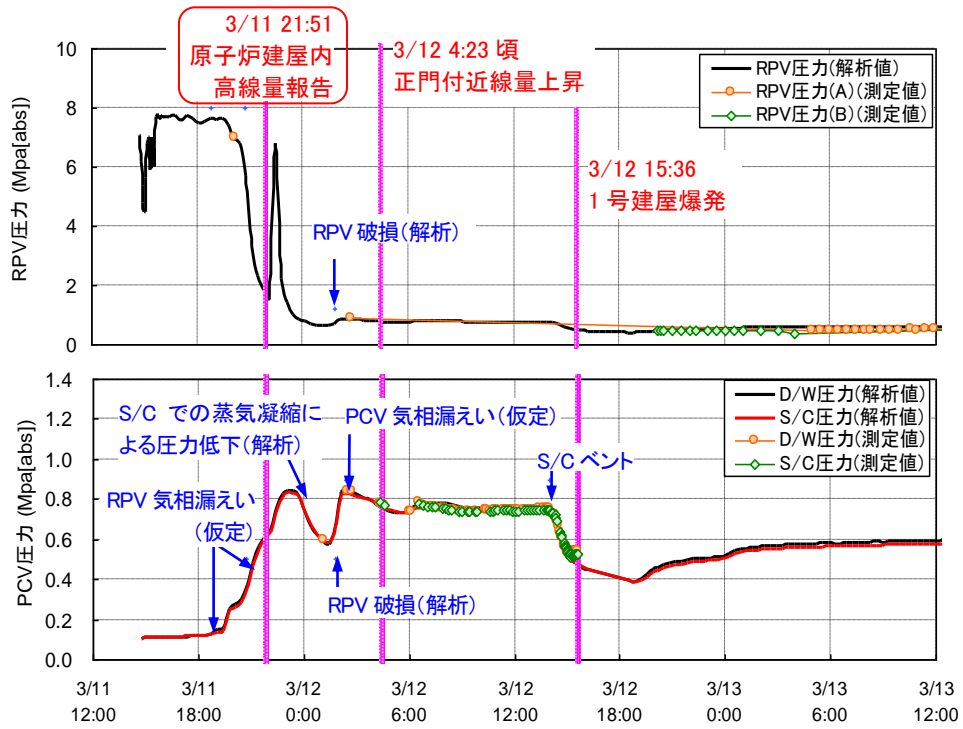
Figure RPV and PCV pressure changes at Unit-1

Unit-1/Issue-7	Unit-1	Category B⑤	Class (2)	Safety measures in [1]: pp.27-36 (strengthening of water injection means)
Dose rate increase in Unit-1 reactor building on March 11 th				Results: -
<p>At 17:19 on March 11th, shift operators approached the Unit-1 reactor building, carrying a GM survey meter for contamination inspections, in order to check the RPV pressure indicators and the IC shell side remaining water levels. When they opened an outer airlock door, their GM survey meter gave a value higher than normal (recording 300cpm, about three time the usual background). They returned to the MCR to report this at 17:50.</p> <p>There is a further record that at about 21:00 on March 11th, when shift operators entered the reactor building, their APDs measured 0.8mSv instantaneously and they reported it upon return to the MCR at 21:51.</p> <p>By referring to the written records on the MCR whiteboard for consideration, the dose rate at the spot could be 288mSv/h, <i>if</i> "instantaneously" were assumed as 10 seconds. When compared to the dose limit 100mSv for emergency operations, this dose rate (288mSv/h) is high enough to impede the accident management operations.</p> <p>It is not clear whether the dose rates in the reactor building were high, when shift operators entered the reactor building at 20:07 on March 11th to check the RPV pressure indicators. It has been confirmed that, later at 23:00, the dose rates before the airlock doors of the reactor building were high (1.2mSv/h in front of the outside of the north airlock door, and 0.52mSv/h in front of the outside of the south airlock door).</p> <p>Thus, the high dose rates are recognized at an early stage of the accident at Unit-1, but there is no direct evidence which shows the exact timings and paths of fission product leaks. It is necessary to clarify them, in combination with the Unit-1/issue-8 and 9, in order to assess the accessibility to the reactor building for accident management operations as well as to estimate the conditions of the core and the PCV.</p>

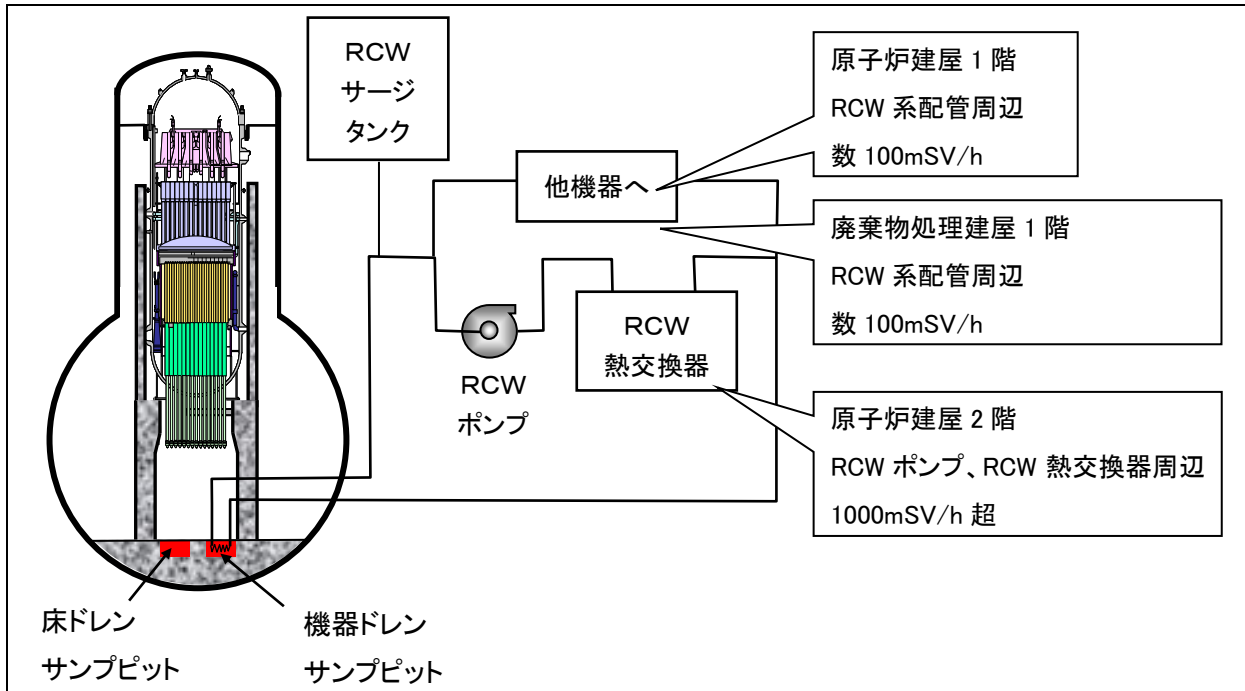
Figure Schematic diagram of RCW system

Therefore, there may be a possibility that part of the molten fuel fell into the equipment drain sump and damaged the RCW piping, allowing the transfer of high dose rate steam or water containing radioactive materials into the RCW piping. Identification of the causes of high dose rates in the RCW piping may help to estimate the conditions of the core and the PCV.

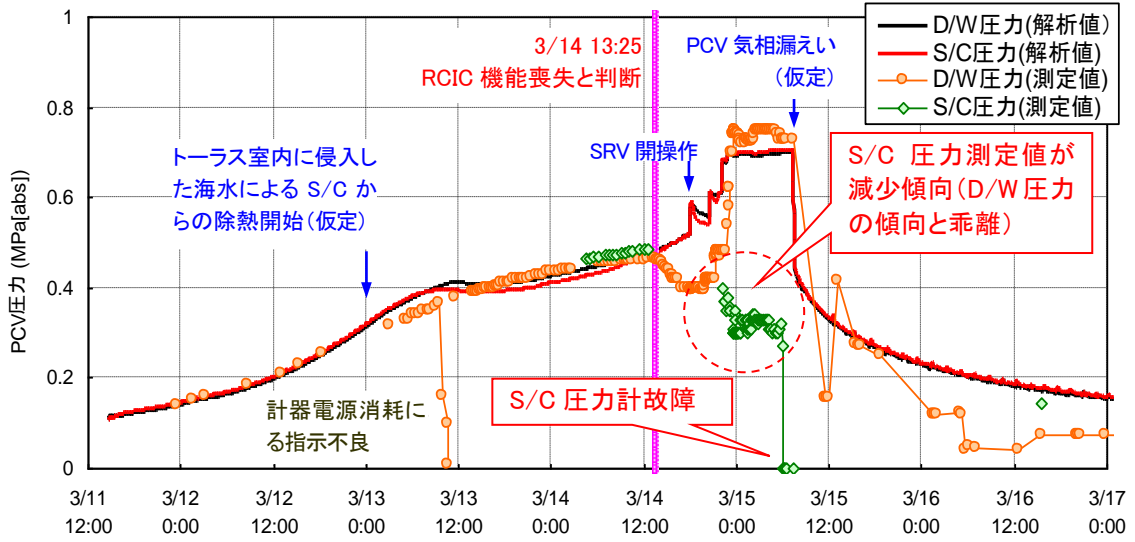
Figure PCV pressure changes in Unit-2

Unit-2/Issue-3	Unit-2	Category A⑤	Class (2)	Safety measures in [1]: -
Behavior of S/C pressure of Unit-2 after 21:00 on March 14 th				Results: Attachment 2-17
<p>The D/W pressure of Unit-2 gradually increased while the RCIC was in operation, and after the RCIC was shut down it began to decrease at about 13:00 on March 14th. Thereafter it increased at about 20:00, about 21:00, about 23:00 and reached about 0.75MPa[abs] probably due to incondensable gas accumulation in the D/W because of hydrogen generation and the SRV opening.</p> <p>In the meantime, the S/C pressure measured about the same value as that of the D/W from 04:30 to about 12:30 on March 14th by the pressure indicator originally installed to this plant. The measurement was interrupted thereafter by defective readings. When the measurement was resumed at 22:10 by an S/C pressure indicator introduced for accident management (AM), it showed a lower value than that of the D/W. The S/C pressure indicator for AM was to measure the reference leg pressure of the S/C water level indicator mounted on a branch line off the S/C venting line.</p> <p>Such a discrepancy between the D/W and S/C pressures is very unrealistic for the PCV structural reasons. These pressure indicators should indicate consistent values. For this reason, the S/C pressure indicator is likely to have indicated wrong values. Eventually, the S/C pressure indicator downscaled at 06:00 on March 15th and the instrumentation system seems to have gone out of service. There is a possibility that the behavior of these pressure indicators and the timing of their failure may provide some meaningful information.</p>

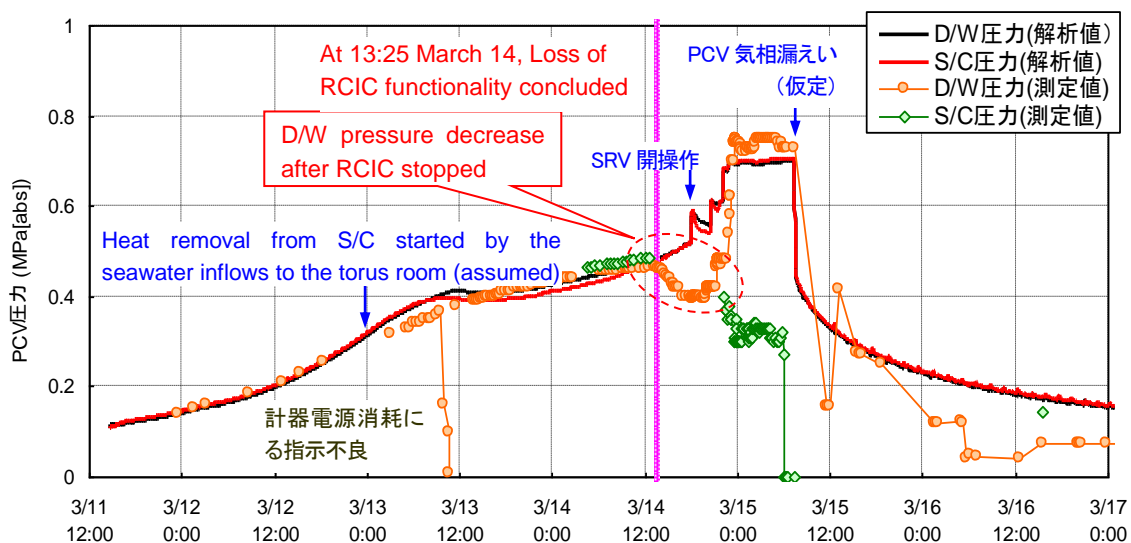
Figure PCV pressure changes in Unit-2

The D/W pressure of Unit-2 increased gradually while the RCIC was in operation. It began to decrease at about 13:00 on March 14th after the RCIC had been shut down. Theoretically, the decay heat in the RPV is transferred to the S/C by steam whether the RCIC is in operation or shutdown, and the D/W pressure is anticipated to increase gradually.

The above-mentioned D/W pressure decrease could be explained by possible leaks from the PCV. But it cannot explain the pressure increase afterward. Another possible interpretation was that the D/W pressure decrease was due to the continued total S/C energy inventory decrease by the heat removal by the water accumulated in the torus room, because the energy could not be transferred to the PCV (D/W) via the S/C by the RCIC turbine until starting energy transfer via SRV. However, the latest MAAP analysis could not reproduce the phenomena of the PCV pressure decrease. There is another inconsistency: the PCV pressure decrease started more than 1 hour later than 12:00 noon when the RCIC is estimated, from the RPV pressure increasing trend, to have completely stopped. This timing almost coincides with the timing when the energy transfer from the SRV to the S/C started; therefore, the scenario of continued heat removal through the S/C walls combined with the energy flow (to the S/C from the RCIC turbine) termination cannot be explained.

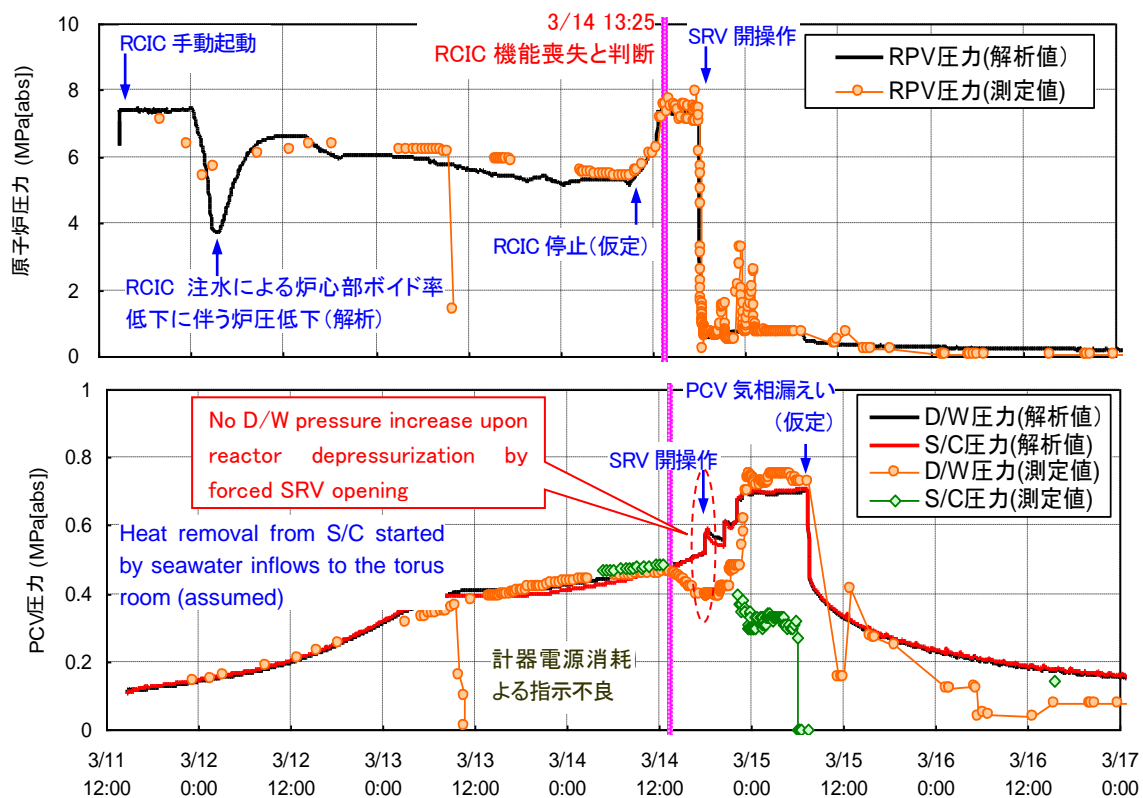
Figure Pressure changes of RPV and PCV at Unit-2

Unit-2/Issue-6	Unit-2	Category B①	Class (2)	Safety measures in [1]: -
PCV pressure behavior upon forced SRV opening at Unit-2				Results: Attachment 2-6
<p>At Unit-2 the manual forced depressurization of the reactor was successfully completed at 18:02 on March 14th by the opening operation of the SRV(s). Theoretically, the D/W pressure should increase by a large amount of steam (energy) flow into the S/C upon forced depressurization by the SRV(s). Nevertheless, it remained at about 0.4MPa[abs] from 17:00 through 20:00.</p> <p>It should be noted that, thereafter at about 20:00, 21:00 and 23:00 on March 14th, the D/W pressure showed an increase and reached about 0.75MPa[abs], probably due to the accumulation of the incondensable gases.</p> <p>The MAAP analysis predicted the pressure increase upon forced depressurization. It is necessary to clarify the pressure change behavior upon forced depressurization by the SRV(s).</p>

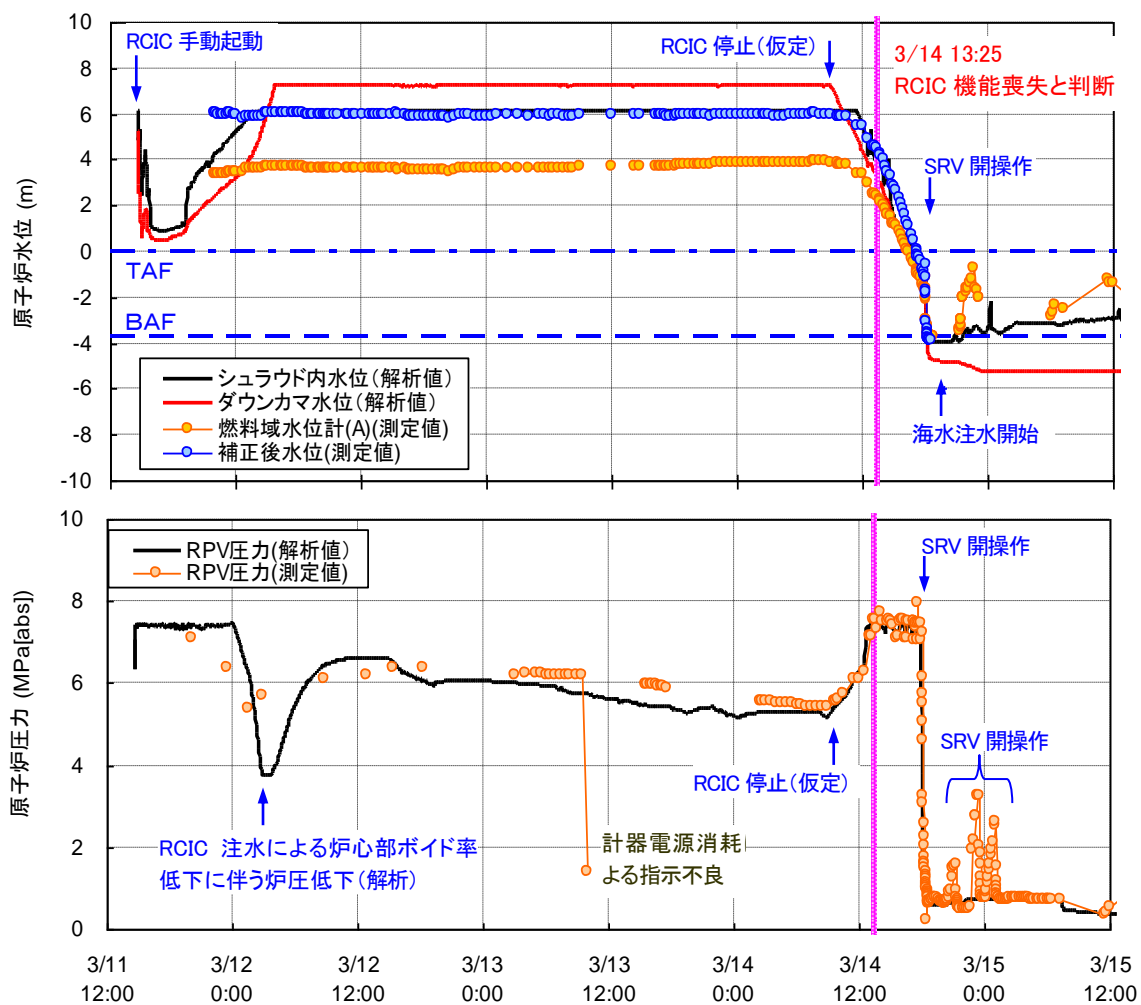
Figure RPV water level and pressure changes at Unit-2

Unit-2/Issue-8	Unit-2	Category B③	Class (1)	Safety measures in [1]: pp.27~36
Leaks in gaseous phase from Unit-2 RPV				Results: Attachment 2-10
<p>At Unit-2 the forced depressurization of the reactor was successfully completed at 18:02 on March 14th by the opening operation of the SRV(s).</p> <p>The SRV(s) were repeatedly opened thereafter in order to control the intermittent reactor pressure increase. But the operation records of SRV opening and the RPV pressure decrease do not always coincide. For instance, the operations of manual opening are recorded twice at 21:20 on March 14th and at 01:10 on March 15th, but no record of confirming the SRV manual opening exists at the time of reactor pressure increase and decrease at about 23:00 on March 14th.</p> <p>The reactor water level indicator readings showed about the BAF level at the time of the forced depressurization, and the core melting progressed thereafter. In view of this, gaseous leaks might have occurred from the reactor vessel, due to, for example, damage of TIP tubes, which composed the pressure boundary. In addition, no further operations of SRV opening for depressurization were taken after a certain time.</p> <p>But there is no direct evidence in the measured plant parameters or observed events which shows when and from where the leaks actually occurred. Clarification is needed.</p>

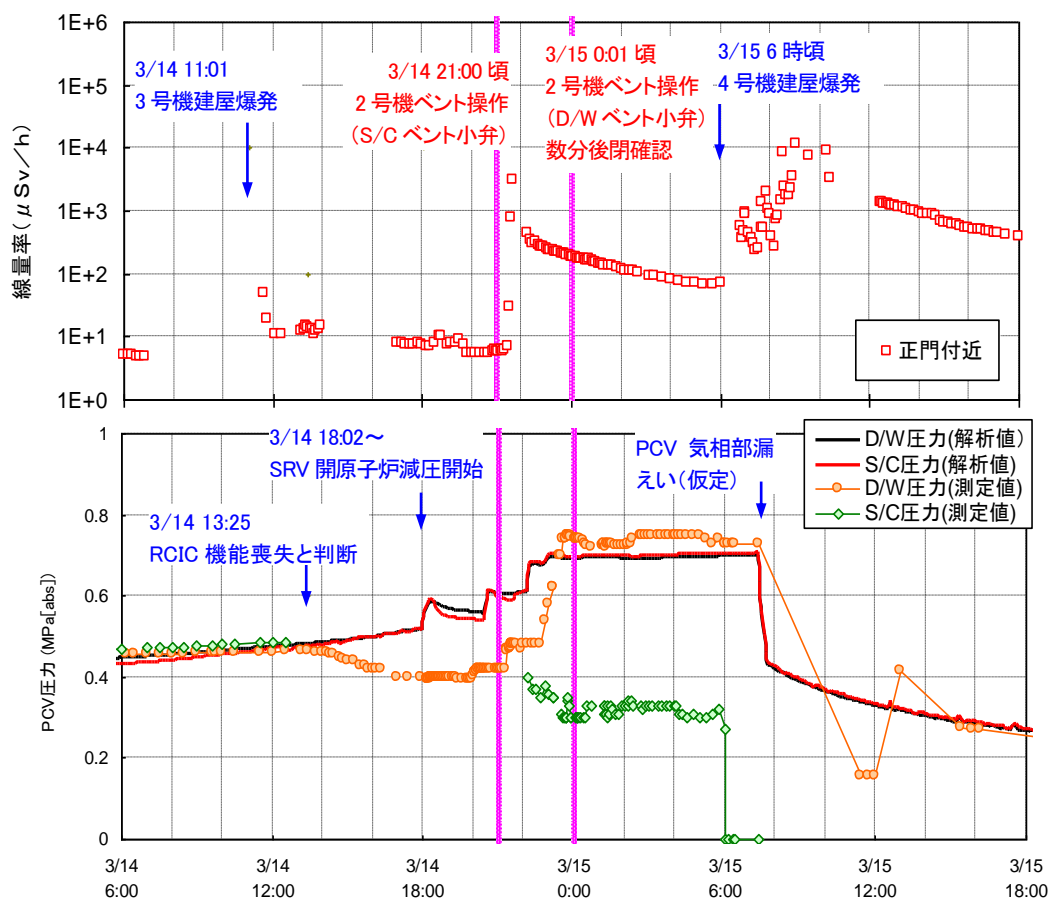
Figure Radiation dose near the main gate and PCV pressure changes upon Unit-2 venting
[Back to List of Issues/Unit-2](#)

Unit-2/Issue-9	Unit-2	Category B①	Class (2)	Safety measures in [1]: p.40
Consideration of possible rupture disc actuation at Unit-2				Results: Attachment 4
<p>At Unit-2 the RCIC could continue injecting water with no power source for control, which had been lost due to the tsunami. But, since the need to vent the PCV was foreseen in due course, the venting line was configured by 11:00 on March 13th except for the rupture disc actuation.</p> <p>However, the large S/C vent valve (AO-valve) was confirmed to have been closed by the impacts of the explosion of the Unit-3 reactor building. Finally, the valve is considered to have become inoperable for opening actions due to the defective solenoid valve.</p> <p>At about 21:00 on March 14th, the small S/C vent valve was slightly opened by activating its solenoid valve. The venting line configuration was completed again except for the rupture disc actuation, but it was reported that the small S/C valve had been in the “Closed” position at 23:35 on March 14th.</p> <p>The S/C venting was thus being prepared for, but no clear evidence exists whether it actually was successful. Even if the S/C pressure indicators did not provide true values, the measured D/W pressure exceeded the rupture disc working pressure (528kPa[abs]) at about 23:00 on March 14th (540kPa[abs]). The S/C venting flow rate with the opened small S/C vent valve is limited, and so the D/W pressure decrease also will be limited. On the other hand, the monitoring car measured a sharp radiation dose increase near the main gate at about 21:20 on March 14th when the SRV opening was recorded.</p> <p>Clarification is needed to interpret the causes of the radiation dose increase, including the possibilities of PCV venting being implemented and the rupture disc actuation.</p>

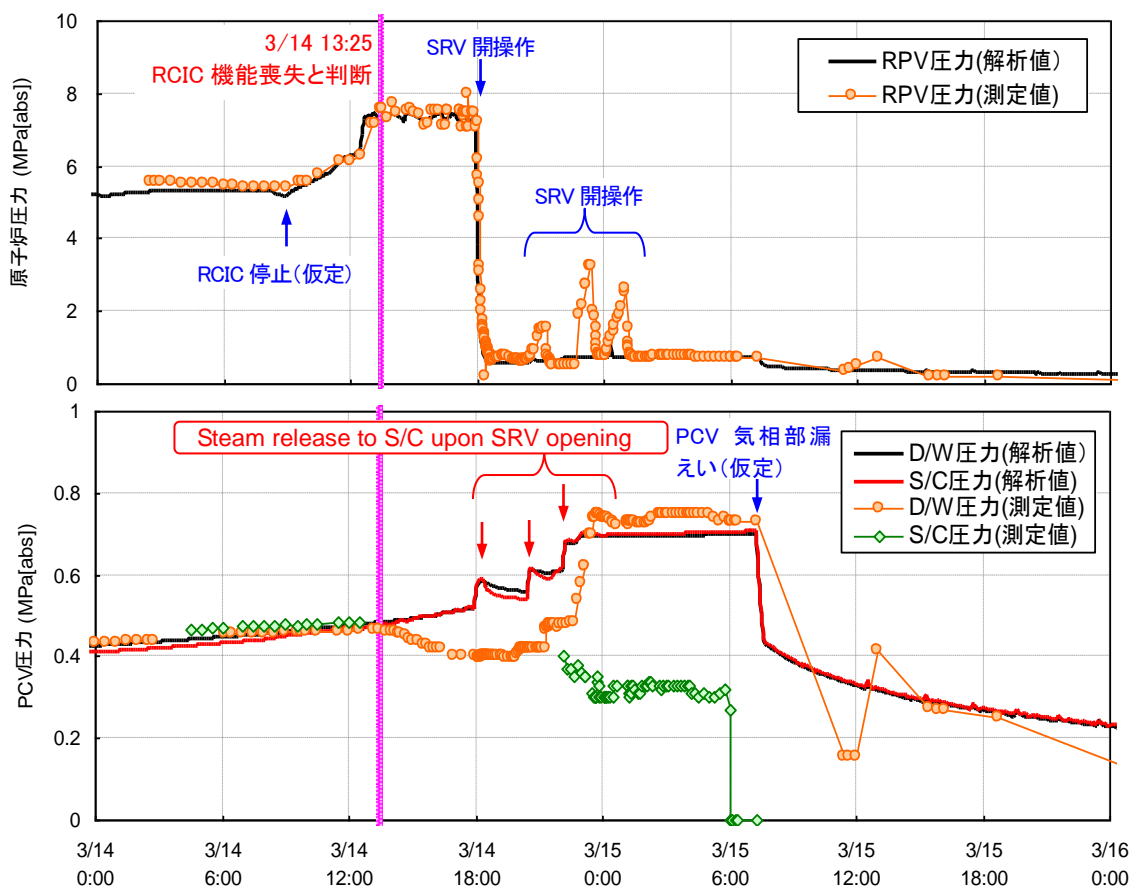
Figure RPV and PCV pressure changes at Unit-2

At Unit-2 the forced depressurization of the reactor was successfully completed at 18:02 on March 14th by the opening operation of the SRV. Further at about 21:00 on March 14th, an attempt was made to open another SRV because the reactor pressure had increased, but the pressure did not decrease. Further a third SRV was then actuated and the reactor pressure decreased at 21:20.

The reactor pressure was about 1.5MPa when it increased at about 21:00, when the core melting is considered to have been already progressing. Therefore, the exhaust upon reactor depressurization would have contained a large amount of hydrogen gas, a non-condensable gas. The non-condensable gas in the exhaust will cause pressure increase behavior different from that due to only steam in the exhaust. Clarification is needed concerning possible impacts on the S/C integrity due to hydrogen-rich steam release.

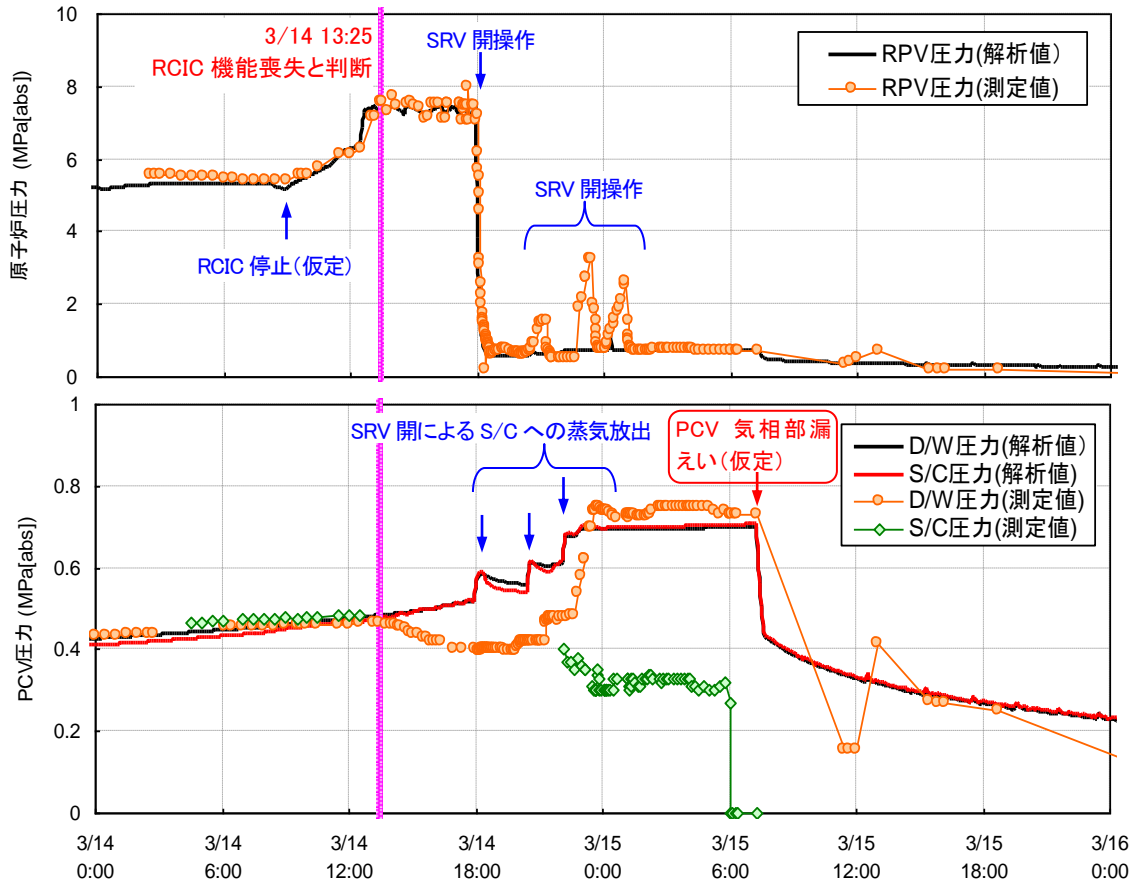
Figure RPV and PCV pressure changes at Unit-2

It can be further considered that the leaks had started sometime between about 23:30 on March 14th, when the PCV pressure had changed above 0.7MPa[abs], and about 07:20 on March 15th.

But no direct evidence has been identified from the measured plant parameters or observed facts concerning at what time and at what point the leaks actually occurred. Clarification is needed.

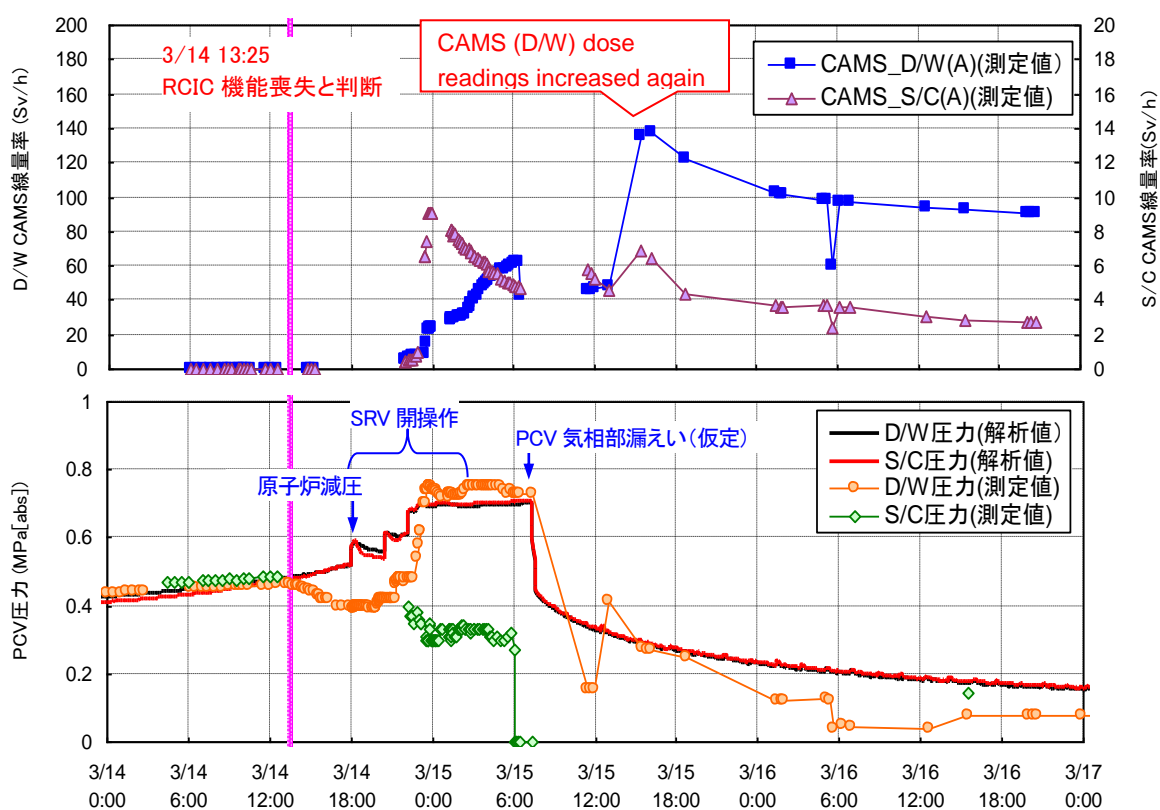
Figure Changes of CAMS readings and PCV pressures at Unit-2

The CAMS (D/W) readings of Unit-2 recorded from the morning of March 15th were monotonically increasing before around 06:00 (63Sv/h at 06:20). After about a 6-hour blank period, it read 46Sv/h at 11:25. This can be interpreted as having reflected the dose rate decrease in the PCV as the result of FP release to the environment.

Thereafter, the CAMS (D/W) recorded a rapid increase to 135Sv/h at 15:25 on March 15th. This rapid increase may have been caused by some unknown changes of the situation in the RPV and PCV. It will be investigated what phenomena could have occurred around this time period.
