List of issues to be investigated

Reference [1] "Safety measures at the Kashiwazaki-Kariwa Nuclear Power Station of Tokyo Electric Power Company (First version, March 2013)"

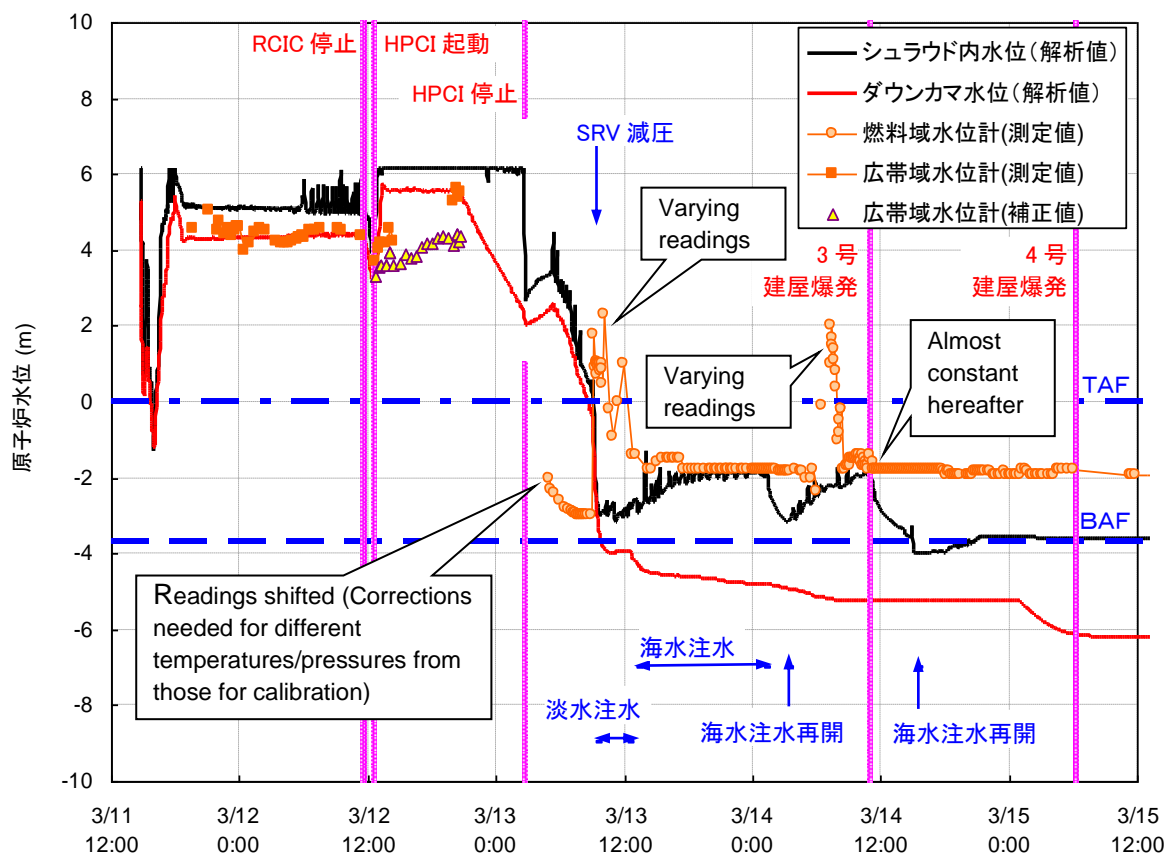
Figure Reactor water level changes at Unit-3

Unit-3/Issue-2	Unit-3	Category A⑤	Class (2)	Safety measures in [1]: P.27~36
RPV water level indicator readings at Unit-3 after loss of true value indications			Results: Attachment 3-9	
<p>The reactor water level indicators of Unit-3 showed roughly constant values after about 12:00 on March 13th, irrespective of the water injection conditions. It can be considered that the water level indicators were out of order, like those of Unit-1, because of the water level decrease both in their reference leg and variable leg.</p> <p>The condensing chamber type water level indicators installed in the Fukushima Daiichi NPS reactors lose their water in their internal piping (reference leg and variable leg) by evaporation, causing them to show wrong values, when the PCV temperatures increase or the reactor pressures decrease.</p> <p>But, the water level indicator readings represent the pressure difference between the reference leg and the variable leg. This may provide some relevant information concerning the timing of reactor pressure decrease and/or reactor water level</p>

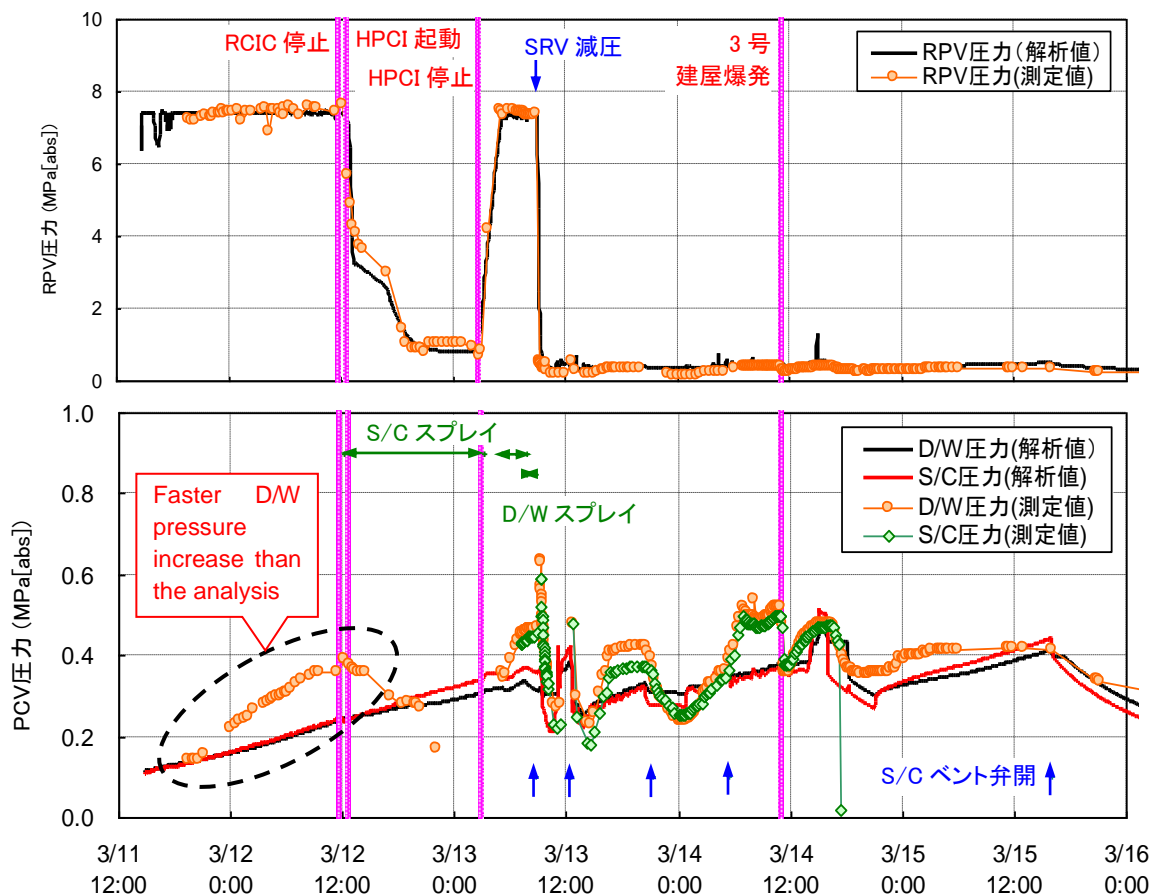
Figure Pressure changes of RPV and D/W of Unit-3

Unit-3/Issue-3	Unit-3	Category B①	Class (1)	Safety measures in [1]: pp. 17, 18, 39, 40
Thermal stratification in the S/C of Unit-3			Results: Attachment 3-7	
<p>The D/W pressure of Unit-3 was in an increasing trend due to the exhaust steam from the RCIC and SRV(s), while the RCIC was in operation after the tsunami arrival.</p> <p>When compared with the MAAP analysis results with the use of design conditions, the observed pressures until about 22:00 of March 12th showed a larger and faster increase. The MAAP analysis could not simulate this pressure behavior (the D/W pressures increases were much larger as compared with the MAAP results until about 12:00 when the HPCI started operation, and the analysis pressures by MAAP continued to increase afterward while the observed pressures decreased rapidly).</p> <p>JNES suggested a possibility (*) of thermal stratification in the upper part of the S/C pool water causing a local temperature rise which led to the larger D/W pressure increase as compared with the uniform temperature rise of the S/C pool water. The thermal stratification would have been generated by the high temperature exhaust steam from the RCIC turbine only heating the S/C pool surface water.</p> <p>Further examination is due into the D/W pressure changes until about 22:00 on March 12th.</p> <p>(*) “Examinations into the impacts of thermal stratification in the suppression chamber water on the containment vessel pressures, and other parameters”, issued Feb. 1st, 2012, by the Japan Nuclear Energy Safety Organization (in Japanese)</p>

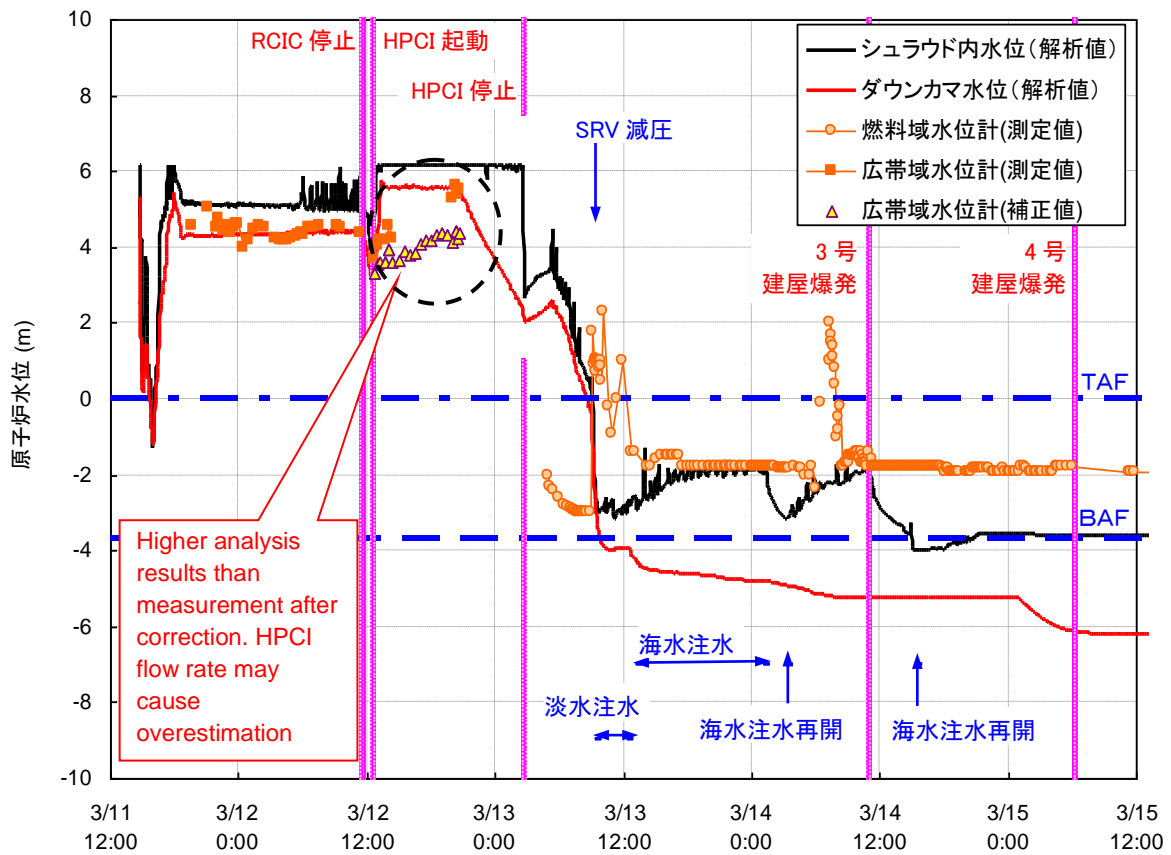
Figure Reactor water level changes at Unit-3

In the earlier MAAP analysis results, which TEPCO had disclosed in March 2012, the amount of water injection by the HPCI had been set to simulate the reactor water levels observed by the water level indicators (wide range). In the simulation, the reactor water levels measured until 20:36 on March 12th were used without corrections corresponding to the reactor pressures and PCV pressures. This caused the overestimation of the amount of water injected to the reactor in the MAAP analysis (The water level in the analysis is about 1m higher than that of measurement after such corrections). In consequence, it is likely that the amount of water actually injected by the HPCI was less than that assumed in the MAAP analysis.

The amount of HPCI water injection will be reviewed and the real progression of the accident will be examined for estimating the core and PCV status.

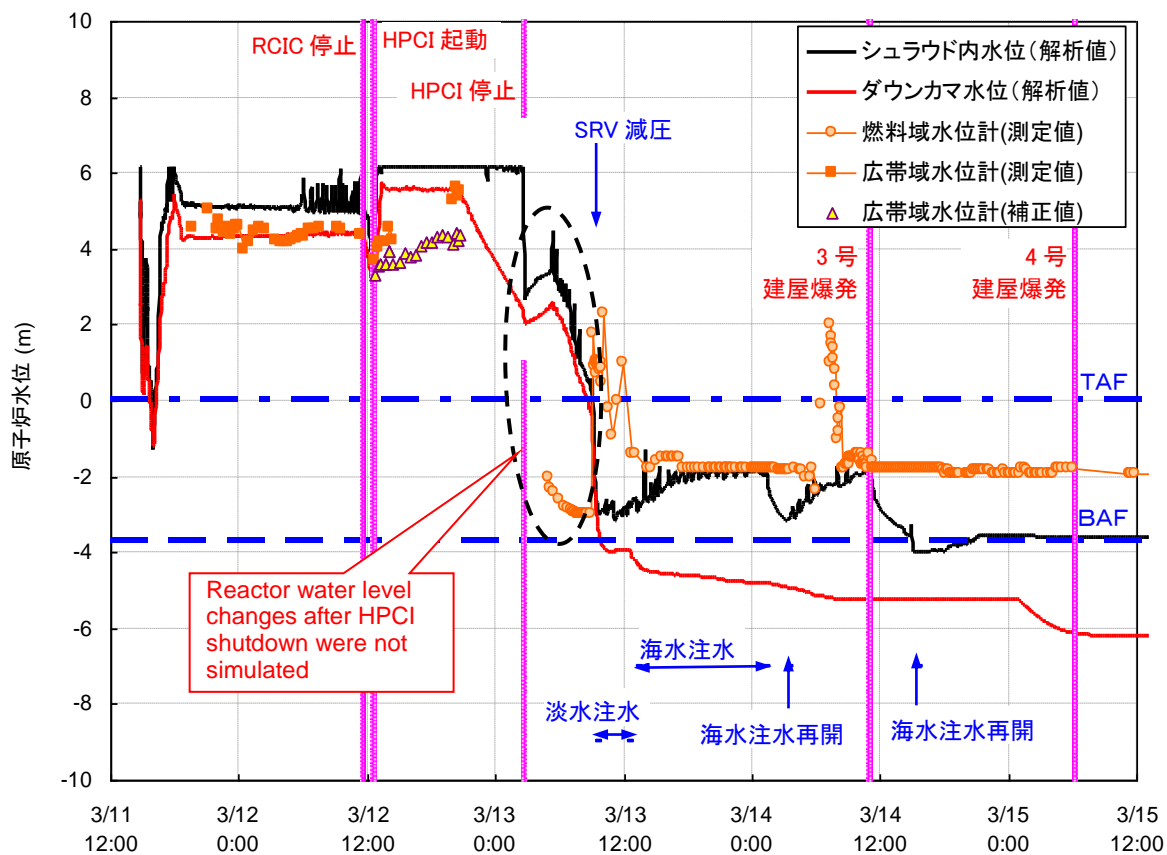
Figure Reactor water level changes at Unit-3

In view of a high likelihood of a smaller amount of water actually being injected than that assumed in the analysis, the overestimated amount of HPCI water injection will be reviewed and the actual progression of the accident will be investigated for estimating the core and PCV status.

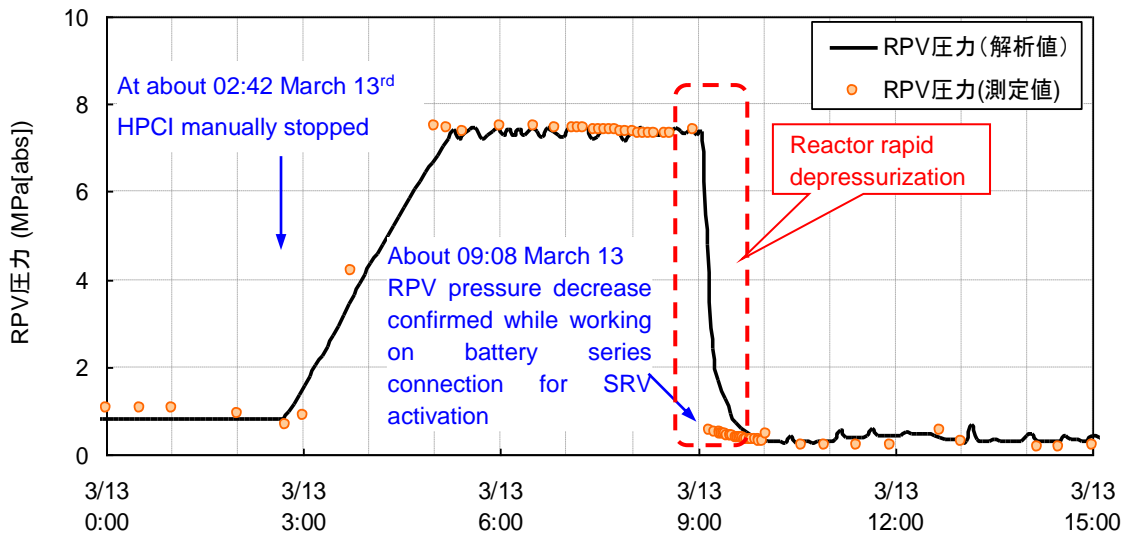
Figure Reactor pressure changes at Unit-3

This pressure decrease can be confirmed in two types of observed data: measured values recorded by the operators and the chart records. From the chart records, continuous transient behavior can be read, although the exact values are not known. The pressure decrease rate thus read is as large as about 7MPa[abs] down to about 1MPa[abs] in 2 to 3 minutes.

At this time, the battery connection work to the SRV control panel was not completed. The pressure decrease did not occur by the SRV manual actuation. It is necessary to investigate the depressurization mechanism.

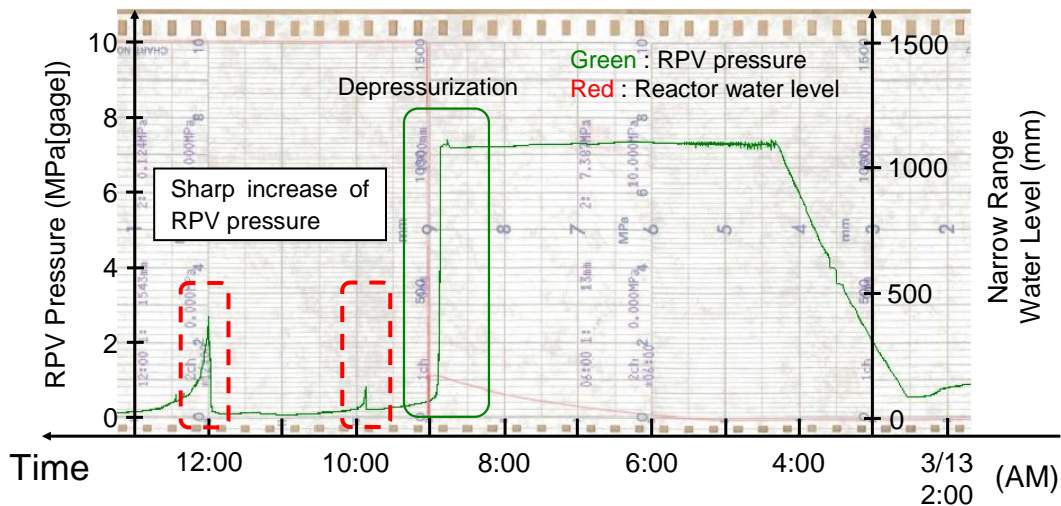
Figure Strip chart records (March 13th, 2011)

This pressure behavior, especially the pressure decrease, was considered and reported to be the responses to the SRV opening operations at 09:50 on March 13th upon the completion of battery connection and at about 12:00 upon the recovery from having found disconnected wiring. However, the pressure rise at these two times is very sharp as compared with the pressure increase at 02:42 on March 13th, when the HPCI had stopped operation.

The pressure behavior should be similar in the two cases, when the HPCI turbine steam regulator valve is closed upon the HPCI being shut down and when the SRV(s) are closed, because both cases are equivalent in having lost the steam discharge paths. But the observed pressure increase behavior is actually different. The sharp pressure increase might have been caused by the relocation of molten fuel down to the lower plenum or the generation of a large amount of hydrogen.

The pressure change mechanism and its relevance to the accident progression will be investigated.

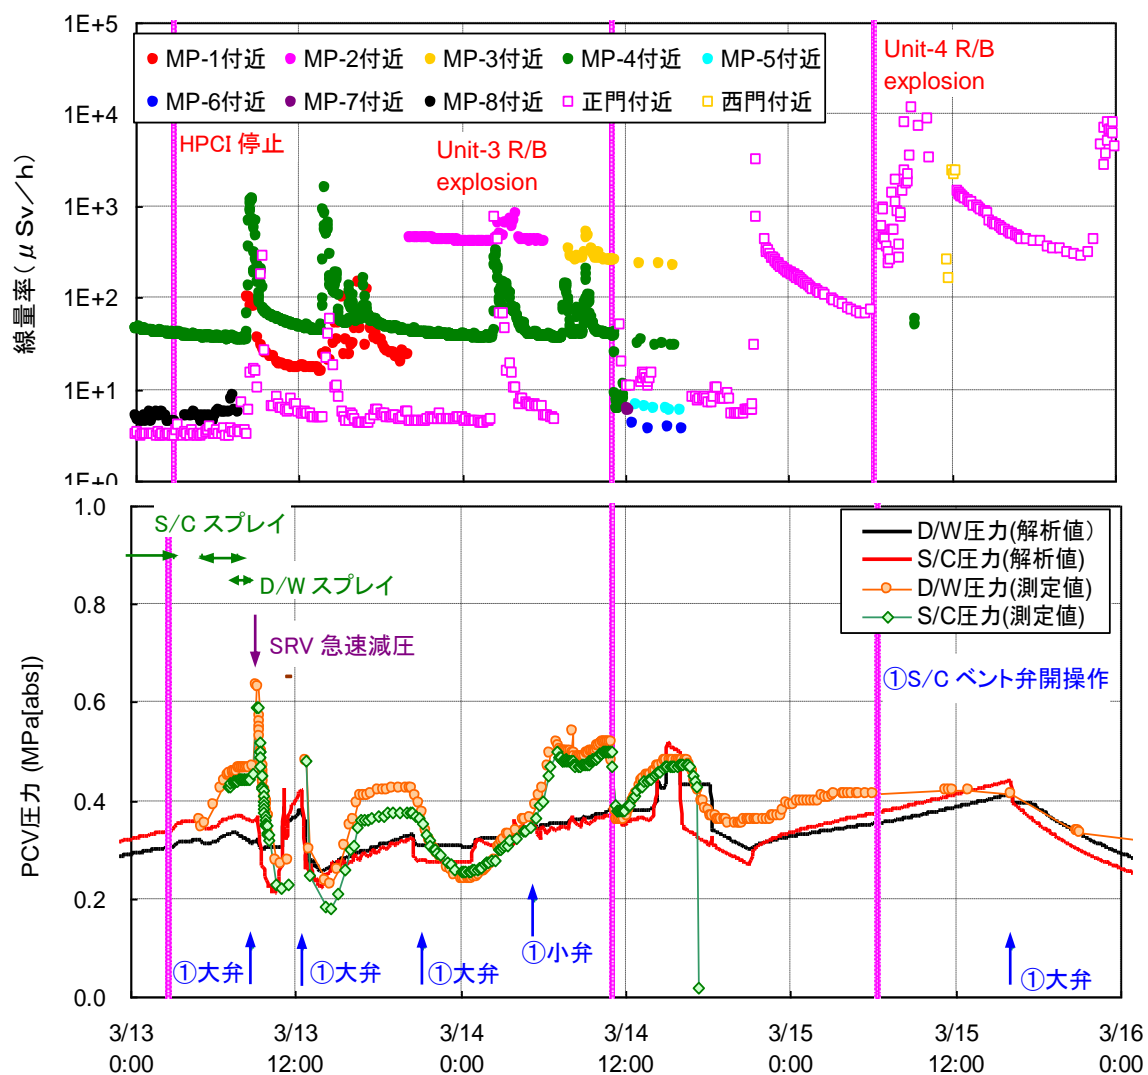
Figure Dose rate changes at the NPS (upper) and D/W pressure changes at Unit-3 (lower)

Unit-3/Issue-8	Unit-3	Category B①	Class (2)	Safety measures in [1]: p.40
PCV pressure behavior upon venting operations at Unit-3			Results: Attachment 3-8, 3-11, 3-12	
<p>The Emergency Response Center at the Fukushima Daiichi NPS concluded that the PCV had been vented once at Unit-3 when the D/W pressure decrease had been observed at 09:24 on March 13th following the completion of S/C venting line configuration at 08:41 on March 13th. Thereafter, the large S/C vent valve (air-operated) was closed several times due to problems of driving air pressure or the actuation circuit using a temporary small generator. Each time it was attempted to open the large S/C vent valve by solving the problem causes.</p> <p>The D/W pressures observed during this period repeatedly went up and down, but their timings were mostly not consistent with the timings of repeated opening operations of the large S/C vent valve. The flow rate changes anticipated by the small S/C vent valve opening operations seem too limited to explain the measured D/W pressure changes.</p> <p>The causes of the D/W pressure changes during the series of venting operations will, therefore, be investigated.</p>

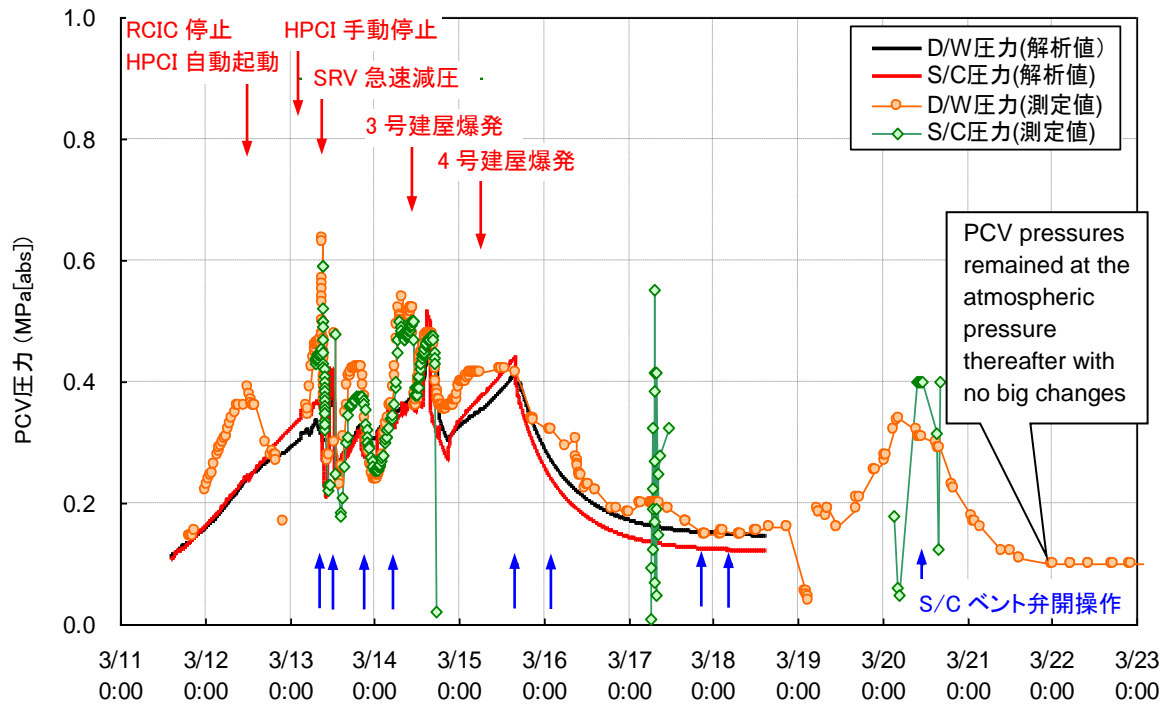
Figure PCV pressure changes at Unit-3

At Unit-3, the D/W pressure increase due to the rapid reactor depressurization at about 09:00 on March 13th led to the S/C pressure increase big enough to exceed the rupture disk working pressures. Thereafter the D/W pressure decrease at 09:24 on March 13th was confirmed and the PCV venting was concluded to have been implemented.

The MAAP analysis assumed no PCV leaks in Unit-3, but the steam leak from the PCV seems probable because the steam explosion occurred in the Unit-3 reactor building, steam release was observed near the reactor well in the reactor building, and the D/W pressure showed no big changes after March 21st at around atmospheric pressure.

It is considered, therefore, Unit-3, for which the operators attempted to repeat venting operations, would have had the largest leaks in the gaseous phase. Further investigation is needed to clarify when and from where the leaks in the gaseous phase actually occurred.

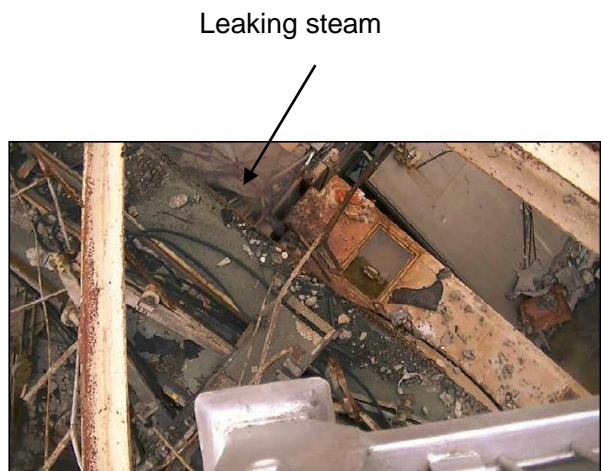
撮影者：東京電力株式会社
撮影日：平成23年8月24日

Movie sequences on August 24th, 2011, taken at the time of dust sampling above the reactor building, show steam leaking from the shield plug margin and the periphery of the deformed dryer separator (DS) pit gates.

Steam thus observed seems to be leaking from the PCV and it may provide some useful information to identify the leak locations.
