Status of investigation on estimating situation of cores and containment vessels

1. Introduction

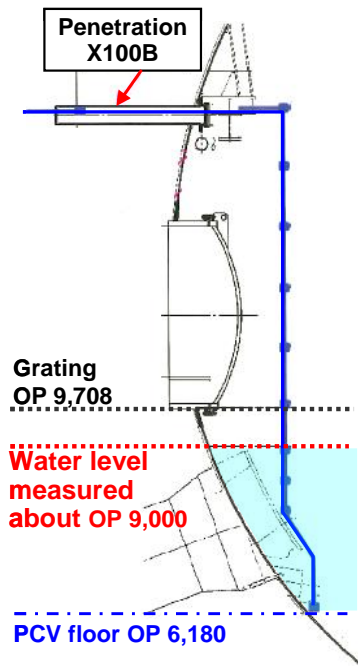
Figure 2-1 Measured level of water retained in Unit-1 PCV

The level of water retained was measured by lowering the CCD camera cable down to the water surface through the grating above in the PCV. The water level was found to be about 2.8m above the D/W floor (as of October 10, 2012) (Figure 2-1).

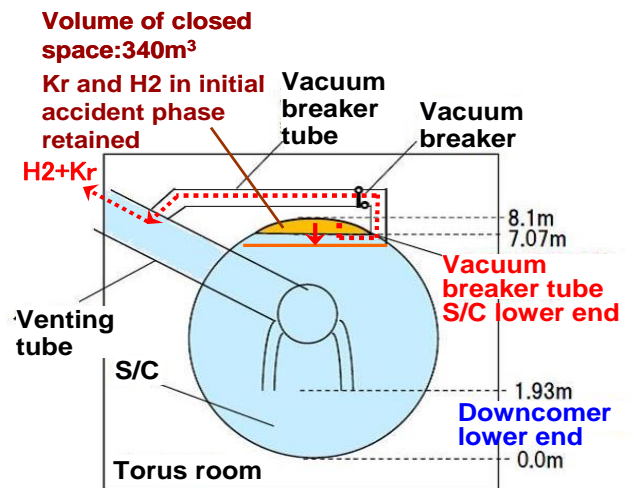
Figure 2-2 Status of the closed space in the gas phase section in S/C Unit 1

In September 2012, a nitrogen gas injecting test was conducted into the suppression chamber (S/C), in which the theory was demonstrated that Kr-85 and hydrogen gas formed early in the accident were retained in the S/C upper space, pushed down the S/C water level and were discharged to the D/W through the vacuum breakers. This helped to confirm that the S/C was currently almost filled with water (the level at around the lowest end of the vacuum breaker tube (Figure 2-2). [2-2]

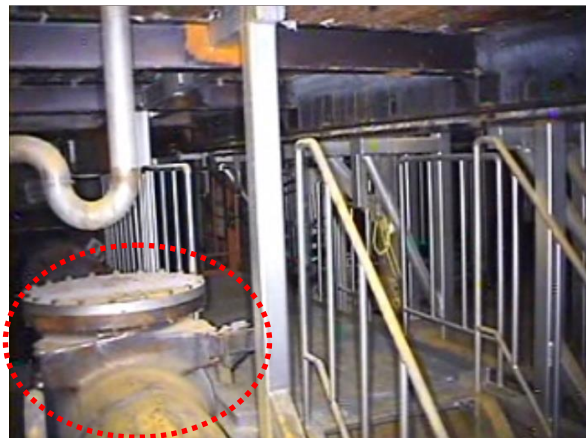
Figure 2-3 Photo of an S/C vacuum breaker in the torus room of Unit-1 (part)

No water leaking position in the S/C has been located yet. At least, no leak was confirmed on the flange of one of the eight vacuum breakers, as far as the photos showed (Figure 2-3).

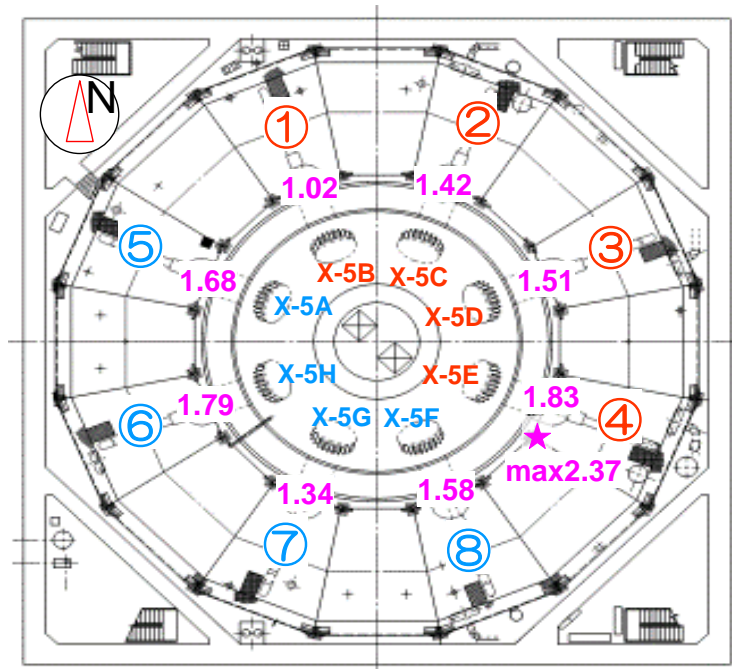
Figure 2-6 Dose rate distribution measured during the torus room investigation underneath vent tubes of Unit-1

The vertical distribution of radiation doses measured when lowering the instrumentation boat in November 2013 was similar to that measured in February 2013 (in the area surrounding the torus). Dose distribution along the boat traveling route was about 1 to 2 Sv/h, and the highest spots were in the southeast area (Figure 2-6).^[2-5]

In June 2011, steam blown from the pipe penetrations was witnessed at the southeast corner of the first floor of the reactor building. This would mean that radioactive materials carried by the steam were blown to the torus room after the accident and they deposited on the walls and structure surfaces there. The dose rate in the torus room is considered to be the sum of dose rates due to these contamination sources. The estimated dose rate on the water surface due to water-retained radionuclides (7.3×10^4 Bq/cm³ of Cs-134 and 1.5×10^5 Bq/cm³ of Cs-137, sampled on February 22, 2013) are about 100 mSv/h and not a dominant contributor to the 1 to 2 Sv/h dose rates measured. [2-6]

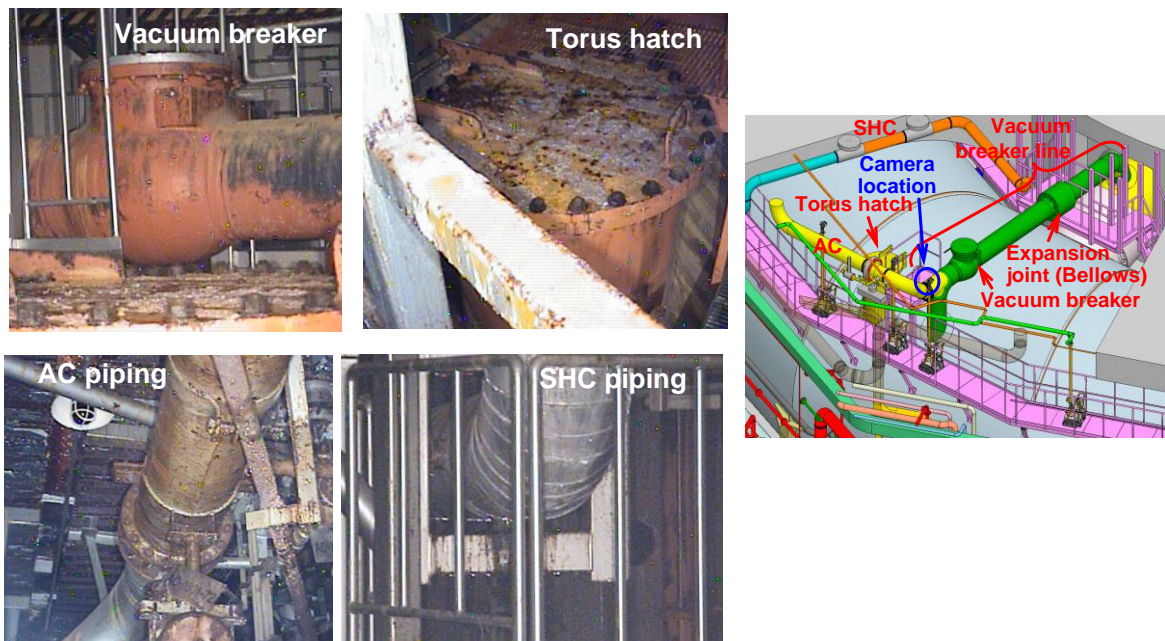
Figure 2-7 Camera images of Unit-1 S/C top area exploration (around vent tube X-5E) (part)

In May 2014, survey instrumentation robot was introduced through a drilled hole in the northwest area of the first floor of the Unit-1 reactor building to explore the S/C top area in order to locate the leak source near the vent tube X-5E, where leaking had been confirmed. By using the outer catwalk, the instrumentation robot made a camera survey around the vent tube X-5E, and the water leak was confirmed to be from the protective cover of the expansion joint on the vacuum breaker line. No leaks were noticed from the vacuum breaker valve, torus hatch, shutdown cooling system (SHC) piping or atmospheric control system (AC) piping (Figure 2-7). [2-7]

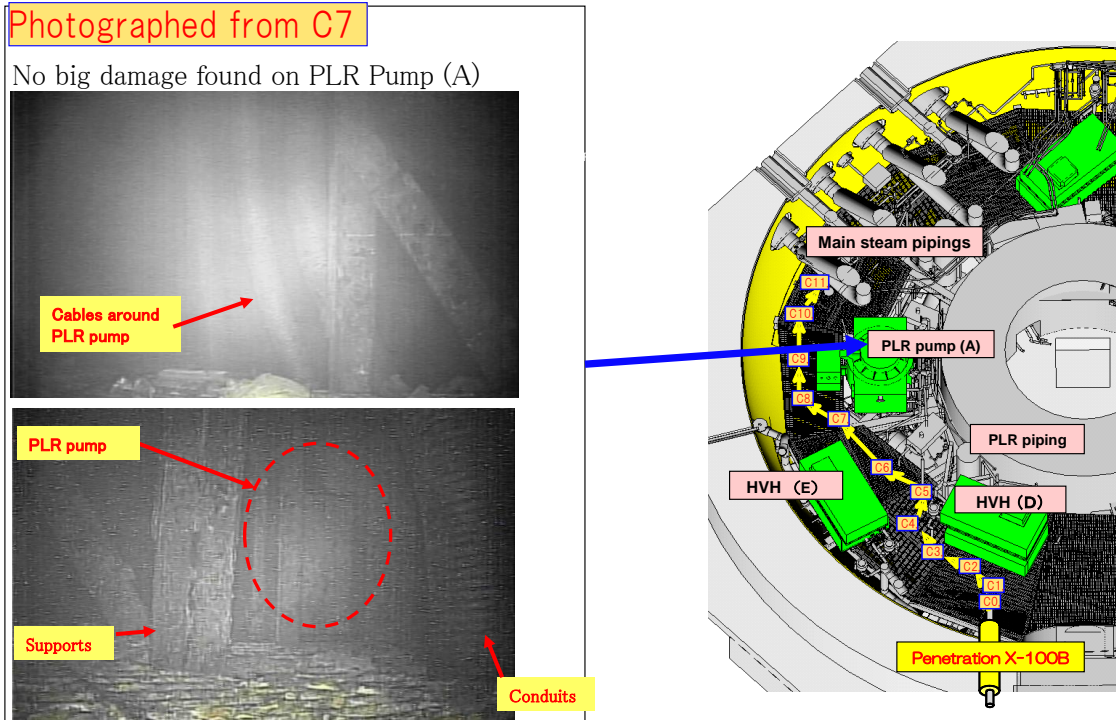
Figure 2-10 Photos taken during the clock-wise patrol [2-9]

The grating floor on the ground level outside the pedestal of Unit-1 was investigated from April 10 to 18, 2015. A running robot machine was sent through the PCV penetration X-100B. The robot patrolled clock-wise and anti-clock-wise by about 180 degrees for investigating damaged conditions of existing structures and presence of obstacles. Figure 2-9 and Figure 2-10 present a part of the photos taken during the anti-clock-wise and clock-wise patrols, respectively. As seen in Figure 2-9, no big damage was recognized on the HVH (heating ventilating handling unit), PLR piping, pedestal walls, PCV inner walls, etc., although fallen objects were noticed on the patrol path.

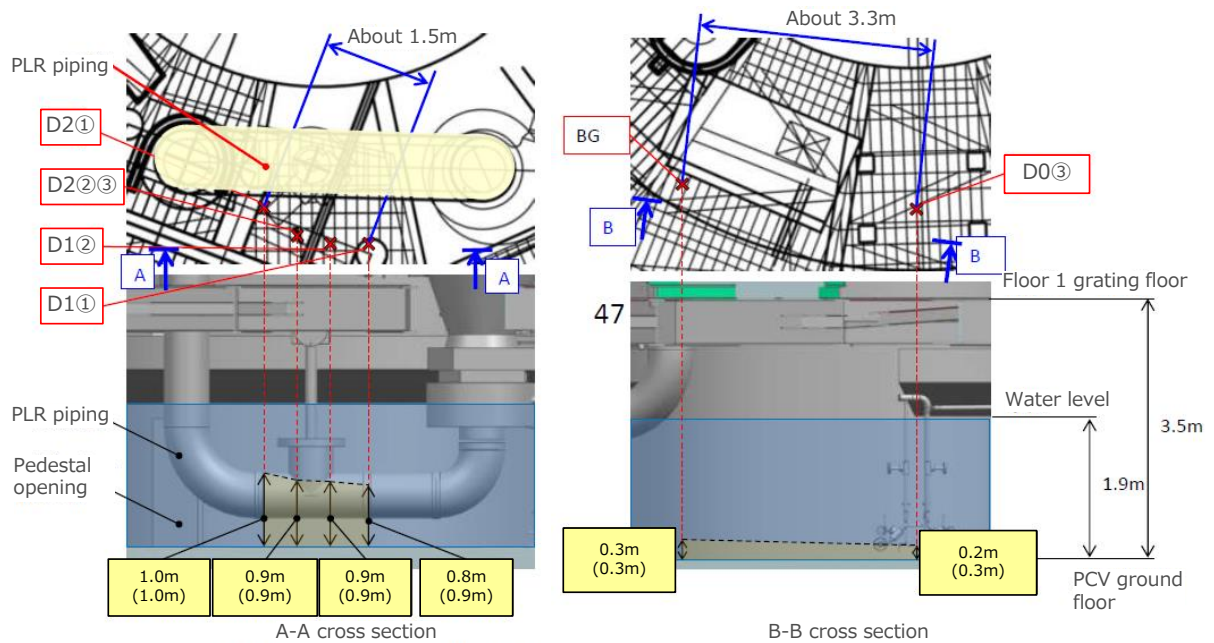
D1 and D2 near the pedestal opening, and 0.2 to 0.3 m at Points BG and D0 away from the pedestal opening. The sediment height was confirmed to be higher closer to the pedestal opening than at a distance from the pedestal opening.

- ※1: Sediment heights estimated from the distance between the sensor and sediment using the structure from motion (SFM) technique and the distance the sensor was lowered
- Numbers in the yellow frames are the sediment heights estimated from photo image analysis
- Numbers in parentheses are the lowest elevation of the sensor
- Sediment thicknesses below the surface are not confirmed

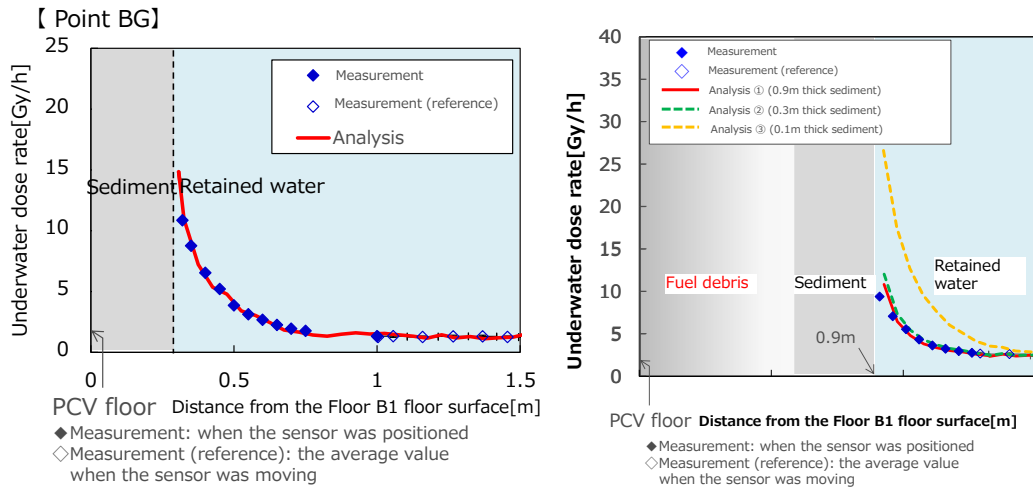
Figure 2-21 Dose rate measurements (Left: at Point BG, Right: Point D2) [2-7]

Dose measurements focused on the relationship between the distance from the sediment surface and its dependence on the dose rate attenuation to investigate the presence of fuel debris under the sediment. The results are seen in Figure 2-21. The blue points in Figure 2-21 (left), representing dose rate measurements at Point BG, confirmed the good agreement with the results of analysis (red line) of a situation when Cs-137 had existed in the sediment surface layer and no fuel debris was in underlayers. It was estimated, therefore, that no or very little fuel debris was present in the sediment underlayers. The same thing was also confirmed at Point D0③.

Figure 2-21 (right) compares, on the other hand, the dose rate measurements at Point D2③, and the results of analysis of a situation when 0.9 m, 0.3 m or 0.1 m thick sediments were assumed to cover the fuel debris. A big difference was evident in the dose rate attenuation behavior between the cases of 0.1 m or 0.3 m thick sediments, but the difference was very minor in the cases of 0.3 m or 0.9 m thick sediments. After all, it could not be confirmed whether fuel debris was present underneath the sediments. This was the case, too, at Points D1 and D2.

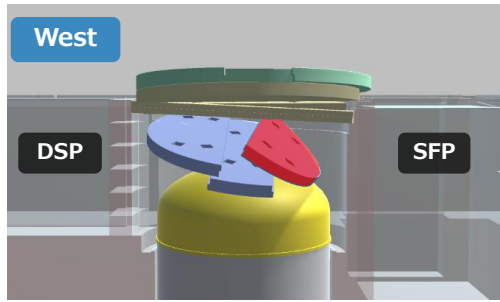
Figure 2-24 An image layout of well-plugs estimated from investigation [2-17]

Figure 2-23 shows the well-plug damage conditions as observed on the operating floor. The position of each well-plug is estimated to have moved, as shown in Figure 2-24. The north piece of the upper well-plug was found to have moved to the west by about 720 mm. The center and north pieces of the upper well-plug were found to have been deformed downward by a maximum of 155 mm and 84 mm, respectively.

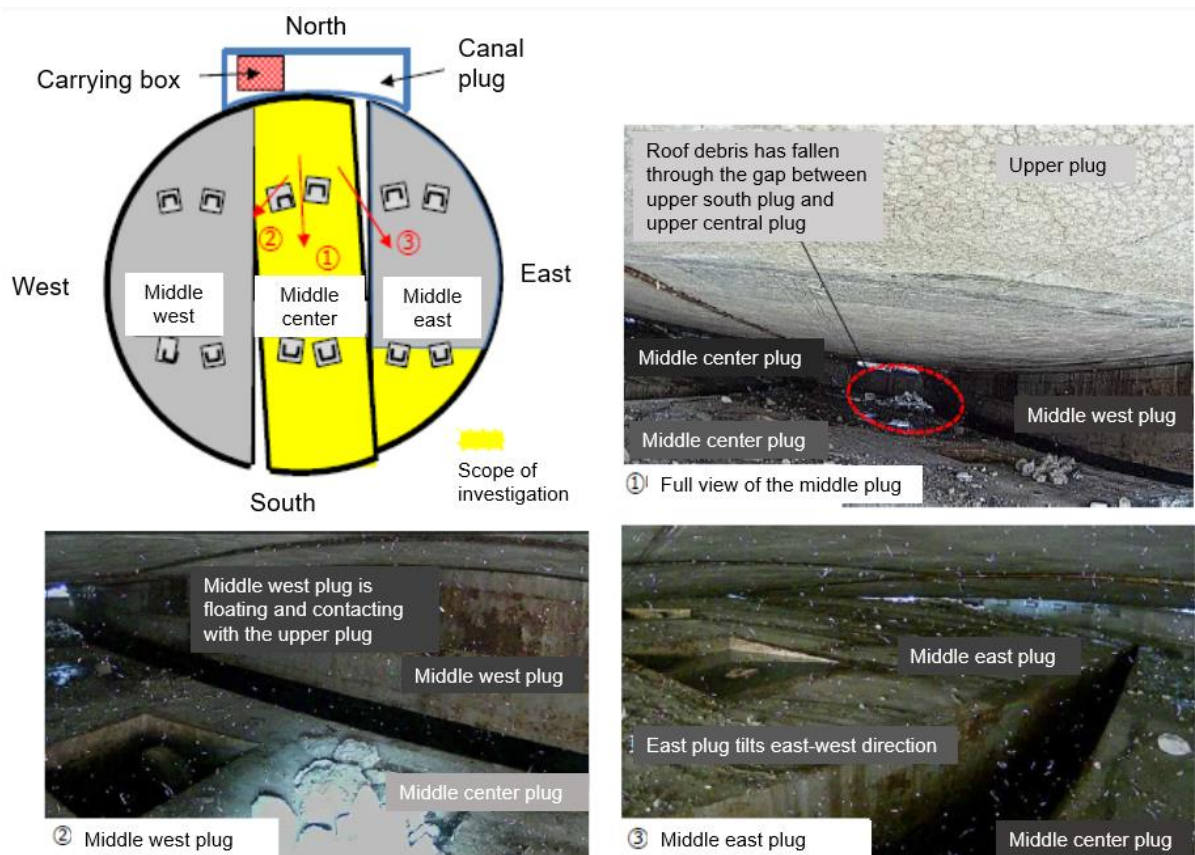
Figure 2-28 Confirmation of middle plug status [2-19]

The investigation consisted of suspending the camera from the point where the well-plug was tilted, 3D measurement, dose rate measurement, and smear sampling. As a result of the investigation, the status of the middle and lower plugs was confirmed. The results of Figures 2-28 and 2-29 confirmed the positional relationship between the upper and middle plugs, the inclination of the plugs, and the condition of the lower plug. 3D measurements of the lower surface of the upper plug, the upper surface of the middle plug, and a part of the west side of the lower plug were

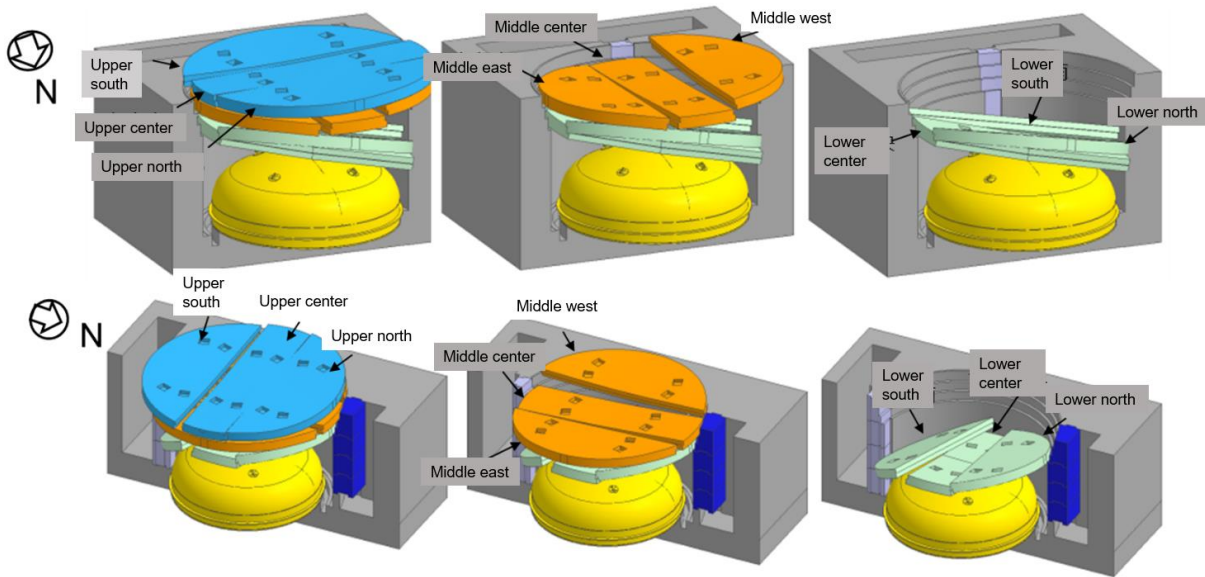
Figure 2-30 3D measurement results of well-plug [2-20]

conducted to the extent possible, and it was confirmed that the plug had such deformations as a deflection (Figure 2-30).

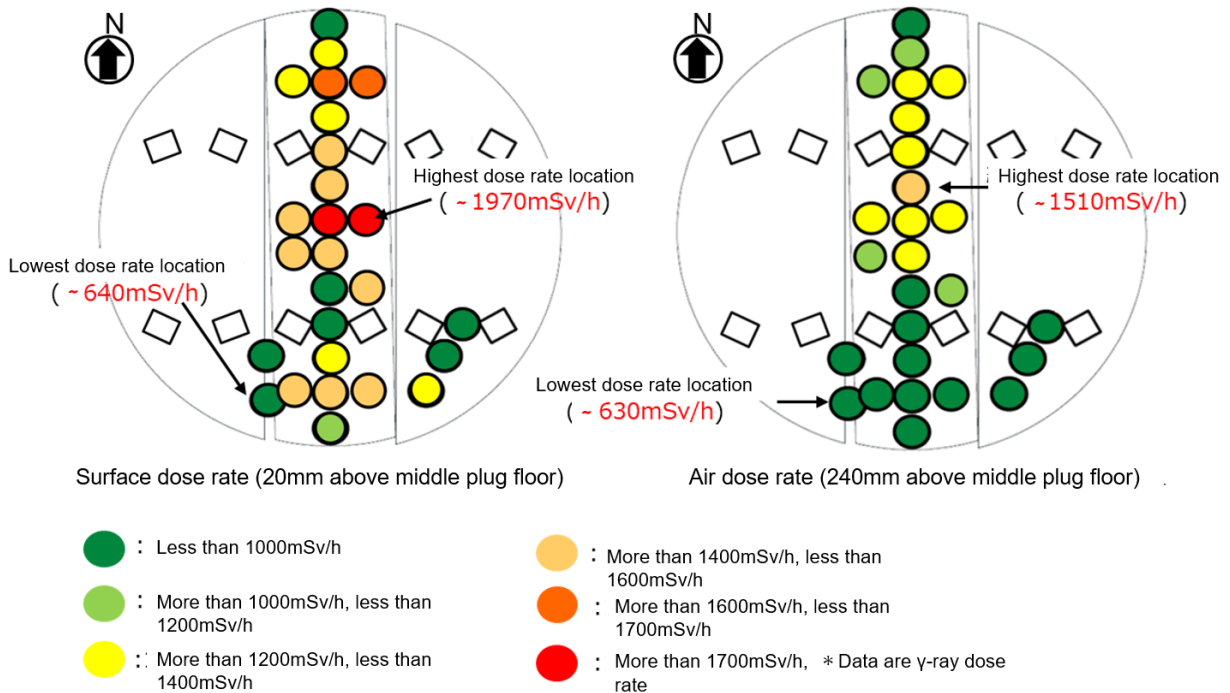
Figure 2-32 Dose rate measurement on the middle plug [2-20]

In the air dose rate measurements, the dose rate tended to be higher near the center of the middle plug and lower toward the outer periphery. On the other hand, surface dose rates varied widely. This is presumably due to the contribution of roof debris falling through gaps in the upper plug and runoff to the lower part of the plug due to rainwater intrusion (Figures 2-32 and 2-33).

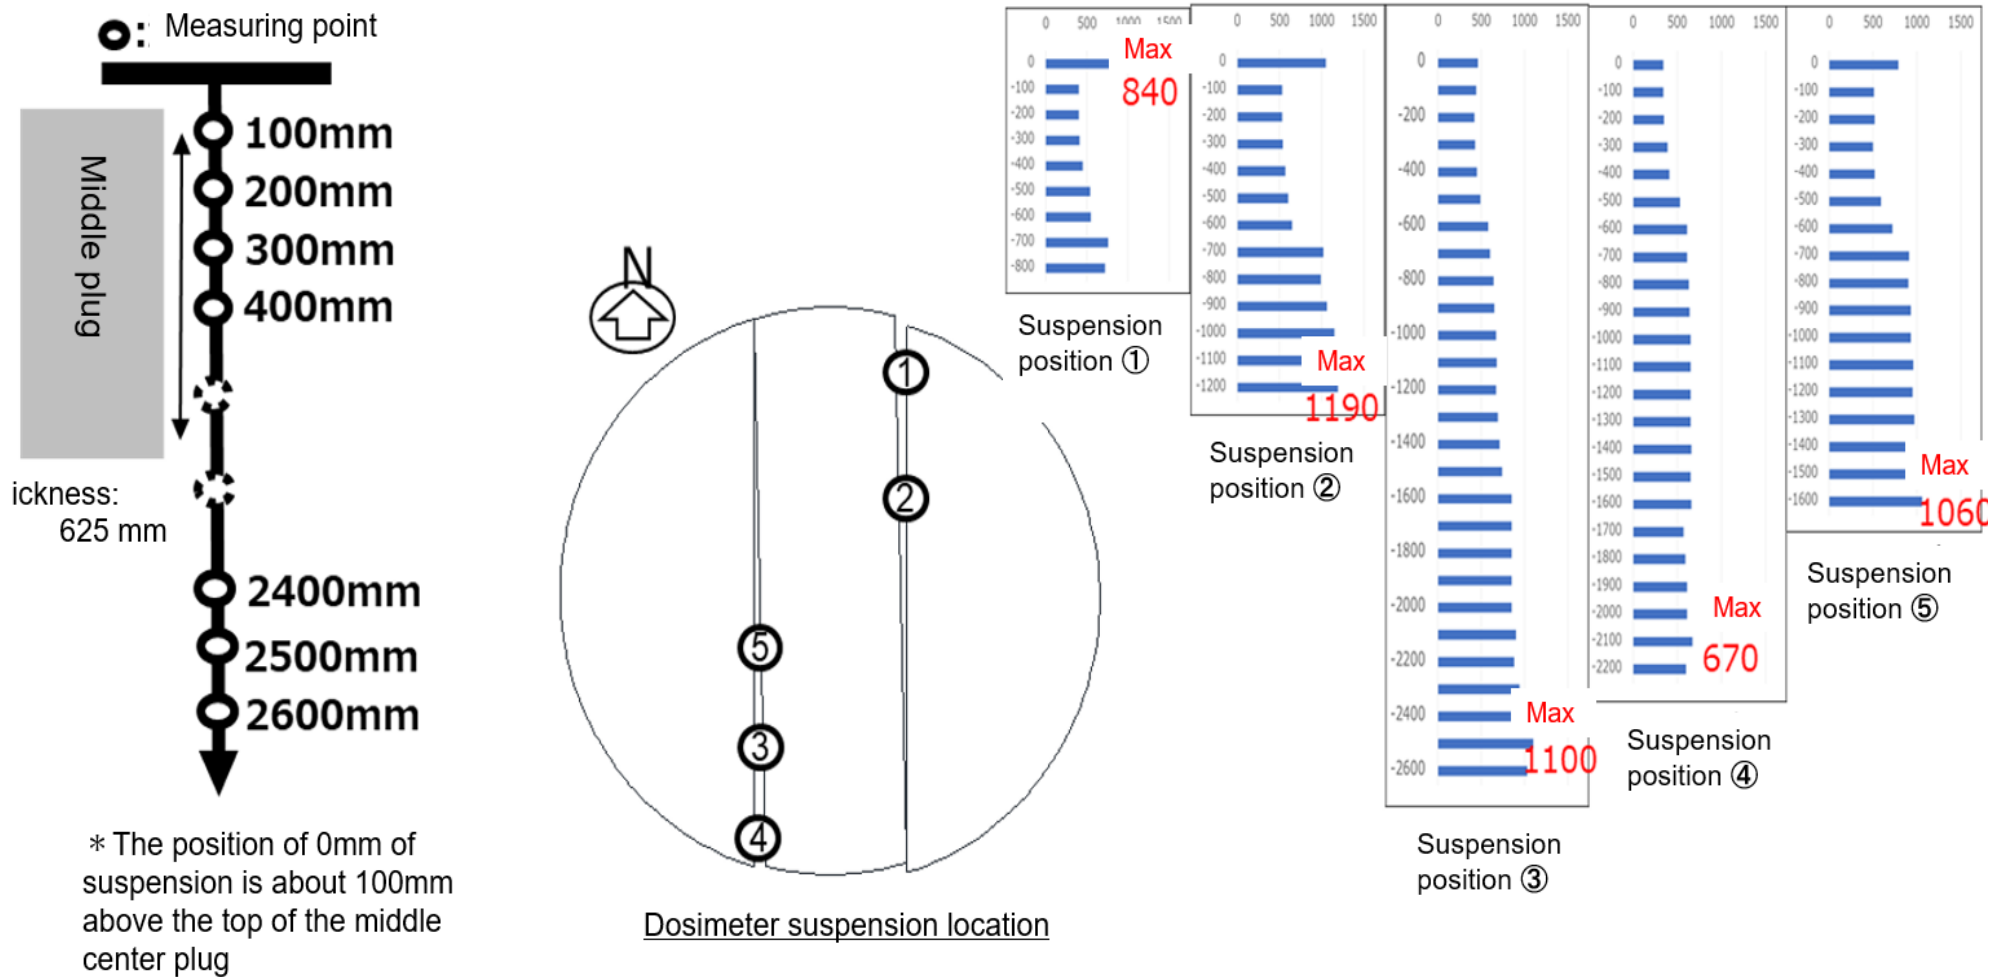
Figure 2-34 Result of dose rate measurement between middle plug and lower plug [2-20]

In Figure 2-34, air dose rates were measured by hanging a dosimeter in the gap between the middle plugs. The dose rate tended to be higher below the middle plug at each measurement location.

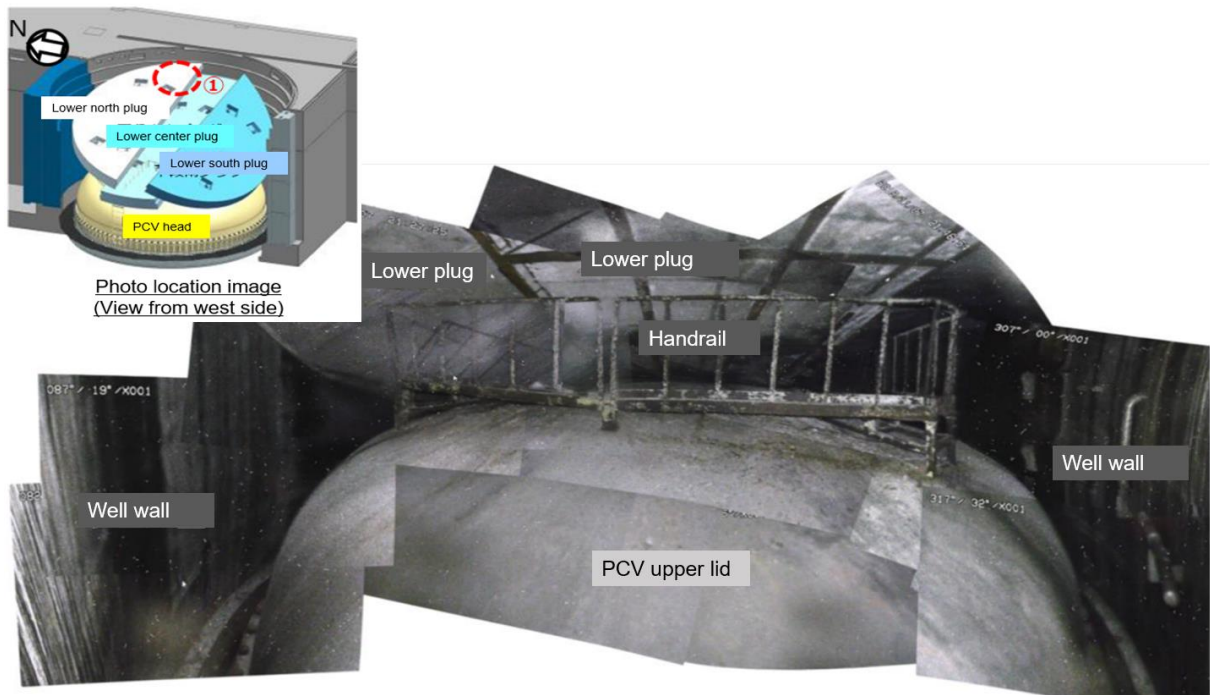
Figure 2-36 Status of the upper part of the PCV upper lid (multiple photos superimposed): View from the east side [2-22]

In parallel with the work to construct an access route for the investigation inside the containment vessel of Unit-1, the status of the flange of the PCV top head (PCV upper lid), which is estimated to have been the main leakage path during the accident, was confirmed in November 2019. Video images were obtained of the situation inside the reactor cavity (well), and no significant damage to the PCV top head or other parts was observed (Figure 2- 36). No significant damage or major deformation was observed in the flange section as well, although there was some deterioration of the paint (Figure 2-37). Since high contamination was estimated from the white noise in the video, leakage from the flange was considered to have occurred under the high PCV pressure conditions at the time of the accident.

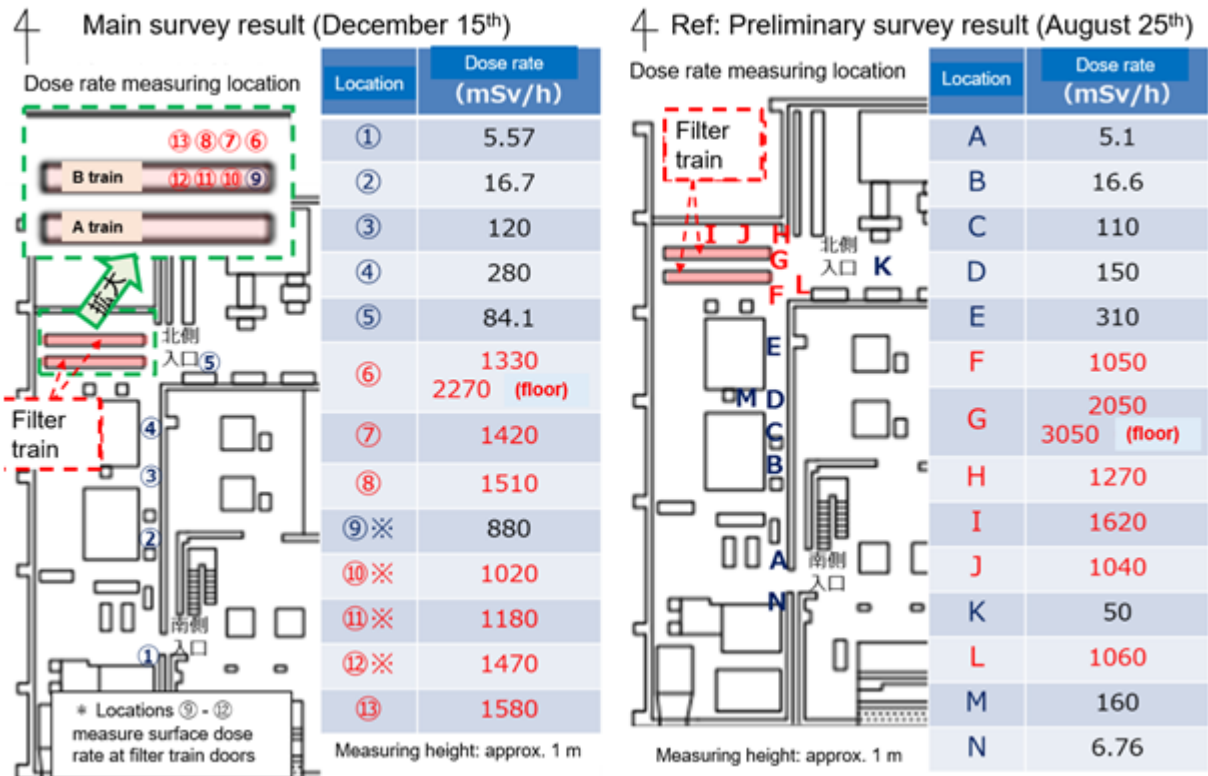
Figure 2-39 Results of air dose rate measurements in the SGTS room [2-24]

As a survey related to Unit-1/Issue-10, dose rate measurements of the Unit-1 SGTS room and filter train were conducted in December 2020 using a remotely operated robot. The results of the dose rate measurements in the room confirmed high air dose rates of about 1500 mSv/h in the vicinity of the filter train, and surface dose rates at the filter train door increased toward the downstream side of the train (Figure 2-39). In addition, γ imaging measurements confirmed contamination along the SGTS piping connected to the vent line (Figure 2-40). These results clearly indicated that Unit-1 had a backflow of vent gas into its own unit.

In addition, a survey conducted by the Nuclear Regulation Authority in January 2022 confirmed dose rates of up to 3380 mSv/h in the SGTS room and 1140 mSv/h near the filter train. [2-23]

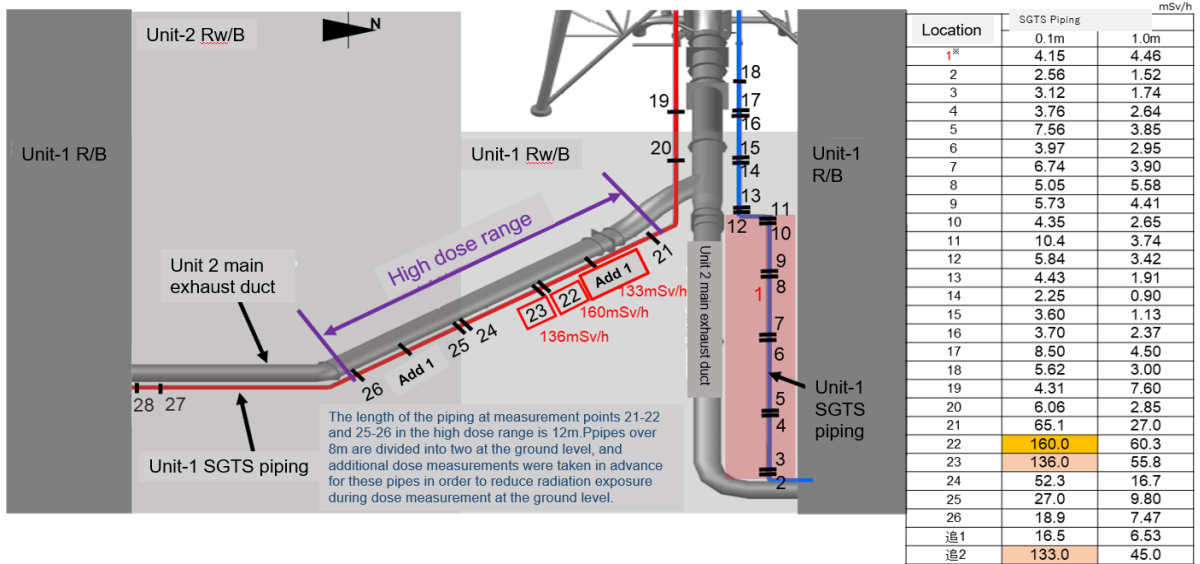
Figure 2-45 SGTS piping dose rate survey results (conducted in 2021) [2-26]

In May 2021, another SGTS piping dose rate survey was conducted, and the results showed that the Unit-2 side was higher and the Unit-1 side was lower, similar to the results of the 2020 survey (Figure 2-45). This trend is assumed to be due to the fact that the SGTS system (filters, rupture disks, etc.) in the reactor building in Unit-2 acted as resistance to the Unit-1 piping, which had a faster venting flow velocity, suppressing the flow velocity and causing retention.

* The area with the highest radiation dose is near the top 3.0m inside the red frame.

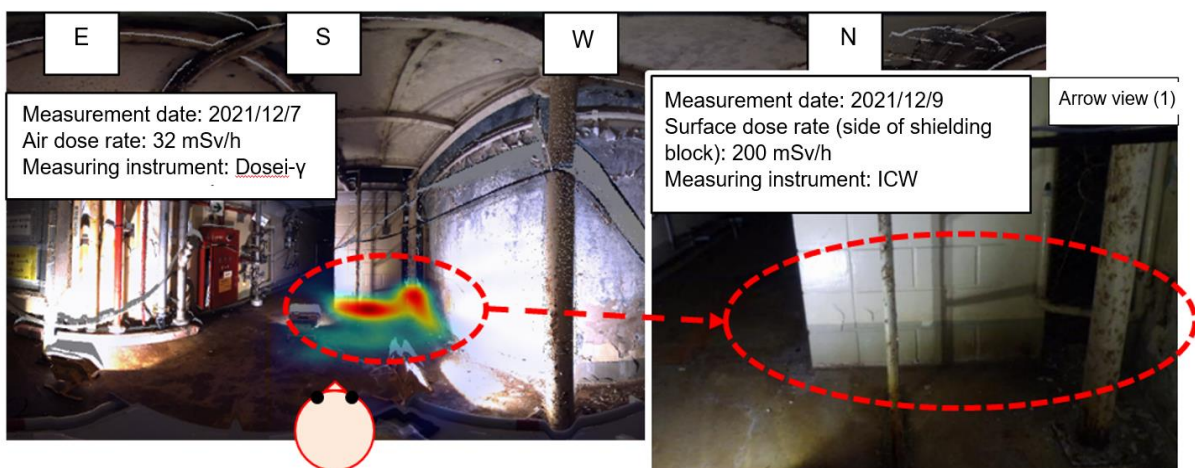
Fig. 2-46 γ imaging measurement results (inside the shielding block of the 3rd floor east side) [2-27]

As a result of the γ imaging measurements, a hot spot was confirmed on the floor inside the shielding block where the AC piping (D/W vent piping) and D/W vent valve were installed on the east side of the third floor (Figure 2-46). As a possible cause of hot spots, gases in the D/W leaked from the PCV penetration or the D/W vent valve to the building side due to the D/W pressure increase and high temperature caused by hydrogen formation, and radioactive materials may have adhered to the floor surface after condensing inside the shielding block.

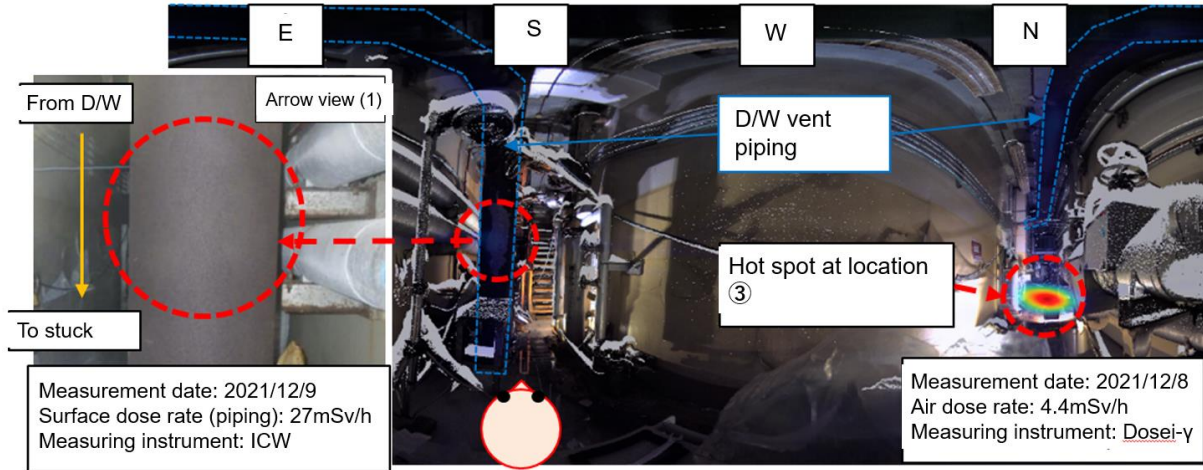
Figure 2-47 γ imaging measurement results (3rd floor east side AC piping (D/W vent piping)) [2-27]

The D/W vent piping on the east side of the third floor is connected to the S/C vent piping used during the accident. Since rust was confirmed on the surface of the piping during a previous survey, the condition of the piping and its contamination were confirmed (Figure 2-47). It was further confirmed that the dose rate was high along the piping, and it was presumed that the inside of the piping was contaminated. The cause of the contamination was estimated to be that although the D/W vent valve was closed, some of the gas in the D/W might have leaked downstream from the valve or some of the S/C vent gas might have flowed into the piping due to the D/W pressure increase and high temperature. Unlike the surrounding piping, rust was observed on the entire surface of the D/W vent piping. As a possible cause of the rust, it was estimated that the rust may have occurred due to deterioration of the piping coating because of the passage of high temperature gas and the heat generated by radioactive materials adhering to the inner surface.

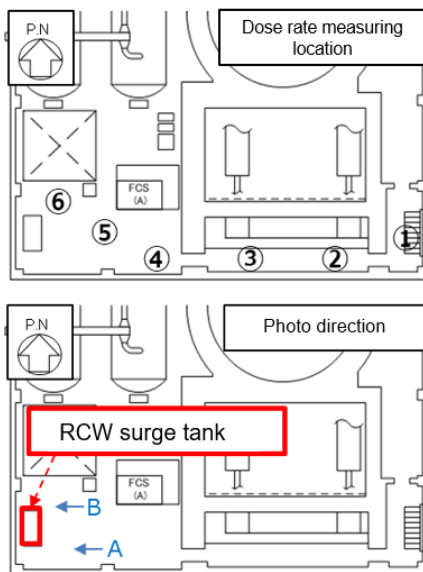
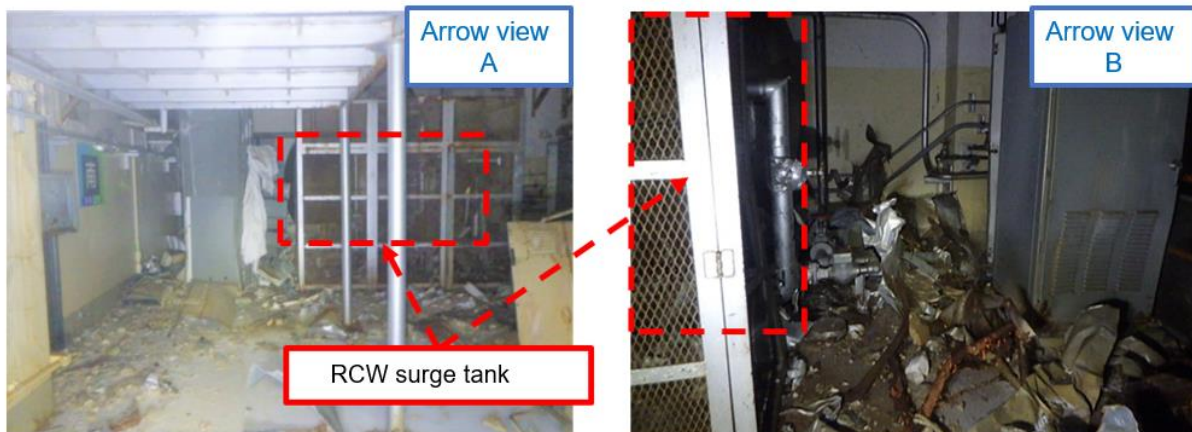
Figure 2-48 Status around the RCW surge tank on the west side of the 4th floor [2-27]

This time, as a result of investigating the area around the RCW surge tank again, it was confirmed that the dose rate in the area was high (Figure 2-48).

Location No.	Air dose rate [mSv/h]
①	7.5
②	1.0
③	1.0
④	6.0
⑤	20
⑥	21

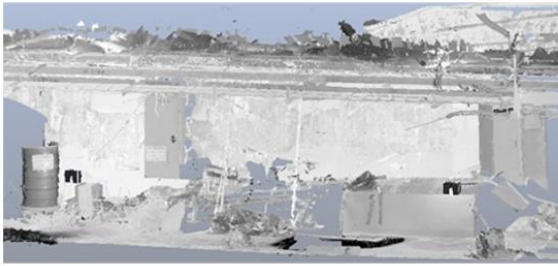
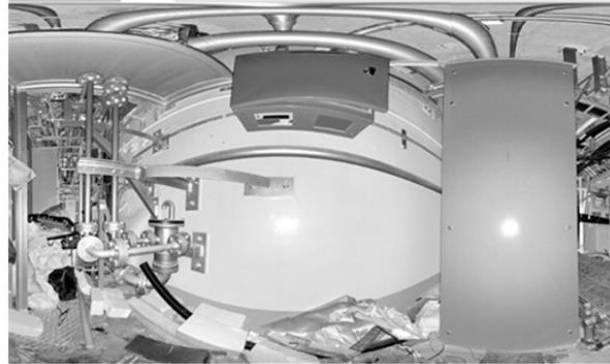
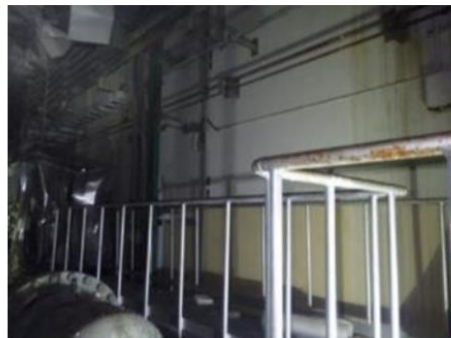
Figure 2-49 Survey results of reactor shell wall and pool wall [2-27]

In addition, in order to obtain information that would contribute to the evaluation of the integrity of the reactor building, condition survey and point cloud data acquisition using a 3D scanning device were conducted on the reactor shell walls on the west, north, and east sides of the third floor and the pool wall on the southwest side of the fourth floor (Figure 2-49). As a result of the survey, peeling paint and cracks were observed in some areas, but no damage or signs of aging deterioration (e.g., peeling of surface concrete and rust) that could lead to a decrease in seismic performance were observed.

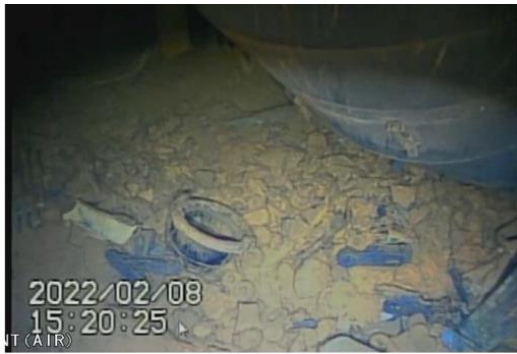
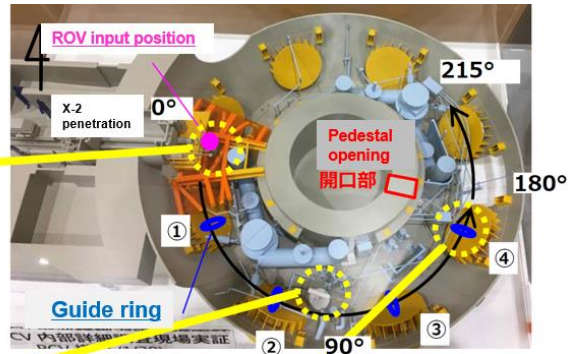
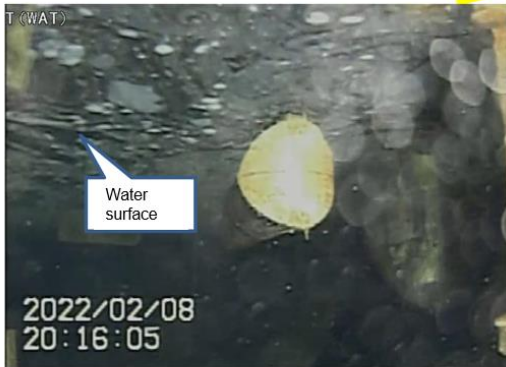
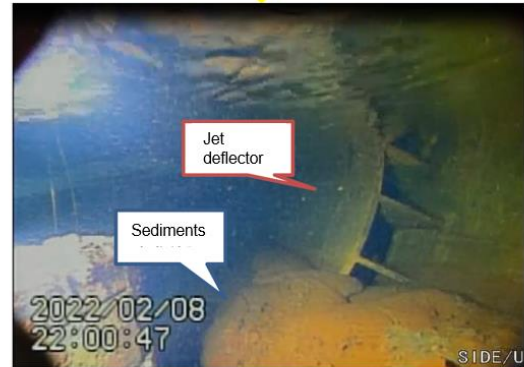
Figure 2-50 PCV interior as confirmed by the underwater ROV-A [2-29]

In February 2022, a guide ring (a ring to prevent cable entanglement of the underwater ROV) was installed using the underwater ROV-A prior to the survey. At that time, floating material on the water surface and sediments at the bottom of the PCV were identified (Figures 2-50 and 2-51). In addition, the condition inside the pedestal opening was checked from near or around the opening, and massive sediments and what appeared to be rebar were confirmed (Figure 2-52).

Floating material on water surface

Sediments near jet deflector ④

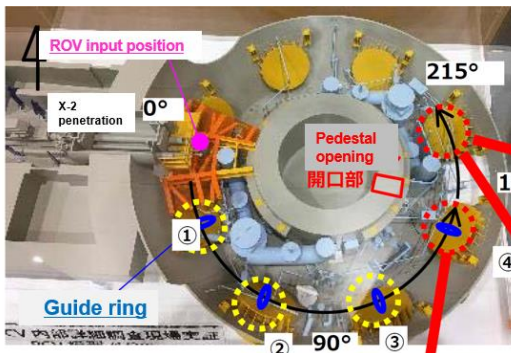
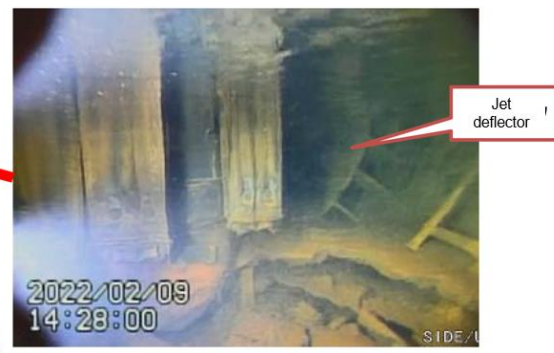
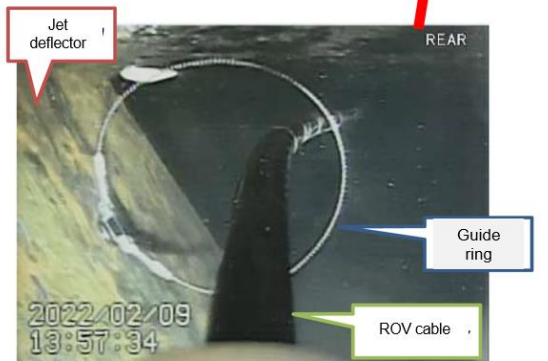
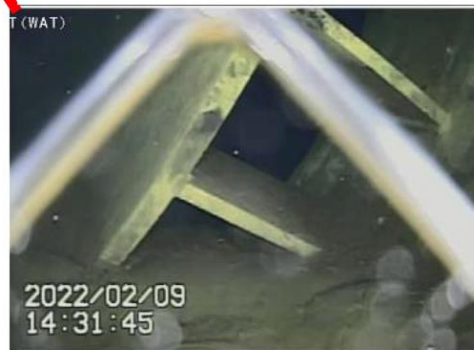
Figure 2-51 Installation status of guide ring (4) and PCV east-northeast (215°) [2-30]

Status near east-northeast of PCV (overhead view)

Status near east-northeast of PCV (close-up)

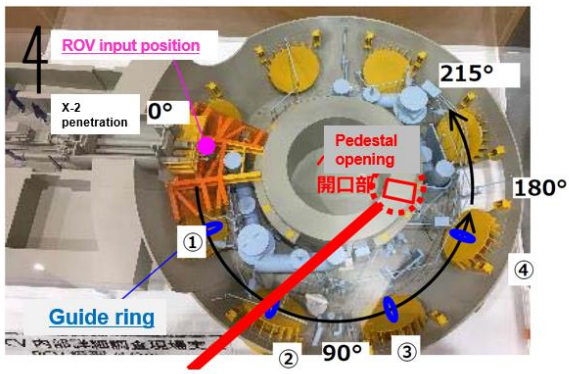
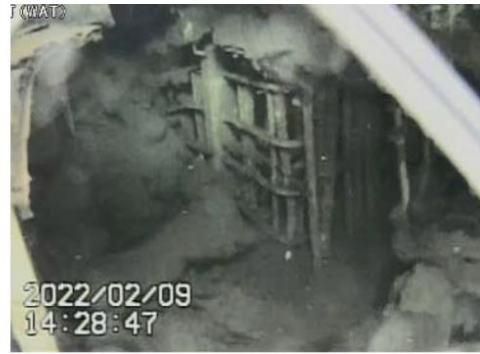
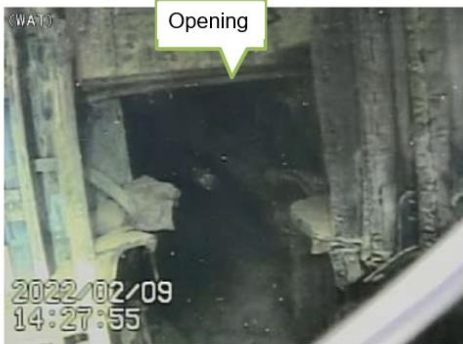
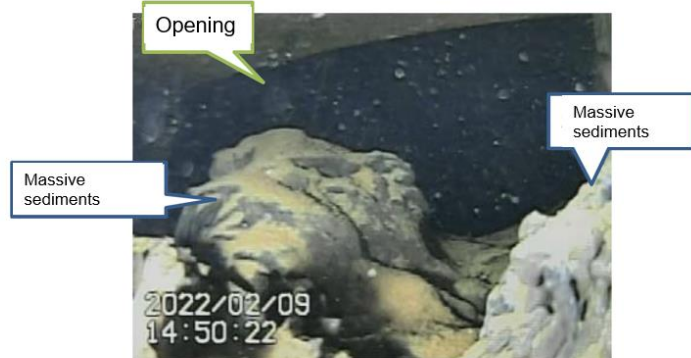
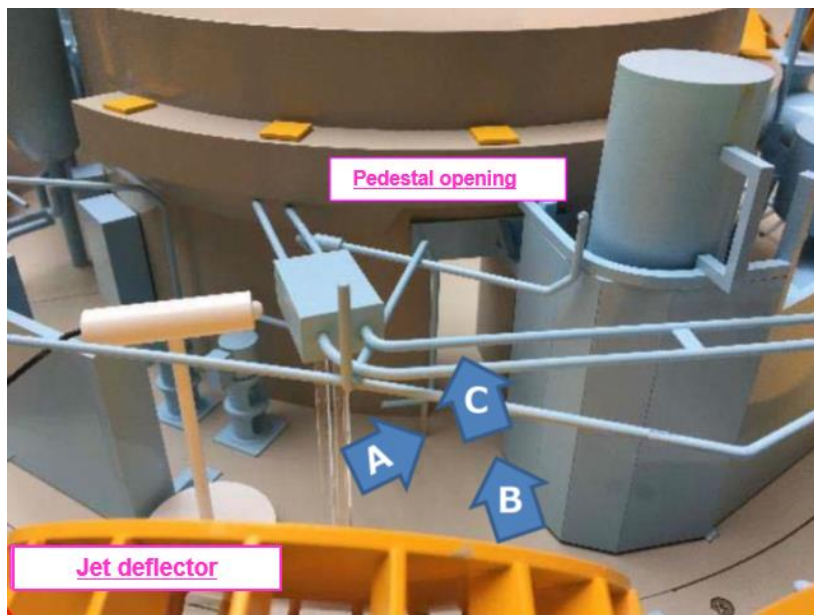
Figure 2-52 Survey status near the pedestal opening [2-30]

A. Near pedestal opening

B. Overhead view of pedestal opening

C. Inside the pedestal opening

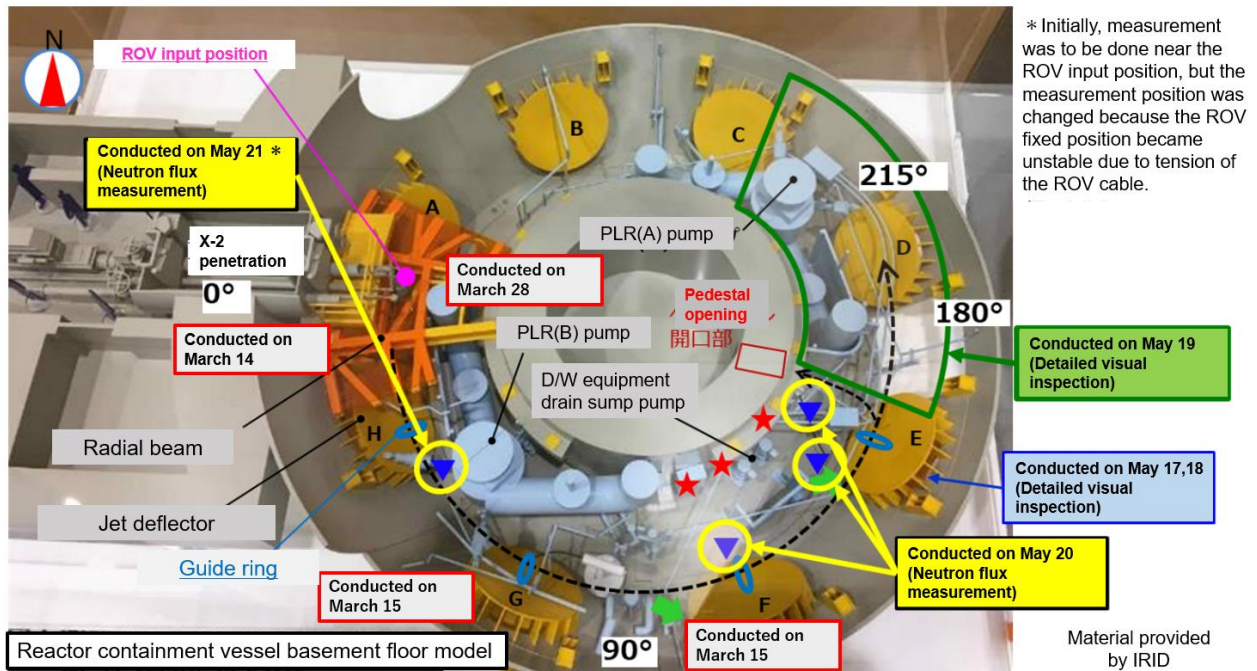
Figure 2-53 Survey area by underwater ROV-A2 [2-31]

From March to May 2022, the underwater ROV-A2 was used to investigate the condition of the existing structures around the pedestal, the spread of sediment, etc., and make neutron flux measurements of the sediment. The survey area is shown in Figure 2-53.

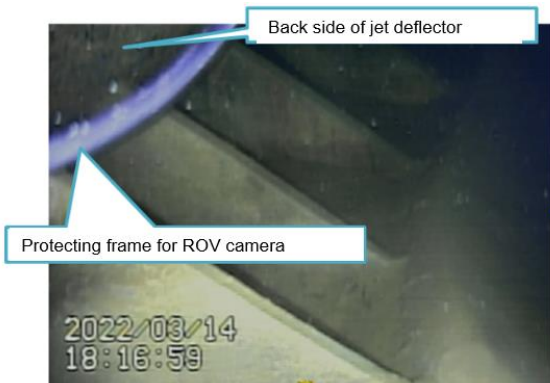
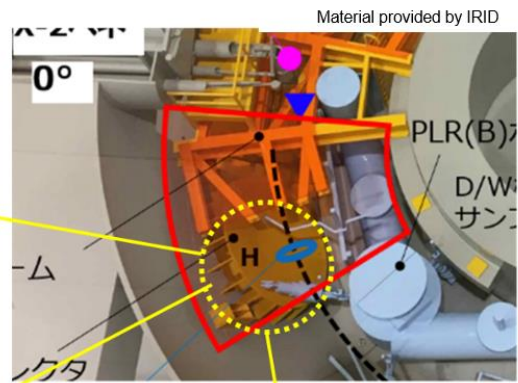
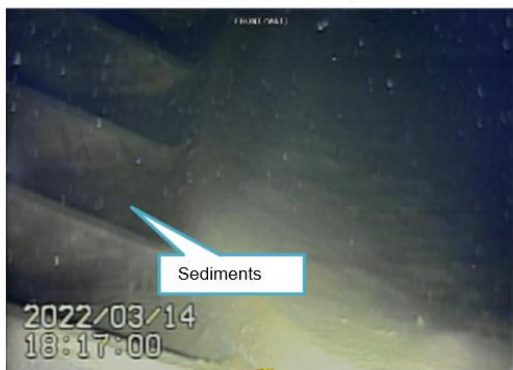
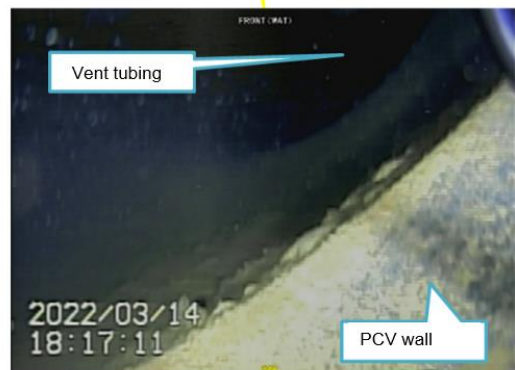
Figure 2-55 Status near the jet deflector (H) [2-32]

- Sediments were observed behind the jet deflectors (H, G, F, E, D) (on the side of the pressure suppression chamber) (Figures 2-55, 2-56, 2-58, 2-65, and 2-70).

Photo 1. Status near jet deflector (H) back side ①

Photo 2. Status near jet deflector (H) back side ②

Photo 3. Status near jet deflector (H) back side ③
