Status of investigation on estimating situation of cores and containment vessels

1. Introduction

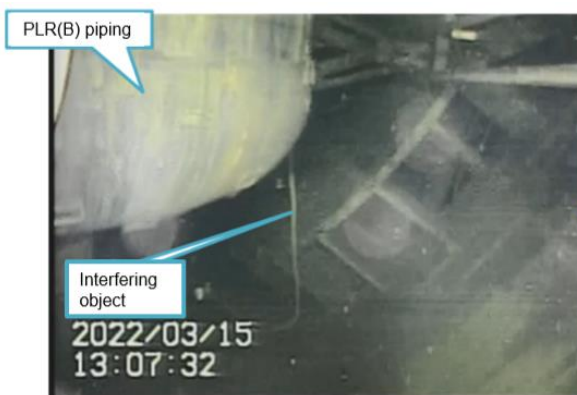
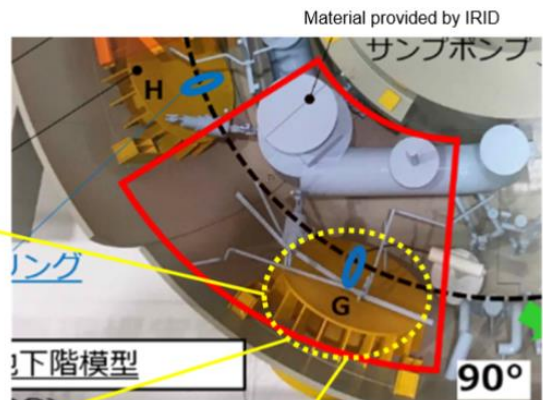
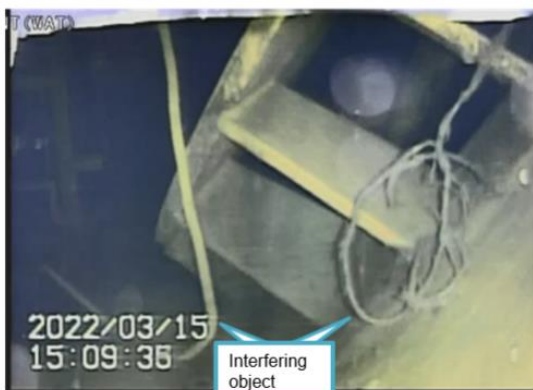
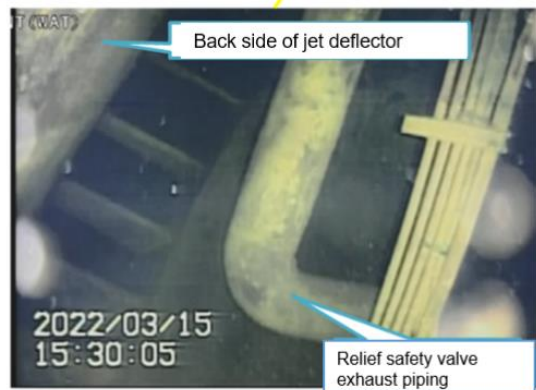
Figure 2-56 Status near the jet deflector (G) [2-32]

- Sediments were observed behind the jet deflectors (H, G, F, E, D) (on the side of the pressure suppression chamber) (Figures 2-55, 2-56, 2-58, 2-65, and 2-70).

- An interfering object was observed near the jet deflector (G) (Figures 2-56 and 2-57).
- The bottom of the jet deflector (A) was visible, and the height of sediments near the jet deflector (A) was lower than that near the worker access (Figure 2-60, Photo 2).

Photo 1. Overhead view of jet deflector (G)

Photo 2. Status near jet deflector (G)

Photo 3. Status of jet deflector (G) back side

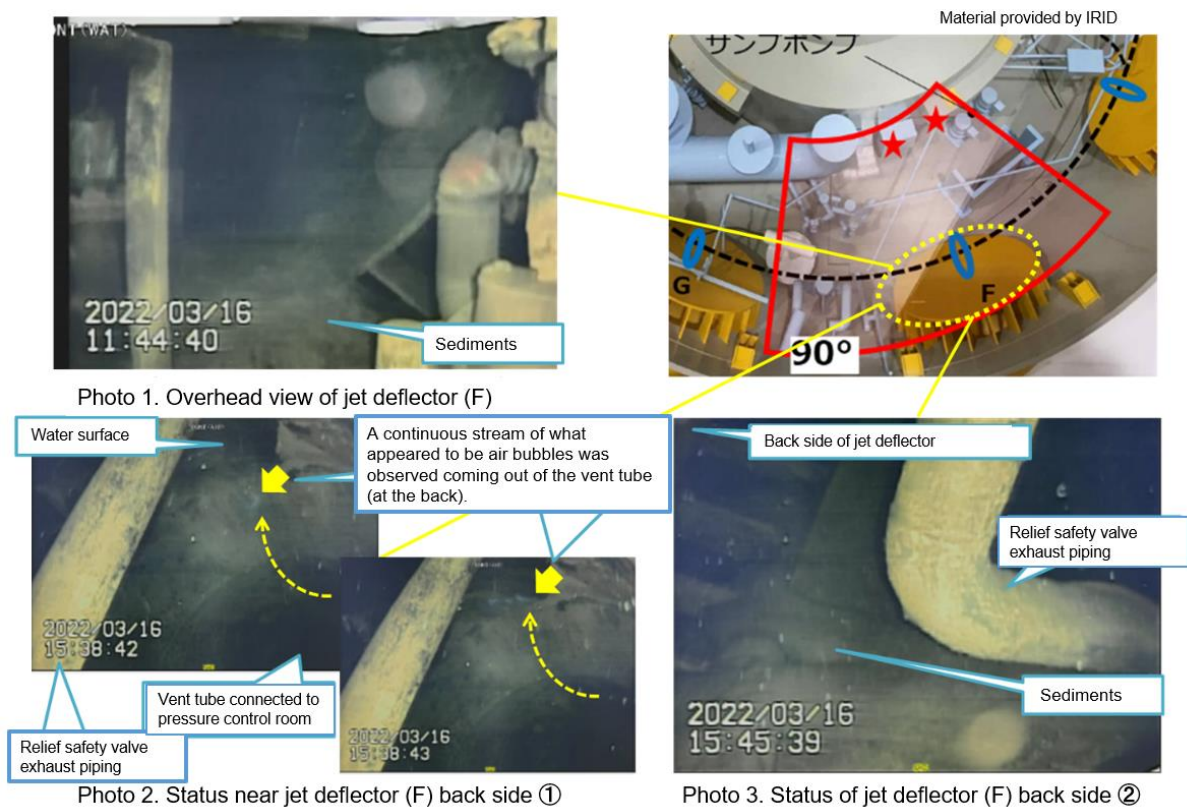
Figure 2-58 Status near the jet deflector (F) [2-32]

- On the back side of the jet deflector (F) (suppression chamber side), bubbles were observed to be coming out continuously from the vent pipe connected to the pressure suppression chamber (Figure 2-58, Photo 2).

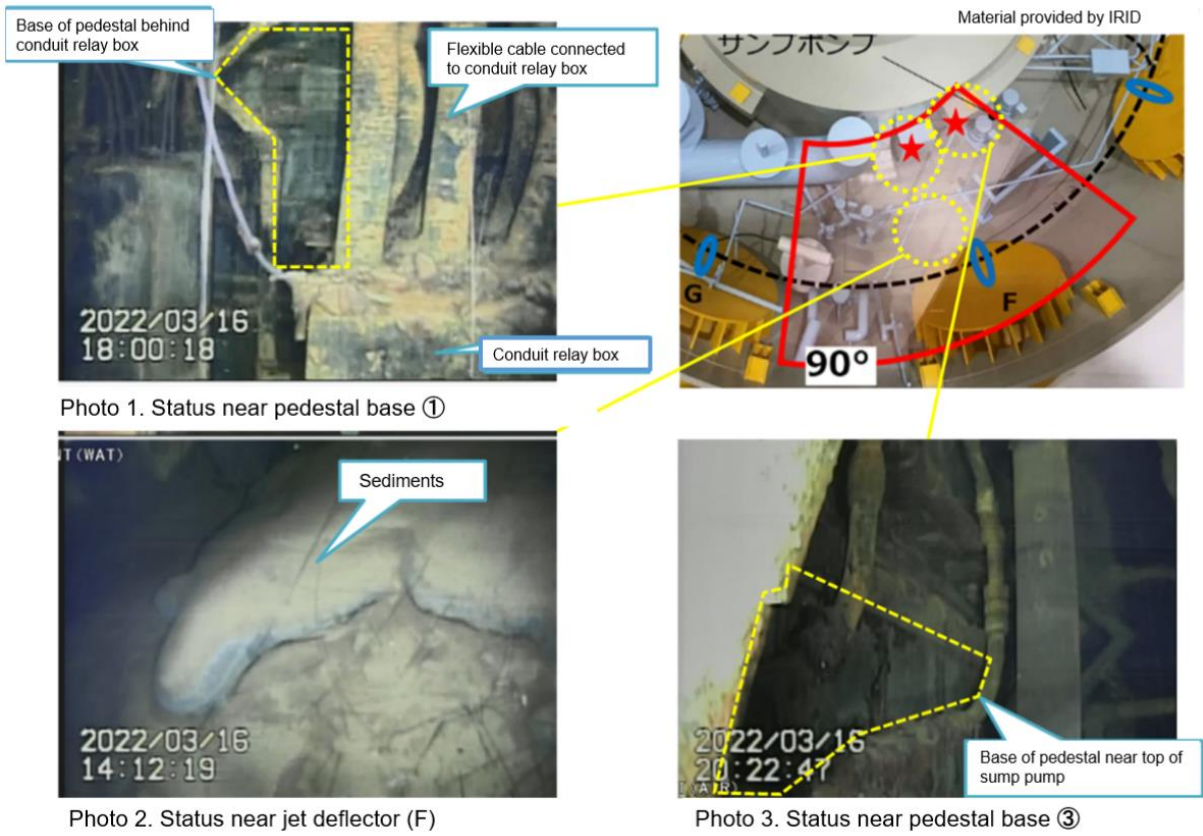
Figure 2-59 Status near the pedestal and near the jet deflector (F) [2-32]

- Sediments were observed below the lead wool mats near the inlet valve of the PLR (B) (bottom of the PCV) and near the jet deflector (F) (Figure 2-54, Photo 3; Figure 2-59, Photo 2).

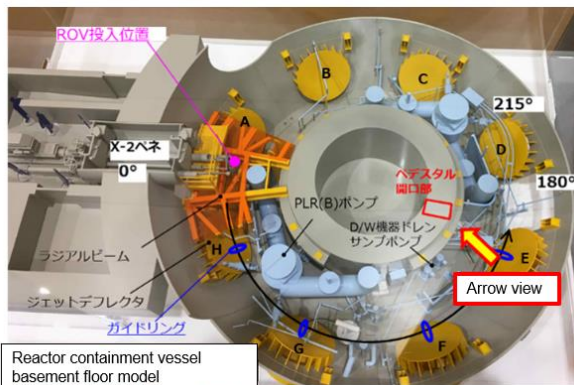
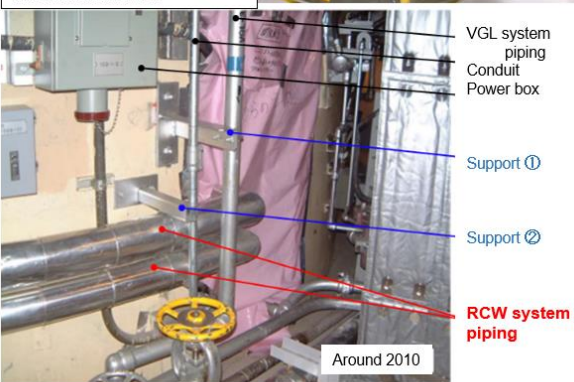
Figure 2-62 RCW system piping near pedestal opening [2-34]

- The piping was missing near the pedestal opening where the RCW system piping was presumed to have been installed (Figure 2- 62).
- It was confirmed that the sediments at the bottom of the PCV near the equipment drain sump formed upper and lower layers, leaving the interior hollow (Figures 2-63 and 2-64, and Figures 2-66 to 2-68).

Confirmed high dose in the RCW system in the reactor building of Unit 1
 ⇒ It was presumed that the radioactive materials inside the PCV flowed back into the RCW system due to the damage to the RCW piping inside the PCV.

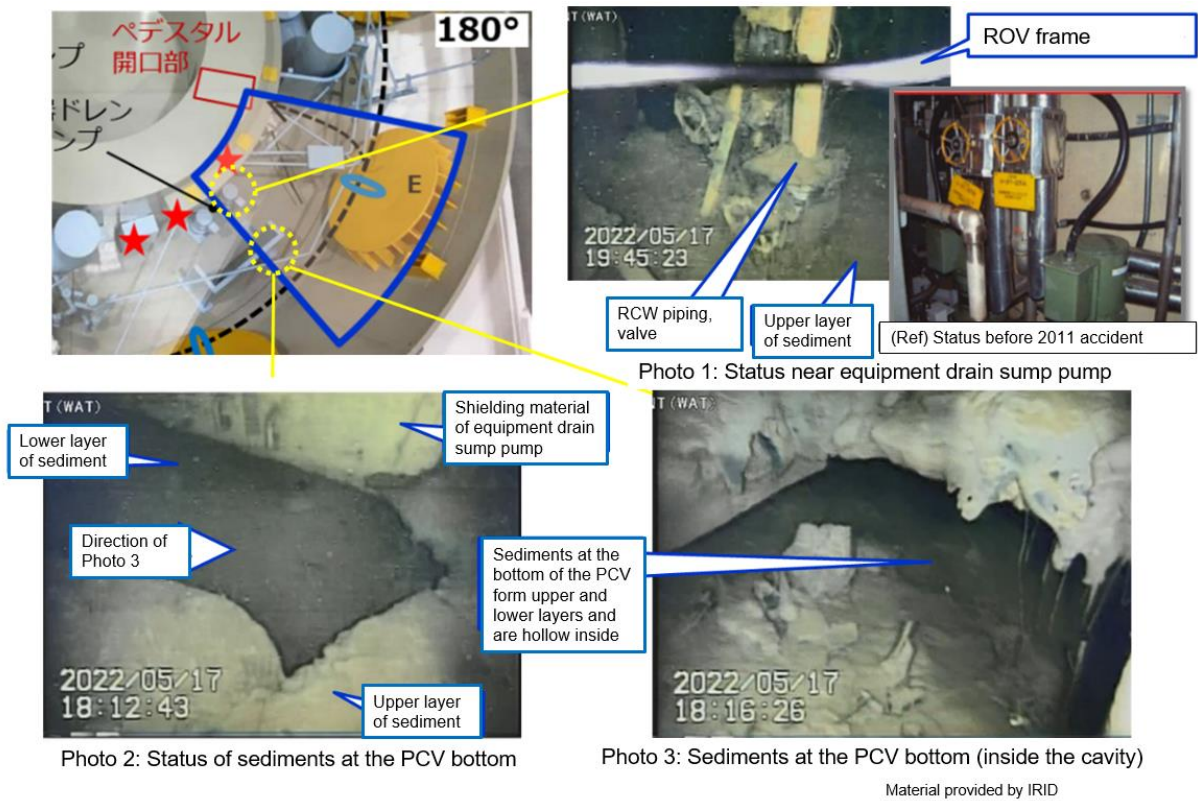
Figure 2-64 Status near the pedestal [2-31]

- The concrete near the pedestal opening (base) was found to have exposed pedestal rebar and inner skirt (Figure 2-64 and Figures 2-66 to 2-69).
- The sediments at the pedestal opening (base) had upper and lower layers with a hollow interior, and the rebar of the pedestal base was exposed in the hollow. The pedestal base remained above the upper layer (Figures 2-59, 2-64, and 2-68).
- Multiple bulky deposits were observed at the pedestal opening (in front of the interior) (Figure 2-69).
- In the vicinity of the jet deflector (C), sediments were observed (Figure 2-70).

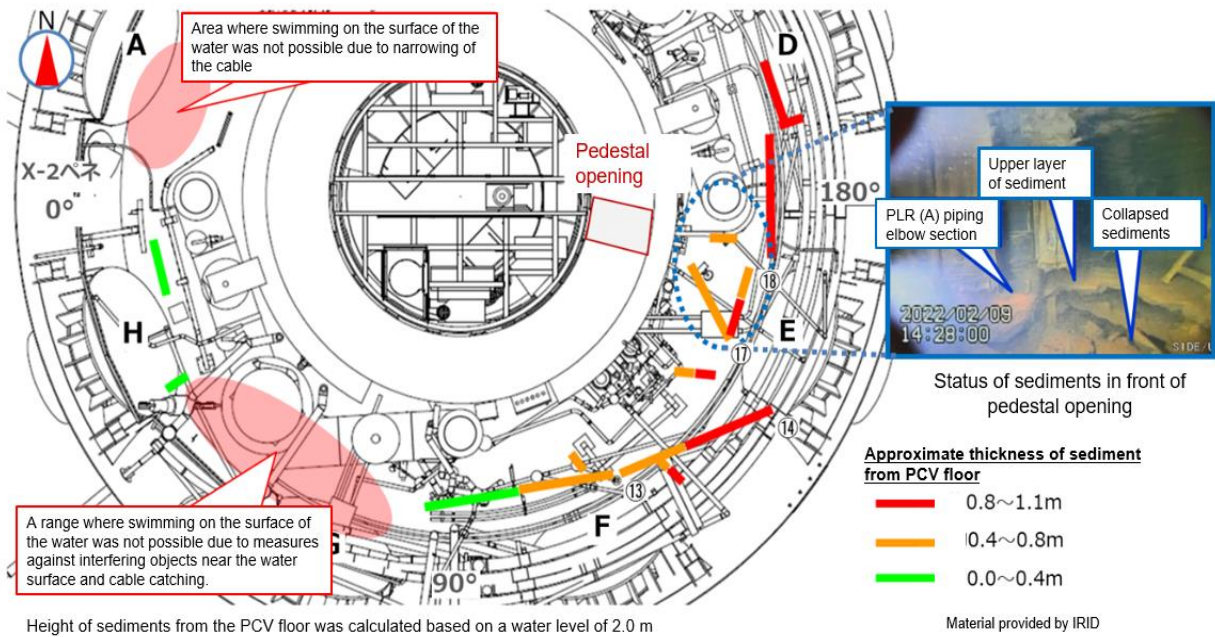
Figure 2-73 Evaluation results for survey points 13-14 [2-35]

As a survey point that characterizes the state of the deposits, a cavity was confirmed from the survey video at ⑬-⑭ in Figure 2-72, and the measurement results also confirmed a difference in level in the cavity (Figure 2-73). At ⑰-⑱ in Figure 2-72, the collapsed deposits were confirmed from the survey videos, and the unevenness of the collapsed deposits was also confirmed in the measurement results (Figure 2-74).

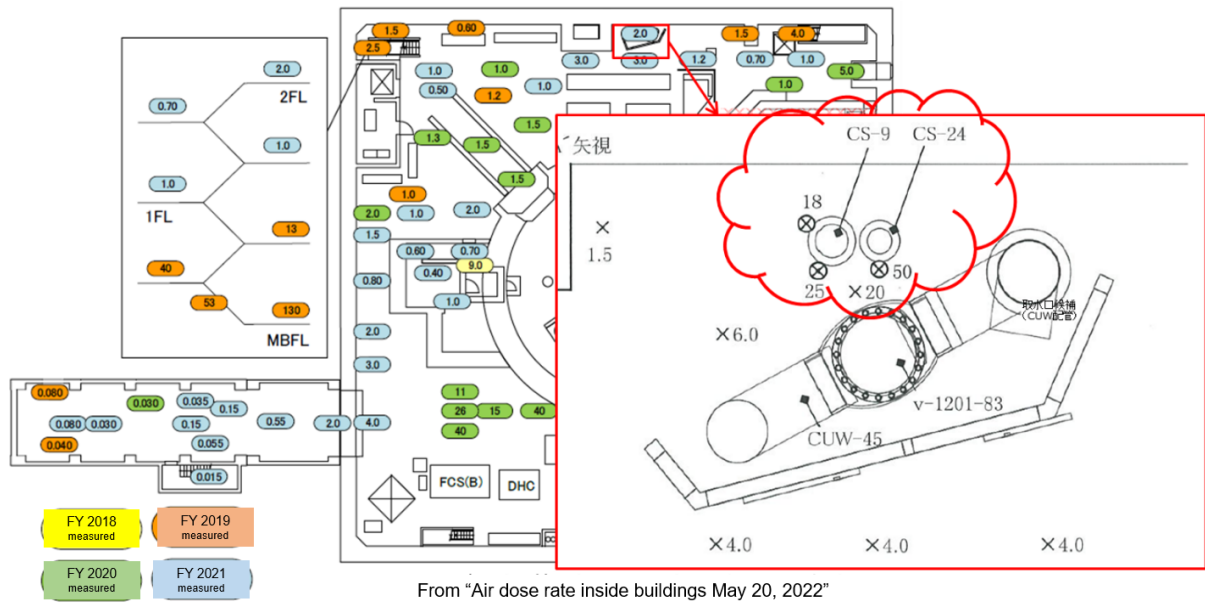
Figure 2-76 System status of CS (A) system piping [2-36]

The reason for the high dose rate in the abovementioned piping is assumed to be the migration of fission products (FPs) from the RPV or S/C. Since CS-24 had a higher dose rate than CS-9*, where FPs could easily migrate from the RPV, FP migration from S/C is considered (Figure 2-76).

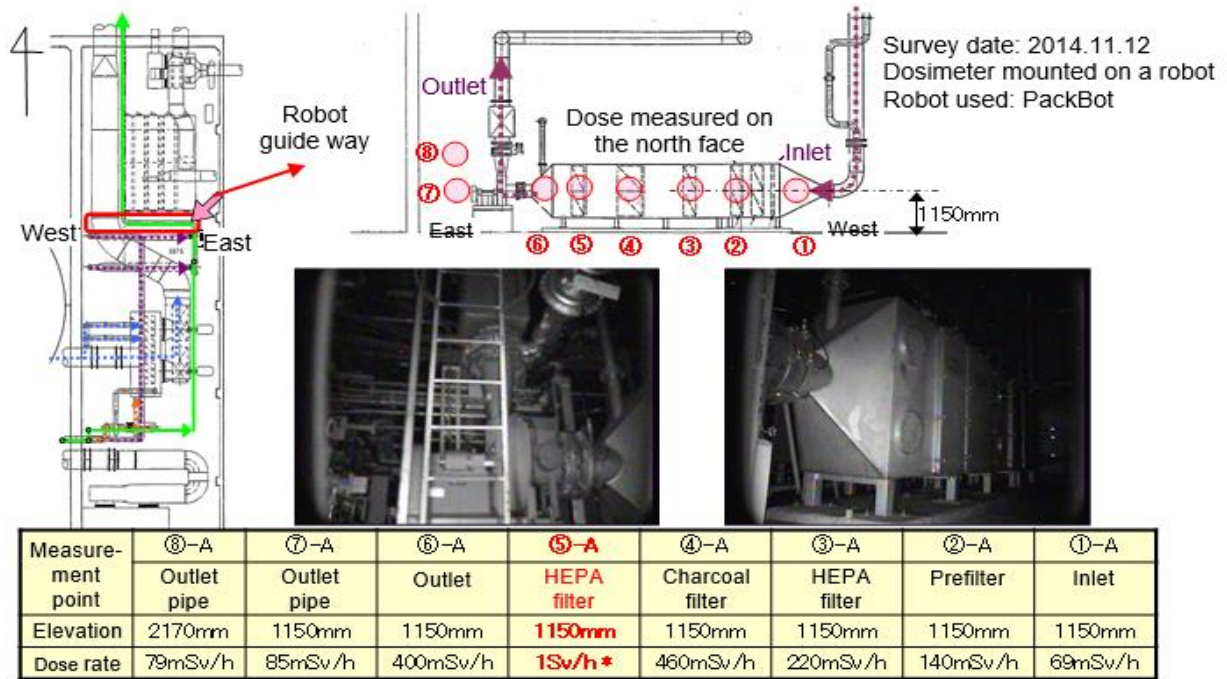
Figure 3-10 Radiation level observed (SGTS filter (A))

Figures 3-10 and 3-11 show the radiation measurement results around the SGTS filters (A) and (B), respectively. For both filters (A) and (B), radiation levels as high as about 1Sv/h were obtained. The maximum contamination has been observed on the HEPA filter at the SGTS filter outlet. Generally, the SGTS filter captures radioactive materials from its inlet side, which means that the results observed may indicate the gas containing the radioactive materials flowed into the SGTS filter from the opposite direction (backward flow). As clearly recognizable from Figure 3-8, there are two possible paths for this backward flow: from the Unit-2 venting line and the Unit-1 venting line (this is the same situation as having occurred when hydrogen gas flowed backward from Unit-3 to Unit-4).

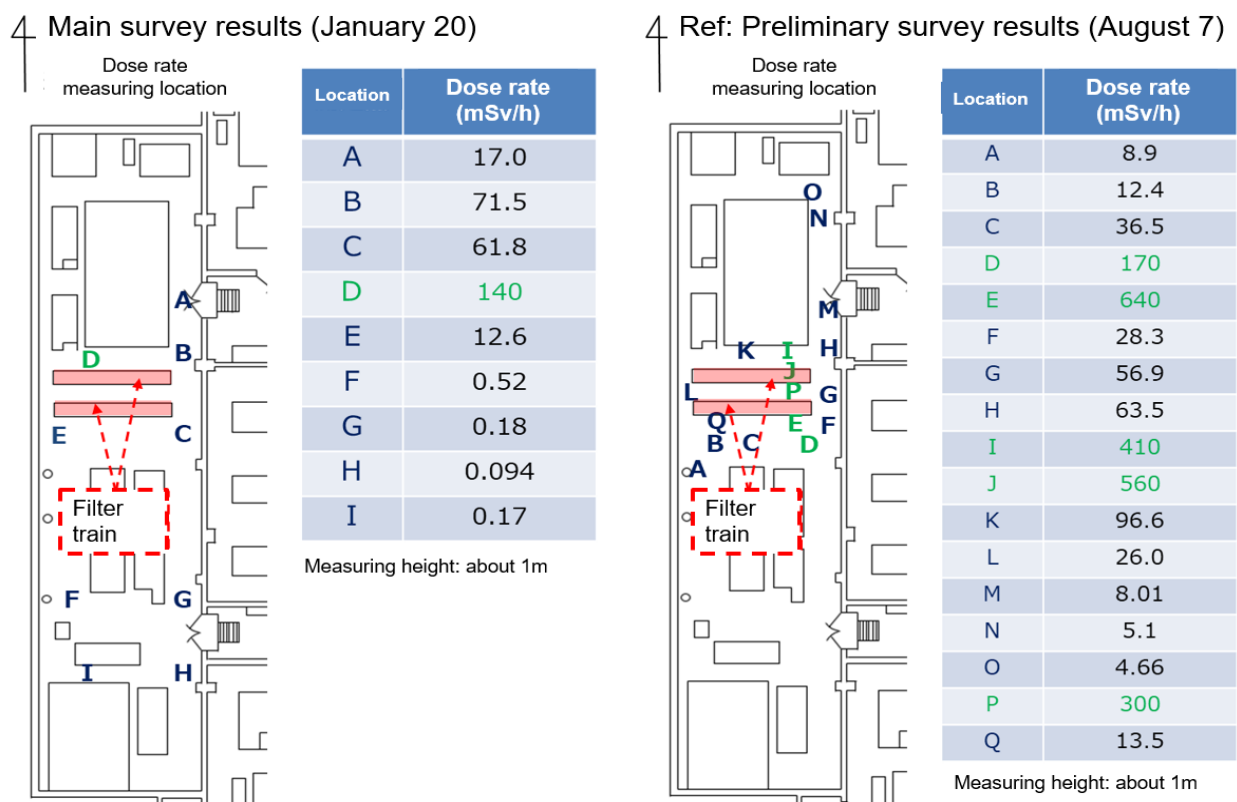
Figure 3-12 Results of air dose rate measurements in SGTS room [3-9]

Therefore, from December 2020 to January 2021, dose rate measurements were conducted in the Unit-2 SGTS room, around the filter train, and around the rupture disk using a remotely operated robot. The results of the dose rate measurements in the room showed that the air dose rate was higher near the downstream side of the filter train, with a maximum of 640mSv/h (Figure 3-12). The γ imaging measurements confirmed the presence of contamination downstream from the filter train (Figures 3-13 and 3-14). The results of dose rate measurements around the rupture disk confirmed that there was little contamination around the rupture disk (Figure 3- 15). Based on these results, it was concluded that the rupture disk was not activated and venting was not successful in Unit-2. It was also determined that the contamination in the filter train was due to backflow from Unit-1, with which it shared an exhaust stack.

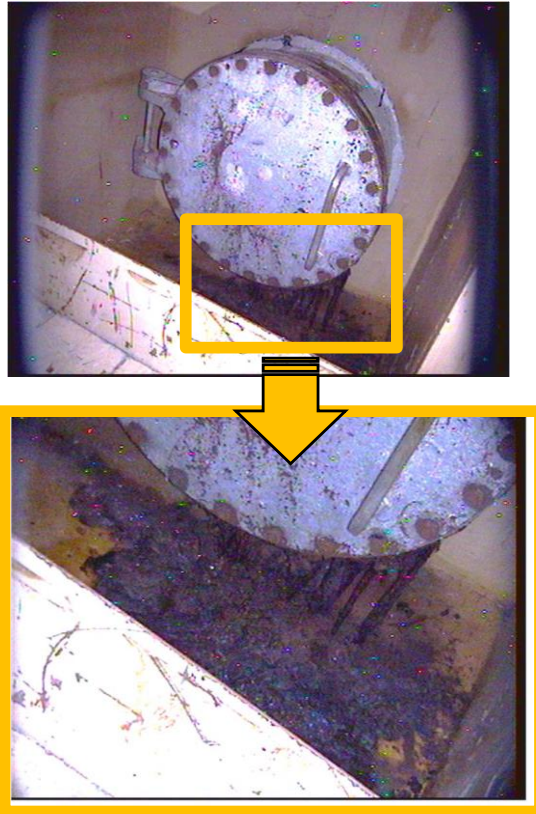
Figure 3-18 Melted matter at the penetration flange [3-11]

Figure 3-18 shows a photo of the melted matter. The melt hung from the penetration flange and lay spread on the floor. It is thought to be materials that had covered cables of the CRD replacement machine or O-ring materials of the penetration flange seals. The melt on the floor was solidified and confirmed to be easily removable by spatulas or similar tools.

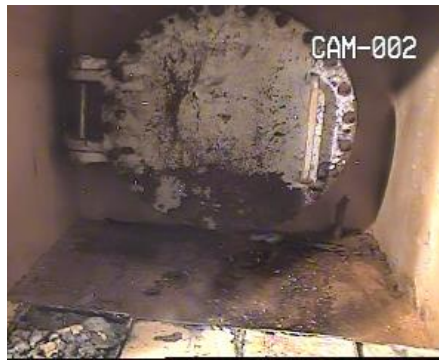
Flange of Penetration X-6
(after removal the iron plate)

In preparation for the internal investigation of the PCV and pedestal, shield blocks and iron plates were removed (between June 11 to October 1, 2015) from the front of the PCV penetration X-6 (see Figure 3-17 Building layout), which had been selected as the access route. When the area around the penetration was investigated, during the removal work, some melted matter was found and a high dose rate of more than 1,000mSv/h was noticed on the penetration flange and on the floor.

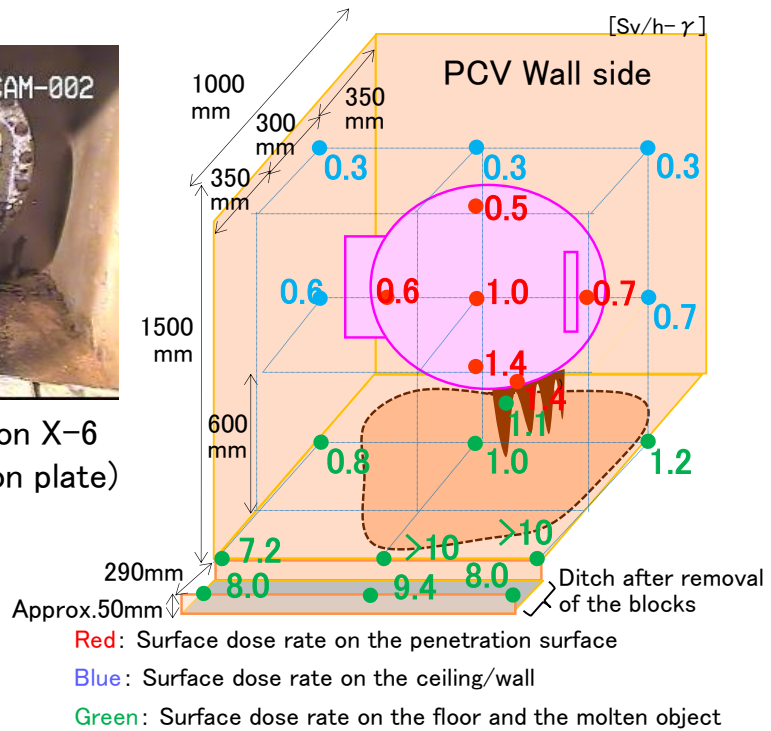
Figure 3-19 Measurement results of surface radiation dose rate [3-12]

Figure 3-19 gives the radiation dose rate measured on the surface. An increasing tendency for the surface dose is noticed in the order: on the ceiling < in the middle < on the floor; and especially a high dose rate is observed in the ditch after the shield blocks had been removed. The contamination might have spread from the area where the melt lay into the ditch. If the radiation dose rate difference between the locations at the penetration and on the wall comes from the contribution of a radiation source inside the penetration X-6, it is estimated to be approximately 1Sv/h at the maximum.

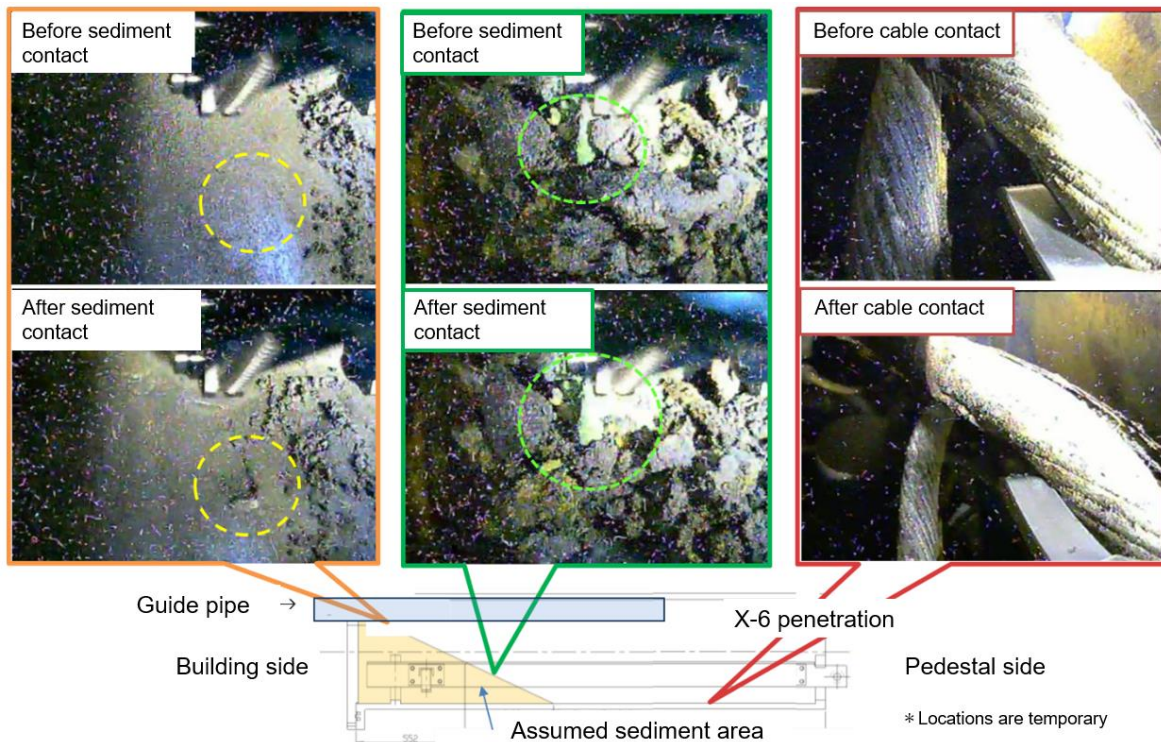
Figure 3-21 Contact survey of sediments in X-6 penetration result (1) [3-13]

As a result of the contact survey, it was confirmed that the sediments changed shape upon contact and that the cables were not adhered to anything and could be lifted (Figure 3-21). In addition, deposits, cable status, and the X-6 penetration hatch hole were confirmed by video (Figure 3-22). The 3D scan results showed that the sediments in the X-6 penetration were deposited on the slope from the reactor building side toward the pedestal (Figure 3-23).

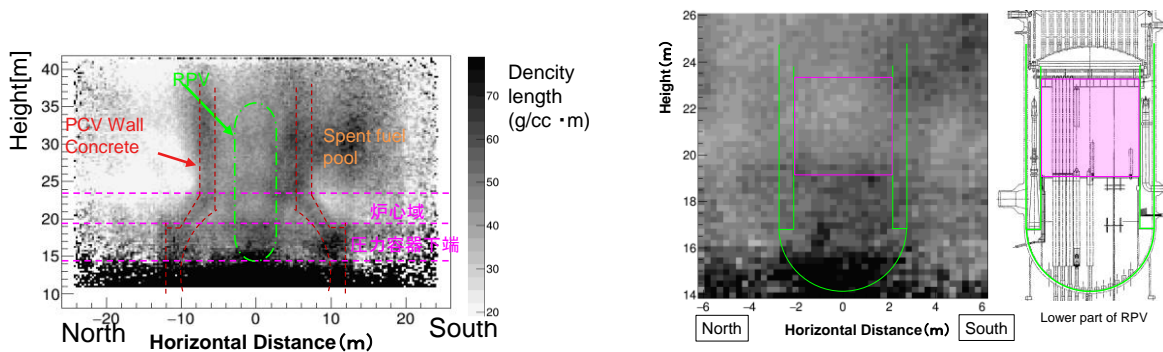
Figure 3-26 Distribution map of material quantities by muon measurements [3-14] (Left, overall view; right, lower part of reactor pressure vessel)

Figure 3-26 shows the analysis results of material quantities (density length) obtained from the muon measurements (left) and the enlarged portion of the RPV lower part (right). Besides the PCV and fuel in the spent fuel pool, dark tones were identifiable in the RPV lower part, too, indicating the presence of high density materials. Evaluation by muon technologies becomes difficult below about O.P. 15m due to reduced muon population detectable, but the dark tones at the RPV lower part can be believed to be significant, since those in the PCV at a similar elevation are identifiable.

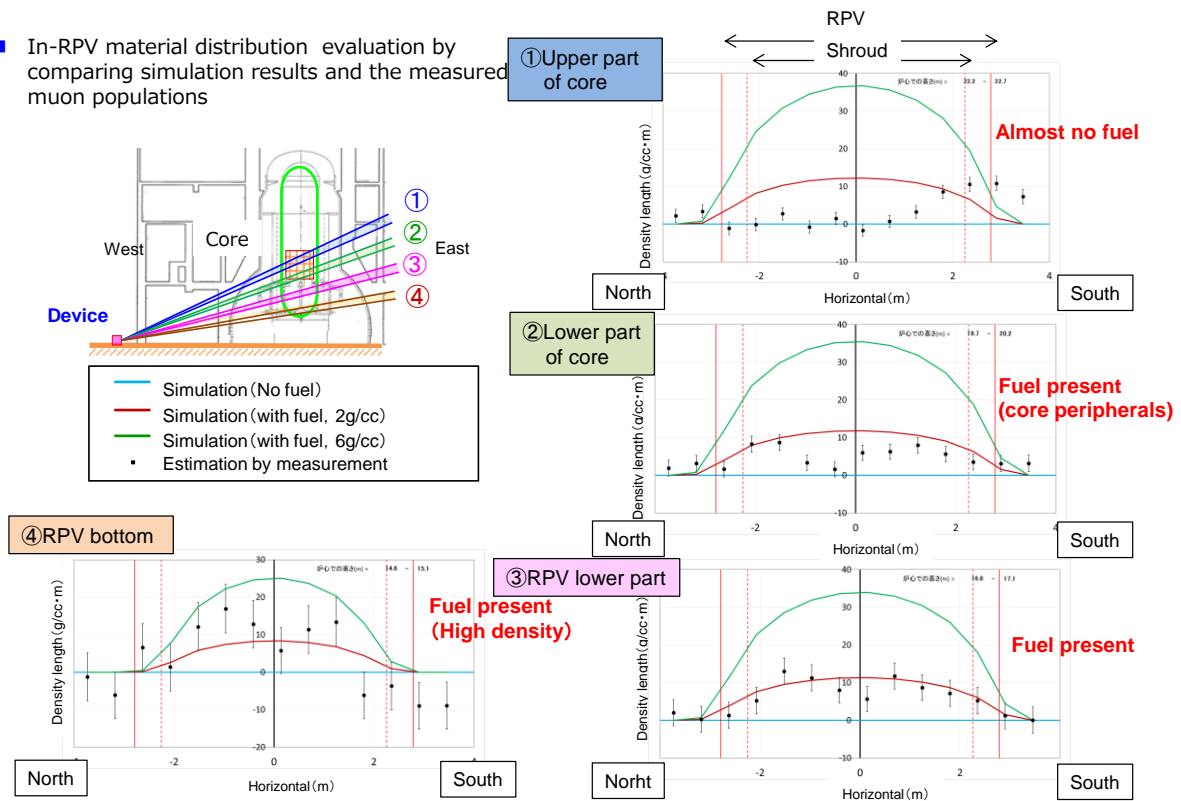
Figure 3-27 Distributions of material quantities in RPV [3-14]

Figure 3-27 compares the results of measurements and simulation. In the simulation, two cases were assumed: one was the case in which high density materials (2g/cc or 6g/cc) simulating nuclear fuel were present in each evaluation region; and the other was the case in which they were not present. From the comparison, it was estimated that nuclear fuel had been present in the

peripheral region of the core lower part and in the RPV bottom part, where the measured results had been closer to the results simulating the presence of high density materials there.

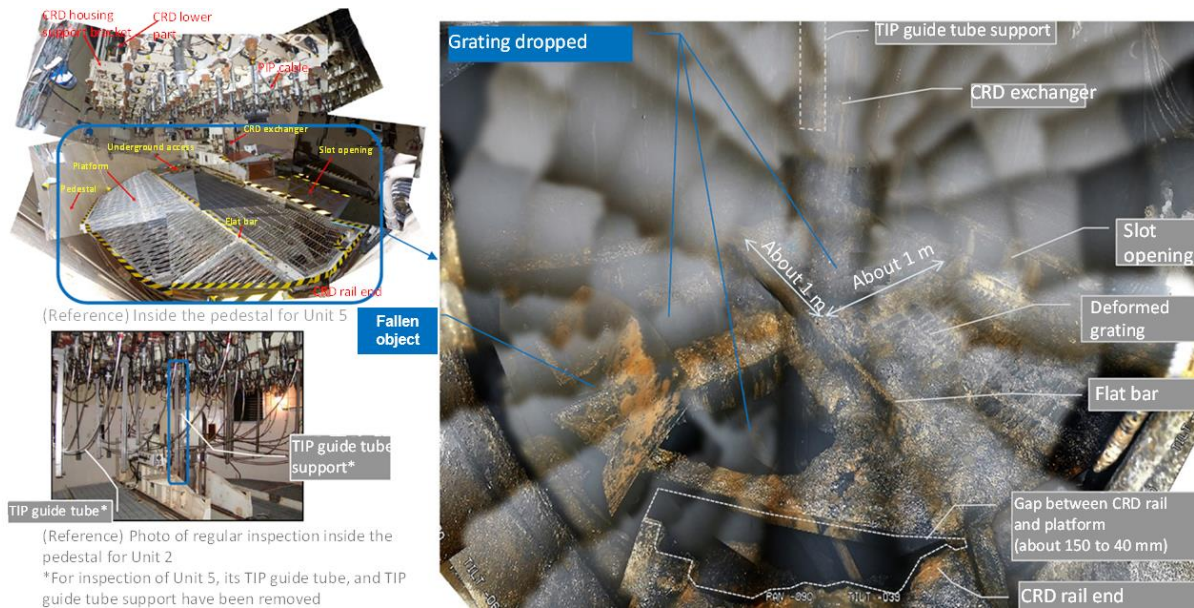
Figure 3-29 Status inside the pedestal [3-15]

The inside of the pedestal was observed on January 30, 2015 with a pan-tilt camera mounted on a guide pipe, as a preparatory survey for the investigation using the self-propelled investigation device. Figure 3-29 presents an integrated photo combining parts of images taken by the camera after image processing for clarification. When compared to the similar arrangement at Unit-5 shown in the figure (left), the grating of Unit-3 can be found to be missing. At and above this place, cable-shaped fallen objects, and other fallen objects looking like TIP guide-tubes have been identified.

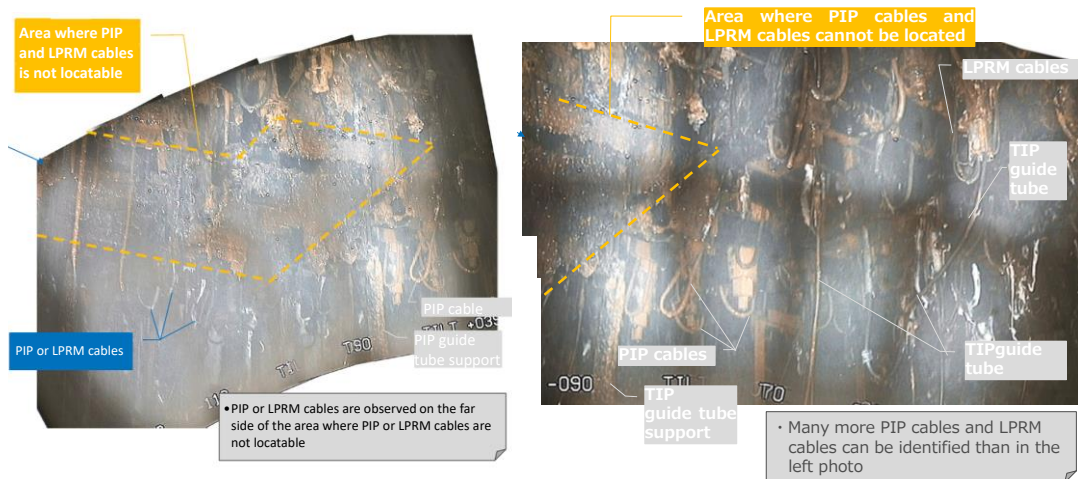
Figure 3-30 Status inside the upper pedestal [3-15]

Figure 3-30 is a photo of the upper part inside the pedestal. Damaged portions of the local power range monitoring system (LPRM) and control rod position indicator probe (PIP) cables can be identified. PIP cables and LPRM cables can be located at some places but cannot be located at other places. Figure 3-31 summarizes damage conditions in the pedestal, investigation results of cables in the upper part of inside the pedestal and other findings.

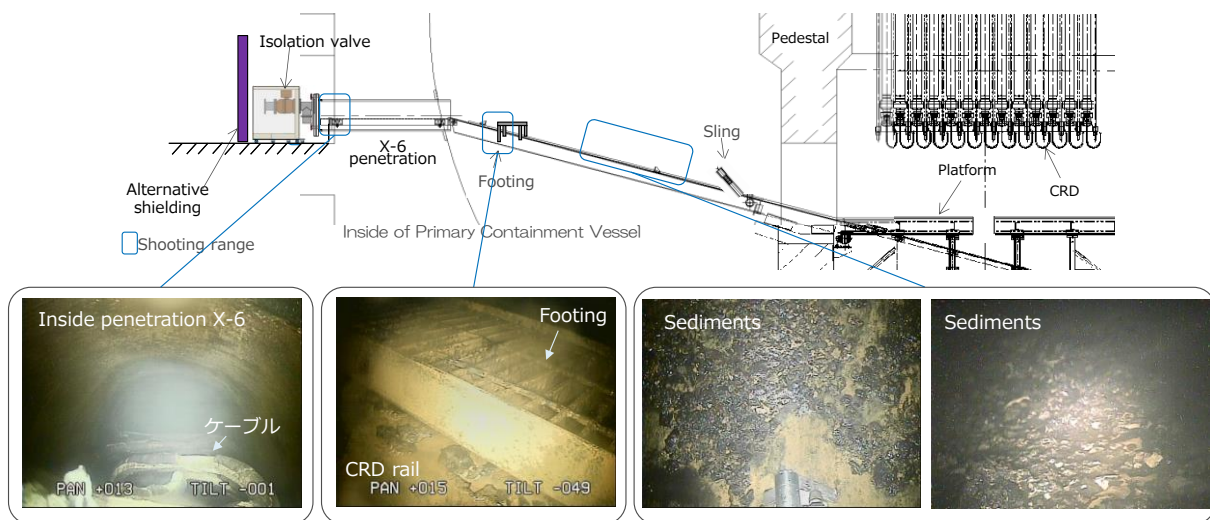
Figure 3-32 Images on the CRD rails starting from the X-6 penetration [3-16]

From February 7 to 9, 2017, attempts were made to remove sediments on the CRD replacement rail using the sediment removing equipment. Figure 3-32 is the photo taken by the camera mounted on the equipment. The sediments were mixtures of black paste-like materials, thin fragmented objects, and pebble-shaped objects. The sediments became more sticky and difficult to remove when the equipment approached the pedestal from the PCV penetration. On February 16, 2017, the self-propelled investigation device was sent in for investigation. The equipment failed to reach inside the pedestal, but could collect data on temperatures, dose rates and conditions of structures around it.

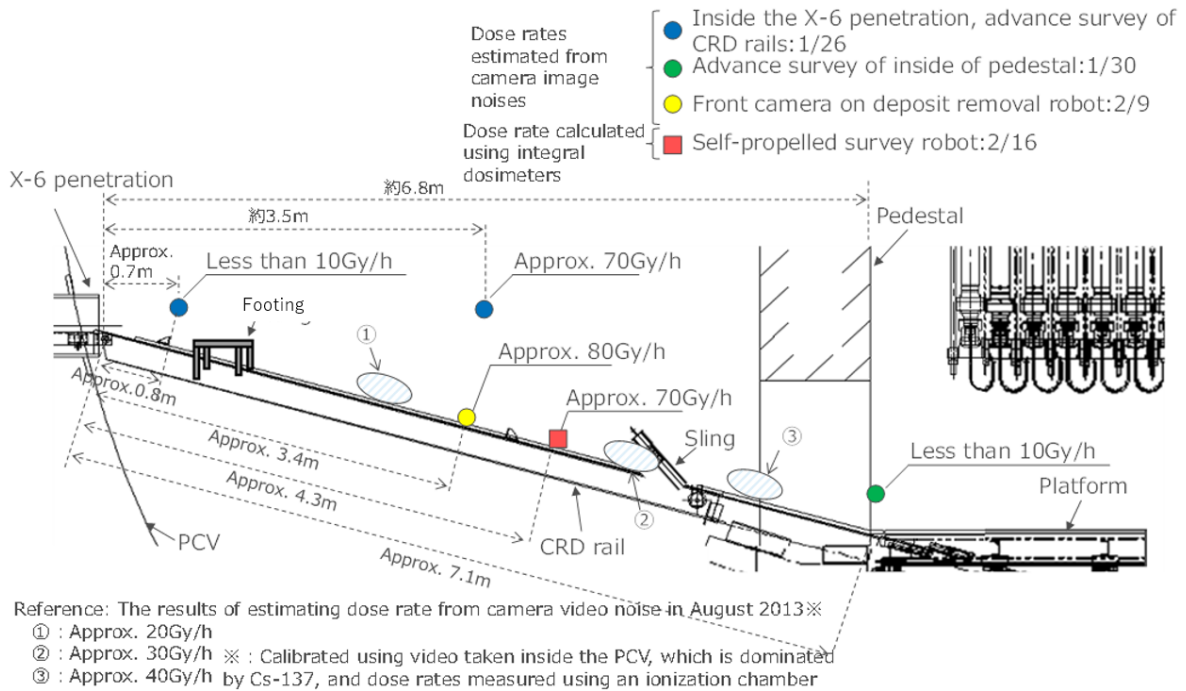
Figure 3-33 Dose rates measurement [3-17]

Figure 3-33 shows the dose rates at four points obtained in this investigation. Around the

pedestal opening, the dose rates inside the pedestal were lower than outside.

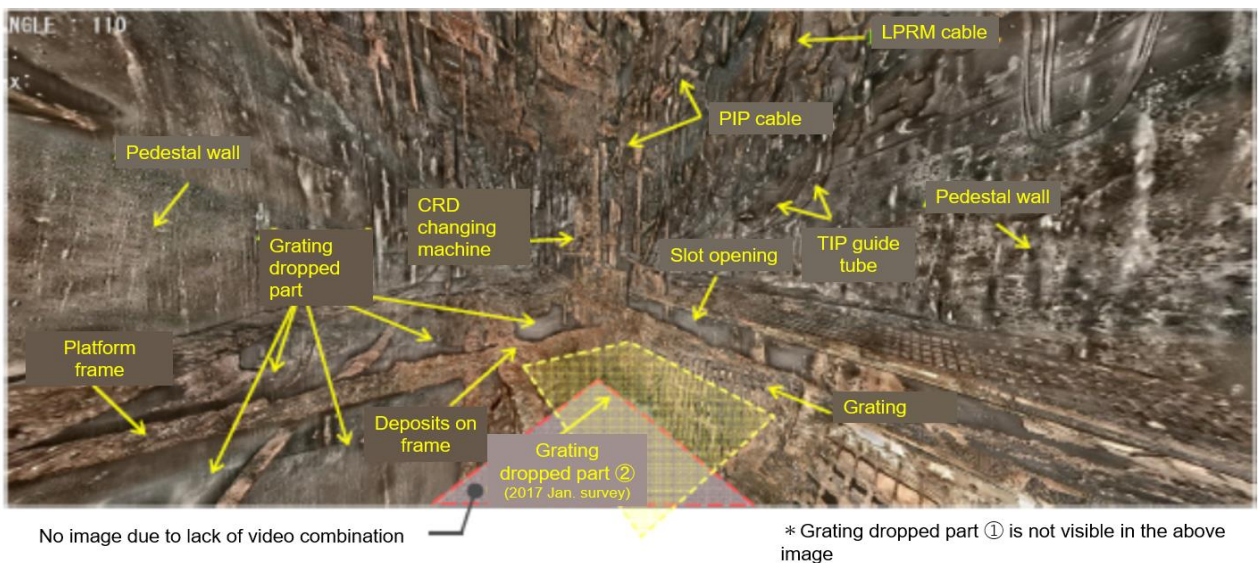
Figure 3-37 Investigation results on the platform [3-19]

Similar to the January 2017 investigation, no major deformation or damage was observed for the CRD exchanger, platform frame, or other structures. In addition, no damage to the interior wall surface of the pedestal was observed. Damage or falling down of the TIP guide tube, PIP cable, and grating on the front side of the camera was confirmed, and there was also a relatively large amount of adhered material on the platform frame, which may have been a path by which the fuel debris dropped down. The processed images for the investigation results obtained on the platform are shown in Figure 3-37.

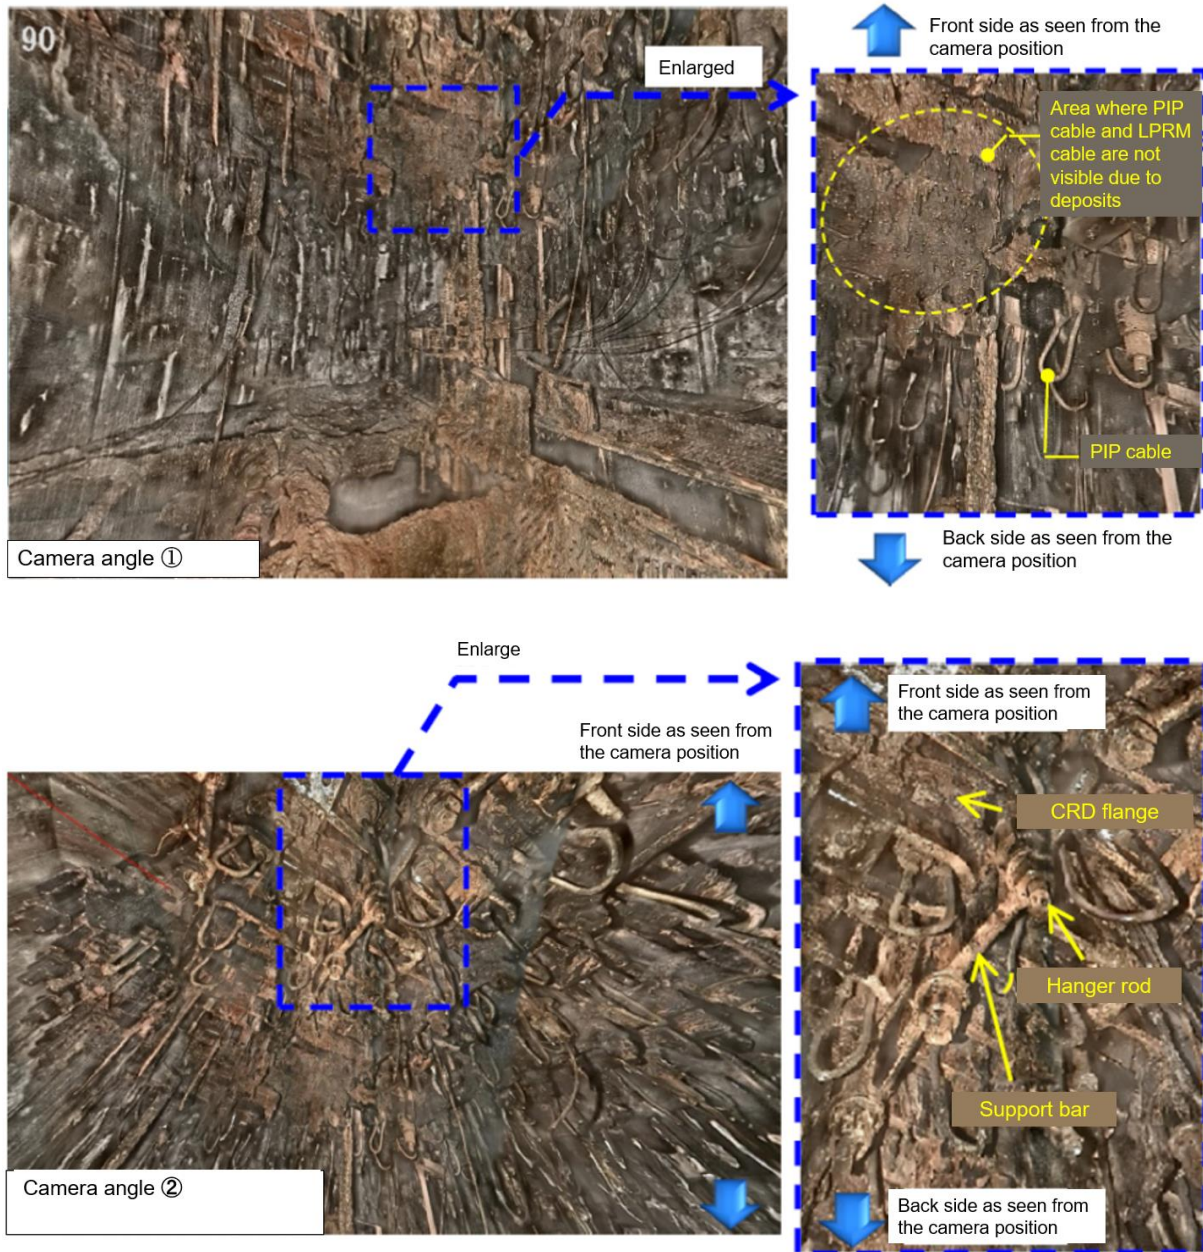
Figure 3-38 Image of the investigation around the CRD housings [3-19]

As far as could be confirmed, there was no dropping of the CRD housing support. However, there were areas where the TIP guide tube, PIP cable, and LPRM cable could not be confirmed due to deposits, and the grating directly below them was confirmed to have dropped down.

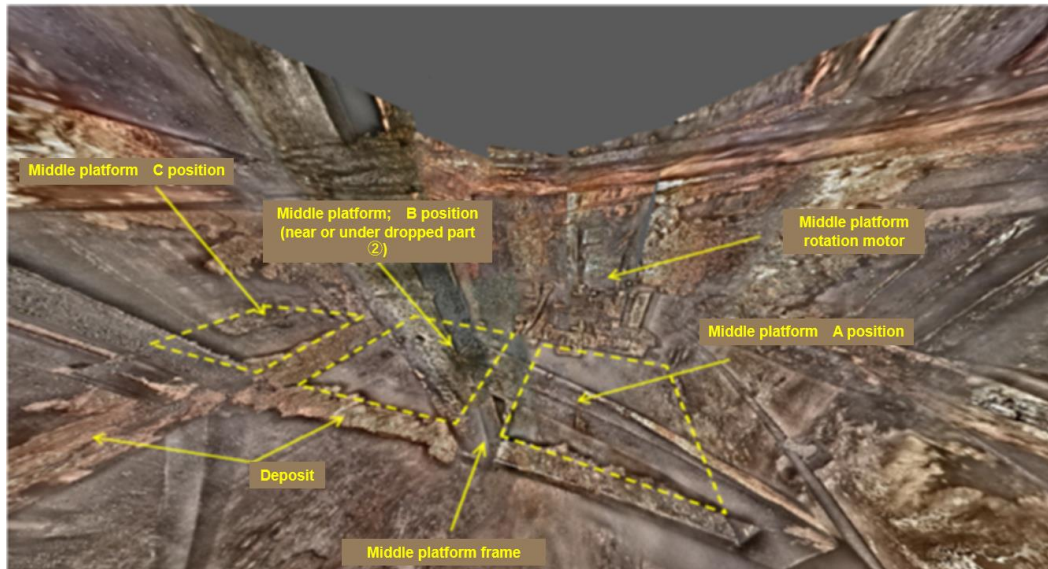
Figure 3-39 Middle platform investigation image [3-19]

As viewed from the camera suspension position, the grating was found to have dropped down at the location of the intermediate work platform, but no major damage to the platform frame was observed (Figure 3-39).

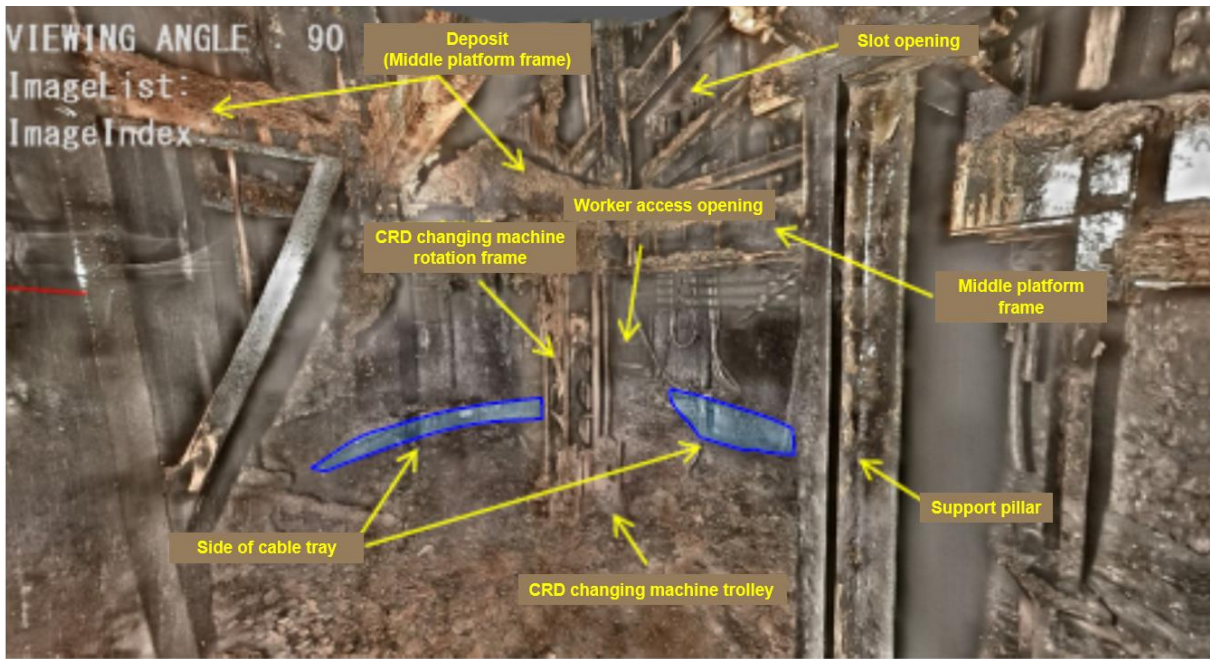
Figure 3-40 Pedestal bottom sediments [3-19]

From the investigation of the pedestal bottom using a camera, it was confirmed that there was no major deformation or damage to the structures such as the CRD changing machine rotation frame, middle platform frame, support columns, and cable tray (Figure 3-40). In addition, pebbly or rocky sediments were found to be deposited all over the pedestal bottom. Since no deformation of the cable tray (4 mm thick stainless steel) was observed, it is possible that the temperature of the sediments when they began to accumulate on the tray was not high enough to cause its thermal deformation. The height of the sediments was considered to be over 70cm near the cable tray on the left side from the camera, and 40 to 50cm near the CRD changing machine elevator trolley.

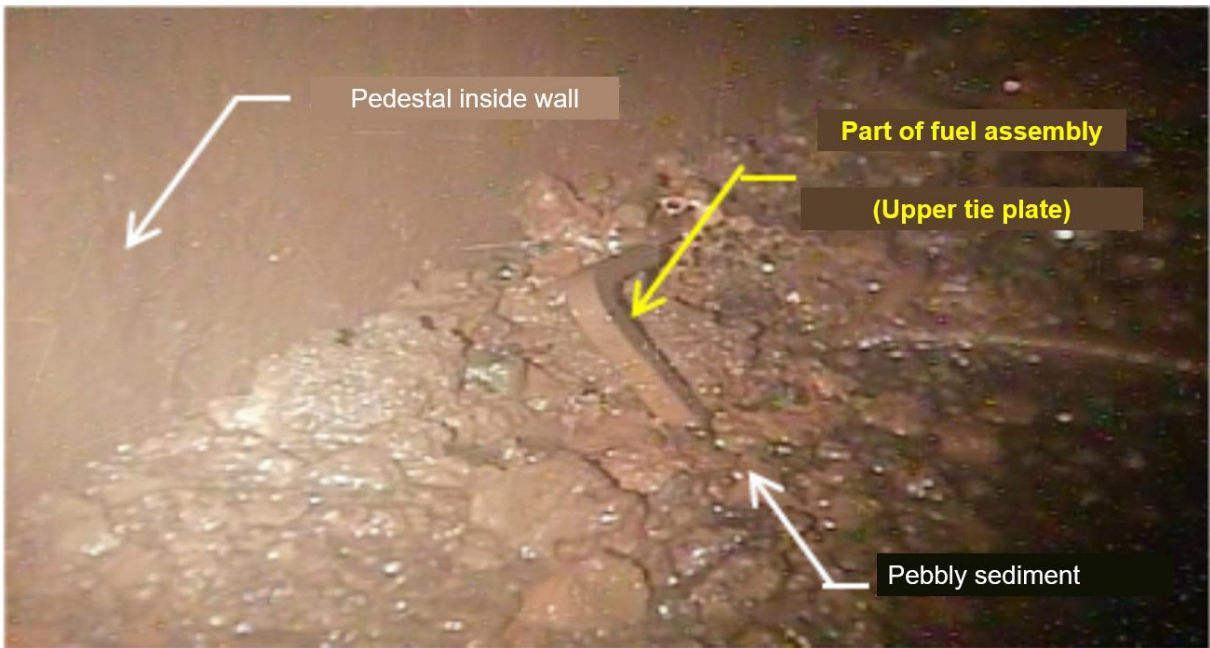
Figure 3-41 Sediments and dropped upper tie plate [3-19]

In addition, upper tie plate and other fallen objects were observed in the sediments (Figure 3-41). Since structures inside the pressure vessel had fallen down, the bottom of the pressure vessel was damaged, and it was considered that a hole had opened that was large enough for the upper tie plate to fall through.

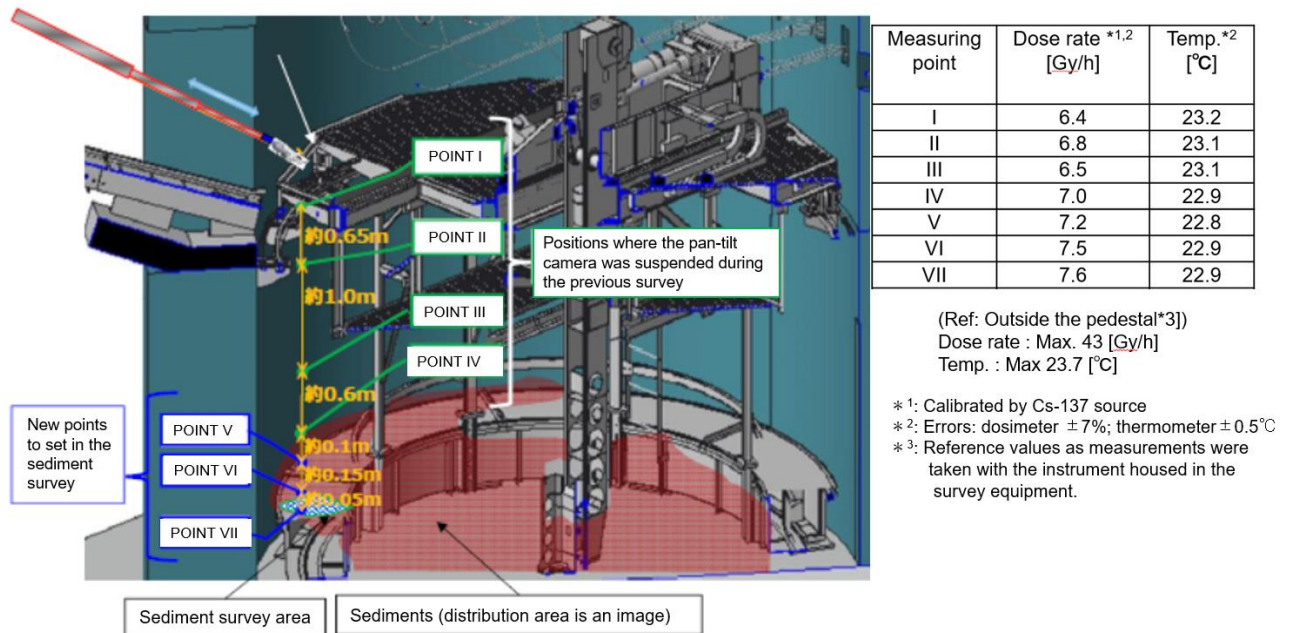
Figure 3-44 Dose rate and temperature during survey of sediments [3-21]

In February 2019, survey equipment was lowered to the same location as the January 2018 survey to make contact with the sediments at the pedestal bottom. The temperature and dose rate at that time are shown in Figure 3-44, and the area where the contact survey was conducted is shown in Figure 3-45. The temperature was almost constant regardless of the measurement height, while the dose rate tended to increase as the pedestal bottom was approached. The sediments were classified into three types: pebbly, rocky, and apparent parts of structural materials, and the contact investigation results for each are shown in Figures 3-46 to 3-48. This investigation confirmed that the pebbly and structure-related sediments could be picked up and moved, and that there might be hard and rocky sediments that could not be picked up. By bringing the camera closer to the sediments, it was possible to obtain images that contributed to the estimation of the contours and size of the sediments.
