Status of investigation on estimating situation of cores and containment vessels

1. Introduction

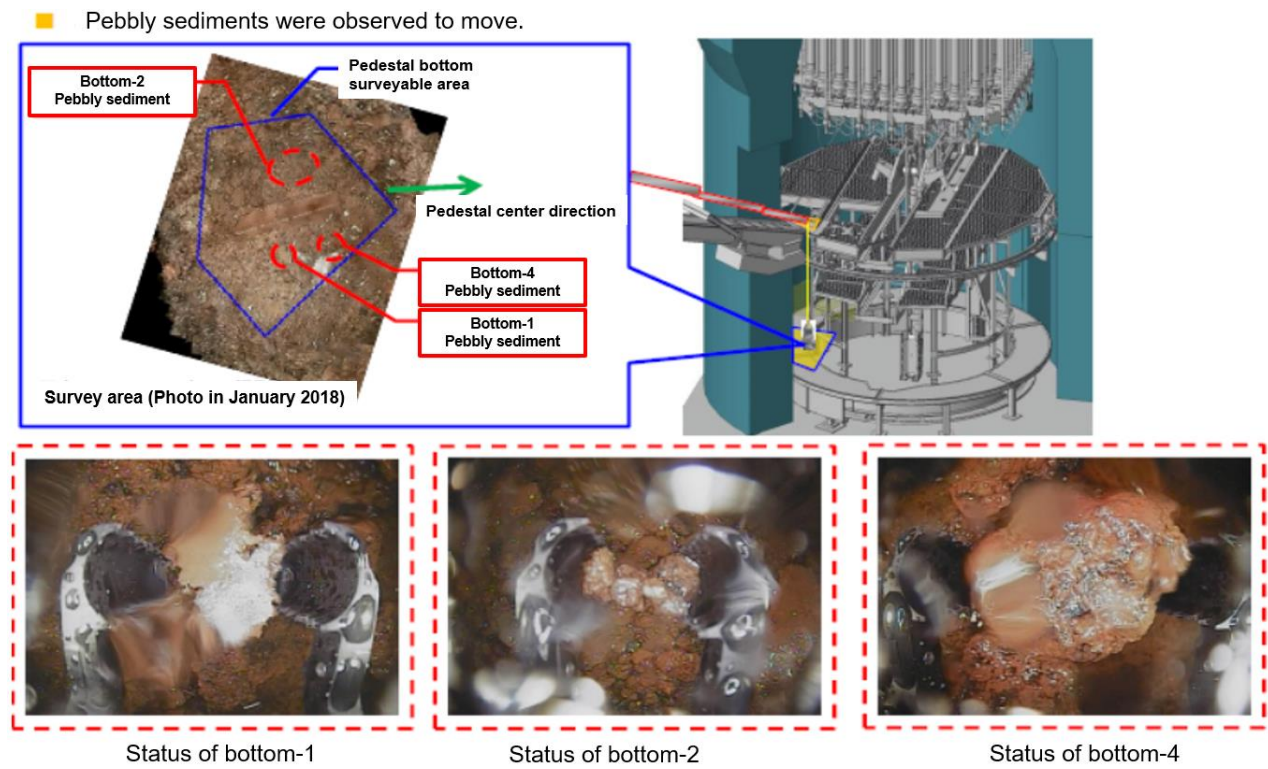
Figure 3-46 Pedestal bottom sediment contact investigation result (1) [3-21]

- Pebbly sediments and structure-shaped sediments were observed to move.

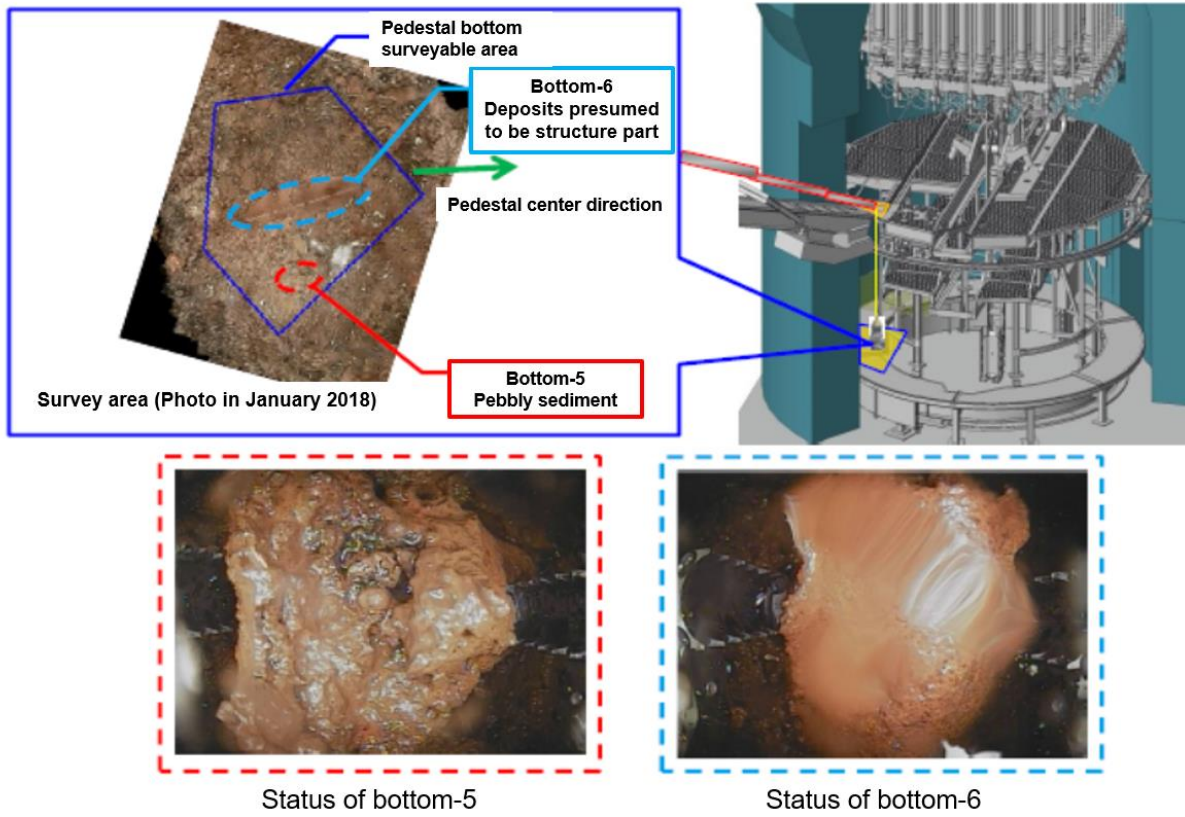
Figure 3-47 Pedestal bottom sediment contact investigation result (2) [3-21]

- The pebbly sediments were observed to be movable. No contact marks could be observed from video.

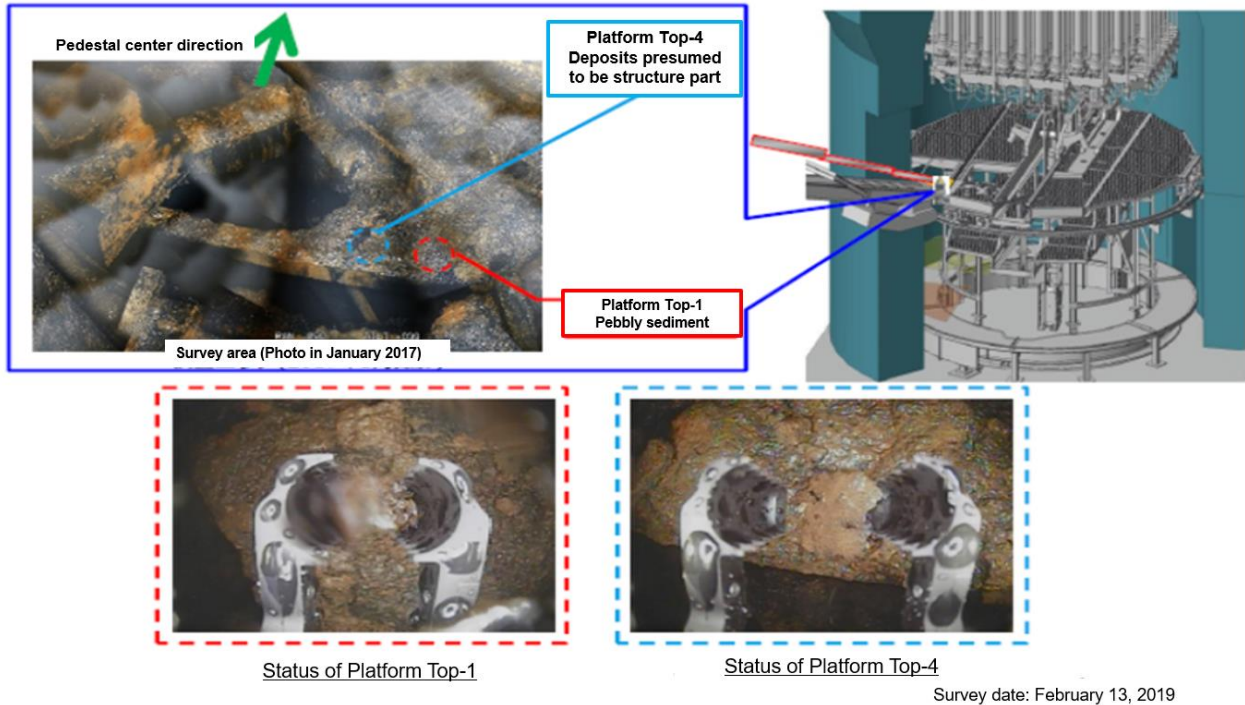
Figure 3-49 Platform sediment contact investigation result (1) [3-21]

■ Pebbly sediments and structure-shaped sediments were observed to move.

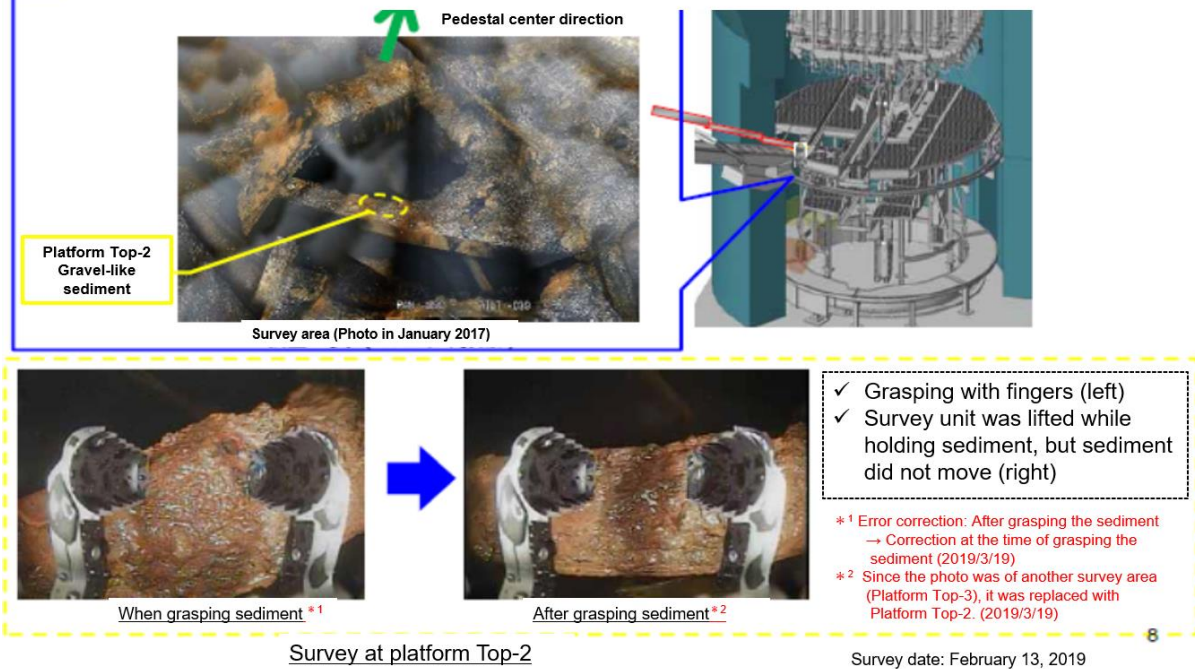
Figure 3-50 Platform sediment contact investigation result (2) [3-21]

■ The gravel-like sediments were observed to be movable. No contact marks could be observed from video.

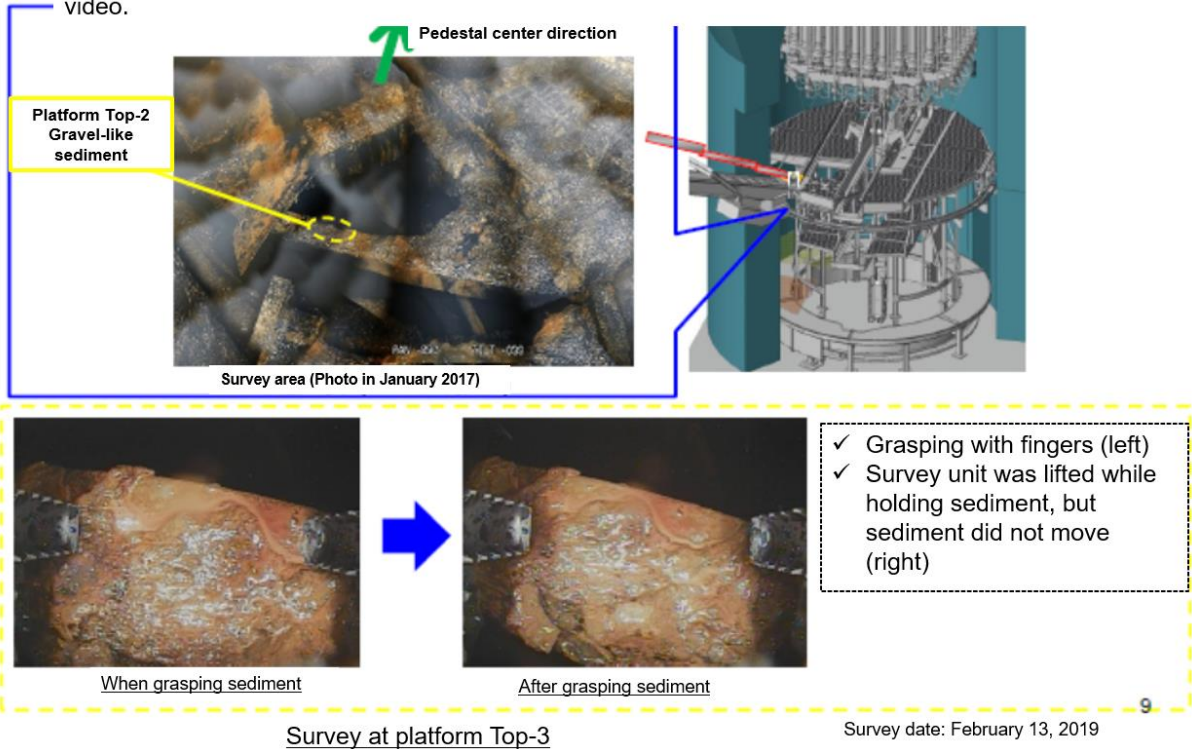
Figure 3-51 Platform sediment contact investigation result (3) [3-21]

- The gravel-like sediments were observed to be movable. No contact marks could be observed from video.

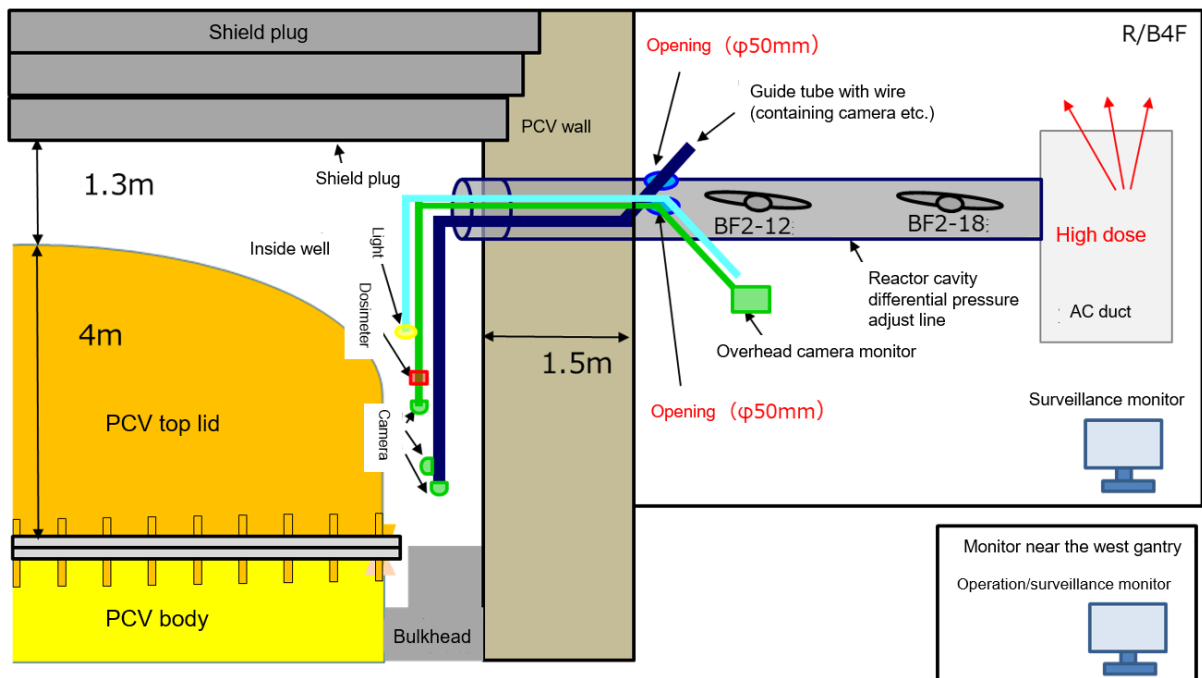
Figure 3-58 Outline of the investigation inside the reactor well [3-24]

Subsequently, in May 2021, dosimeters and cameras were placed inside the reactor well via the west reactor cavity differential pressure adjustment line to conduct an investigation of dose rates and conditions inside the well. Figure 3-58 shows an outline of the investigation.

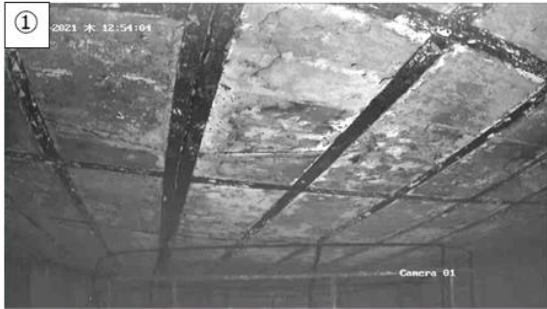
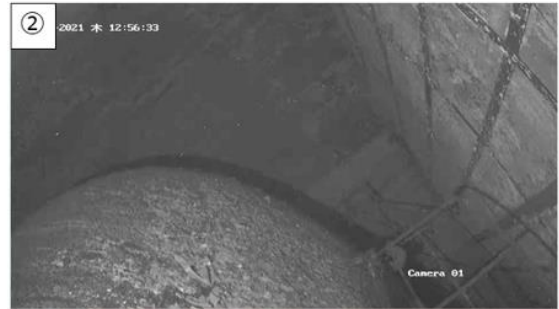
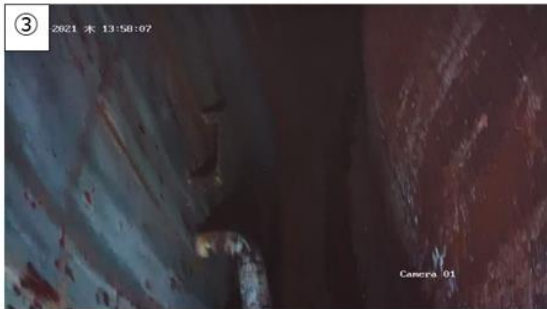
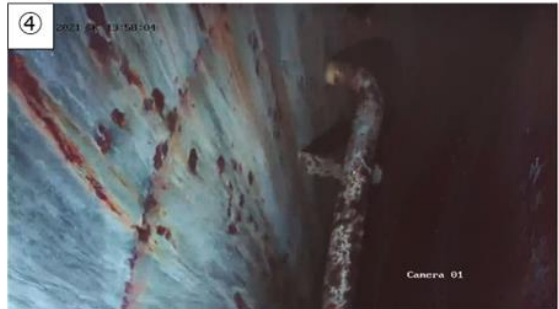
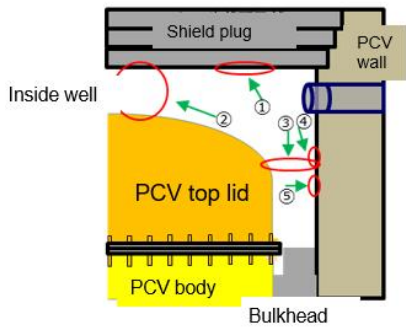
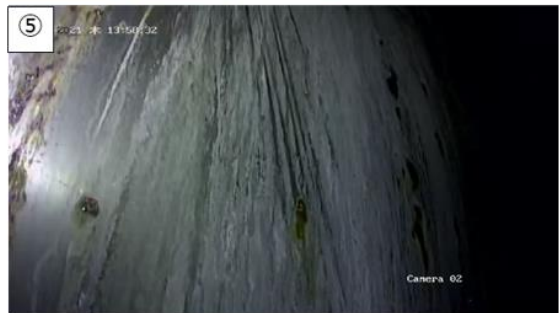
Figure 3-59 Status inside reactor well ① [3-24]

By observing the situation in the well with the camera, it was confirmed that there was no major damage to the PCV top head and other parts (Figures 3-59 and 3-60). The maximum measured dose rate was 530mSv/h obtained near the PCV flange (Figure 3-61). An investigation inside the piping of the reactor cavity differential pressure adjustment line was also conducted, and it was confirmed that the BF-2-12 valve was in the open status and that the piping upstream from the valve (SUS) had no rough surfaces and no sediments such as those observed in the piping and valve box (carbon steel) (Figure 3-62).

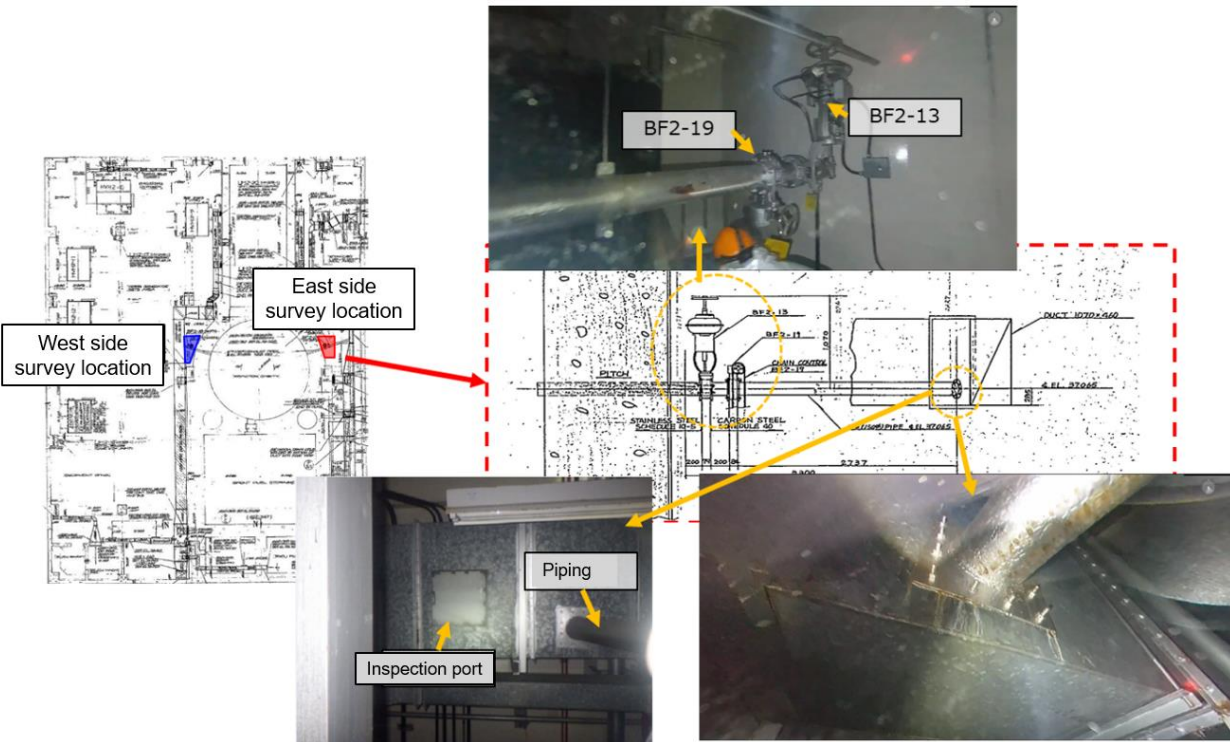
Figure 3-63 External investigation of the reactor cavity differential pressure adjustment line (east side) [3-24]

In addition, on-site inspection of the reactor cavity differential pressure adjustment line laid on the east side was conducted. The BF-2-13 valve was in the open status similar to that on the west side, and no significant deterioration was observed on the side, bottom, and inspection port of the duct (Figure 3-63). The dose rate measurement around the piping had a maximum value of 51 mSv/h (Figure 3-64).

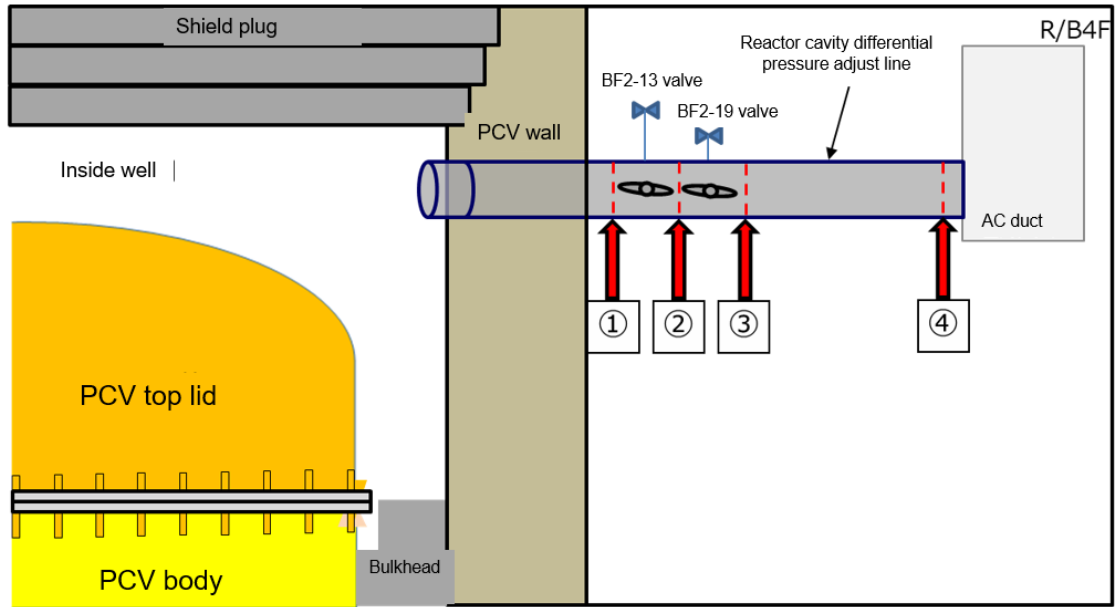
Figure 3-64 Dose rate measurement results around the reactor cavity differential pressure adjustment line (east side) [3-24]

Measuring location		①	②	③	④
		PCV wall – BF2-13 valve	BF2-13 valve – BF2-19 valve	BF2-19 valve – duct	Near duct
Piping	Top (mSv/h)	13	41	25	18
	Bottom (mSv/h)	13	51	37	20

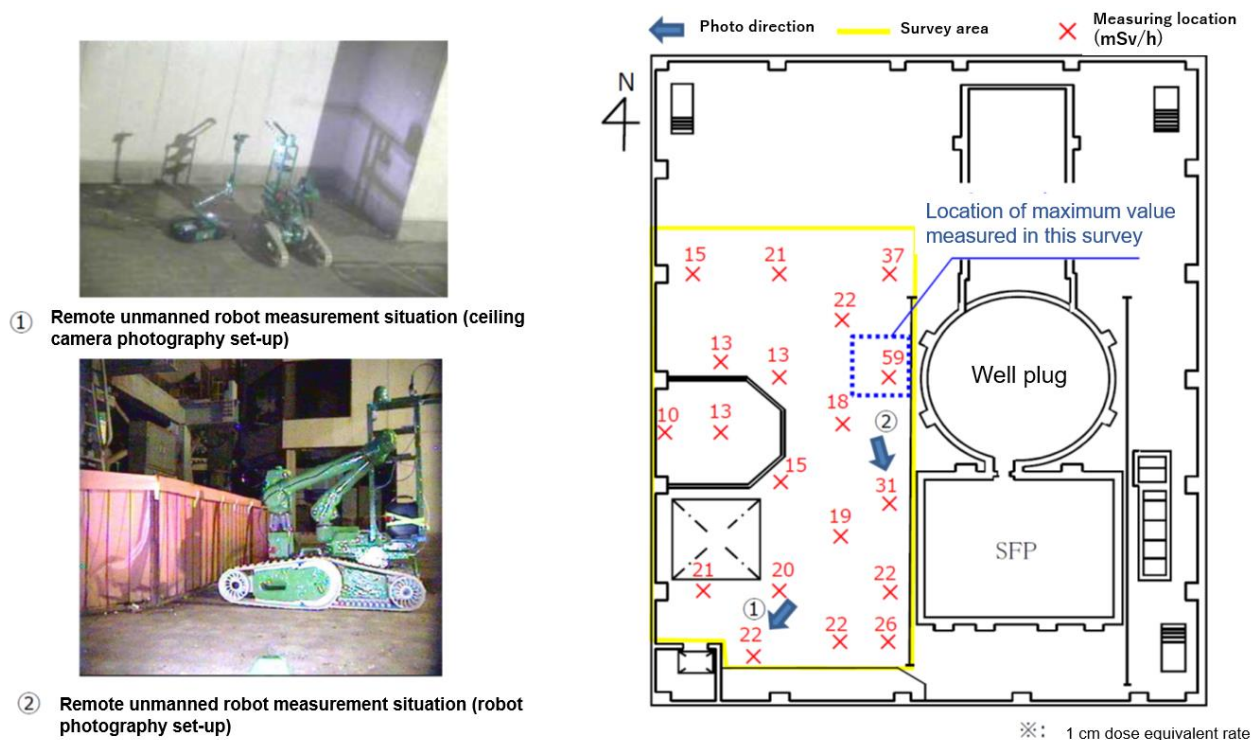
Figure 3-65 Dose rate measurements on the west side of the operating floor (obtained in June 2018) [3-25]

After the construction of an outer wall opening on the west side of the reactor building completed in June 2018, an investigation of the dose rates, etc. in the vicinity of the west wall opening of the operation floor was conducted in July 2018 to allow future inside work for the operation floor to proceed smoothly. From measurement of air dose rates, it was estimated that the main radiation source was the well-plug because the dose rate near the well-plug was high and the rate tended to decrease on moving away from it (Figure 3-65).

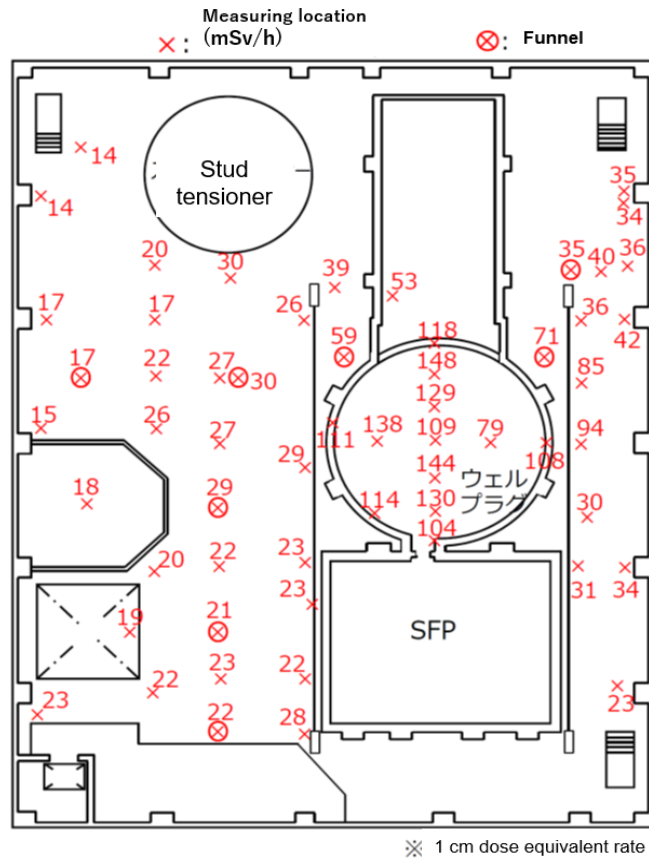
Figure 3-66 Air dose rates measured on the operation floor
 (from November 2018 to February 2019) [3-26]

From November 2018 to February 2019, an investigation of the contamination and equipment conditions throughout the operation floor was conducted. Based on the air dose rate measurements (Figure 3-66), the dose rate on the well-plug was high and this plug was estimated to be the main contamination source. In addition, the dose rate decreased compared to the past investigation results, and it was estimated that natural attenuation, the effect of rainwater that flowed into the building, and the effect of moving and cleaning up materials were contributing factors to the drop. The surface dose rate on the well-plug was high (Figure 3-67), and it was estimated that the contamination on its top surface was caused by steam that had been retained between the well and the protecting sheet, and then dried up. Since the $\beta+\gamma/\gamma$ ratio on the well was similar to that on the floor, it was estimated that the effect of surface contamination was significant and the effect of γ radiation from inside the reactor was small.

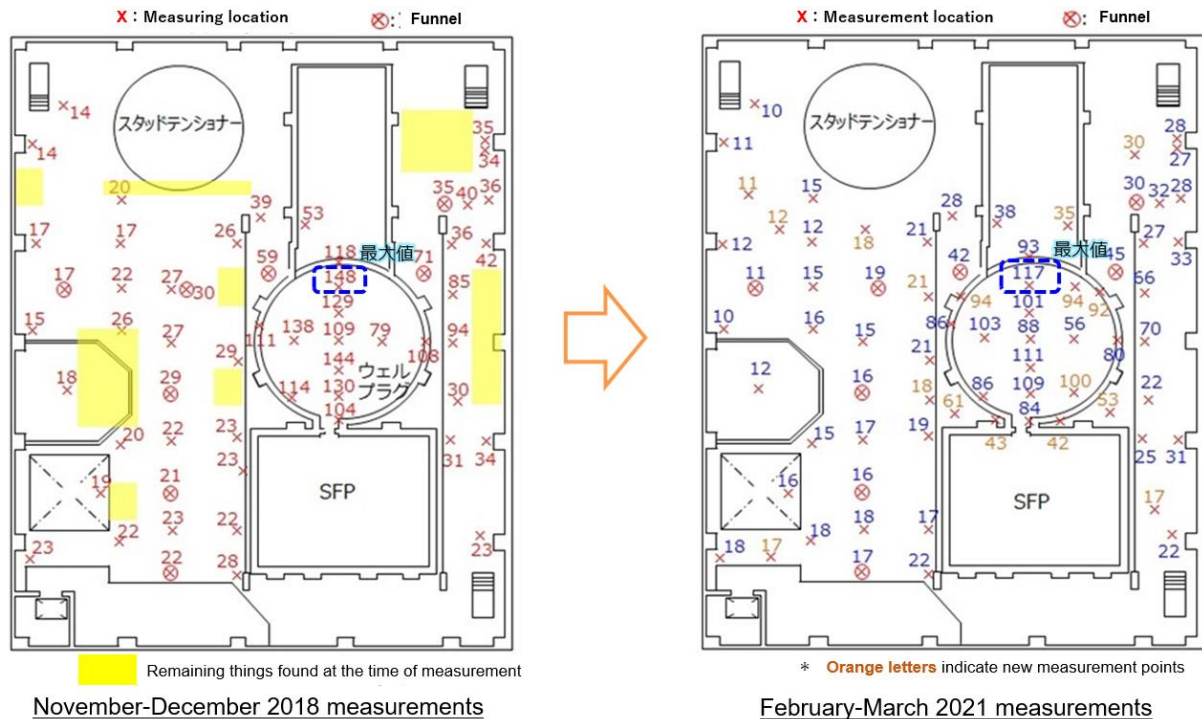
Figure 3-68 Comparison of measured air dose rates on the operation floor (obtained in December 2020) [3-27]

The air dose rate for the operation floor was measured again in December 2020 after work on the floor to clean up and remove remaining objects was completed. The overall dose rate was confirmed to have been reduced by about 20% compared to the results of measurements in 2018 (Figure 3-68). As factors contributing to the dose rate reduction, it was estimated that about 10% of the dose rate reduction was contributed by the cleanup and removal of objects, and about 10% by natural attenuation.

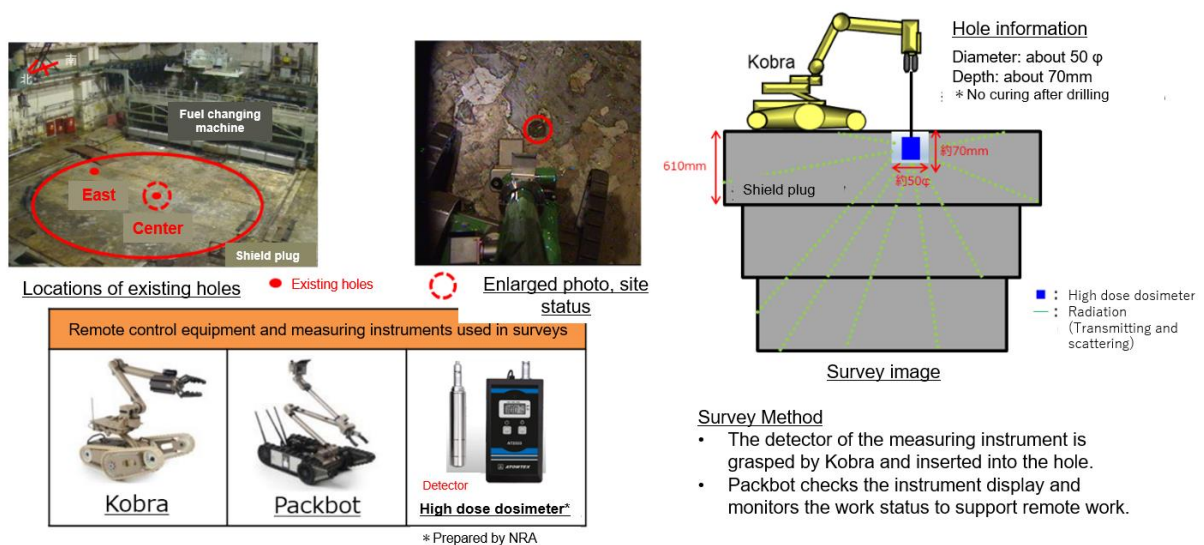
Figure 3-71 Outline of survey [3-29]

Based on the above results, a survey was conducted from August to September 2021 using the existing shield plug drilling locations (center and east), which are less susceptible to surface contamination from the operation floor, for the purpose of improving the evaluation accuracy of the amount of radioactivity that was estimated to have accumulated in the gap between the upper and middle sections of the shield plug. An outline of the survey is shown in Figure 3-71. Based on the results (Figure 3-72), the dose equivalent rate of Cs-137 and Cs-134 accumulated in the gaps of the shield plug was calculated, and the possibility of radioactive materials including cesium adhering to and depositing in the gaps was high, and from the results of the center and east side, the overall contamination status of the shield plug was evaluated as widely variable throughout the shield plug (Figure 3-73).

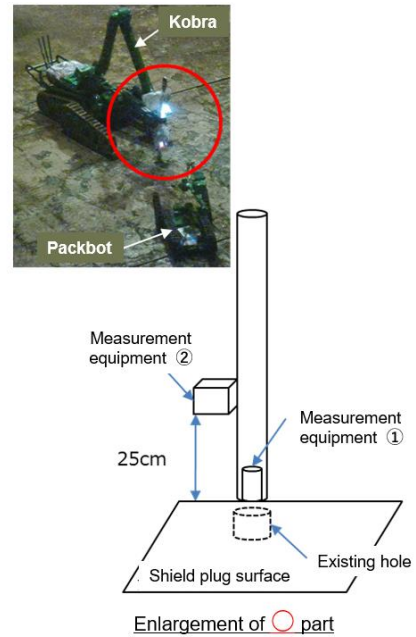
Figure 3-72 Measurement results (obtained in August 2021) [3-29]

Location	Distance from floor to tube bottom [cm]	Equipment ①	Equipment ②
East	7.0	255	52.5
	6.0	277	51.5
	5.0	290 – 300	52.1
	4.0	292	50.9
	3.0	255	50.7
	2.0	225	51.9
	1.0	172	51.9
	7.0	255	51.5
Center	6.0	1169	230
	5.0	1070	236
	4.0	944	235
	3.0	825	225
	2.0	682 – 690	226
	1.0	600	225
	0.0	532	225

- There is a high possibility that radioactive materials including Cs are adhering to and depositing in the crevice.
- The measurement results at the center and the east side indicate that there may be a large variation in the contamination status throughout the shield plug.

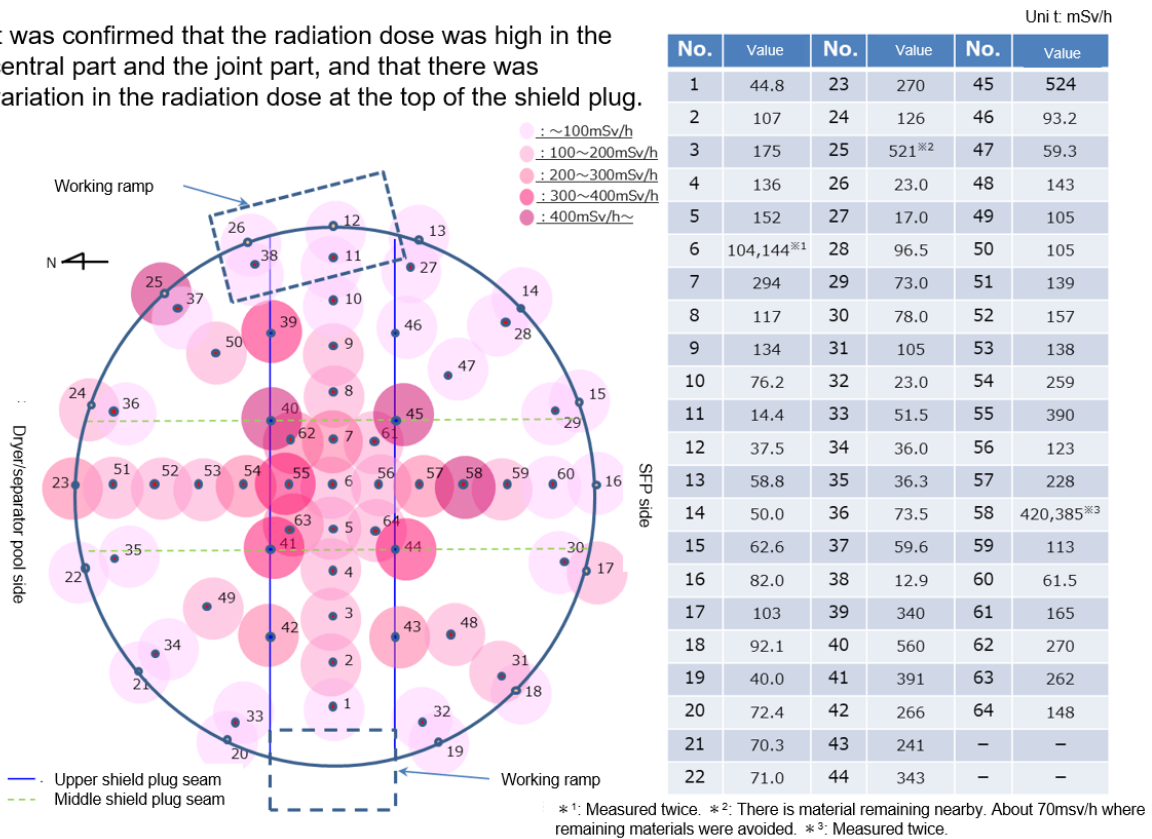
Figure 3-74 Dose rate results above the shield plug (obtained in October 2021) [3-30]

To further understand the contamination status of the shield plug, an investigation using newly drilled locations was planned. First, a dose rate investigation on the shield plug was conducted in October 2021, and it was confirmed that the dose rate was high in the center and at the joints, and that the dose rate varied above the shield plug (Figure 3-74). Based on the dose rate above the shield plug, 13 new locations were selected for drilling, and a dose rate investigation for them was conducted from November to December 2021. The status of the dose rate investigation is shown in Figure 3-75. These measured dose rates were lower than those of the previously existing holes. The dose rates at measurement points Nos. ①, ②, ⑩, and ⑪, which are close to the outer

- It was confirmed that the radiation dose was high in the central part and the joint part, and that there was variation in the radiation dose at the top of the shield plug.

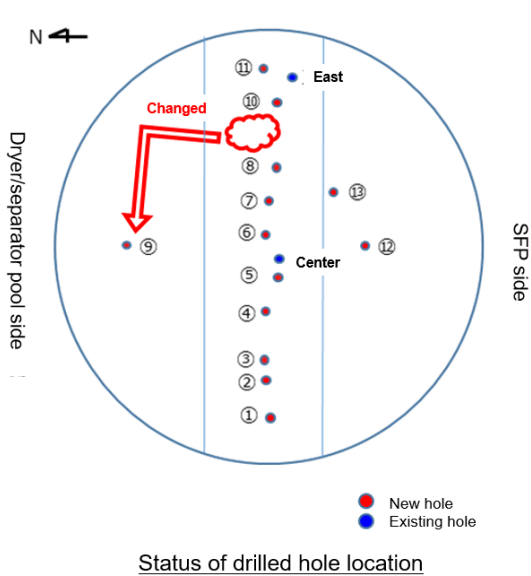
Figure 3-75 Dose rate results measured at newly drilled locations (Part 1) (obtained in December 2021) [3-30]

circumference of the shield plug, were low, while those at Nos. ④, ⑨, ⑫, and ⑬ exceeded 100mSv/h (Figure 3-75). In order to confirm the influence of the rebar arrangement in the shield plug, the measurement of perforation points and the dose rate on the floor surface around the perforation points was conducted again (Figure 3-76). Based on these results, the Nuclear Regulation Authority conducted an evaluation of the total amount of contamination accumulated in the gap between the upper and middle sections of the shield plug and concluded that the amount of contamination was at the same level as the previous evaluation results (tens of PBq of Cs-137 were present) (Figure 3-77).

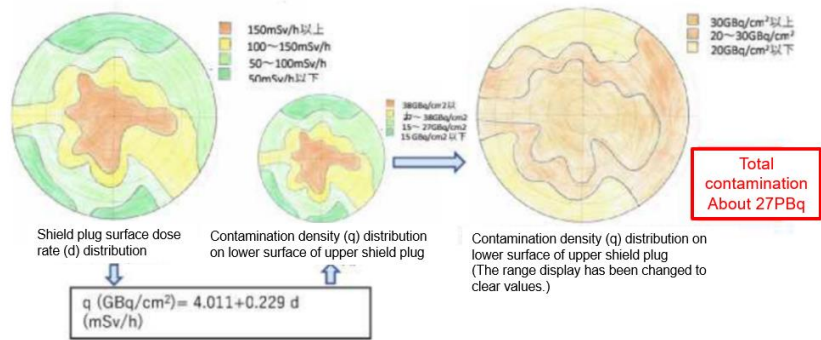
Figure 3-77 Evaluation results of total pollution [3-30]

- (1) Calculate the contamination density in the crevices that can give the equivalent dose rate from the dose rate^{*3} of 13 new holes and the calculation result of the calculation code egs5.
- (2) Based on the floor dose rate^{*4} of 13 new holes and (1) above, the correlation between the floor dose rate and the contamination density in the crevices is obtained.
- (3) Estimate the contamination density distribution in the gap from the dose measurement result (Ref.4) above the shield plug and (2) above, and calculate the total amount of contamination in the crevices.

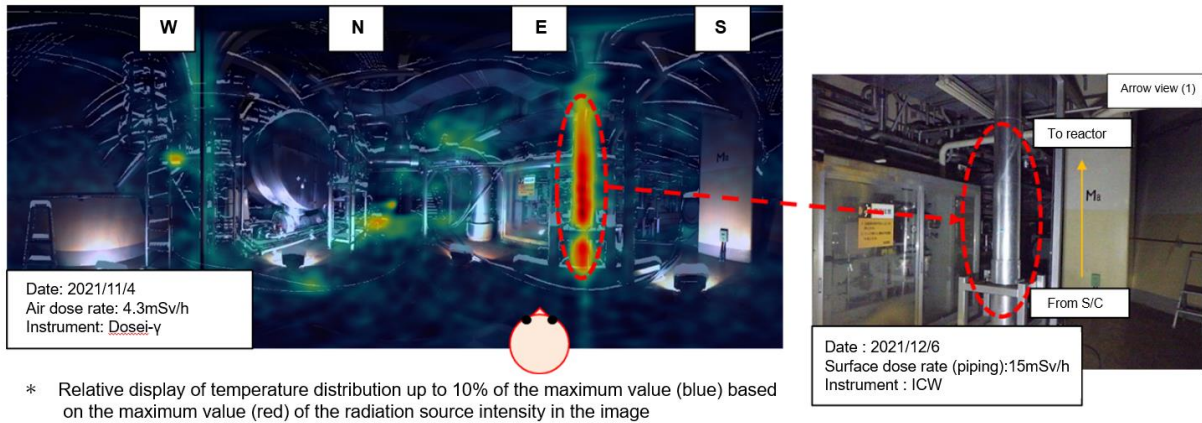
Figure 3-78 Measurement results obtained with the γ imager (CS (A system) piping on the northeast side of the second floor) [3-31]

The γ imager measurements revealed a hot spot in the CS (A system) piping on the northeast side of the second floor (Figure 3-78). The inner surface of the piping seemed to be contaminated. The piping has not been used for water injection from the time of the accident to the present, and the cause of the contamination is unknown at this time.

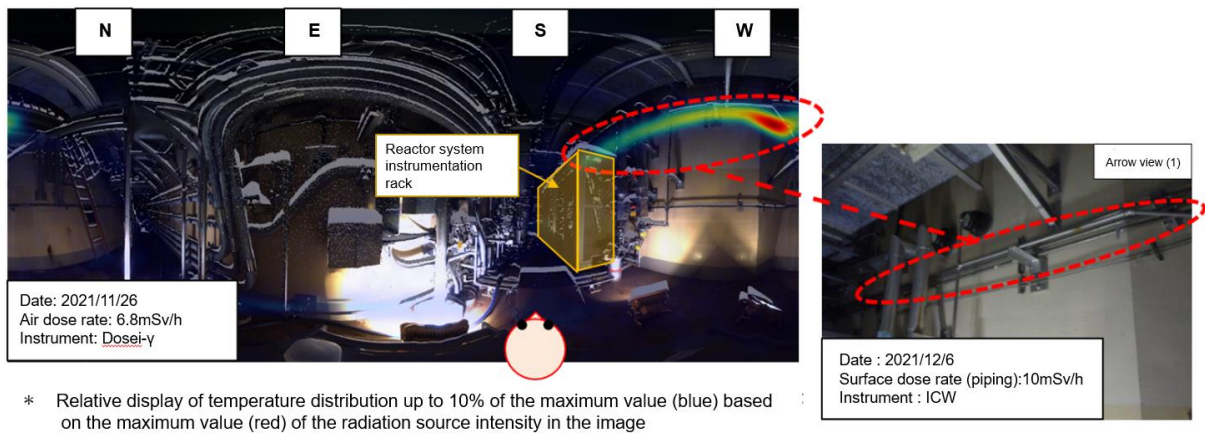
Figure 3-79 Measurement results obtained with the γ imager (reactor instrumentation piping on east side of the second floor) [3-31]

Hot spots were also identified in the reactor instrumentation piping (reactor pressure and reactor water level) on the east side of the second floor (Figure 3-79). It seemed that the inner surface of the piping was contaminated. As to the cause of the contamination, since both the pressure gauges and the water level gauges measure water inside the reactor, it is possible that water inside the reactor that came into contact with molten fuel or gas produced inside the reactor flowed into the piping and radioactive materials were deposited.

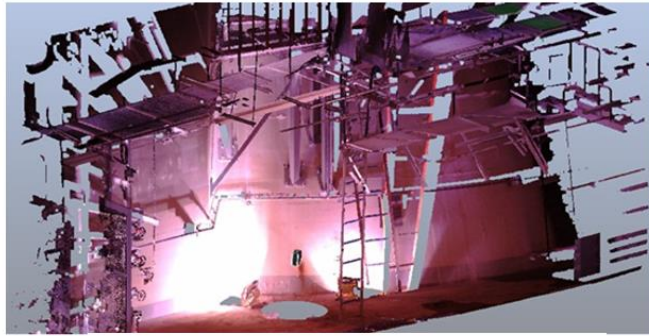
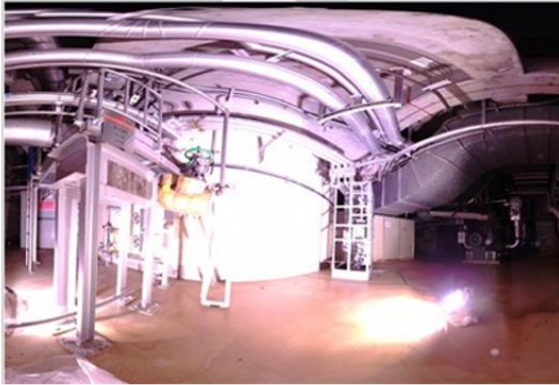
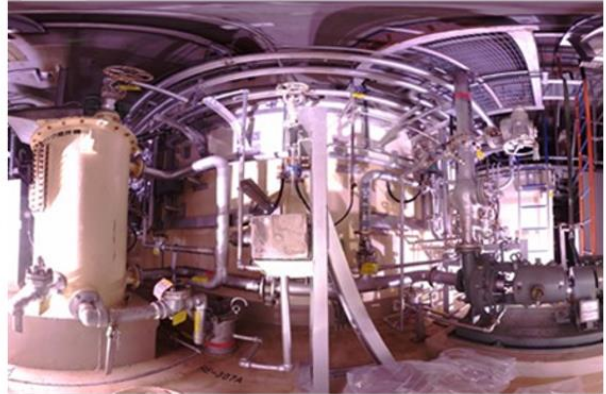
Figure 3-80 Investigation results of reactor shell wall and pool wall [3-31]

Furthermore, to obtain information that would contribute to the evaluation of the integrity of the reactor building, investigations of the conditions of the reactor shell walls and pool walls on the first (northwest and southwest), second (north, east, and southwest), and third (northeast and southwest) floors were conducted, and point cloud data was obtained using 3D scanning equipment (Figure 3-80). From these investigations, peeling paint and cracks were observed in some areas, but no damage or signs of aging deterioration (e.g., peeling surface concrete and rust) that would lead to a decrease in seismic performance were confirmed.

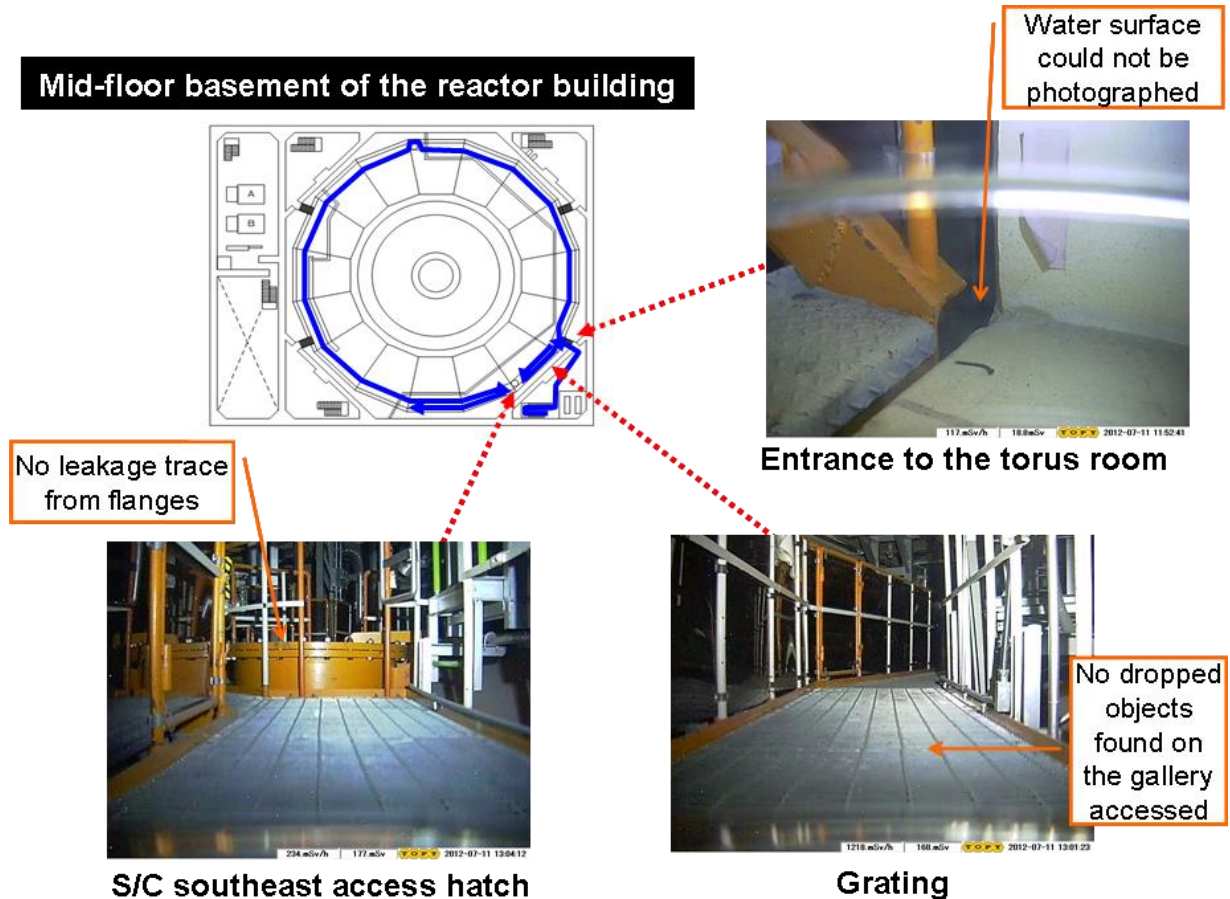
Figure 4-1 Photos in the torus room of Unit-3 (part)

No water leaking position in the S/C has been located yet. At least, no leak was confirmed on the flange, etc. of the S/C manholes, as far as the photos show (Figure 4-1).

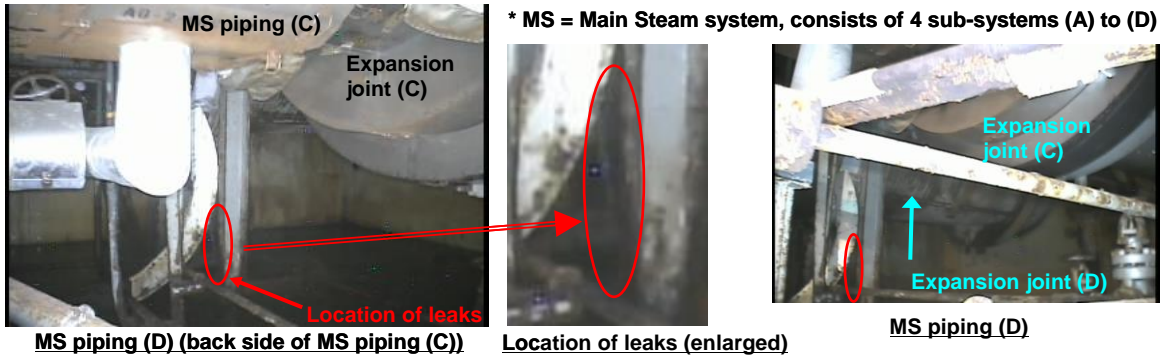
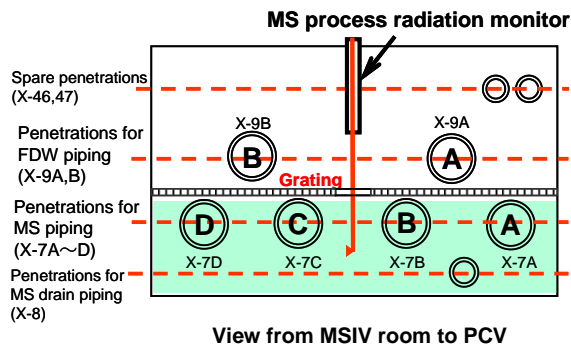
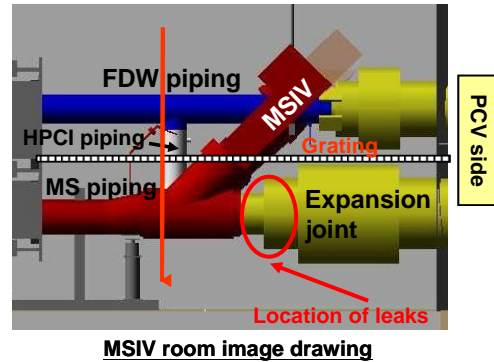
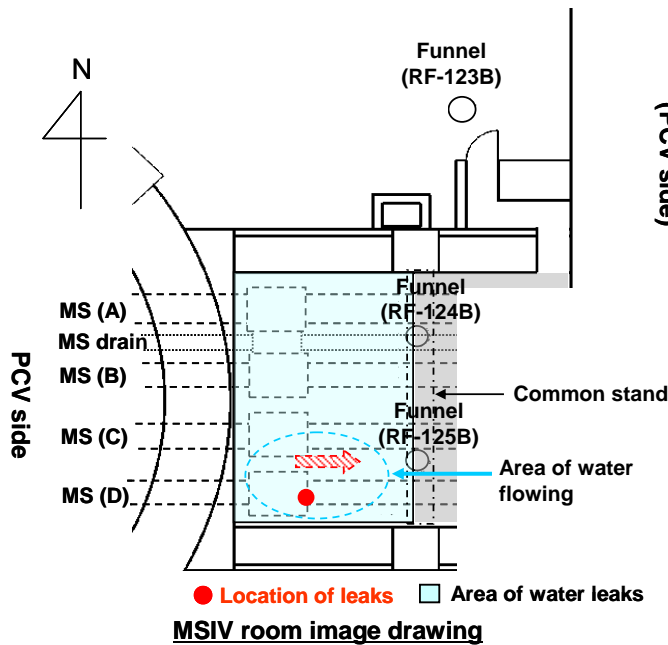
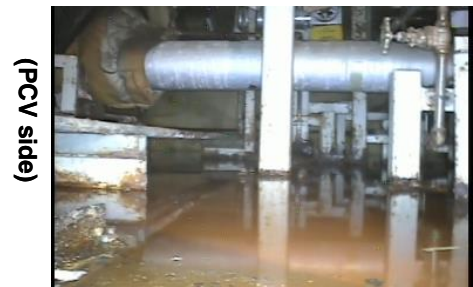
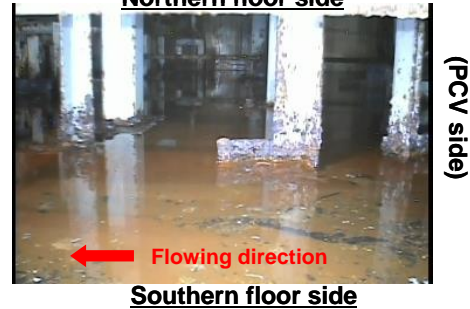
Figure 4-3 Water leaks from main steam line D in MSIV room

The water level in the PCV is estimated as about OP.12 m (about 2m above the reactor building first floor) by converting the S/C pressure obtained by the existing pressure indicators to water head. This elevation is on the level of PCV penetrations for main steam lines, thus indicating the possibility of water leaks from the PCV penetration in the MSIV room as the source of the water flow. In consideration of this possibility, instrumentation was inserted into the MSIV room from the HVAC system room on the floor above, in April and May 2014, and photos were taken and dose rates were measured in the room, in order to locate the water flows in the room. Water leaks were from near the expansion joint of main steam line D. It was concluded that the leakage had occurred only from the main steam line D, based on: (1) confirmation of no leaks from the main steam lines A, B and C, and their main steam drainpipes; and (2) the flow directions of leaked water on the floor (Figure 4-3). [4-4]

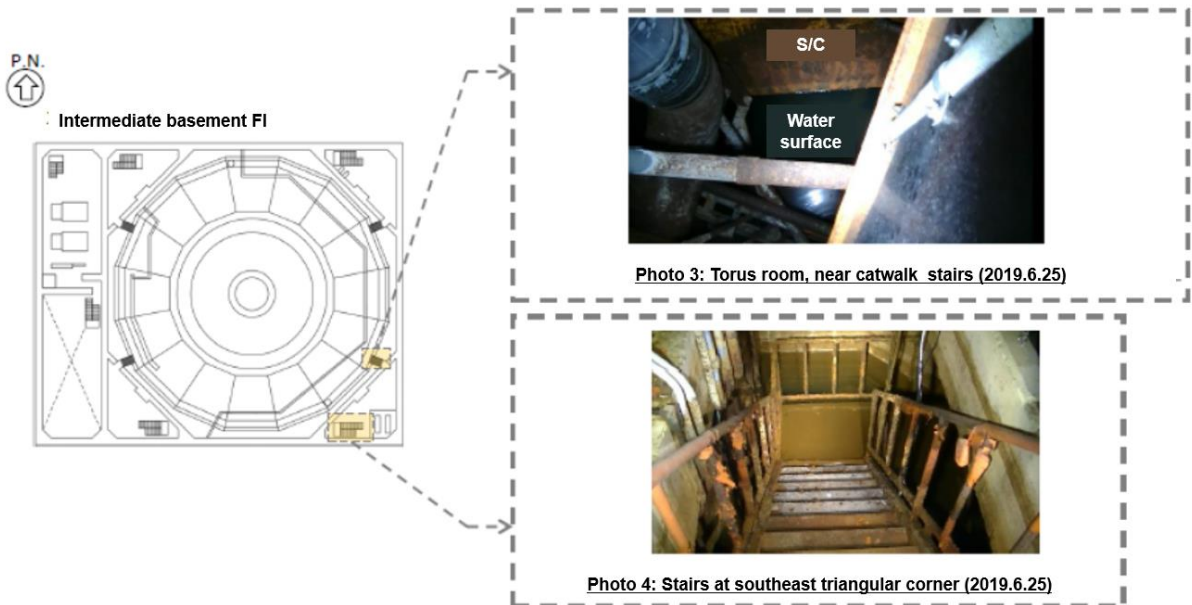
Figure 4-5 Site investigation of the intermediate basement floor of Unit-3 [4-5]

In addition, investigation of the intermediate basement floor was conducted to confirm the feasibility of installing a pump and other equipment for the PCV at the southeast corner of the Unit-3 reactor building. It was confirmed that there was space for installing a pump and temporary hoses at the stairs in the southeast triangular corner and by the ascending catwalk and the stairs in the torus room (Figure 4-5). The dose rate at the site ranged from about 11 to 30mSv/h.

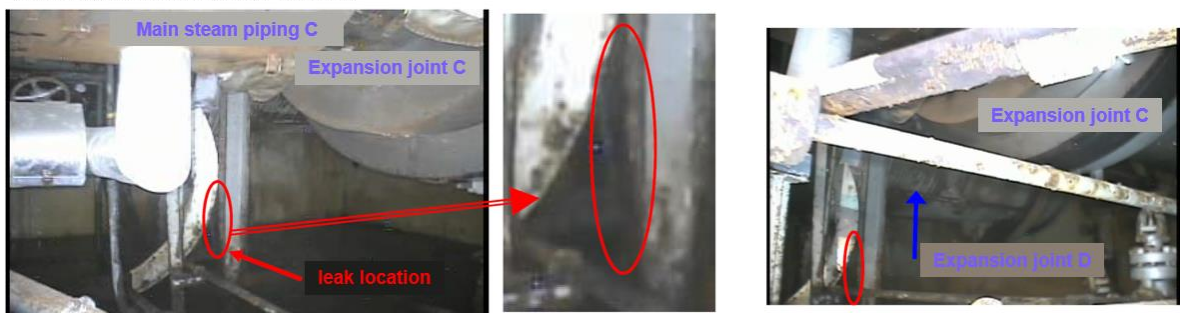
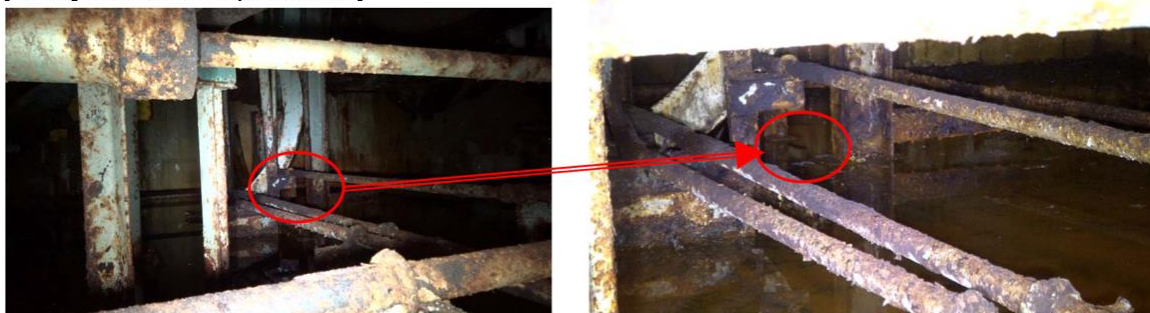
Figure 4-6 Investigation result of main steam piping D^[4-6]

the joint of the main steam piping D, which was confirmed during the investigation in May 2014, was no longer present (Figure 4-6). On the other hand, although the joint of the main steam piping A was in the blind spot of the camera and could not be observed, it was confirmed that there was a possibility of leakage due to fluctuation of the water surface below the piping (Figure 4-7). The main steam piping A was located far from the camera and was not clearly imaged in the previous investigation, but it was imaged in this investigation because of the better camera performance. Main steam pipings A and D were installed at the same location (height), but the location (height) of the leak might be different. Since the current reactor containment vessel (PCV) water level is lower than in the previous investigation, it was thought that the leak on the piping D side has stopped while the leak on the piping A side is lower than the PCV water level, and therefore continuing.^[4-6]

Main steam piping D (at the rear of main steam piping C) Enlargement of leak location
