Status of investigation on estimating situation of cores and containment vessels

1. Introduction

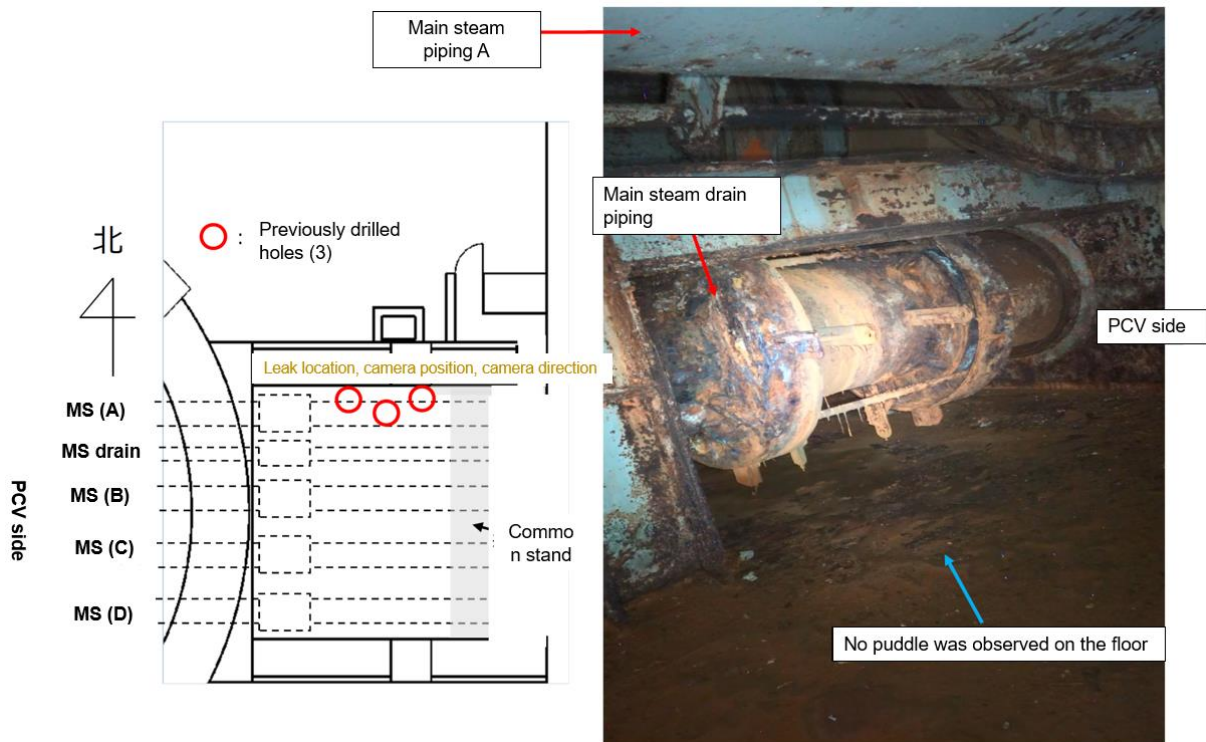
Figure 4-8 Investigation results of main steam piping A (obtained in June 2022) [4-7]

In June 2022, an investigation around the expansion joint of the main steam piping A was conducted again for the purpose of identifying the leakage point around this joint. It was confirmed that no water was dripping from the joint or from the main steam drain piping in the vicinity of the joint, and that there was no water puddle on the floor below the joint (Figure 4-8). This investigation did not lead to identification of the leakage point around the joint.

Since the calculated PCV water level has continued to decline slowly as of June 2022, it is assumed that some leakage points exist at a lower location than the PCV water level, in addition to the leakage points near the joints in question.

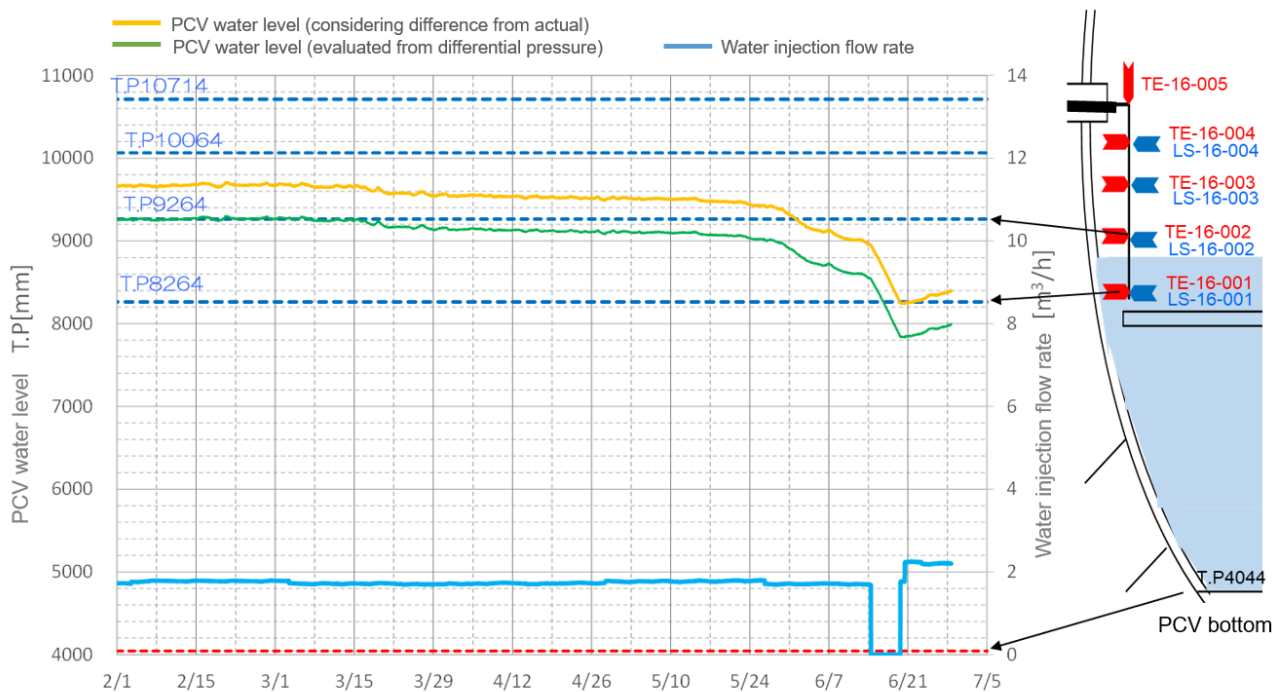
Figure 4-9 Change in PCV water level due water injection halting test (long-term trend) [4-8]

Furthermore, based on the results of the water injection stop test conducted in June 2022 and the PCV water level declining trend, it was estimated that the leakage point is about 4.2m (T.P. 8264) from the bottom of the PCV (Figure 4-9).

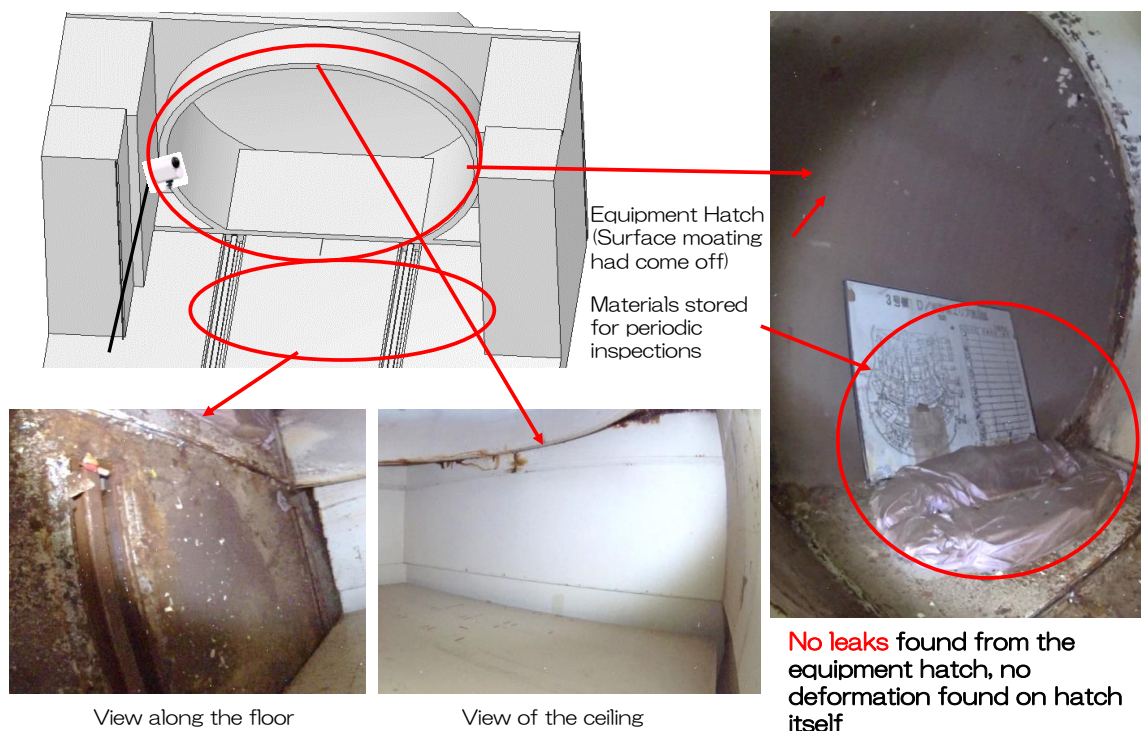
Figure 4-10 Photos of the equipment hatch^[4-9]

In the current investigation, a small camera was inserted through the space between the shield plug and the wall originally surrounding the shield plug and the equipment hatch conditions were surveyed. Figure 4-10 presents photos taken of the hatch and around it. No water leaks from the hatch were recognized and no deformation of the hatch itself was recognized, either. Furthermore, no damage was found on the materials for periodic inspections that had been stored in front of the equipment hatch. Rather, it was noticed that the surface coating on the equipment hatch had come off and fragments of coating and other things had been accumulated on the floor in front of the equipment hatch.

At the original location for the shield plug, water (raindrops or condensed dew) was dripping from above and the floor seemed wet. Water puddles were recognized in the ditches for the shield plug travelling rails.

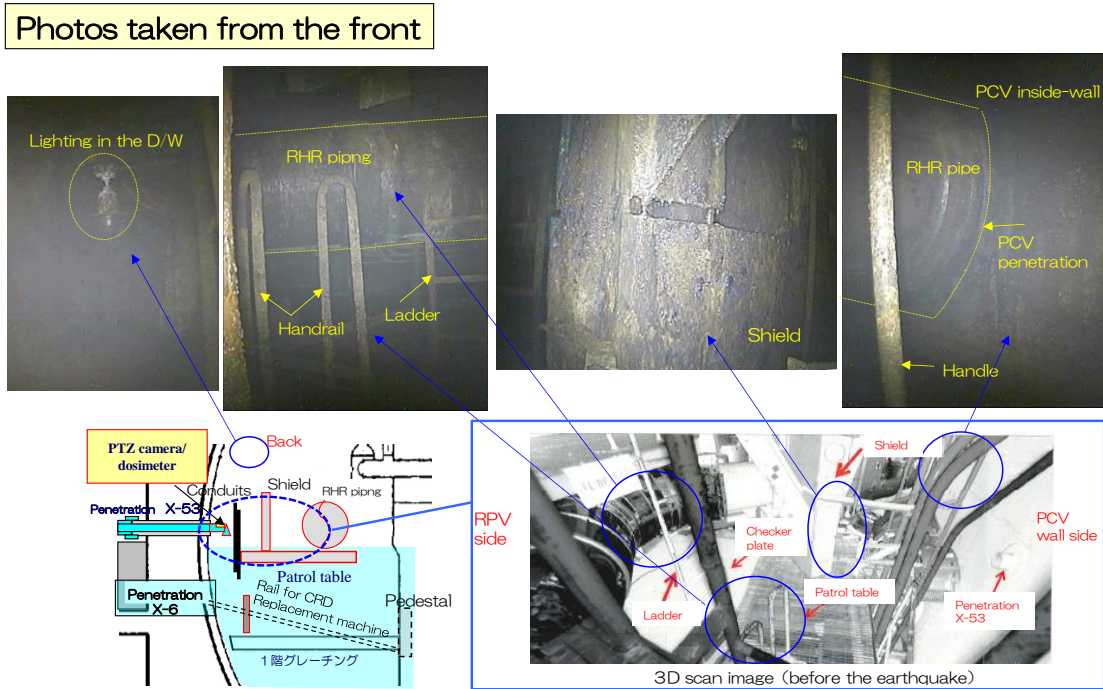
Figure 4-11 Photos of penetration X-53 taken from the front [4-10]

Figure 4-11 shows photos of the penetration X-53 taken from the front. Structures like piping, a ladder and other things were visible, but no damage was recognized. Including the underwater photos, no damage was recognized in the PCV in the current investigation.

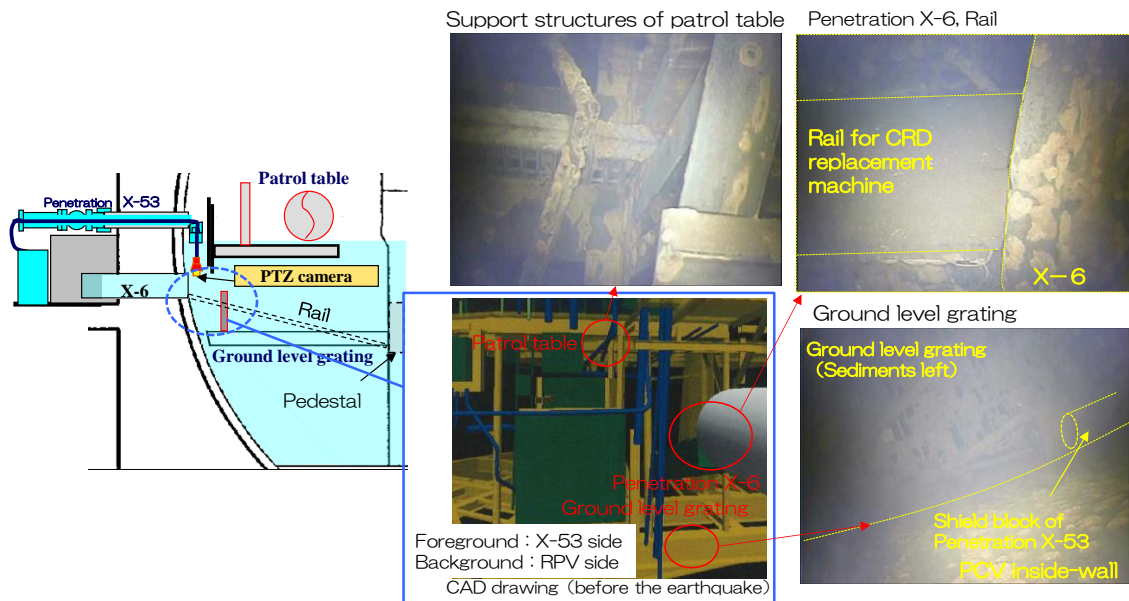
Figure 4-12 Photos taken in the water retained in the PCV [4-10]

Figure 4-12 shows photos taken underwater by a PTZ camera. The camera was inserted through penetration X-53. Sediments were recognized on the grating and the rails for the CRD replacement machine.

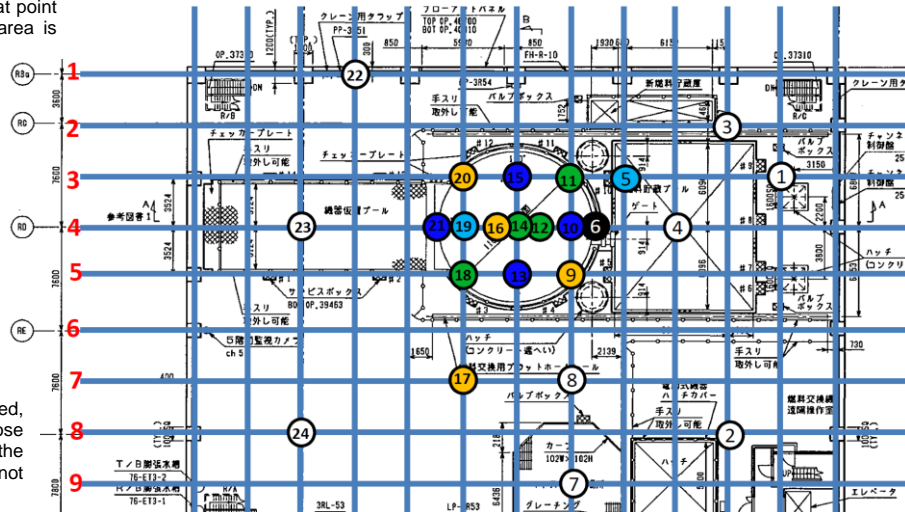
Figure 4-14 Dose rate distribution ratios evaluated from the gamma-ray total spectrum (Normalized to 1.0 at location ⑳) [4-11]

Figure 4-14 shows the distribution of dose rates (relative) evaluated from the measured gamma spectra. Higher dose rates were observed at the periphery of the reactor well-cover (⑥, ⑨, ⑪, ⑱, ⑳) and at the slab interfaces (⑫, ⑰).

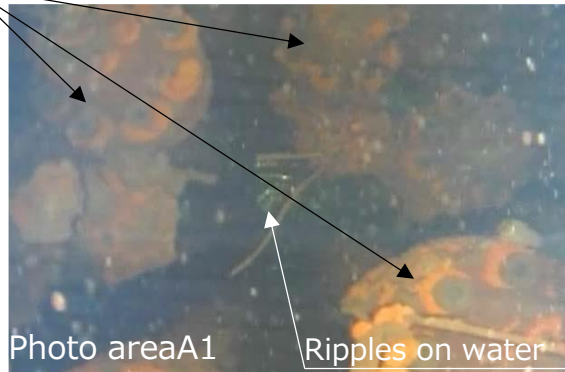
Figure 4-17 Photo [4-13]

The video camera filmed the CRD housing from below in Areas A1 and A2 inside the pedestal shown in Figure 4-16. Figure 4-17 and Figure 4-18 show photos taken. Figure 4-17 confirmed the CRD flanges were disarrayed; they should have been in place at uniform intervals and with the same elevation. Figure 4-18 confirmed an object looking like a control rod (CR) guide tube, which is part of the core internals and should be in the RPV, was now outside the RPV. Near the CRD housing damaged or fallen-off CRD housing support brackets were confirmed, and solidified molten objects were stuck to CRD flanges or other pieces. In Figure 4-17, ripples on the water surface, which could be photographed when looking from below toward the water surface, could be confirmed. This indicated a possibility that water was dripping from above. Similar water surface ripples could be confirmed near the pedestal inner wall, too. This indicated a possibility that, besides an opening at the center of RPV bottom head, another opening might exist in the RPV peripheral region, too.

Levels and intervals of two adjacent CRD flanges not uniform

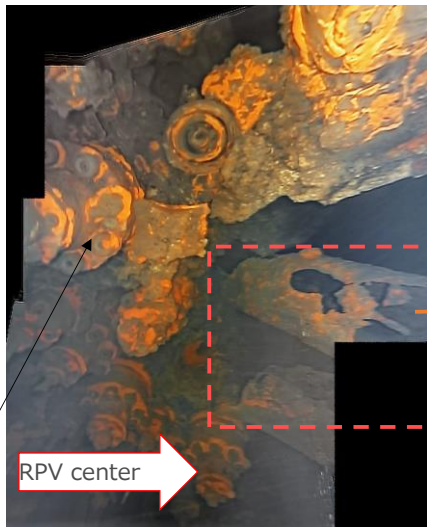
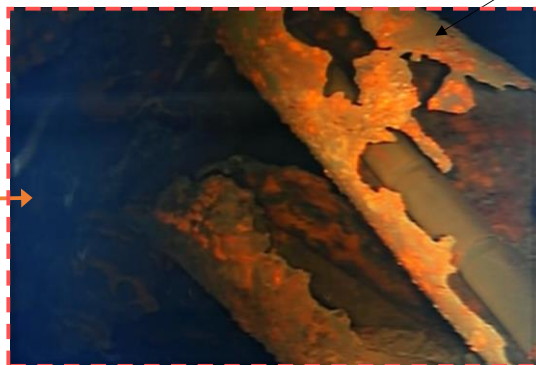
Figure 4-18 Photos

(A structure, apparently a CR guide tube; photo taken near CRD housing in photo area A3) [4-13]

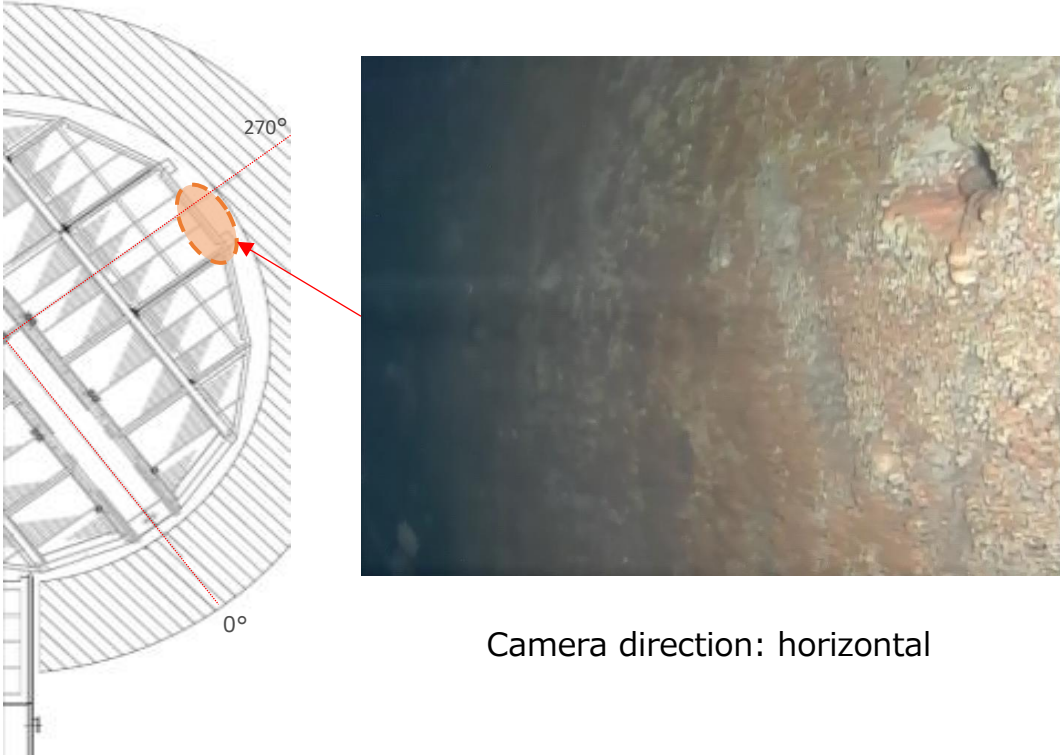
Figure 4-19 Photo (pedestal inner wall) [4-13]

Figure 4-19 and Figure 4-20 are photos of the pedestal inner wall. On part of the inner wall, the epoxy-based coating was stripped off and the wall surface was rough, but no big pedestal damage or deformation was confirmed as a whole (Figure 4-19). Part of the cables for the RPV bottom thermometers laid on the pedestal inner wall was found to be missing (Figure 4-20). It is estimated that high-temperature molten debris deposited on the cables when falling down.

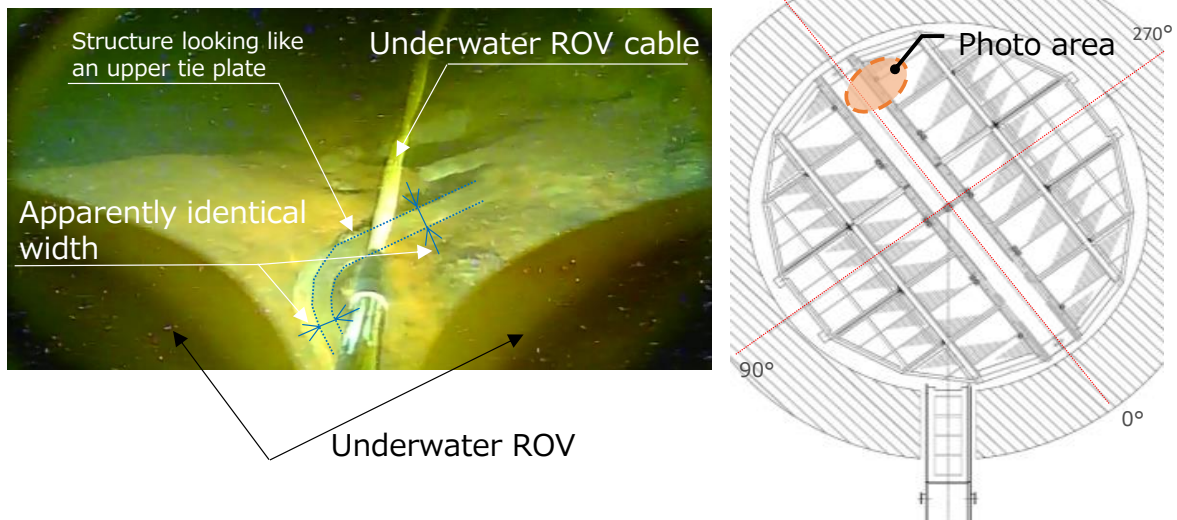
Figure 4-21 Photo

Figures 4-21 and 4-22 are photos taken at a lower part inside the pedestal. Although not clearly identifiable, fallen objects looking like upper tie-plates of fuel assemblies or fuel support fitting plugs (Figure 4-21), or a control rod falling speed limiter (Figure 4-22) were found. In the pedestal lower part, pebble-like or lump sediments were confirmed besides sand-like sediments (Figure 4-22). The opening in the pedestal basement for human access was not checked visually, but sediments were confirmed to be present in the vicinity.

(A structure, possibly an upper tie-plate observed inside the lower pedestal) [4-13]

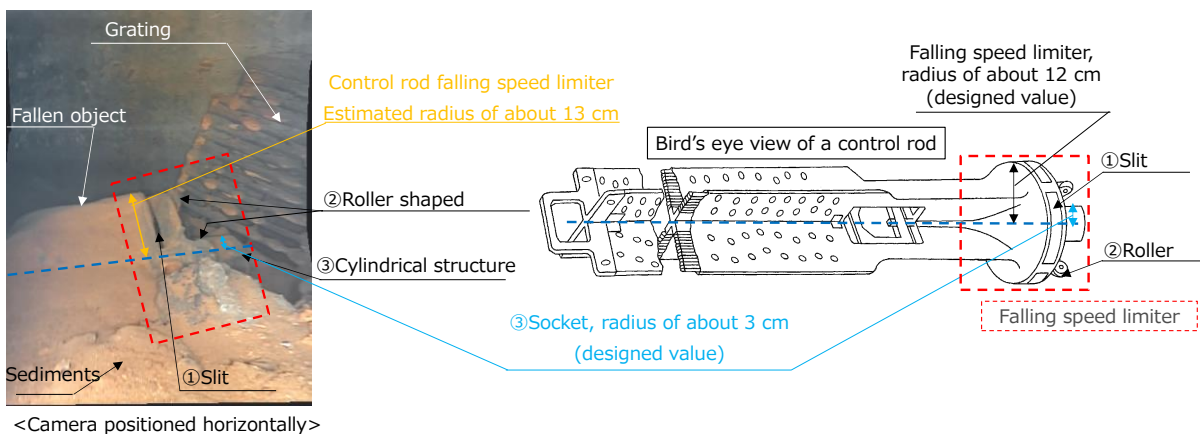
Figure 4-22 Photo

(A fallen object, possibly a control rod falling speed limiter observed inside the lower pedestal, Area C2) and schematic drawing of a control rod [4-13]

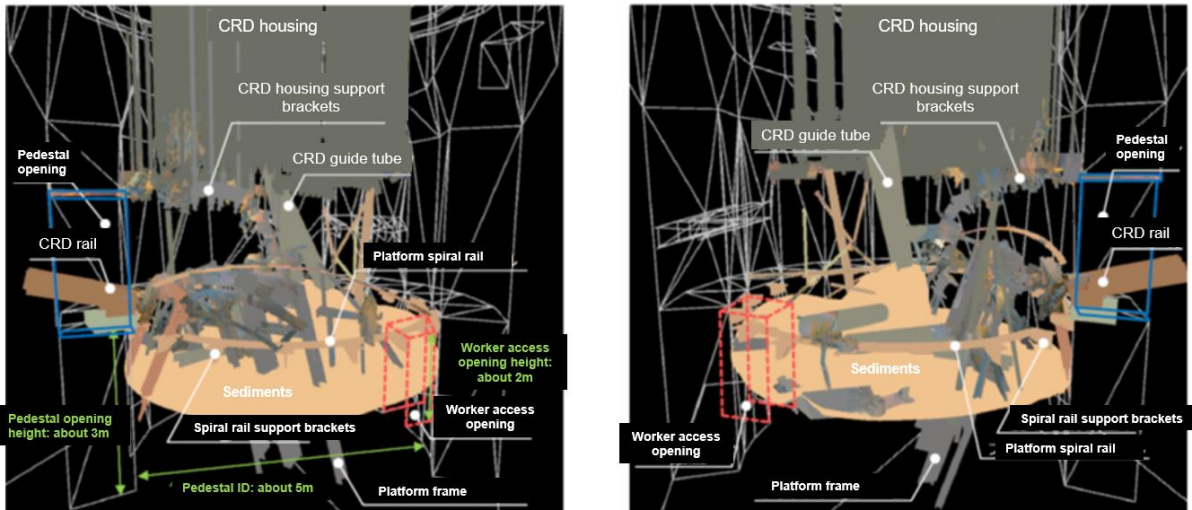
Figure 4-27 3D reconstruction figure of the inside of the pedestal [4-14]

A summary of the information from the reconstructed data is shown in Figure 4-27. The reconstructed sediment height is highest at the center, and considering that the platform has fallen down and the CRD exchanger was not confirmed, it may be higher due to molten material falling on top of the CRD exchanger, which may contain fuel debris.

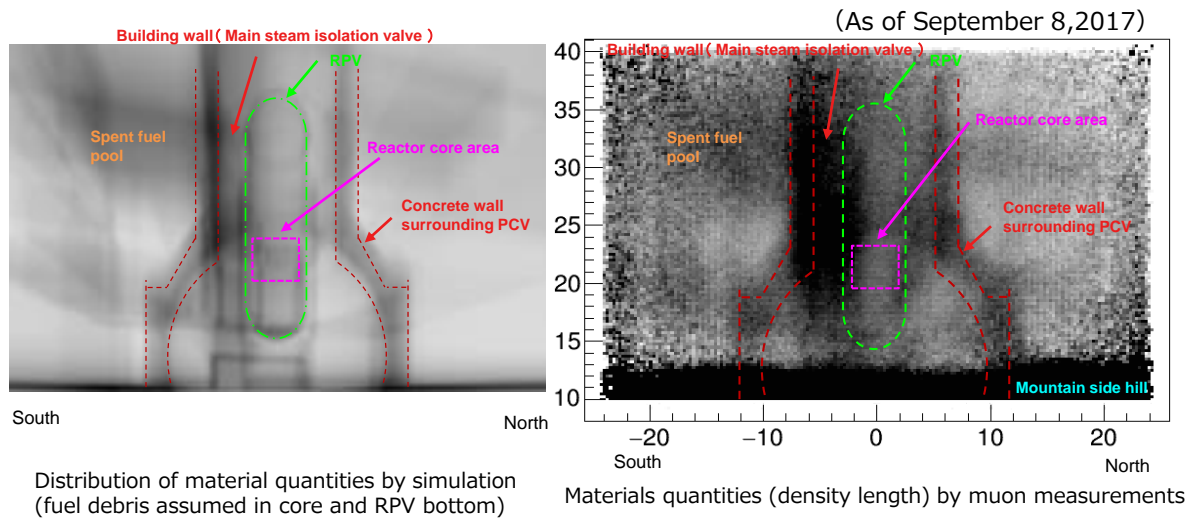
Figure 4-29 Distribution of material quantities from simulation (left) and muon measurement (right) ^[4-15]

An investigation with the muon device was conducted for Unit-3 in May to September 2017 following the investigations for Unit-1 and Unit-2. Figure 4-28 shows the location where the muon device was set up. Figure 4-29 compares the distribution of material quantities (density length) obtained from a simulation based on design and those obtained from muon measurements. Concrete in the PCV peripherals, spent fuel pool and reactor building walls could be identified in the distribution of material quantities from the muon measurements.

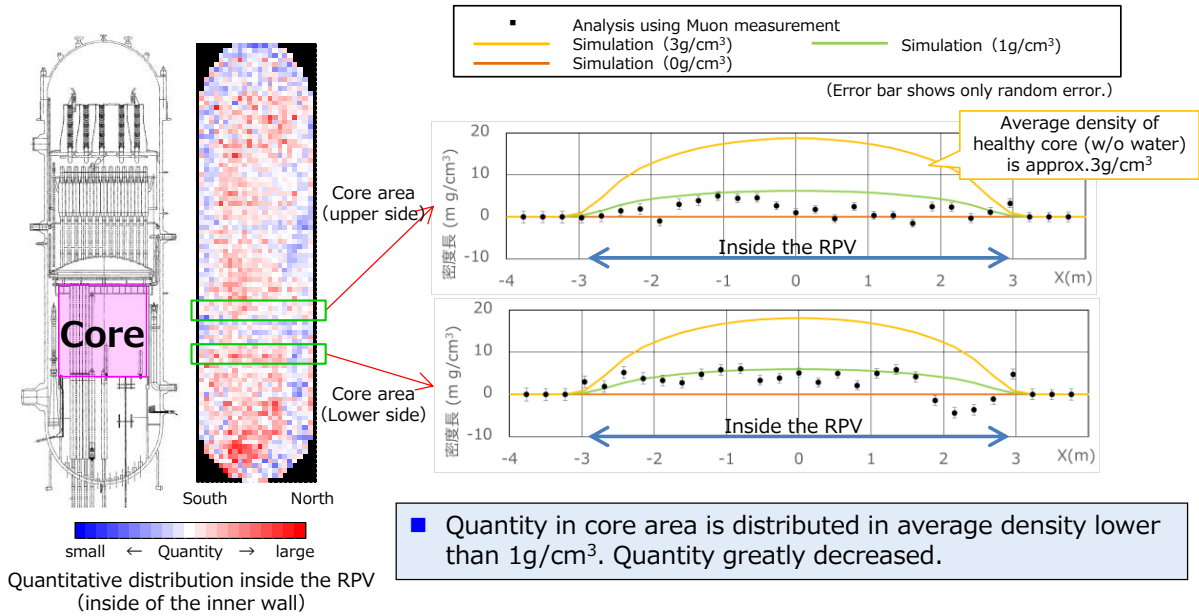
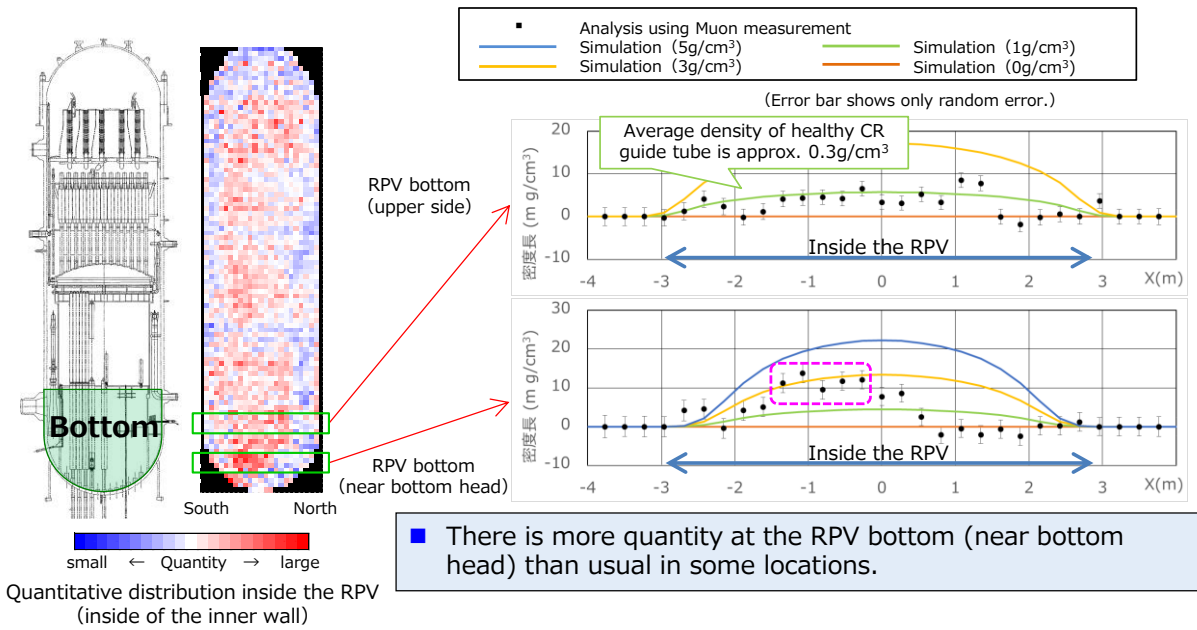
Figure 4-30 Distribution of material quantities in the RPV (Top, core region; bottom, RPV bottom) [4-15]

The distribution of material quantities in the RPV was derived from the measured results by eliminating the influences from structures like R/B walls and the PCV based on the simulation model. The results are given in Figure 4-30 (left). These were compared with the simulation results, in which high density materials (3g/cm^3 , 1g/cm^3 , and in addition 5g/cm^3 at the PCV bottom) were assumed to be present in the RPV or not present. The comparison led to the estimation of the presence of fuel materials at different RPV elevations (Figure 4-30 (right)). Materials of about 1g/cm^3 or below were present at the core region, far lower than the normal average densities in the core (about 3g/cm^3). On the other hand, more material quantities were identified than normal in some part of the bottom of the RPV. Quantitative evaluation results of material quantities are given in Figure 4-31 for respective positions in the RPV. By considering the big reduction of material quantities in the core region as compared with those before the accident, most of the fuel can be estimated to have been relocated downward together with structural materials. No big fuel debris is considered to be left in the core region. To the contrary, the material quantities at the RPV bottom increased from the quantities before the accident. This is an indication, with some uncertainties being admitted, that part of the fuel debris remains at the RPV bottom.

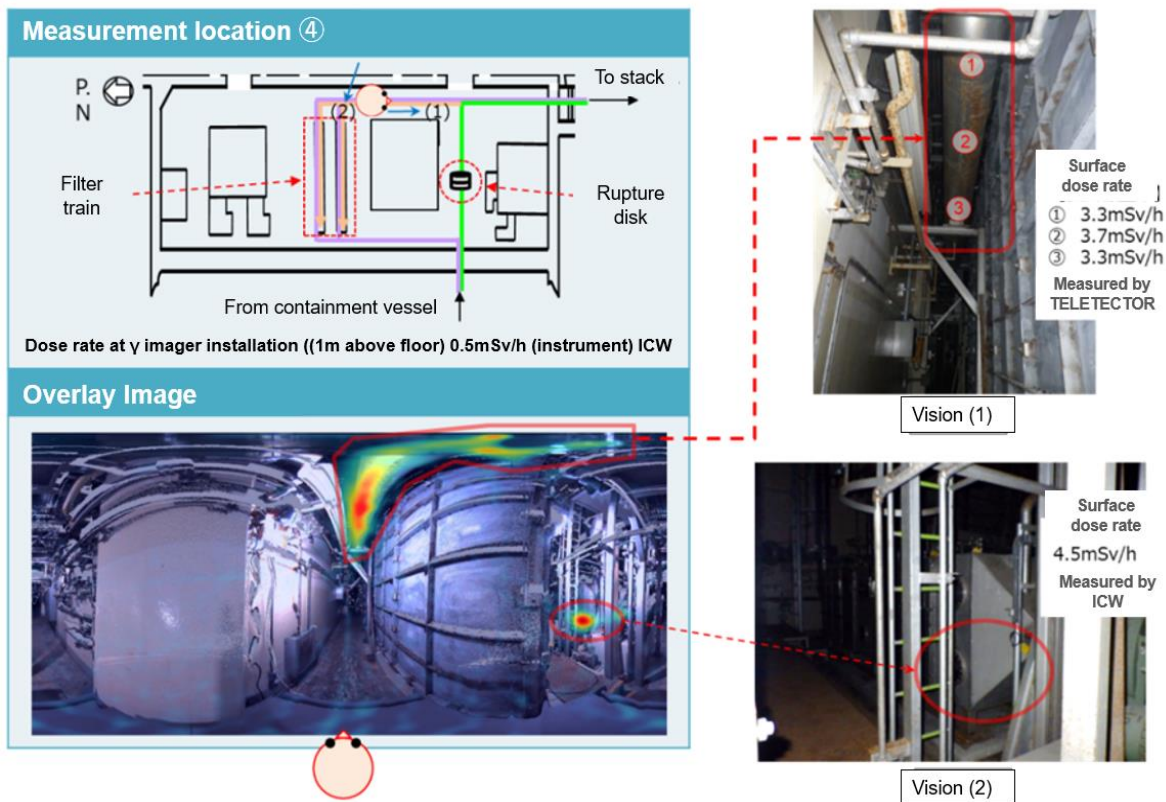
Figure 4- 32 Results of γ imager measurements in the SGTS room (Room No.1) [4-16]

As a result of the γ imaging measurements, contamination was confirmed along the SGTS piping leading from the vent line to the filter train and also downstream from the filter train (Figure 4-32). Furthermore, contamination was confirmed along the vent line (Figure 4-33). These results clearly indicated that there was a backflow of vent gas into Unit-3 itself.

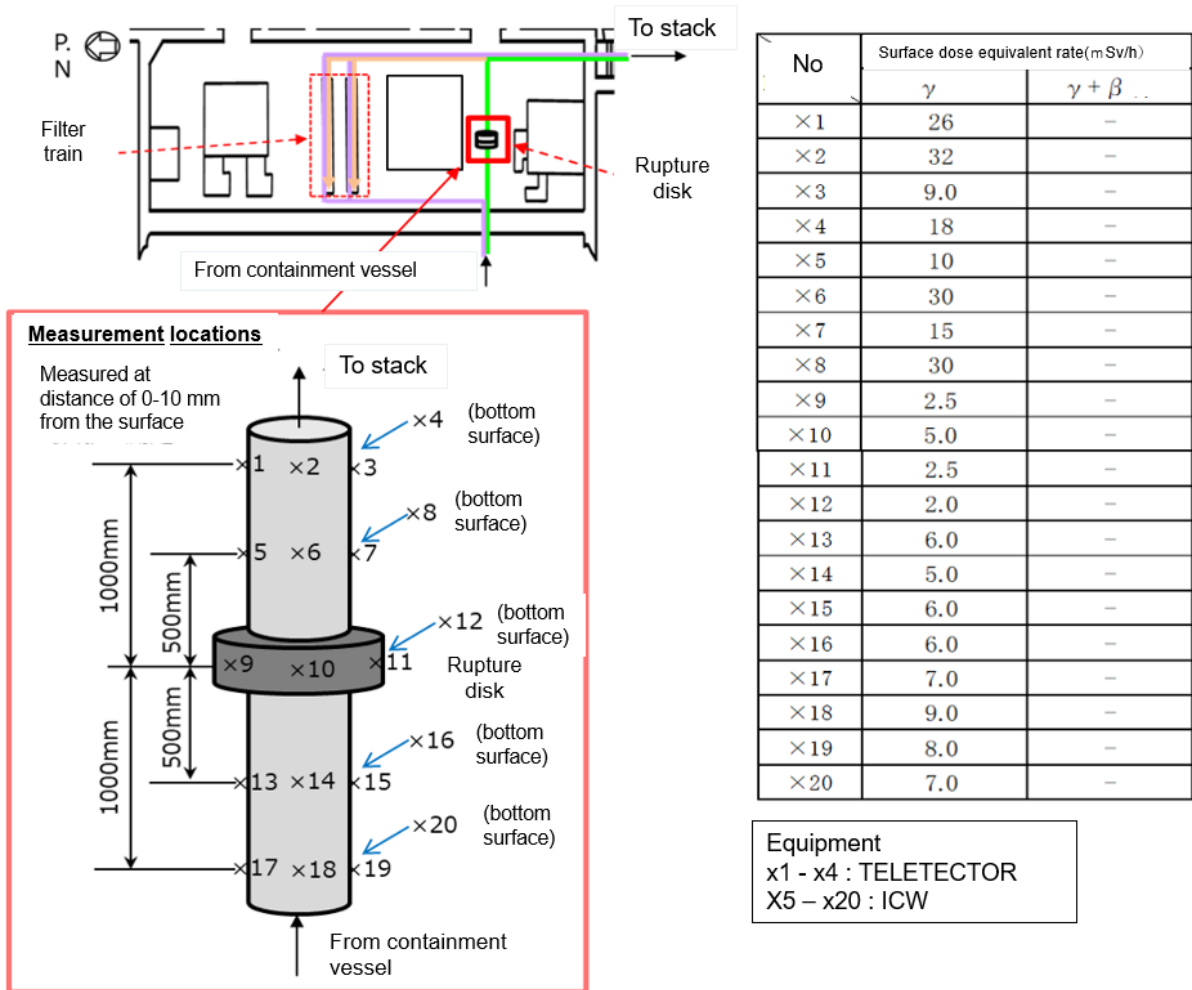
Figure 4-34 Dose rate measurement results around the rupture disk [4-16]

The dose rate measurements around the rupture disk showed that the measured dose rate increased in the order of "rupture disk < upstream from rupture disk < downstream from rupture disk" (Figure 4-34). This is significantly different from the fact that almost no contamination was observed around the rupture disk (closed due to non-operation) in Unit-2, where no venting was performed.

It was confirmed in an investigation conducted by the Nuclear Regulatory Agency in July 2019 that the dose rates were 2.5mSv/h downstream from the rupture disk, 8.0mSv/h on the surface of the rupture disk, and 5.5mSv/h upstream from the rupture disk.[4-17]

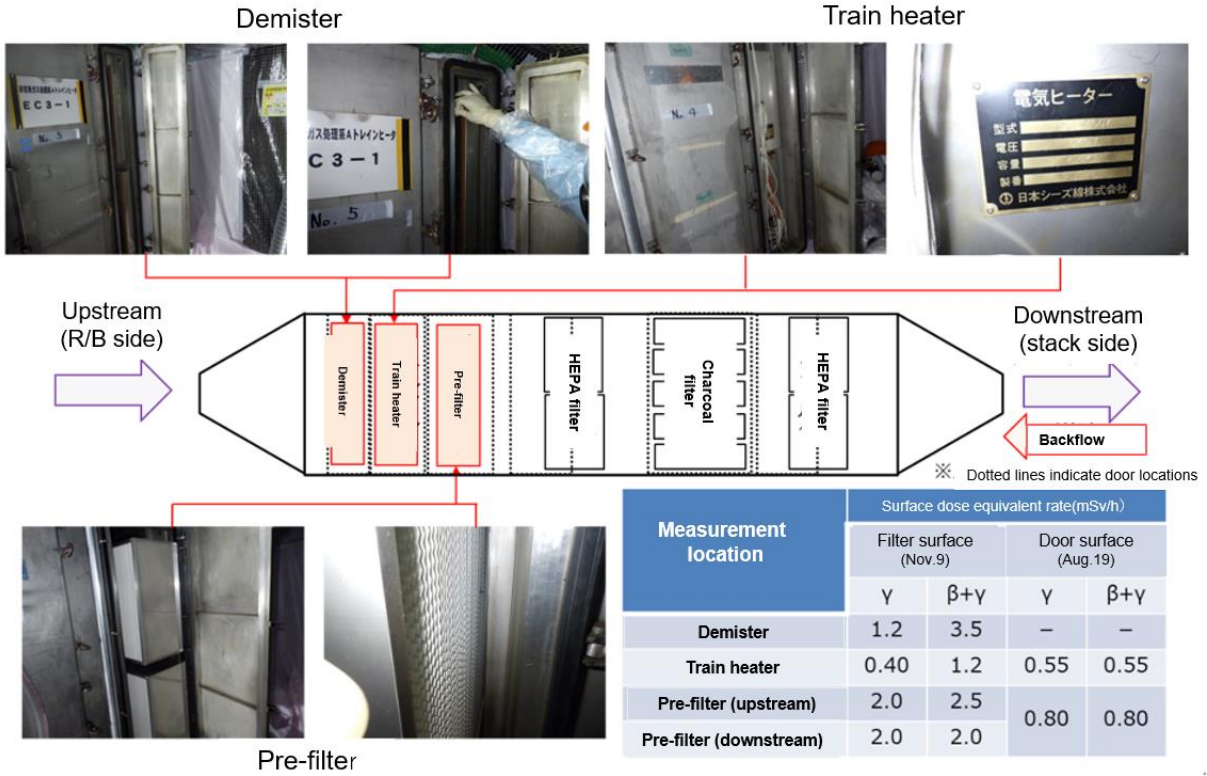
Figure 4-35 Investigation inside filter train A result ① [4-16]

As a result of the surface dose rate measurement and smear sampling of the filters inside the filter train done by opening the train, it was confirmed that each filter was contaminated, but no damage was observed (Figures 4-35 to 4-38). In addition, there was a pool of water inside the B train when it was opened. It was estimated that this was condensed when the vent gas passed through.

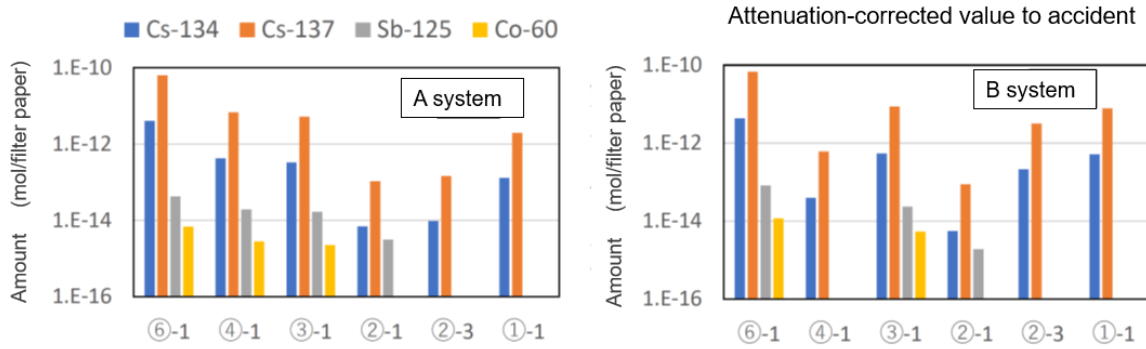
Analysis of smear samples from the filter surface confirmed that the demisters located furthest upstream and the HEPA filter located furthest downstream tended to have a higher presence ratio of nuclides (Figure 4- 39). It was estimated that this result suggests that in addition to the forward flow direction, vent gas containing nuclides flowed back into the filter train during venting operation.

- The most upstream filter (⑥) and the most downstream filter (①) tend to have higher values.
 ⇒ In addition to the normal flow direction (from the reactor building side to the stack side), this suggests that the vent gas containing nuclides flowed back into the filter train when the containment vessel vent was activated.

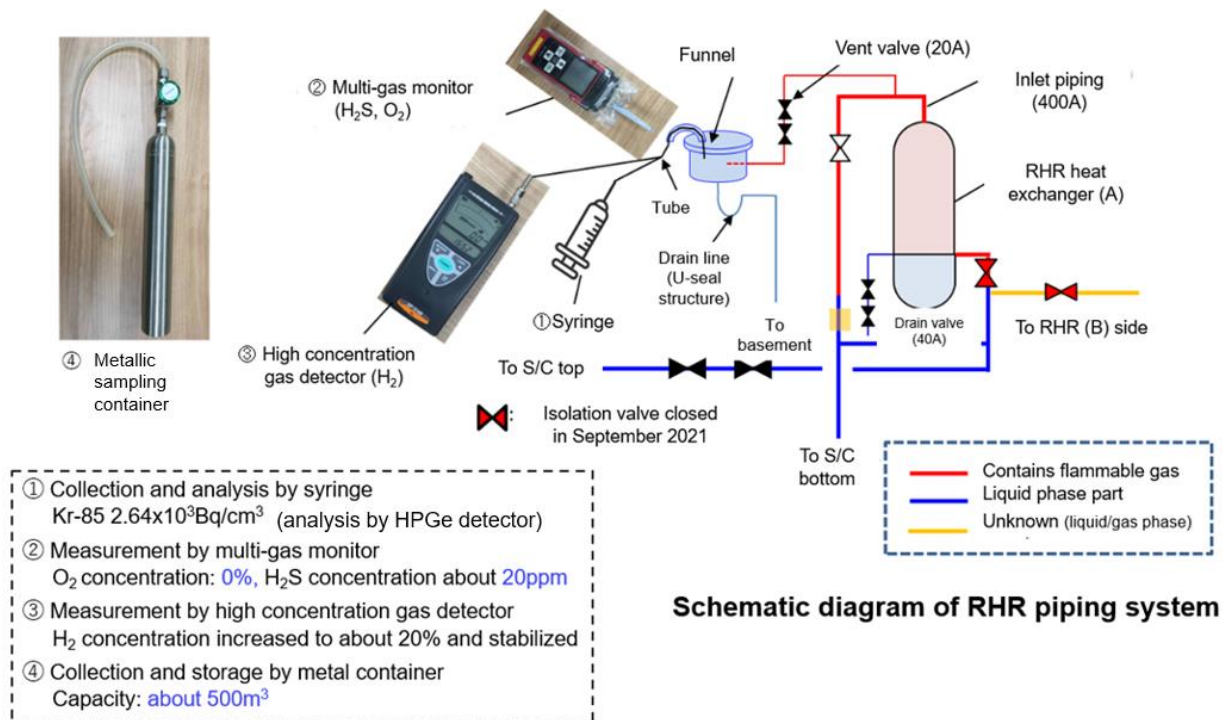
Figure 4- 41 Results of stagnant gas concentration measurement (H₂, etc.) and sampling [4-20]

After the analysis, when proceeding with the installation of the PCV intake system, the vent valve around the residual heat removal system (RHR) heat exchanger (A) was opened in December 2021 as a preliminary preparation for draining the existing piping, and it was confirmed that a flammable gas was present in the exhaust. From collecting and analyzing the gas, Kr-85, a long half-life nuclide, was detected (Figure 4-41). The source of this stagnant gas is unknown, but it was thought that it might have been caused by the inflow of gas into the system due to some operation during the accident, radiolysis of water held in the system, or other sources.
