Additional examination of station black-out due to tsunami

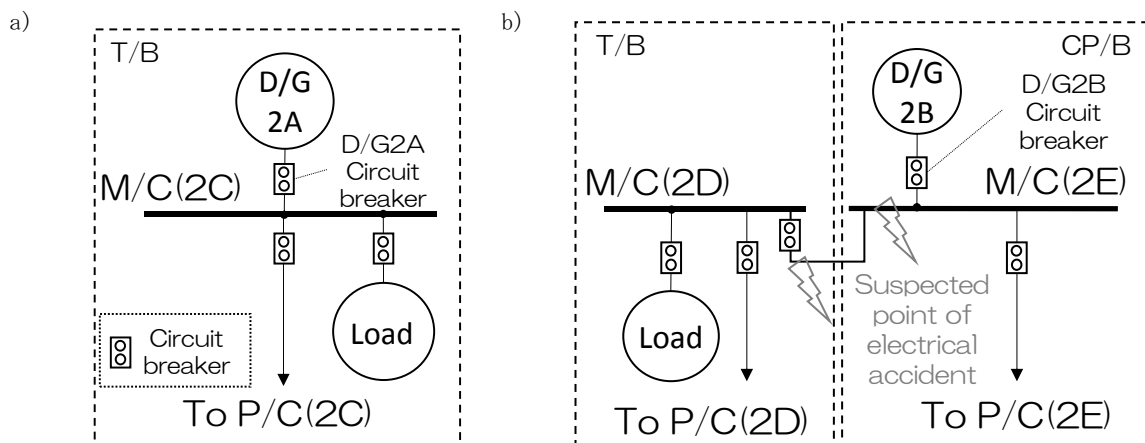
Figure 6 Schematic diagram of Unit-2 emergency AC Power equipment
(a: Line A, b: Line B)

As was seen in Figure 3, the Unit-2 Line A systems (D/G2A and M/C2C) lost their functions relatively early, while the Line B systems (D/G2B and M/C2D) gave relatively inconsistent correlations between the path lengths and function loss timings in the overall trend. To reveal the cause, the process computer data were analyzed in detail. Figure 6 presents a schematic diagram of emergency AC power equipment of Unit-2 Line A and Line B. In Line A, both D/G2A and M/C2C were housed in the T/B and connected to each other via the circuit breaker D/G2A (this configuration is the same as D/G1A, 1B, 3A, 3B, 5A and 5 B of other units). The M/C is connected directly to its loads or to the low voltage power distribution panel power center (P/C in the figure) after voltage reduction. In Line B, on the other hand, the D/B2B and M/C2E are housed in the CP/B and connected via the D/G2B circuit breaker. The M/C2E is further connected to the M/C2D in the T/B via a circuit breaker.

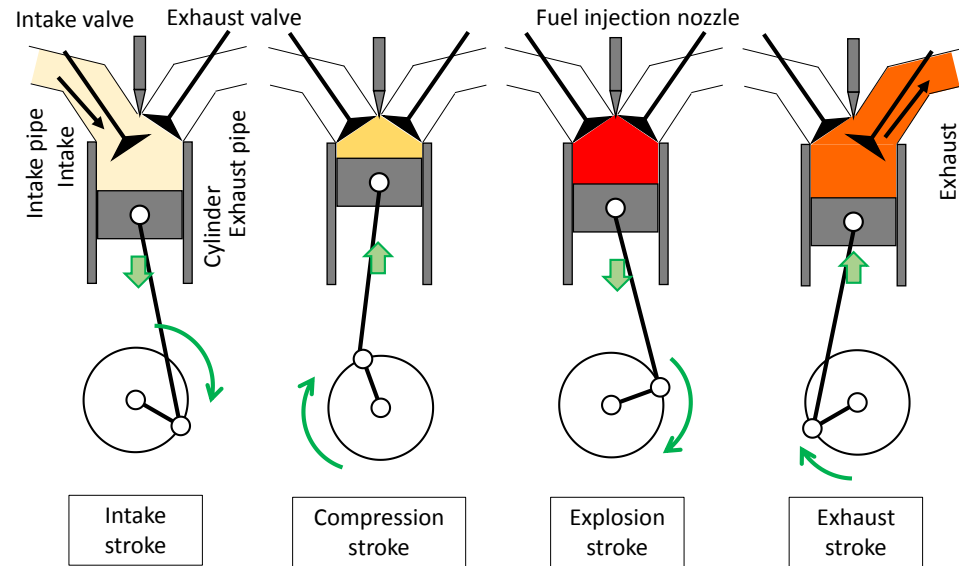
Figure 11 Operation of a 4-cycle diesel engine

A possible scenario of the D/G3A having stopped is that seawater flowed into the D/G cylinder through the intake silencer. Figure 10 shows the installation location of the

silencer, and Figure 11 illustrates the operation of a 4-cycle diesel engine. The D/G3A silencer was installed on the seaside at a lower elevation, as can be seen in Figure 10. It is possible seawater flowed to the inside of the D/G engine through the silencer. If this seawater reached the cylinder via the intake pipe, as shown in Figure 11, it would have caused insufficient combustion in the diesel engine. Furthermore, if the seawater reached other cylinders, the D/G rotating speed would have gradually dropped, the voltage would have dropped and eventually the D/G would have stopped. It should be noted that silencers of Unit-1 D/G1A and 1B, and Unit-2 D/G2A were also installed on the seaside at lower elevations, like Unit-3 D/G3A. The inundation path lengths to all these silencers are not very different. Therefore, the tsunami could have eventually flowed into the D/G cylinders of Units-1 and -2 as well. But it is unlikely that seawater, having flowed into the cylinders, stopped Unit-1 D/Gs and Unit-2 D/Gs, because their power supply was stopped earlier than Unit-3 Line A, and their voltage and current drop behavior is different from the unique behavior of Unit-3 Line A. It should also be noted that no seawater would have flowed into the silencers of Unit-3 D/G3B, Unit-5 D/G5A and 5B, because the silencer of Unit-3 D/G3B was installed at an elevated position, and those of Unit-5 D/G5A and 5B were enclosed by side-walls.
