Estimation of causes of high contamination of RCW piping at Unit-1

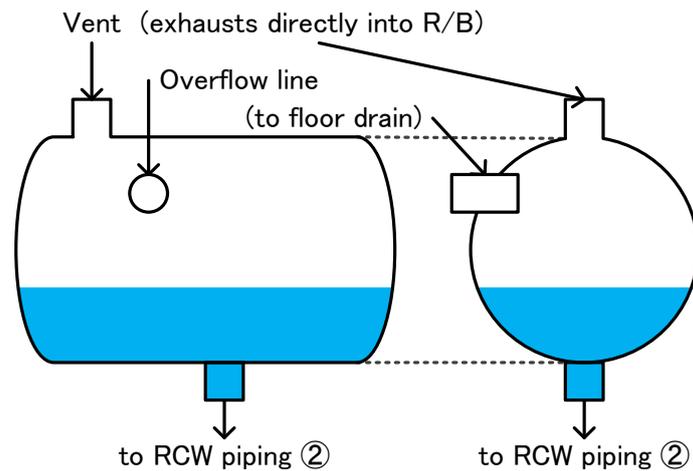
Figure 7 Structure of RCW surge tank (image)

The RCW system discharged its surge tank vent exhaust directly to the air in the R/B (Figure 7). Therefore, the pressure distribution in the RCW lines is considered to have been in a distribution with the pressure at the surge tank at 1 atmospheric pressure (about 0.1MPa[abs]). On the other hand, it has been confirmed that the PCV pressures of Unit-1 in the accident progression were kept high after the DW pressure of 0.6MPa[abs] had been measured at about 23:50 on March 11th until the PCV wet well venting (W/W venting) was successfully carried out, and then decreased over the period from 14:30 to 14:50 on March 12th when the W/W venting was implemented. Since it is probable that the migration behavior of radioactive materials in the RCW piping depended on the PCV pressures, investigation was made in Sections 4.1 and 4.2 concerning the destination of radioactive materials in the respective cases of high PCV pressures and low PCV pressures.

around the surge tank on the R/B Floor 4 (Figure 5). Migration to other lines depends on the distance and paths to the destination equipment or on the elevational relations with the surge tank, which is an easier destination for migration. But all downstream lines return to the heat exchanger outlet line in a closed circuit. Therefore, the line pressures are considered close to the RCW pressures and it can be considered to have been hard for radioactive materials to migrate to these lines. It should be noted that the relatively high dose rates observed in the vicinity of the MG set (A) could have been affected by the RCW heat exchanger, as mentioned in Section 2, and they could have been caused not only by the contamination in the piping.
