Analysis of the hydrogen explosion at the Unit-1 Reactor Building

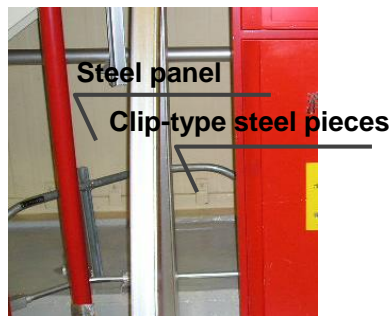
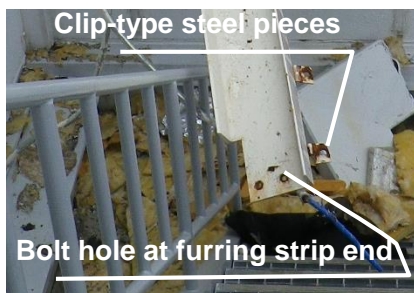
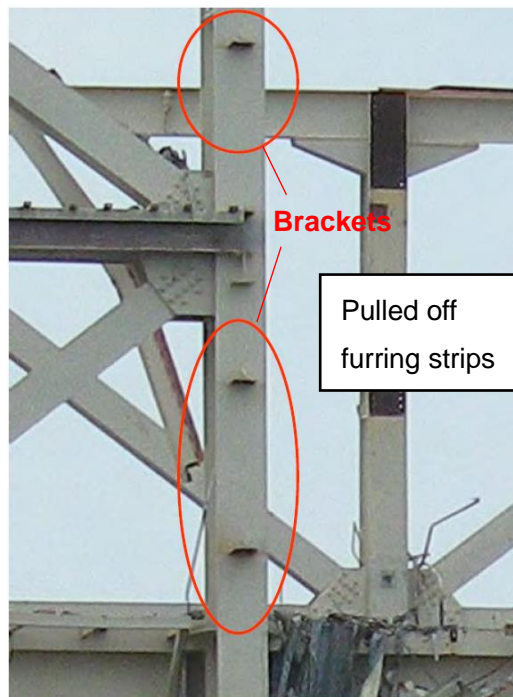
Figure 5 Joints between Floor 5 side wall and R/B structures

Figures 5 (A) to (C) show joints of the Floor 5 side wall and the R/B. The side wall of Floor 5 was made of steel panel and fixed to furring strips by dedicated clip-type steel pieces (A). The end of furring strips was fixed to brackets by two M-16 bolts (B) (C). After the hydrogen explosion, almost all furring strips were found to have been pulled off. This indicates that the bolts fixing the furring strips and brackets were damaged by the increased internal pressure (pressures of Floor 5) due to the hydrogen explosion.

As the bolt breakdown criteria, the internal pressure of 16 kPa was set. This value was derived by converting the bolt shear capacity obtained from tensile strengths of bolt material. In the analysis, the Floor 5 side wall was assumed to be damaged as soon as the Floor 5 internal pressure exceeded the criterion.

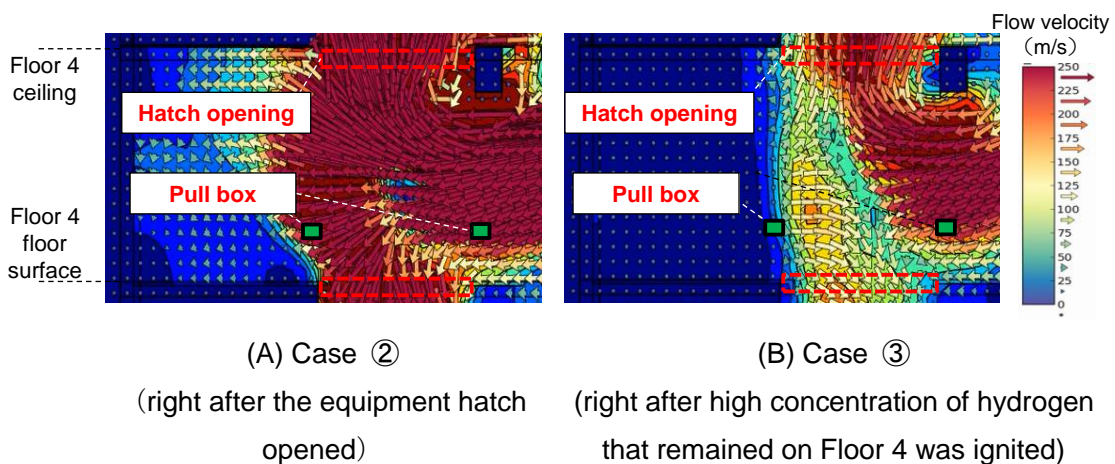
Figure 18 Maximum blast velocity at the pull box location

Figure 18 shows the blast analysis results in Case ② and Case ③, indicating that, in these cases, strong horizontal blasts collided against the pull box, after the high concentration hydrogen on Floor 4 had been ignited. The damage condition of the pull box shown in Figure 16 (B) indicates no marks of horizontal blasts.

From these comparisons, it is concluded that: the deformed shape of the pull box near the equipment hatch on Floor 4 is consistent with the blast directions in Case ① and Case ④ when hydrogen leaks on Floor 5 were assumed; whereas, it is inconsistent with the blast directions in Case ② and Case ③ when hydrogen leaks on Floor 5 and Floor 4 were assumed.

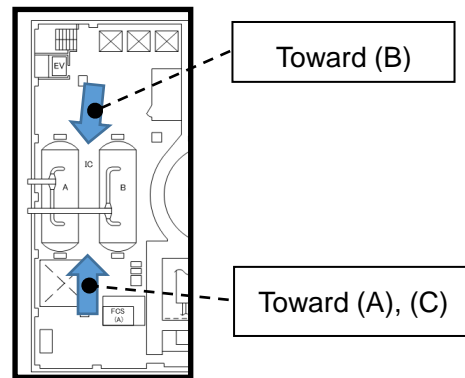
(D) Floor 4 west plan view

Damage conditions of IC tank thermal insulators and covers are shown in Figures 19 (A) to (C). Figure 19 (D) gives the directions in which the camera was pointed. The IC tank body looked orange-colored. The IC tank was originally covered by white-colored thermal insulators (C) having silver-colored insulator covers (B). On the IC tank south side, the insulator covers were peeled off, exposing the insulators (A). On the IC tank north side, the insulator covers remained intact (B). It should be noted that part of the insulator and their covers had flaked off and remained in the vicinity of the IC tank south side (C).

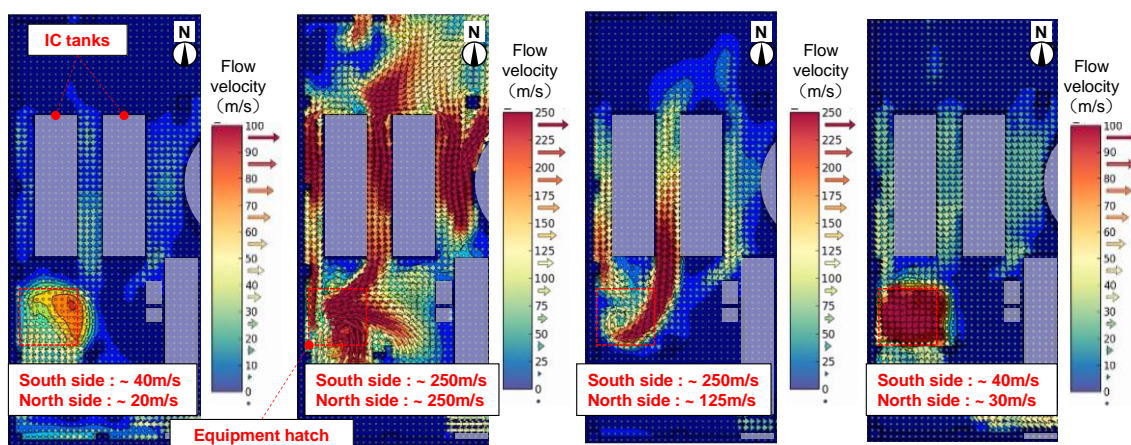
Figure 20 Maximum blast velocities on the horizontal cross section at the IC tank central elevation

Figure 20 shows the analysis results of the maximum blast velocities in the vicinity of the IC tank, presenting velocity vectors on the horizontal cross section at the IC tank central elevation. In Case ② and Case ③, the maximum blast velocities on the IC tank south side and north side are as high as about 125 m/s to 250 m/s, while in Case ① and Case ④ they are about 40 m/s on the IC tank south side and about 30 m/s on the north side. It is not certain whether the blast velocity on the IC tank south side is strong enough to strip the insulator covers off, but the velocity on the IC tank north side is comparatively lower

If violent blasts as seen in Case ② and Case ③ are assumed, stripped off insulators and their covers may be scattered over some distance by the blast pressures. In reality, however, part of the stripped off insulators and their covers remain in the vicinity of the IC tank, as seen in Figure 19 (C). The blast velocities may have been not that violent.

From these comparisons, it can be understood that: the damaged conditions of insulators and their covers seem to be consistent with Case ① and Case ④, when hydrogen leaks were assumed on Floor 5; while blast velocities may be too big in Case ② and Case ③, when hydrogen leaks were assumed on Floor 5 + Floor 4.

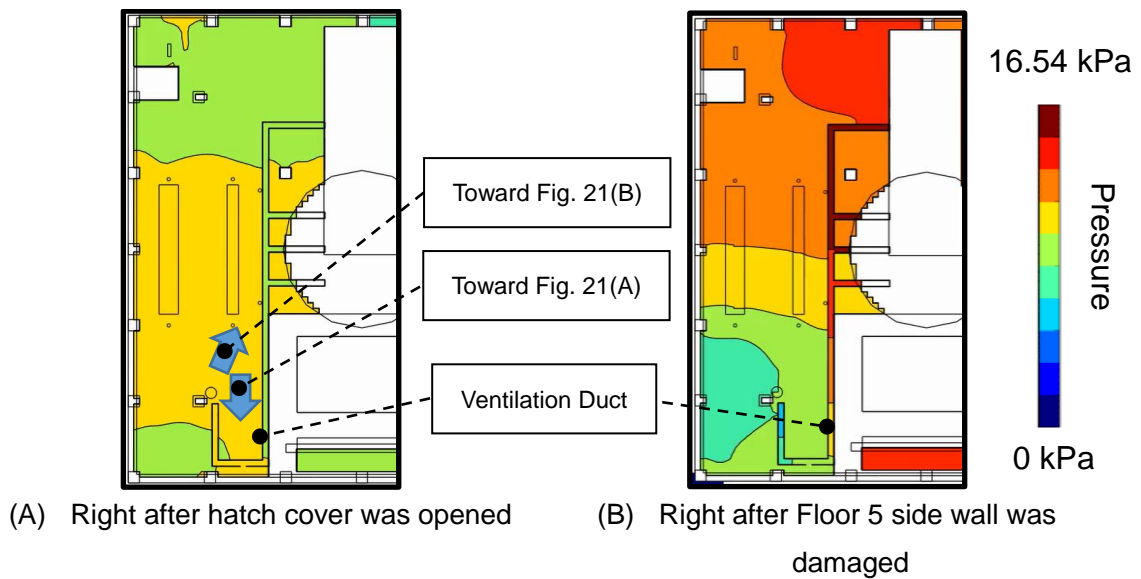
Figure 22 Pressure distribution at the elevation of the Floor 4 ventilation duct (Case ①)

Figure 22 gives the analysis results of pressure distribution at the elevation of the ventilation duct. At the timing when the R/B pressure rapidly increased by the hydrogen combustion (A), the pressure in the duct could not follow the R/B pressure changes and remained lower. On the contrary at the timing when the R/B pressure rapidly dropped due to the Floor 5 side wall damage (B), the in-duct pressure exceeded the R/B pressure. Thus,

A similar pressure difference could have been generated in hollow structures of the ventilation ducts, MCC and temporary toilet, and consequently inward and outward deformations as was seen in Figure 21 might have been caused in the course of the R/B pressure increase and decrease. Figure 22 shows the results in Case ① as an example, but the above correlation (pressure difference between inside and outside the ventilation duct) is commonly observed in all cases and none of them is considered inconsistent with the damage conditions.

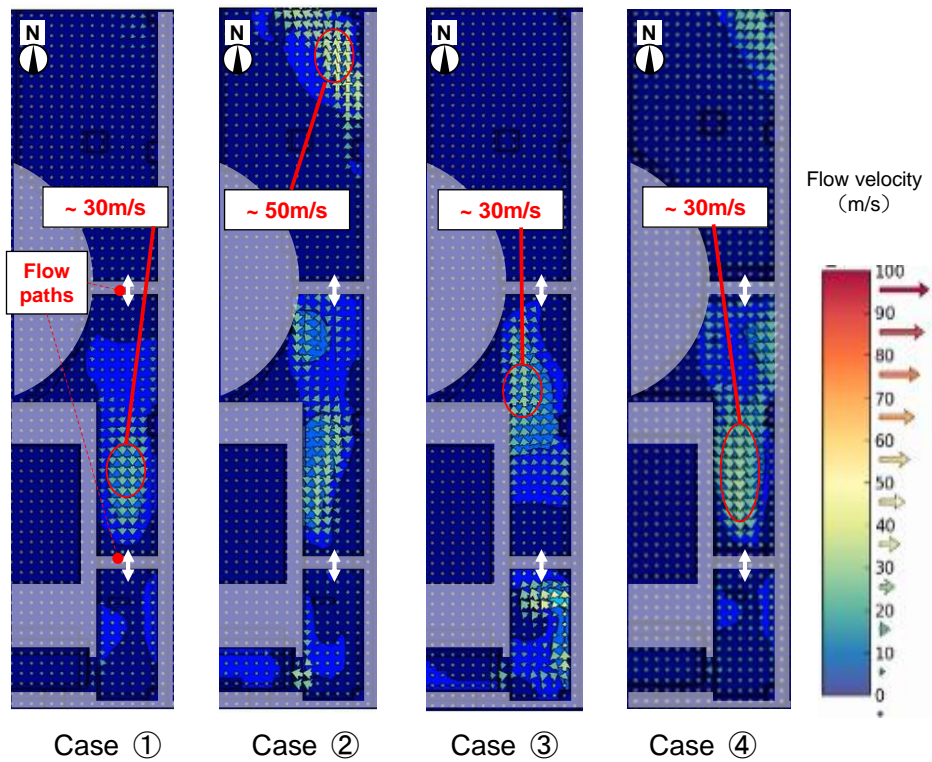
Figure 23 Maximum blast velocities in Floor 4 east side area

Damage on the east side area on Floor 4 was minor as compared with that on the west side area, as mentioned earlier. The ceiling in the east side area was lower and it was harder for the leaked hydrogen to flow in from Floor 5 or Floor 4 west side. As a result, hydrogen concentration was low and no hydrogen combustion occurred in any of the analysis cases.

Figure 23 shows the analysis results of maximum blast velocity in the east side area on Floor 4. In this east side area, the access paths were relatively narrow and the resultant maximum blast velocities were less than those in the west side area. This is not inconsistent with the damage conditions.

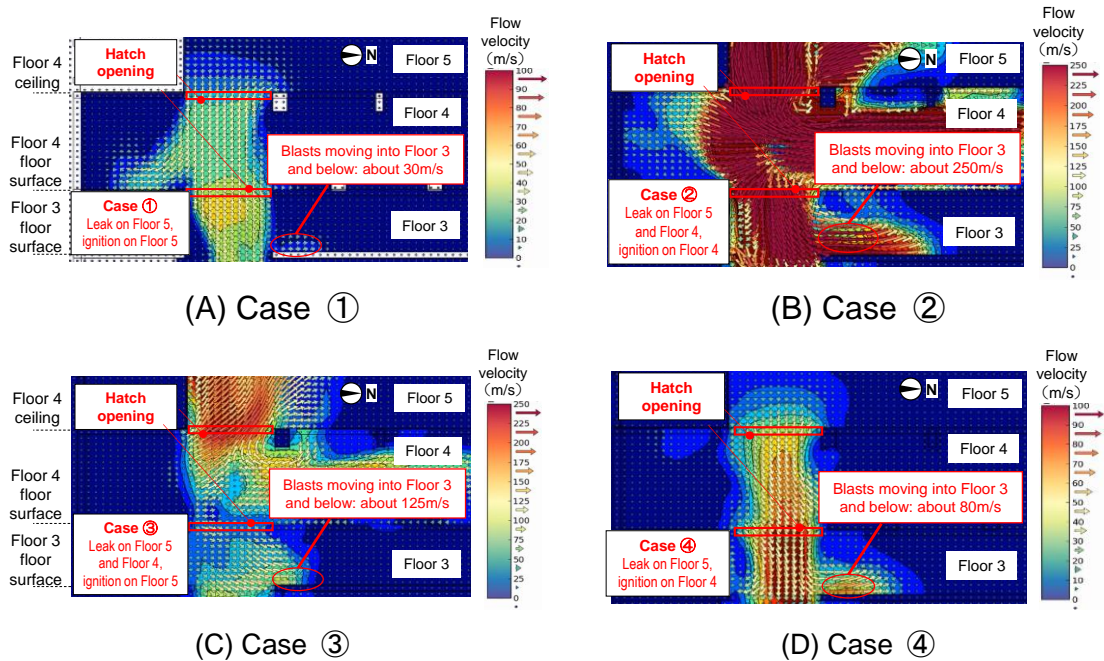
Figure 25 Maximum velocities of blasts moving to Floor 3 and below

Figure 25 presents the analysis results of maximum velocity of blasts moving down to Floor 3 and below. Velocity vectors on the vertical planes around the equipment hatch are shown in the figure. The direction in which the camera was pointed is the same as that in Figure 16 (A). The maximum velocities in the analysis of blasts moving into Floor 3 and below in Case ② and in Case ③ are much higher than in Case ① and Case ④. Blasts in Case ② and Case ③ could be too strong from the viewpoint of the blast velocities moving in.
