Identification of causes of high dose rate observed in the southeast area on the 1st floor of Unit 1 reactor building

1. Introduction

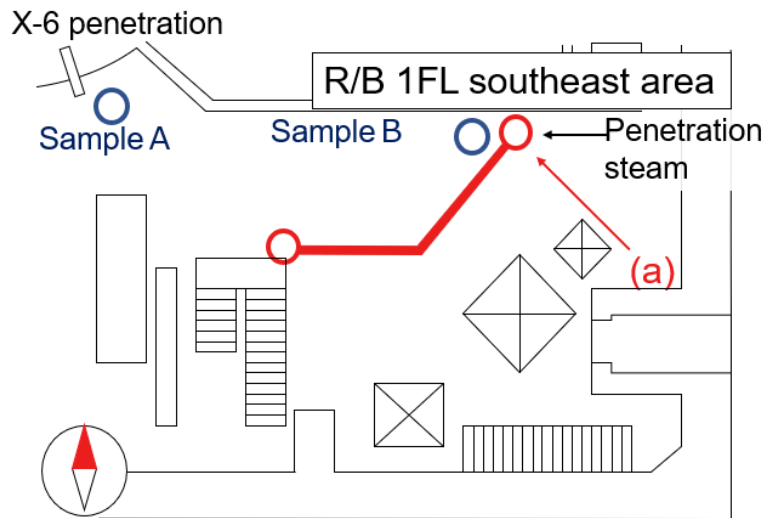
Figure 3.1.3 Locations of floor sample collection in the southeast area of the 1st floor  
 ((a) is the photo direction in Figure 3.1.2)

Figure 3.1.3 shows the floor sampling locations in the southeast area on the 1st floor, and Figure 3.1.4 shows the floor samples collected. Table 3.1.1 lists the surface dose rate measurement results for floor samples. Sample A was collected near the X-6 penetration and had a surface dose rate of 0.14 mSv/h, with no water marks on the surface. Sample B was collected near the AC piping penetration where the steam flowed out, and had a surface dose rate of 0.38 mSv/h, with water marks on the surface. The measured surface dose rate of sample B was

2.7 times higher than that of sample A, but it is not a significant enough value to cause the air dose rate of several 1000 mSv/h observed in the southeast area. In addition, the air dose rate in the southeast area measured in December 2013 shown in Figure 3.1.5 is characterized by being higher at 150 cm above the floor than at 5 cm above the floor. Given that floor contamination is the dominant contamination source in the southeast area, this cannot be considered to be the dominant contamination source because it is inconsistent with the contamination characteristics of this area.

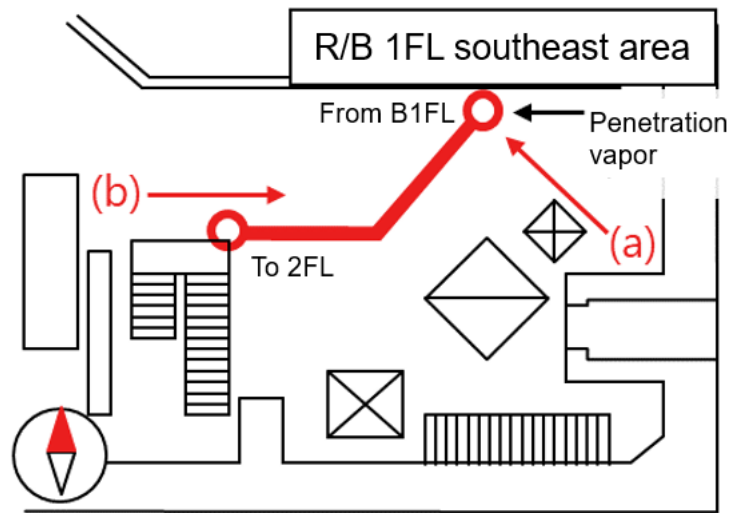
Figure 3.2.1 Locations of gamma camera measurements in the southeast area of the 1st floor (partially modified from [6])

A contamination survey was conducted in December 2013 around the southeast area of the 1st floor where the AC piping is laid, as shown in Figure 3.1.5. Figure 3.2.1 shows the gamma camera measurement locations in the southeast area of the 1st floor, and Figures 3.2.2 and 3.2.3 show gamma camera photos of this area. According to the gamma camera measurement survey, the air dose rate due to the AC piping at 150 cm above the floor was estimated to be approximately 900 mSv/h, which is generally consistent with the air dose rate in the southeast area of the 1st floor. In addition, the AC piping used for venting was laid so that it rises from the 1st floor penetration where the steam was outflowed, passes 200 cm above the floor in the southeast area of the 1st floor parallel to the floor surface, and exits to the 2nd floor. Therefore, the air dose rate on the upper side of the 1st floor is expected to be higher, which is consistent with the characteristic that the air dose rate at 150 cm

From the gamma camera photos in Figures 3.2.2 and 3.2.3, no dominant contamination sources can be seen on the floor, walls, or structures in the southeast area, and only contamination along the AC piping can be seen. Therefore, there is no possibility that radioactive materials that passed through the piping leaked from the AC piping in the southeast area, and it is considered that the contamination is still inside the piping.

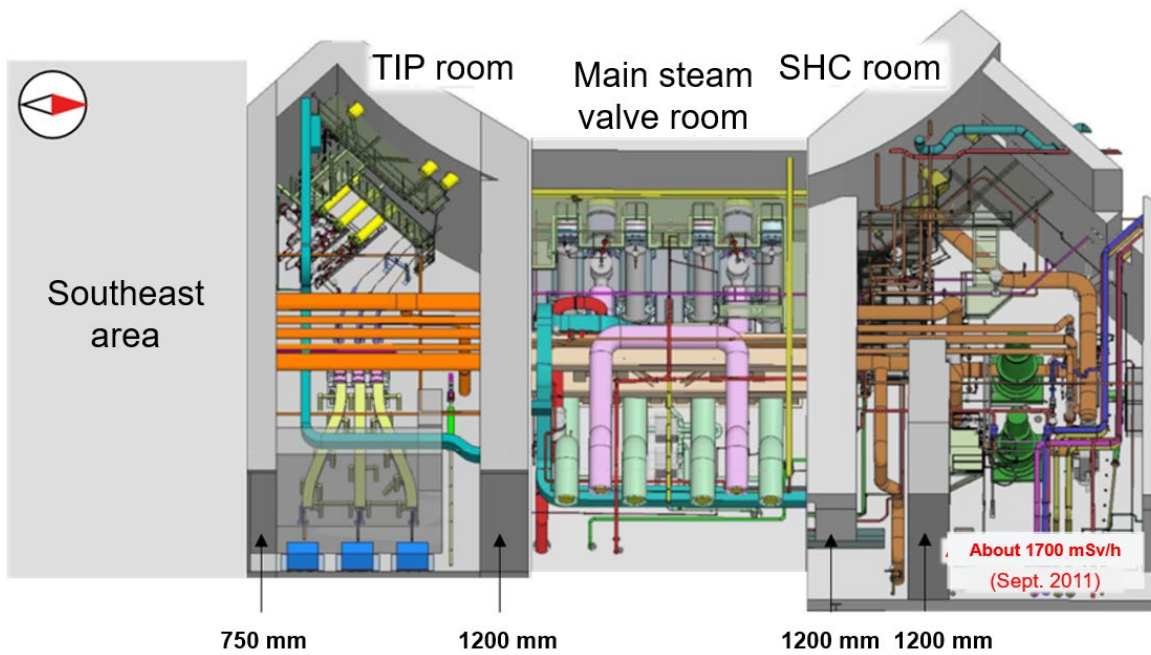
Figure 3.3.2 Locations of TIP room, main steam valve room, and SHC room (partially modified from [8])

The concrete thickness of the R/B 2nd floor concrete is 600 mm, which indicates that the radiation from the 2nd floor RCW-Hx is sufficiently attenuated in the southeast area. The concrete thickness from the SHC pump room to the southeast area is shown in Figure 3.3.2, and it is clear that the radiation from the contamination source in the SHC pump room is sufficiently shielded by the frame.
