Behavior of the S/C pressure gauge of Unit 2 after 21:00 on March 14

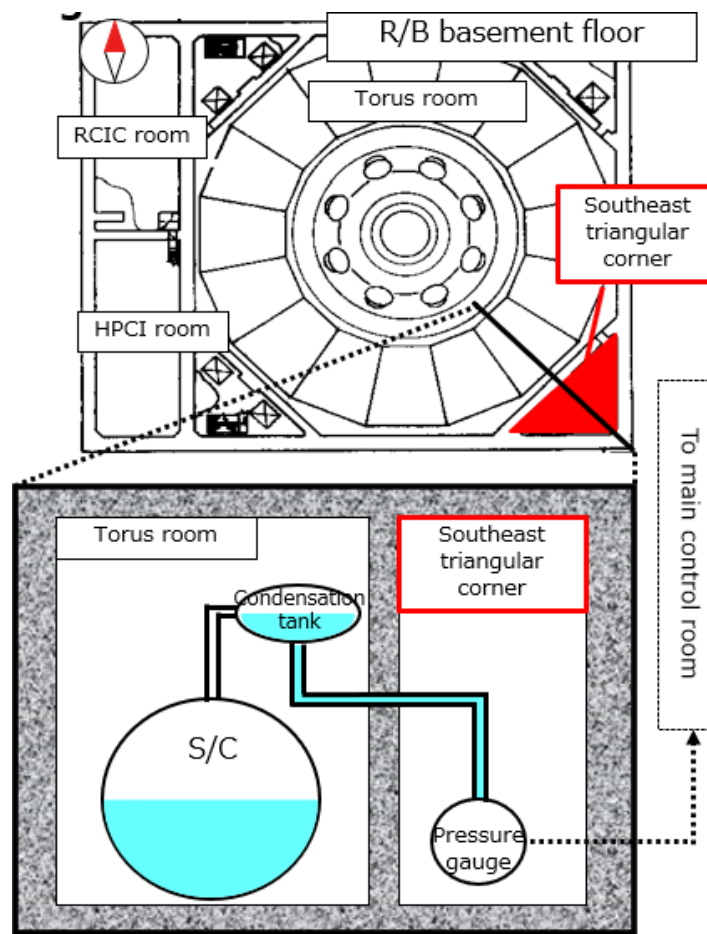
Figure 2.1 Location of S/C pressure gauge for AM

Figure 2.1 shows the location of the S/C pressure gauge for AM focused on here; it is located in the southeast triangular corner of the basement floor of the Unit 2 R/B, at a height of 60 cm from the floor (T.P. -3496). The pressure is detected from the condensation tank of the S/C water level gauge for AM (installed height: T.P. 7119), which is connected to the S/C gas-phase section, and the pressure change in the condensation tank piping is measured in accordance with the pressure change in the S/C gas-phase section.

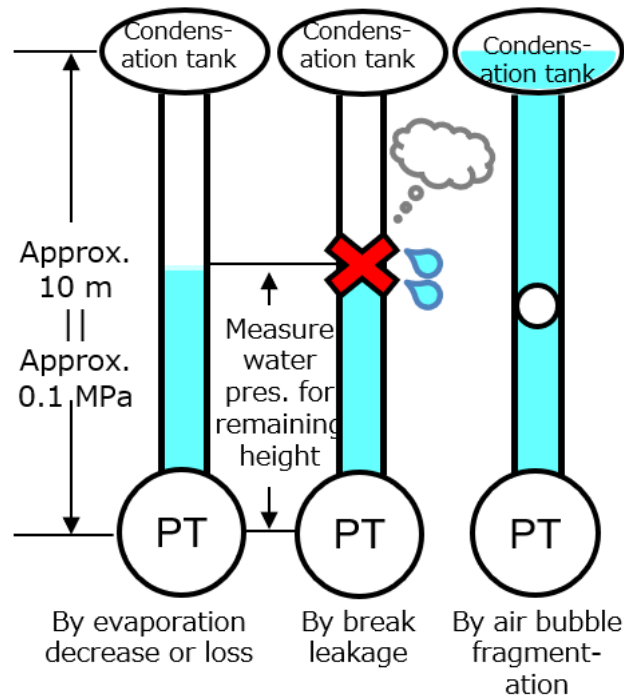
Figure 4.2.2 Image of decrease and loss of water in condensation tank piping

include "evaporation of water in the piping," "leakage of water in the piping due to a break in the piping," and "separation of water in the piping due to bubble formation." The possibility of these phenomena occurring is discussed (Figure 4.2.2).

Gases dissolved in water in the piping exist as bubbles and as the temperature rises, there is a possibility that the water in the piping is separated by the bubbles collecting and coalescing at a single location. The behavior of the pressure gauge due to the separation of the water in the piping cannot be ruled out as a possible contributing factor to the decrease in the indicated values, since there is a large degree of uncertainty in conditions such as the position, size, and shape of the bubbles, and it is difficult to estimate how the indicated values would change. However, it is unlikely that the change would exceed the 0.1 MPa drop in the indicated values when all the water in the piping evaporated. Therefore, even if this event were to occur, its effect on the indicated values is not considered dominant.

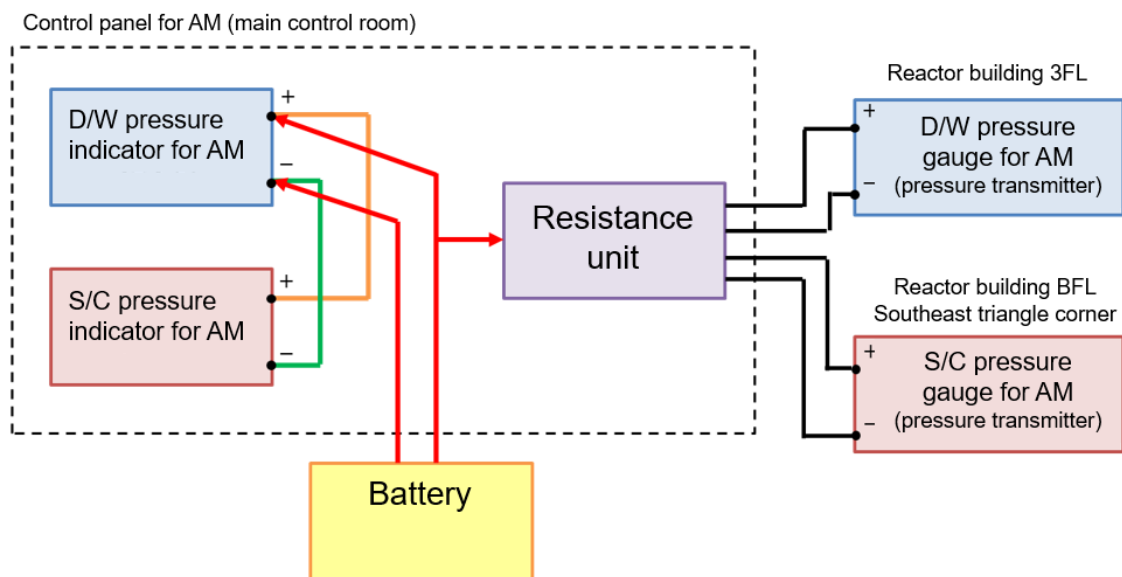
Figure 4.3.1 Connection of battery to control panel for AM (outline)

Based on the above, it is unlikely that the S/C pressure gauge for AM showed DS or low indicated values due to battery depletion or insufficient voltage supply.

(Regarding Figure 4.3.1: As shown by the red line, the battery is connected to the D/W pressure indicator for AM, but the + terminal, as shown by the yellow line, and the - terminal, as shown by the green line, are connected to the D/W pressure indicator for AM and the S/C

pressure indicator for AM, so the two pressure indicators shared the battery. The D/W pressure indicator for AM (pressure transmitter) and the S/C pressure indicator for AM (pressure transmitter) were connected to the resistance unit shown in purple, and the two pressure indicators (pressure transmitters) also shared a battery because their battery was also connected to this resistance unit as shown by the red line).

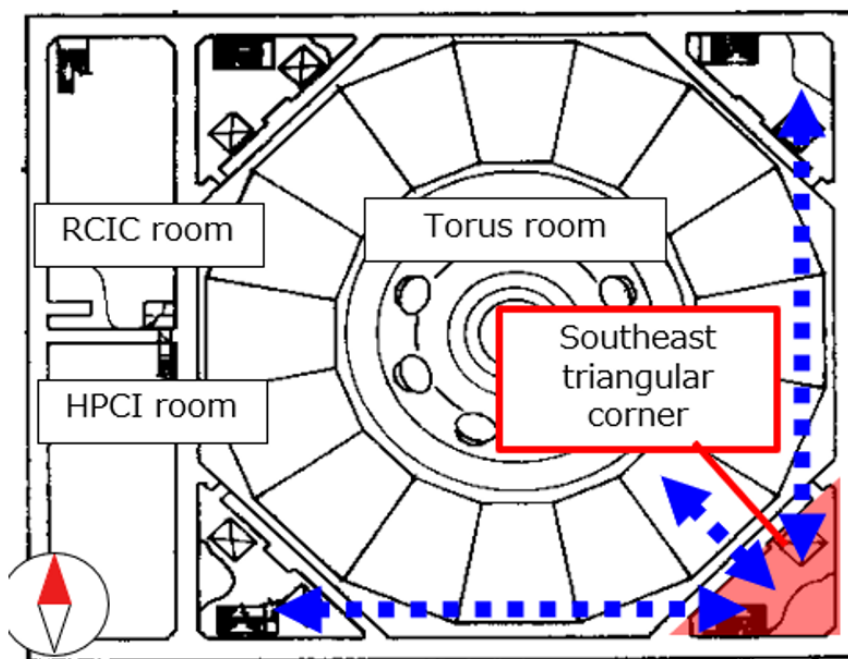
Figure 4.3.3 Water connection to each room through funnel/piping penetrations at the southeast triangular corner (image)

Based on the above, the water level at the southeast triangular corner rose continuously from about 30 cm above the floor during the March 12-15 period of interest, and it is highly likely that the S/C pressure gauge for AM installed at a height of 60 cm above the floor was submerged (Figure 4.3.4).

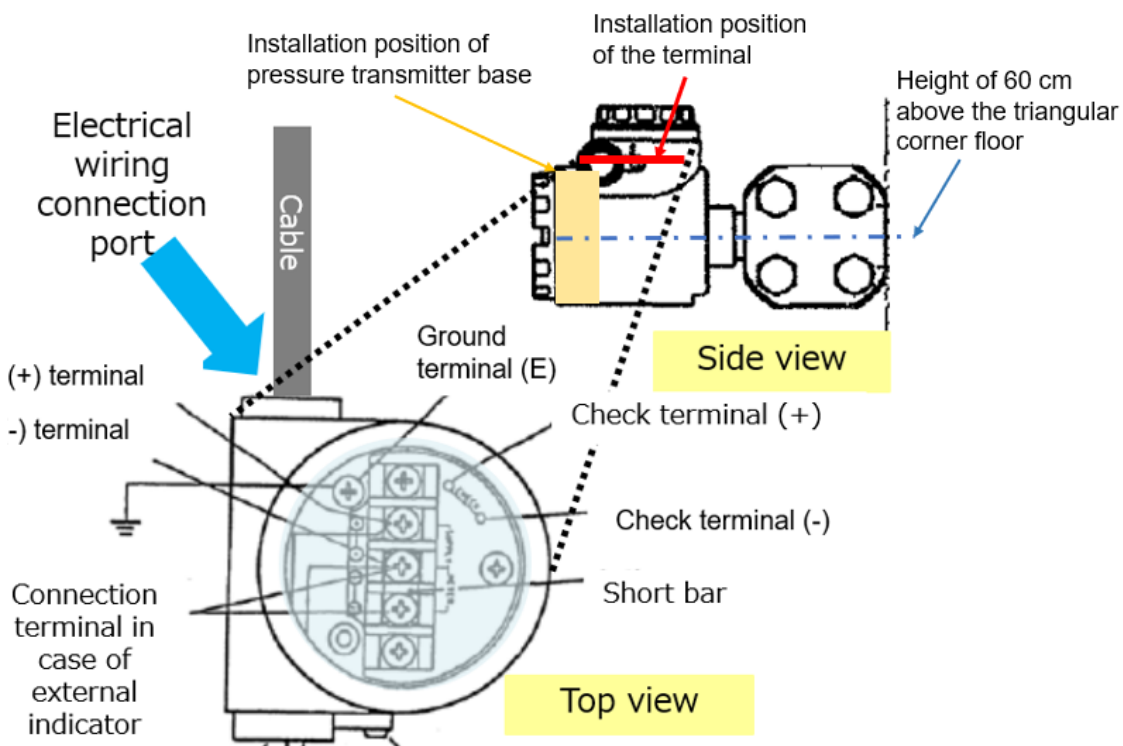
Figure 4.3.5 Outline of S/C pressure gauge for AM

Therefore, it is possible that the S/C pressure gauge for AM was submerged for a long period, causing seawater to enter through the electrical wiring connection port and flood the terminals of the pressure gauge (Figure 4.3.5). In addition, submerged tests of the same type of pressure gauges conducted by the manufacturer also showed that water entered the inside through the electrical wiring connection port and flooded the terminals, and that water droplets entered the base of the pressure transmitter when the submerged height was raised (Figures 4.3.6, 4.3.7, and 4.3.8.) Therefore, it is highly likely that the S/C pressure gauge for AM was submerged at the time of the accident as well, allowing seawater to enter the interior and flood the terminals and base.
