Dose increase around March 20th, 2011

1. Background

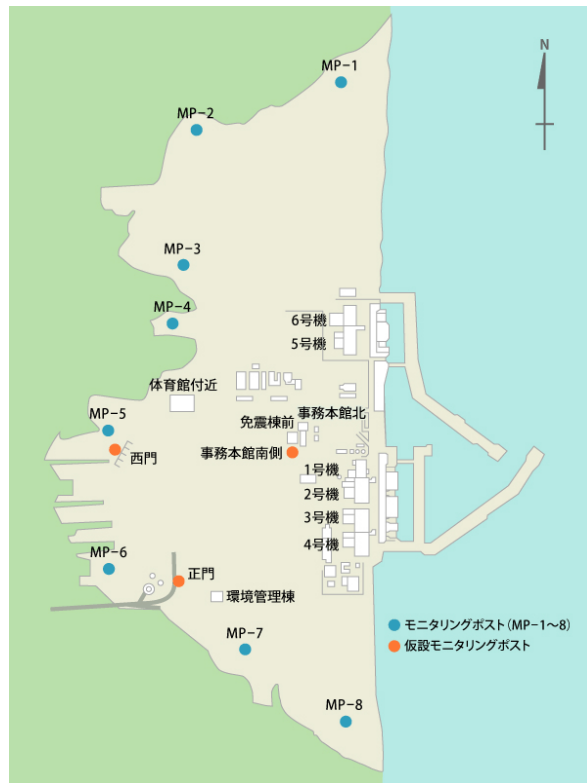
Figure 2 Approximate locations of dose measurement

Figure 2 shows the locations where the dose was measured.

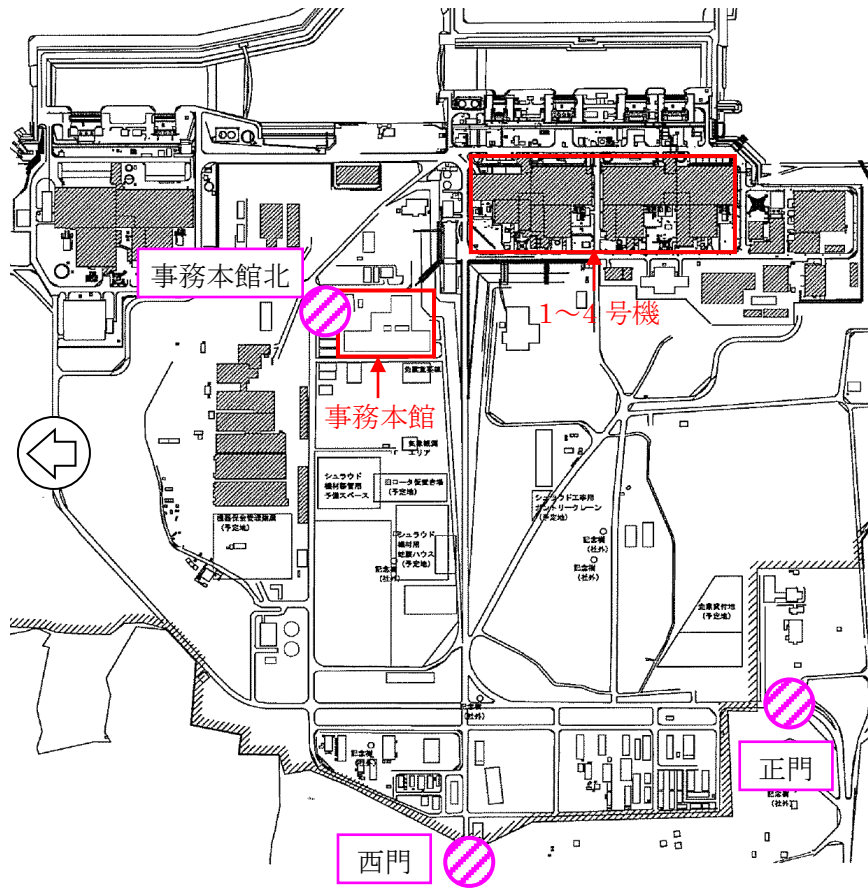
Figure 13 Air dose changes and wind direction

To assess this possibility, the car position at the time of the dose increase was checked as to whether it was downwind. Figure 13 shows the correlation between wind direction and air dose during the period of March 18th to 23rd [2]. The relation between the monitoring car position and wind direction was reviewed, especially at the time points ① to ④ in Figure 13, when the air dose increase had been observed. The monitoring car was positioned at these times at the north side of the main administration building, the west gate or the main gate.

Time period	Wind fractions in the "south-east, south-south-east, and south" directions over each time period
1	15:10 - 17:20 on March 18 th (Time period ① of dose increase in Fig. 13)	86%
2	17:30 - 20:00 on March 18 th (Time period ① of dose decrease in Fig. 13)	31%
3	13:00 - 16:00 on March 20 th (Time period ③ of dose increase in Fig. 13)	95%
4	16:10 - 19:40 on March 20 th (Time period ③ of dose decrease in Fig. 13)	32%
5	Time periods other than above during March 18 th to 20 th	7%

Time period	Wind fractions in the "east-south-east, east, and east-north-east" directions over each time period
1	08:00 - 09:40 on March 19 th (Time period ② of dose increase in Fig. 13)	64%
2	09:50 - 11:30 on March 19 th (Time period ② of dose decrease in Fig. 13)	9%
3	Time periods other than above during March 18 th to 22 nd	8%

Time period	Wind fractions in the "east, east-north-east, and north-east" directions over each time period
1	16:50 - 18:30 on March 21 st (Time period ④ of dose increase in Fig. 13)	38%
2	18:40 – 19:40 on March 21 st (Time period ④ of dose decrease in Fig. 13)	0%
3	Time periods other than above during March 18 th to 22 nd	4%

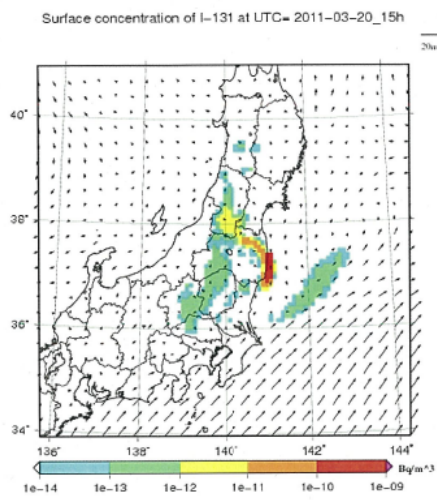
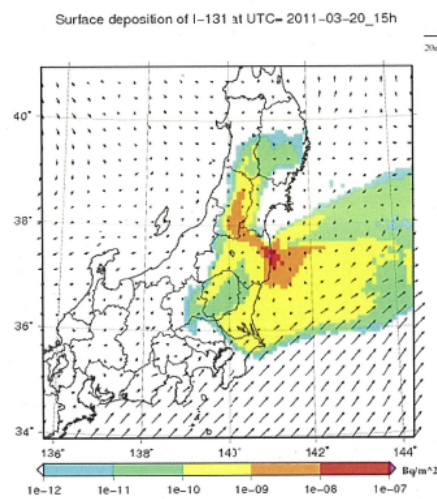
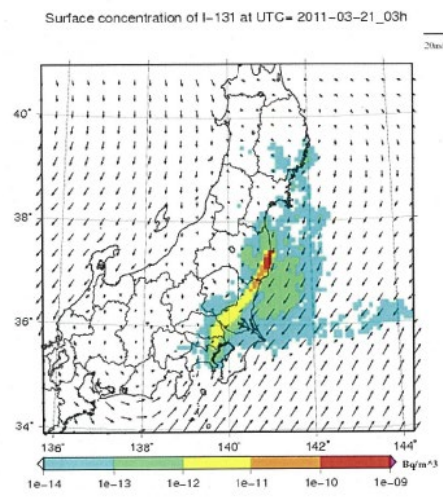
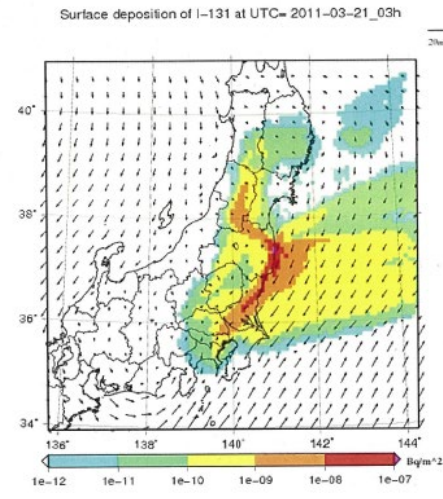
Figure 15 Dispersion state (calculated) as of 00:00 on March 21st and 12:00 on March 21st

A dose increase was observed around March 20th and 21st, 2011, at the Fukushima Daiichi NPS. At about that time, a dose increase was also noticed in parts of the Kanto region. The recommendation of refraining from tap water intake was made by some local governments because of the increased radioiodine concentration. In connection with wide region dispersion of radioactive materials, Table 5 and Figures 15, 16 and 17 cite results (published on March 20th, 2011 [3]) calculated by WSPEEDI (Worldwide version of System for Prediction of Environmental Emergency Dose Information), a simulation code developed by JAEA.
