Estimation of status inside reactor pressure vessels
and containment vessels
after the accident at the Fukushima Daiichi Nuclear
Power Station

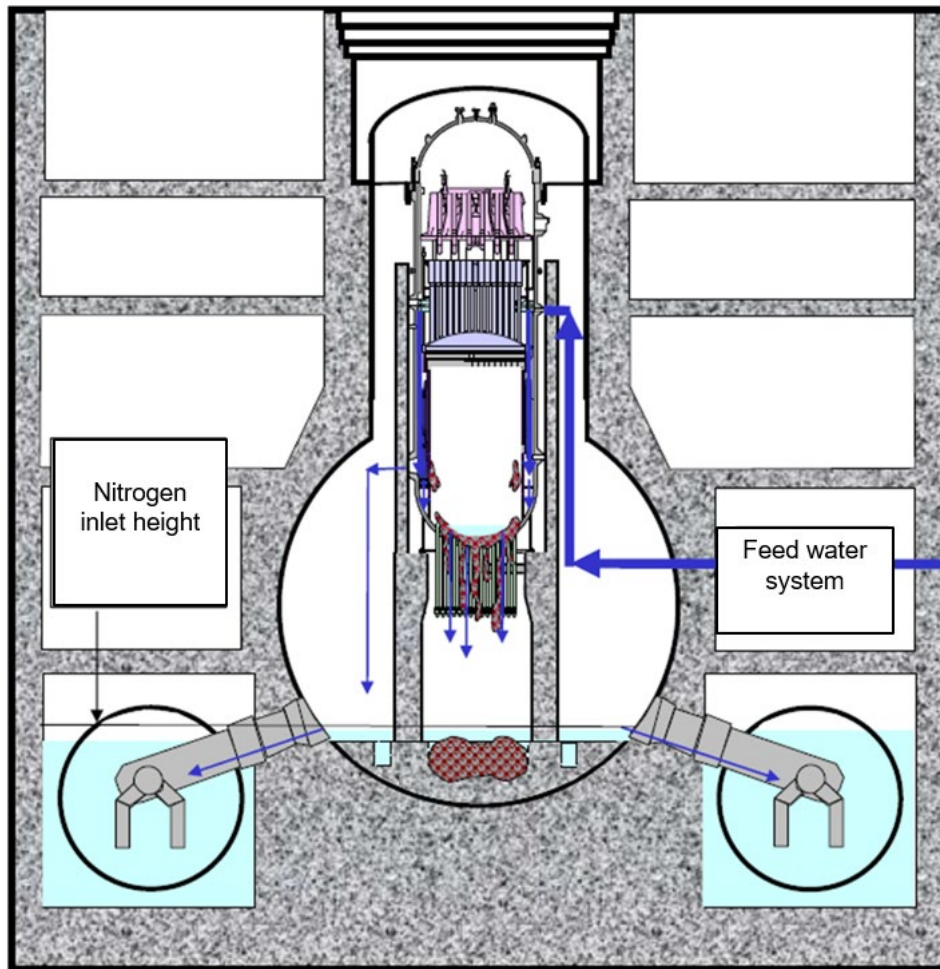
Figure 4.1.1-1 Unit 1 estimated as of November 30, 2011 [1-1]

The estimated diagram in Figure 4.1.1-1 was selected from the reactor damage patterns ① to ⑥ shown in Figure 4.1.1-2, and the condition of Unit 1 was estimated to be ⑥. The

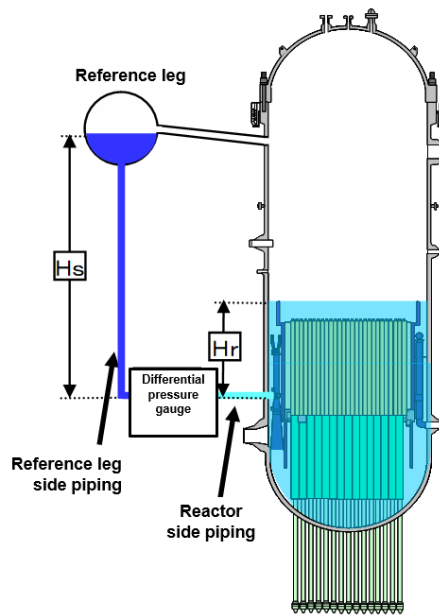
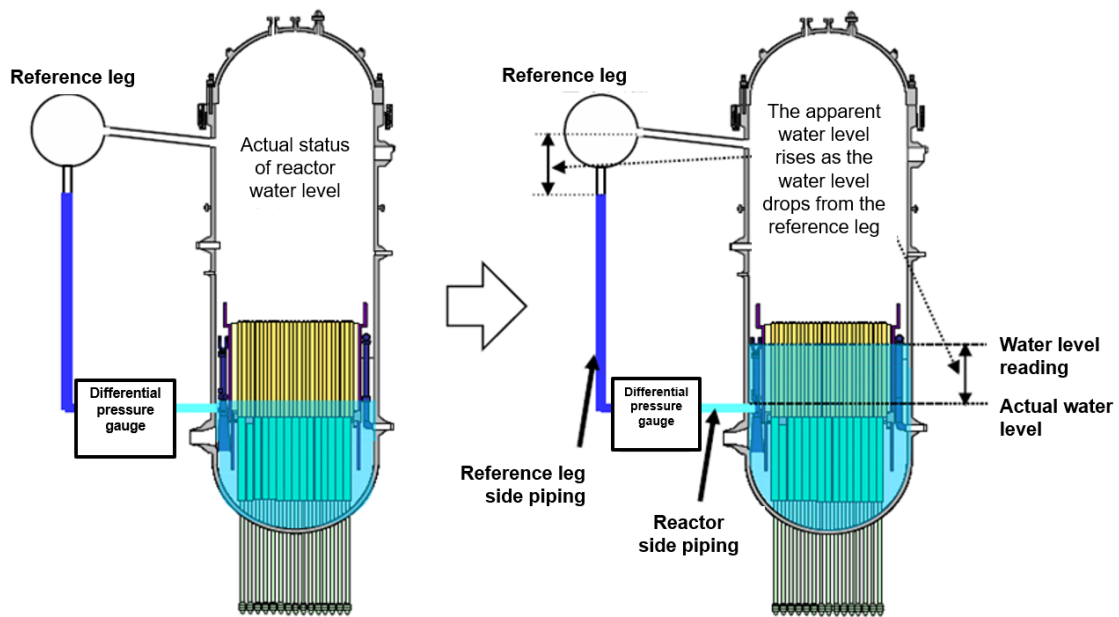
Figure 4.1.1-4 Schematic diagram of a reactor water level gauge ^[1-1]

In Unit 1, a temporary differential pressure gauge was installed on May 11, 2011, and water was injected into the reference leg and instrumentation piping to calibrate the reactor water level gauge. As a result, the reactor water level was found to be 5m below the top of active fuel (TAF). Therefore, it was estimated that the water level is not currently at the original fuel position, and it is unlikely that the fuel remains in its original position while maintaining its shape.

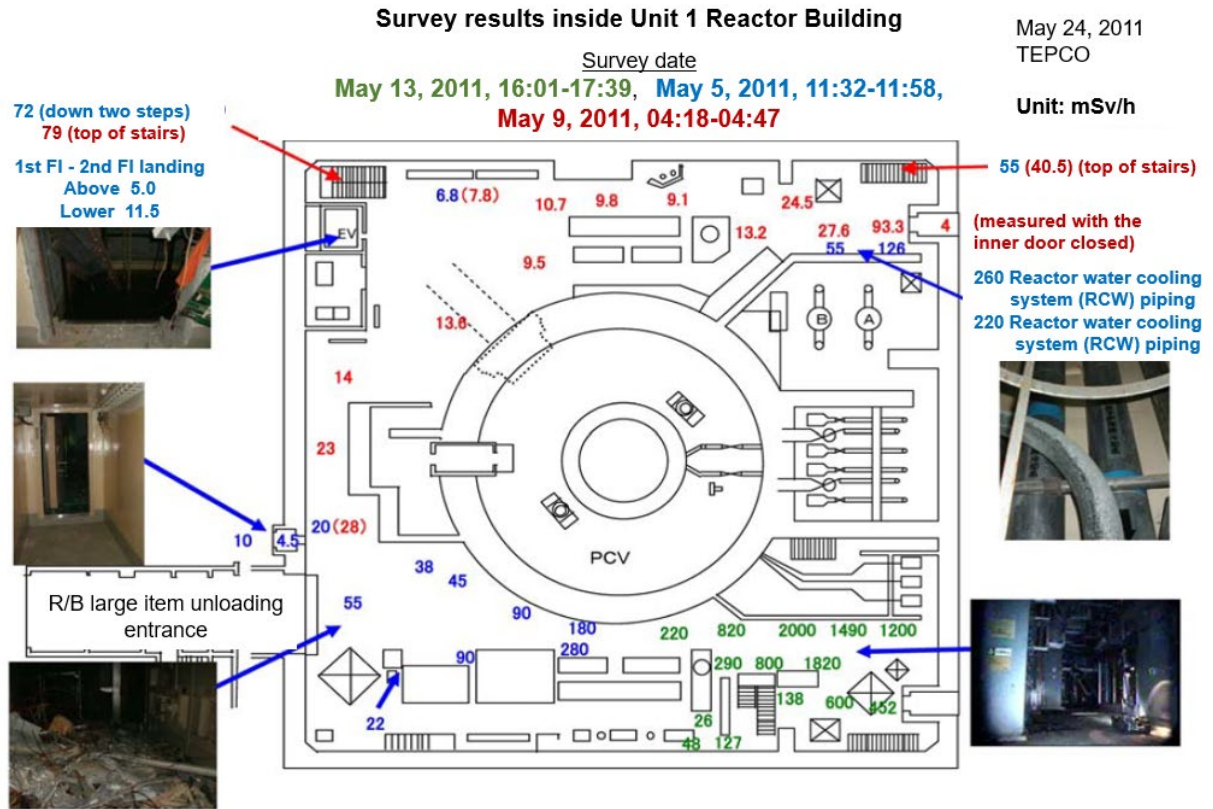
Figure 4.1.1-6 Results of reactor building dose survey for Unit 1 [1-1]

In the reactor building of Unit 1, radiation dose was measured at various locations, and a high dose was measured in the RCW piping (Figure 4.1.1-6). The RCW is a closed-loop system mainly for cooling auxiliary equipment in the reactor building, and it is not designed with a release section inside the PCV. Therefore, contamination leading to dose rates as high

as several hundred mSv/h is unlikely to occur under normal conditions. However, the RCW piping is laid over a wide area within the reactor building and it also plays a role in cooling the equipment in the PCV. Specifically, as shown in Figure 4.1.1-7, RCW piping is laid in the equipment drain pit at the bottom of the PCV for drain cooling. Therefore, the high level of contamination of the RCW piping in Unit 1 was most likely caused by fuel falling into the equipment drain pit and damaging the RCW piping. The damaged piping is considered to have caused steam or water to migrate into the RCW piping, with large amounts of radioactive materials occurring in the piping at the same time. However, if the RCW was damaged by fuel debris that fell into the PCV, water from the RCW piping may have entered the PCV and contributed to cooling the fuel debris.

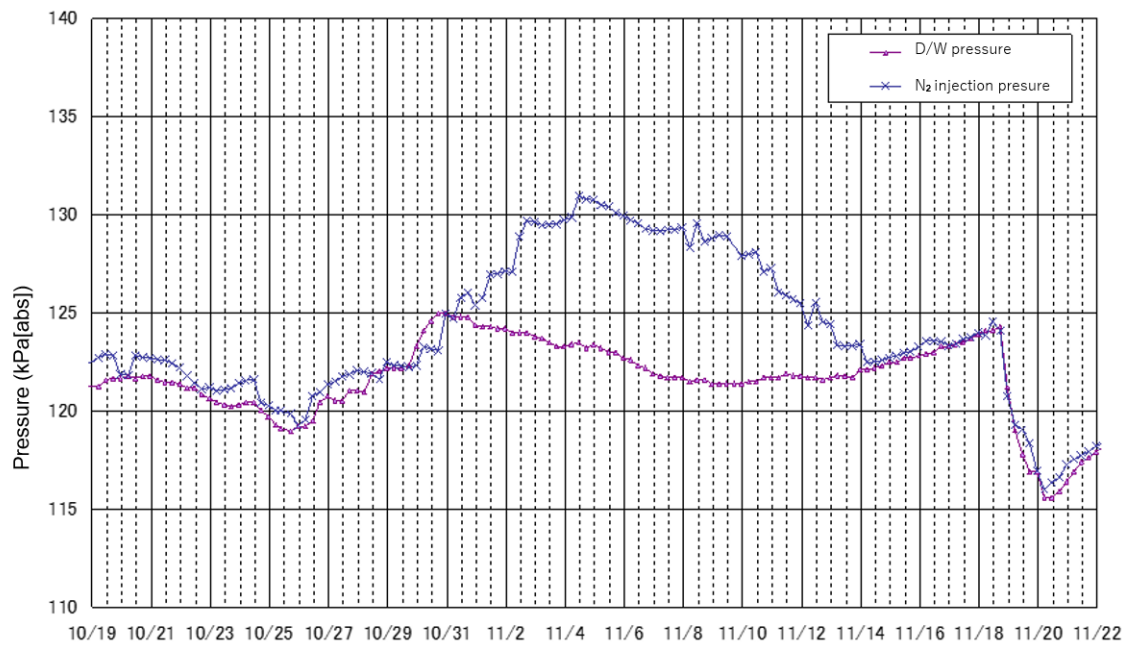
Figure 4.1.1-8 Change of D/W pressure and nitrogen injection pressure (2011) ^[1-1]

Figure 4.1.1-8 shows a graph of the D/W pressure and the nitrogen injection pressure that is measured to monitor the nitrogen injection status. If the nitrogen inlet is within the volume containing the gas phase, the nitrogen injection pressure shows the same behavior as the D/W pressure, but if the inlet is submerged, the pressure is higher than the D/W pressure because it requires a pressure that exceeds the water head pressure in addition to the D/W gas phase pressure. Figure 4.1.1-8 shows that after water injected into the Unit 1 reactor had increased on October 28, 2011, the nitrogen injection pressure exceeded the D/W pressure on about November 1, and the deviation became larger. Therefore, at that time, the D/W water level rose with the increase in water injection and exceeded the nitrogen inlet height, that is to say, the D/W water level was estimated to be in this vicinity.

* Regarding the D/W pressure data in the graph, the correct value is about 2kPa lower until 10/28 05:00, and then about 0.5kPa higher after 10/28 11:00. ^[1-2]

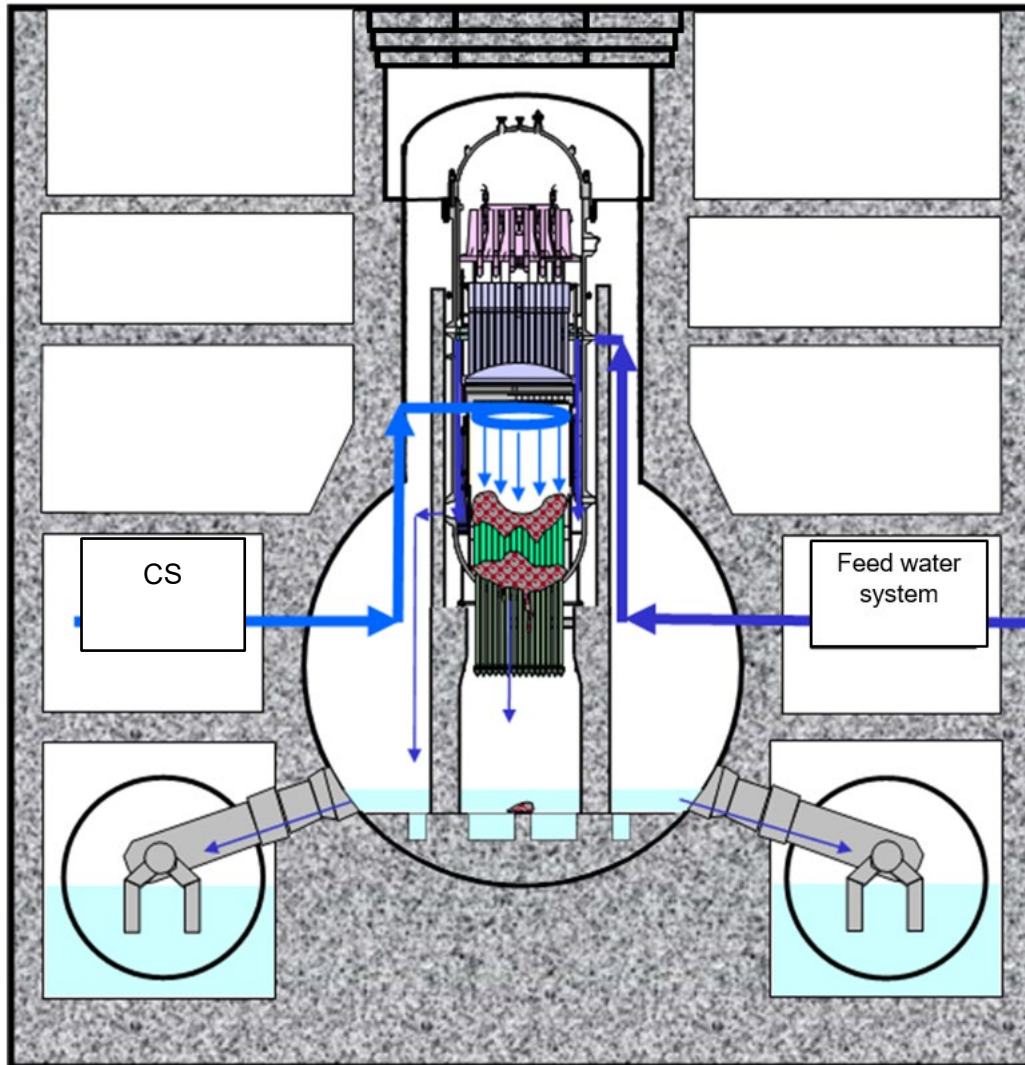
Figure 4.1.2-1 Unit 2 estimated as of November 30, 2011 [2-1]

The estimated figure in Figure 4.1.2-1 was selected from the reactor damage patterns of ① through ⑥ shown in Figure 4.1.2-2, and the condition of Unit 2 was estimated to be pattern ④-(1). The findings that were useful in selecting the pattern are described below.

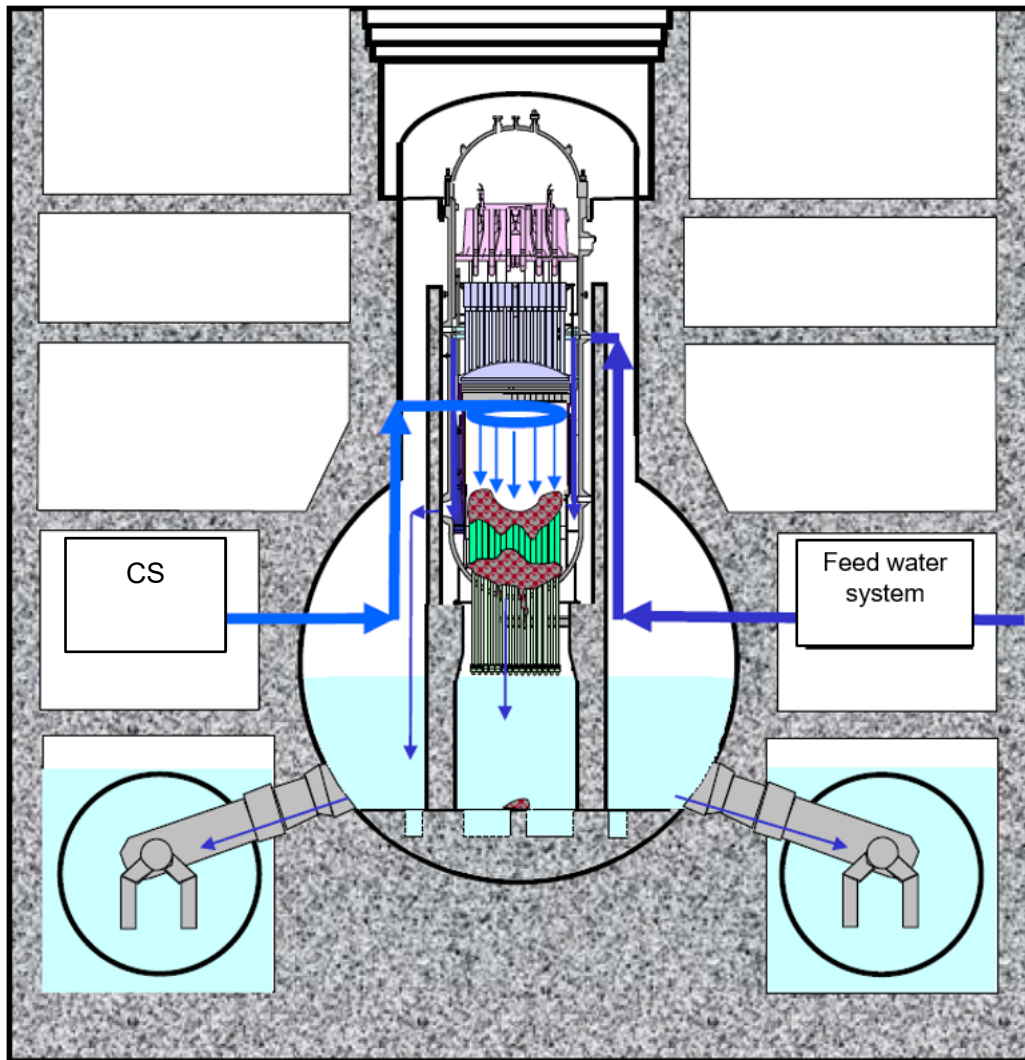
Figure 4.1.3-1 Unit 3 estimated as of November 30, 2011 ^[3-1]

The estimated diagram in Figure 4.1.3-1 was selected from the reactor damage patterns ① to ⑥ shown in Figure 4.1.3-2, and the condition of Unit 3 was estimated to be pattern ④-(1). The findings that were useful in selecting the pattern are described below.

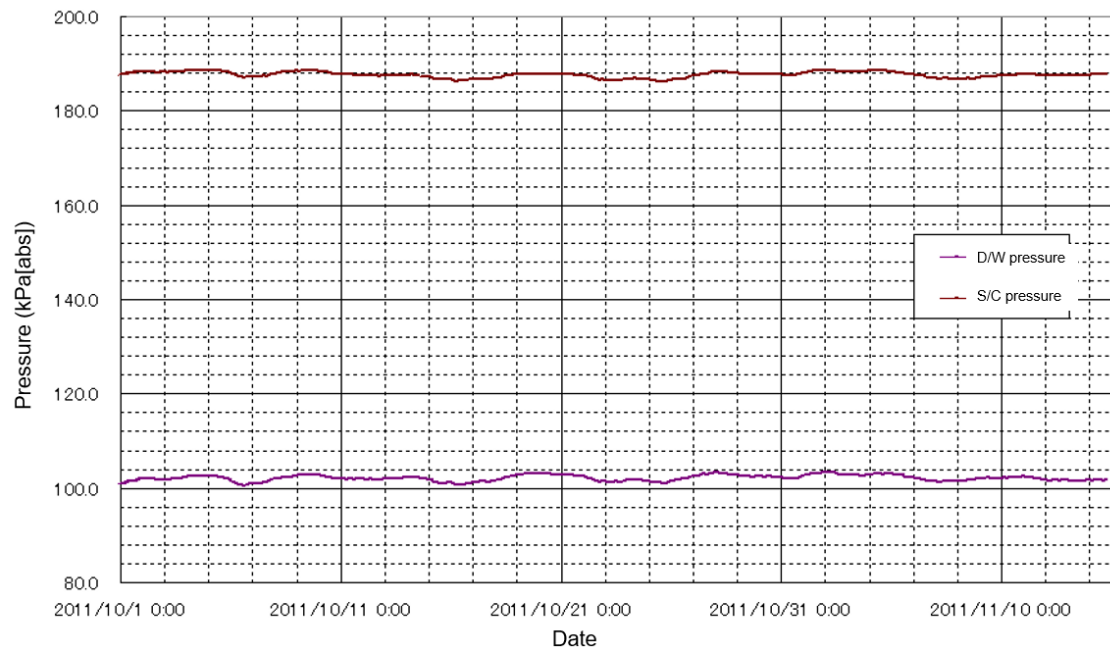
Figure 4.1.3-4 D/W pressure and S/C pressure^[3-1]

Figure 4.1.3-4 shows graphs of D/W pressure and S/C pressure from October to November 2011. Since the D/W and S/C are connected through the vacuum break valve, they basically show the same behavior. However, when the S/C water level rises and exceeds the vacuum break valve, this relationship is broken, and the S/C pressure becomes higher than the D/W pressure because, in addition to the D/W gas phase pressure, the water head pressure corresponding to the D/W water level is added to the S/C pressure. The trends of D/W pressure and S/C pressure in Figure 4.1.3-4 show that S/C pressure has always been higher than D/W pressure since October 1. Based on this differential pressure, the water level in the PCV (D/W) was estimated to be around 6.5m to 7.5m from the D/W floor. The amount of fuel falling into the PCV in Unit 3 was estimated to be small at that time, and the fuel in the PCV was estimated to be submerged, since water was being injected in sufficient quantities for sensible cooling, and the PCV atmosphere temperatures did not have any outstandingly high spots.

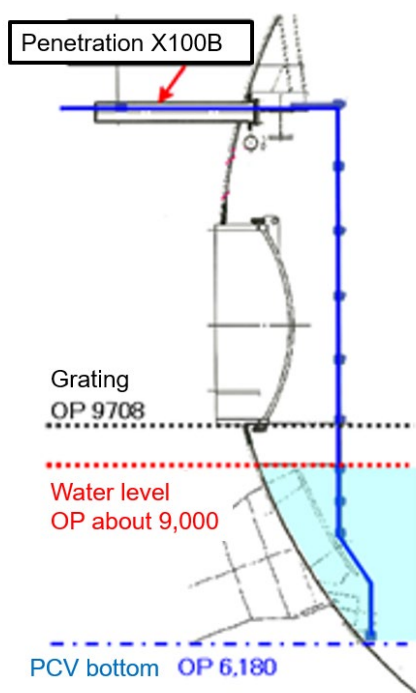
Figure 4.2.1-2 Residual water level measurement results in Unit 1 D/W [1-4]

The water level in the D/W was measured by the cable feed length from the top of the grating to the point where the CCD camera came in contact with the water surface, and was confirmed to be approximately 2.8m from the D/W floor (Figure 4.2.1-2).

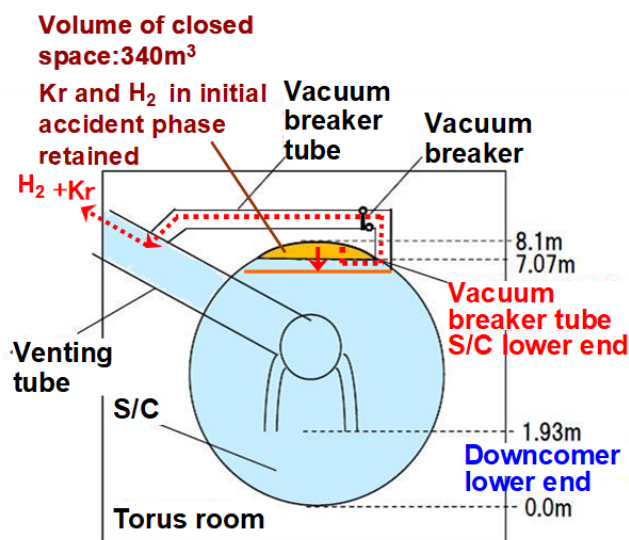
Figure 4.2.1-3 Situation of gas phase trapped in Unit 1 S/C [1-5]

In a test conducted to verify the mechanism, the hydrogen concentration and Kr-85 radioactivity concentration measured by the PCV gas control equipment began to increase with a time delay after the S/C pressure (measured by the existing instrument) increased following the nitrogen injection test start, and each concentration began to drop when nitrogen injection was stopped. This is thought to reflect behavior of residual gas in the closed space of the upper S/C, which is pressurized by nitrogen injection into the S/C, pushing down the water level there and forming a gas flow from the vacuum breaker tube to the D/W. The residual gas in the closed space is then pushed to the D/W by the injected nitrogen.

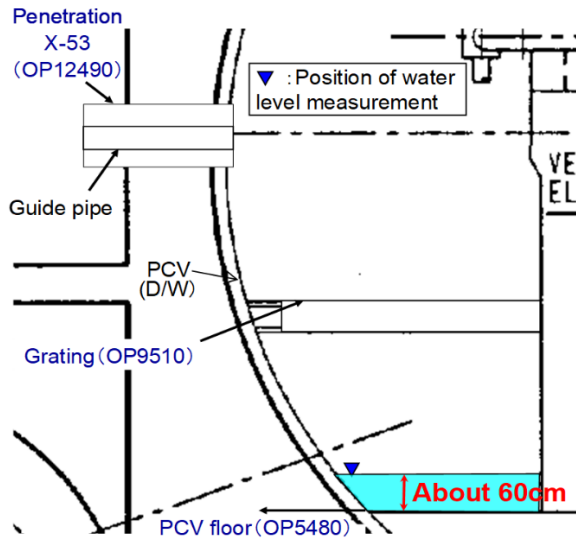
Figure 4.2.2-2 Residual water level measurement results in Unit 2 PCV [2-3]

The water level was confirmed to be about 600mm (as of March 26, 2012) from the D/W floor using a video image scope (Figure 4.2.2-2).

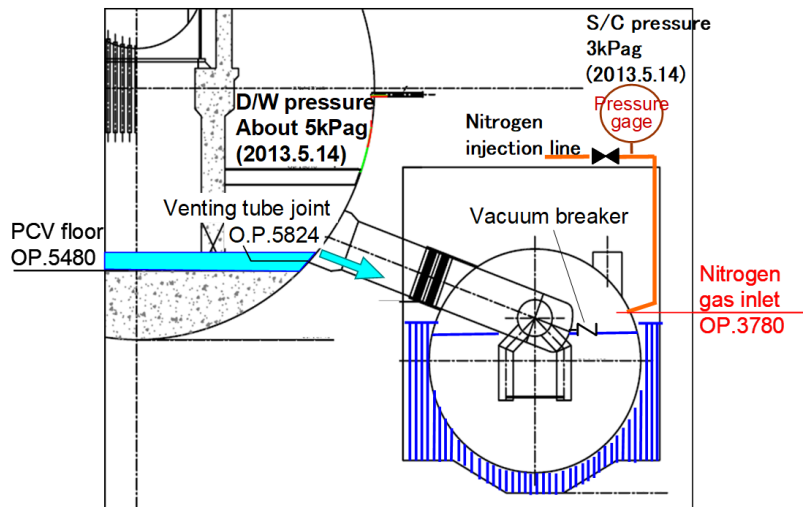
Figure 4.2.2-3 Situation of gas phase closed space in the Unit 2 S/C [2-2]

A nitrogen injection test conducted in May 2013 confirmed that the S/C pressure was 3kPa(gage) (as of May 14, 2013), and although the exact value of the water level in the S/C is unknown since a nearly full water level in the S/C would result in a reasonable hydraulic head pressure, it was indicated to be around the nitrogen gas inlet (approximately 6.3m from the bottom of the S/C). Together with the low water level in the D/W, it is estimated that water injected into the reactor flows from the D/W into the S/C via the vent piping and leaks from the lower part of the S/C into the reactor building. In this case, the water level in the S/C is considered to be the same as the level of water in the torus room (Figure 4.2.2-3).

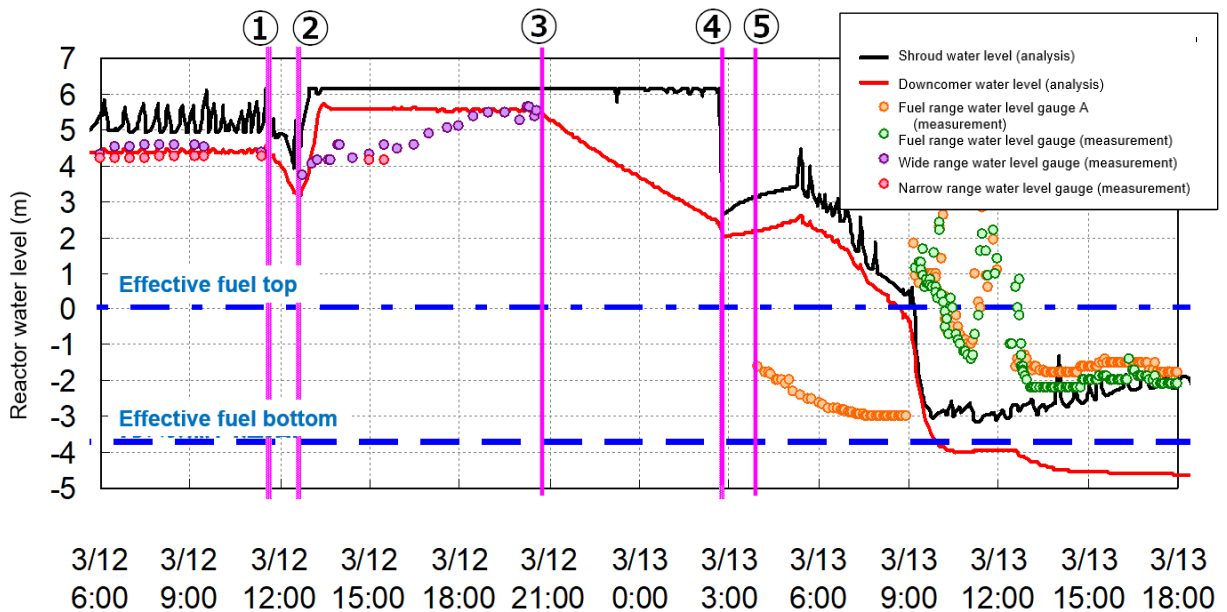
Figure 4.2.3-2 Measured and analyzed reactor water levels (2011) [3-3]

Measured and analyzed values of the reactor water level during March 12-13, 2011 (results of the analysis published on March 12, 2012) are shown in Figure 4.2.3-2. The timings of ① to ⑤ shown in the figure are as following.

Regarding the water injection into the reactor, since the reactor water level was unknown after 20:36 on March 12, an analysis was conducted with a reduced amount of water injection by HPCI. However, a large discrepancy was found between the analyzed value and the measured value (fuel range water level gauge value) for the reactor water level after 04:00 on March 13 when the water level gauge measurement was restarted. It was considered that this meant that the water injection to the reactor was not sufficient even before the manual shutdown of the HPCI at 02:42 on March 13.

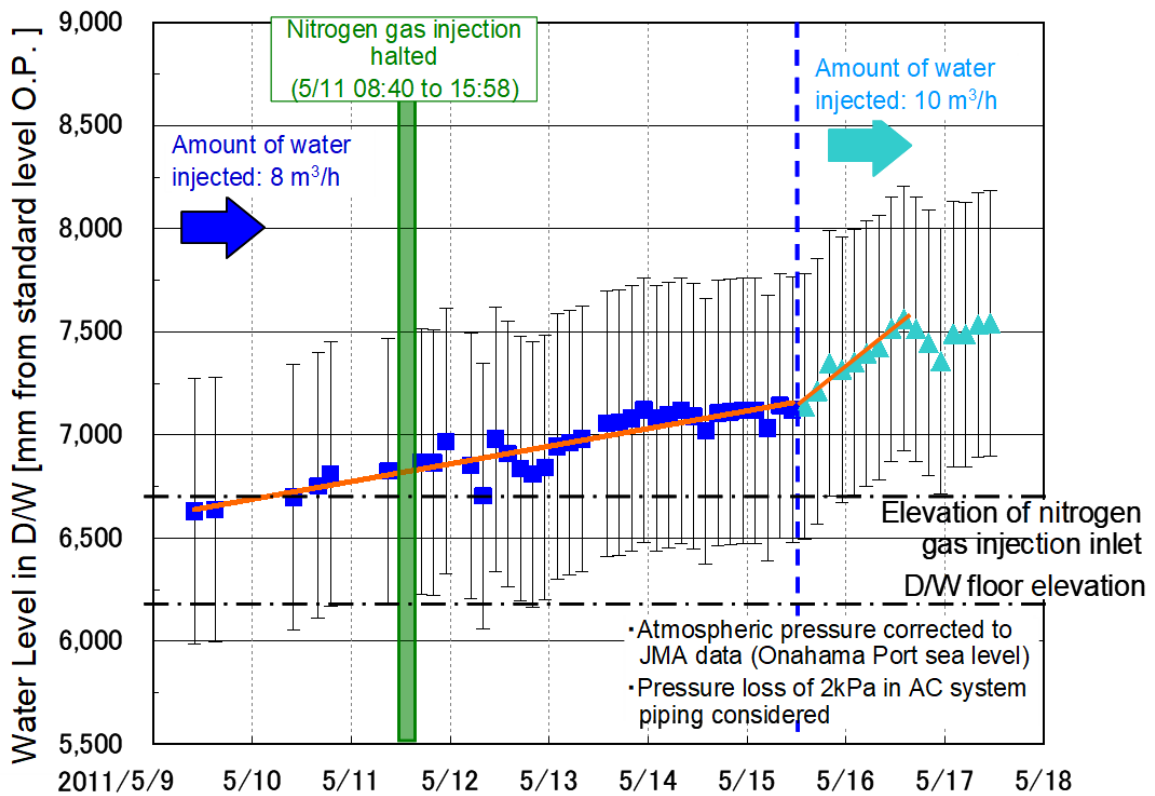
Figure 4.3.1-3 D/W water level (estimated) during Unit 1 D/W flooding operation [1-6]

In addition, water flowed from both sides of the X-5E vent piping through the surface of the S/C, suggesting that the leakage was coming from the vacuum breaker tube directly above the vent piping (e.g., the vacuum breaker tube bellows). The height of the bottom of the vacuum breaker tube is about 8.2m from the bottom of the S/C. This is the height at which the D/W water level stopped rising and leveled off when the amount of water injected into the reactor was increased to flood the D/W in May 2011, which was thought to be the height at which the leak port was located. The height of the leak (about 8.0m from the bottom of S/W) is almost the same as the height of the D/W (about 7500mm O.P. in Figure 4.3.1-3), where the leak was thought to occur.

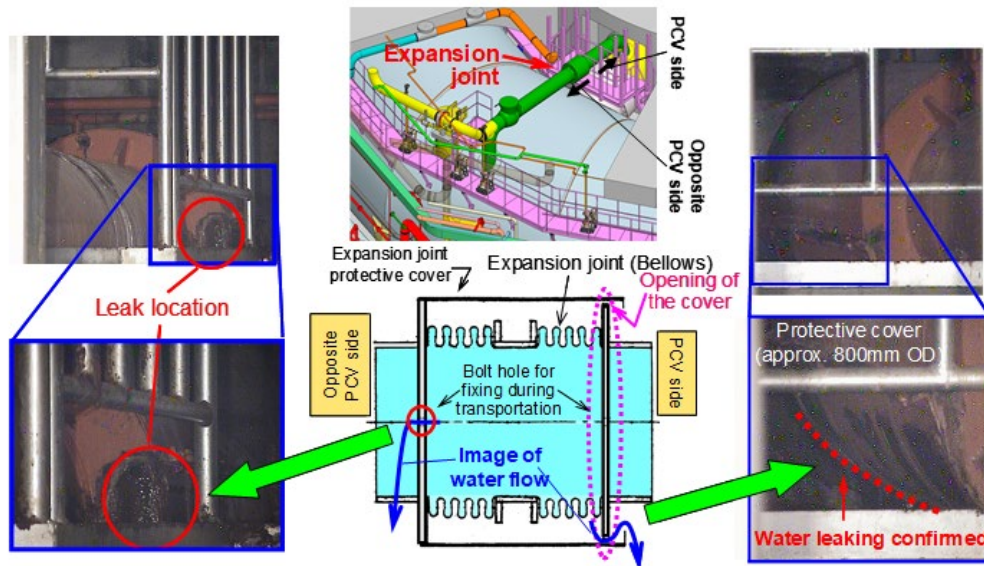
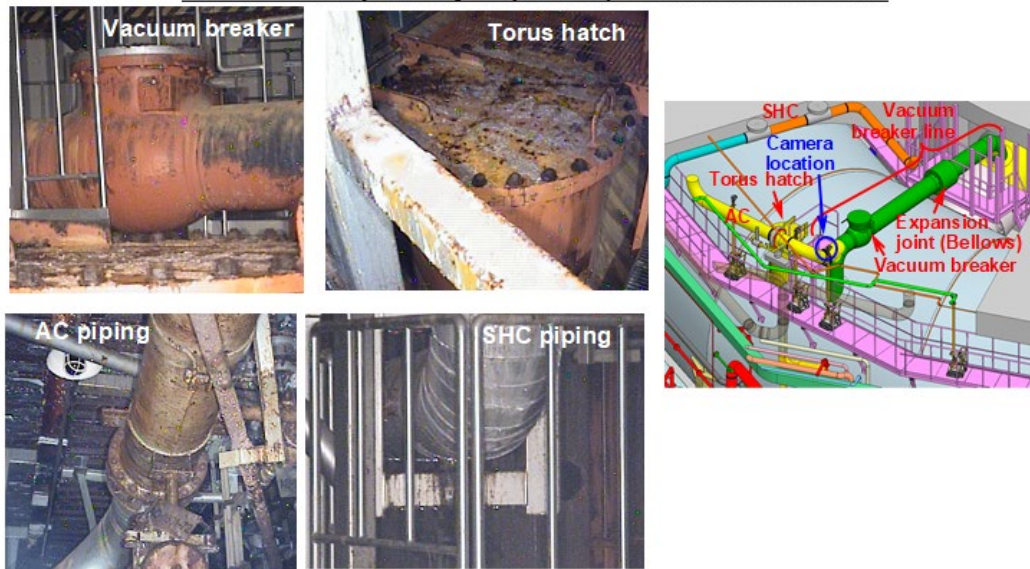
Figure 4.3.1-4 Camera image (excerpt) from the investigation at the top of Unit 1 S/C (around X-5E vent piping) [1-8]

Then, in May 2014, in order to identify the location of the leakage near the X-5E vent piping, where the water flow was confirmed, inspection equipment for the top of the S/C was deployed from a drilled point in the northwest area on the first floor of the Unit 1 reactor building, and a video survey of the area near the X-5E vent piping was conducted by moving on the outer catwalk. No leakage was confirmed to occur from the protective cover of the expansion joint of the vacuum break line. No leakage was observed in the vacuum breaker valve, torus hatch, SHC piping, or AC piping on the line (Figure 4.3.1-4).

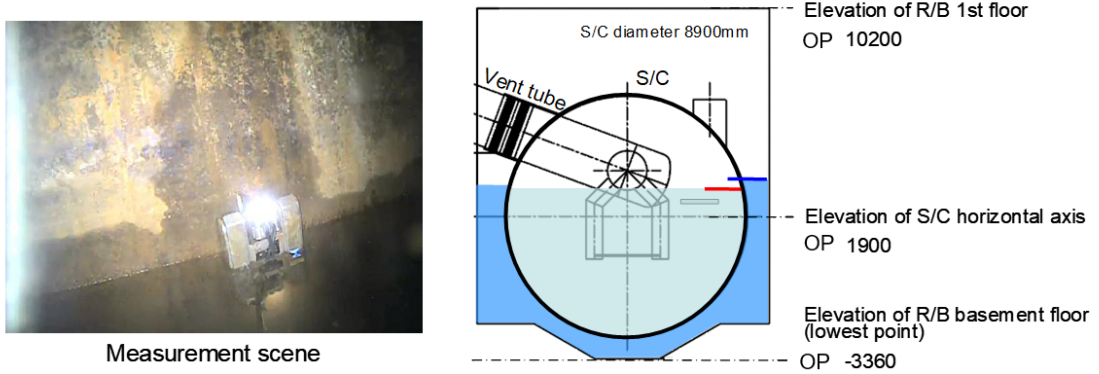
Figure 4.3.2-4 Results of water level measurement in the S/C of Unit 2 [2-7]

The water level in the S/C was linked to the accumulated water level in the torus room at almost the same level, as estimated by the nitrogen injection test in the S/C, and it was confirmed that liquid phase leakage was occurring from the lower part of the S/C (including the piping).

From the above, it was confirmed by ultrasonic measurement that the water level in the S/C is about O.P. 3150mm, or about 5.7m from the bottom of the S/C.

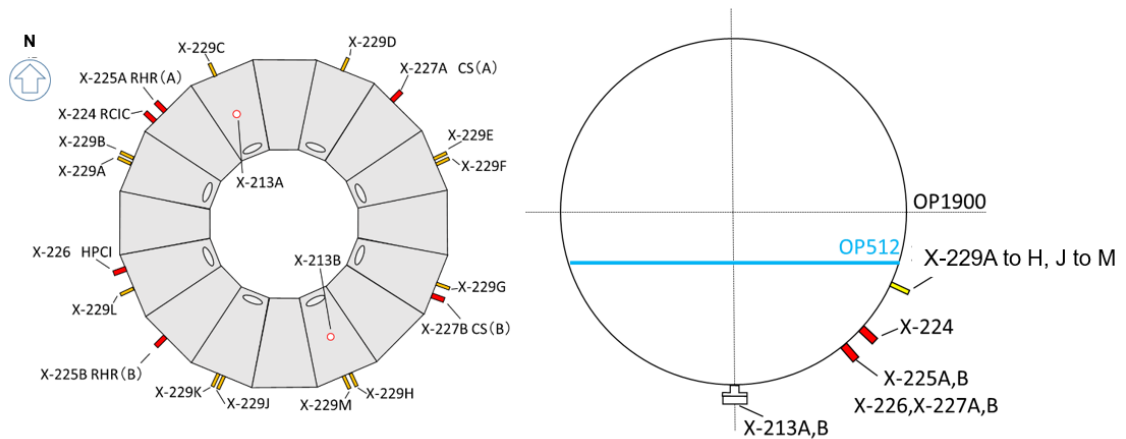
Figure 4.5.2-2 Unit 2 S/C structure [2-9]

- The leak hole was set at the bottom of the S/C and S/C water level fluctuation was calculated based on the measured data, which revealed that S/C water level fluctuated under the influence of D/W pressure, accumulated stagnant water level, and water injection volume.
- The leakage area that is consistent with the measured temperature data is about 9cm², and the leakage hole is located below O.P. 512mm (about 3m from the bottom of the S/C) (Figure 4.5.2-2). The piping penetrations below the location of the abovementioned leak hole are shown in Table 4.5.2-1.

Based on the above, the S/C connection lines where the S/C leak hole may exist are the closing plate for the drain, the pump suction of RCIC, RHR, HPCI, and CS, and the pneumatic system line for the vacuum breaker valve drive.

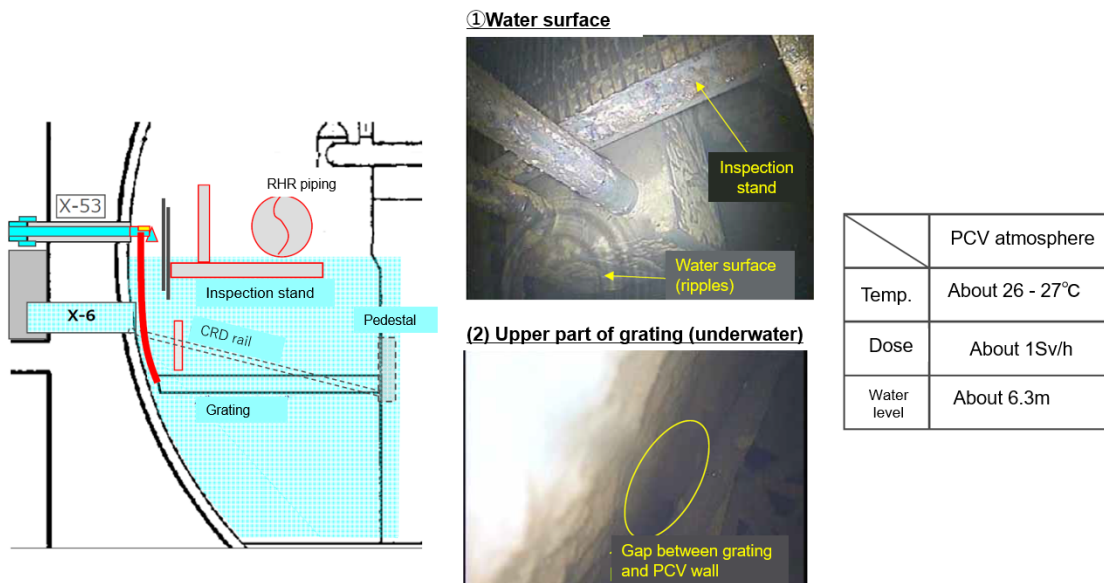
Figure 4.5.3.3 Results of PCV internal investigation [3-9]

During the PCV internal investigation conducted on October 20 and 22, 2015, the investigation device was inserted through the X-53 penetration to take internal photographs, check the water level, and confirm the temperature and radiation dose. The water level of the stagnant water in the D/W was about 70cm below the X-53 penetration and about 6.3m above the D/W floor and was generally consistent with the value estimated from the containment vessel pressure described in Section 4.1.3.

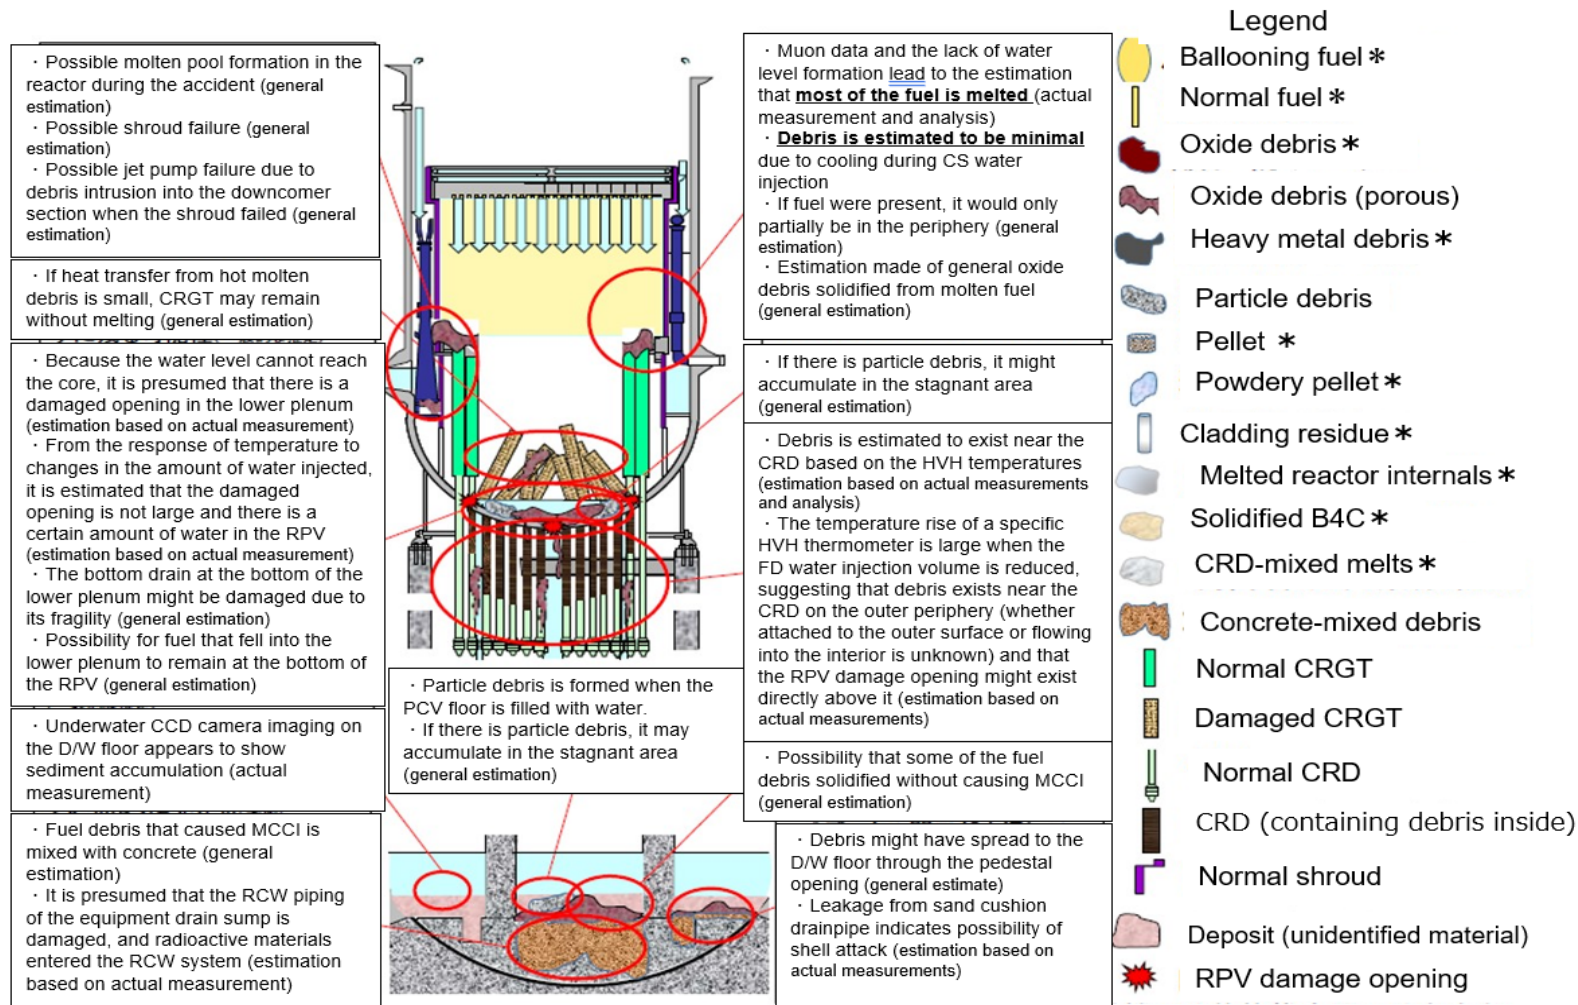
Figure 4.6.1-2 Unit 1 estimation figure as of July 2016 (enlarged) [1-13]

Regarding the status of the structures in the RPV and PCV, the CRGTs at the bottom of the RPV were damaged in the process of fuel melting and falling, and fuel debris is estimated to have penetrated into the CRD housings below the RPV.

- ① The fuel debris is estimated to be in various states, including oxidized, particulate, and matter that fell into the PCV and reacted with concrete.
- ② Damaged CRGTs are estimated to exist at the bottom of the RPV.
- ③ Some CRGTs are estimated to remain in the periphery of the bottom of the RPV.
- ④ Damage openings are estimated to exist in the lower plenum of the RPV.
- ⑤ The center of the CRD housings under the RPV is estimated to be damaged and fuel debris is inside these CRD housings.
- ⑥ Unknown materials are estimated to have accumulated at the bottom of the PCV.

Based on previous findings, CRGTs located in the lower plenum of the RPV are considered to have been melted or damaged in the process of migration because it is on the migration path of fuel that had become hot and migrated downward from the core section. Therefore, there is a possibility that some damaged CRGTs remain at the bottom of the RPV.

Although water is injected into the RPV from the FDW and CS to cool the reactor, a water level is not formed in the core, as indicated by the calibrated reactor water level gauge, which indicates 5m below the TAF. Therefore, it is assumed that a damage opening exists in the lower plenum and water is flowing out from there.

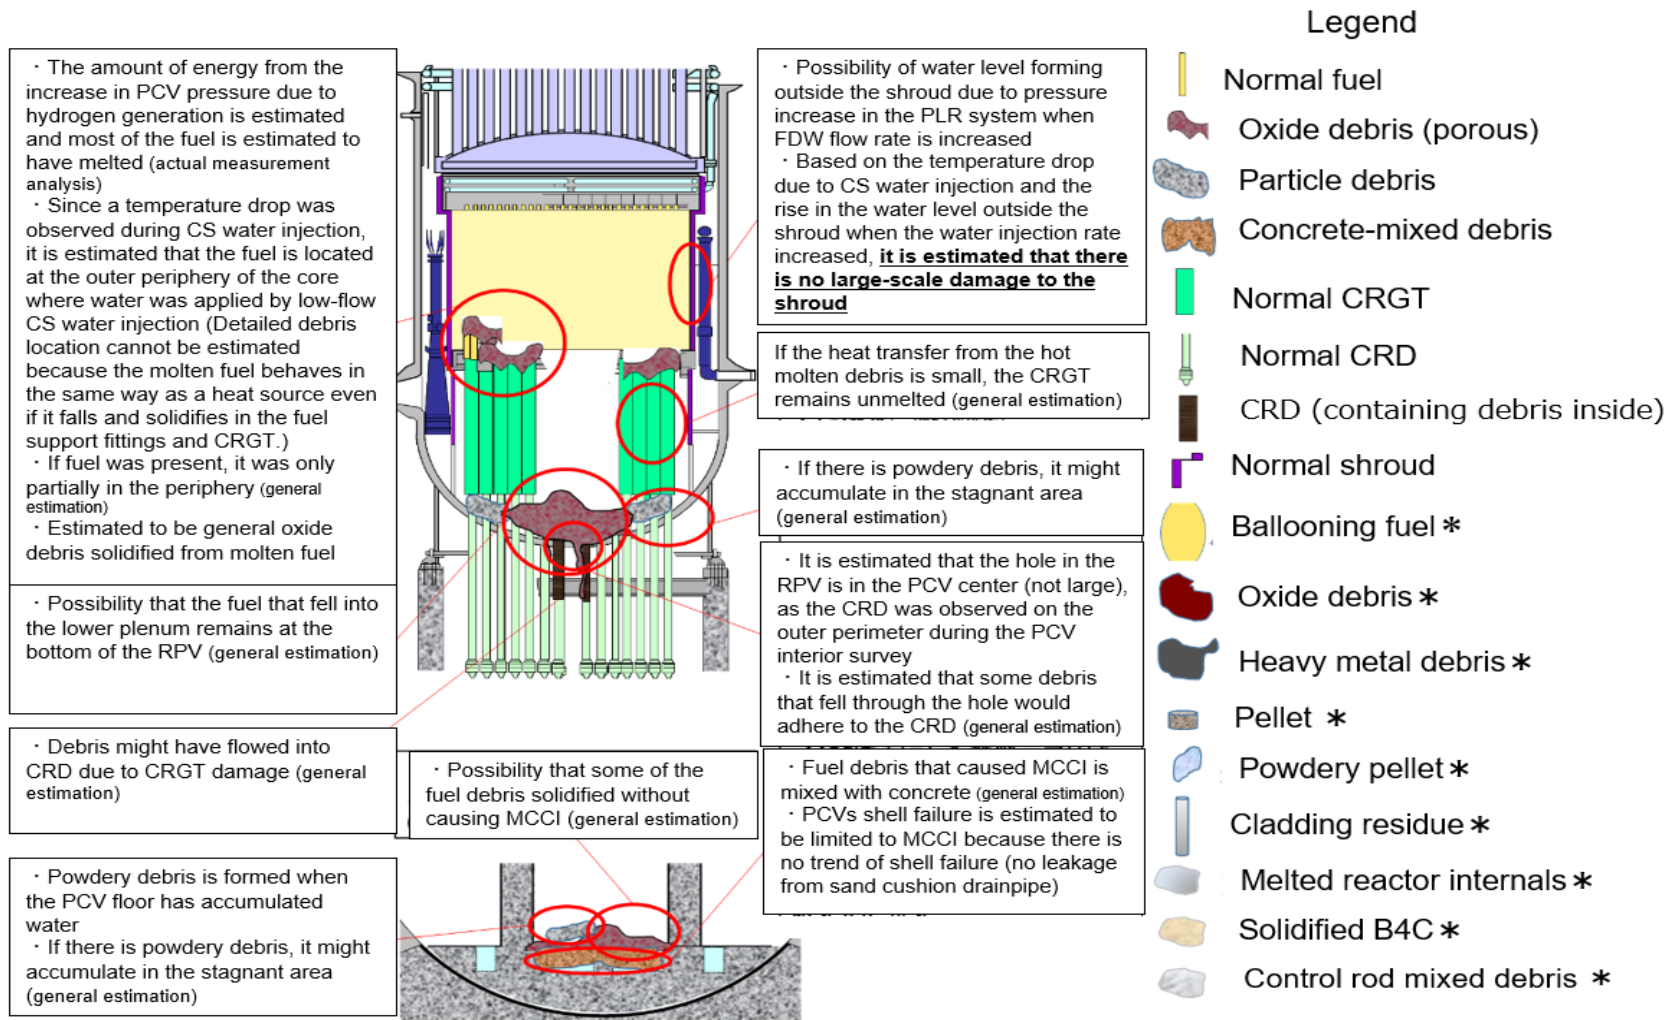
Figure 4.6.2-2 Unit 2 estimation figure as of July 2016 (enlarged) [2-10]

- ① The fuel debris is estimated to be in various states, including oxidized, particulate, and matter that fell into the PCV and reacted with concrete.
- ② Partially melted fuel is estimated to remain in the outer periphery of core.
- ③ The CRGTs are estimated to remain in the periphery of the bottom of the RPV.
- ④ The center of the housings under the RPV is estimated to be damaged and fuel debris is inside the CRD housings.

Based on previous findings, it is assumed that the temperature of the core section rises from the center and fuel melting proceeds from there. Although it is not possible to determine the detailed location of fuel debris in the vertical direction around the inner and outer perimeters of the RPV, it is estimated that partially melted fuel remains in some parts of the outer perimeter of the core.

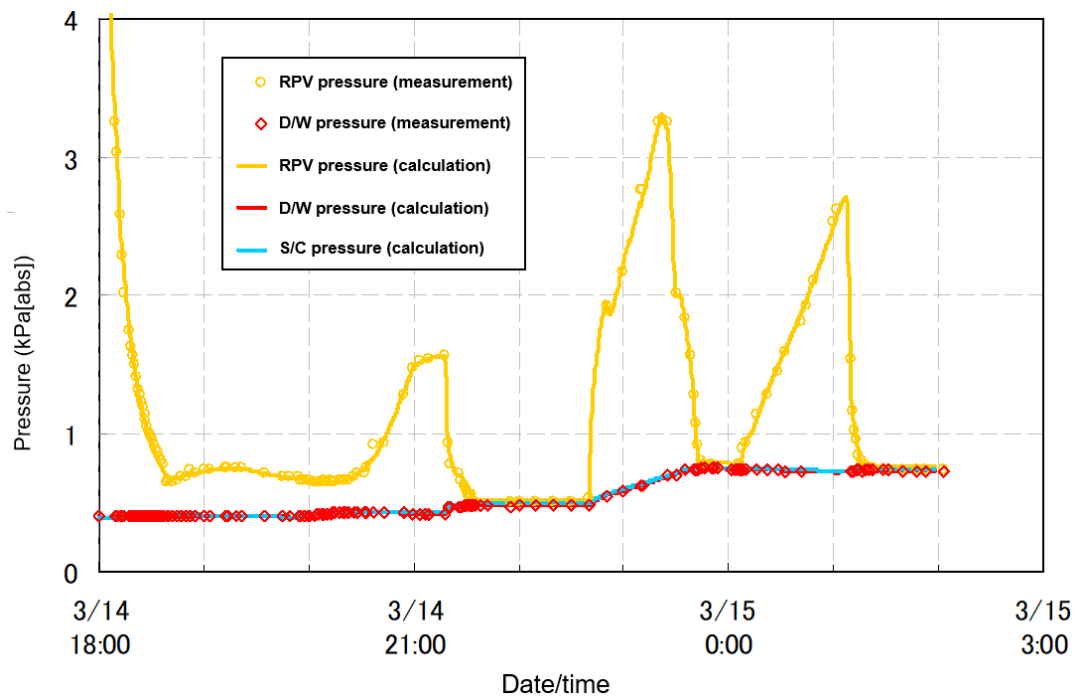
In this examination of unresolved issues regarding the behavior of reactor pressure, the general thermal-hydraulic analysis code GOTHIC (Generation of Thermal-Hydraulic Information for Containments) was used to adjust the amount of steam and hydrogen formation to try to reproduce the actual measured values of reactor pressure and D/W pressure (Fig. 4.6.2-7).

Fig. 4.6.2-7 Comparison of measured reactor pressure and PCV pressure with GOTHIC analysis results [2-13]

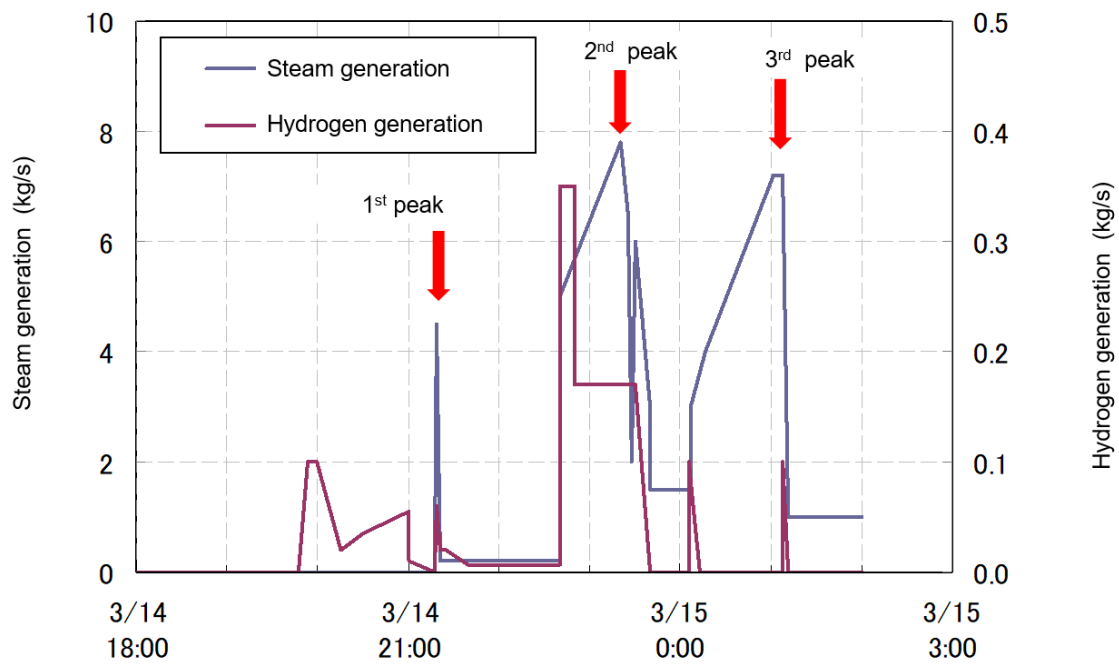
In order to reproduce the actual pressure measurements and have a realistic amount of steam and hydrogen formation, it is necessary to assume the amount of formation shown in Figure 4.6.2-8. The results show that most of the zirconium in the reactor reacted by the timing of the second peak, and the hydrogen formation was particularly significant then.

Therefore, the relationship between hydrogen formed and energy production associated with the water-zirconium reaction suggests that most of the fuel melted at the timing of the second peak. This confirms the previous estimation that most of the core has migrated to the lower part of the RPV.

Figure 4.6.2-8 Steam and hydrogen generation setting for GOTHIC analysis ^[2-13]

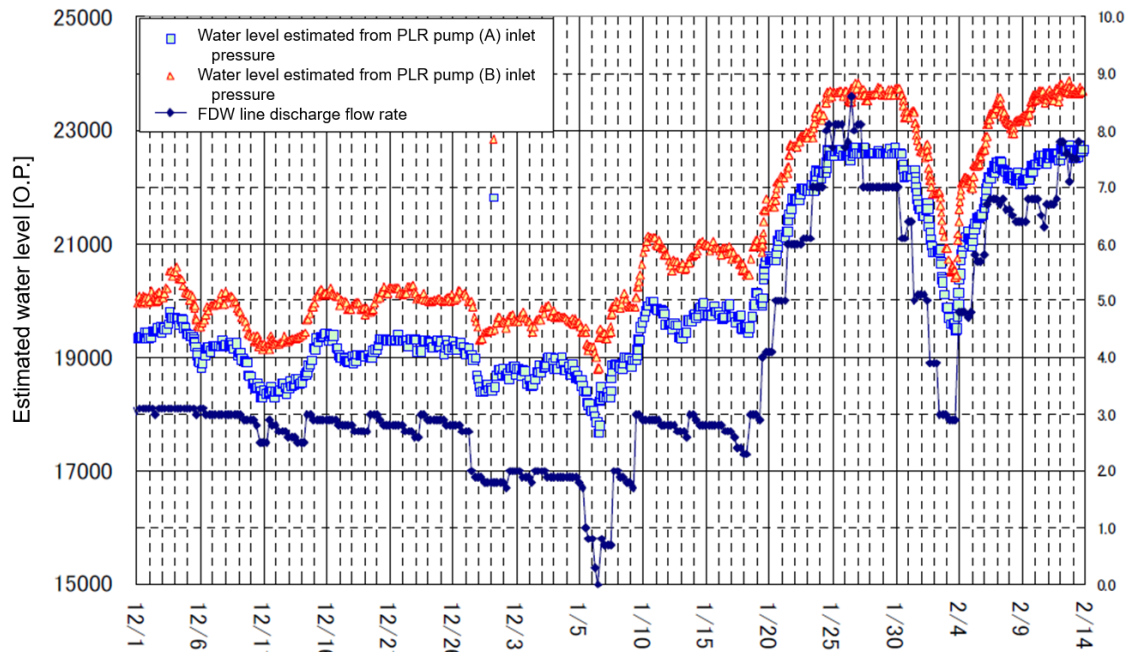
Figure 4.6.2-9 shows the relationship between the amount of water injected from the FDW and the water level in the annulus section estimated from the PLR inlet pressure from December 2011 to February 2012. The water level outside the shroud rises as the amount of water injected from the FDW changes.

Figure 4.6.2-9 Relationship between the amount of water injected from the FDW and the water level in the annulus estimated from PLR inlet pressure (December 2011 - February 2012)^[2-13]

This suggests the following two possibilities. The first is that the degree of damage to the shroud is small and some level of water may have formed outside the shroud. The second is that the amount of water injected from the FDW has increased, and the water level in the RPV is rising, although the shroud is damaged.
