Estimation of status inside reactor pressure vessels
and containment vessels
after the accident at the Fukushima Daiichi Nuclear
Power Station

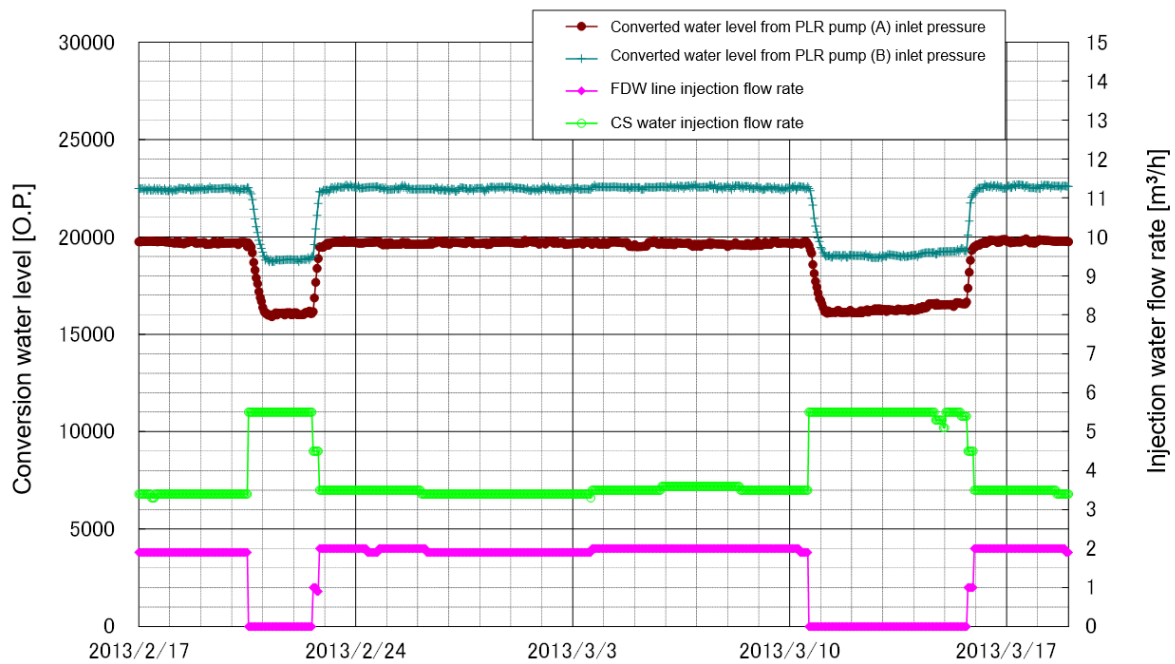
Figure 4.6.2-10 similarly shows the relationship between the amount of water injected from the FDW and the water level in the annulus estimated from the PLR inlet pressure from February 2013 to March 2013. During the time shown in the graph, there are two periods when the amount of water injected from FDW was set to zero, while the total amount of water injected from the FDW and CS remained unchanged. Just at this timing, the water level in the annulus, estimated from the PLR inlet pressure, is decreasing. This behavior can be attributed to the fact that some level of water has formed to some extent outside the shroud, and the first of the two possibilities described above is likely to be true. Therefore, the possibility of significant damage to the shroud is considered small.

4.6.2-10 Relationship between water injected from the FDW and CS and water level in annulus section estimated from PLR inlet pressure (February 2013 - March 2013) [2-10]

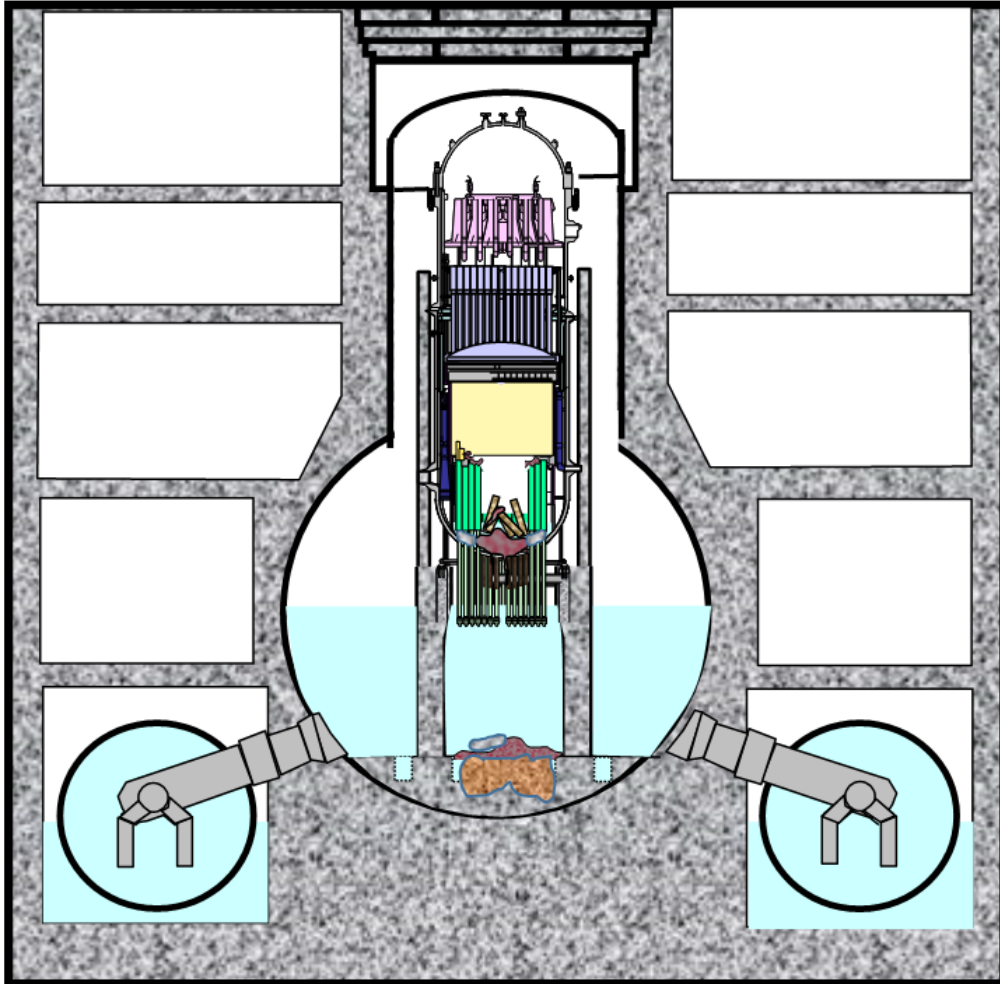
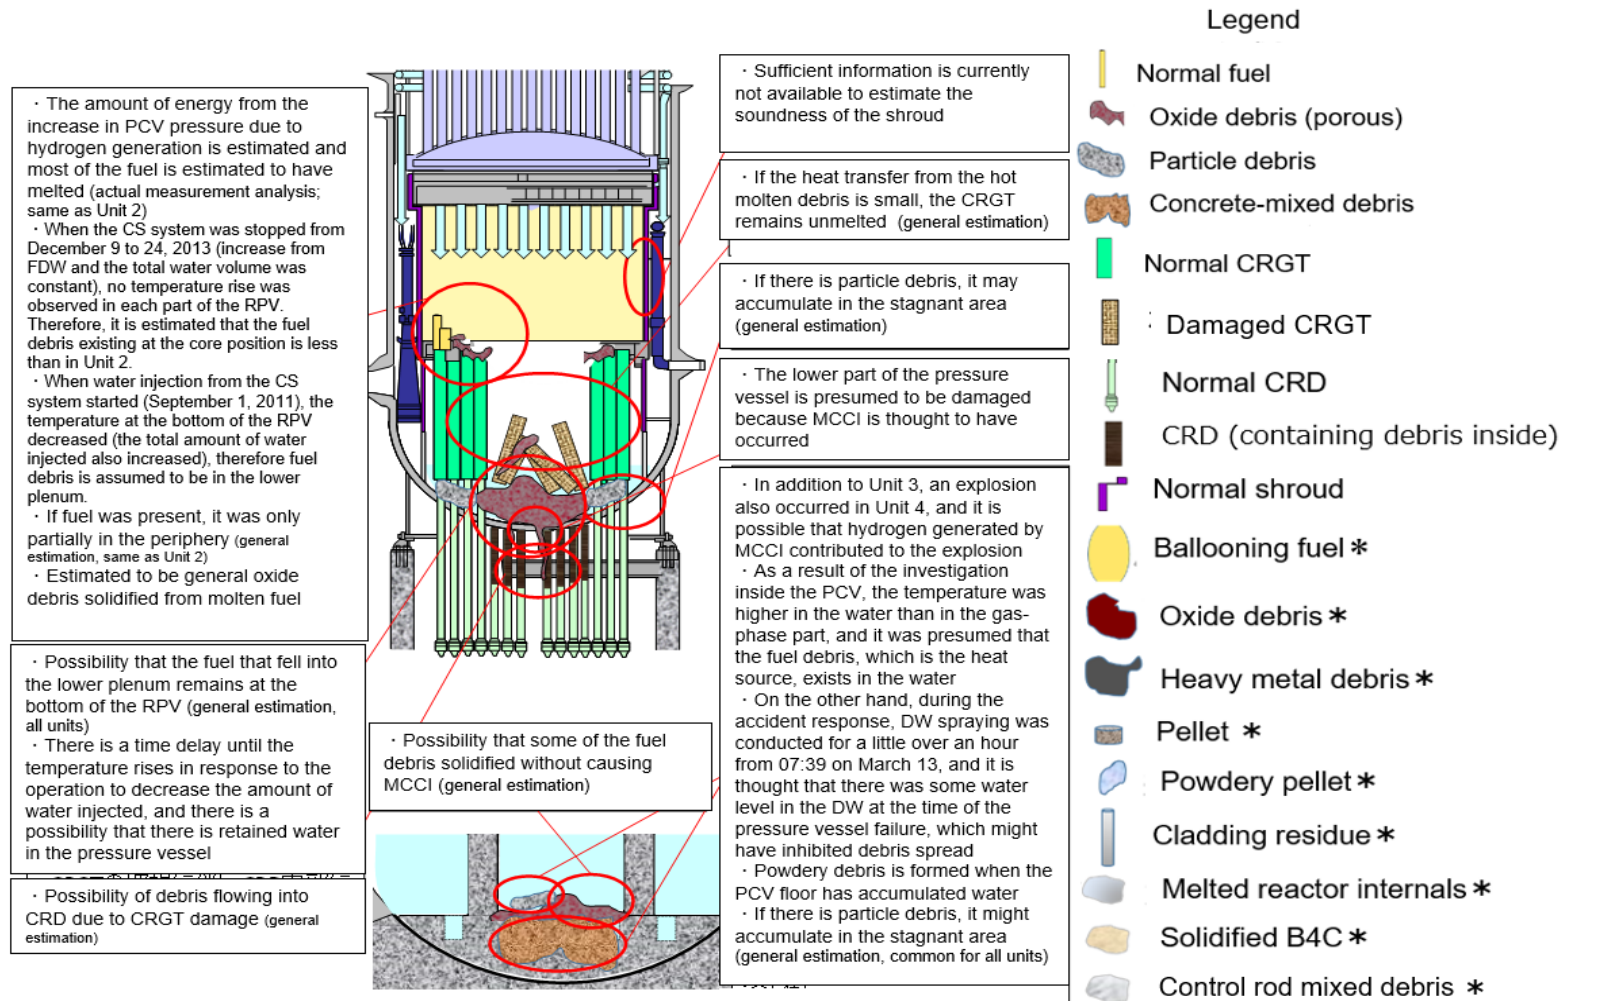
Figure 4.6.3-1 Unit 3 estimation as of July 2016 ^[3-10]

Figure 4.6.3-2 Unit 3 estimation figure as of July 2016 (enlarged) [3-10]

Regarding the status of the structures in the RPV and PCV, it is estimated that the CRGTs at the bottom of the RPV were damaged by the fuel melting and falling down, and that fuel debris has penetrated into the CRD housings under the RPV.

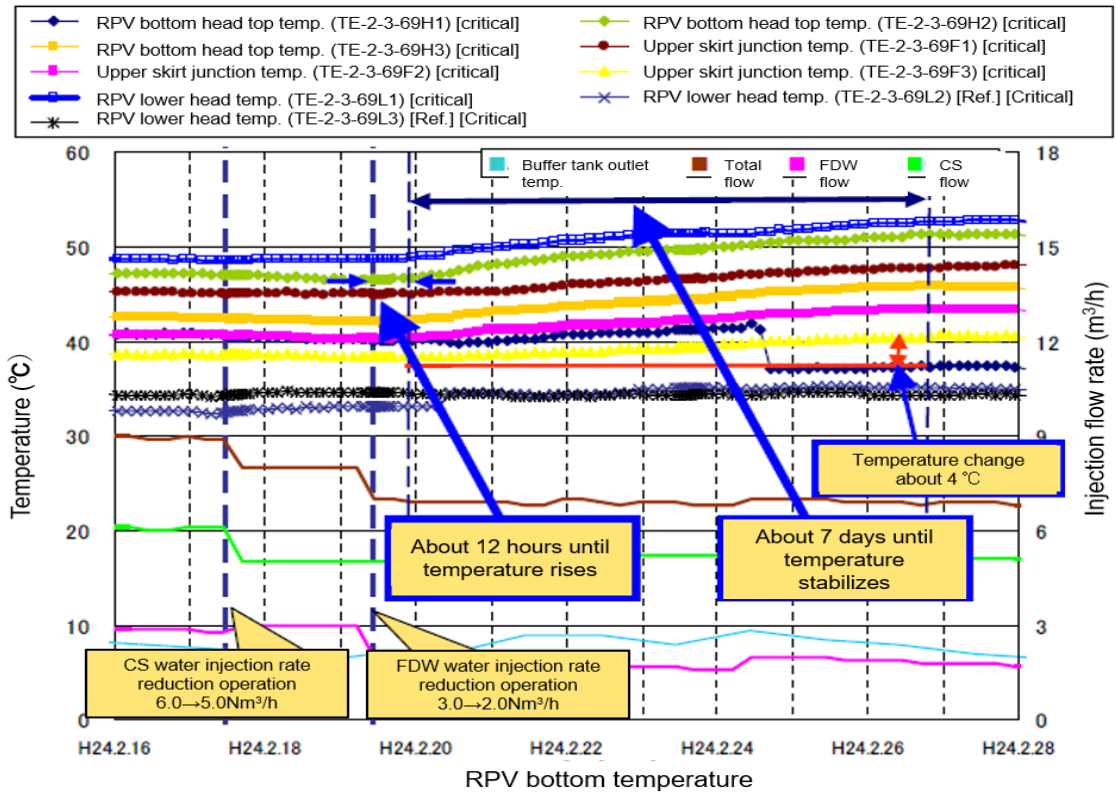
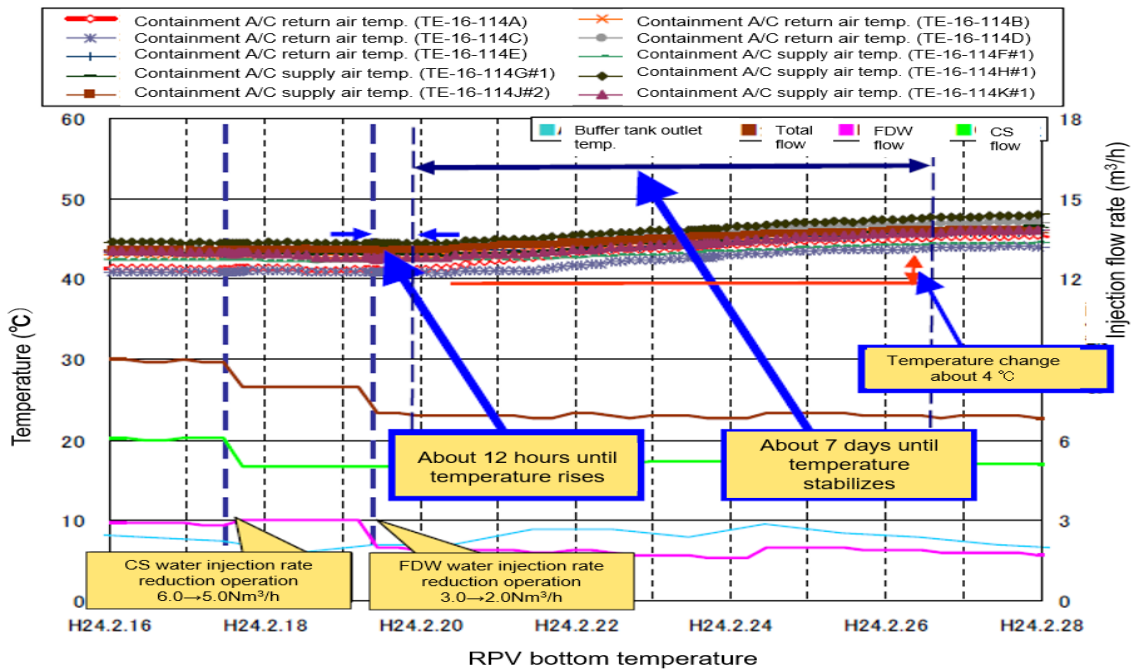
When the amount of water injected from the CS and FDW was reduced in February 2012, a gradual temperature change was observed with a time delay (Figure 4.6.3-3). It took about 12 hours for a clear temperature increase to be observed, followed by

about 7 days for the temperature to stabilize. Therefore, at that time, the reason for this time delay was estimated to be the possibility that there was some amount of water at the bottom of the RPV.

Figure 4.6.3-3 Temperature behavior of each part when water injection rate decreases [3-11]

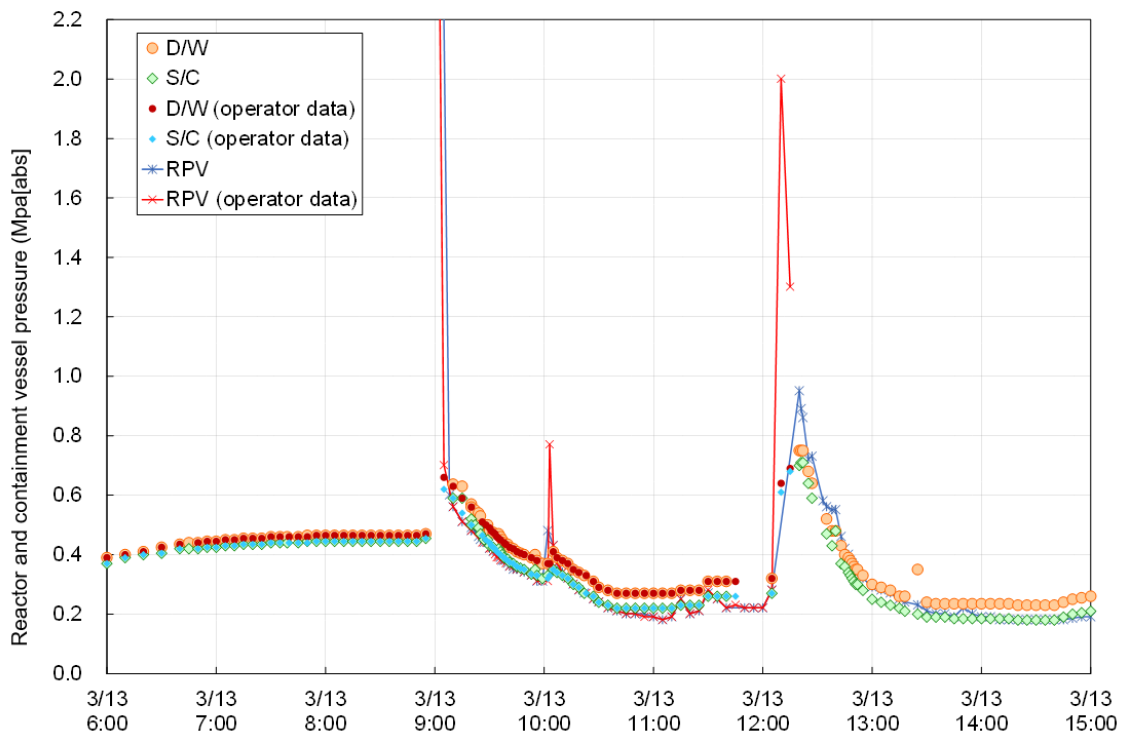
The PCV pressure increased significantly at about 09:00 and after 12:00 on March 13, 2011 (Figure 4.6.3-4). This pressure increase was thought to be caused by a large amount of hydrogen being formed, which melted most of the fuel. Based on the results of the accumulated investigations, including the analyses conducted up to this time, it is considered that there is almost no fuel remaining in the core.

Figure 4.6.3-4 Change in PCV pressure (2011) [3-10]

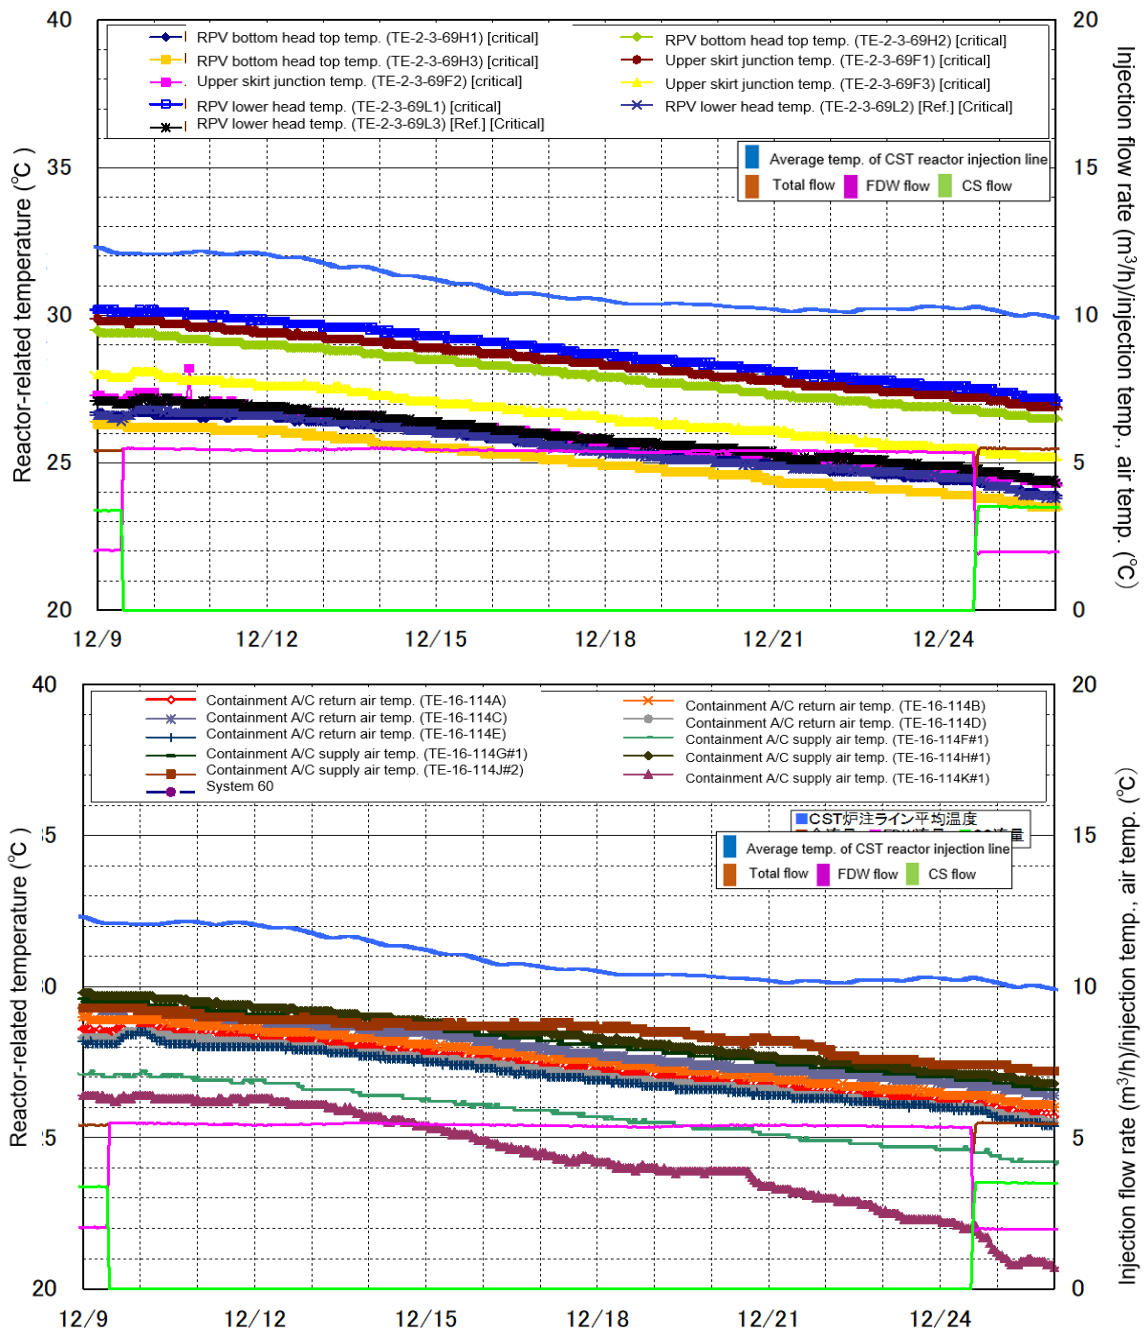
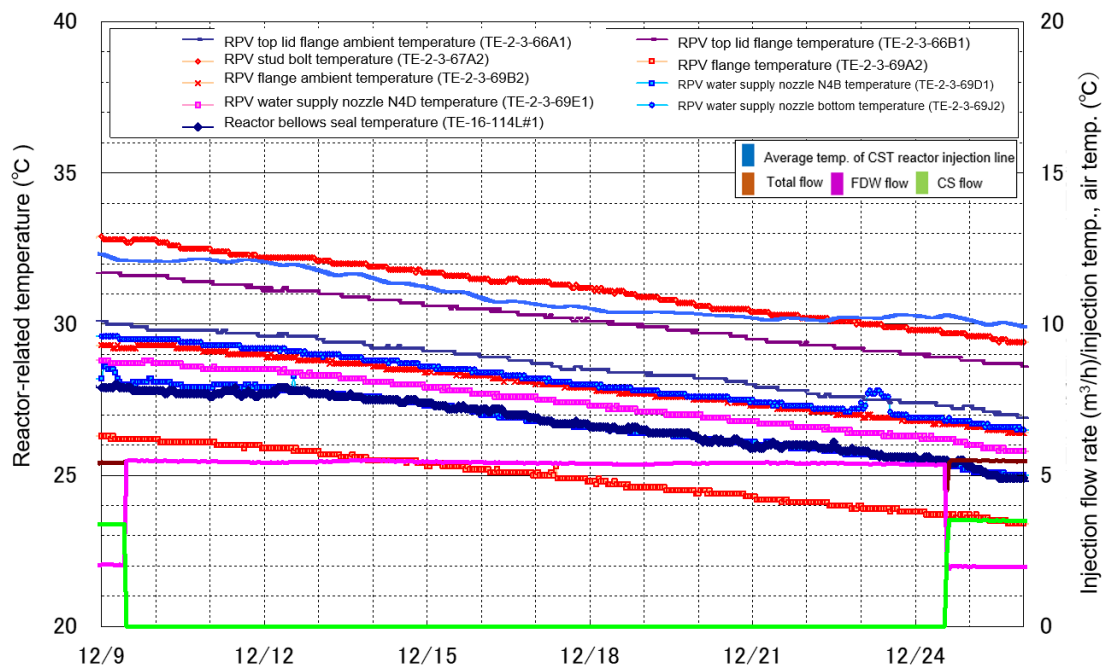
and water injection was conducted only from the FDW (no change in total water injection volume). As shown in Figure 4.6.3-5, no temperature increase was observed due to the suspension of water injection from the CS, and no noticeable effect on the reactor cooling status was observed. Thus, it is considered that there is little fuel debris in the core area because the cooling status of each part did not change even after the water injection from the CS was stopped.

Figure 4.6.3-5 Temperature change during stopping period of water injection in the CS (2013) [3-10]

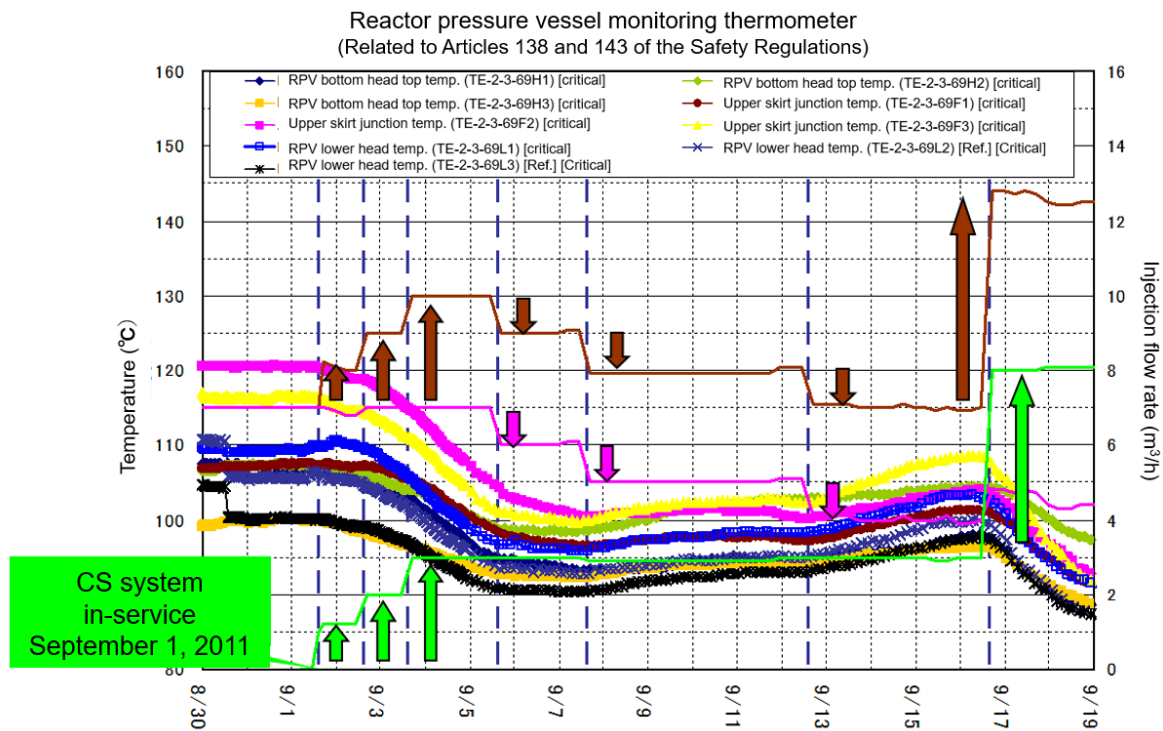
When water injection from the CS began (September 1, 2011), the temperature at the bottom of the RPV decreased (Figure 4.6.3-6). At this time, the total volume of water injection also increased. As mentioned previously, considering the small amount of fuel debris existing in the core area, it is estimated that the main reason for this temperature decrease was not that the fuel debris in the core, which had not been sufficiently cooled down before, was cooled down now with the start of CS water injection (Section 4.1.3), but that the increase in the total amount of water injection resulted in the cooling of the fuel debris existing in the lower part of the RPV. Therefore, fuel debris is considered to exist in the lower plenum to some extent.

Figure 4.6.3-6 Temperature change after water injection by the CS stopped (2011) ^[3-10]

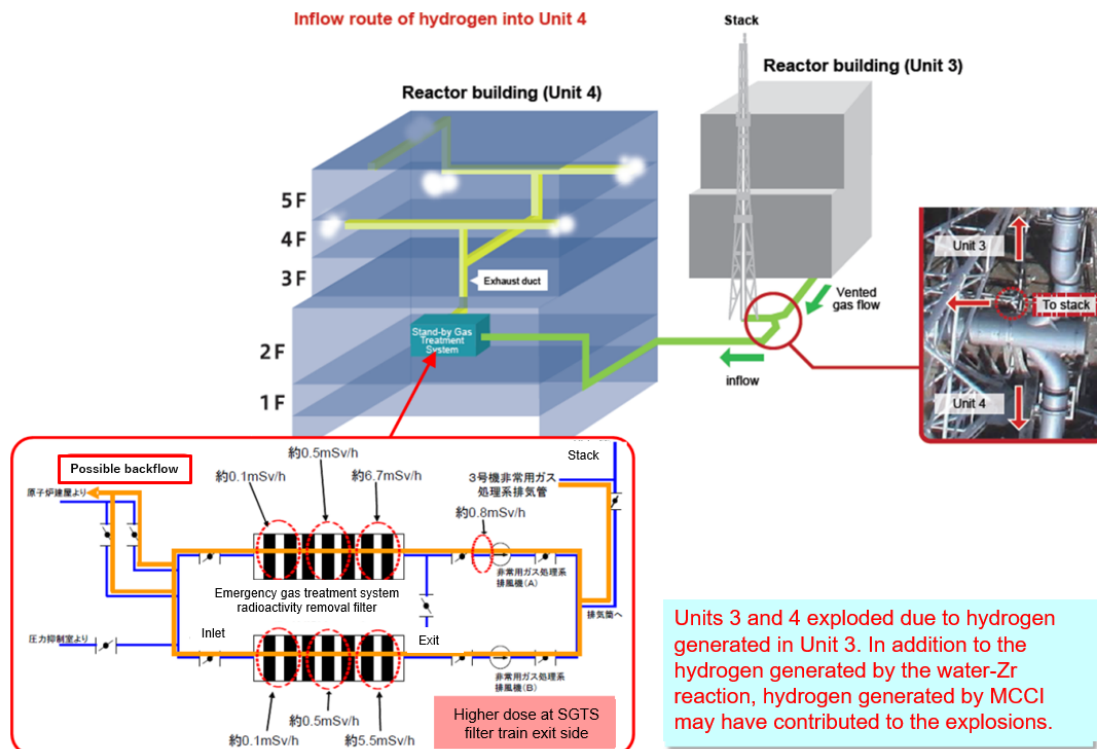
Dose rate measurement of the SGTS filter train in Unit 4 showed a higher dose rate on the outlet side (exhaust stack side), which is considered to be evidence of backflow (Figure 4.6.3-7). In addition, the hydrogen formed in the water-zirconium reaction in the Unit 3 reactor contributed to the explosion in Unit 4, based on consideration of the progression of the accident in Unit 3. Therefore, considering that most of the hydrogen

formed up to that point due to the venting was exhausted from the PCV, it is estimated that the hydrogen formed due to MCCI may have contributed to the explosion in Unit 3. In other words, it is estimated that MCCI may have occurred in Unit 3.

Figure 4.6.3-7 Unit 4 SGTS filter train dose measurement results [3-10]

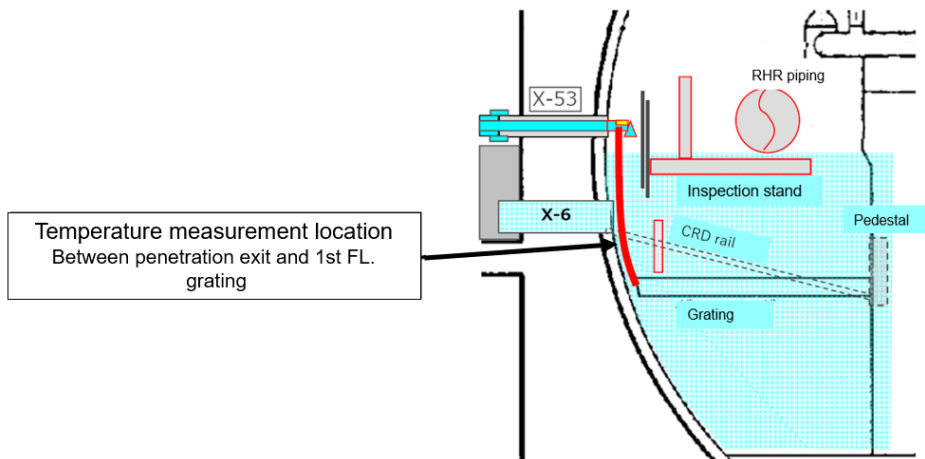
In Unit 3, survey equipment (camera, thermometer, and dosimeter) was inserted through the PCV penetration (X-53) in October 2015 to conduct a survey mainly to confirm the cooling status inside the PCV. The information obtained during this investigation showed that the temperature in the liquid phase was higher than that in the gas phase (Figure 4.6.3-8). Therefore, it was estimated that fuel debris, which is the heat source, is present in the water.

- The water level in the PCV was OP 1800, which was roughly consistent with the estimated value * .
 - * Estimated value: pressure conversion OP: 11970 mm (October 20, 5:00)
- The temperature inside the PCV was about 26-27°C in the gas phase and about 33-35°C in the water.

Figure 4.6.3-8 PCV internal investigation results (conducted in October 2015) ^[3-12]

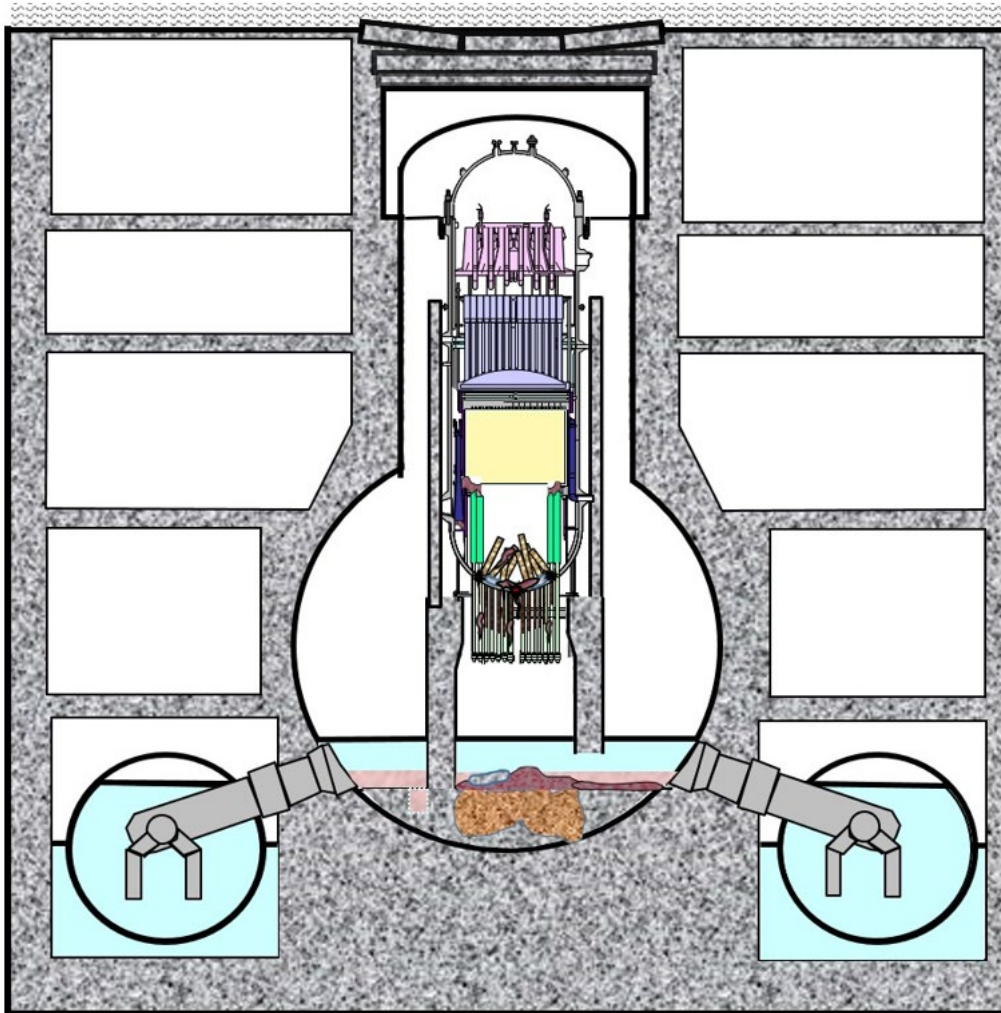
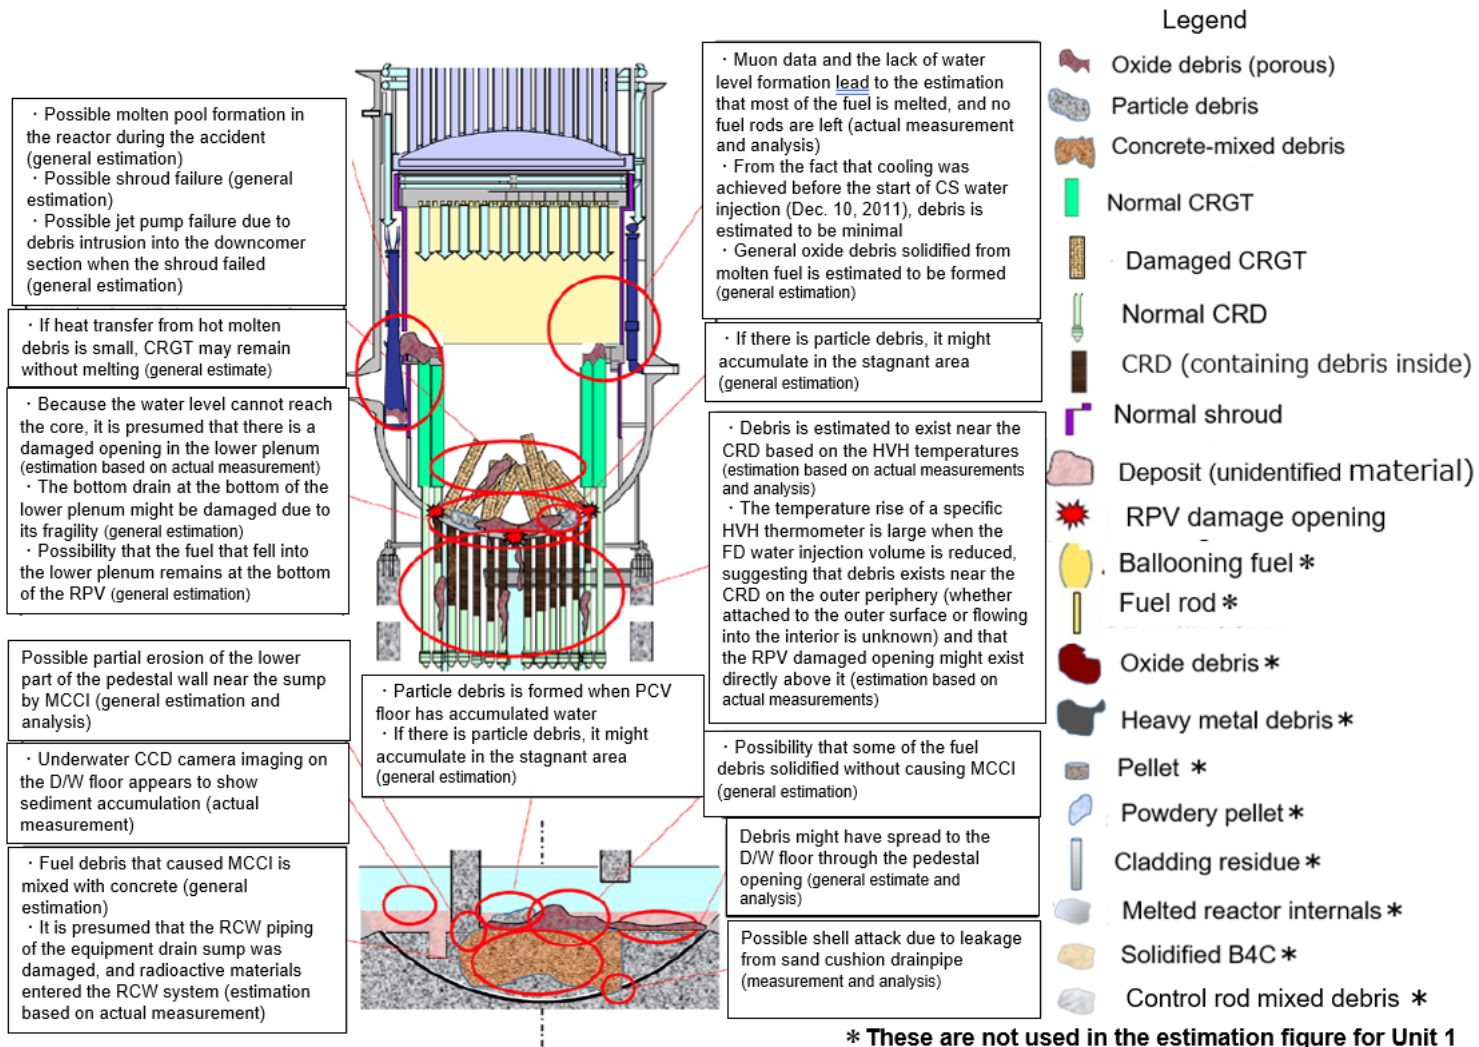
Figure 4.7.1-1 Unit 1 estimation as of March 2017 ^[1-13]

Figure 4.7.1-2 Unit 1 estimation figure as of March 2017 (enlarged) [1-13]

Regarding the status of the structures in the RPV and PCV, it is estimated that the CRGTs at the bottom of the RPV were damaged by the process of fuel melting and falling, and fuel debris has penetrated into the CRD housings below the RPV.

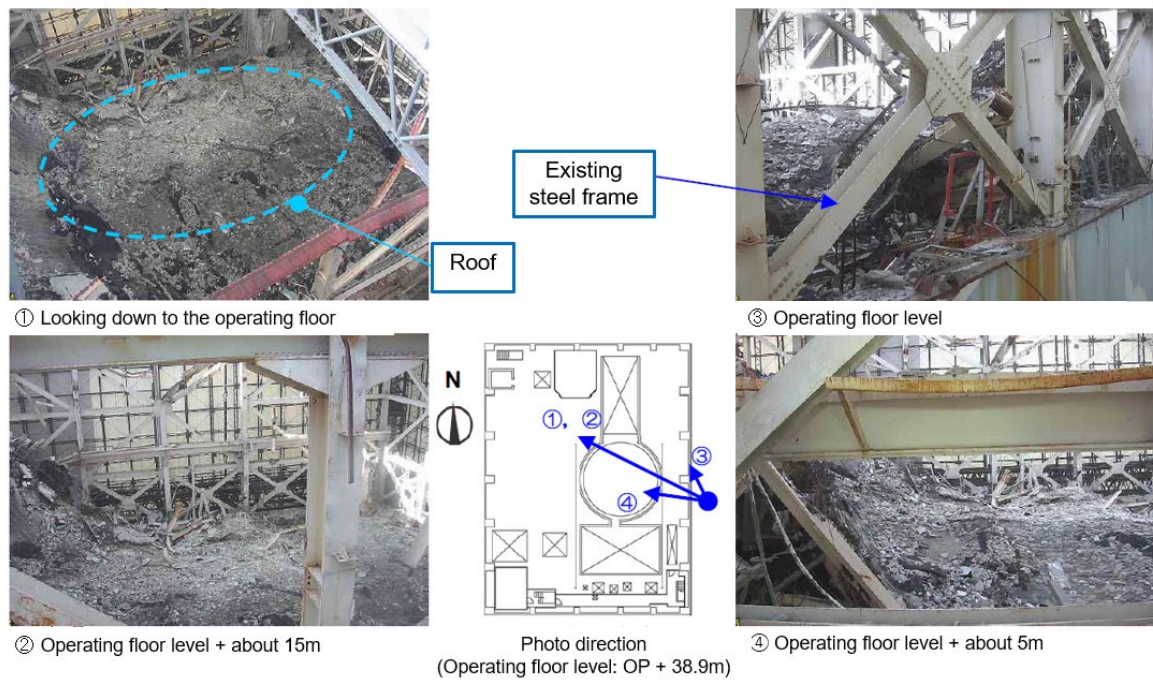
Photographs taken in 2014 for the purpose of installing the building cover of the operating floor confirmed that the collapsed roof had fallen in an almost flat shape and became rubble (Figure 4.7.1-3). In addition, the reactor well-plugs were found to have been shifted and lifted up, and these confirmations were reflected in the estimation figure (Figure 4.7.1-4).

Figure 4.7.1-3 Operating floor confirmation image [1-15]

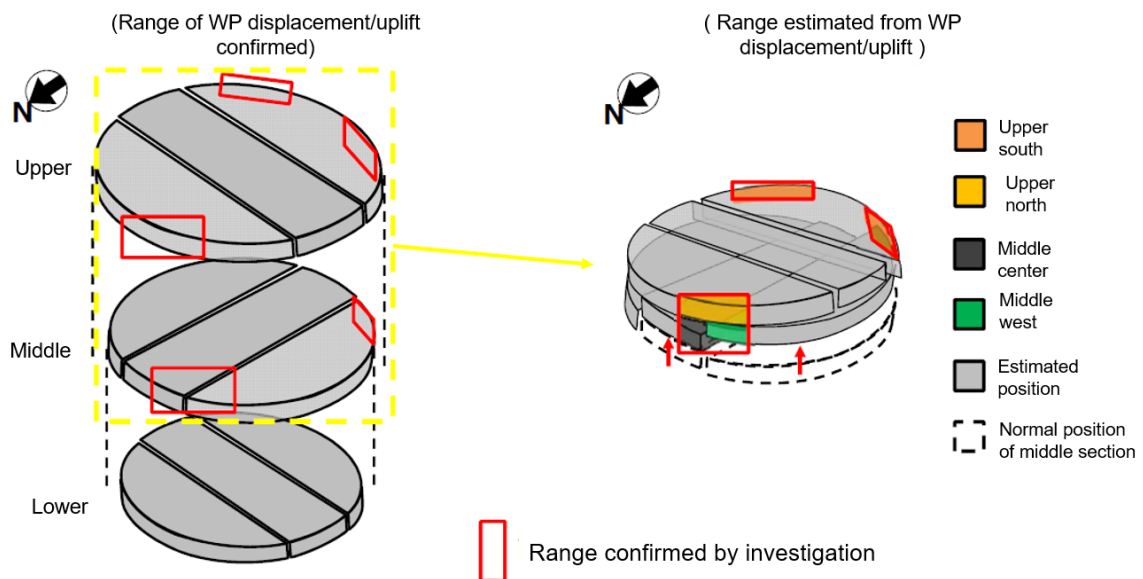
Figure 4.7.1-4 Displacement and lifting up of the well-plug [1-16]

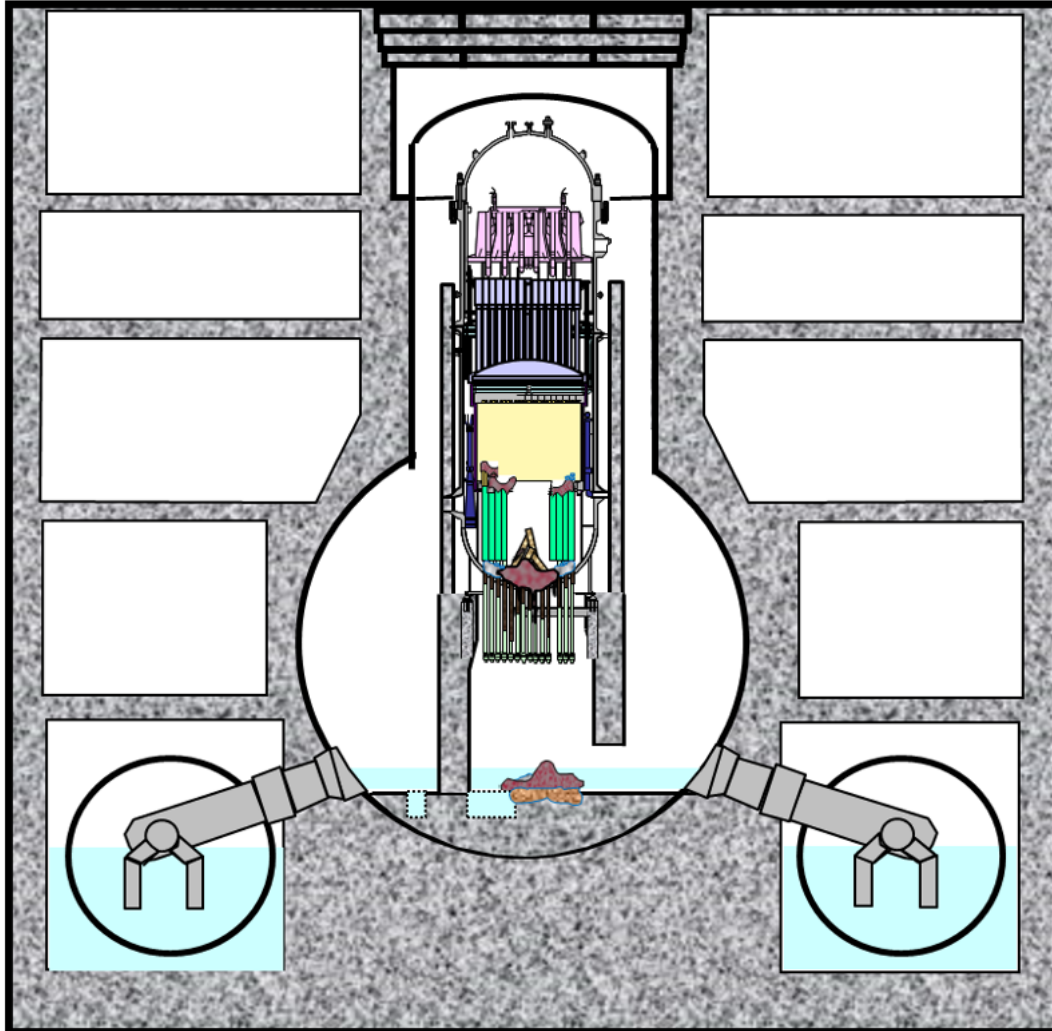
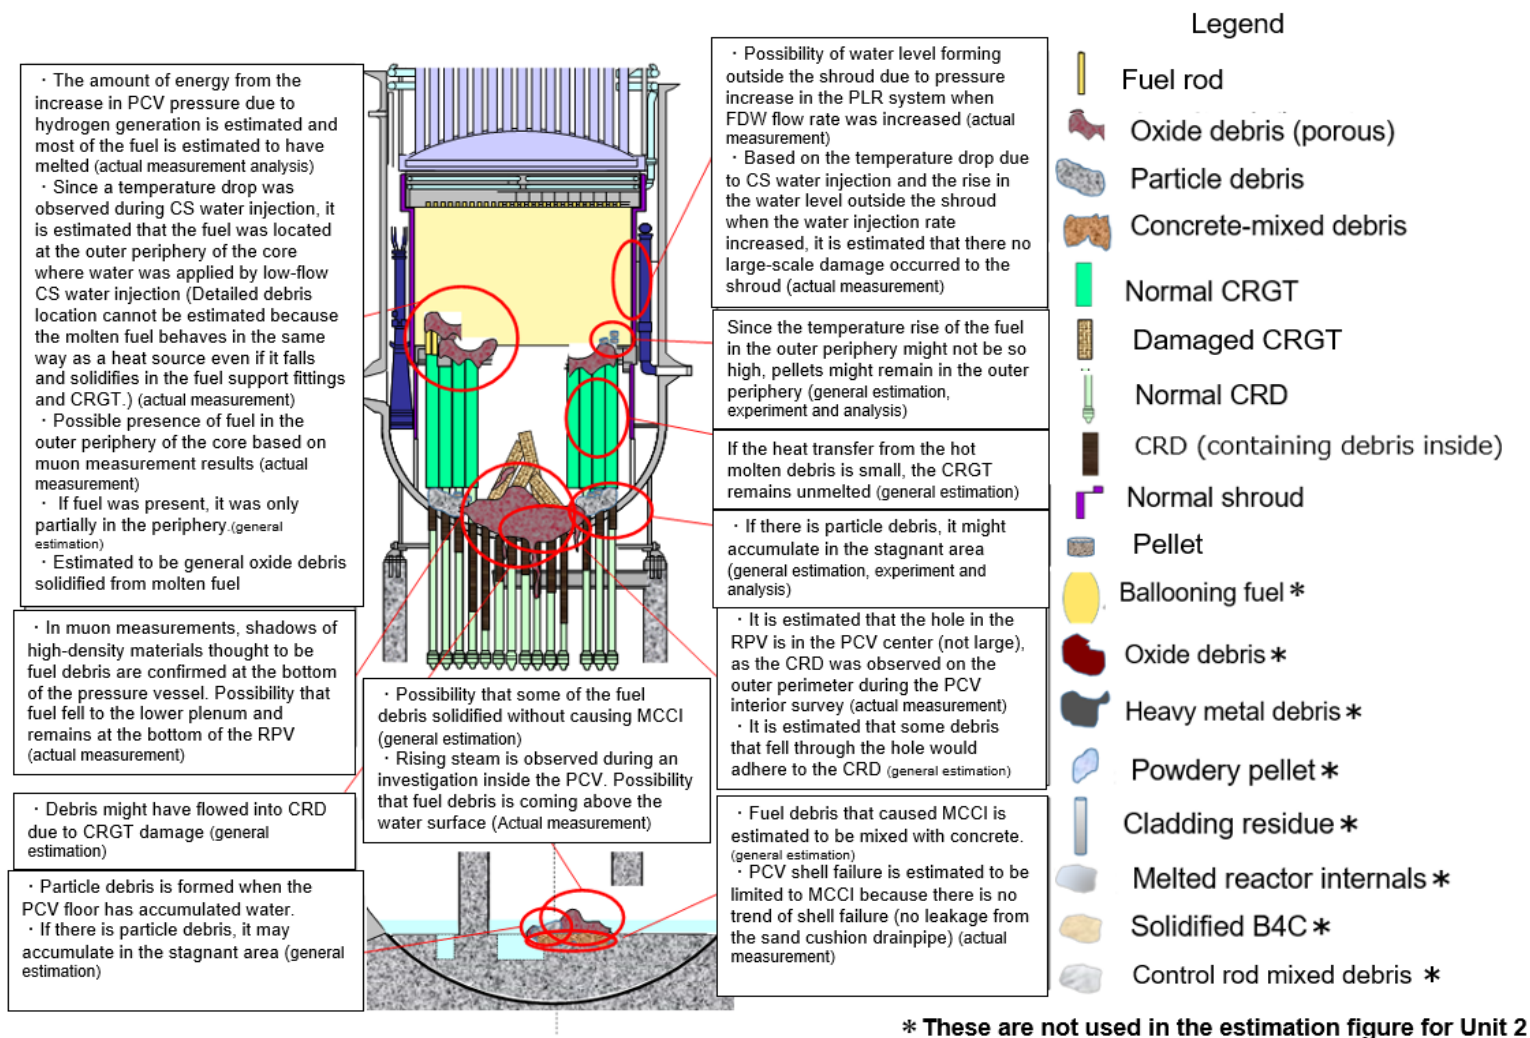
Figure 4.7.2-1 Unit 2 estimation as of March 2017 [2-10]

Figure 4.7.2-2 Unit 2 estimation figure as of March 2017 (enlarged) [2-10]

Regarding the status of the structures in the RPV and PCV, it is estimated that the CRGTs at the bottom of the RPV were damaged by the process of falling molten fuel, and fuel debris has penetrated into the CRD housings under the RPV.

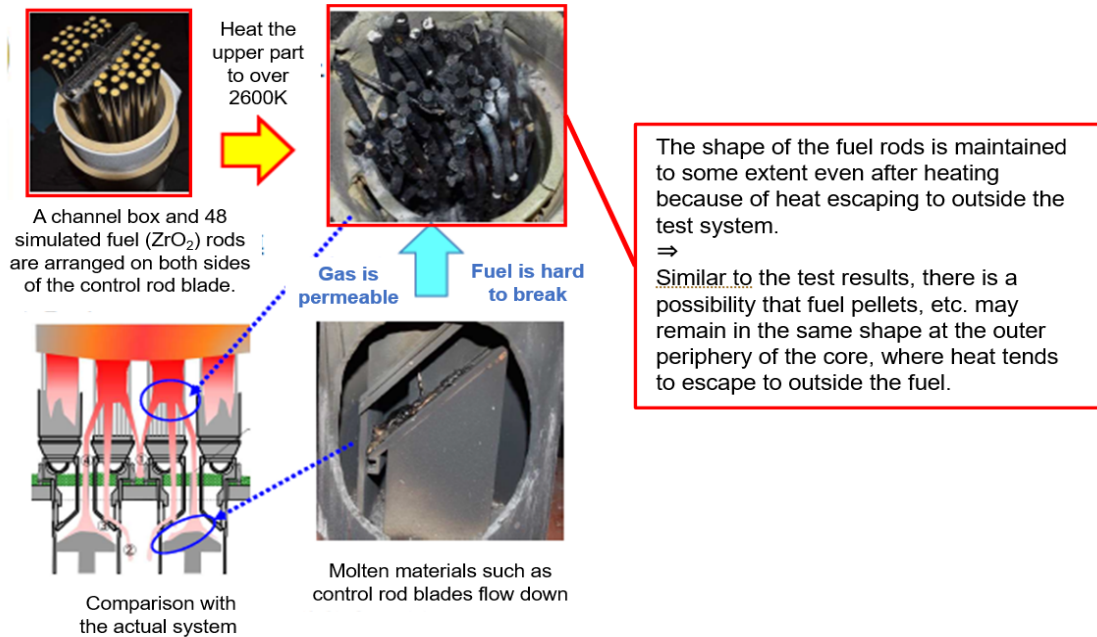
In the "Advancement of comprehensive internal reactor status assessment" project, a test was made in which a channel box and simulated fuel (ZrO_2) were placed on both sides of a control rod blade that was heated by a plasma torch (Figure 4.7.2-3); the purpose was to obtain information on the behavior of fuel melting and migration to the lower part of the fuel. As shown in Figure 4.7.2-3, the fuel rods maintained their shape to some extent even after heating, partly due to the effect of the heat easily escaping outside the test system. It is possible that fuel pellets may have fallen or remained in the shape of the fuel rods in areas with high radiation heat transfer, such as the outer periphery of the core, because the fuel rods did not melt sufficiently since

Figure 4.7.2-3 Simulated fuel assembly failure test [2-14]

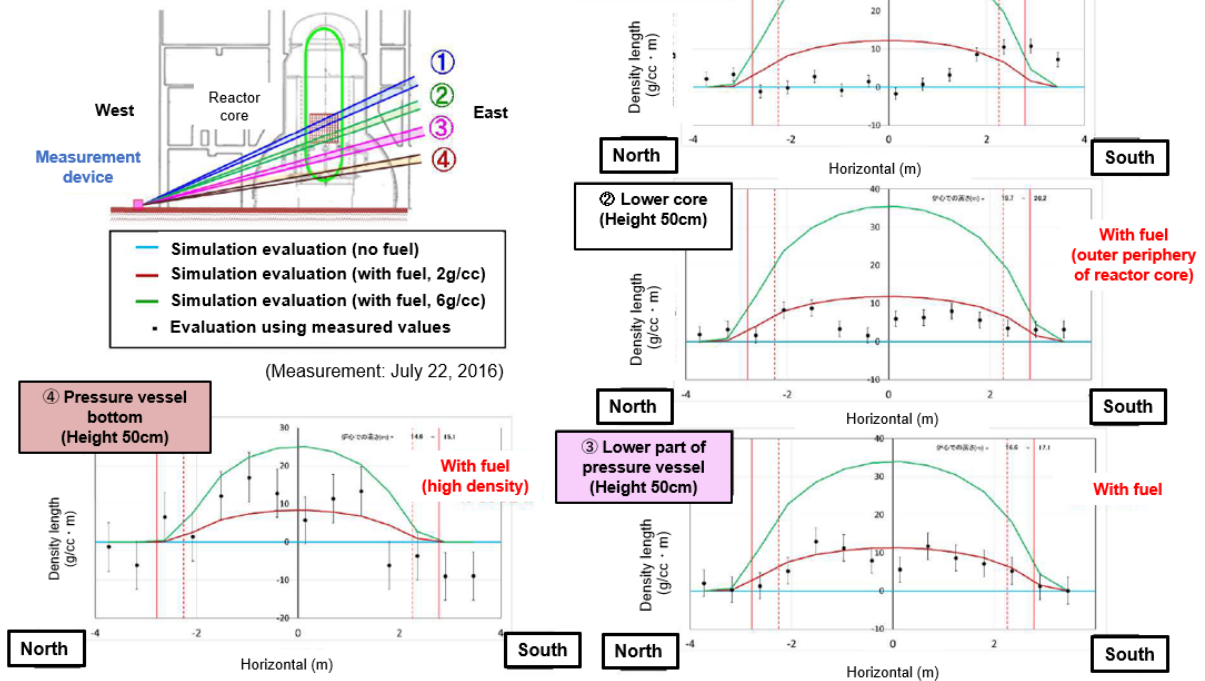
In addition, measurements using the muon transmission method were conducted from March to July 2016 to analyze and evaluate the location of fuel debris in the RPV (Figures 4.7.2-4 and 4.7.2-5). Figure 4.7.2-6 shows the evaluation results on the distribution of the amount of material in the RPV by comparing the number of muons measured with the results of simulations at ① the upper core, ② the lower core, ③ the lower part of the RPV, and ④ the bottom of the RPV. When focusing on the lower part of the core ②, comparison of the measured results and the simulation results assuming "no fuel" and assuming "with fuel" at the outer periphery of the core shows that the simulation results assuming "with fuel" are close to the measured results. Therefore, it is possible that fuel remains in the outer periphery of the core.

- By comparing the numbers of measured and simulated muon counts, the mass distribution in the pressure vessel was evaluated.

Figure 4.7.2-6 Comparison of muon measurement results with simulation results [2-15]

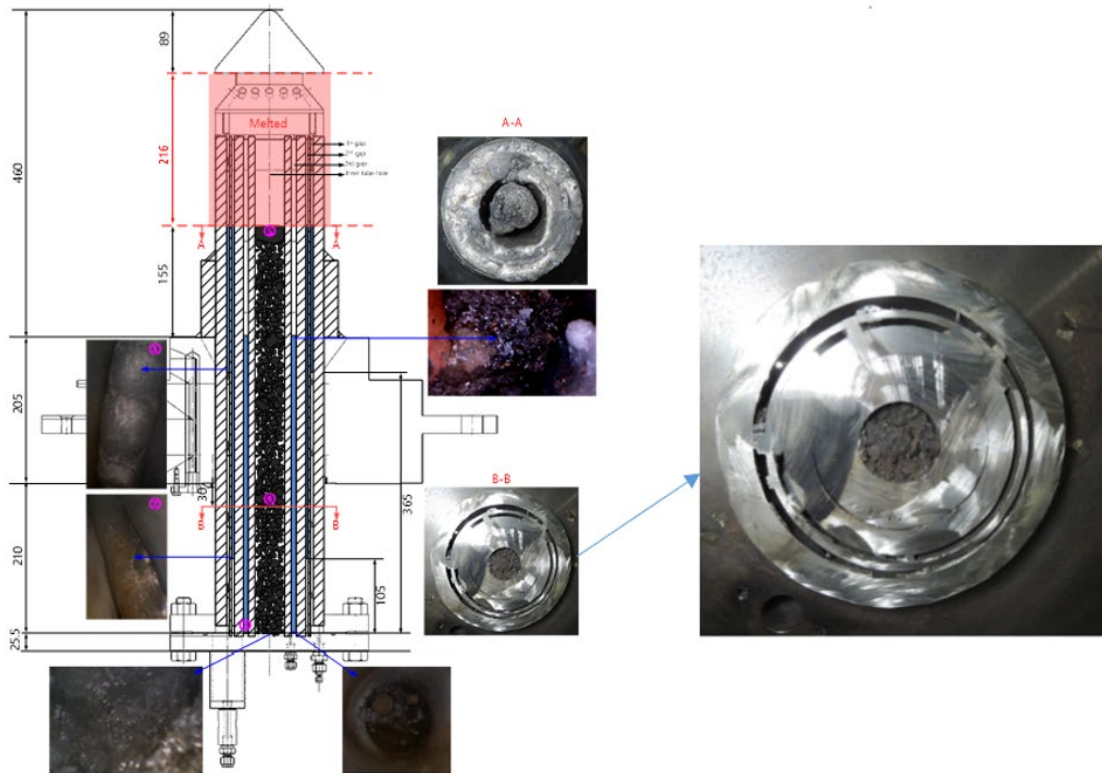
simulating the actual CRD. Although this specimen was shorter than the actual specimen, particulate corium was released from the lower end of the piping in the IRM/SRM test, and corium reached the lower end of the specimen in the CRD test. Considering the piping length of the actual instruments, the corium will penetrate to the piping section projecting outside the RPV. Sensitivity analysis using the SAMPSON model, which assumes that the corium falls while filling the piping, showed that the higher the corium temperature at the time of through-pipe failure, the greater the corium penetration length inside the piping. And if the temperature was high enough for the corium to melt completely, the evaluation showed that the corium would penetrate to the piping section projecting outside the RPV.

Figure 4.7.2-7 Results of cutting inspection of KAERI "through-pipe melt test" body [2-10]

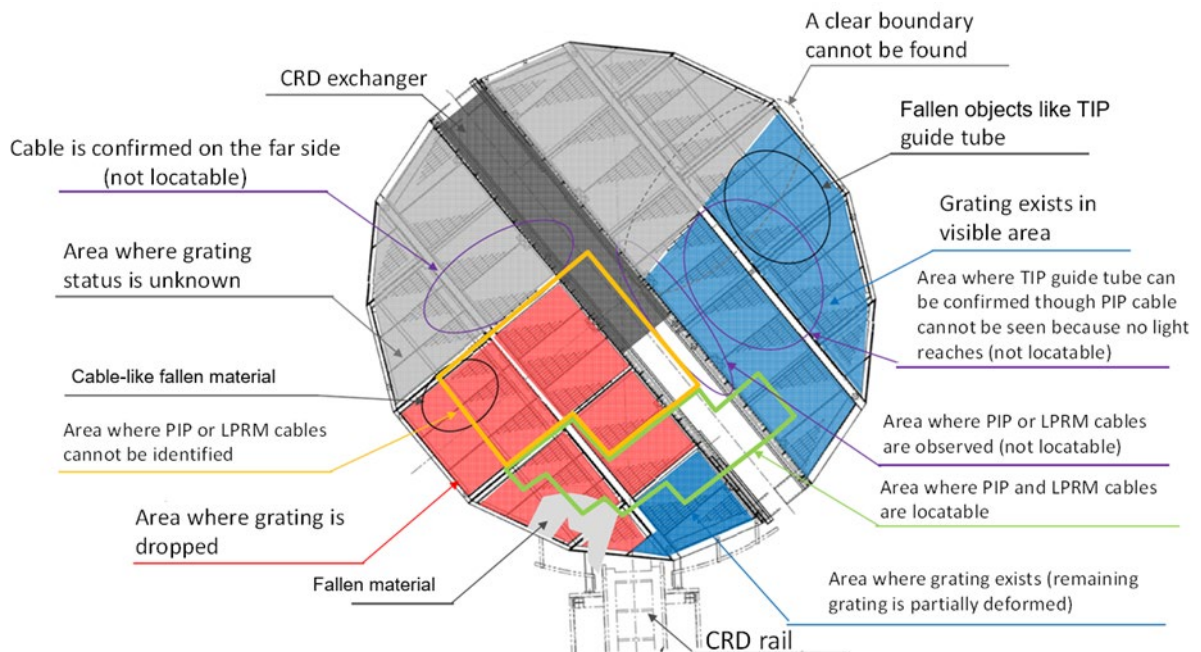
Figure 4.7.2-8 Results of the internal investigation of the pedestal (upper part) [2-16]
