Estimation of status inside reactor pressure vessels
and containment vessels
after the accident at the Fukushima Daiichi Nuclear
Power Station

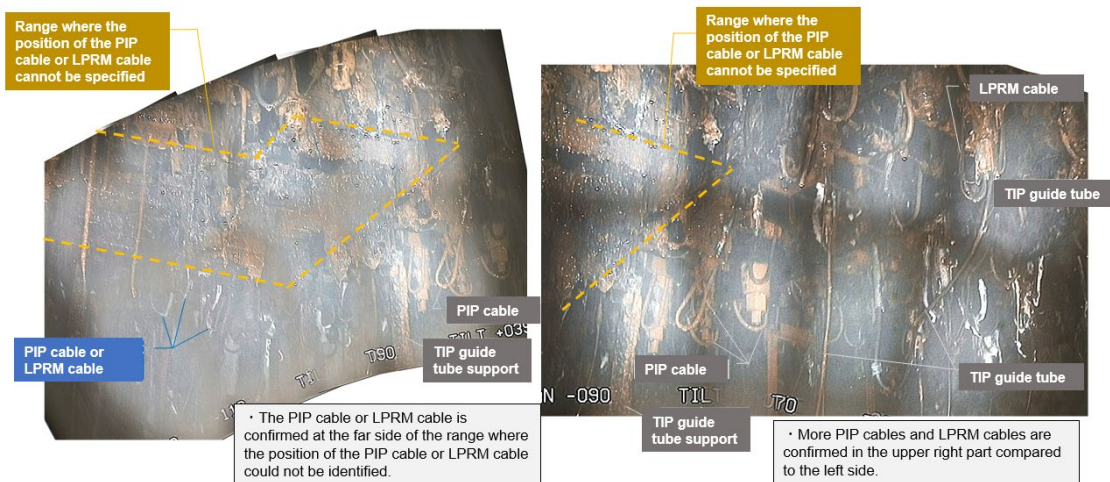
Figure 4.7.2-9 Results of the internal investigation of the pedestal (summary) [2-16]

From the above, it was estimated that the amount of fuel debris penetrating into the CRD housings was larger than in the sixth estimation.

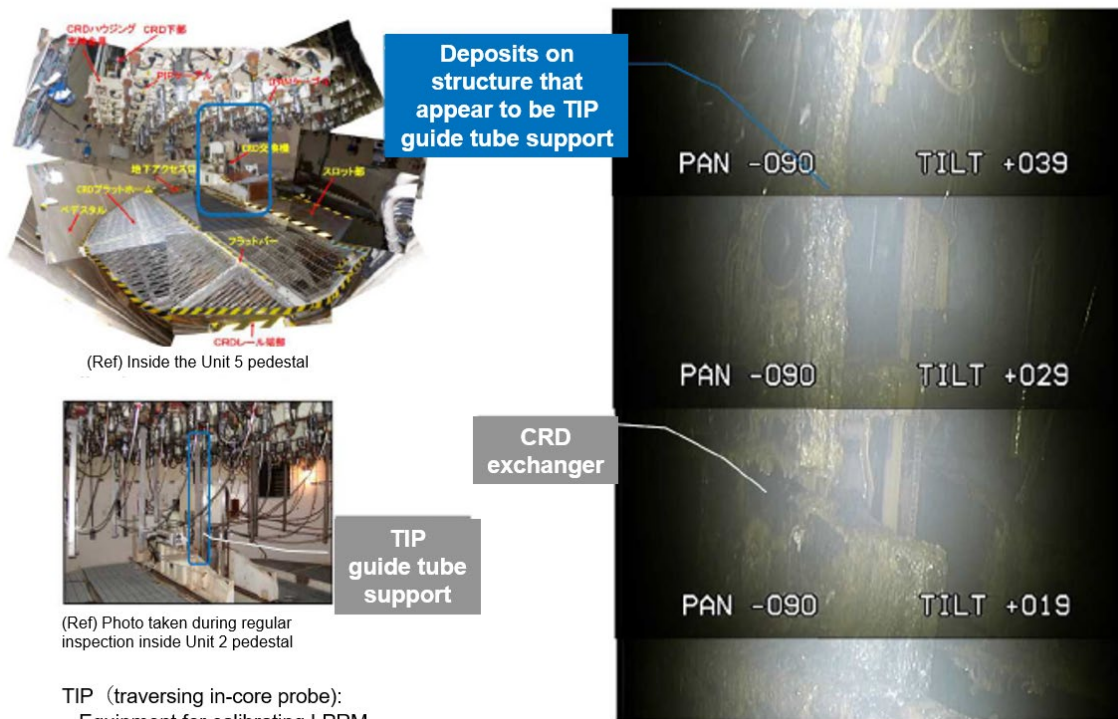
Figure 4.7.2-11 Images showing the inside of the Unit 2 pedestal (2/2) [2-17]

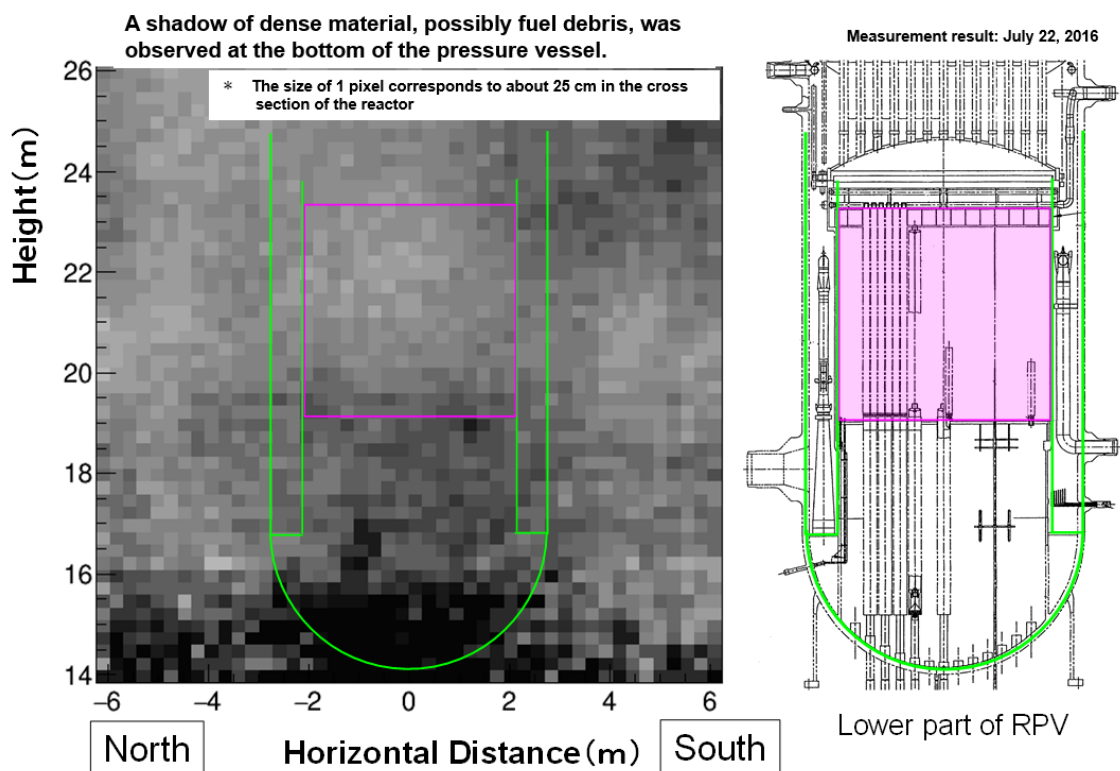
As shown in Figures 4.7.2-12 and 4.7.2-13, muon measurements conducted from March to July 2016 showed shadows of high density material that appeared to be fuel debris at the bottom of the RPV.

Therefore, it is estimated that the fuel debris that fell into the lower plenum remained at the bottom of the RPV and that the amount of debris at the bottom of the PCV was less than previously assumed.

Fig. 4.7.2-12 Muon measurement results for Unit 2 [2-15]

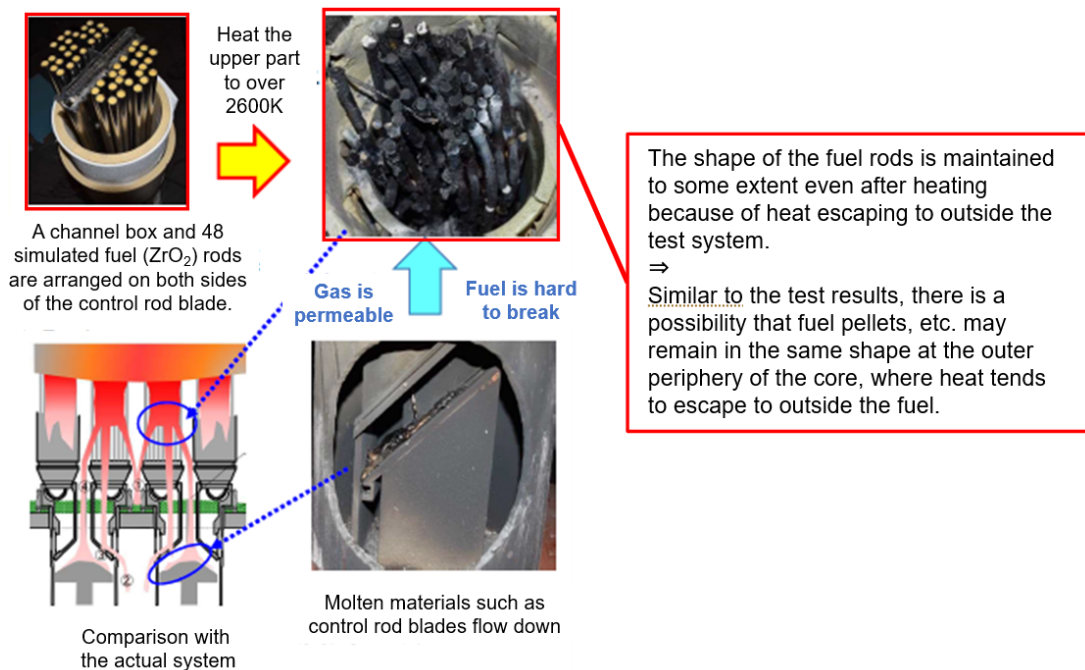
Figure 4.7.3-3 Simulated fuel assembly failure test ^[3-3]

In the "Advancement of comprehensive assessment of internal reactor status" project funded by the subsidy for decommissioning and contaminated water measures, a test specimen with channel boxes and simulated fuel (ZrO_2) on both sides of a control rod blade was heated by a plasma torch (Figure 4.7.3-3); the purpose was to obtain information on the behavior of fuel melting and migration to the bottom. As shown in Figure 4.7.3-3, the fuel rods maintained their shape to some extent even after heating. In Unit 3, there is no information (see Section 4.6.2) on the shape of the shroud being maintained as in Unit 2, but it is possible that the fuel was not fully melted in the area where the radiation heat transfer is large, such as the

outer periphery of the core, because the high temperature is not maintained, and the fuel may fall or remain in the shape of pellets.

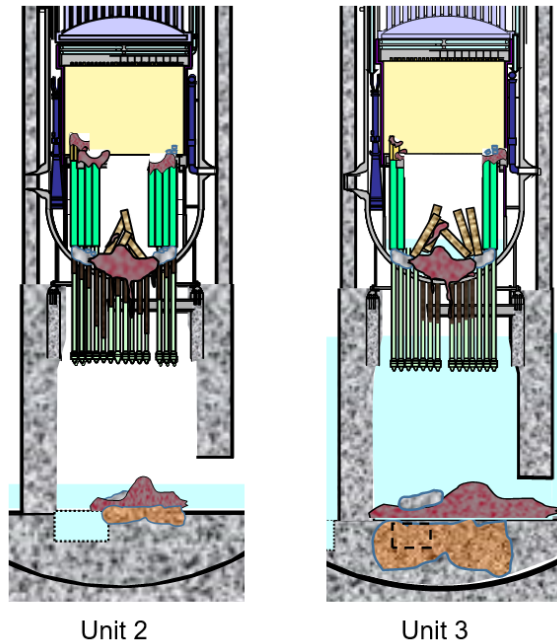
Figure 4.7.3-5 Comparison of the status of remaining structures in RPV (Units 2 and 3)

Based on the above, the number of structures remaining in the RPV in Unit 3 is considered to be smaller than in Unit 2, and the number of CRGTs in the outer periphery of the bottom of RPV is assumed to be smaller than in Unit 2 (Figure 4.7.3-5).

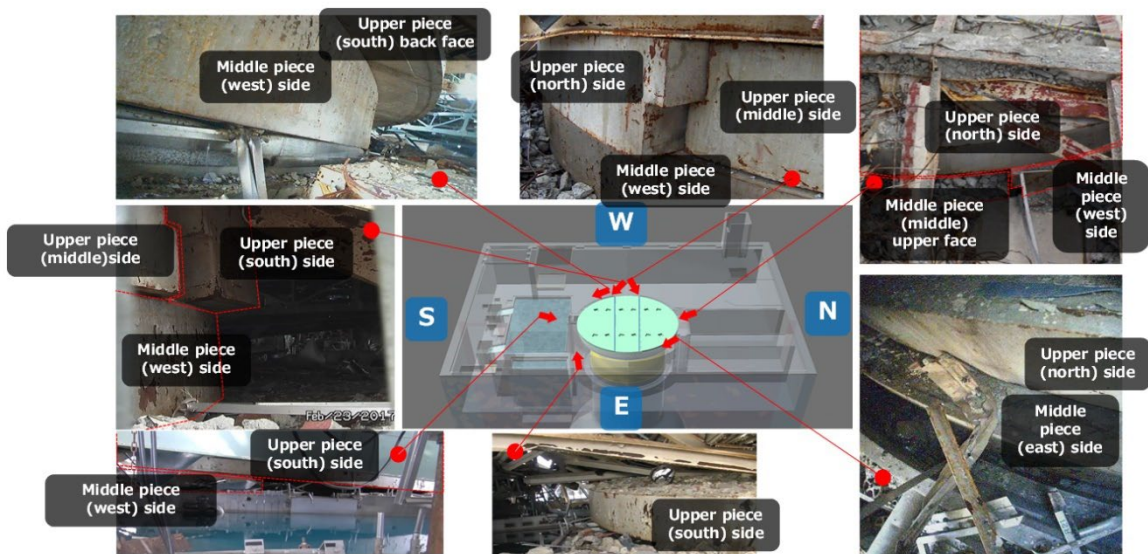
Figure 4.8.1-3 Results of confirming well-plug status on the operating floor^[1-19]

Figure 4.8.1-3 shows results confirming the status of the well-plug damage on the operating floor. Based on the analysis of the images acquired during the investigation, pieces of the well-plug were estimated to have been displaced as shown in Figure 4.8.1-4. As shown in Figure 4.8.1-5, the north side upper layer piece was observed to have moved 720mm to the west. It was also confirmed that the center piece of the upper layer moved a maximum of 155mm and the north side upper layer piece moved a maximum of 84mm downward.

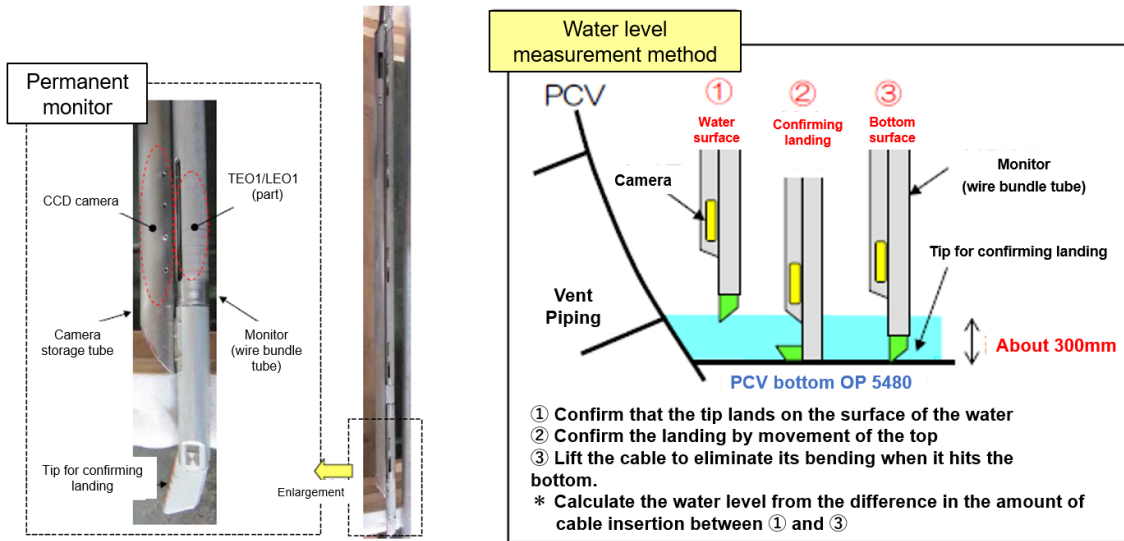
Figure 4.8.2-3 Results of PCV water level measurement during reinstallation of the monitoring instrument in Unit 2 PCV [2-20]

The water level was about 600mm above the D/W floor according to the video scope confirmation of the water level during the PCV internal investigation conducted in March 2012. Since the main purpose of this was to determine the rough location of the water surface, the level of the accumulated water was again confirmed during the installation of the monitoring instrument inside the PCV conducted in June 2014. The action of landing the instrument tip on the water and the position of the bottom of the tip were confirmed by a camera and the water level was measured from the difference in length of cable insertion, resulting in the confirmation that the water level was about 300mm above the D/W floor (Figures 4.8.2-3 and 4.8.2-4).

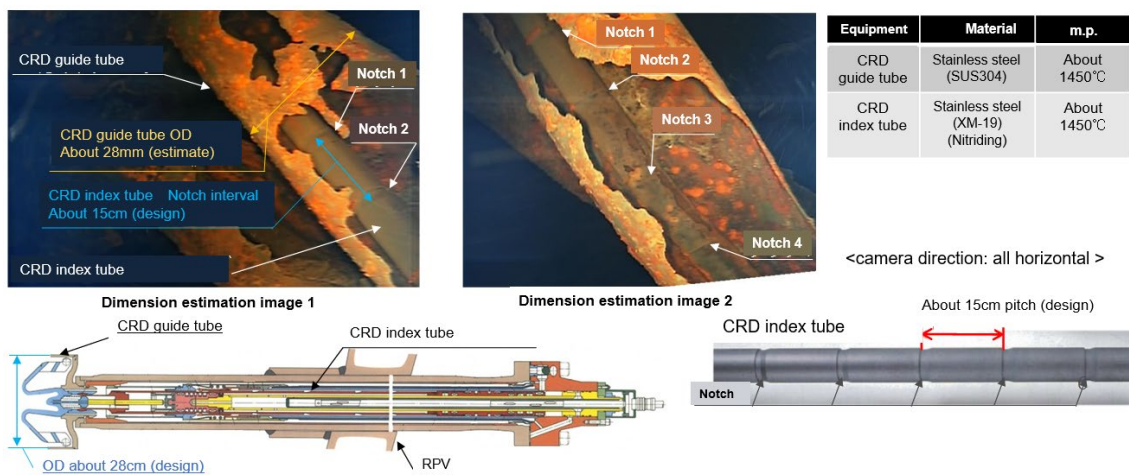
Figure 4.8.3-6 Comparison of the structure near the CRD housings and the CRGT structure [3-15]

As shown in Figure 4.8.3-5, in the image looking up at the bottom of RPV near the center, a cylindrical structure is observed, with a bar-shaped structure inside. Notches that appear to be at regular intervals can be seen on the bar-shaped structure. At the time of the accident, the CR was fully inserted, and the CRD index tube was in a state of containment within the CRGT. Based on these facts, the cylindrical structure is considered to be the CRGT, and the bar-shaped structure is considered to be the CRD index tube. Regarding the size, the outer diameter of the cylindrical structure was estimated from the image based on the fact that the notch interval of the CRD index tube is about 15cm, and the estimated value was about 28cm, which is roughly consistent with the design value of the CRGT outer diameter of about 28cm. Figure 4.8.3-6 shows a comparison of the cylindrical structure and the CRGT structure.

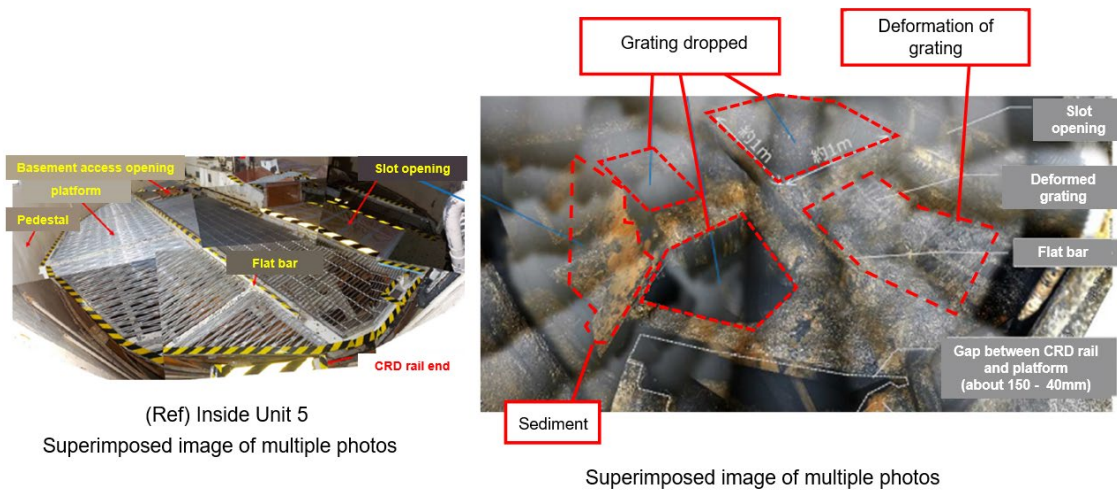
Figure 4.8.3-9 Photos taken near the platform during Unit 2 PCV internal investigation [3-17]

Figure 4.8.3-9 shows images obtained from the Unit 2 PCV internal investigation conducted in January and February 2017, looking into the inside of the pedestal from the pedestal opening leading from the CRD rail, where the workspace called the platform is laid out. Although some of the grating was deformed or fell down, some of the grating near the CRD rail had not collapsed and was still in its original position. Figure 4.8.3-10 shows a photograph of the area near the platform in Unit 3; the grating in a similar location in Unit 3 has collapsed and part of the platform has also collapsed. Around the CRD flanges in Unit 3 more damage was seen than in Unit 2. This damaged status suggests that more fuel debris fell into the Unit 3 PCV than into the Unit 2 PCV, and the information confirms the previous estimation.

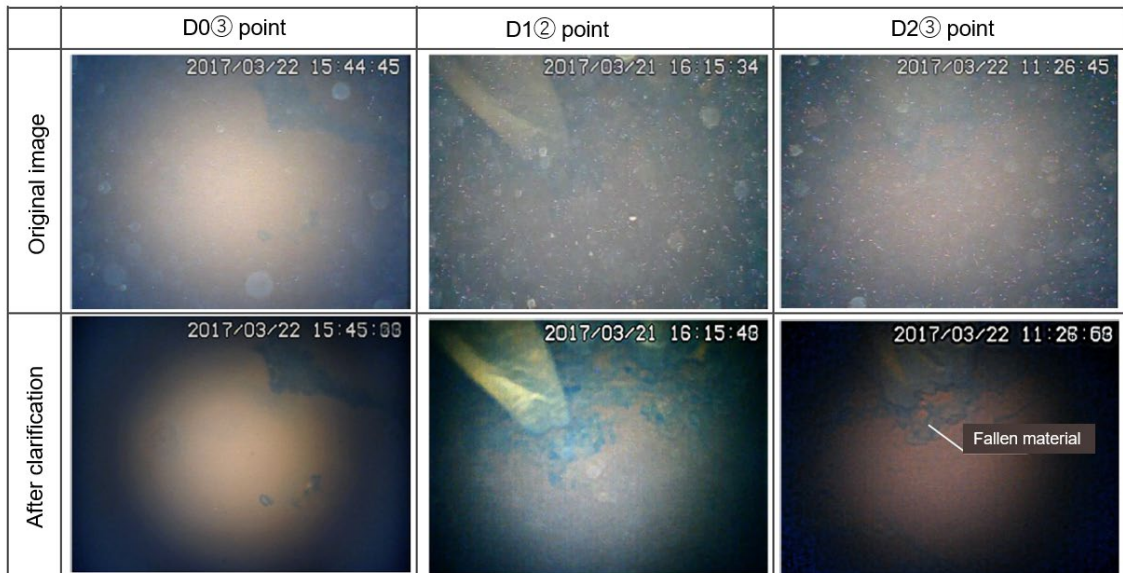
Figure 4.9.1-5 Images taken at the lowest point for each investigation point [1-21]

The investigation robot was deployed from the X-100B penetration to investigate the D/W floor from March 18 to March 22, 2017. Figure 4.9.1-4 shows the measurement points and Figure 4.9.1-5 shows the image taken at the lowest point at each investigation point. The deposits identified during the October 11, 2015 investigation when the CCD camera was inserted from the X-100B penetration were again identified near the floor drain sump, located on the opposite side to the pedestal opening. Similar matter was also observed near the pedestal opening. Figure 4.9.1-6 shows the estimation for the sediment deposit surface height at each investigation point. The surface height was about 0.3m on the opposite side of the pedestal opening, but the maximum surface height of about 1.0m was observed near the PLR piping near the pedestal opening.

- Data other than D0 ② points were also clarified.
- A new fallen material was confirmed at the D2 ③ point, but no new information was obtained at the D0 and D1 points.

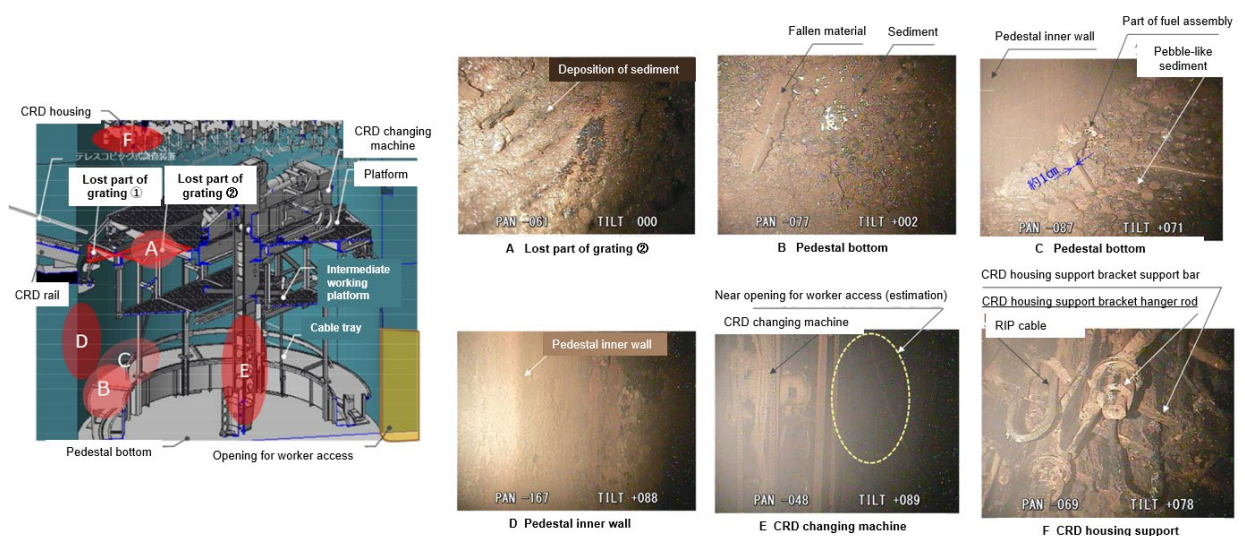
Figure 4.9.2-5 Images of the inside of the pedestal of Unit 2 (3/3) [2-23]

Images obtained during the PCV internal investigation conducted in January 2018 using a guide pipe and telescopic survey equipment (Figures 4.9.2-4 and 4.9.2-5) showed that the upper tie plate of the fuel assembly had fallen to the floor inside the pedestal. If the fuel debris also fell through the hole through which the upper tie plate fell, the material near the upper tie plate that fell to the floor in the pedestal is considered to be fuel debris. Dose rate and temperature measurements were also taken during the same investigation in January 2018. The measurement results are shown in Figure 4.9.2-6. The results showed that there was almost no change in the dose rate and temperature status from the inner pedestal floor to the platform, and that the values were relatively small (dose, 7 to 8Gy/h; temperature, 21.0°C). In other words, the contribution of the dose from the fuel debris dropped on the floor in the pedestal or as a heat source is considered to be small. There was no noticeable damage to the cable tray or other structures in the pedestal, and the deposits were spread over the entire floor of the pedestal, although some local extremities were observed in the deposit heights. This suggests that the fuel debris fell while at a low temperature and a certain degree of fluidity. In addition, most of the fuel debris in the

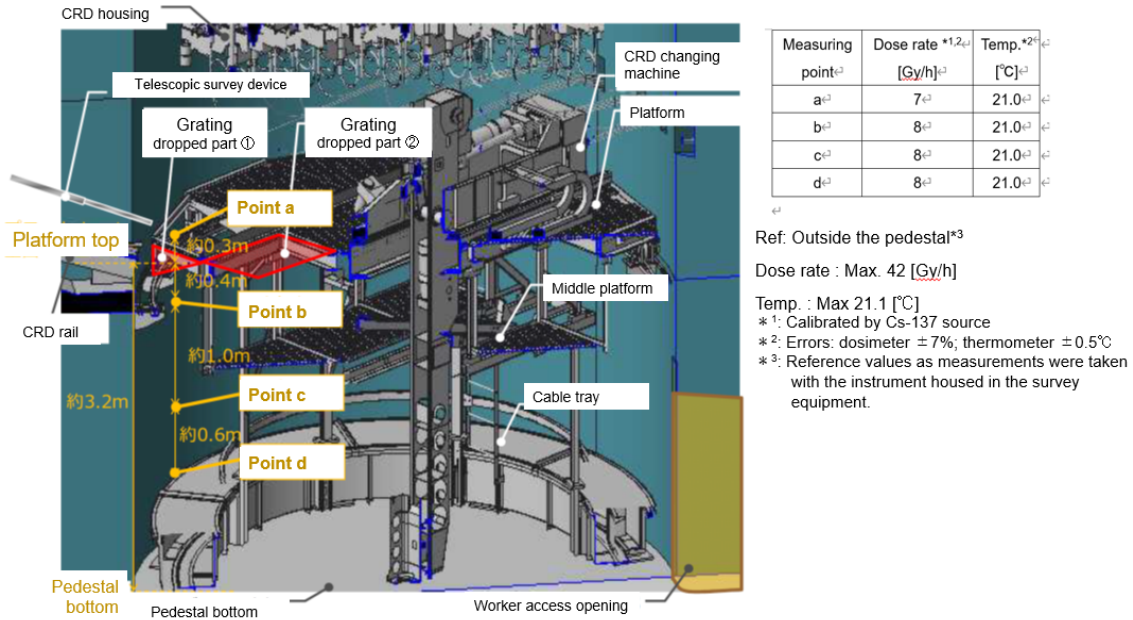
Figure 4.9.2-6 Results of dose rate and temperature measurements inside the pedestal of Unit 2 [2-21]

pedestal is exposed but cooled, suggesting that the decay heat may be relatively low. The fuel debris deposited on the floor of the pedestal may contain a large amount of metal and have a low melting point.

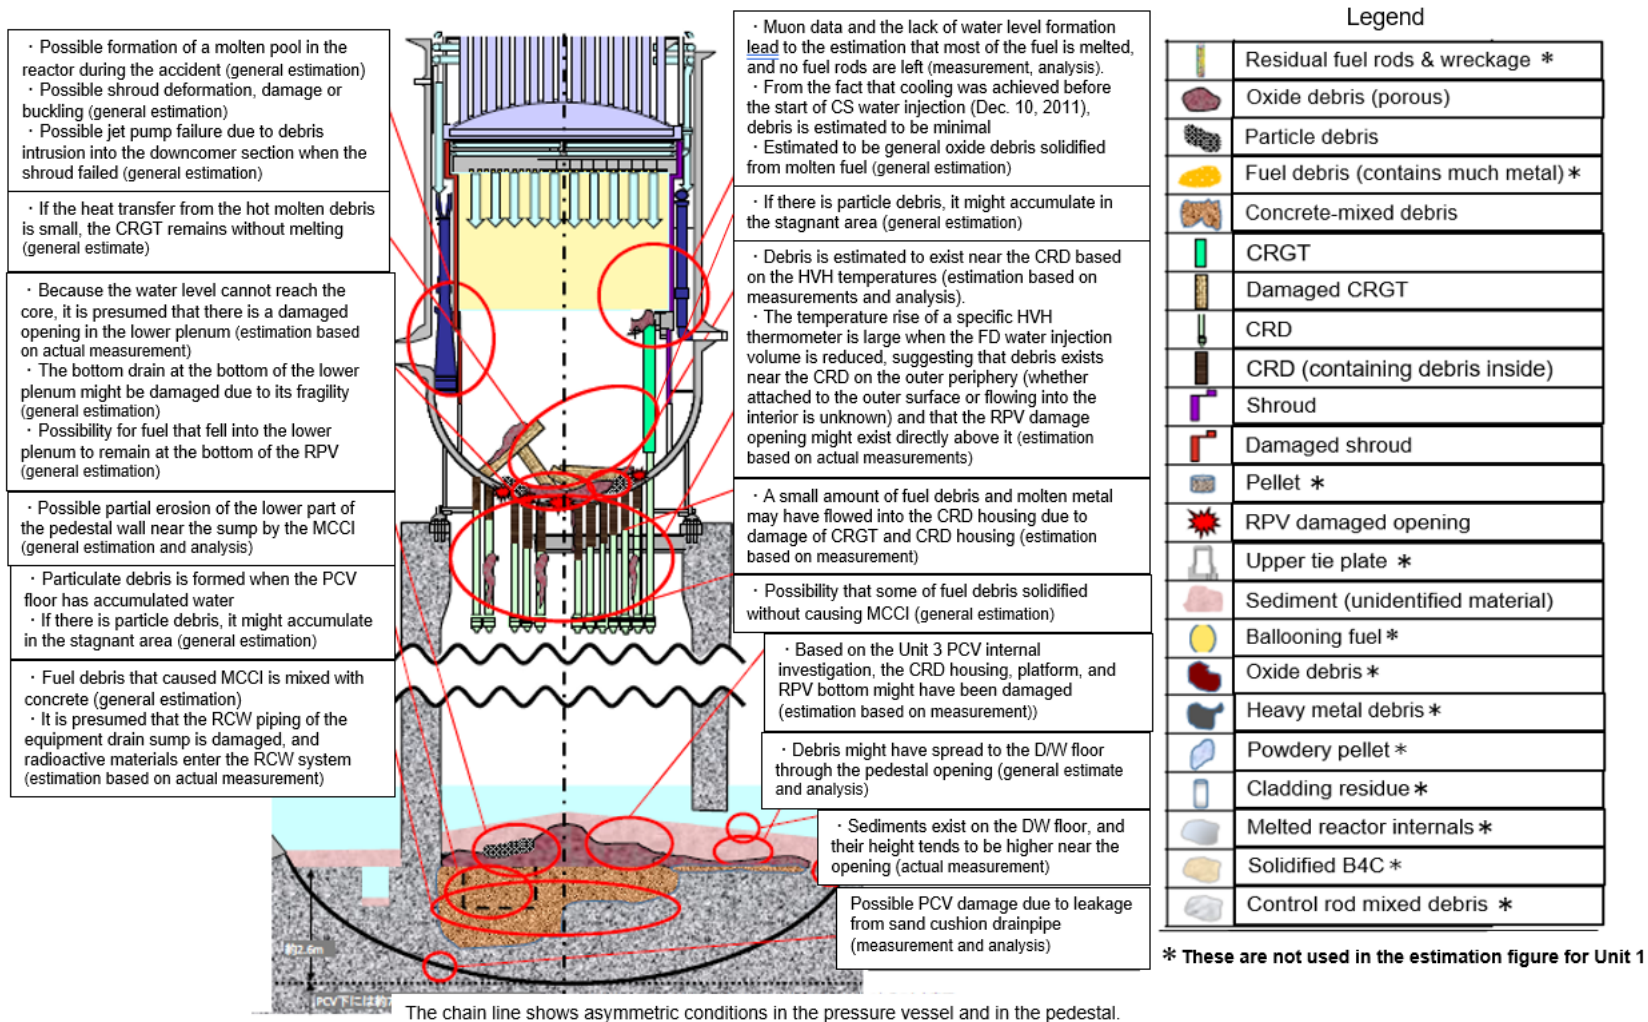
Figure 4.10.1-2 Unit 1 estimation figure as of September 2018 (enlarged) [1-22]

Regarding the status of the structures in the RPV and PCV, it is estimated that the CRGTs at the bottom of RPV were damaged by the process of fuel melting and falling, and fuel debris has penetrated into the CRD housings under the RPV.

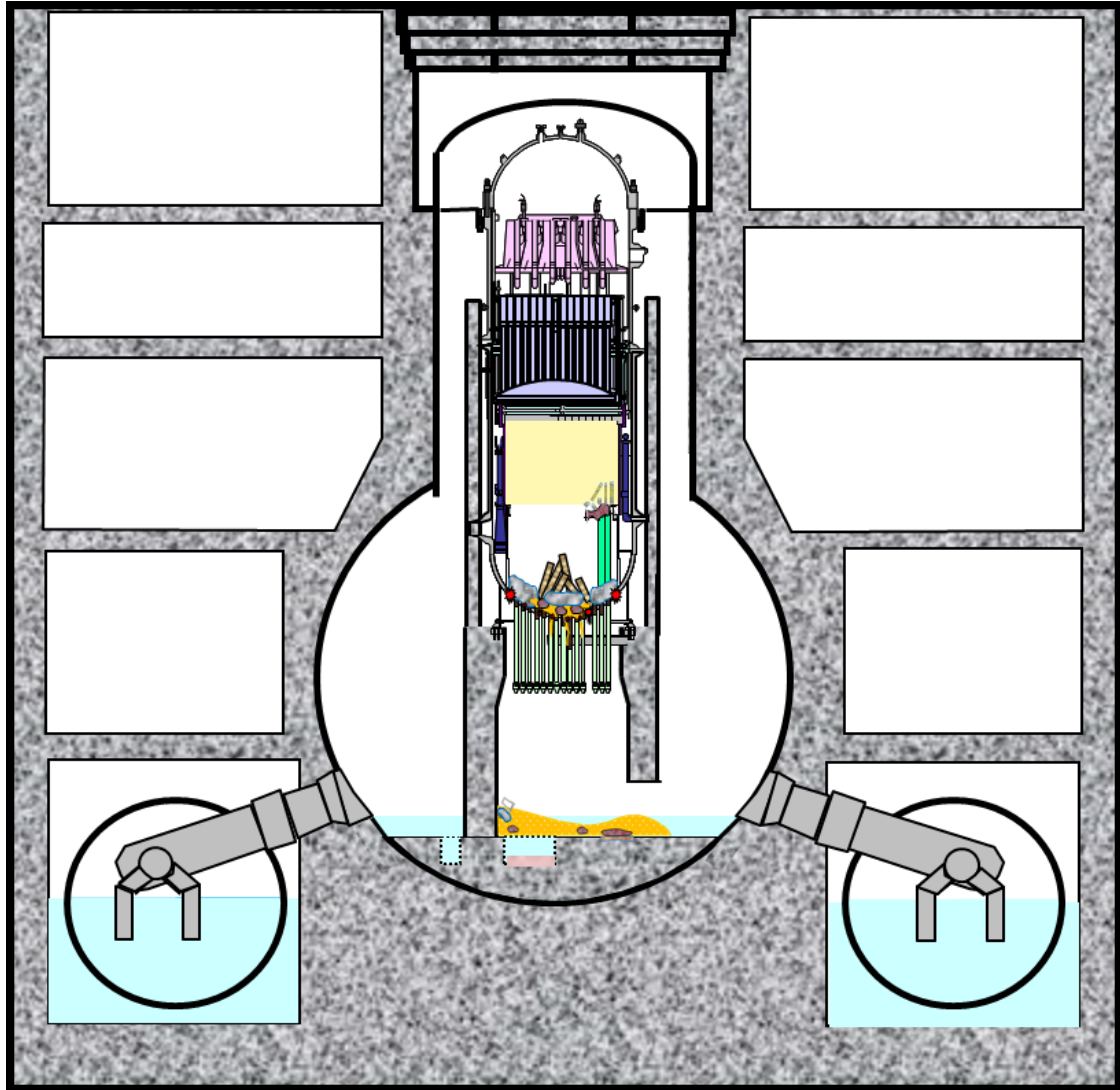
Figure 4.10.2-1 Unit 2 estimation as of September 2018 [2-24]

Regarding the status of the structures in the RPV and PCV, it is estimated that the CRGTs at the bottom of the RPV were damaged by the process of falling molten fuel, and that fuel debris has penetrated into the CRD housings under the RPV.

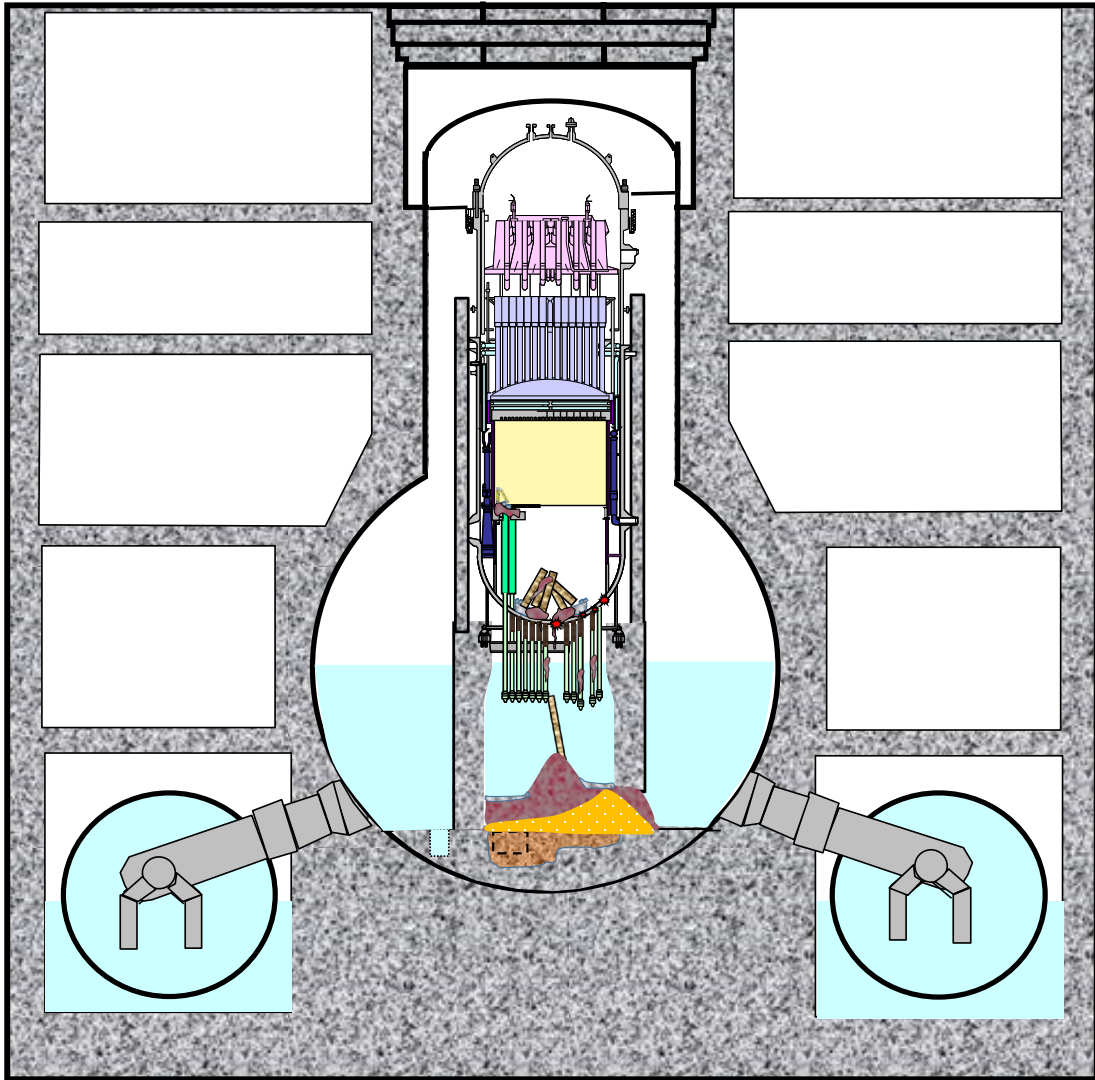
Figure 4.10.3-1 Unit 3 estimation as of September 2018^[3-18]

Regarding the status of the structures in the RPV and PCV, it is estimated that the CRGTs at the bottom of the RPV were damaged by the fuel melting and falling down, and that fuel debris has penetrated into the CRD housings under the RPV.

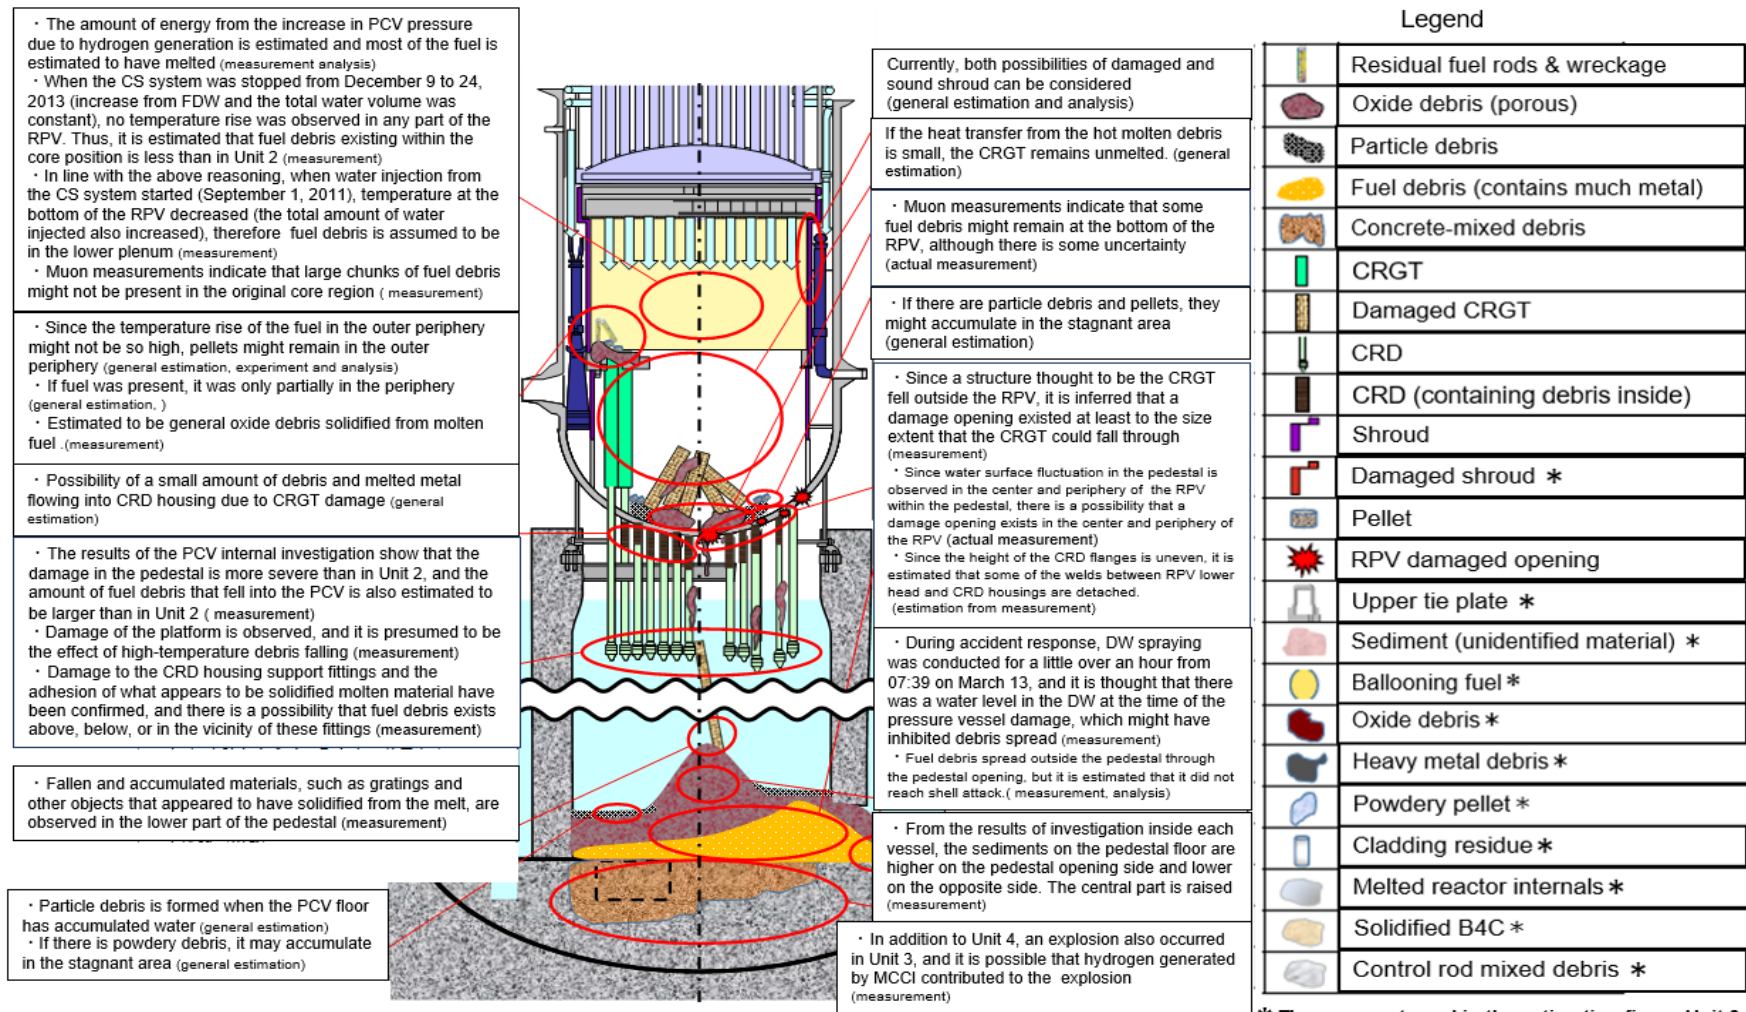
Figure 4.10.3-2 Unit 3 estimation figure as of September 2018 (enlarged) [3-18]

- ① Updated status of damaged CRGTs that fell into the PCV.
- ② Updated distribution of fuel debris deposited at the bottom of the PCV.
- ③ Updated location of CRGTs remaining in the RPV, and the location where the damage to the CRD housings is described.

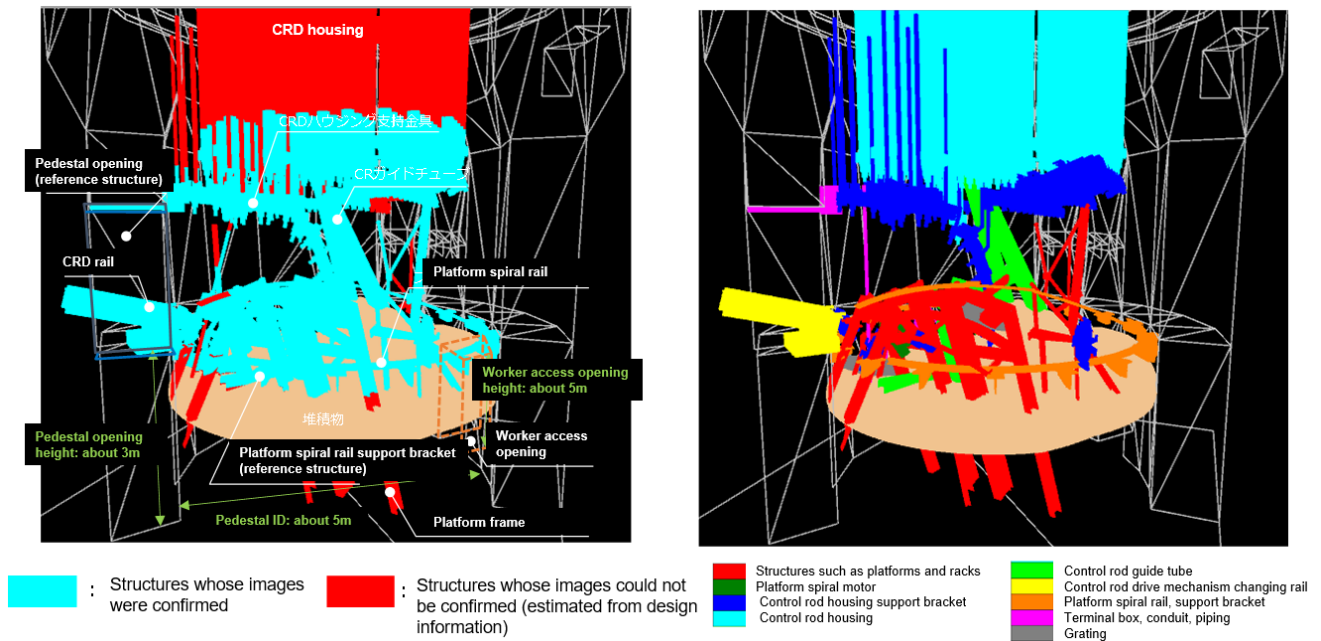
Figure 4.10.3-3 3D reconstructed image of the inside of PCV [3-19]

Figure 4.10.3-3 shows a 3D reconstructed image of the video obtained from the PCV internal investigation conducted in July 2017. In the left figure, the light blue areas are the structures actually identified, and the right figure depicts each structure in a different color. In the right figure, the yellow-green structure standing near the center indicates an object that is thought to be a CRGT, which fell from the center of the RPV and is leaning against CRD housings. This status is represented in the estimation figure.

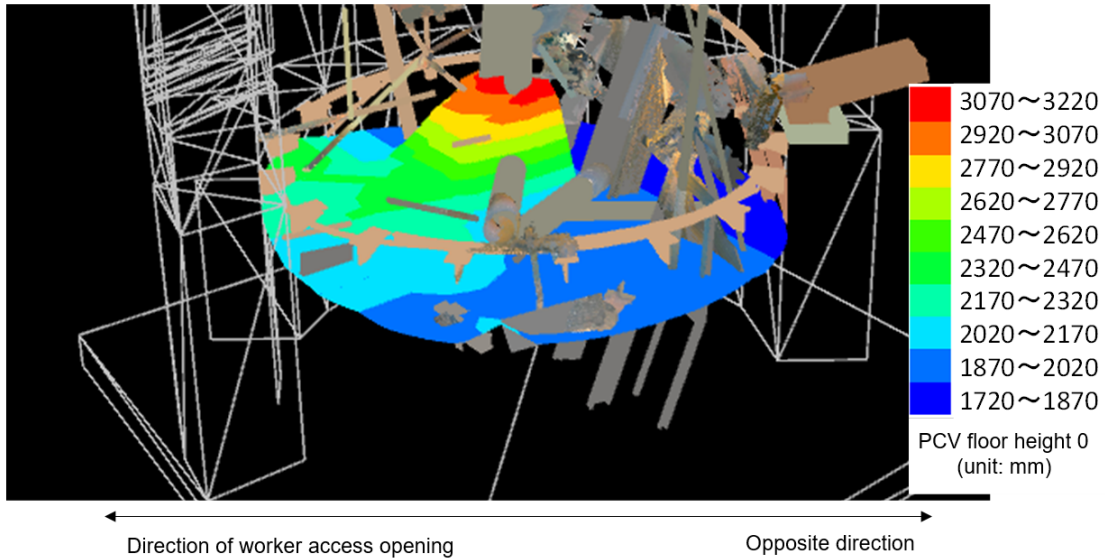
Figure 4.10.3-4 Sediment deposits at the bottom of the PCV [3-3]

The processed 3D reconstruction of the height distribution of sediments at the bottom of the PCV is shown in Figure 4.10.3-4. The greatest height was near the center, and was about 3m from the floor of the PCV. Regarding the height on the inner wall side of the pedestal, it was found that the sediment deposit height tended to be higher in the direction where the worker access opening was located than on the opposite side. This height is considered to be related to the location where the fuel debris fell from the RPV, i.e., the location of the hole at the bottom of the RPV. Therefore, it is assumed that there are damage openings in the RPV near the center and above the worker access opening.

The deposits that accumulated at the bottom of PCV in Unit 3 exceeds the volume of the total fuel, and it is possible that, in addition to fuel components, the deposits may contain melted and solidified metal structures of the RPV and PCV, as in Unit 2. Therefore, fuel debris containing a large amount of metal was depicted.

The height of sediment deposits near the worker access opening is higher than that on the opposite side of the pedestal inner wall, so the area was depicted as possibly containing more metal-rich fuel debris than on the other side of the pedestal.

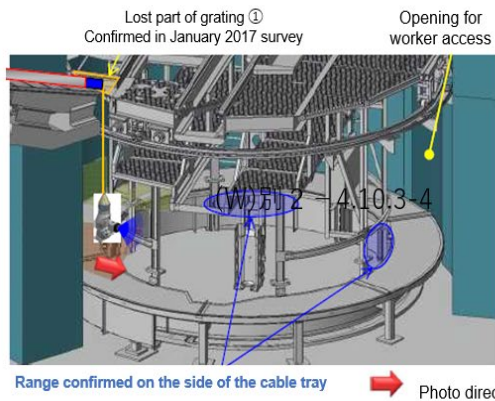
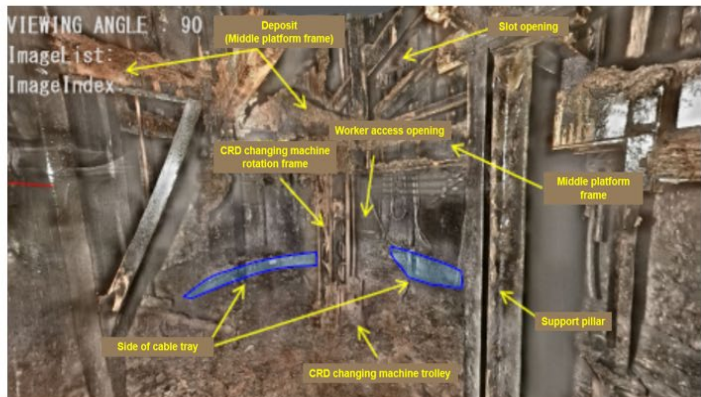
Figure 4.10.3-5 Results of the PCV internal investigation at Unit 2 [3-20]

Figure 4.10.3-5 also shows the results of the Unit 2 PCV internal investigation conducted in January and February 2018. As described in Section 4.9.2, although deposits were found to be spread over the entire floor of the PCV, there was no noticeable damage to the cable tray at the bottom of PCV or structures such as pillars, and the deposits are considered to contain little high-temperature fuel components and a large amount of metals.

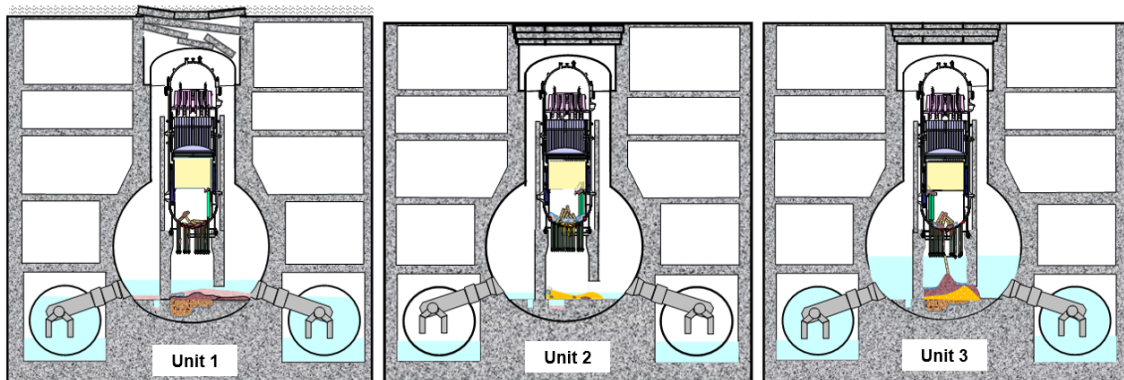
Figure 5.1 Summary of estimation for Units 1-3 [3-3]

Distribution of fuel debris			Water level in containment vessel	
	Core	Pressure vessel bottom	Containment vessel	D/W water level*	SC water level
Unit 1	Almost none	Almost none	Almost all	About 2m	Almost full
Unit 2	Little	A lot	Little	About 0.3m	Middle
Unit 3	Less than U 2	Less than U 2	More than U 2	About 5m	Full

* Water level as of January 2021 (Due to an earthquake on February 13, 2021, the water level in containment vessels (dry wells) of Units 1 and 3 changed.)
