## Construction to Return J Village and the Naraha Municipal Parking Lot to their Original Condition, and Dose Reduction Measures

## Restoration and decontamination work at Naraha town-managed parking lot

# Restoration work at J-Village and its surrounding areas

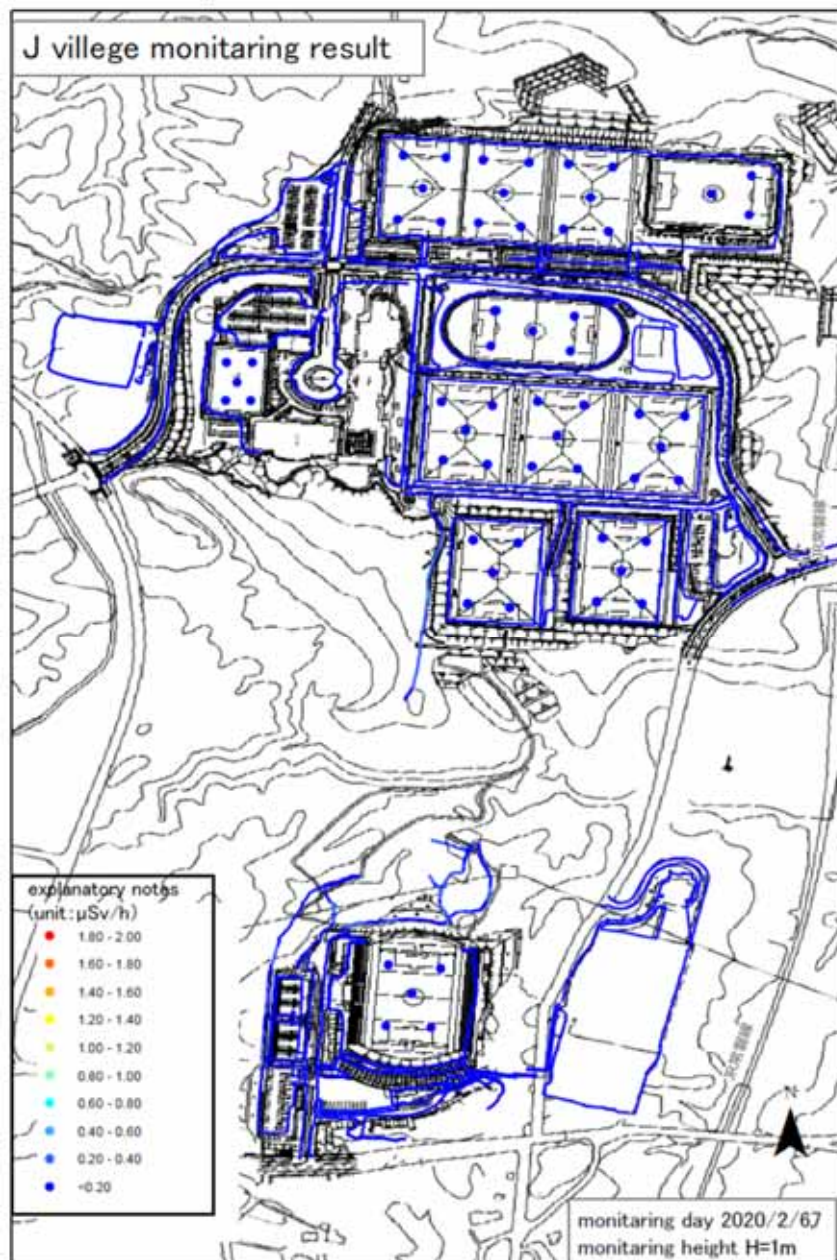
## Air dose rate before/after decontamination (soil replacement, crushed stones)

\*4 Minimum value - Maximum value (average)

\* Reference:  $3.8 \mu\text{Sv/h}$ : Standard of the air dose rate to lift the evacuation order (annual exposure dose is 20 mSv or less)
