# Unit 2 Spent Fuel Pool Internal Investigation Results

July 2, 2020

Tokyo Electric Power Company Holdings, Inc.

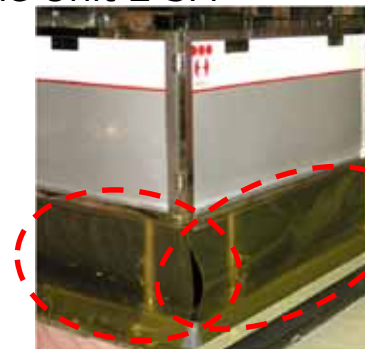
- The tarps that had been attached to railings around the SFP as part of foreign material exclusion measures cannot be found and correspond in thickness to the pieces of tarp found during this investigation, so it is assumed that some of these tarps fell into the SFP during the disaster.

Urethane tarps used for foreign material exclusion

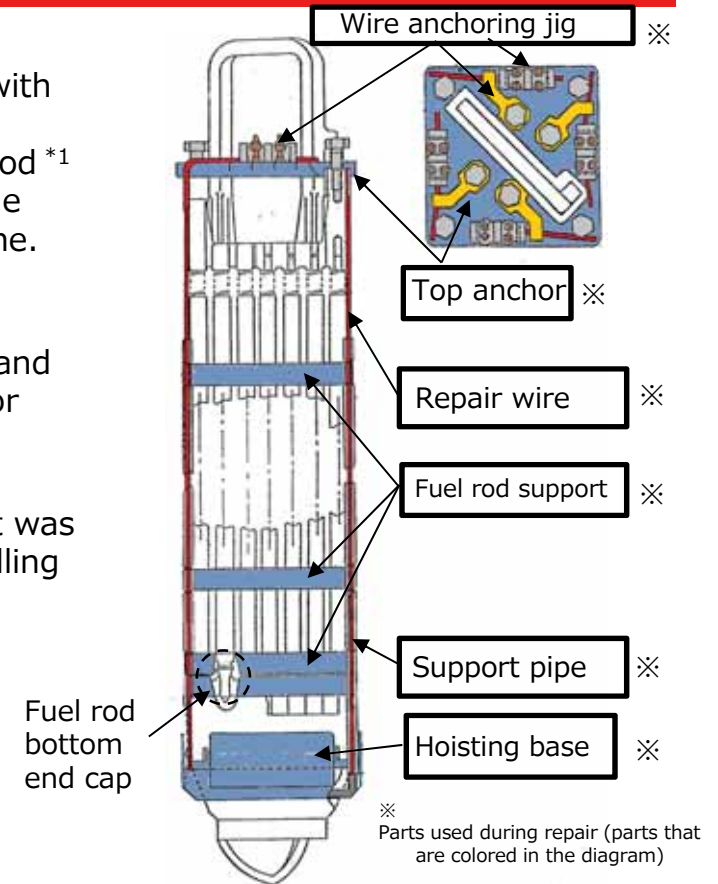
Diagram of wire-repaired fuel

- One of the fuel assemblies in the Unit 2 SFP is being held together with wire. In 1981, when this fuel assembly was being handled, it was dropped thereby damaging the bottom end cap<sup>\*2</sup> of a coupled fuel rod<sup>\*1</sup> and can therefore no longer be hoisted. It was repaired with wire the following year to enable it to be handled with a fuel handling machine. An external inspection of this fuel assembly has shown that the airtightness of the cladding tubes has not been affected.

- The top of this fuel assembly was checked during this investigation and within the scope that the submersible ROV could see, no cut wires or displaced anchoring jigs were found.

- How to handle this fuel assembly is to be deliberated in light of the results of corrosion tests currently being performed on the wire that was used to repair it. A hoisting test will also be performed prior to handling this fuel assembly to ensure that it can be hoisted.
