# Conditions at the Fukushima Daiichi Nuclear Power Station after the earthquake on March 20 (Continued report)

# Conditions after the earthquake (Continued report)

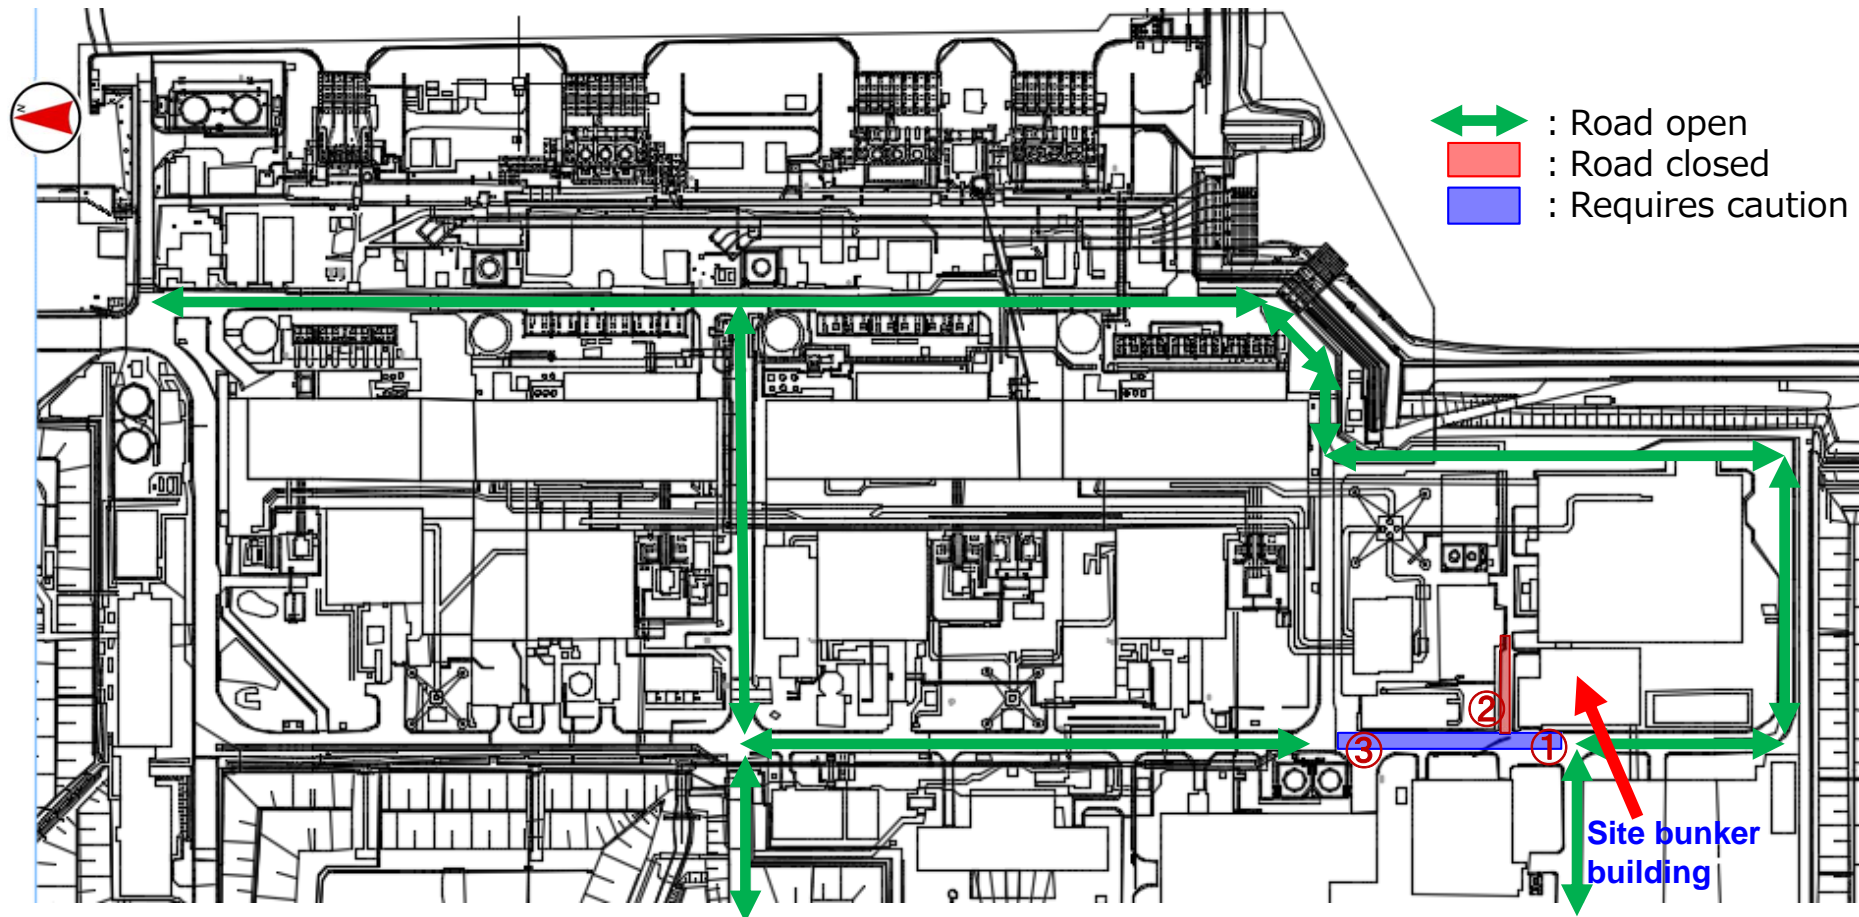
## Current road restrictions

- The following changes have been seen in conjunction with the earthquakes on February 13 and March 20, and rainfall thereafter.
- Rainfall has widened the hole underneath the steel plates in front of the site bunker building's large freight entrance, and will be repaired starting on March 29.
- Other locations will also be repaired after conducting a detailed examination of the conditions (at current time these conditions are not hindering decommissioning work)
