Status of Investigation into the Rise in
Temperature of Temperature Measuring Tube 150-
7S for the Land-Side Impermeable Wall (frozen-
soil wall)

November 25, 2021

Tokyo Electric Power Company
Holdings, Inc.

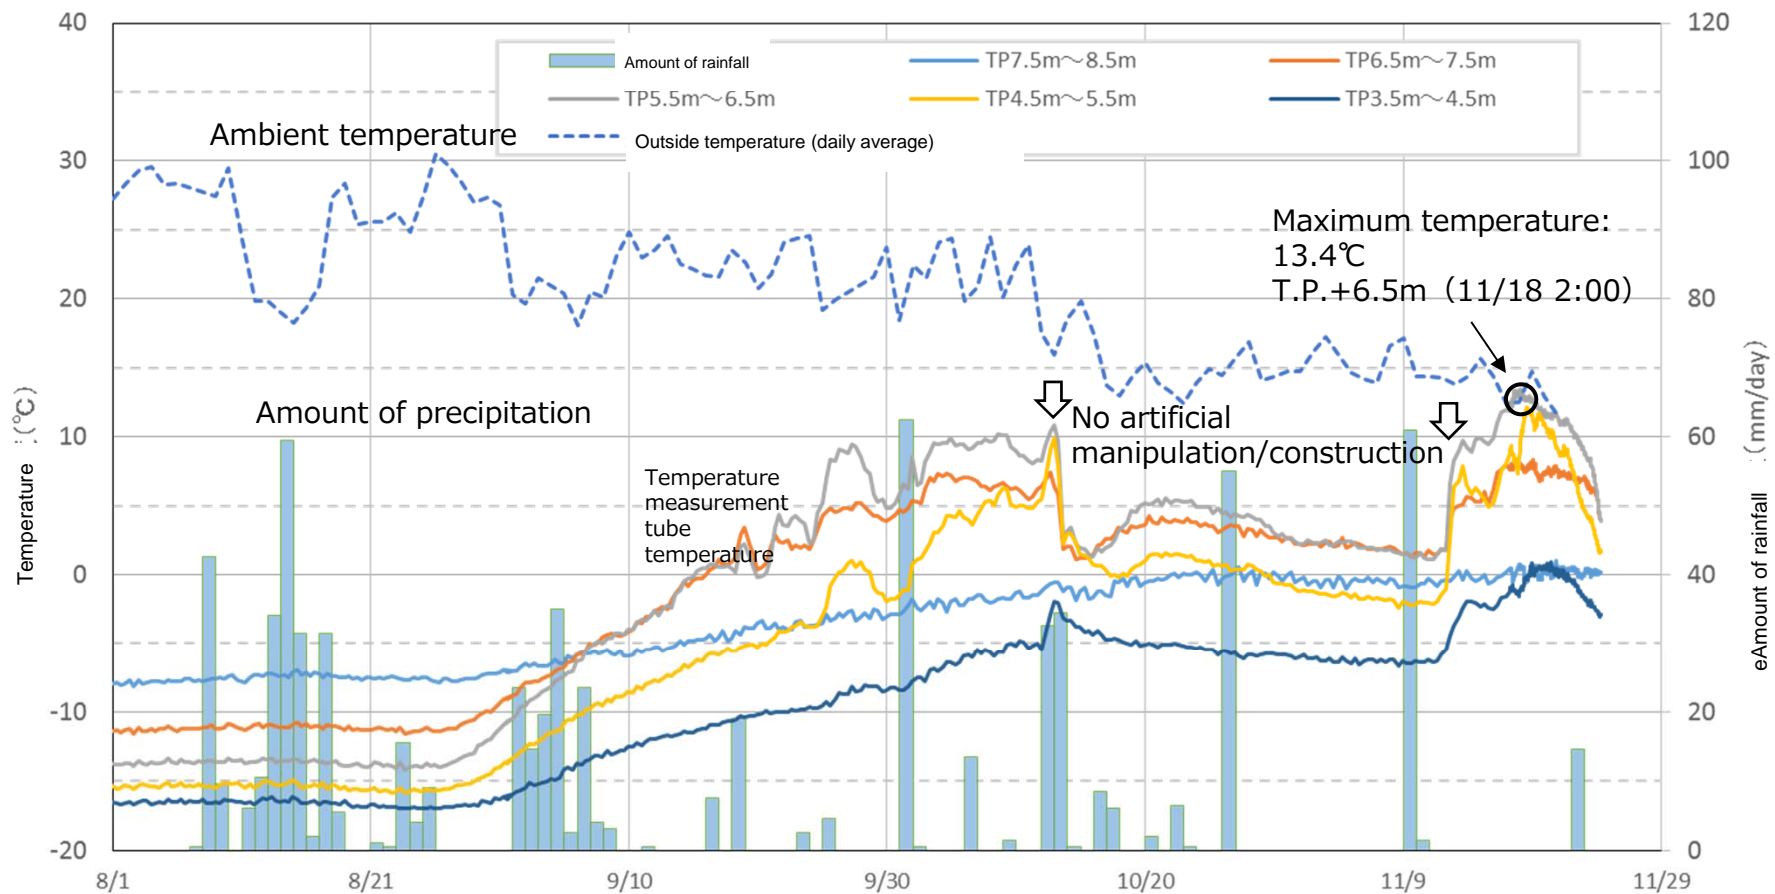
Changes over time in the temperatures measured by temperature measurement to 150-7S (as of 7 AM November 24)

- After the spike in subterranean ground temperature on November 12, the temperature continued to rise until the 18th, and then began to fall after the 19th.
- On November 13, a visual inspection was performed of excavated areas inside the land-side impermeable wall, the inside of drainage channel K, and the surface of the ground around temperature measurement tube 150-7S, but no abnormalities were found.
- Since there were no artificial activities or construction that could cause changes in the flow of groundwater during the period when there were great fluctuations in subterranean temperatures, it is assumed that changes to water pathways in the vicinity caused by rainfall led to the fluctuations in subterranean ground temperatures.

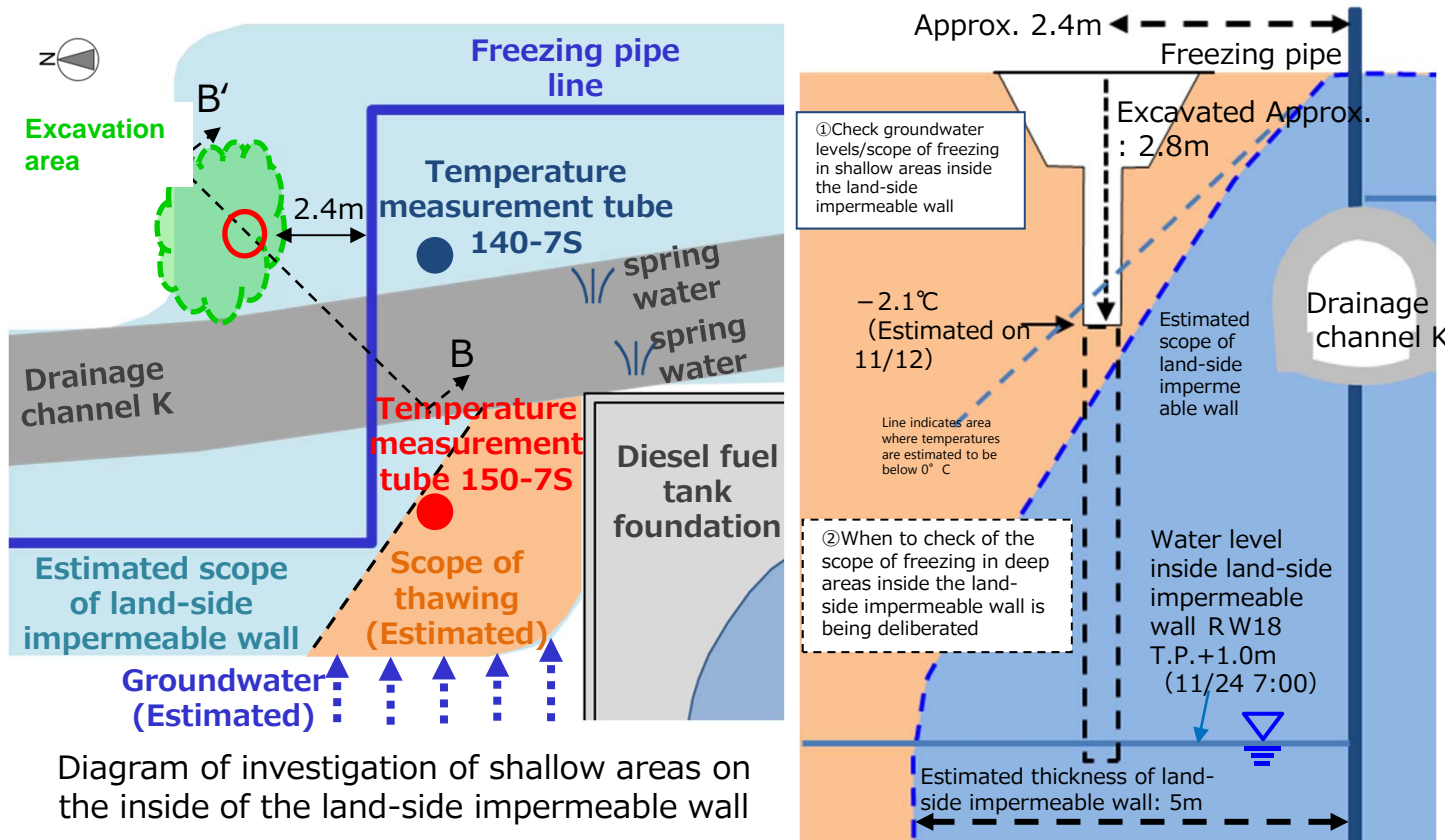
Diagram of investigation of shallow areas on the inside of the land-side impermeable wall

- No groundwater was found in the excavation area inside the land-side impermeable wall, so it was confirmed that water levels inside and outside the wall are being maintained.
- Subterranean temperatures deeper than around G.L.-2.70m were found to be below 0°C, and fixed point temperature readings confirmed that temperatures are being maintained below 0°C
- In light of the above, we believe that the land-side impermeable wall is functioning normally.

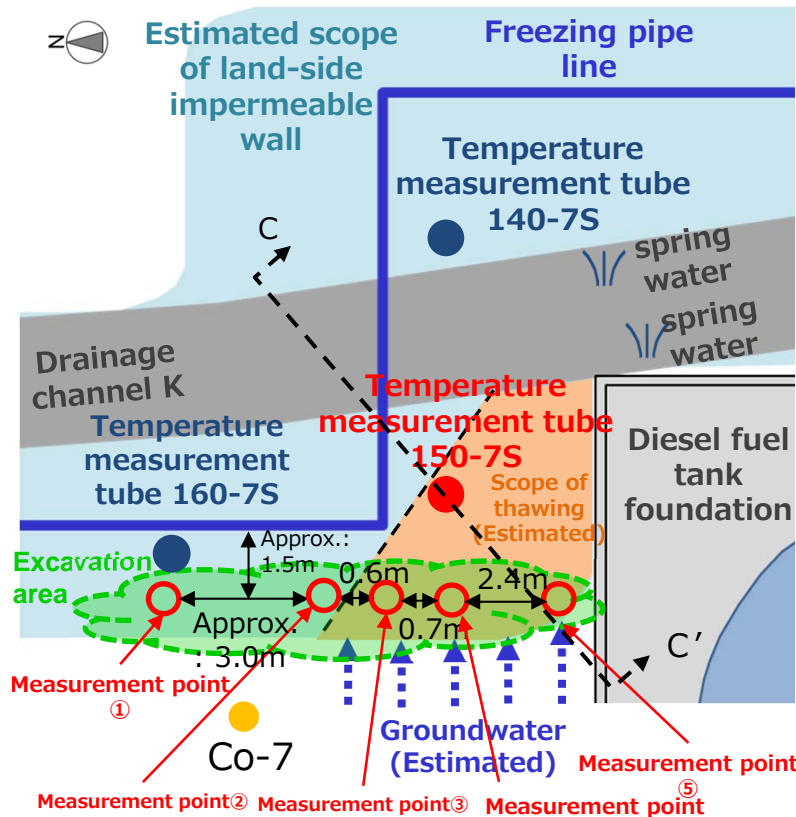
Diagram of investigation of shallow area outside of the land-side impermeable wall

- Measurement point①G.L.-1.30m found to be frozen (solid)
- Subterranean temperature at around Measurement point ②G.L.-1.50m Confirmed to be below 0°C
- Groundwater surface found at around Measurement points ③, ④, ⑤G.L.-2.50m
- The land-side impermeable wall is functioning around temperature measurement tube 160-7S, but some shallow areas outside of the land-side impermeable wall near the diesel fuel tank foundation are not frozen

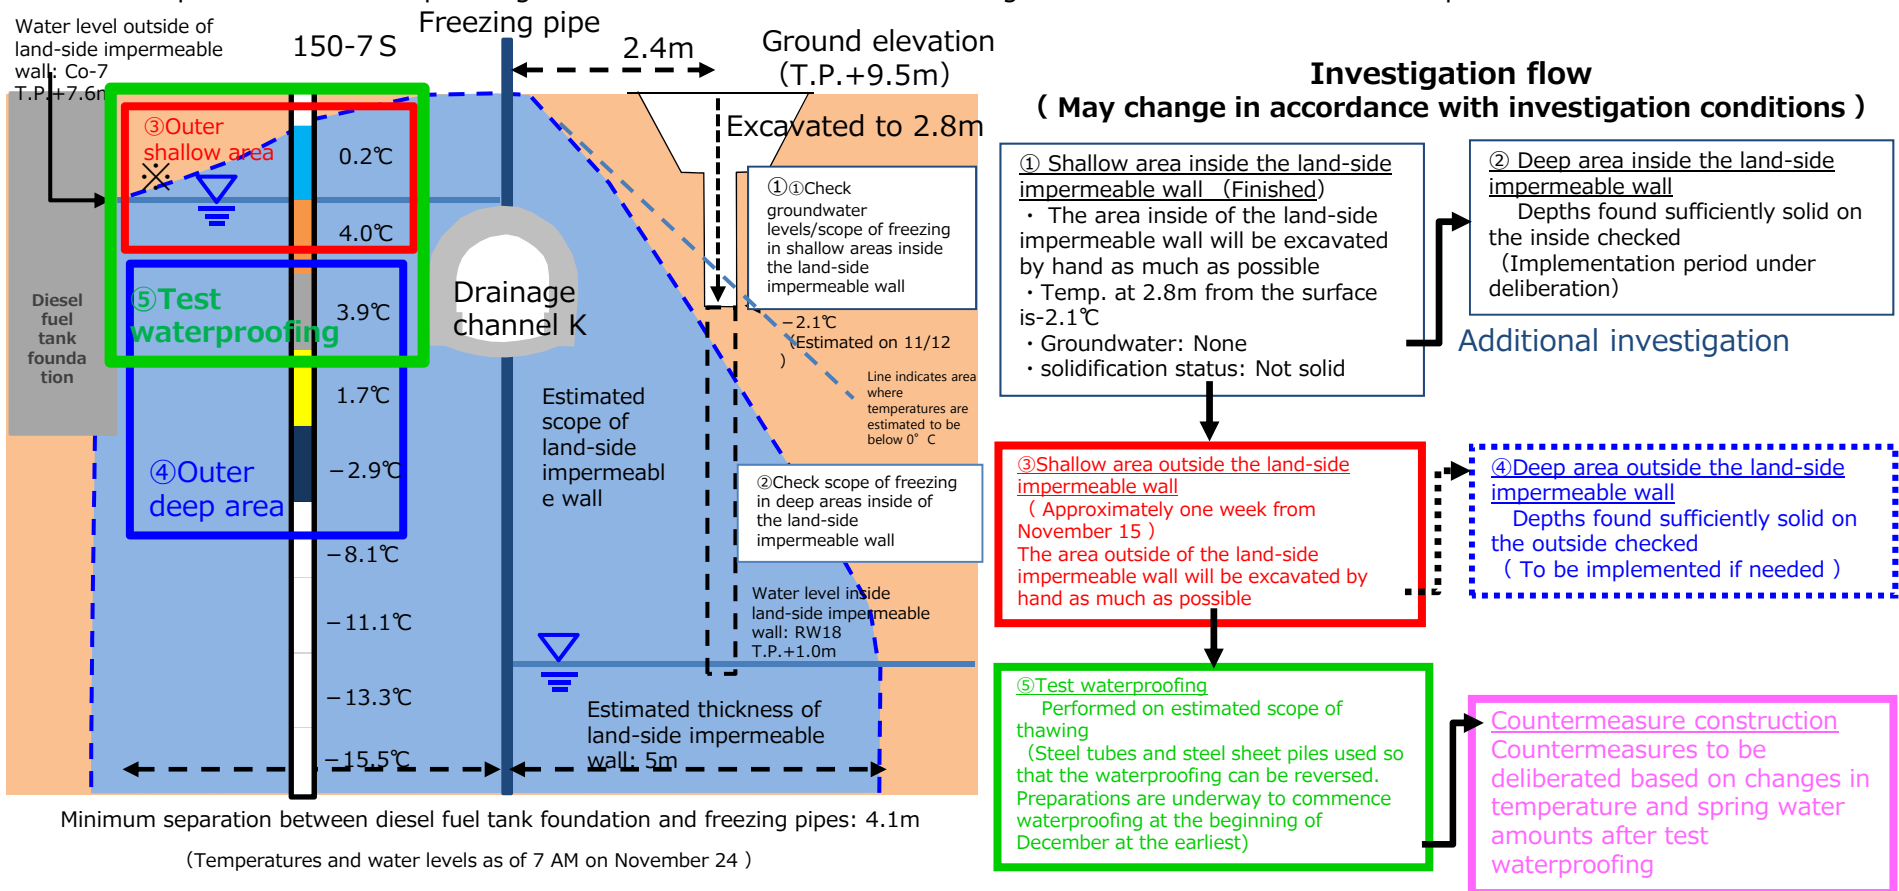
※ The area in the green box around 150-7 may have thawed, but readings from temperature measurement tubes in the vicinity indicate that the area around the land-side impermeable wall is below 0°C

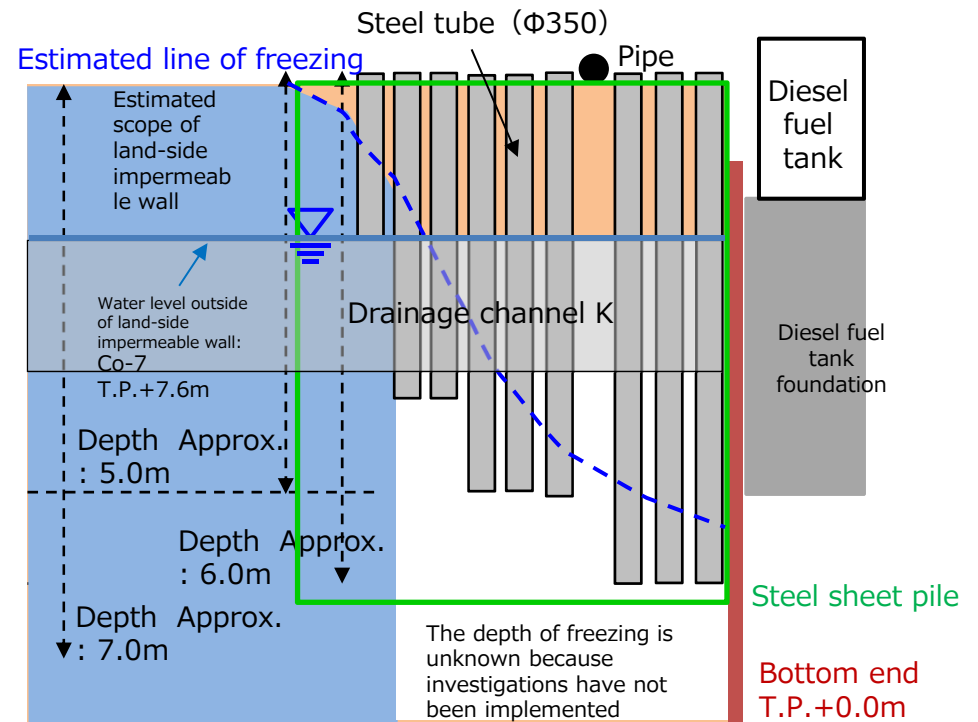
D-D' Cross-sectional diagram

* The depth of steel tube installation shall be adjusted in accordance with frozen conditions of the land-side impermeable wall. Penetration depth shall fundamentally be approximately 1 m from the freezer

- Steel tubes * will be installed on the west side of temperature measurement tube 150-7S from the diesel fuel tank foundation (estimated scope of following of the land-side impermeable wall) in order to quickly commence test waterproofing. After installation of the steel tubes, conditions, such as temperature readings from the temperature measurement tubes, etc., shall be watched, and if necessary steel sheet piles will be installed on the west side of the steel tubes for additional waterproofing.

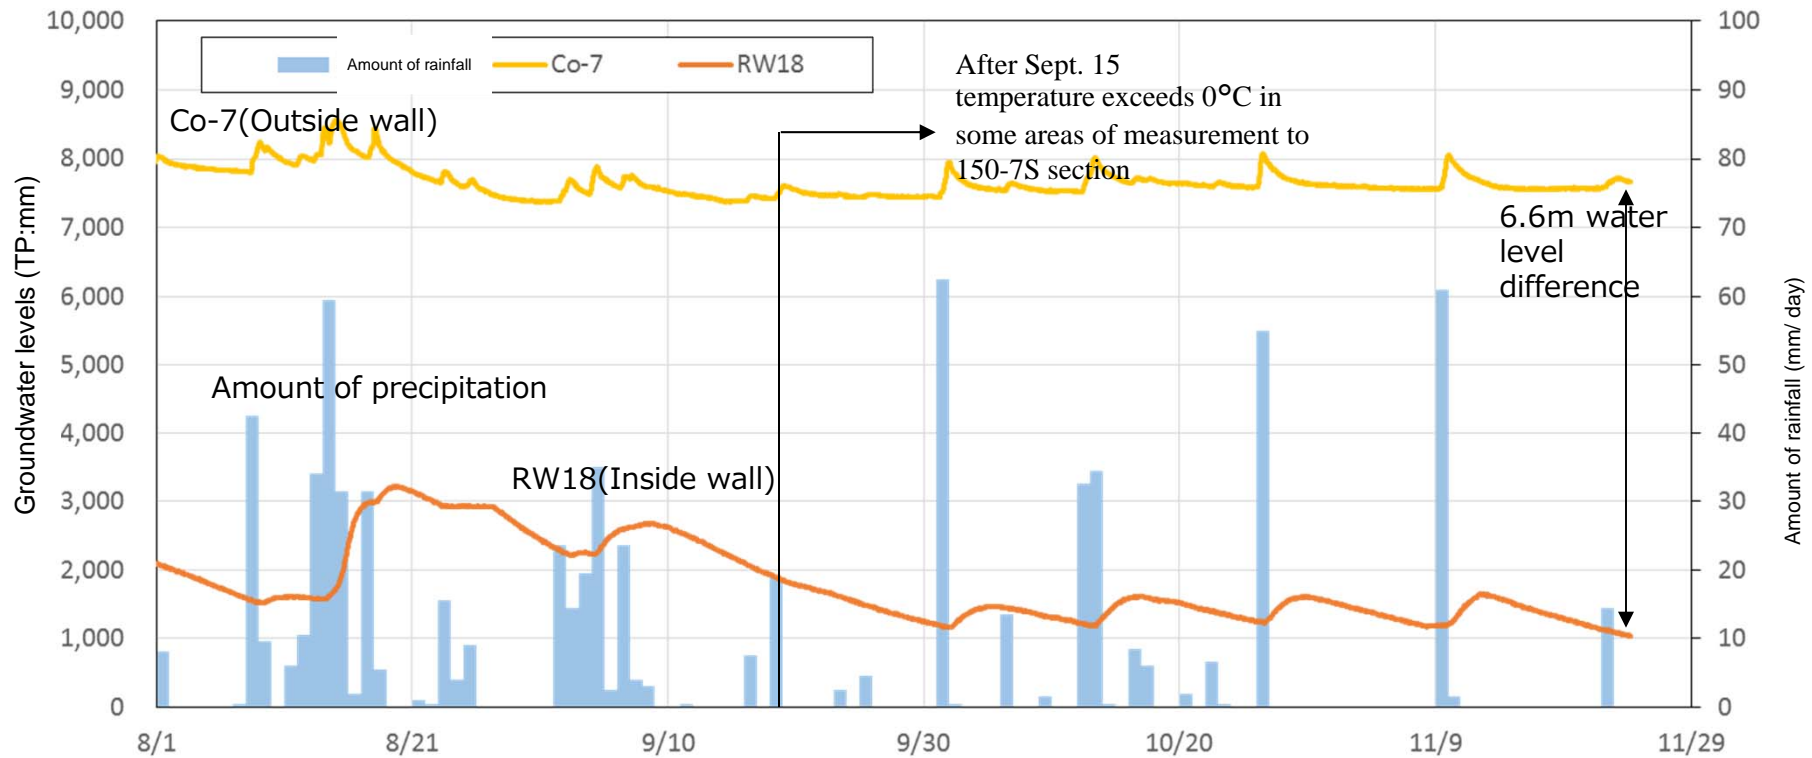
Changes in water levels inside/outside of the land-side impermeable wall over time (as of 7 AM, November 24)

- Water levels inside the land-side impermeable wall temporarily increase with rainfall and decrease as water is pumped up regardless of fluctuations in subterranean temperature.
- Water levels inside the land-side impermeable wall continue to decrease after September 15 even when some temperatures within section 4 temperature measurement tube 150-7S exceeded 0°C. As of November 24, a difference in water levels inside and outside the wall of 6.6m has been maintained, so it is our assessment that the overall impermeability of the land-side impermeable wall has remained intact.

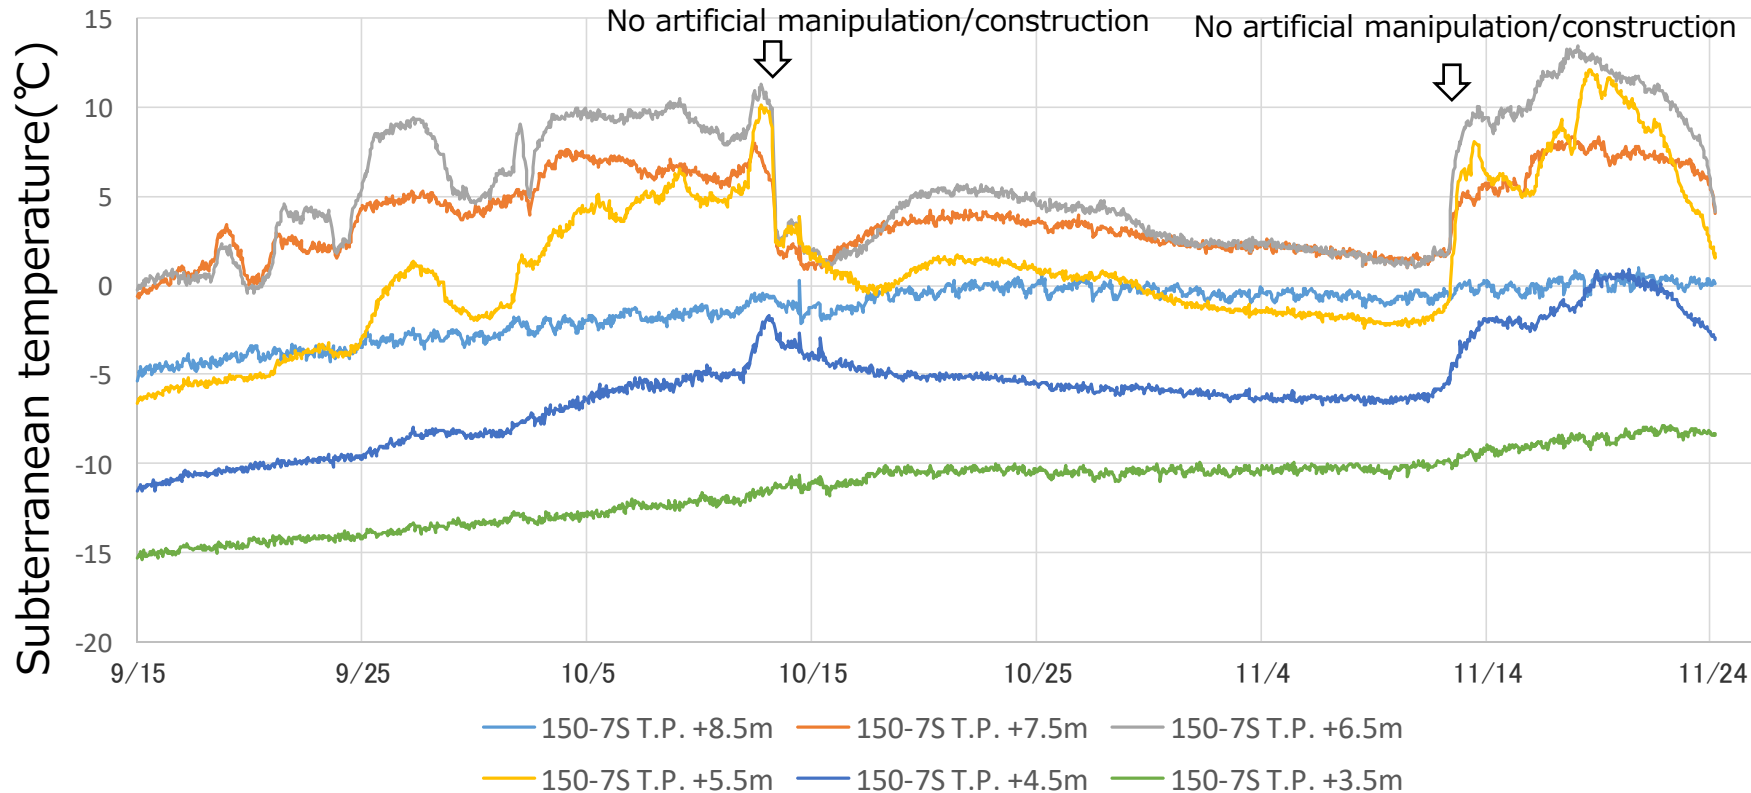
Changes over time for temperature measurement tube 150-7S (as of 7 AM, November 24)

- After spiking on November 12, subterranean temperature continued to rise until the 18th but is now either steady or decreasing.
- On November 13 a visual inspection was performed of excavated areas inside the land-side impermeable wall, the inside of drainage channel K, and the surface of the ground around temperature measurement tube 150-7S, but no abnormalities were found
- Since there were no artificial activities or construction that could cause changes in the flow of groundwater during the period when there were great fluctuations in subterranean temperatures, it is assumed that changes to water pathways in the vicinity caused by rainfall led to the fluctuations in subterranean ground temperatures.

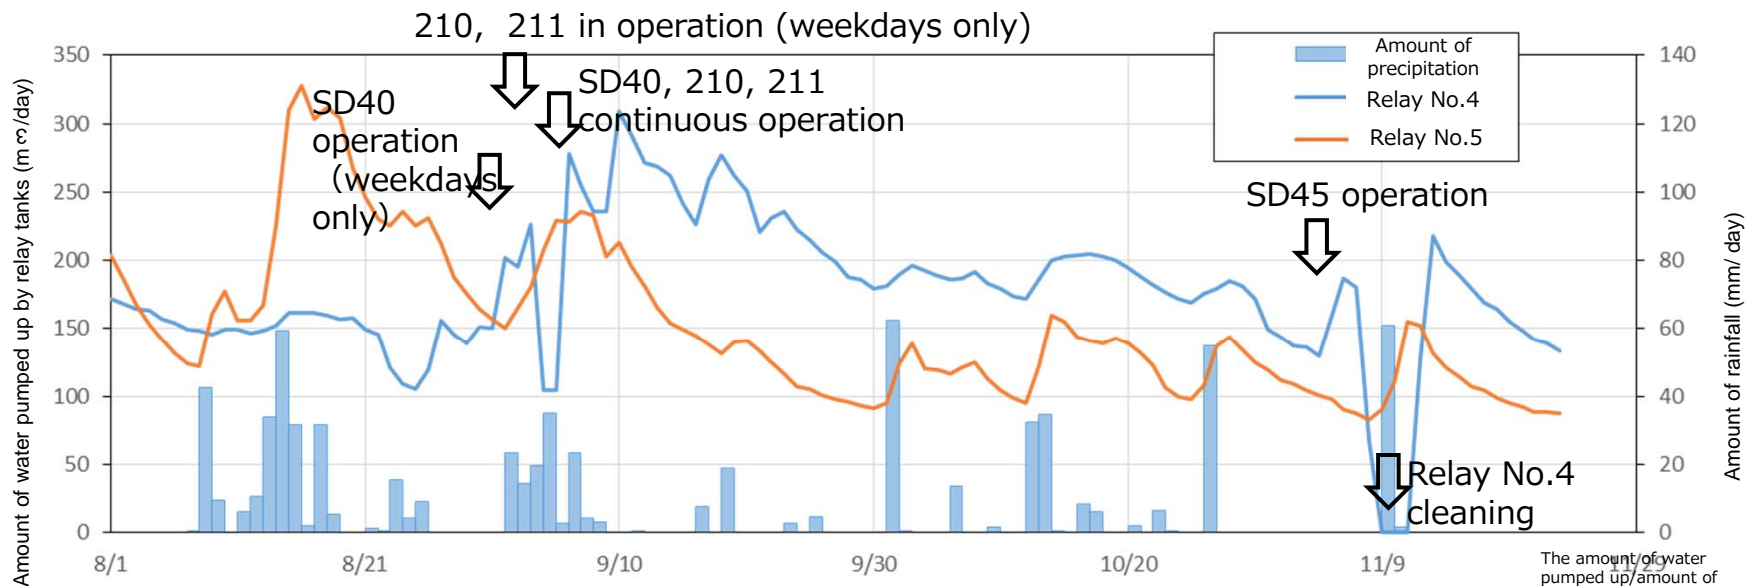
(Reference) The relationship between the amount of water pumped up by subdrains No. 4, No.5 relay tanks and the amount of precipitation

- The amount of water pumped up near the location where the temperature rise was observed fluctuates in accordance with the amount of precipitation and the operation of SD40, etc., however there is a gradual decrease as rainfall drops off.
- At this point in time it is not clear if the amount of water being pumped up is increasing in conjunction with the increase in temperature of temperature measurement tube 150-7S, so monitoring will continue
