# Implementation Status of the Fukushima Daiichi Nuclear Power Station Unit 1 Primary Containment Vessel Internal Investigation (As of February 10)

# Guide ring ④ installation and conditions to the east-northeast of the PCV (215°) (Photos taken from investigation on February 9)

# Conditions around the pedestal opening (From investigation on February 9)

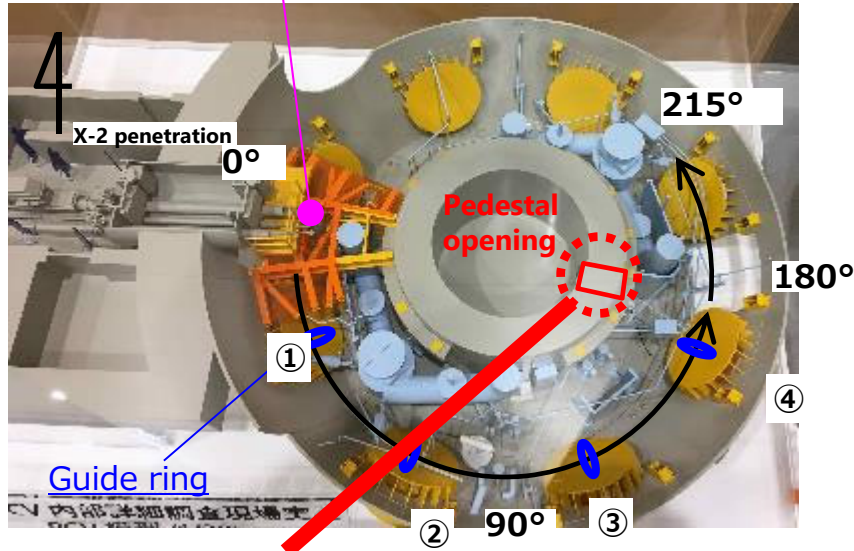
- 
- Conditions around the pedestal opening were also investigated. When the conditions in the area from around the opening to inside the pedestal opening were investigated, clumps of deposits were found, but it could not be determined if these deposits are core internals or fuel debris. Furthermore, objects that are thought to be rebar were also found around the opening. (Referred to slide 5)

Referred to slide 6 for arrow views of each photos

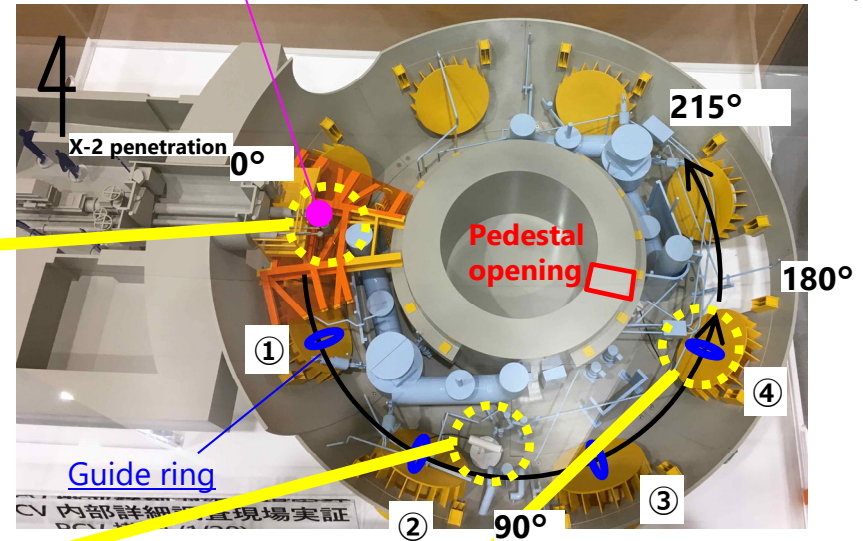
Floating matter on the surface of the water
